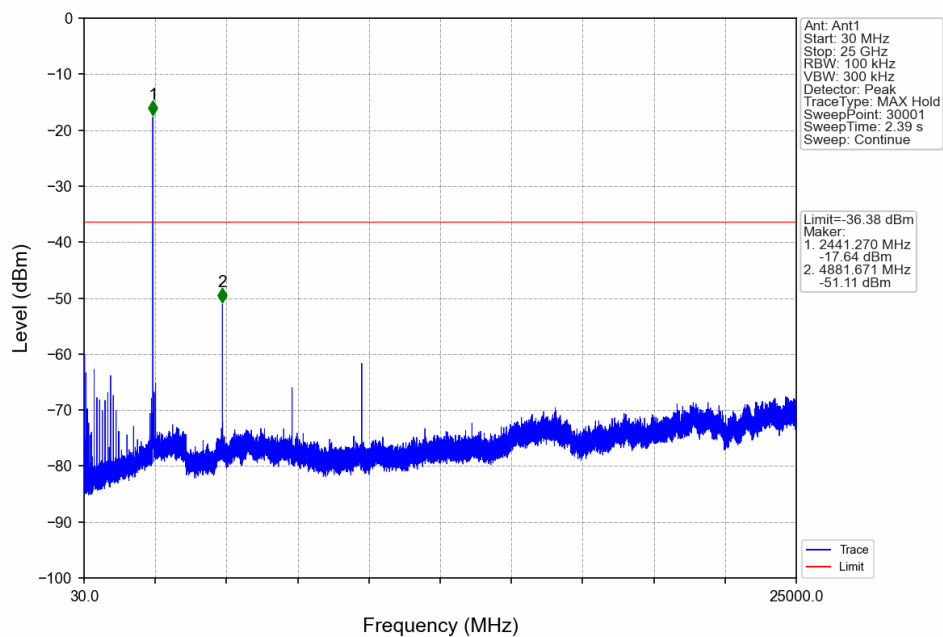
## GFSK\_DH5\_MCH\_2441MHz\_Ant1\_NTNV

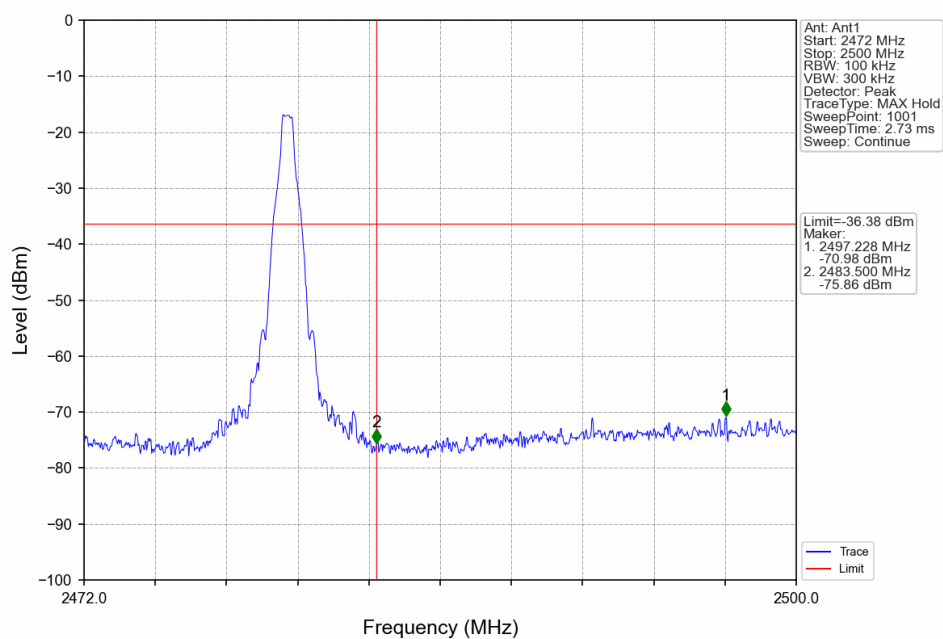
## GFSK\_DH5\_HCH\_2480MHz\_Ant1\_NTNV

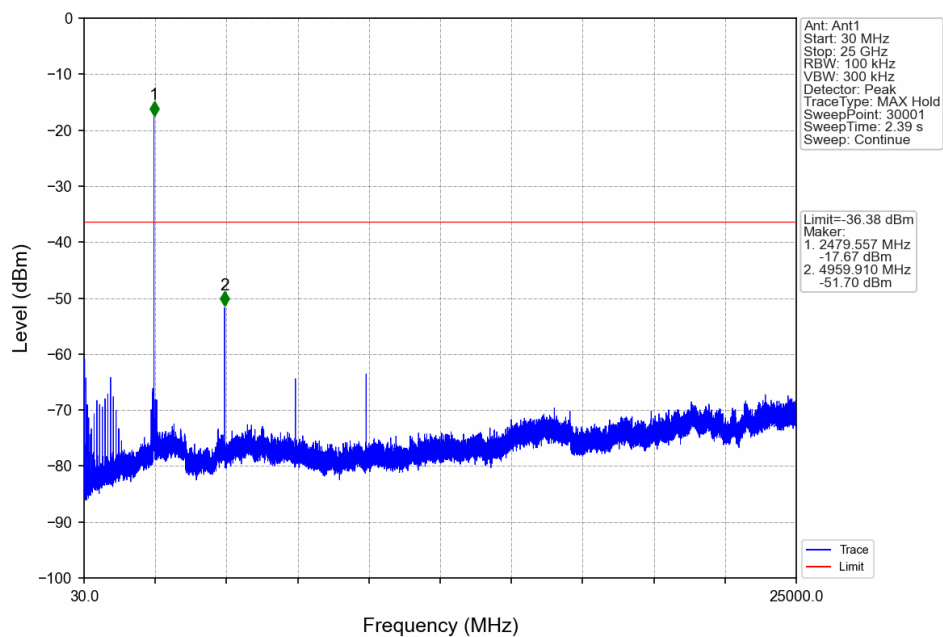
## GFSK\_DH5\_HCH\_2480MHz\_Ant1\_NTNV

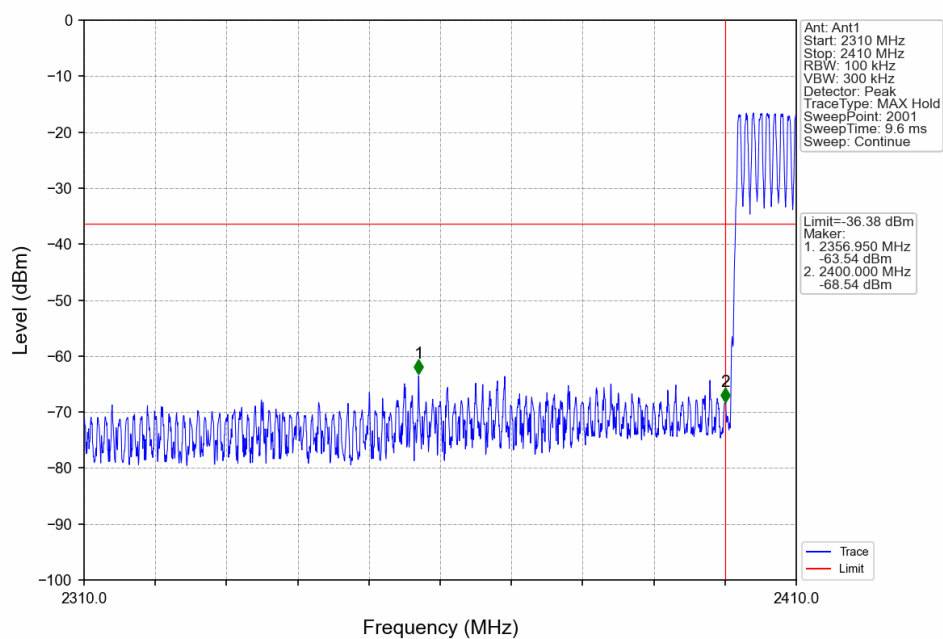
## GFSK\_DH5\_HOPP\_2410MHz\_Ant1\_NTNV

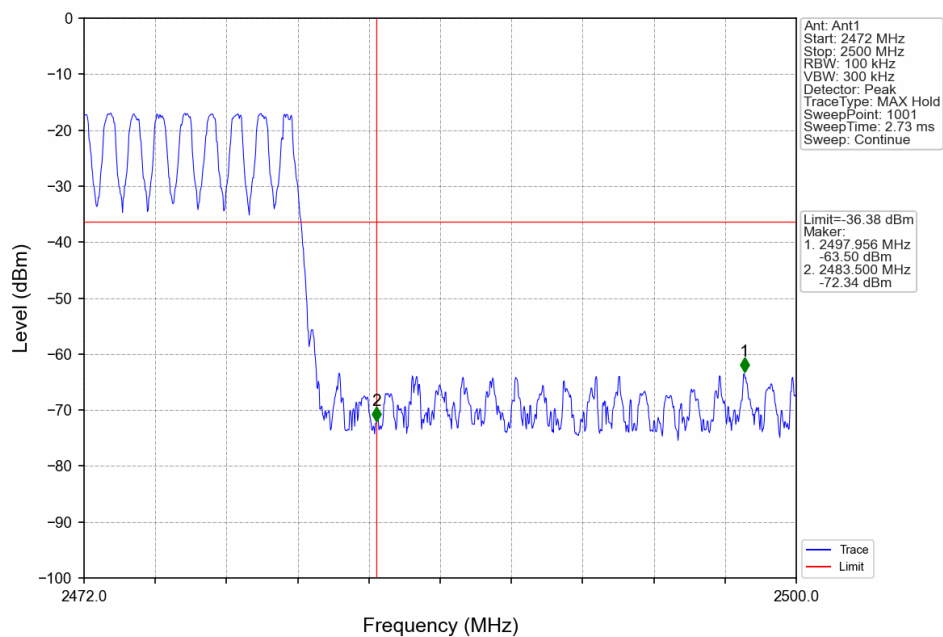
## GFSK\_DH5\_HOPP\_Ant1\_NTNV

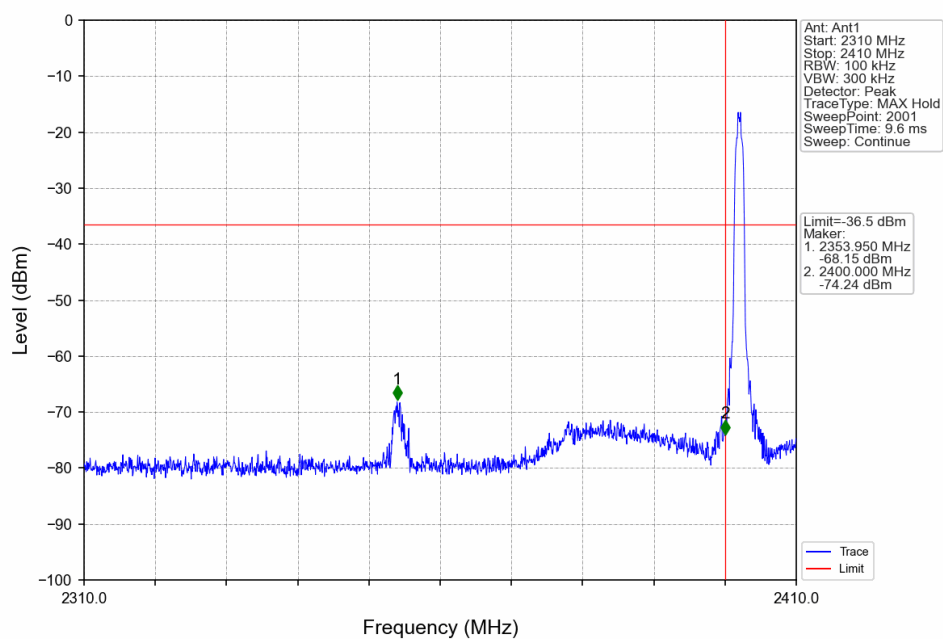
## Pi/4DQPSK\_2DH5\_LCH\_2402MHz\_Ant1\_NTNV

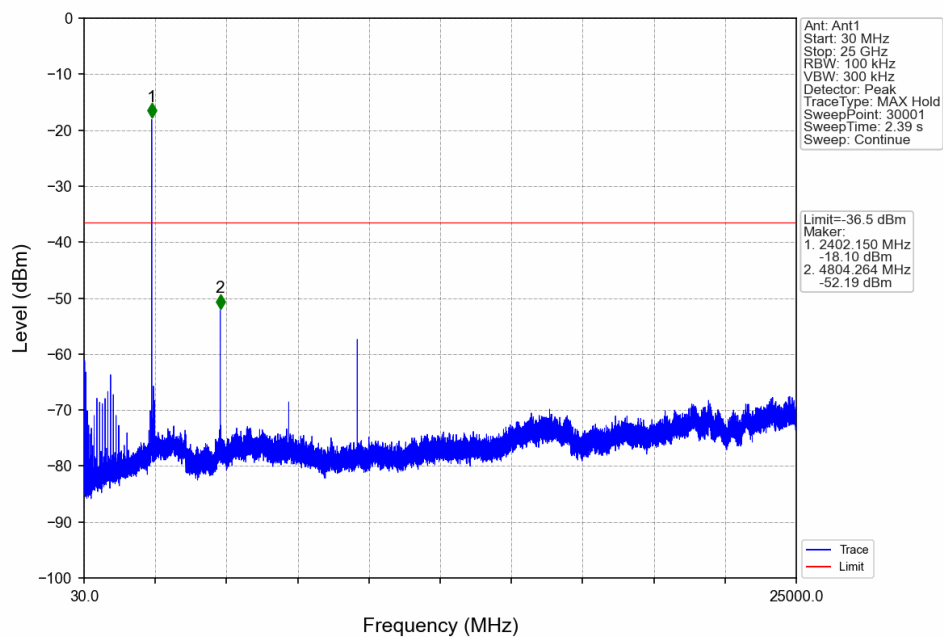
Pi/4DQPSK\_2DH5\_LCH\_2402MHz\_Ant1\_NTNV

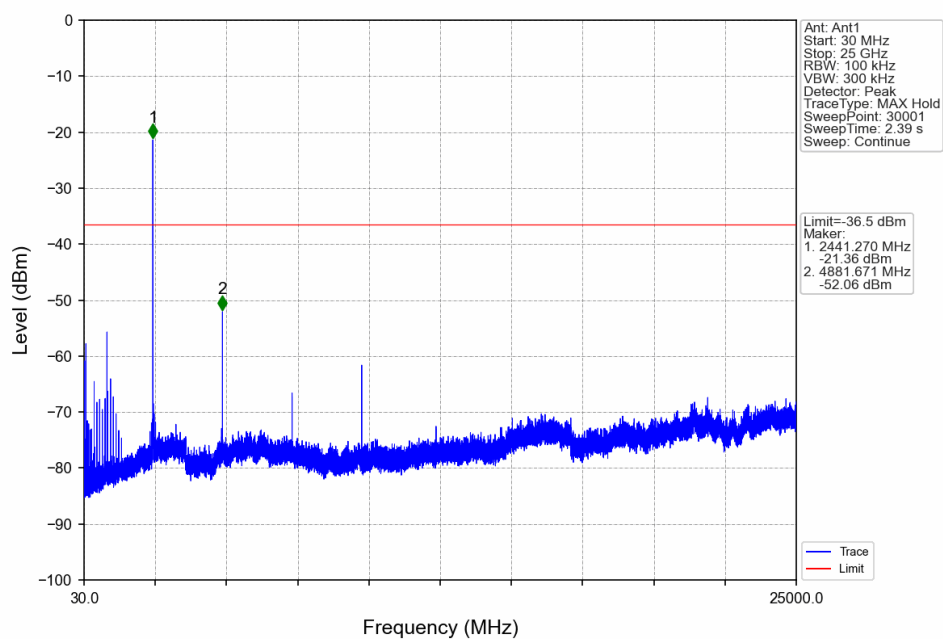
Pi/4DQPSK\_2DH5\_MCH\_2441MHz\_Ant1\_NTNV

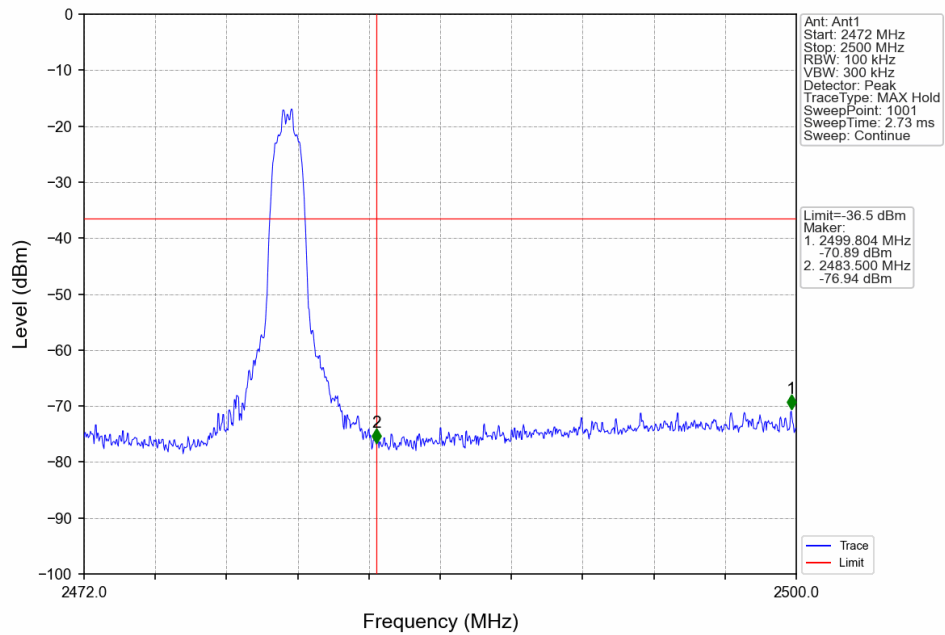
## Pi/4DQPSK\_2DH5\_HCH\_2480MHz\_Ant1\_NTNV

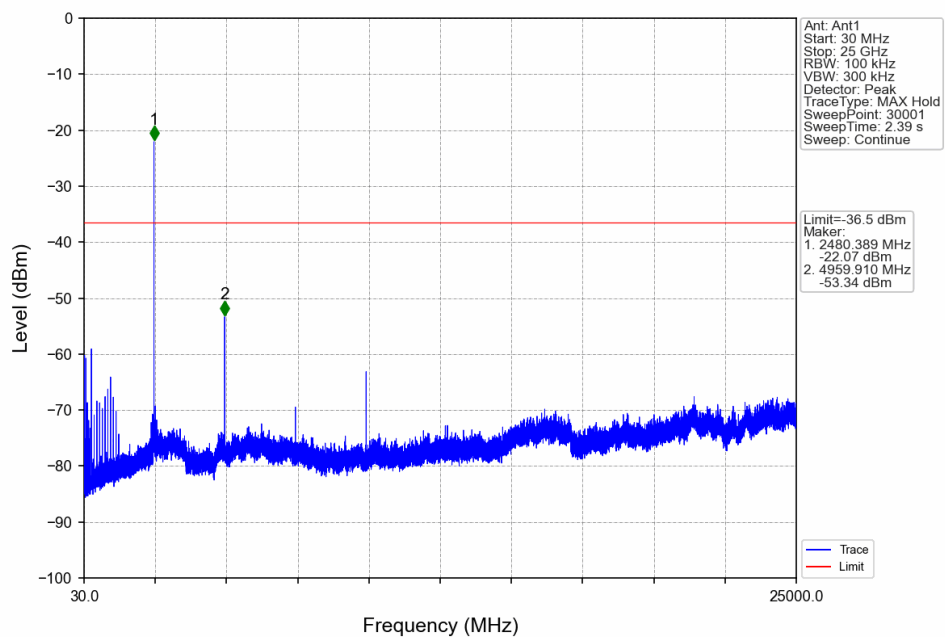
## Pi/4DQPSK\_2DH5\_HCH\_2480MHz\_Ant1\_NTNV

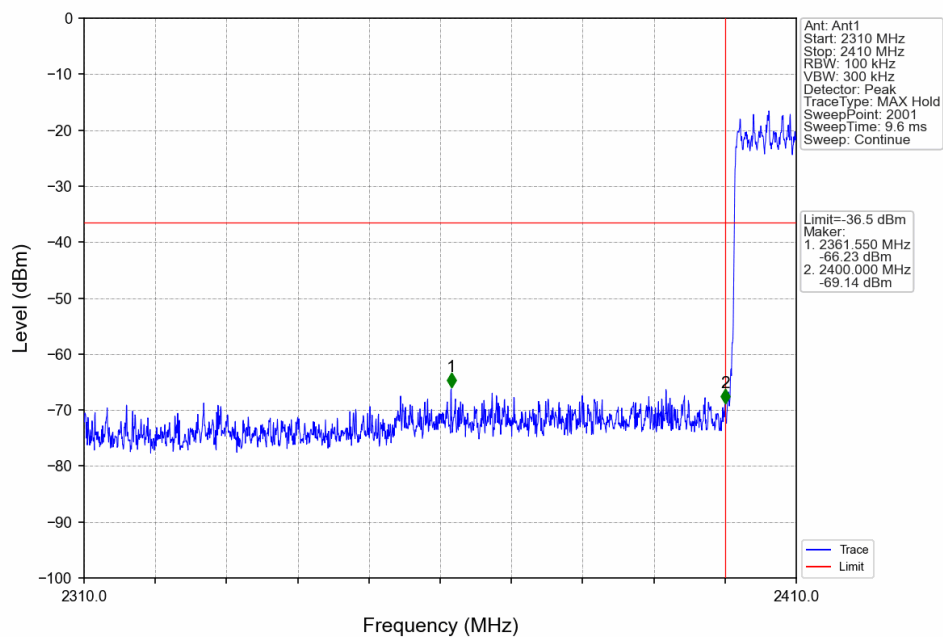
## Pi/4DQPSK\_2DH5\_HOPP\_Ant1\_NTNV

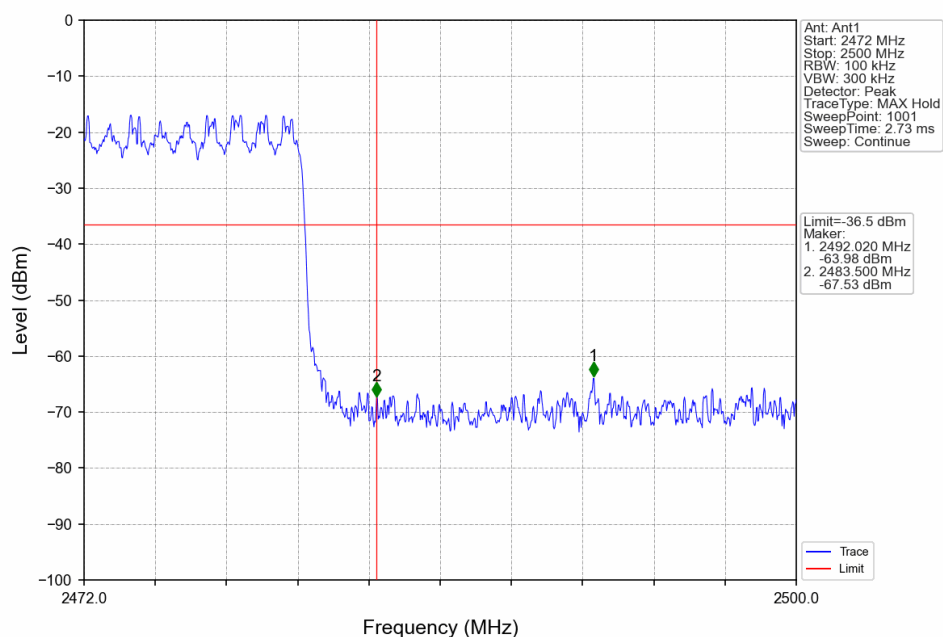
## Pi/4DQPSK\_2DH5\_HOPP\_Ant1\_NTNV

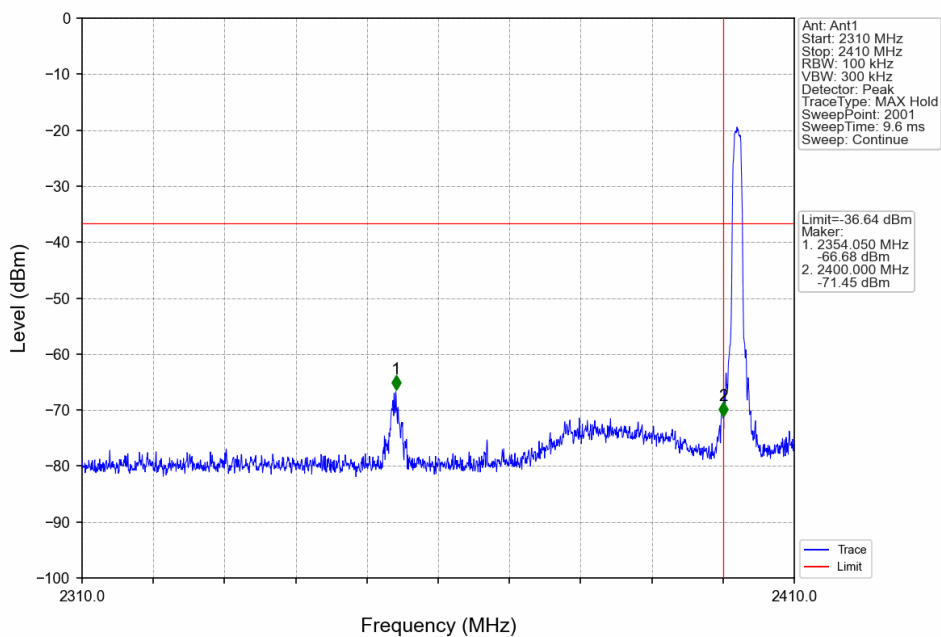
## 8DPSK\_3DH5\_LCH\_2402MHz\_Ant1\_NTNV

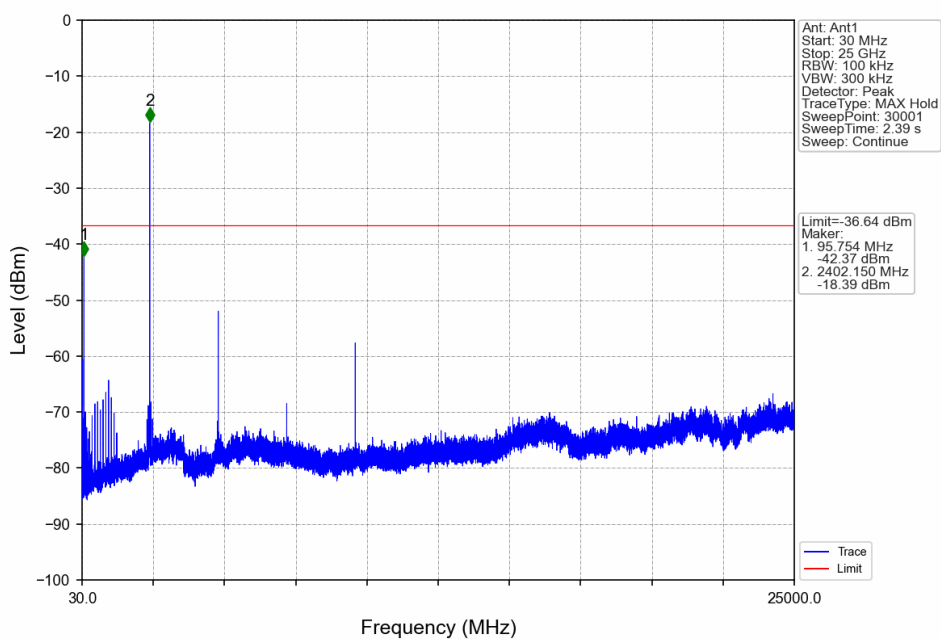
## 8DPSK\_3DH5\_LCH\_2402MHz\_Ant1\_NTNV

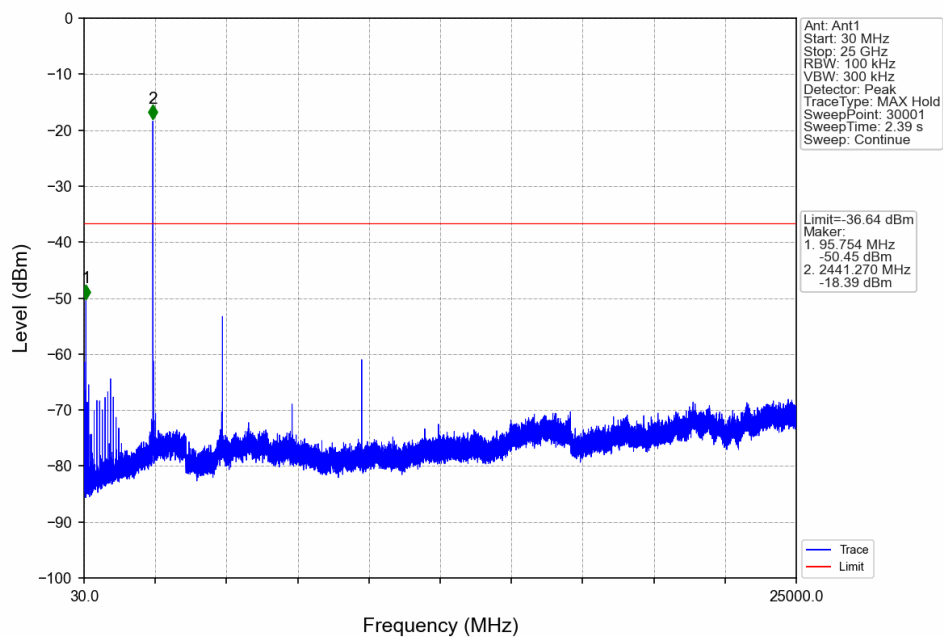
## 8DPSK\_3DH5\_MCH\_2441MHz\_Ant1\_NTNV

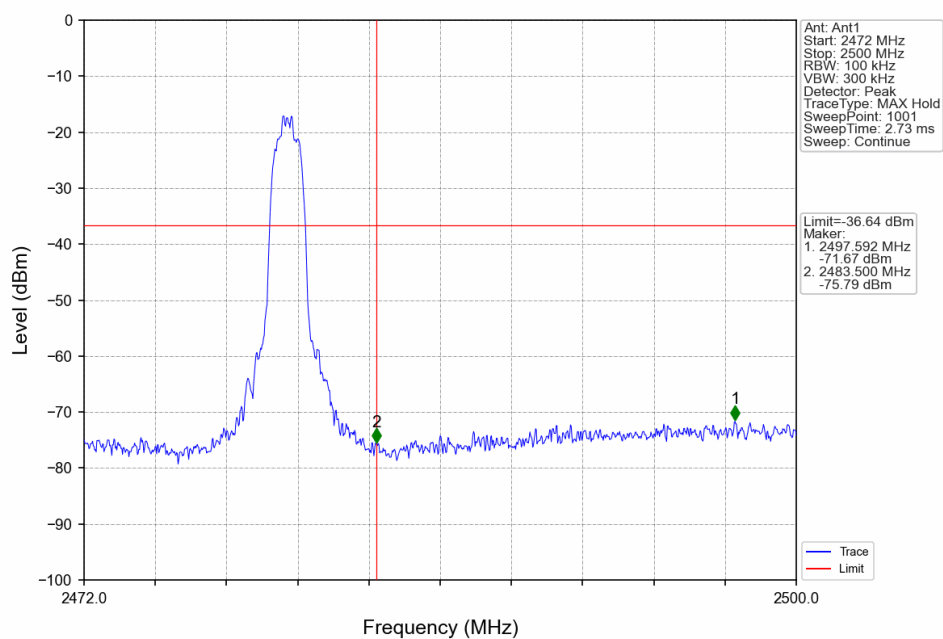
## 8DPSK\_3DH5\_HCH\_2480MHz\_Ant1\_NTNV

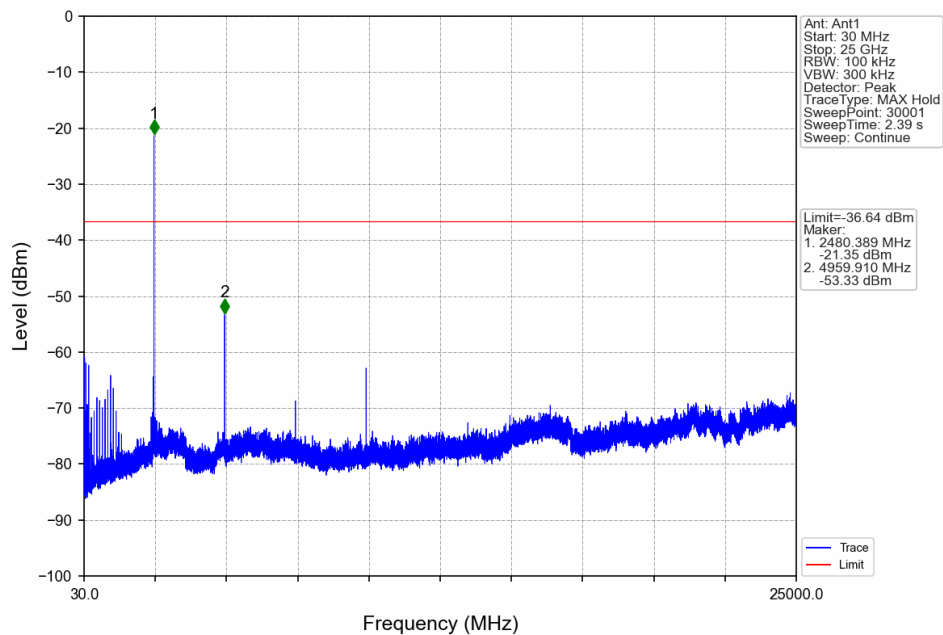
## 8DPSK\_3DH5\_HCH\_2480MHz\_Ant1\_NTNV

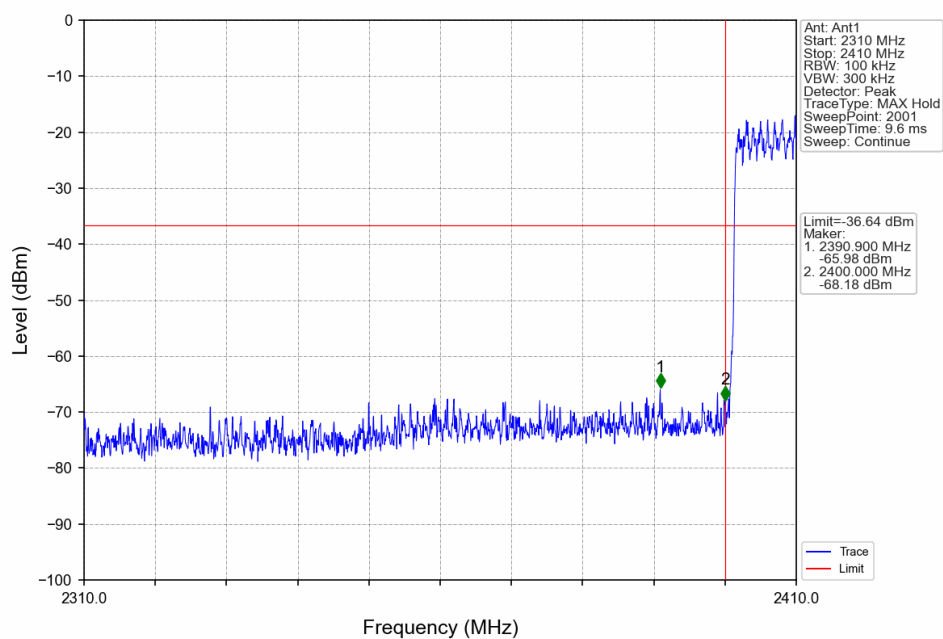
## 8DPSK\_3DH5\_HOPP\_Ant1\_NTNV

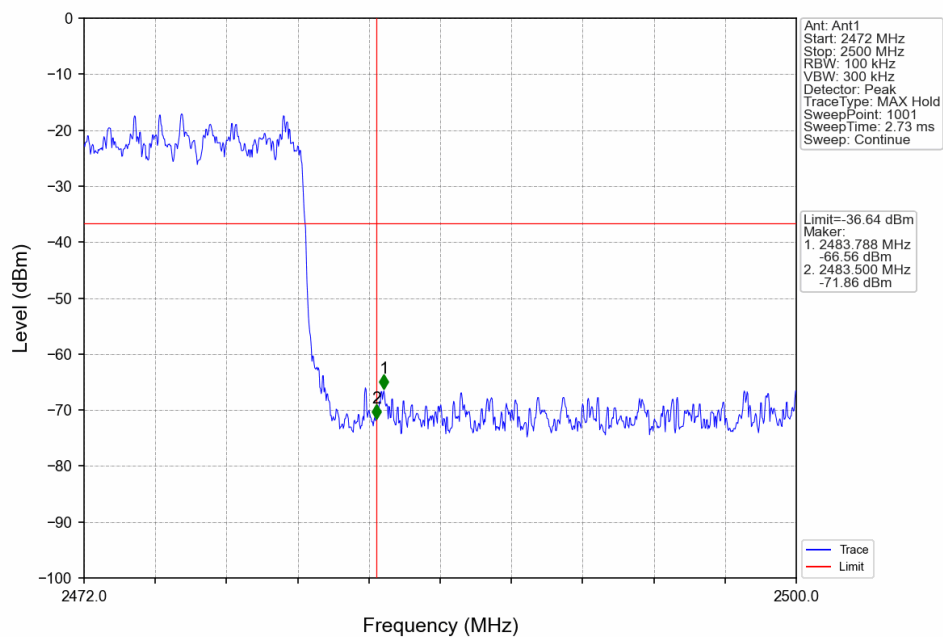
## 8DPSK\_3DH5\_HOPP\_Ant1\_NTNV

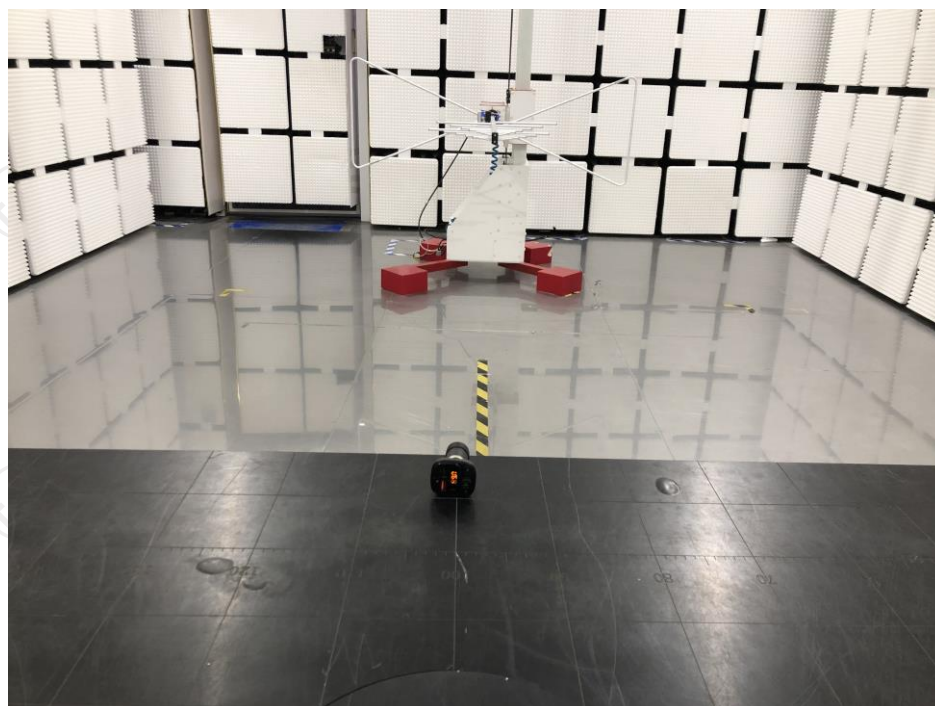
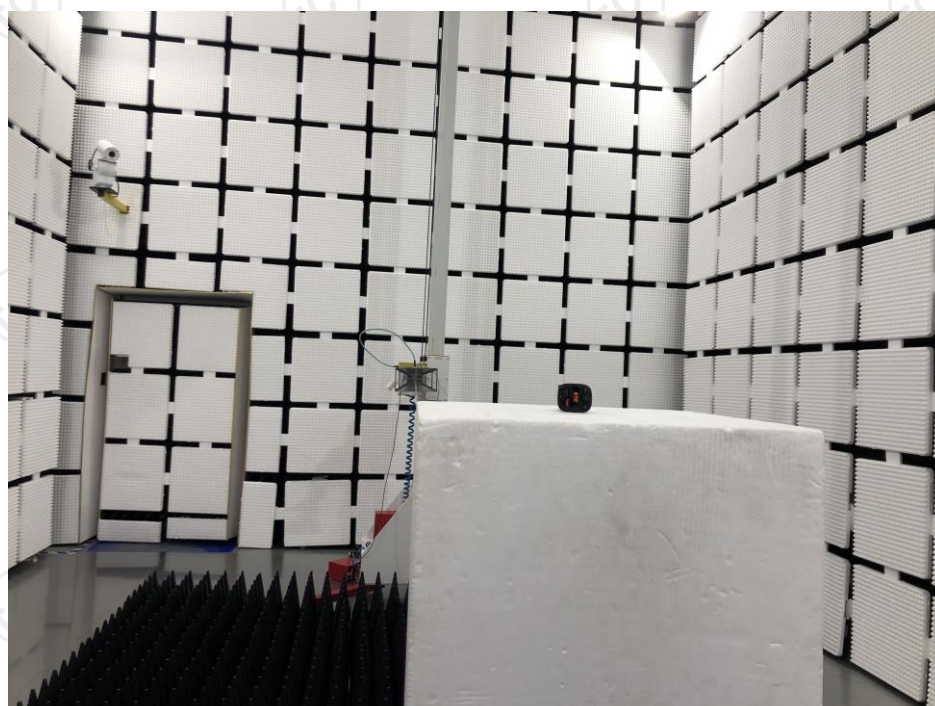
### Radiated Emission
