## 7.9 Dwell Time

*BlueAsia* of Technical Services (Shenzhen) Co., Ltd.

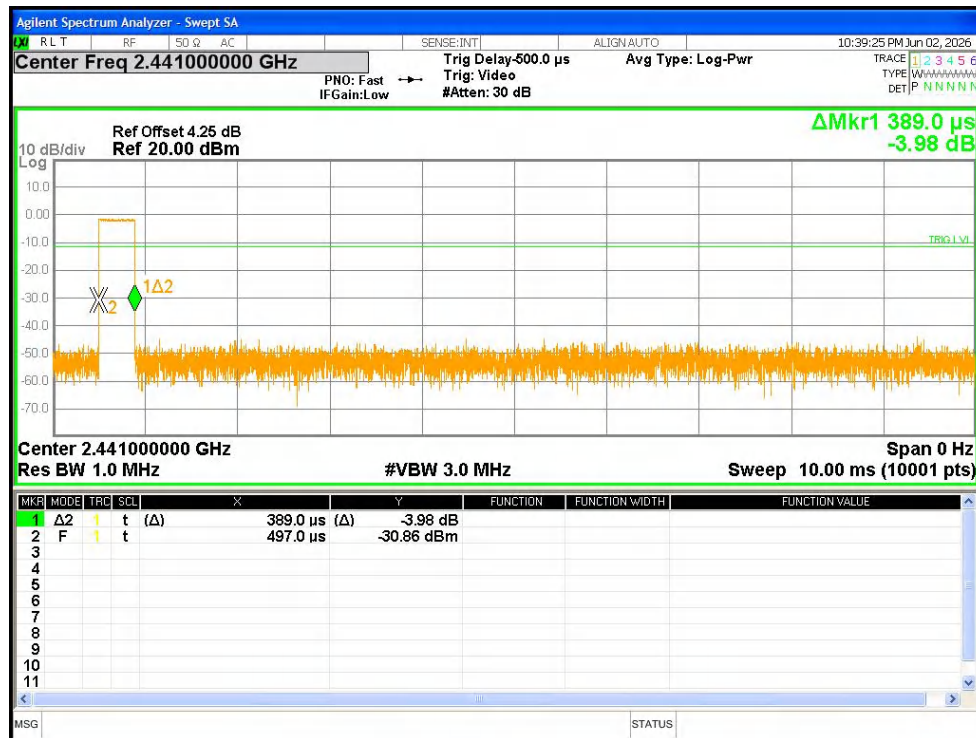
Dwell NVNT 1-DH1 2441MHz Ant1 One Burst

| Condition | Mode | Frequency<br>(MHz) | Antenna | Pulse Time<br>(ms) | Total Dwell Time<br>(ms) | Burst<br>Count | Period Time<br>(ms) | Limit<br>(ms) | Verdict |
|---|---|---|---|---|---|---|---|---|---|
| NVNT | 1-DH1 | 2441 | Ant1 | 0.389 | 194.889 | 501 | 31600 | 400 | Pass |

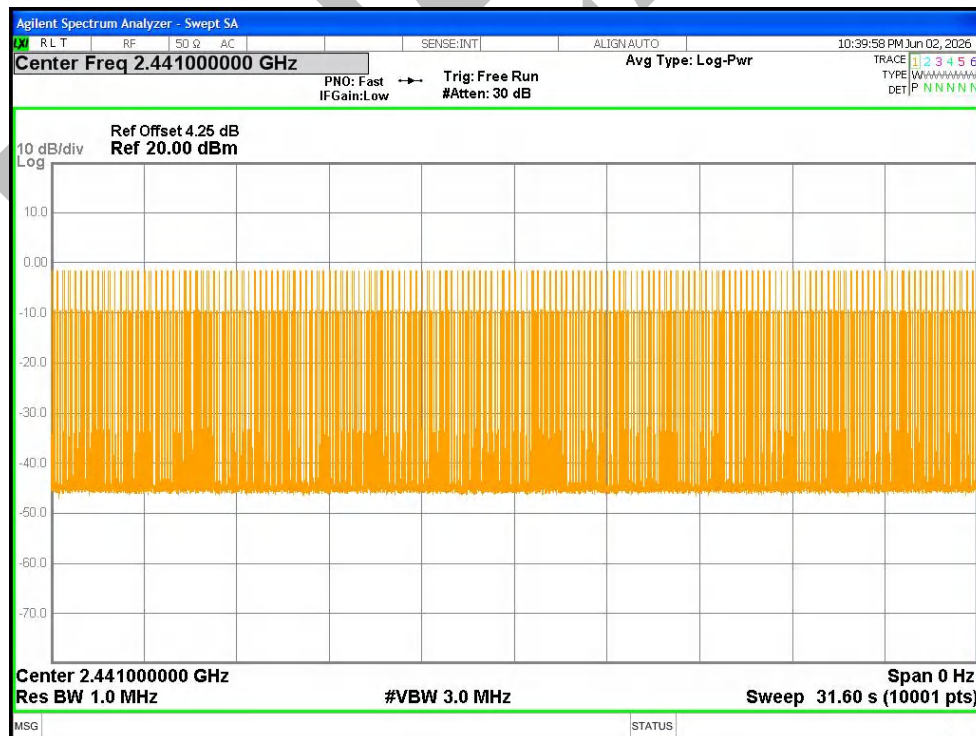
Dwell NVNT 1-DH1 2441MHz Ant1 Accumulated

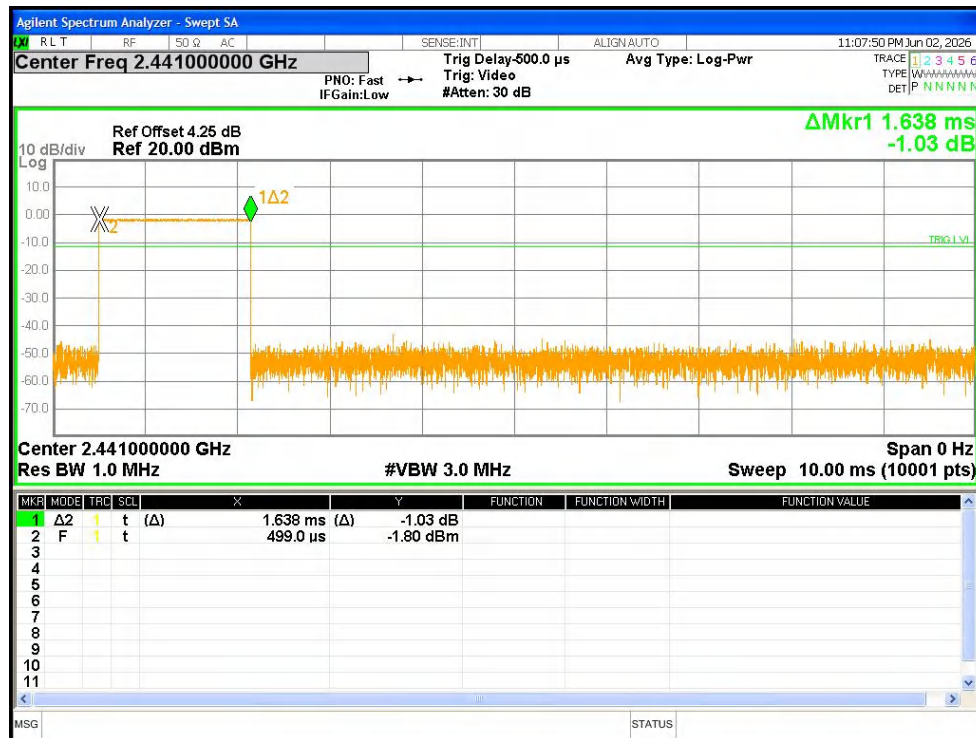
Dwell NVNT 1-DH3 2441MHz Ant1 One Burst

| Condition | Mode | Frequency<br>(MHz) | Antenna | Pulse Time<br>(ms) | Total Dwell Time<br>(ms) | Burst<br>Count | Period Time<br>(ms) | Limit<br>(ms) | Verdict |
|---|---|---|---|---|---|---|---|---|---|
| NVNT | 1-DH3 | 2441 | Ant1 | 1.638 | 244.062 | 149 | 31600 | 400 | Pass |

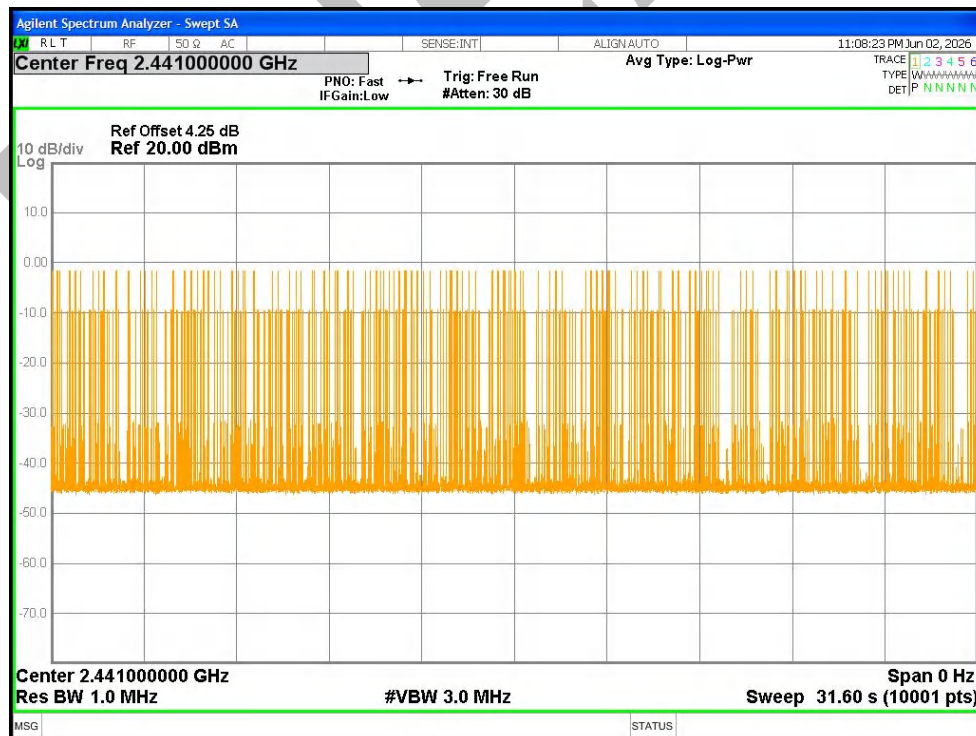
Dwell NVNT 1-DH3 2441MHz Ant1 Accumulated

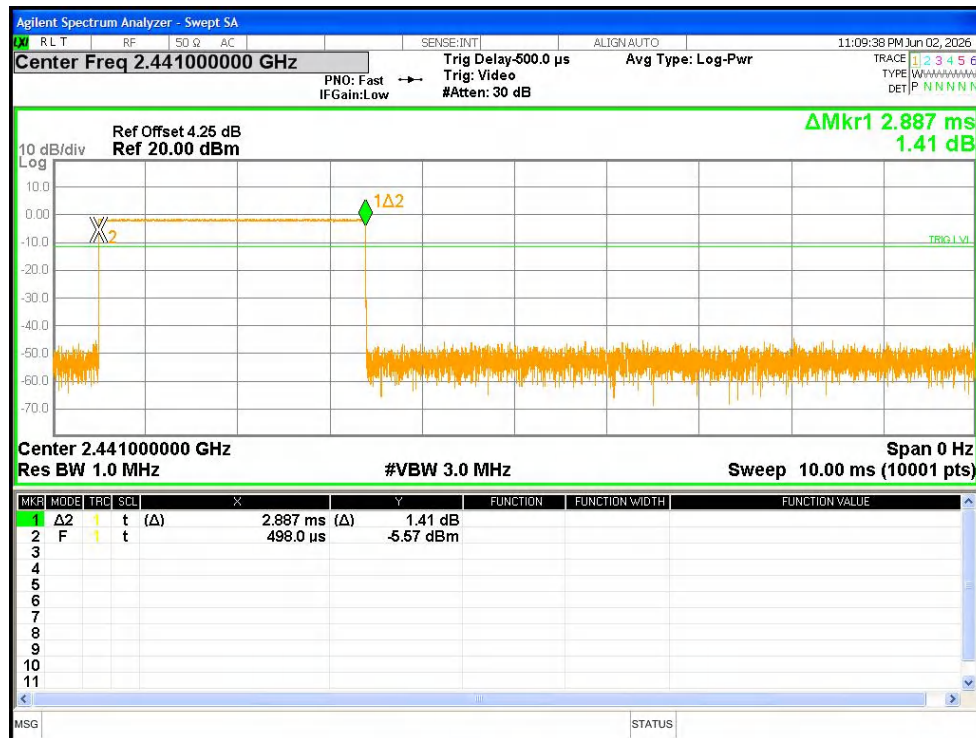
Dwell NVNT 1-DH5 2441MHz Ant1 One Burst

| Condition | Mode | Frequency<br>(MHz) | Antenna | Pulse Time<br>(ms) | Total Dwell Time<br>(ms) | Burst<br>Count | Period Time<br>(ms) | Limit<br>(ms) | Verdict |
|---|---|---|---|---|---|---|---|---|---|
| NVNT | 1-DH5 | 2441 | Ant1 | 2.887 | 282.926 | 98 | 31600 | 400 | Pass |

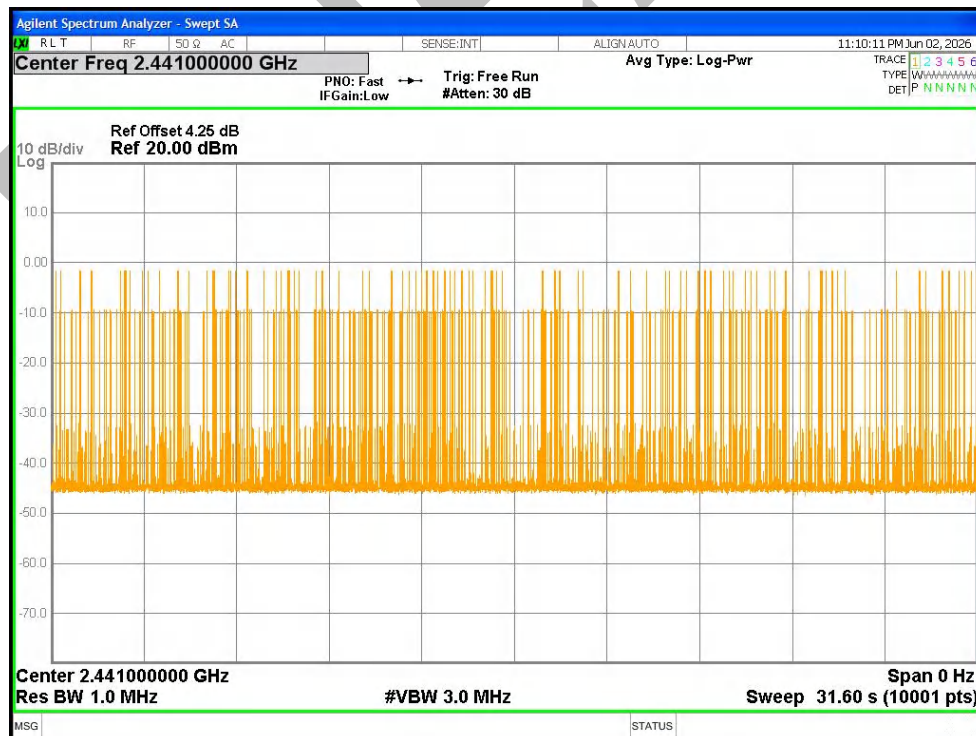
Dwell NVNT 1-DH5 2441MHz Ant1 Accumulated

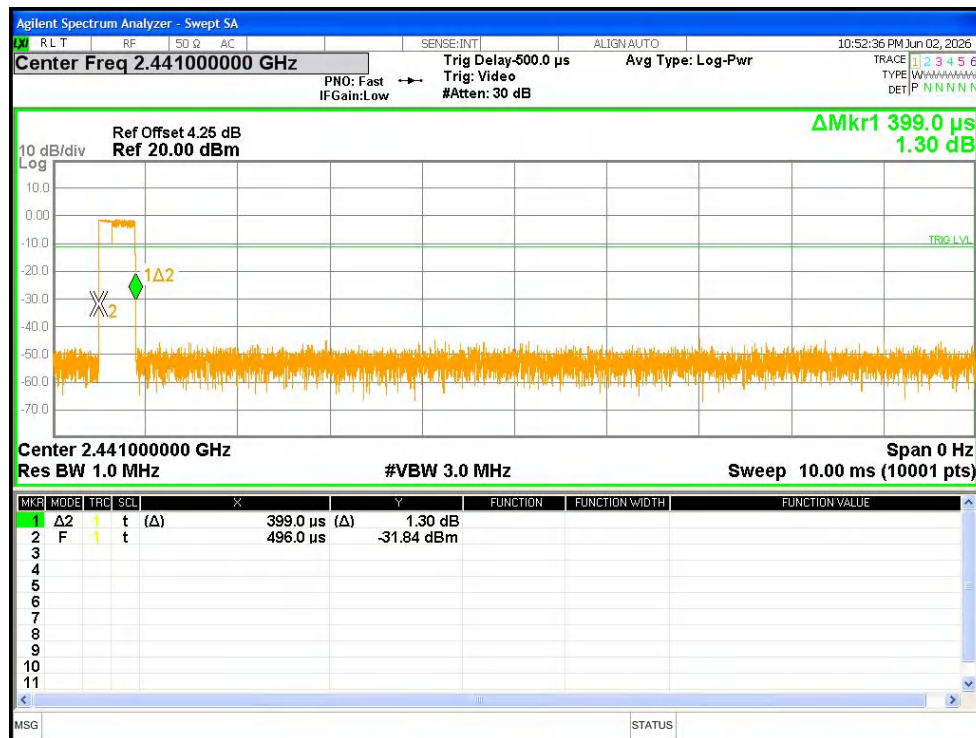
Dwell NVNT 2-DH1 2441MHz Ant1 One Burst

| Condition | Mode | Frequency<br>(MHz) | Antenna | Pulse Time<br>(ms) | Total Dwell Time<br>(ms) | Burst<br>Count | Period Time<br>(ms) | Limit<br>(ms) | Verdict |
|---|---|---|---|---|---|---|---|---|---|
| NVNT | 2-DH1 | 2441 | Ant1 | 0.399 | 199.899 | 501 | 31600 | 400 | Pass |

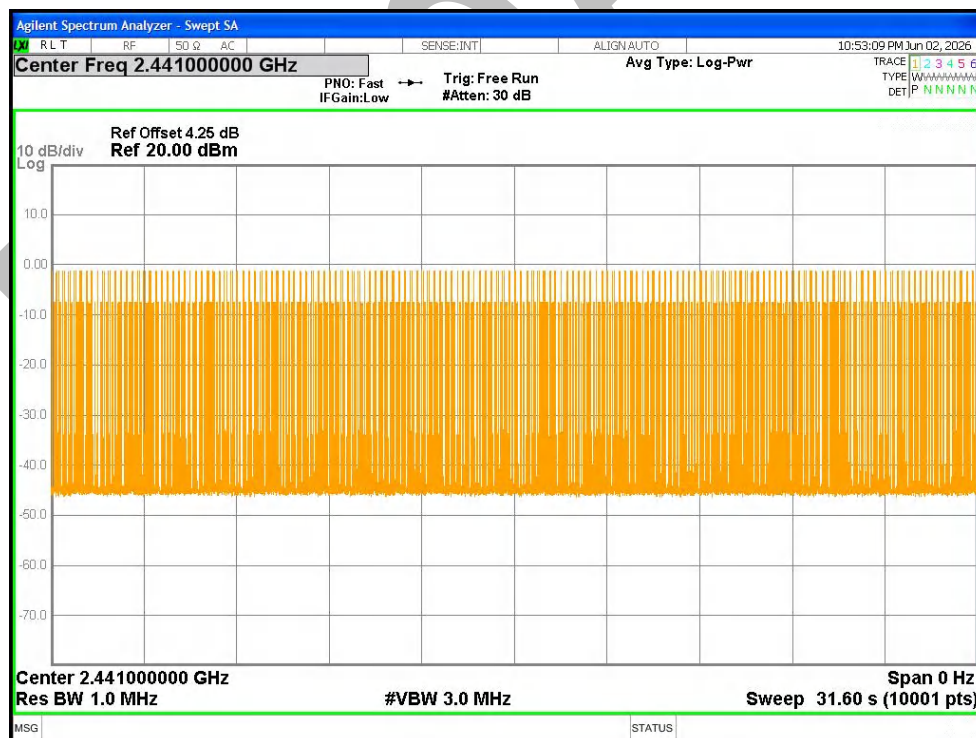
Dwell NVNT 2-DH1 2441MHz Ant1 Accumulated

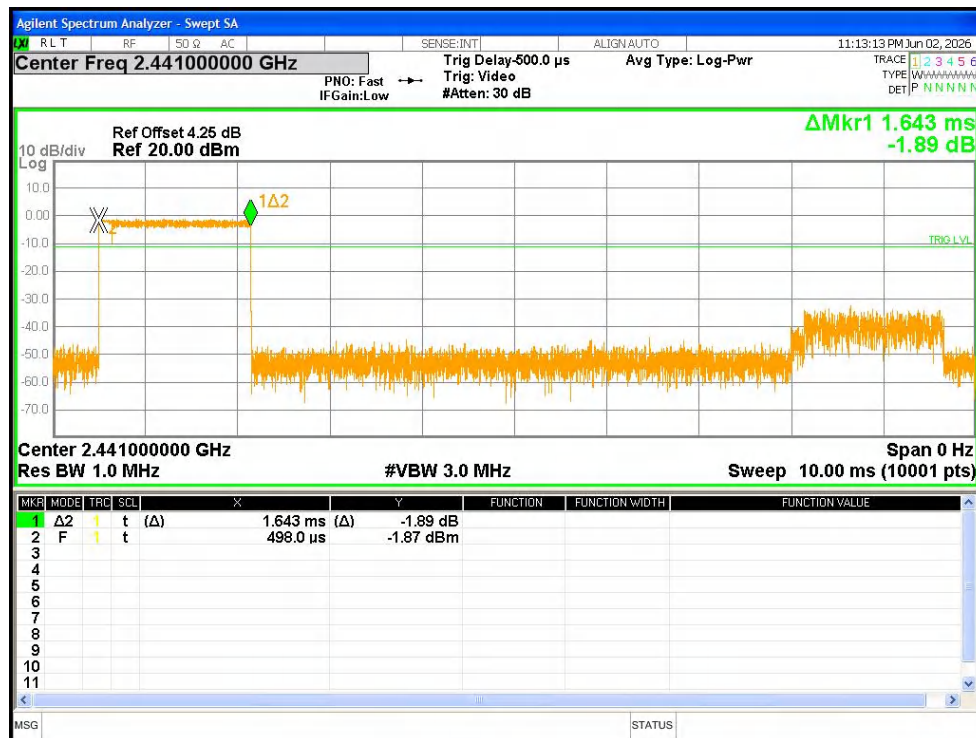
Dwell NVNT 2-DH3 2441MHz Ant1 One Burst

| Condition | Mode | Frequency<br>(MHz) | Antenna | Pulse Time<br>(ms) | Total Dwell Time<br>(ms) | Burst<br>Count | Period Time<br>(ms) | Limit<br>(ms) | Verdict |
|---|---|---|---|---|---|---|---|---|---|
| NVNT | 2-DH3 | 2441 | Ant1 | 1.643 | 244.807 | 149 | 31600 | 400 | Pass |

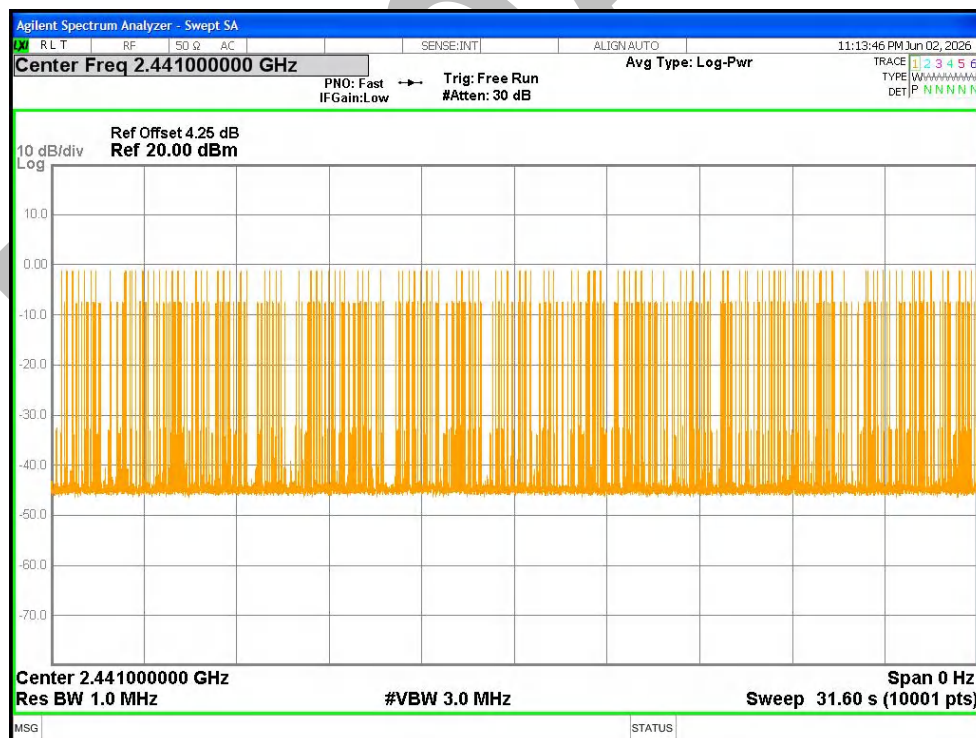
Dwell NVNT 2-DH3 2441MHz Ant1 Accumulated

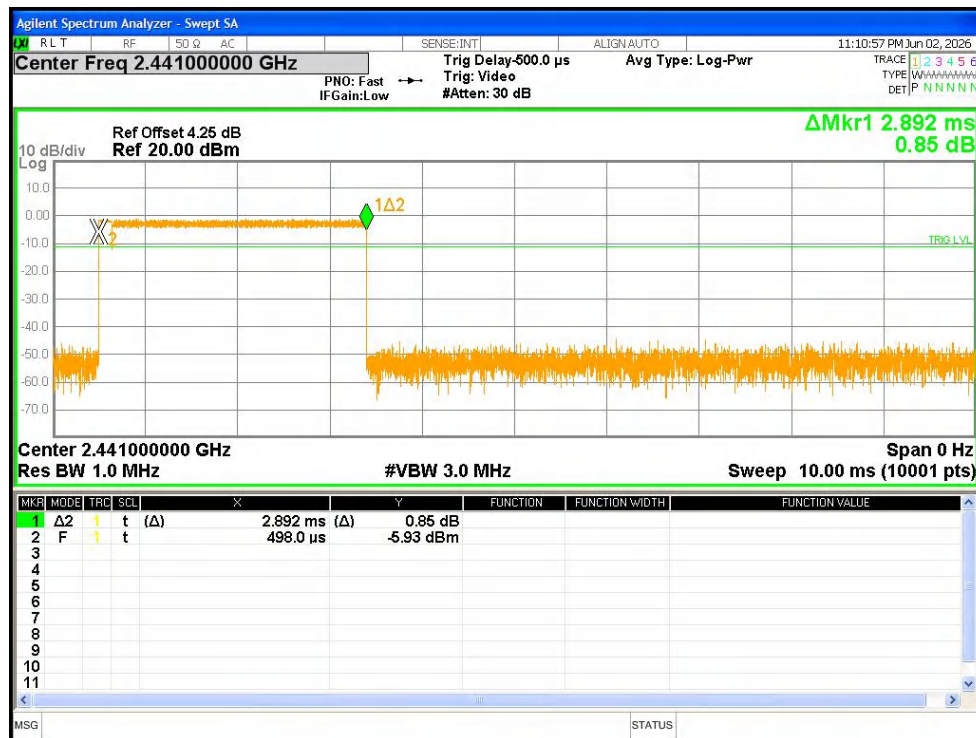
Dwell NVNT 2-DH5 2441MHz Ant1 One Burst

| Condition | Mode | Frequency<br>(MHz) | Antenna | Pulse Time<br>(ms) | Total Dwell Time<br>(ms) | Burst<br>Count | Period Time<br>(ms) | Limit<br>(ms) | Verdict |
|---|---|---|---|---|---|---|---|---|---|
| NVNT | 2-DH5 | 2441 | Ant1 | 2.892 | 329.688 | 114 | 31600 | 400 | Pass |

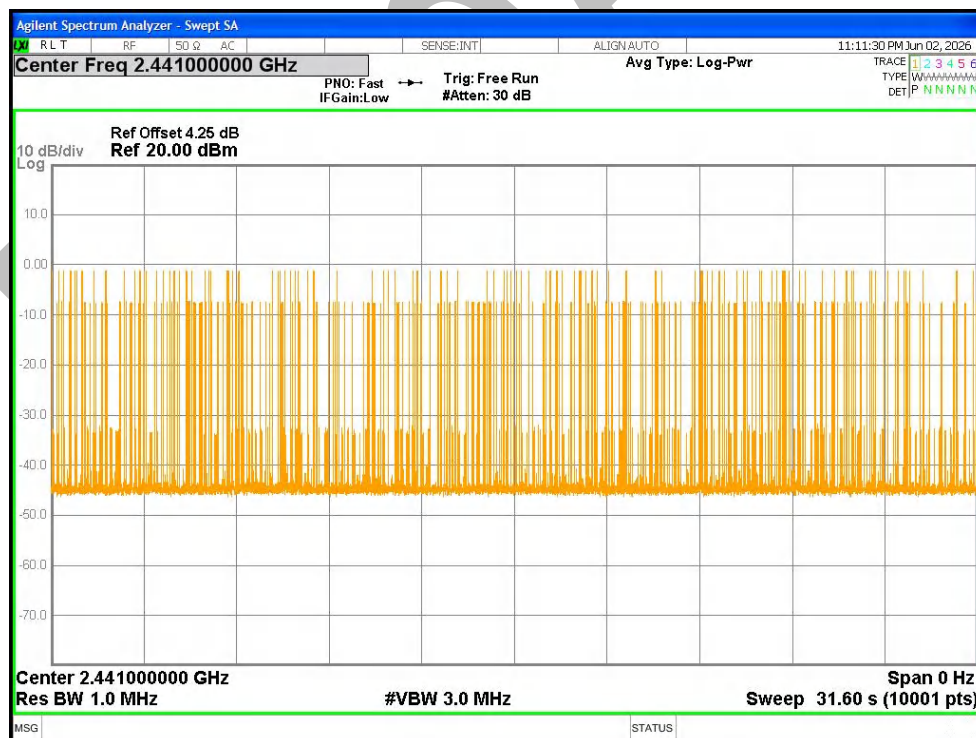
Dwell NVNT 2-DH5 2441MHz Ant1 Accumulated

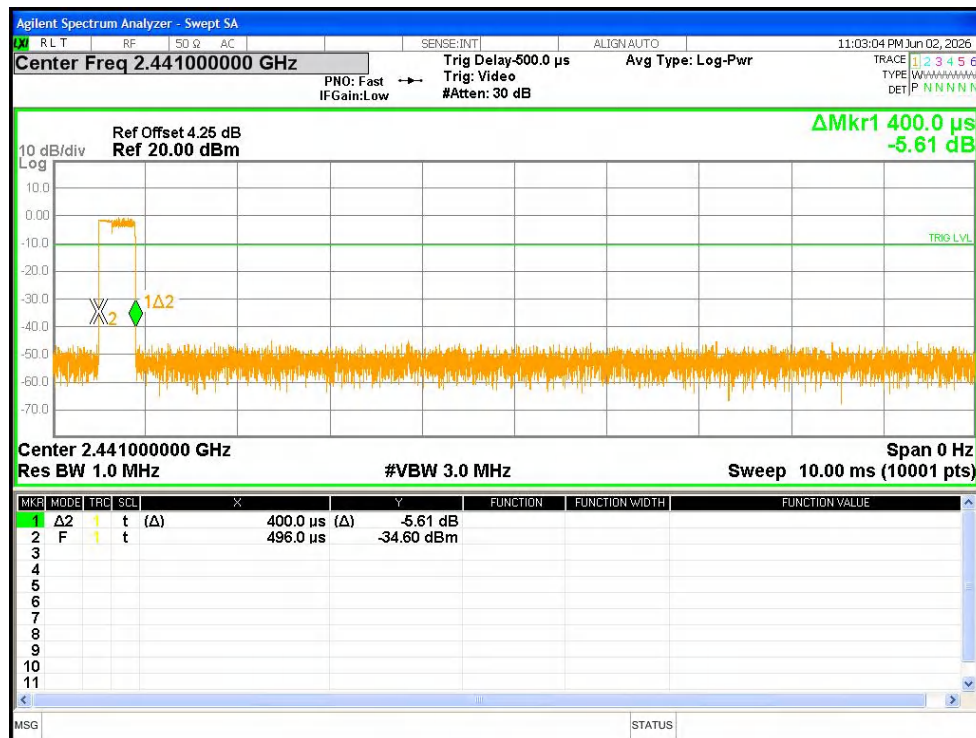
Dwell NVNT 3-DH1 2441MHz Ant1 One Burst

| Condition | Mode | Frequency<br>(MHz) | Antenna | Pulse Time<br>(ms) | Total Dwell Time<br>(ms) | Burst<br>Count | Period Time<br>(ms) | Limit<br>(ms) | Verdict |
|---|---|---|---|---|---|---|---|---|---|
| NVNT | 3-DH1 | 2441 | Ant1 | 0.4 | 200.4 | 501 | 31600 | 400 | Pass |

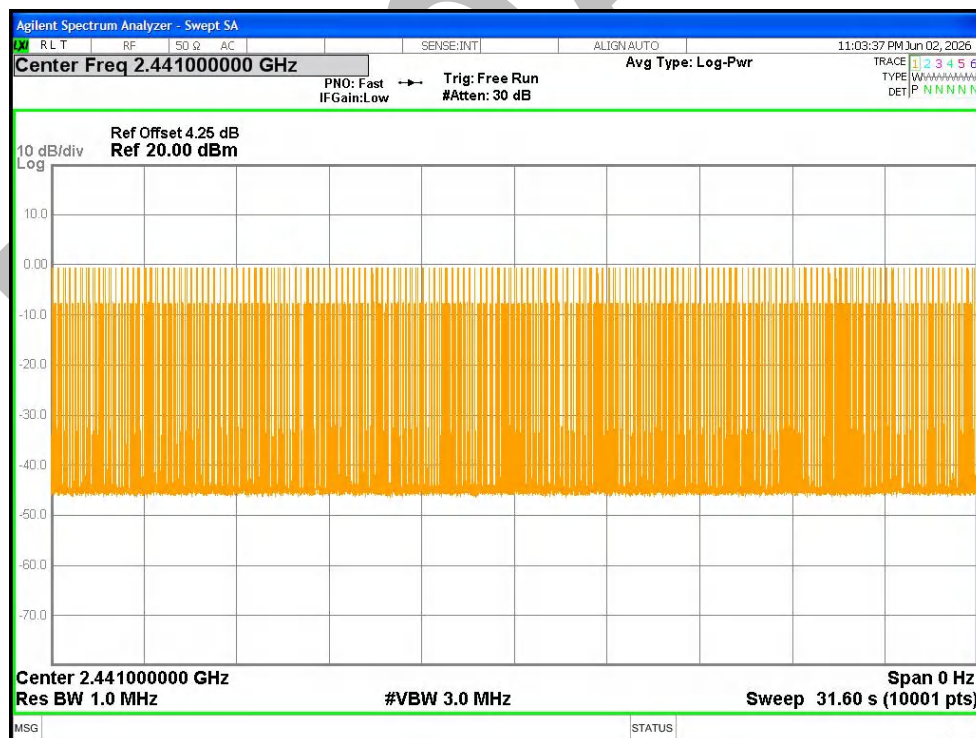
Dwell NVNT 3-DH1 2441MHz Ant1 Accumulated

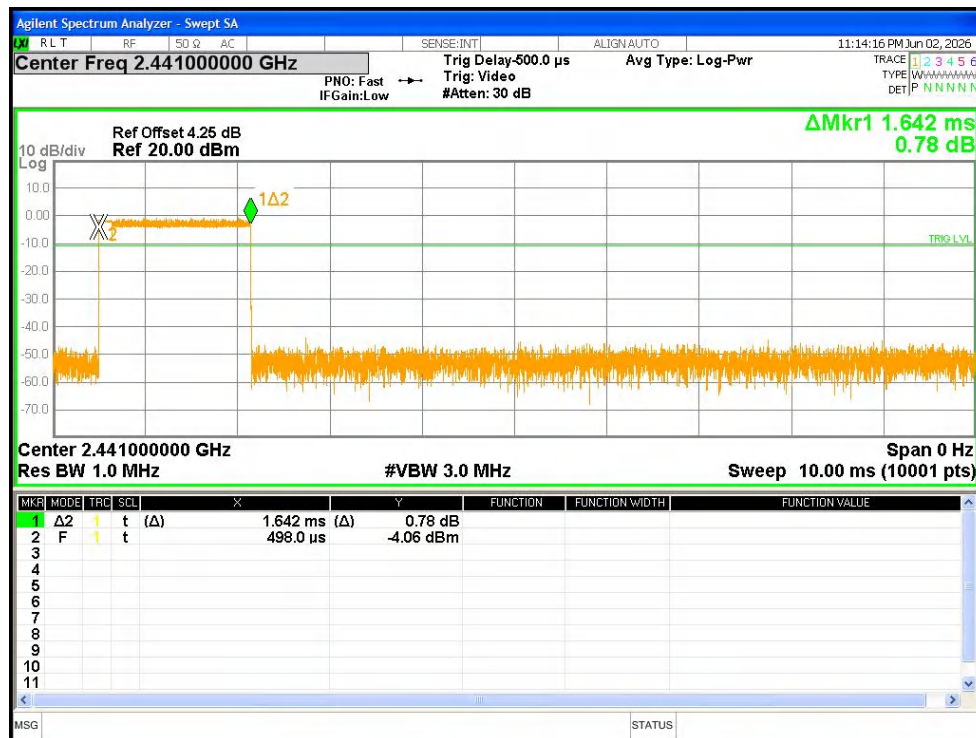
Dwell NVNT 3-DH3 2441MHz Ant1 One Burst

| Condition | Mode | Frequency<br>(MHz) | Antenna | Pulse Time<br>(ms) | Total Dwell Time<br>(ms) | Burst<br>Count | Period Time<br>(ms) | Limit<br>(ms) | Verdict |
|---|---|---|---|---|---|---|---|---|---|
| NVNT | 3-DH3 | 2441 | Ant1 | 1.642 | 262.72 | 160 | 31600 | 400 | Pass |

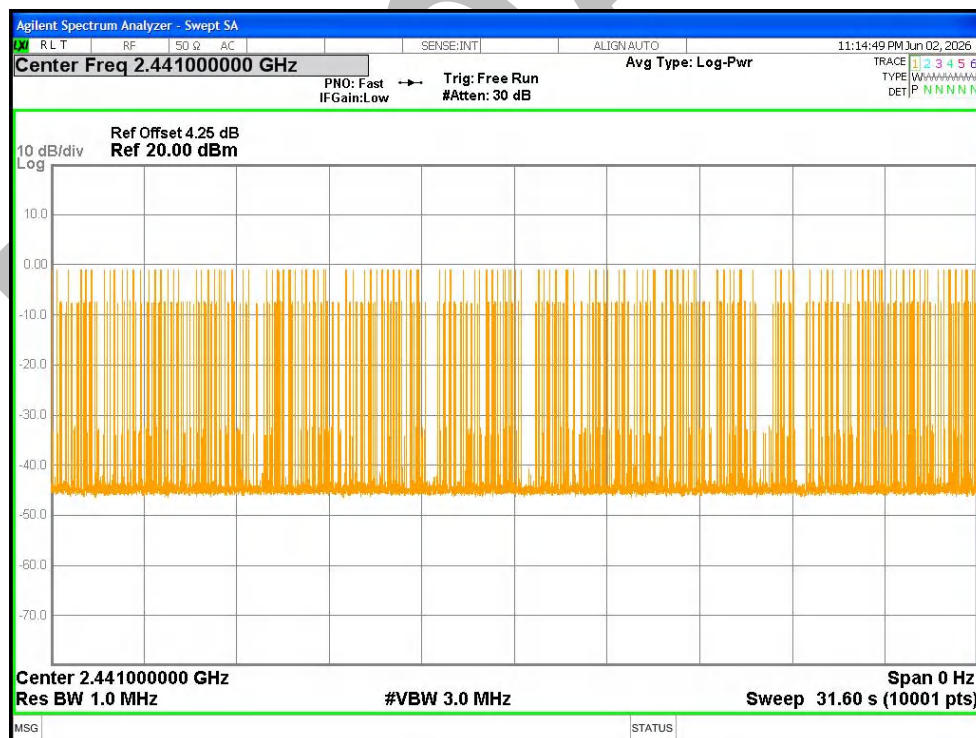
Dwell NVNT 3-DH3 2441MHz Ant1 Accumulated

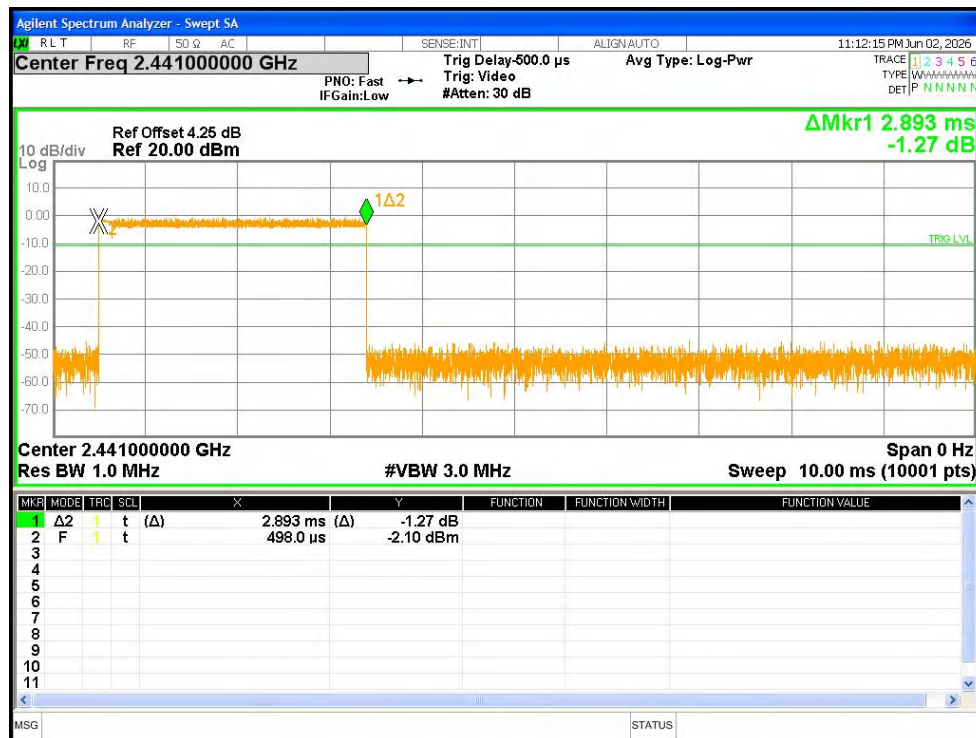
Dwell NVNT 3-DH5 2441MHz Ant1 One Burst

| Condition | Mode | Frequency<br>(MHz) | Antenna | Pulse Time<br>(ms) | Total Dwell Time<br>(ms) | Burst<br>Count | Period Time<br>(ms) | Limit<br>(ms) | Verdict |
|---|---|---|---|---|---|---|---|---|---|
| NVNT | 3-DH5 | 2441 | Ant1 | 2.893 | 321.123 | 111 | 31600 | 400 | Pass |

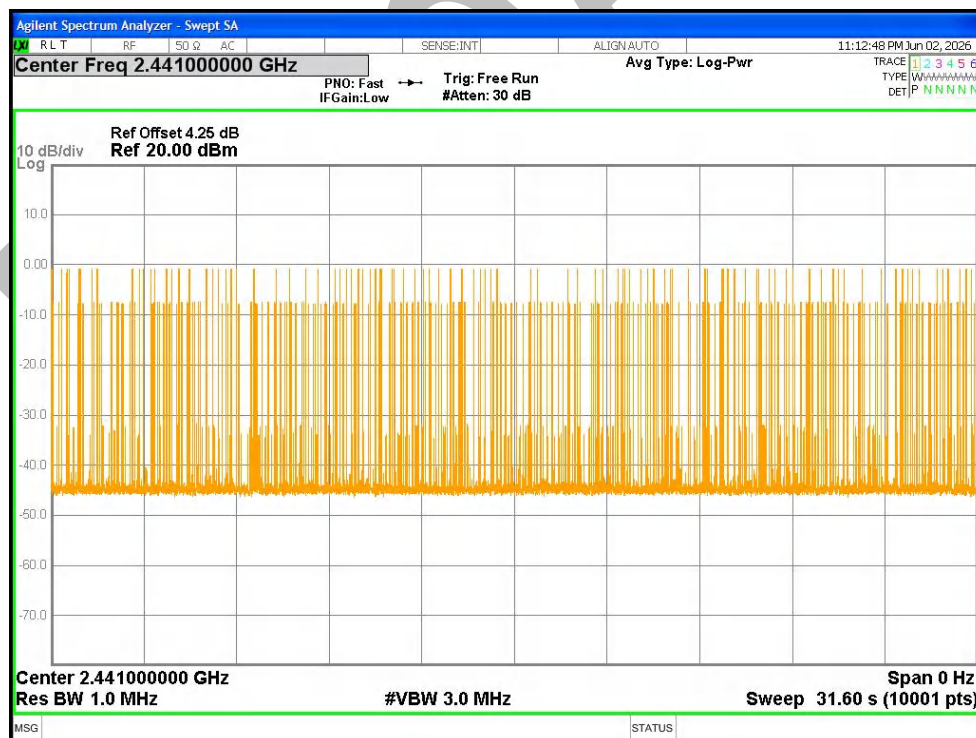
Dwell NVNT 3-DH5 2441MHz Ant1 Accumulated

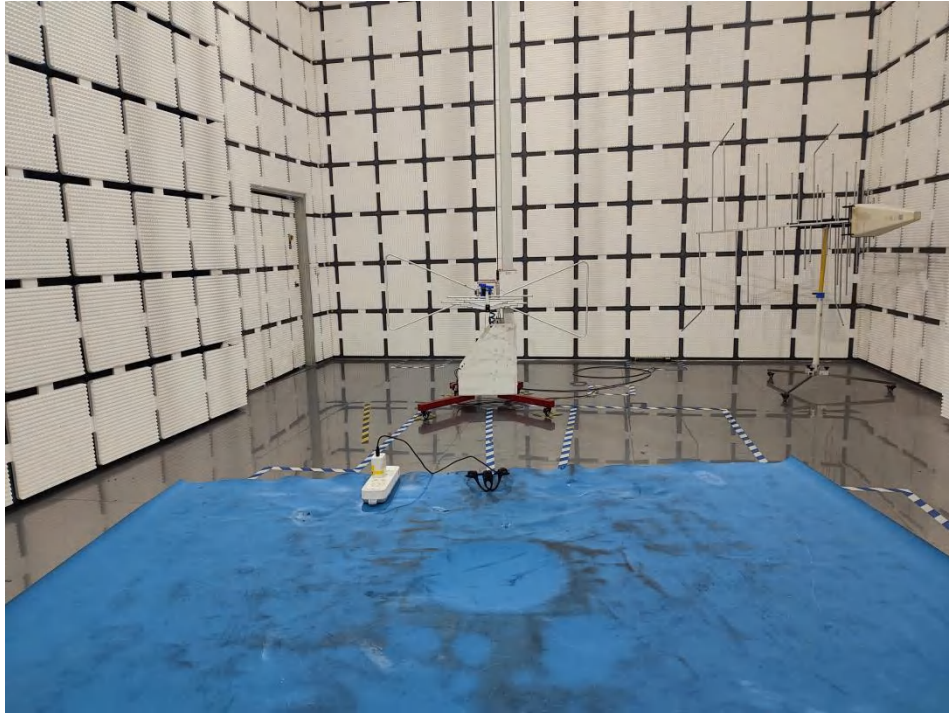
Radiated Emissions (30MHz-1GHz)

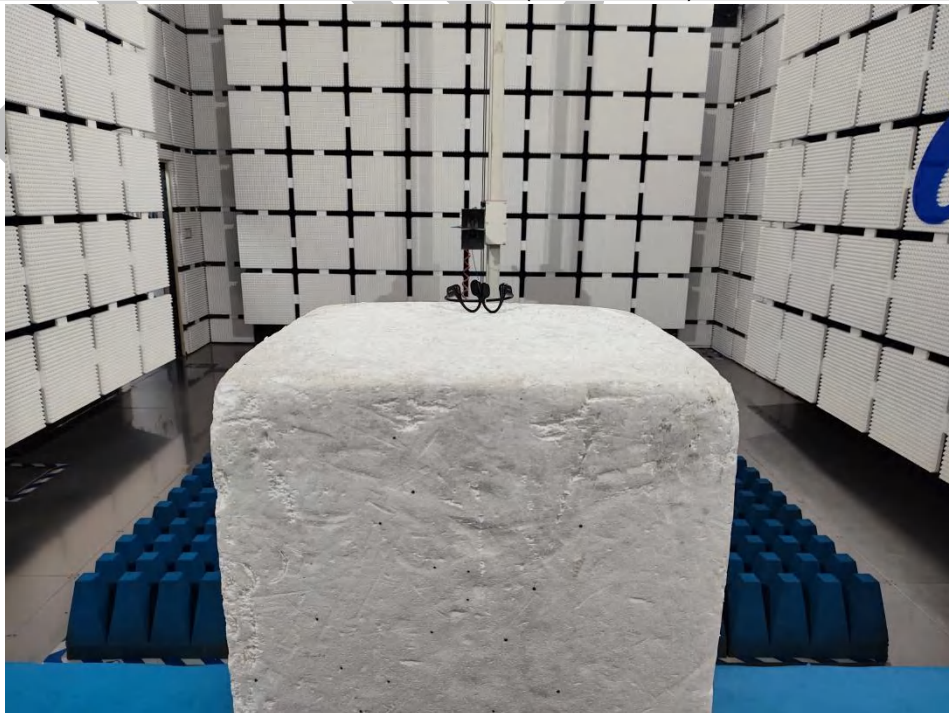
Radiated Emissions (above 1GHz)

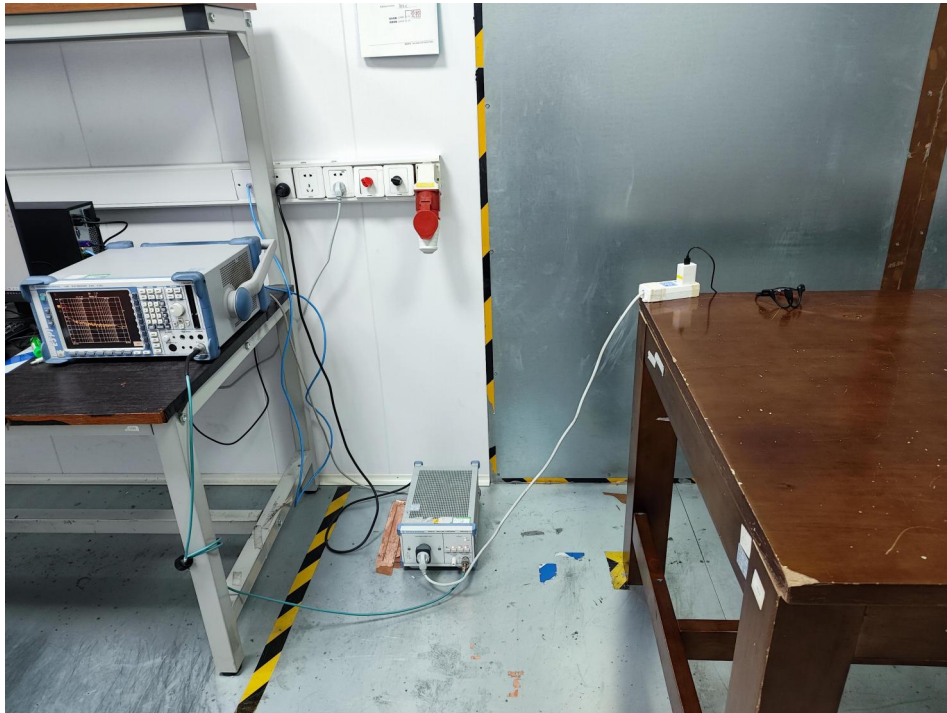
Conducted Emissions at Mains Terminals (150 kHz-30MHz)
