## 7. Form731

## Appendix B: Photographs of Test Setup

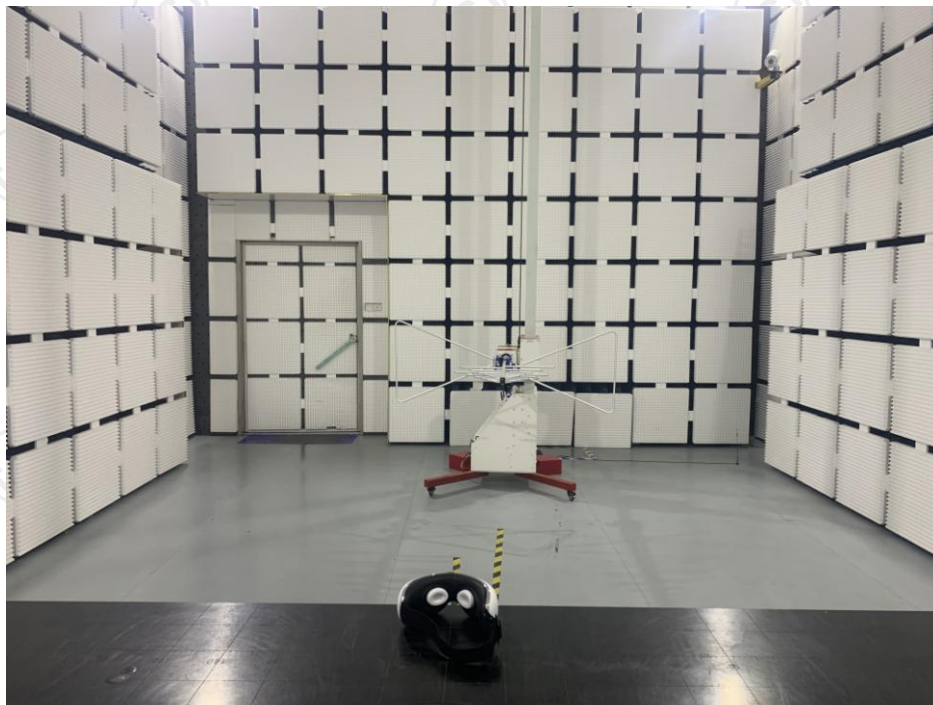
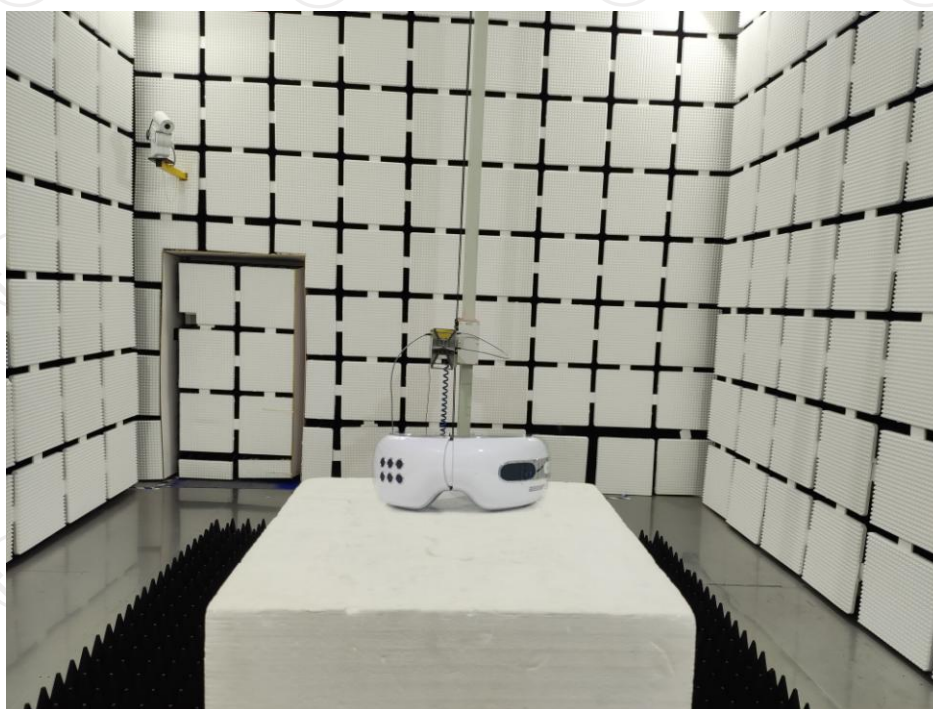
Radiated Emission

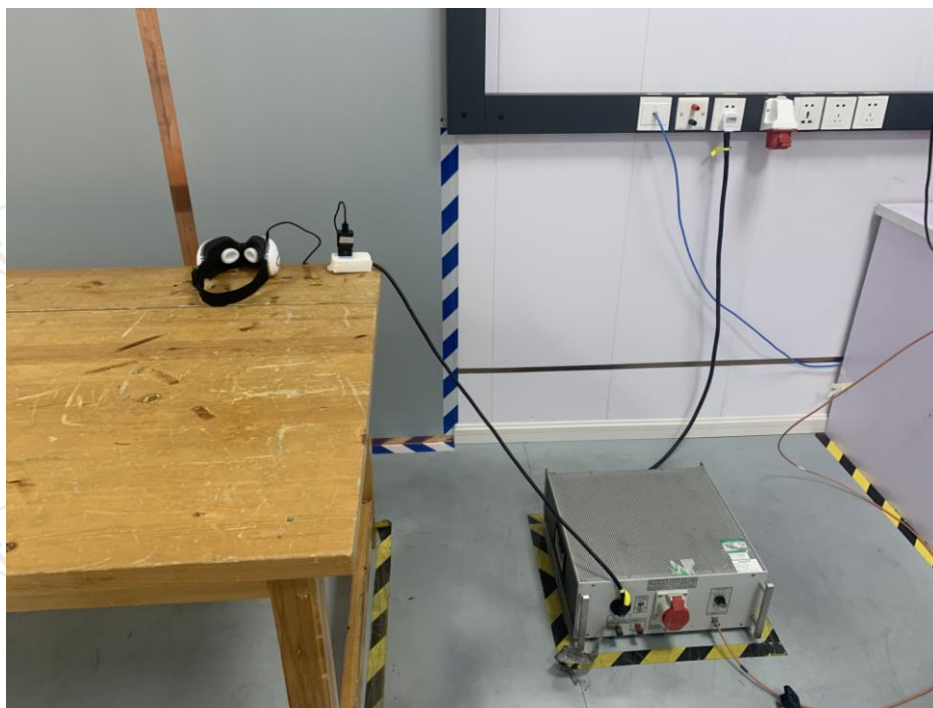
### Conducted Emission
