Appendix 1 - Photographs of test setup

Radio Tests on Genius Motorbrake Type T2080 Genius to 47 CFR Part 15C

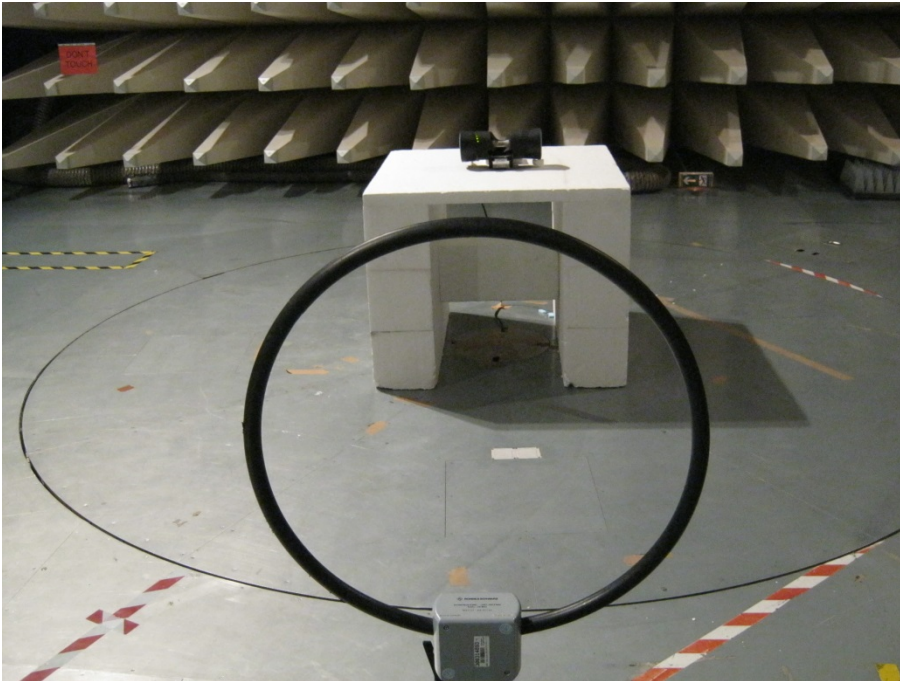
Photograph A1-1: H-Field measurement

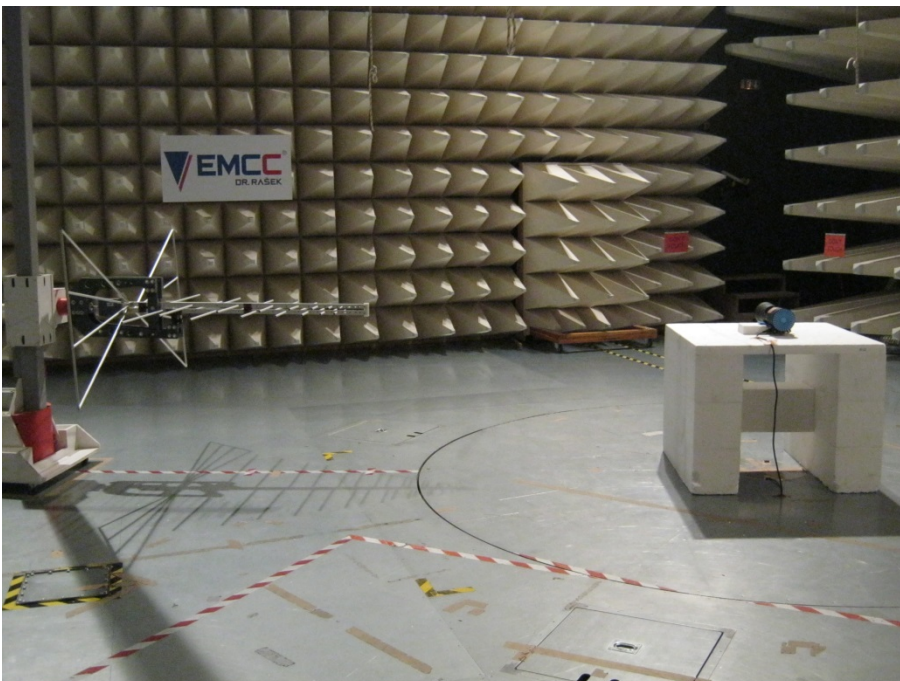
Photograph A1-2: Prescan measurement below 1 GHz (SAC)

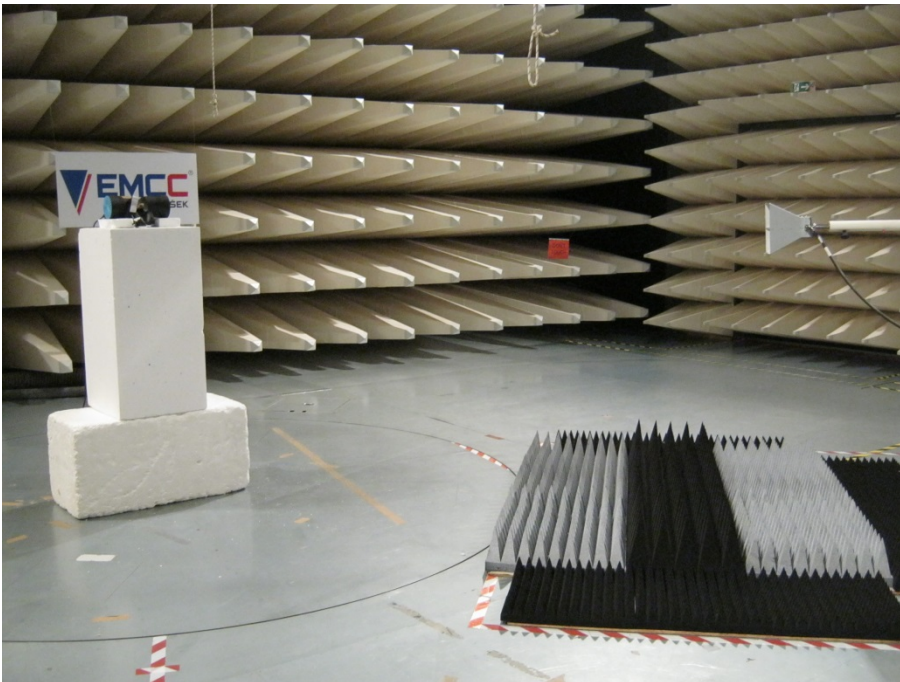
Photograph A1-3: Carrier measurement (SAC), spurious measurement 1 – 18 GHz

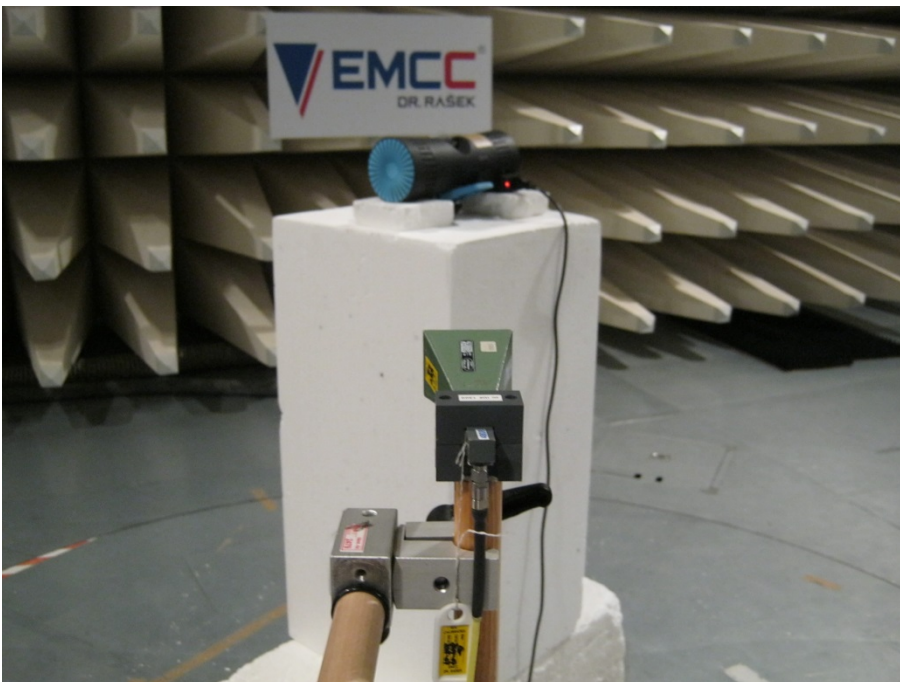
Photograph A1-4: Measurement above 18 GHz (SAC)

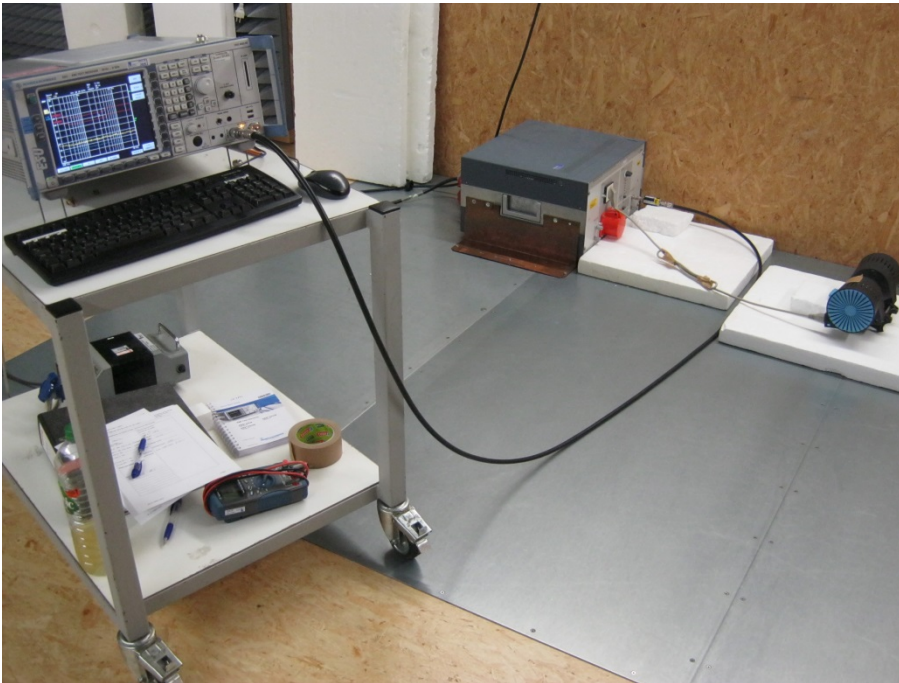
Photograph A1-5: Conducted Emission Measurement

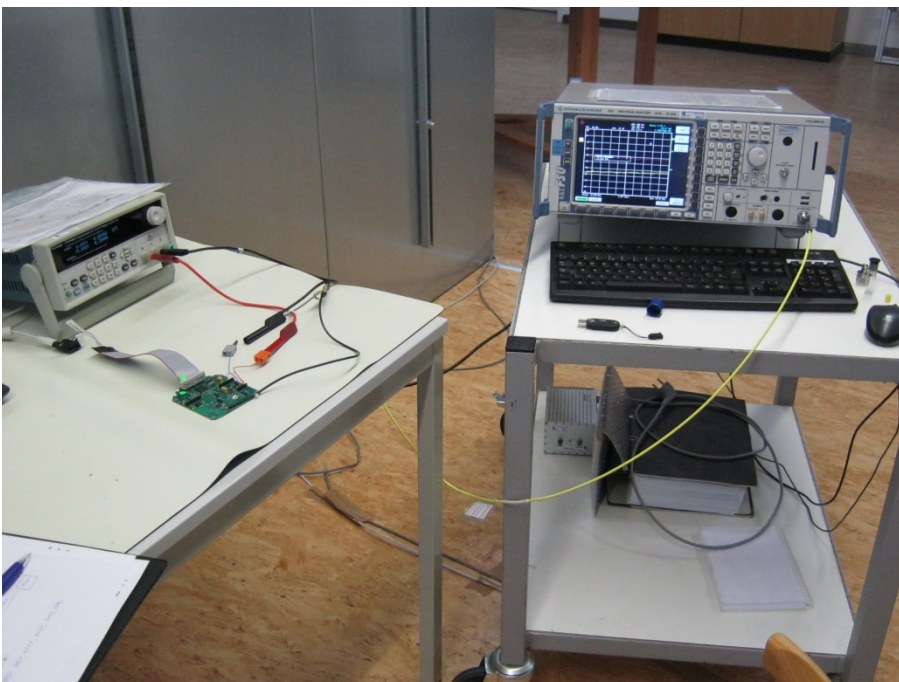
Photograph A1-6: Conducted RF Measurement
