# Photo Report on Test Setups

FCC ID: 2AAQS-ISP1507  
IC: 11306A-ISP1507

**Report Reference:** MDE\_Insight\_1603\_FCC\_Photo\_Setups

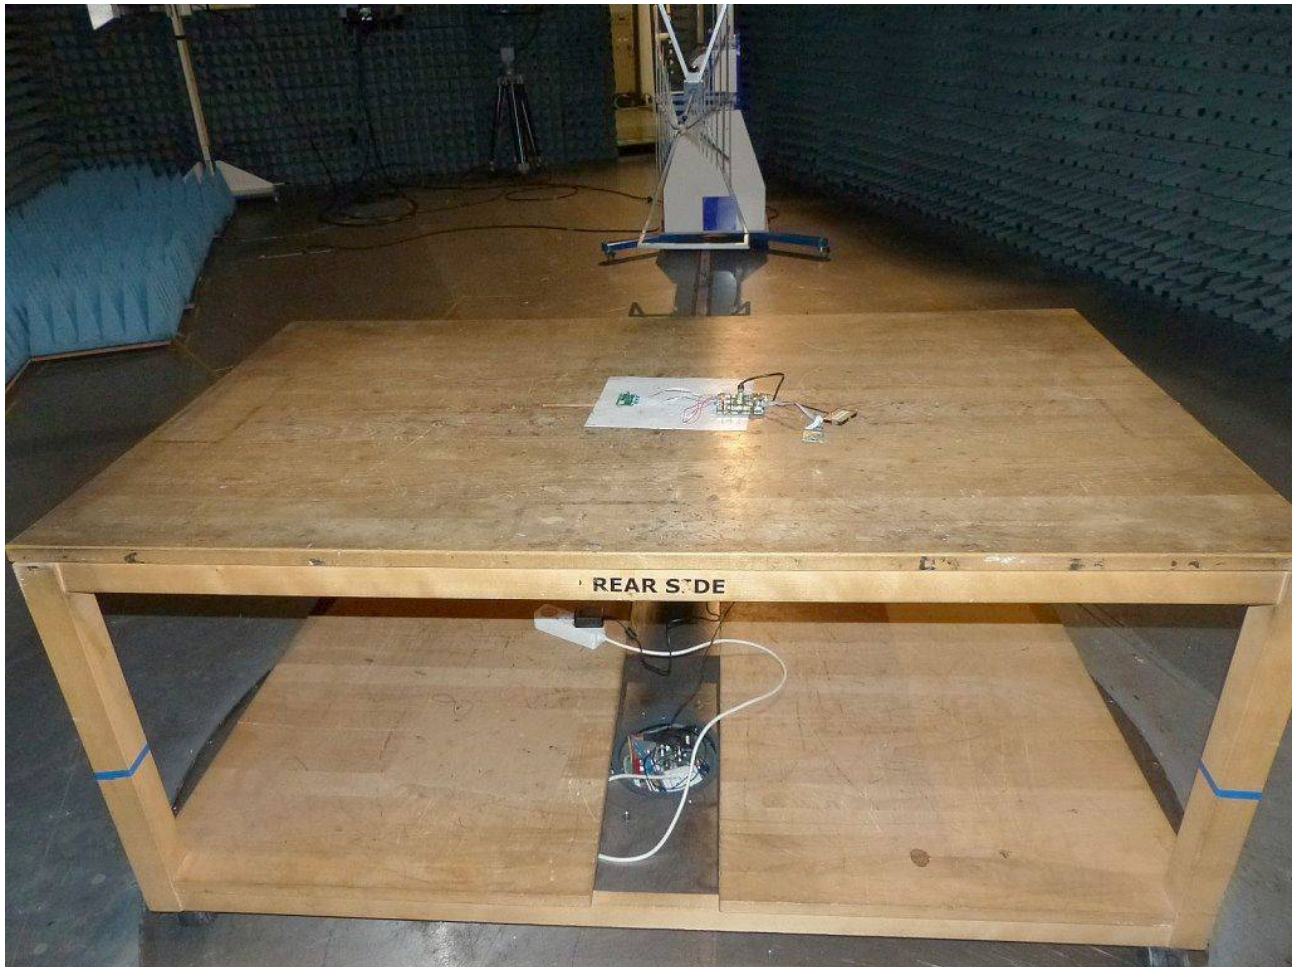
**Photo 2:** Test setup for radiated measurements (Enclosure, semi-anechoic chamber, 30 MHz to 1 GHz, intentional radiator §15, ANSI C63.10)

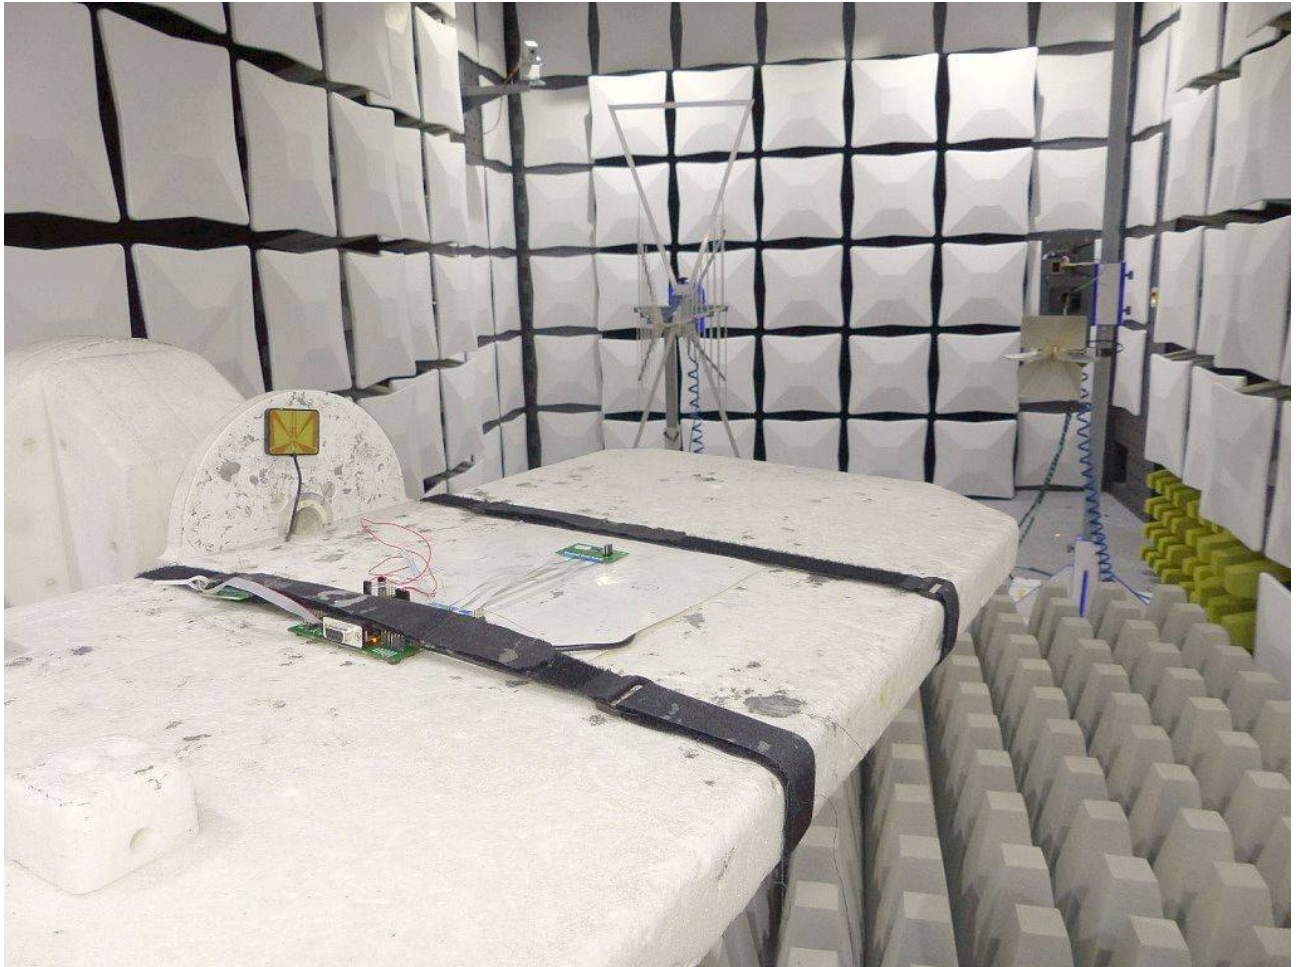
**Photo 3:** Test setup for radiated measurements (Enclosure, fully-anechoic chamber, 1-26 GHz, intentional radiator §15, ANSI C63.10)
