### Appendix G: Conducted Spurious Emission Test Result

Appendix H: Reference level measurement  
Test Result

14. TEST SETUP PHOTO

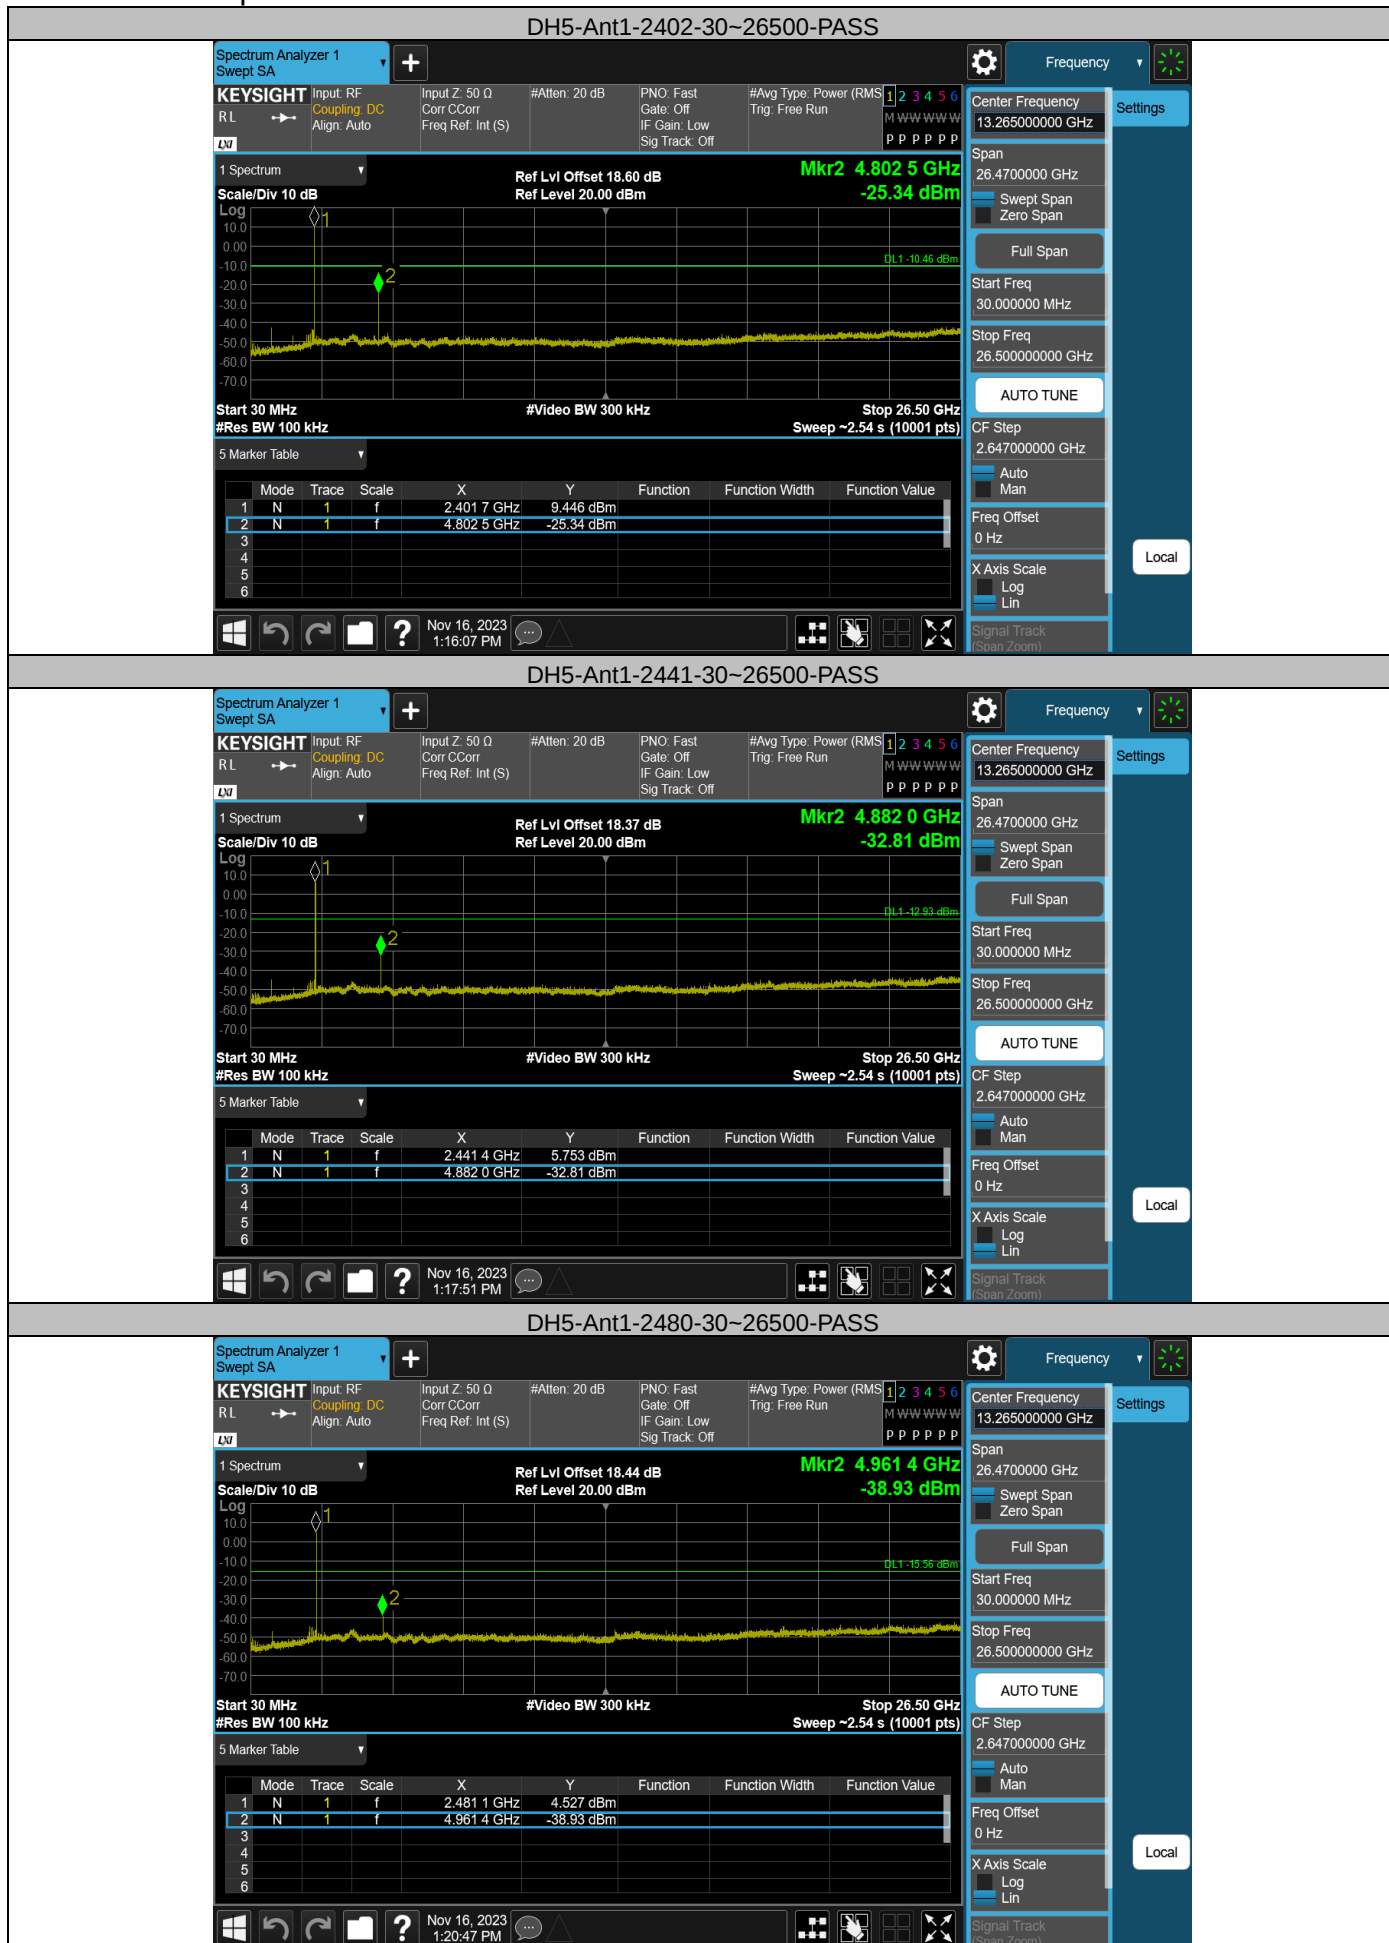
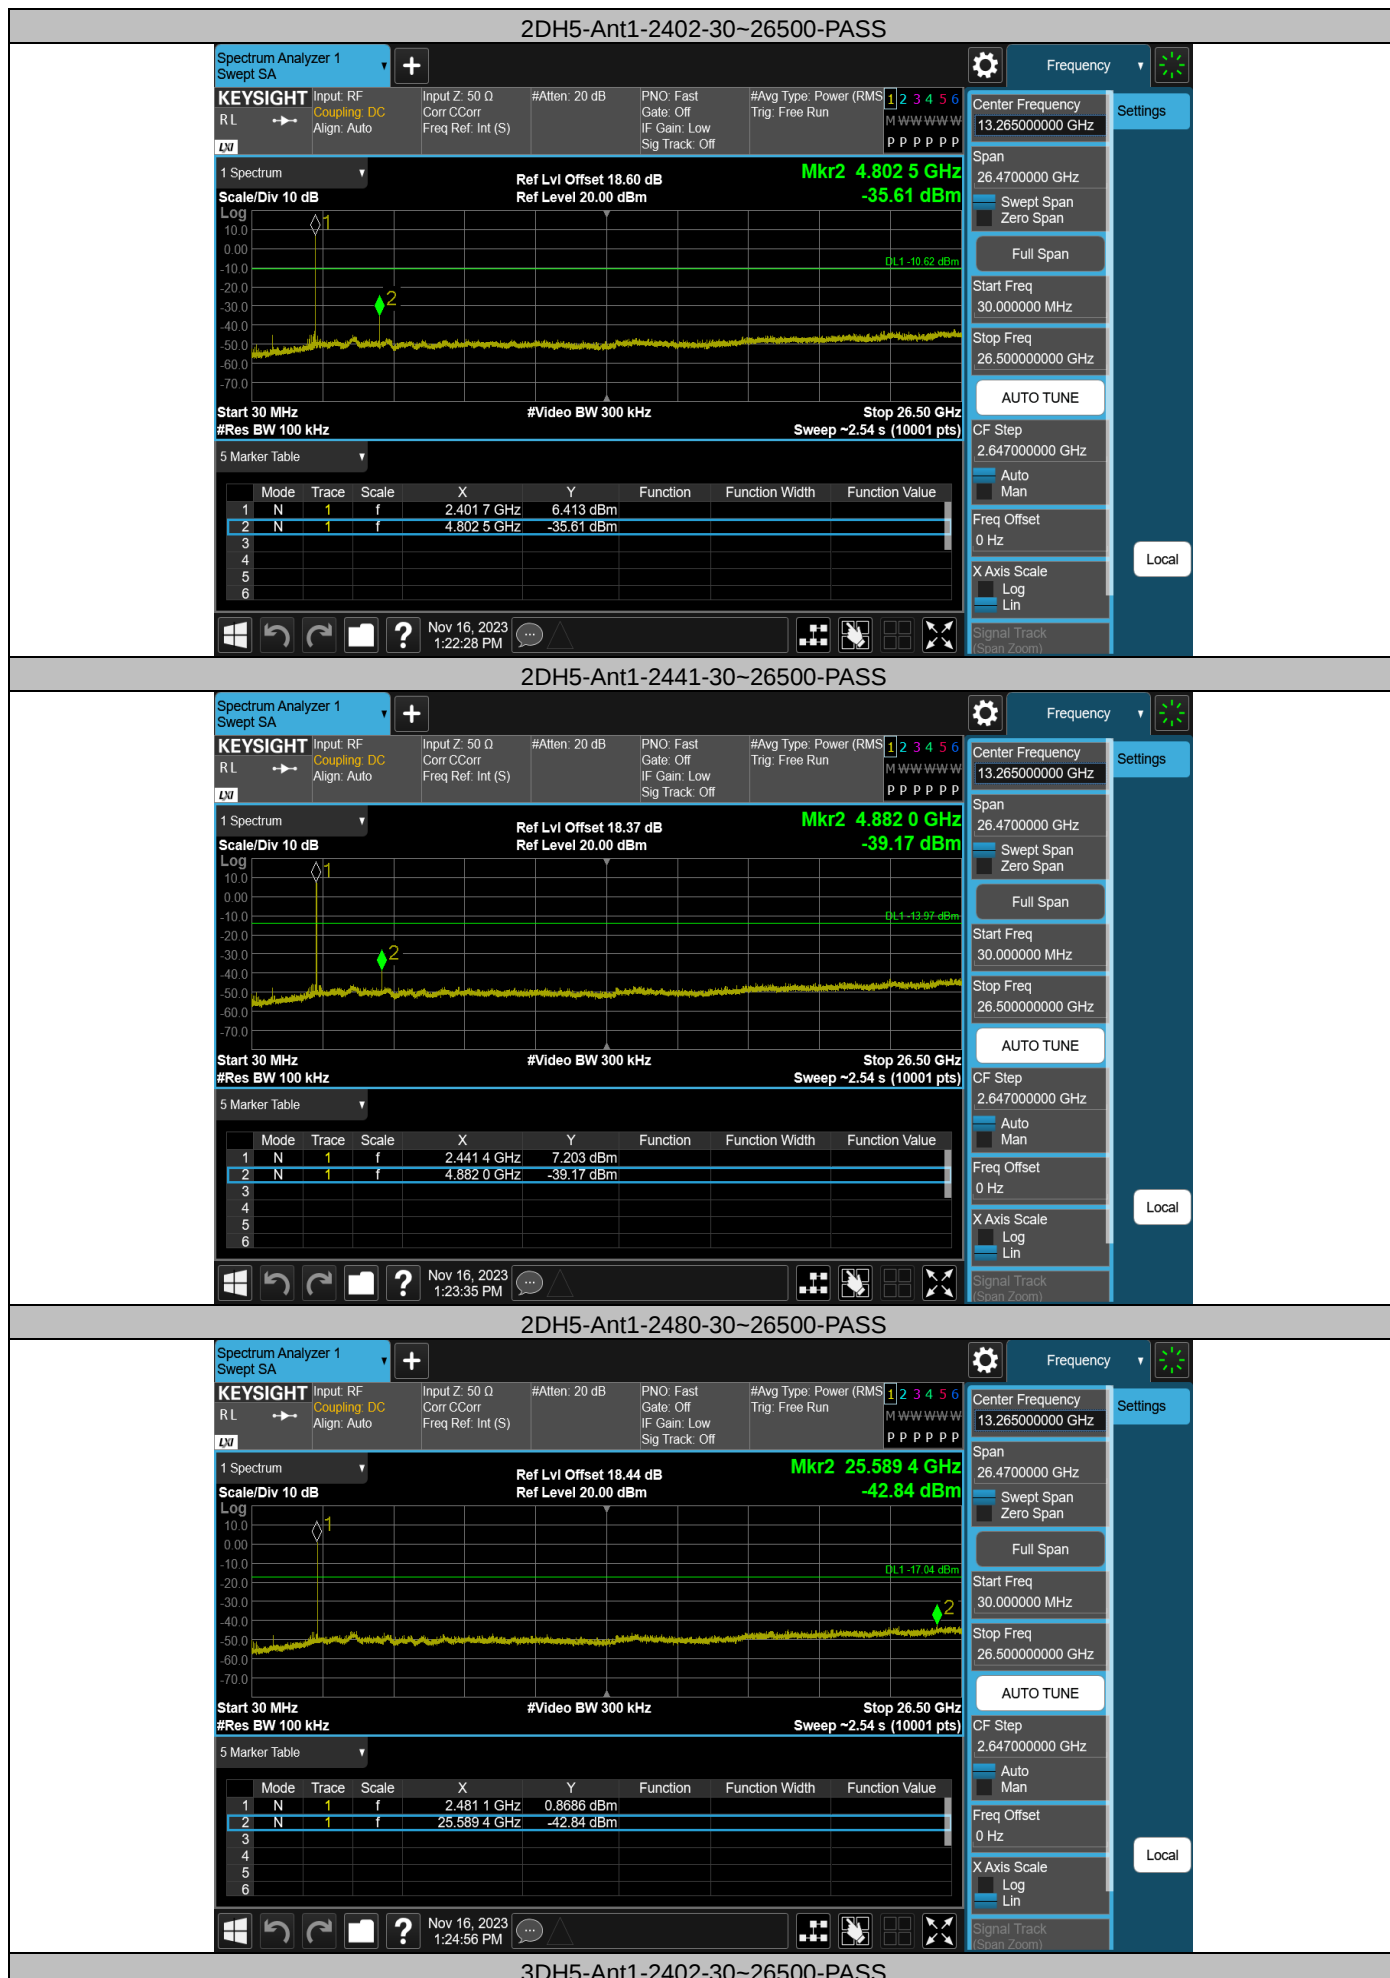
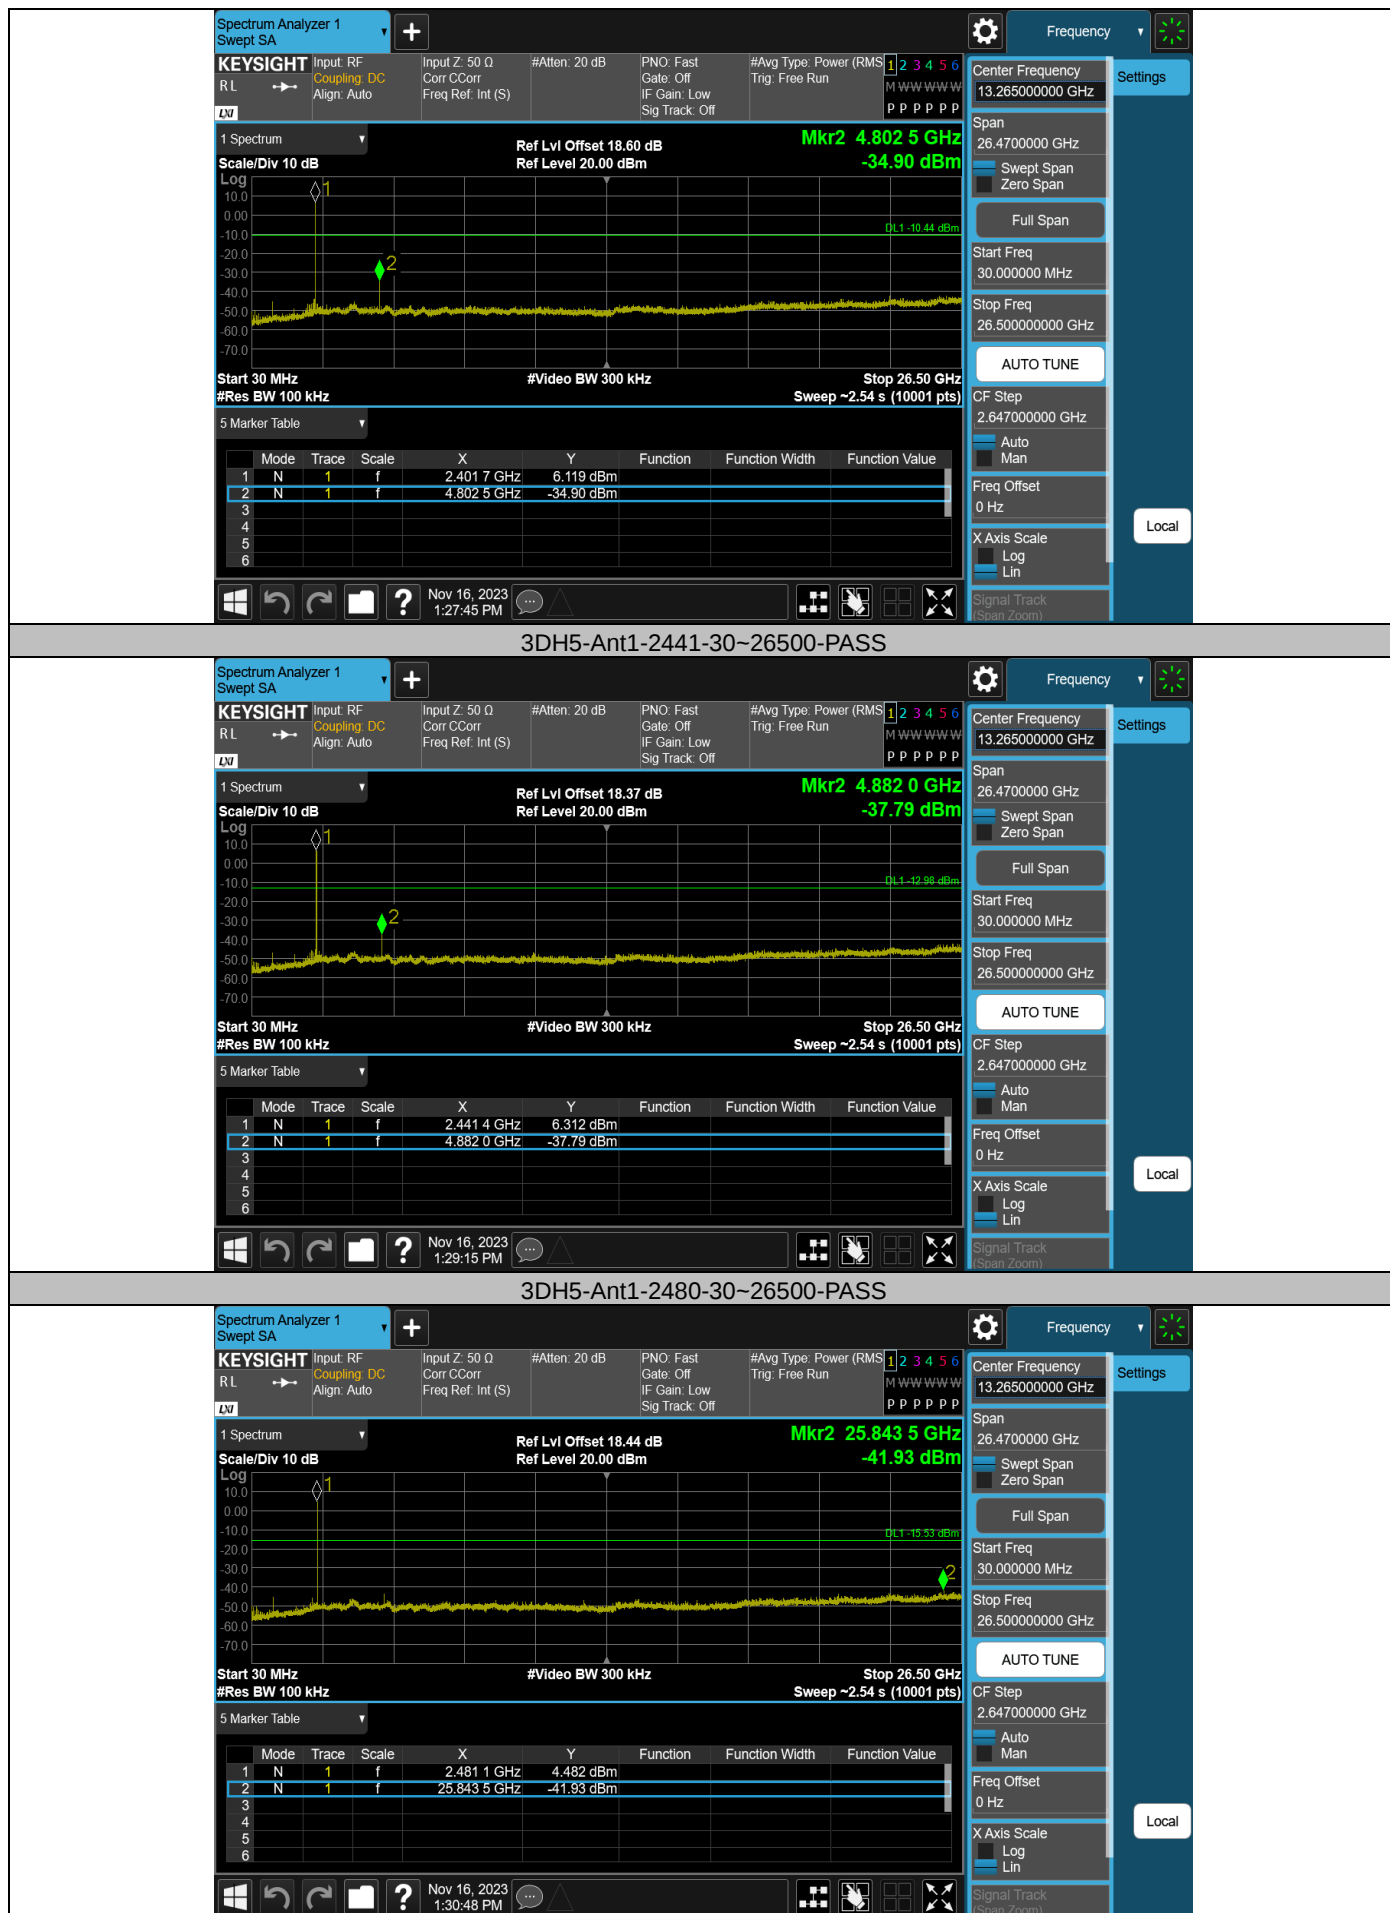
## Test Graphs

| TestMode | Antenna | Frequency[MHz] | FreqRange<br>[MHz] | RefLevel<br>[dBm] | Result<br>[dBm] | Limit<br>[dBm] | Verdict |
| DH5 | Ant1 | 2402 | 30~26500 | 9.54 | -25.34 | $\leq -10.46$ | PASS |
| DH5 | Ant1 | 2441 | 30~26500 | 7.07 | -32.81 | $\leq -12.93$ | PASS |
| DH5 | Ant1 | 2480 | 30~26500 | 4.44 | -38.93 | $\leq -15.56$ | PASS |
| 2DH5 | Ant1 | 2402 | 30~26500 | 9.38 | -35.61 | $\leq -10.62$ | PASS |
| 2DH5 | Ant1 | 2441 | 30~26500 | 6.03 | -39.17 | $\leq -13.97$ | PASS |
| 2DH5 | Ant1 | 2480 | 30~26500 | 2.96 | -42.84 | $\leq -17.04$ | PASS |
| 3DH5 | Ant1 | 2402 | 30~26500 | 9.56 | -34.9 | $\leq -10.44$ | PASS |
| 3DH5 | Ant1 | 2441 | 30~26500 | 7.02 | -37.79 | $\leq -12.98$ | PASS |
| 3DH5 | Ant1 | 2480 | 30~26500 | 4.47 | -41.93 | $\leq -15.53$ | PASS |

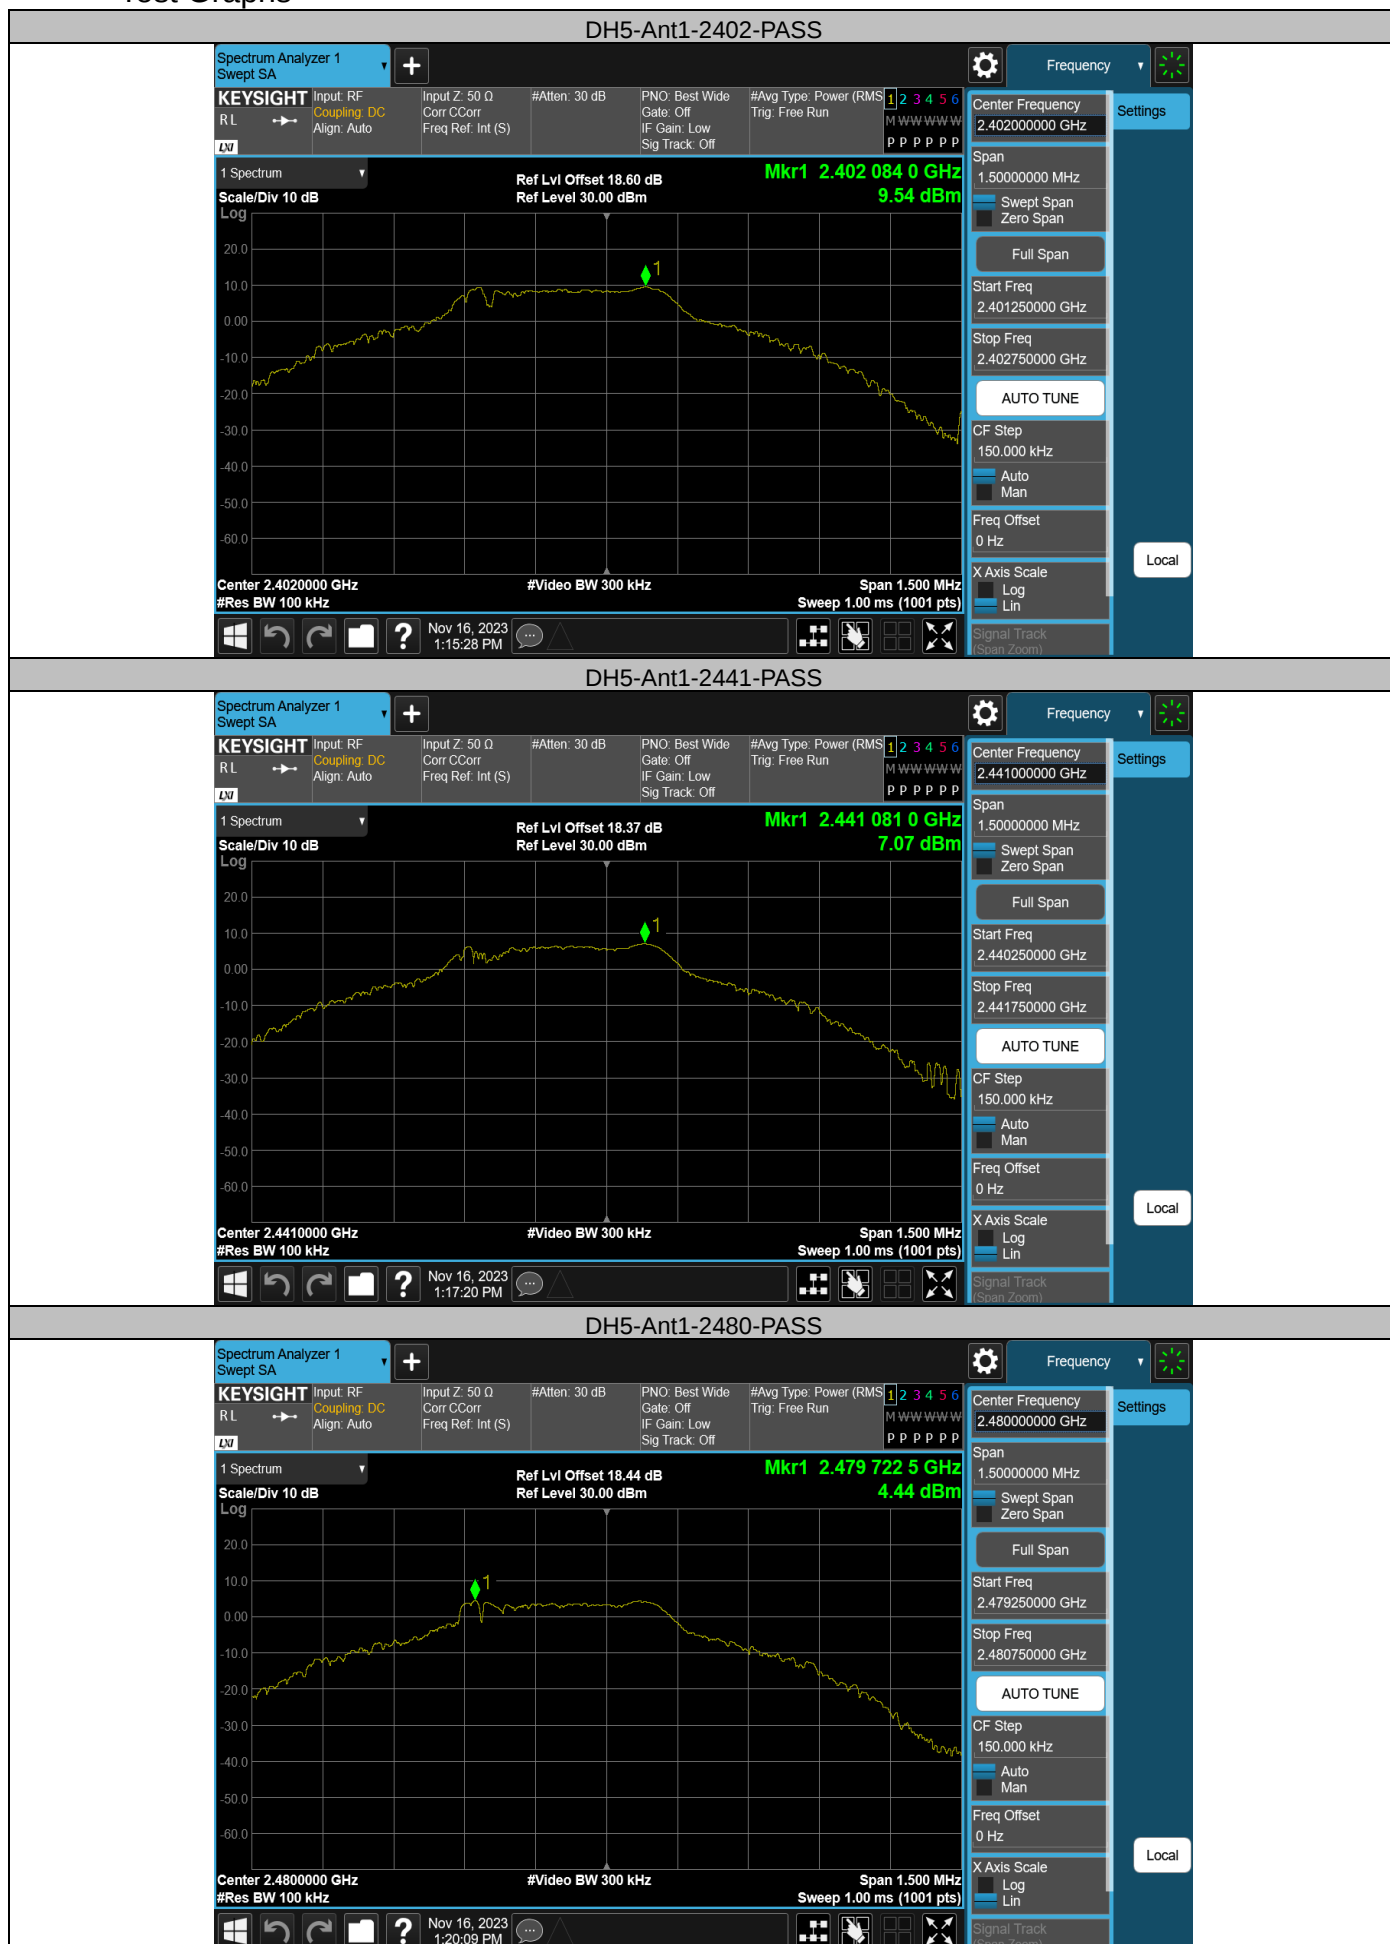
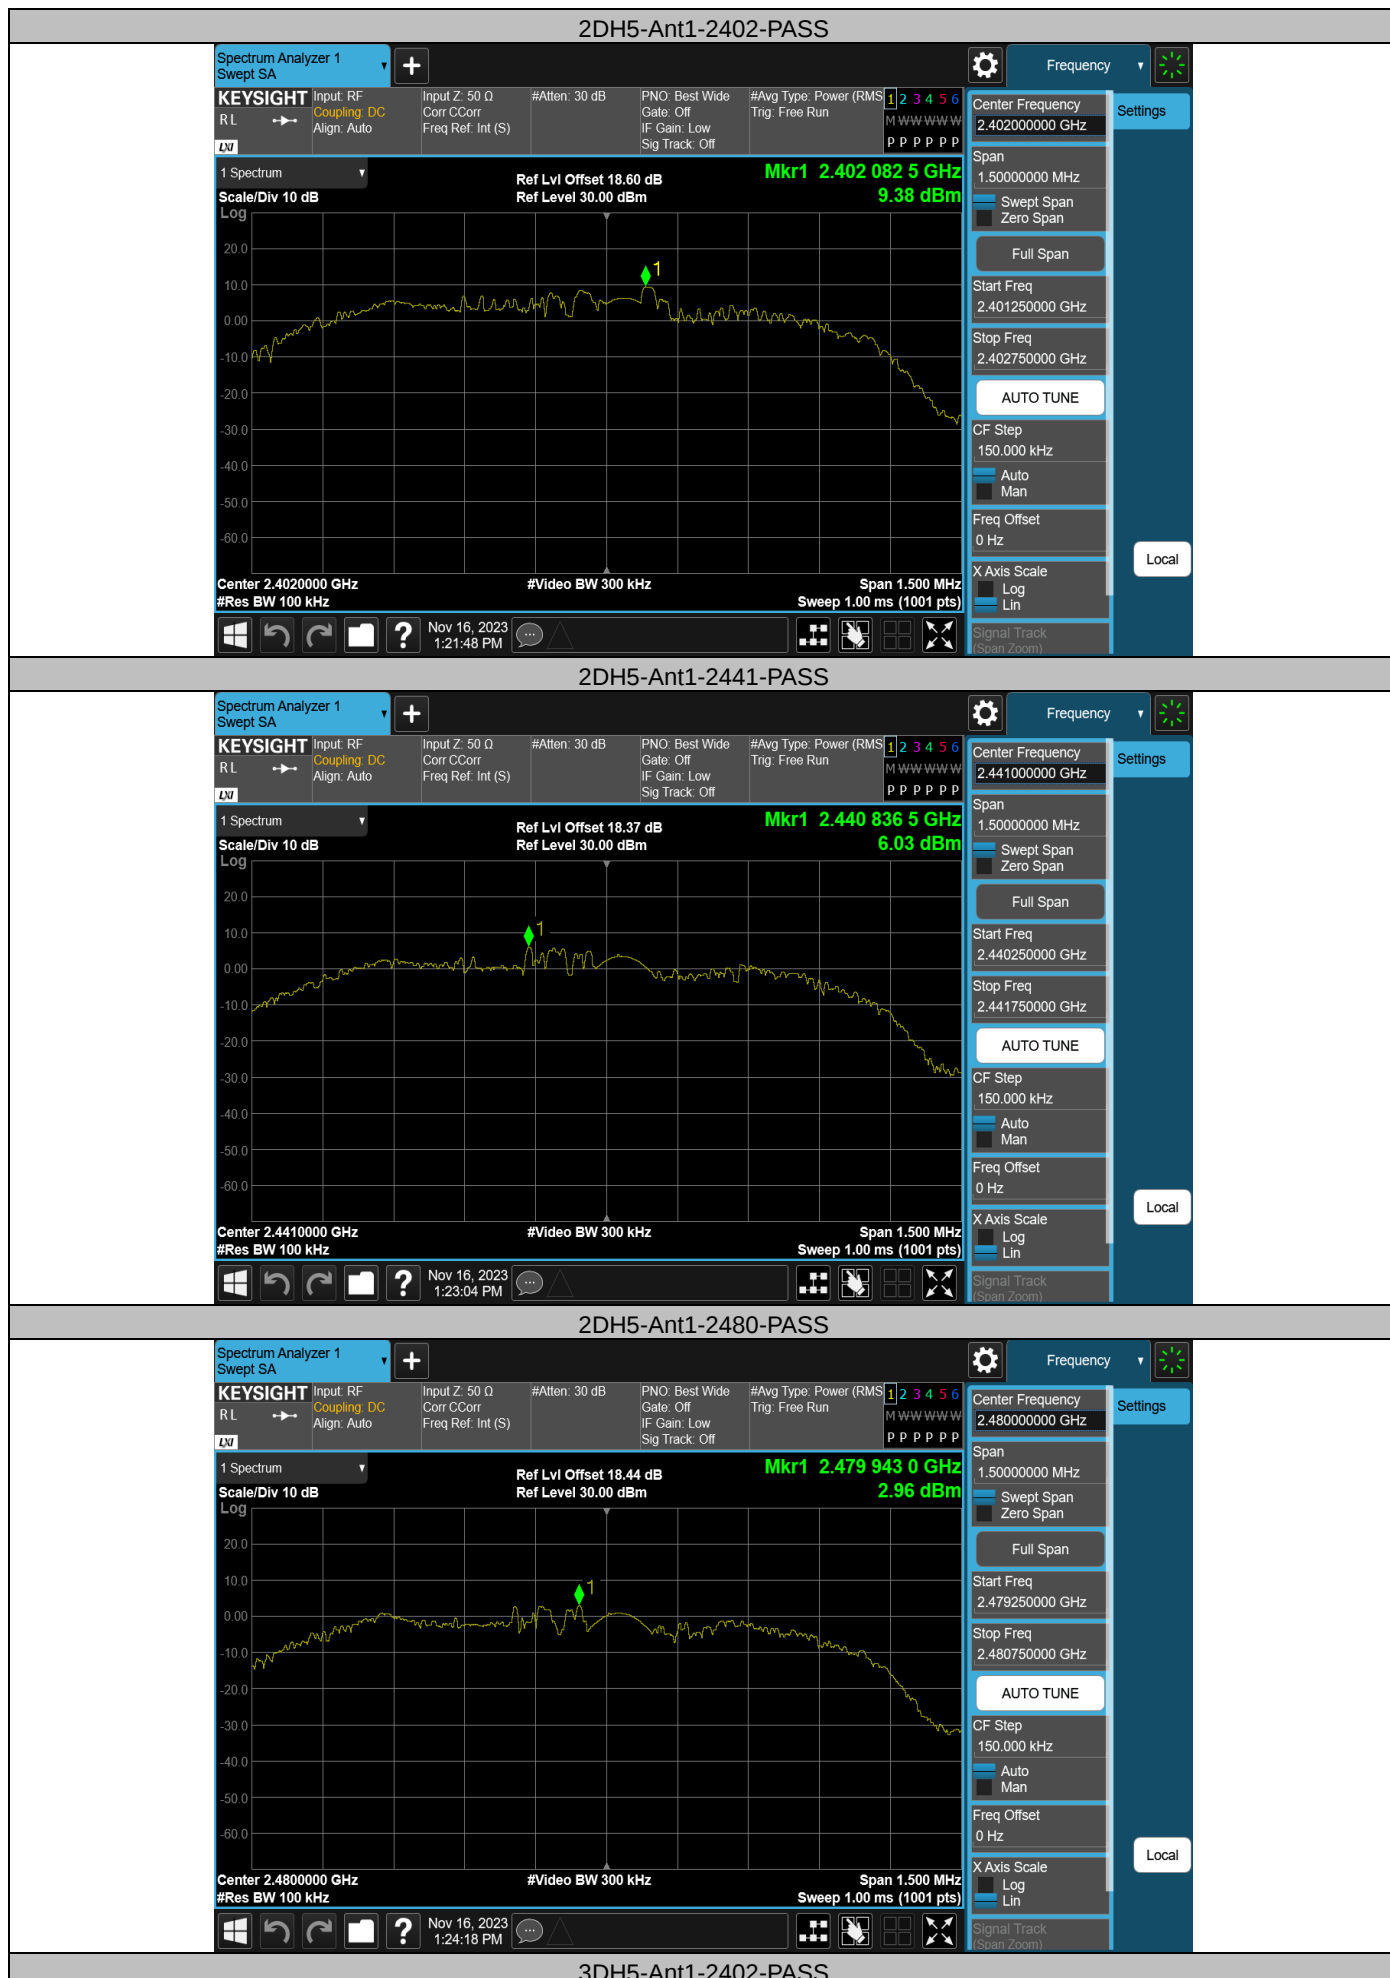
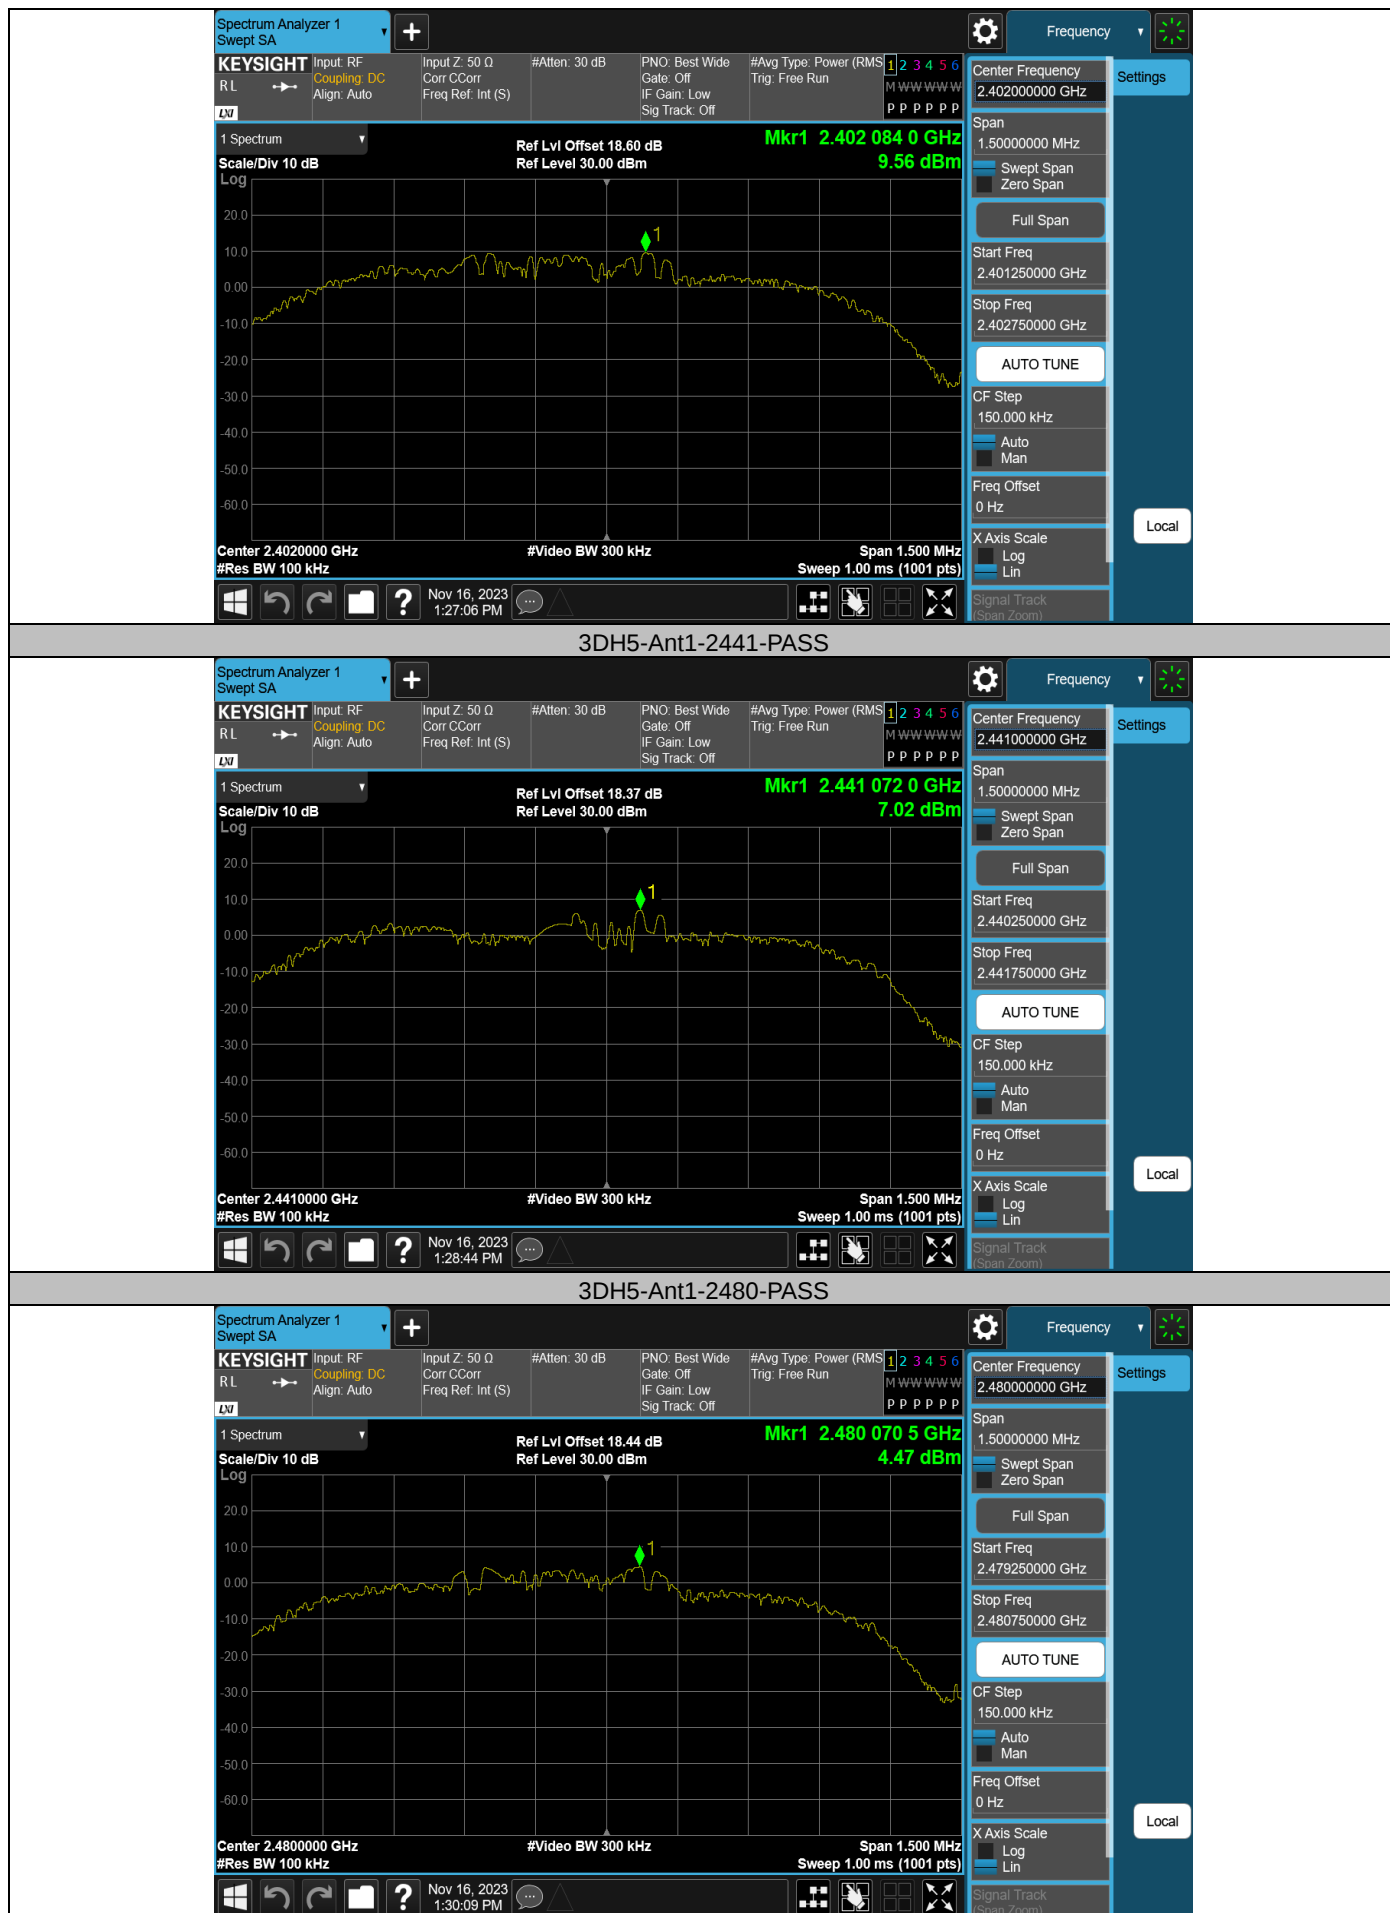
## Test Graphs

| TestMode | Antenna | Freq(MHz) | Max.Point[MHz] | Result[dBm] |
| DH5 | Ant1 | 2402 | 2402.08 | 9.54 |
| DH5 | Ant1 | 2441 | 2441.08 | 7.07 |
| DH5 | Ant1 | 2480 | 2479.72 | 4.44 |
| 2DH5 | Ant1 | 2402 | 2402.08 | 9.38 |
| 2DH5 | Ant1 | 2441 | 2440.84 | 6.03 |
| 2DH5 | Ant1 | 2480 | 2479.94 | 2.96 |
| 3DH5 | Ant1 | 2402 | 2402.08 | 9.56 |
| 3DH5 | Ant1 | 2441 | 2441.07 | 7.02 |
| 3DH5 | Ant1 | 2480 | 2480.07 | 4.47 |

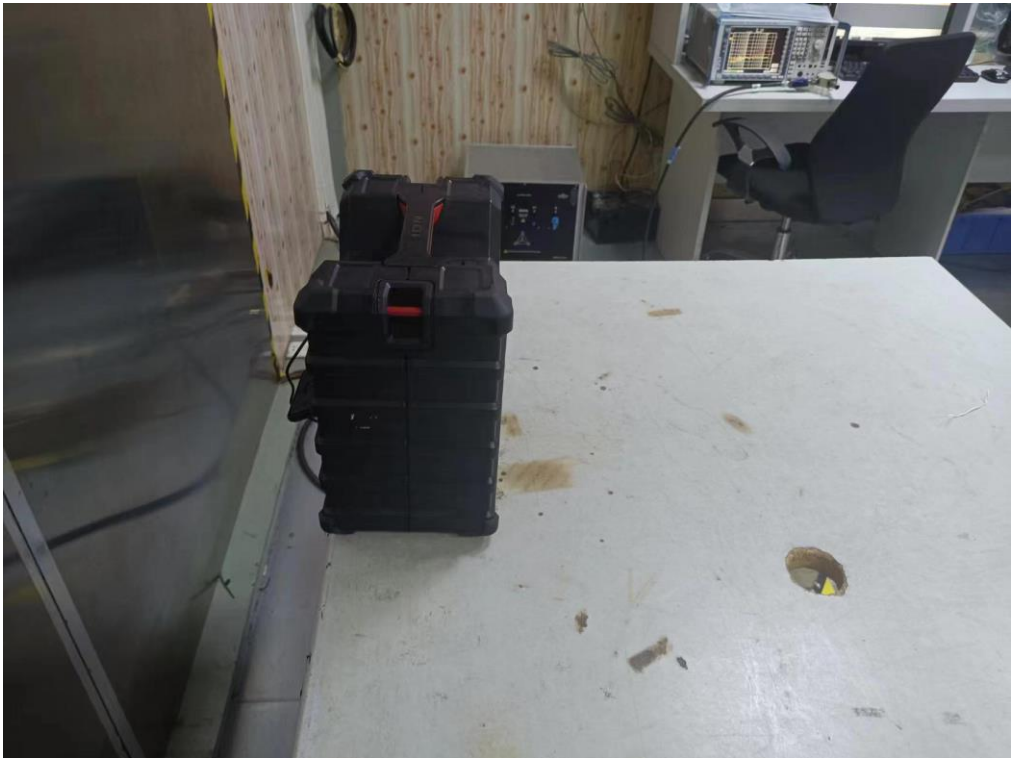
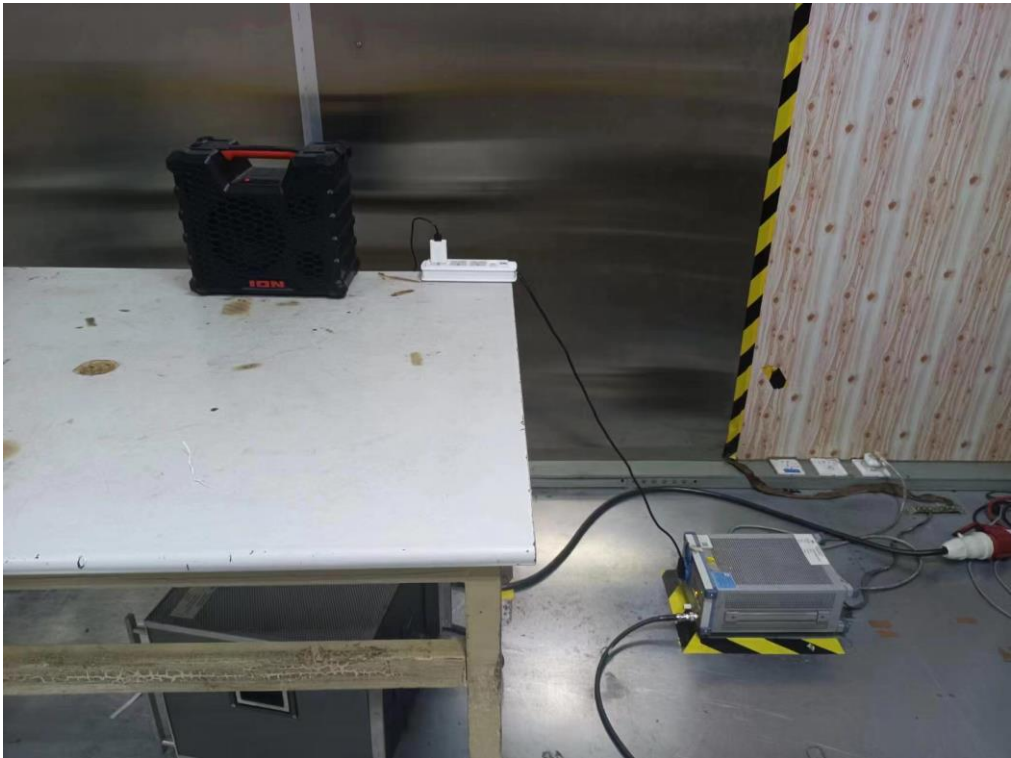
Conducted Test

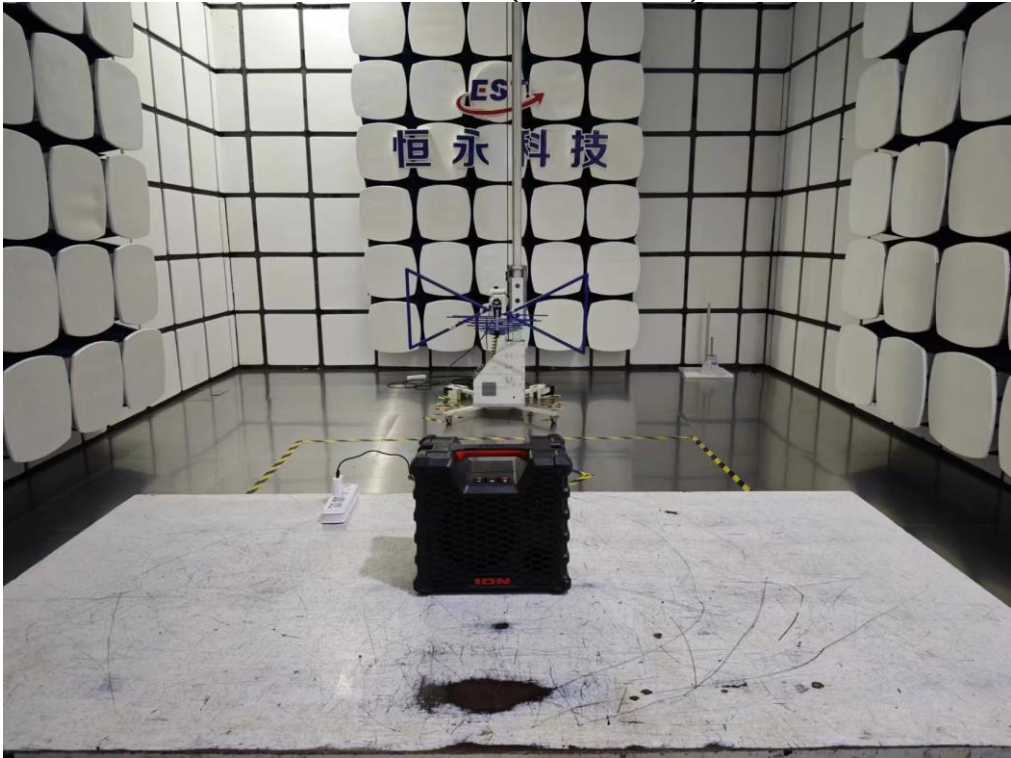
Radiated Test (Below 1GHz)

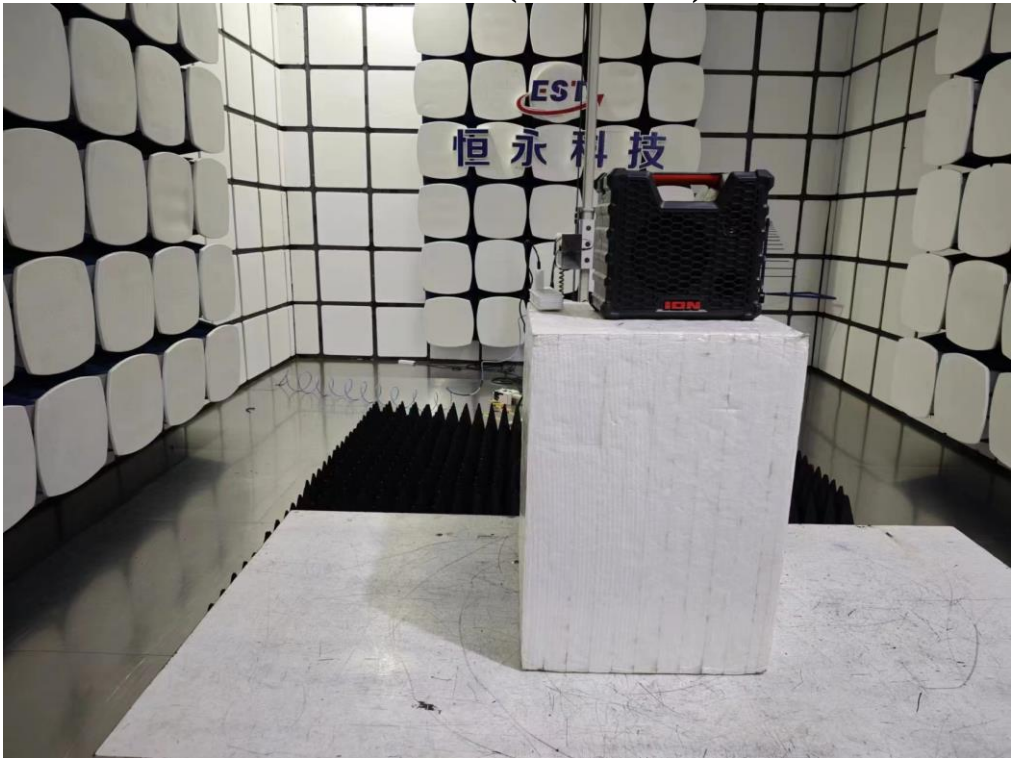
Radiated Test (Above 1GHz)

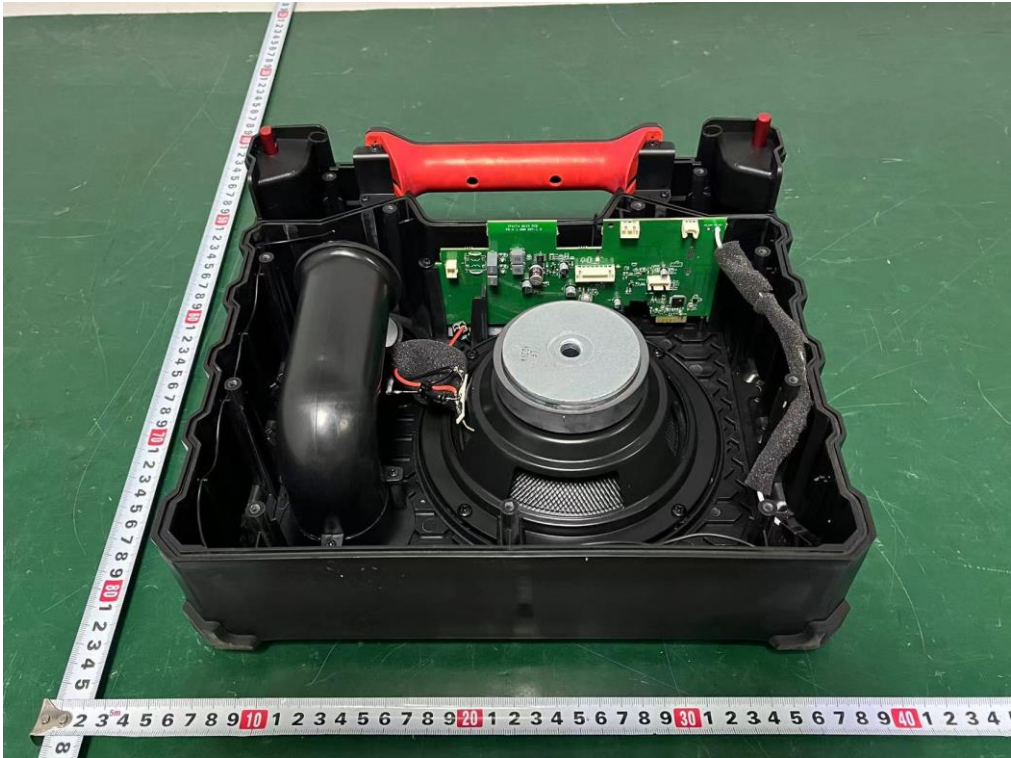
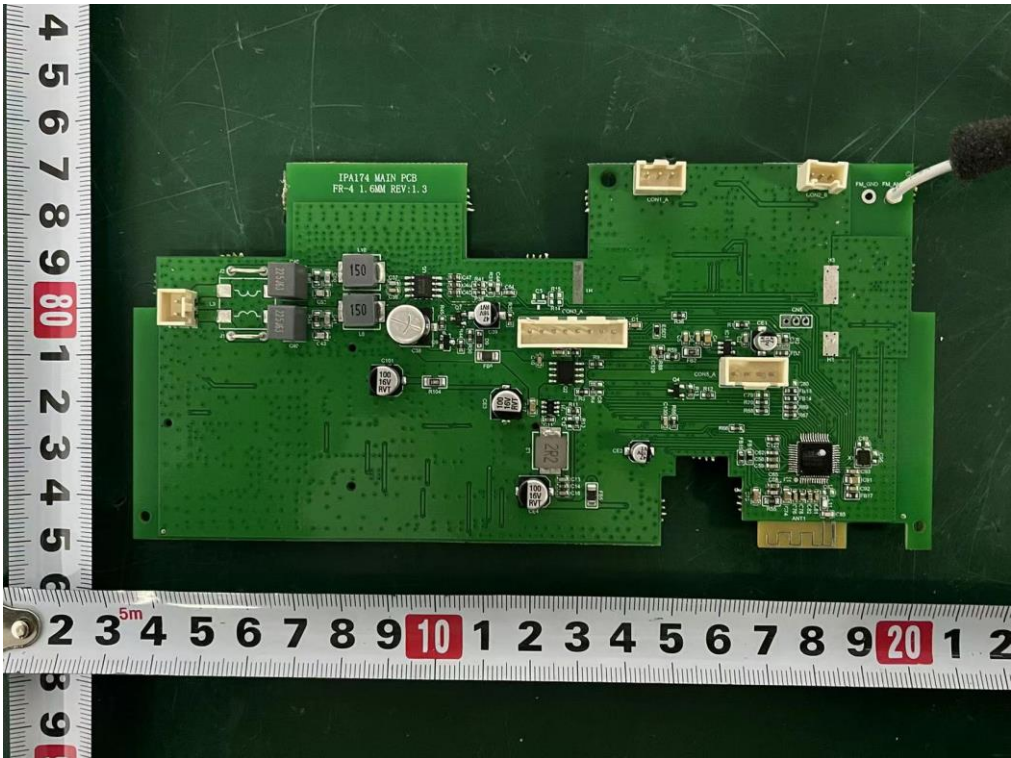
Internal Photos  
M/N: TAILGATER® TOUGH

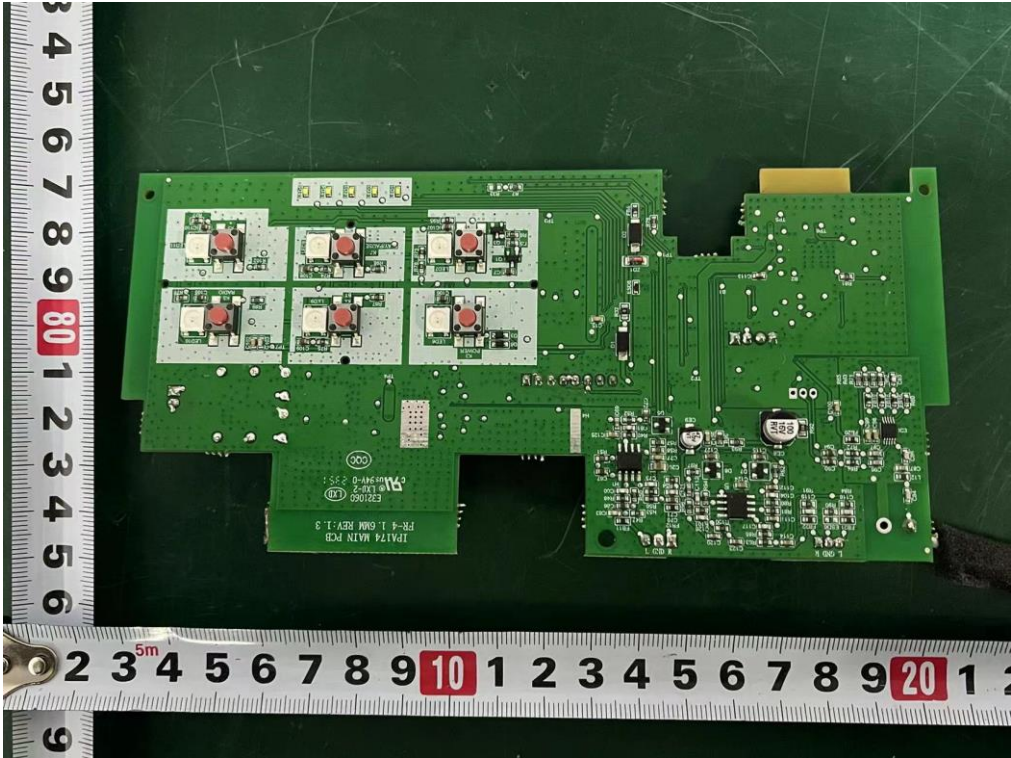
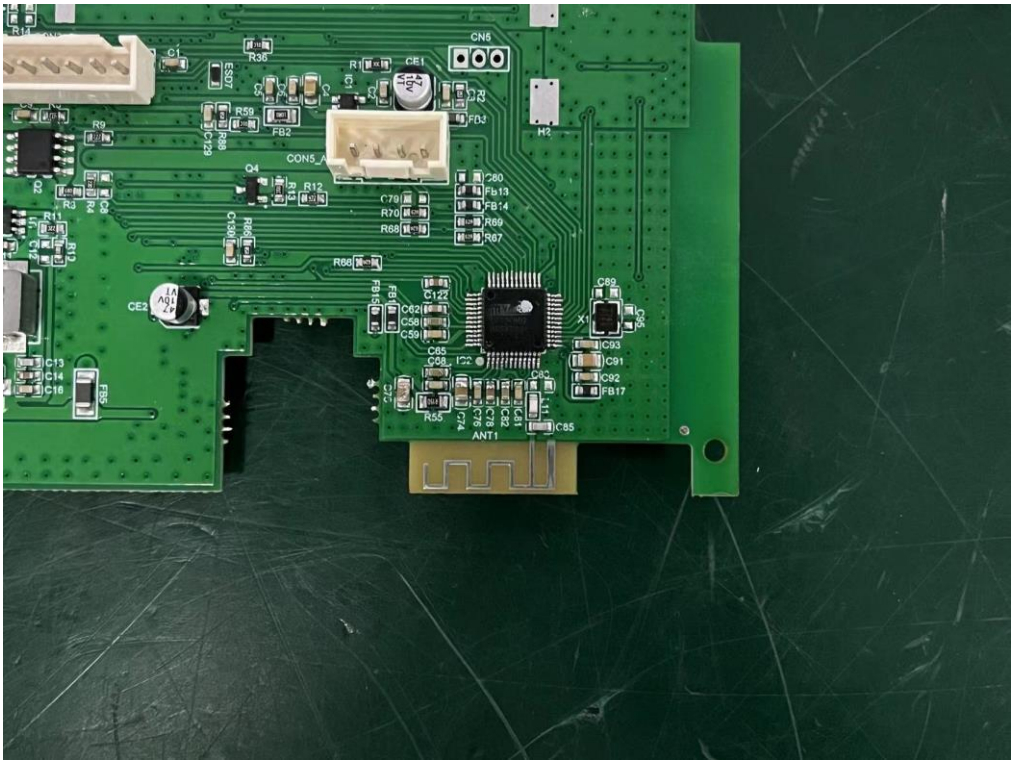
Internal Photos  
M/N: TAILGATER® TOUGH
