### Appendix G: Conducted Spurious Emission Test Result

Appendix H: Reference level measurement  
Test Result

14. TEST SETUP PHOTO

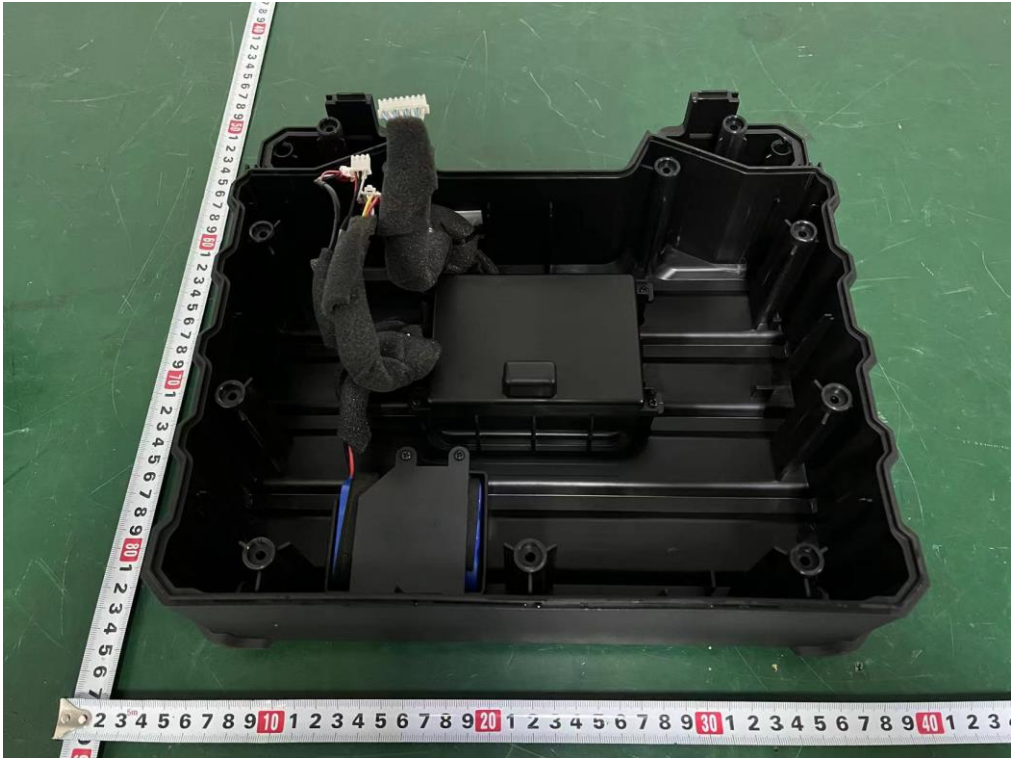
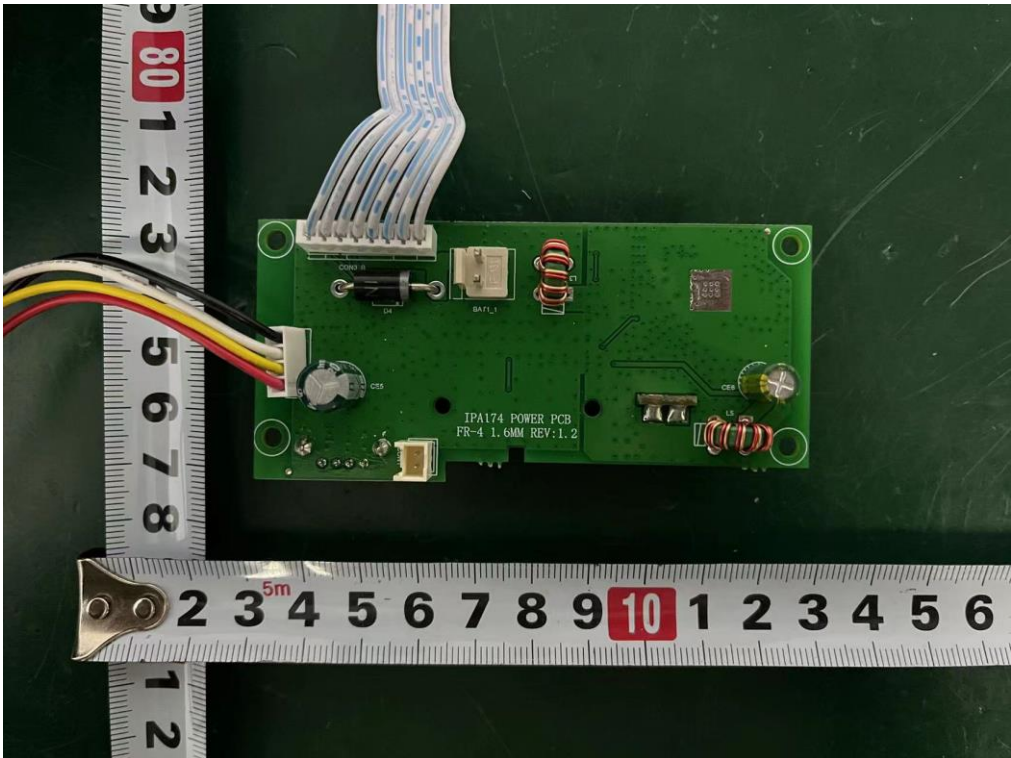
Internal Photos  
M/N: TAILGATER® TOUGH

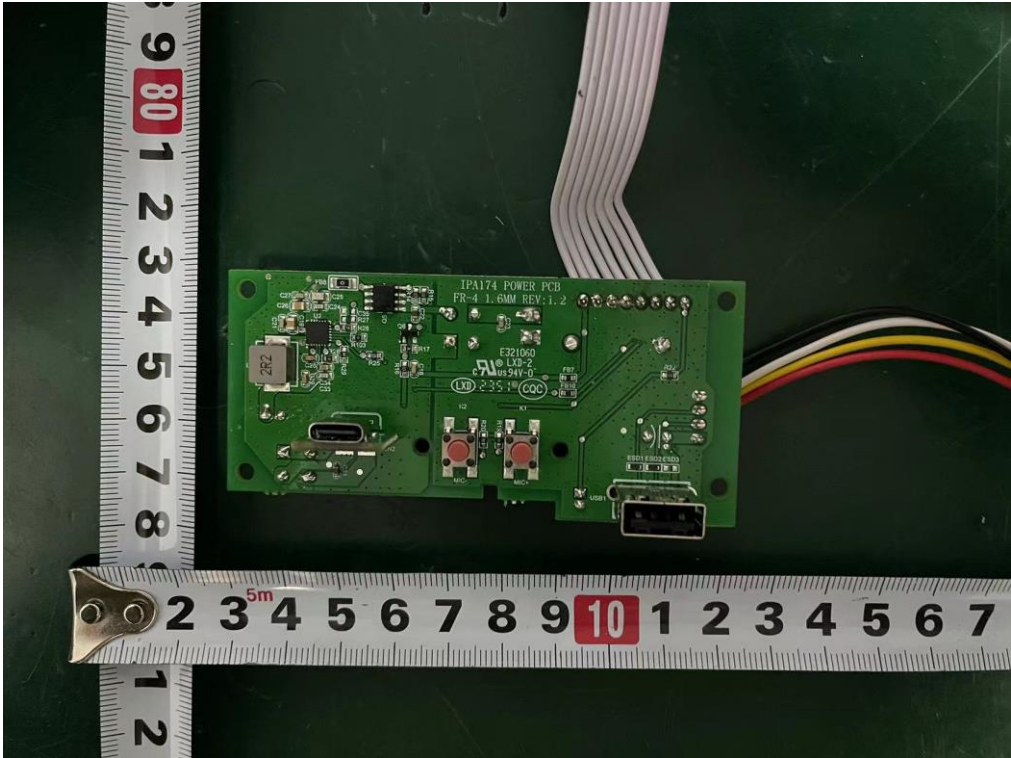
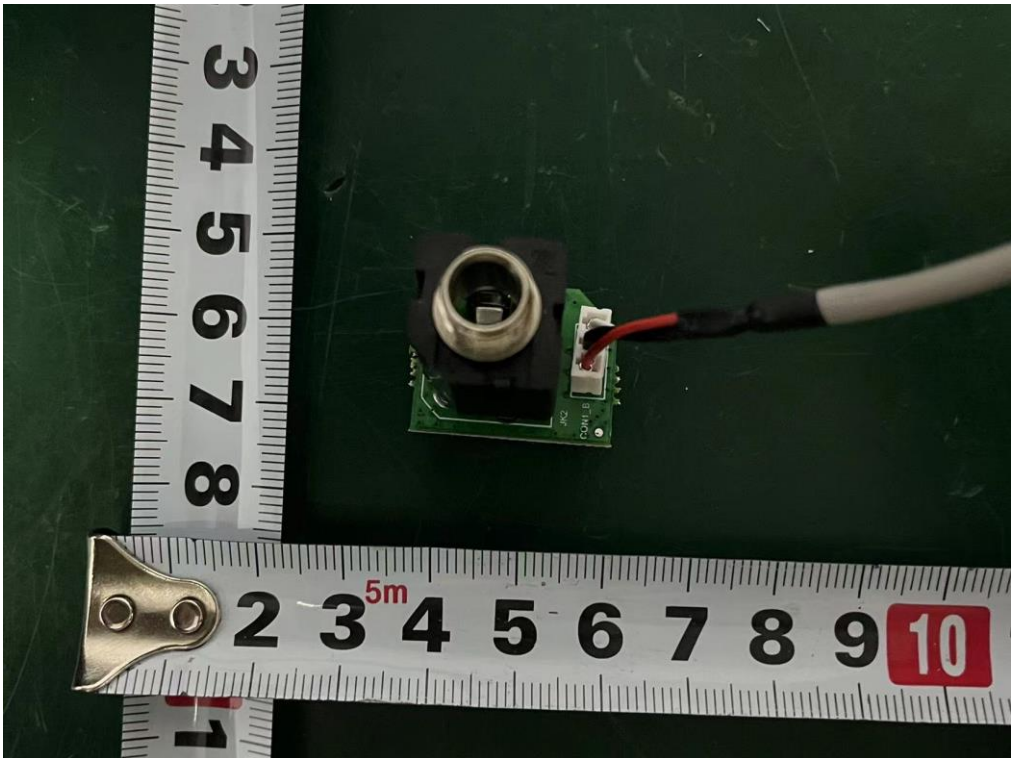
Internal Photos  
M/N: TAILGATER® TOUGH

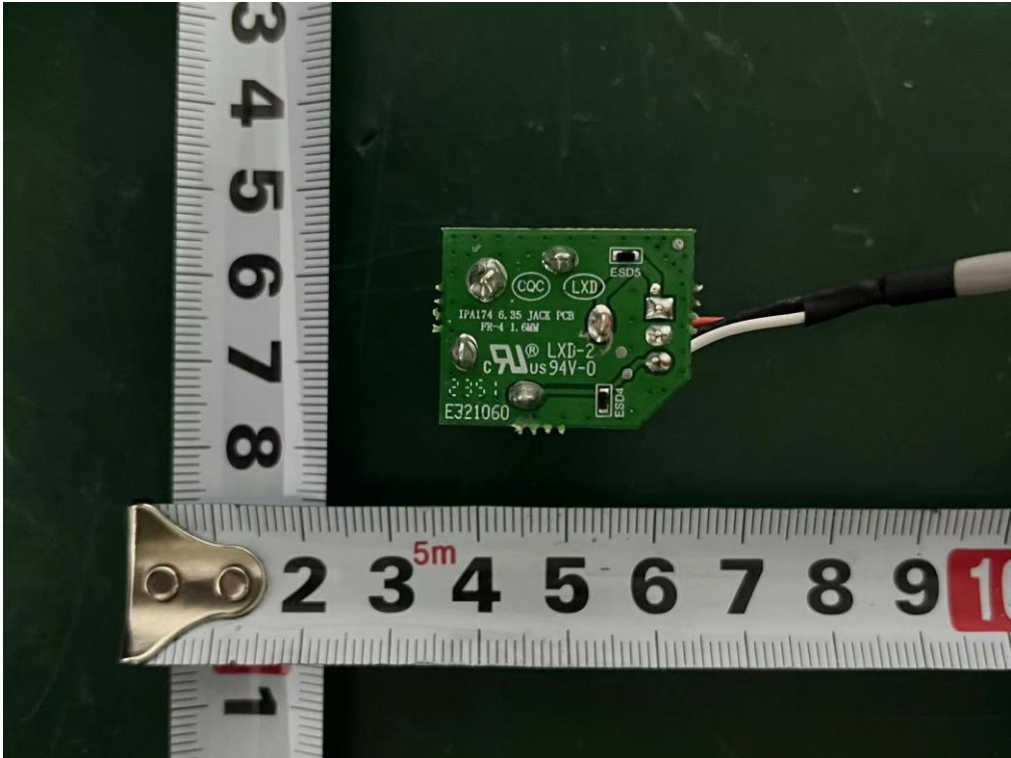
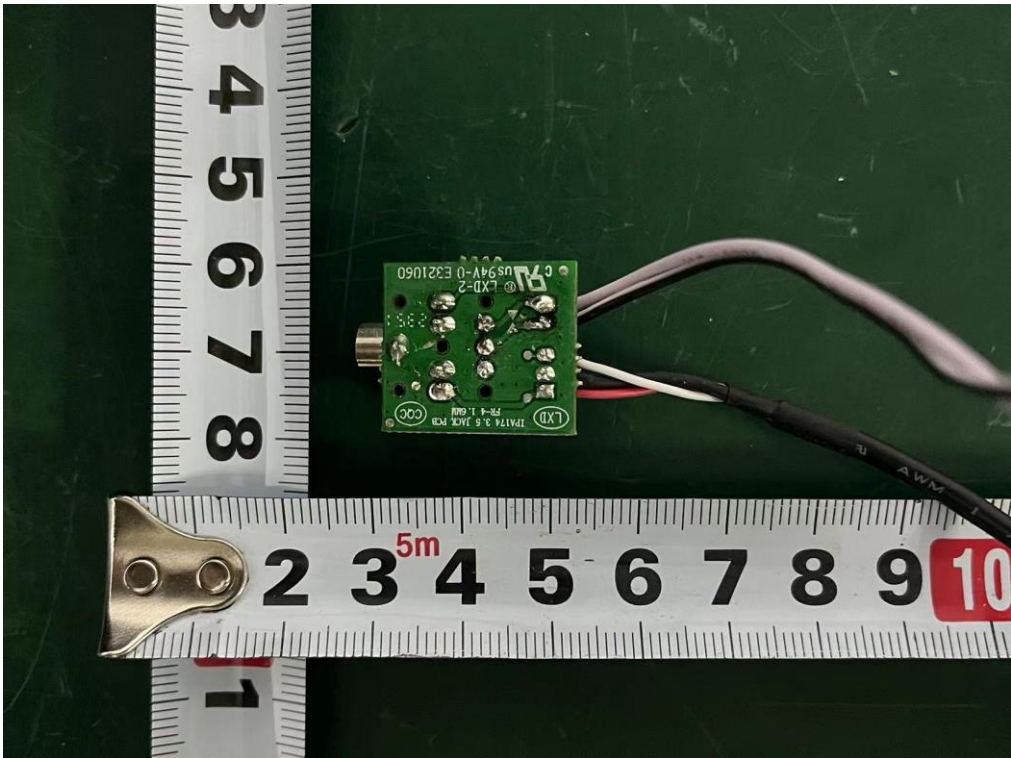
Internal Photos  
M/N: TAILGATER® TOUGH

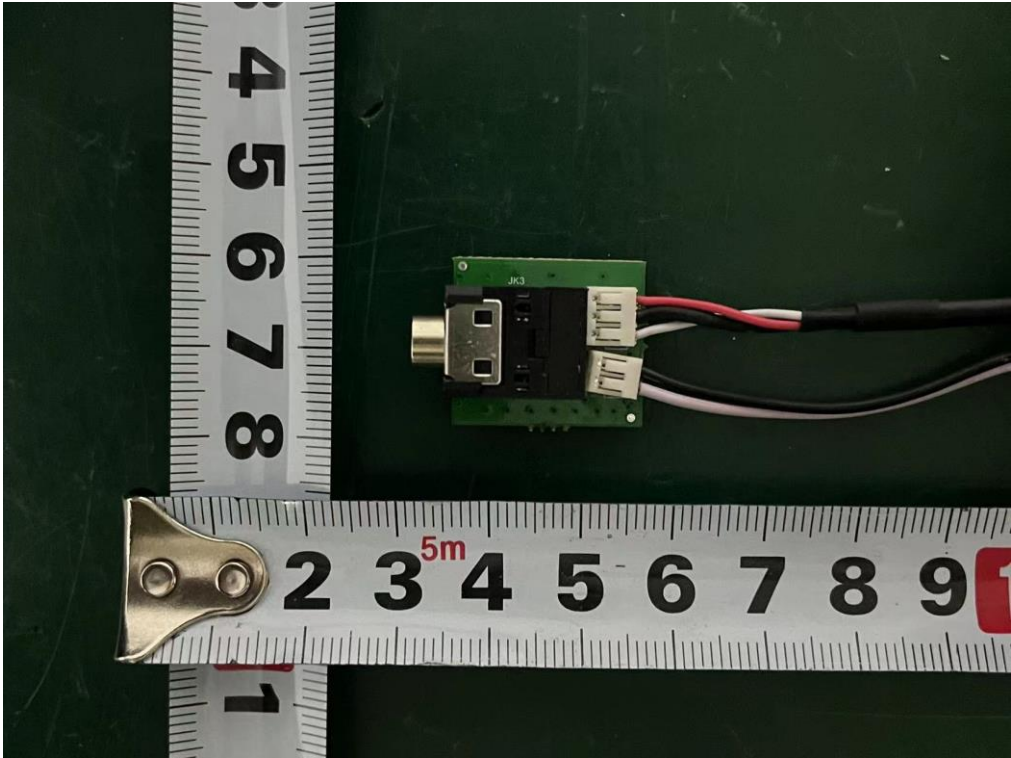
**Internal Photos**  
M/N: TAILGATER® TOUGH

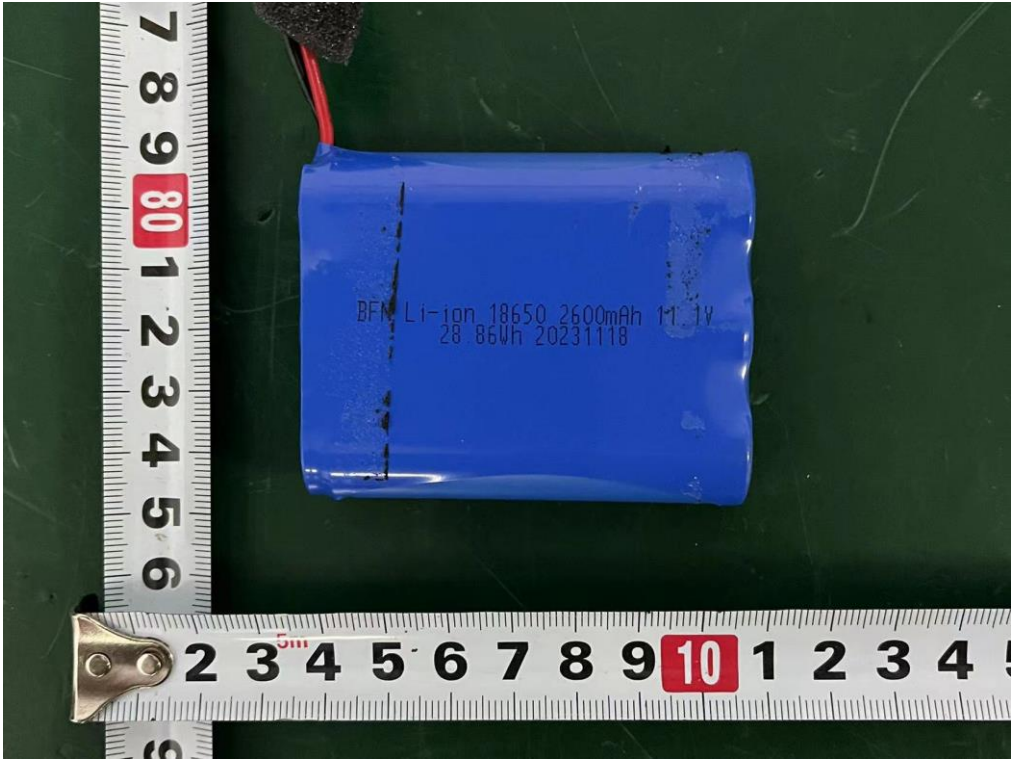
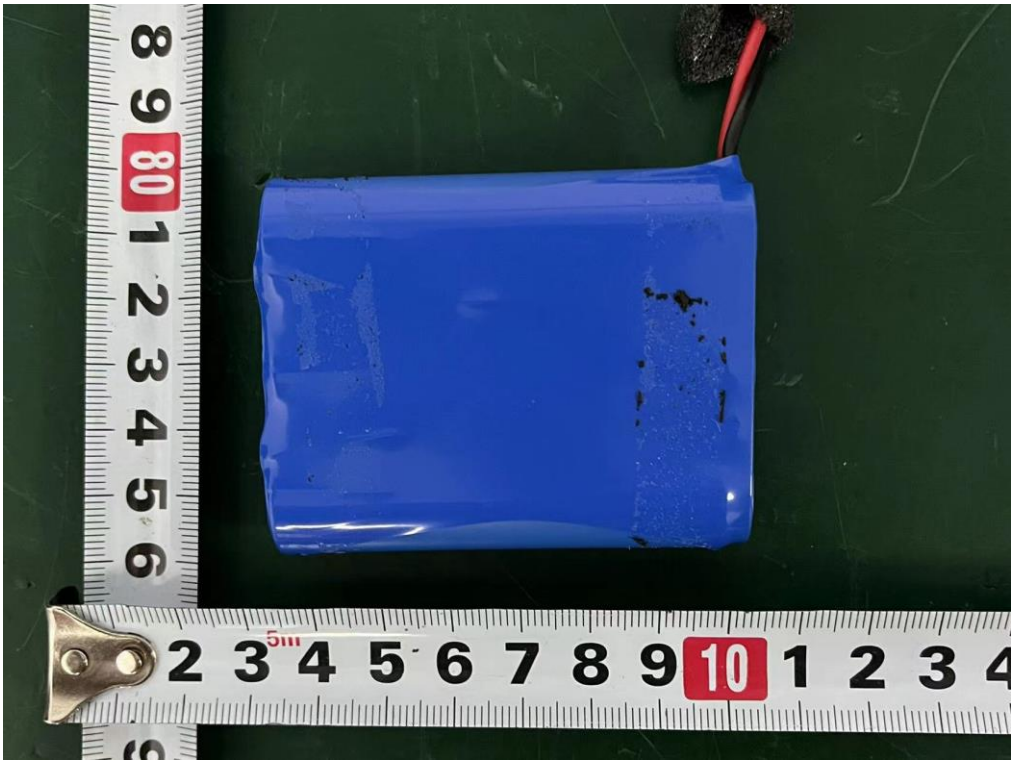
Internal Photos  
M/N: TAILGATER® TOUGH

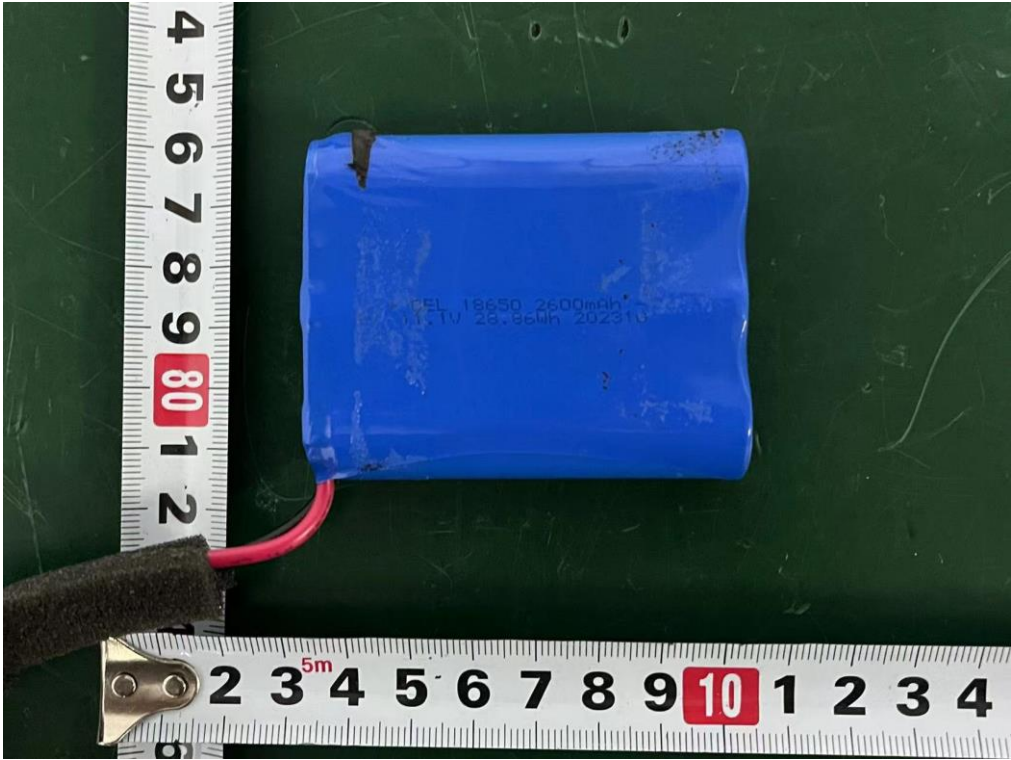
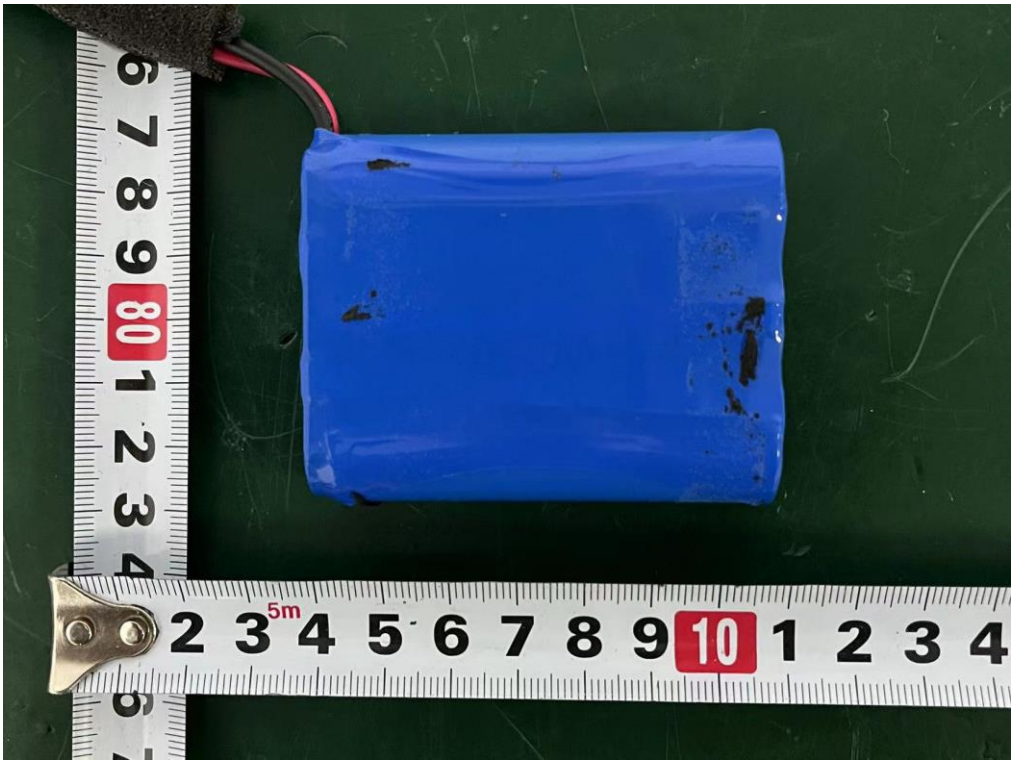
Internal Photos  
M/N: TAILGATER® TOUGH
