## **ENVIRONMENTAL TEST REPORT NO. 5278**

**MARINE RESCUE TECHNOLOGIES LTD  
MARSHALL HOUSE  
ZARYA COURT  
GROVEHILL ROAD  
BEVERLEY  
YORKSHIRE  
HU17 0JG**

1 off man overboard radio transmitter  
Serial No M16130385, MMSI No 972418882.

Process 1 Rain/Spray Non-activation test Non-UKAS

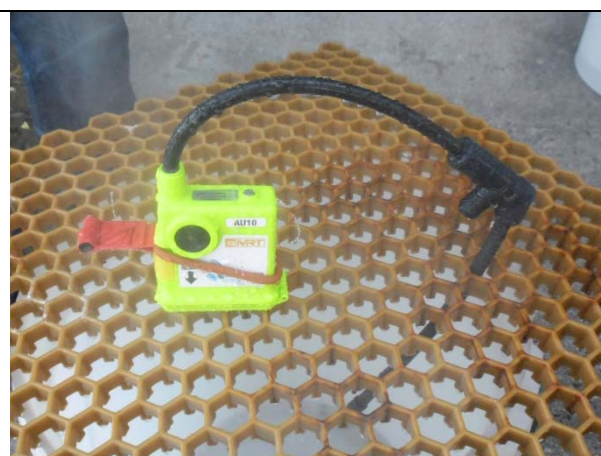
Typical armed state test set up

Whilst in the armed state that sample was monitored for false triggering via an AM radio tuned to 121.65MHz, no instances of false triggering were noted during the test.
