## Test Setup Photos

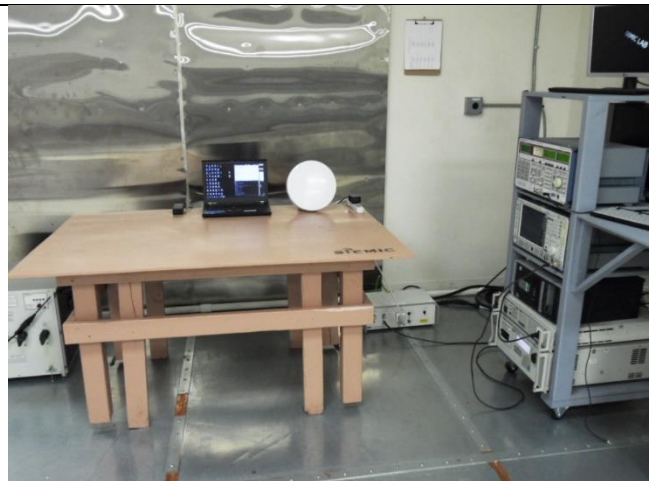
AC Line Conducted Emissions – Front View

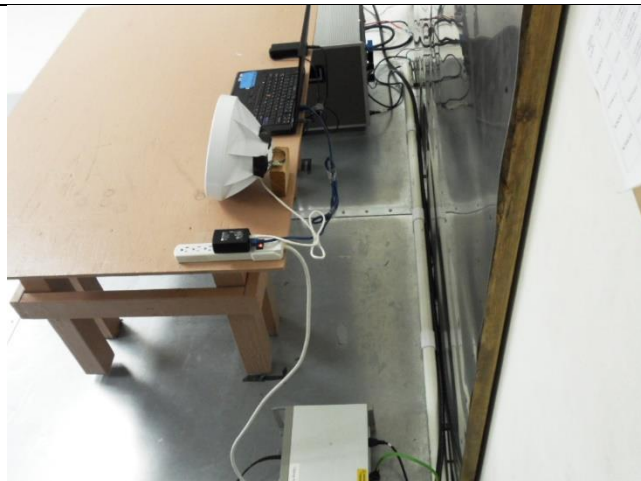
AC Line Conducted Emissions – Rear View

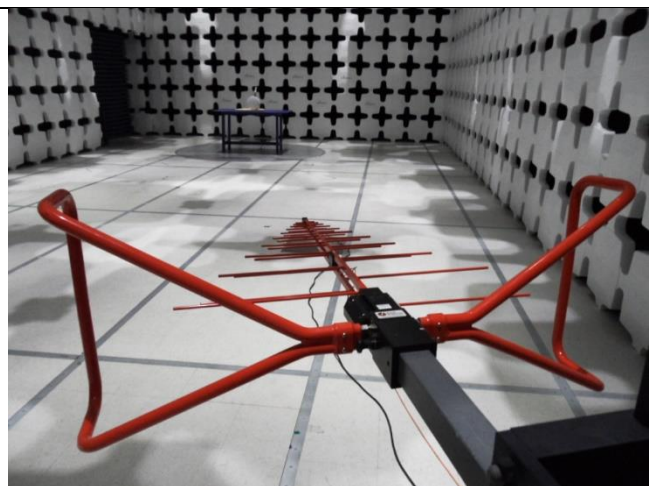
Radiated Emissions (<1GHz) – Front View

Note: The spurious emission in different EUT orientation was investigated, including the EUT standing up position and the laying down position. The EUT orientation shown in above setup photo is the worst case position.

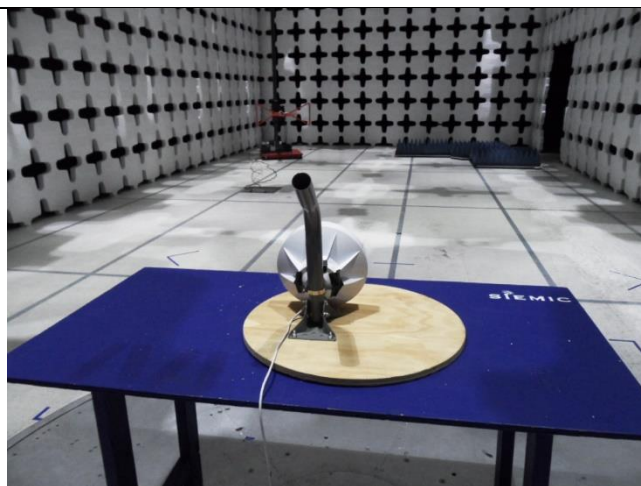
Radiated Emissions (<1GHz) – Rear View

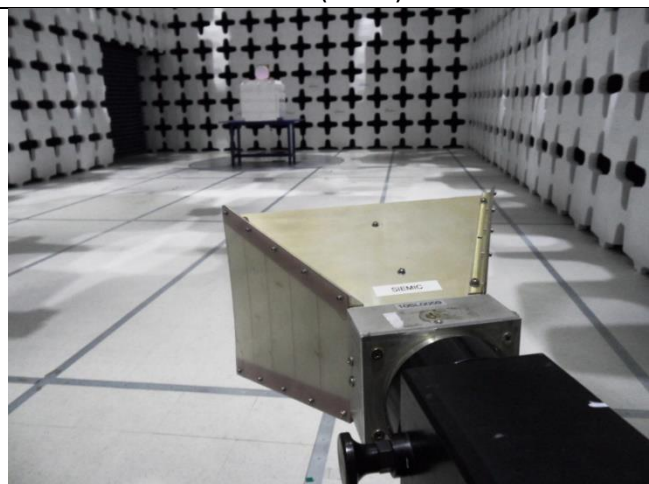
Radiated Emissions (>1GHz) – Front View

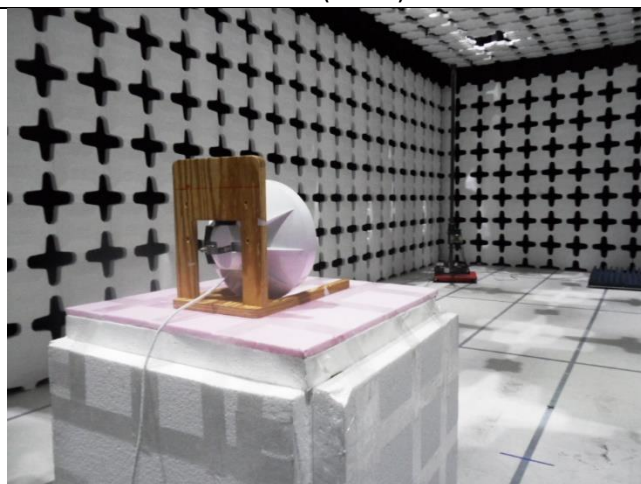
Radiated Emissions (>1GHz) – Rear View
