### **APPENDIX 3: Photographs of test setup**

#### **Radiated Emission**

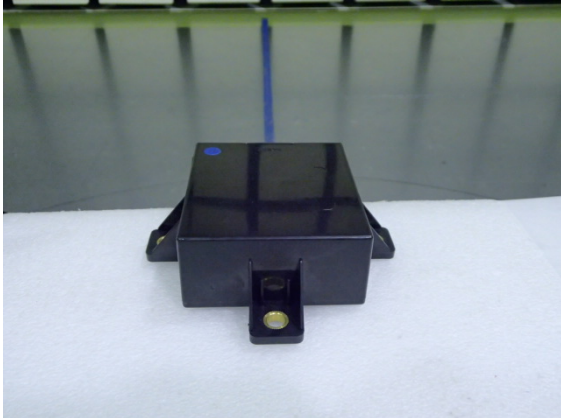
#### CONTROLLER, ID KEY

Below 30MHz : X-axis  
Above 30MHz (Horizontal: Y-axis /  
Vertical: Y-axis)  
X-axis

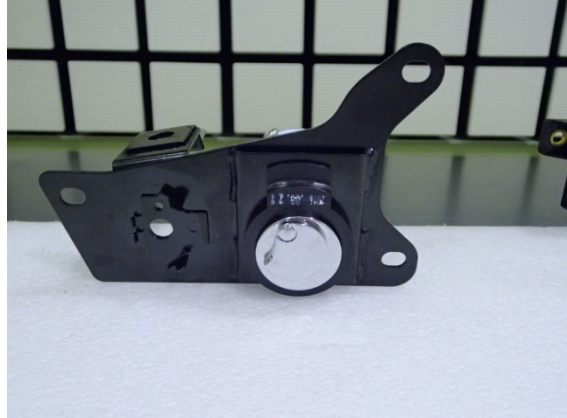
#### ID Receiving antenna

Below 30MHz : X-axis  
Above 30MHz (Horizontal: X-axis /  
Vertical: X-axis)  
X-axis

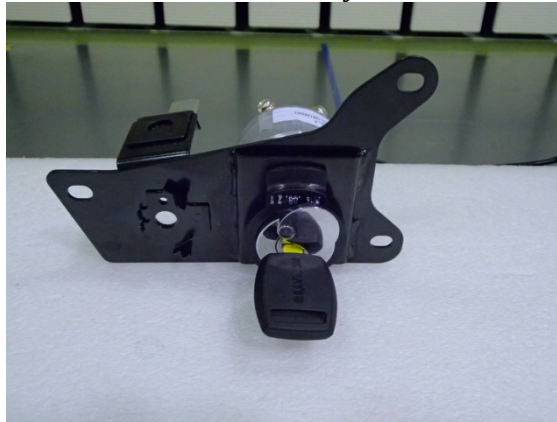
**Insert Key**

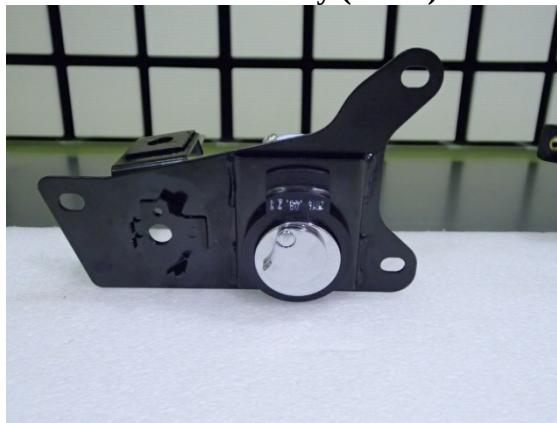
**Not insert Key (worst)**

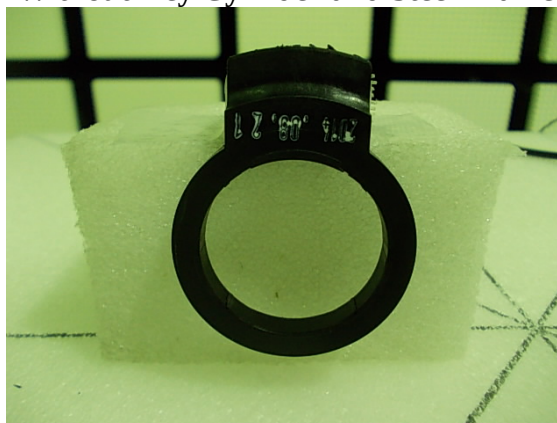
**Without Key Cylinder and Steel Frame**
