**EXHIBIT 4****Section 2.1033 (b)(14) SETUP DRAWINGS OR PHOTOGRAPHS**

The setup drawings and photos for measurement are provided below.

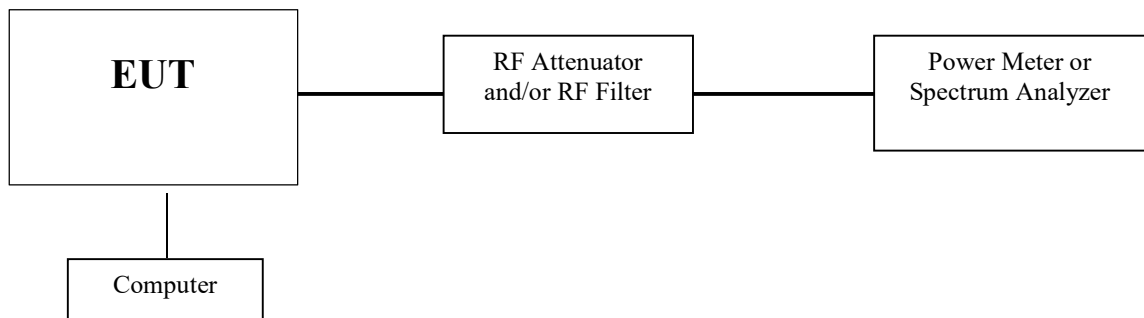
**Figure 1. Setup Diagram of Conducted Test for RF Output Power, Power Spectrum Density, Occupied Bandwidth and Unwanted Emissions.**

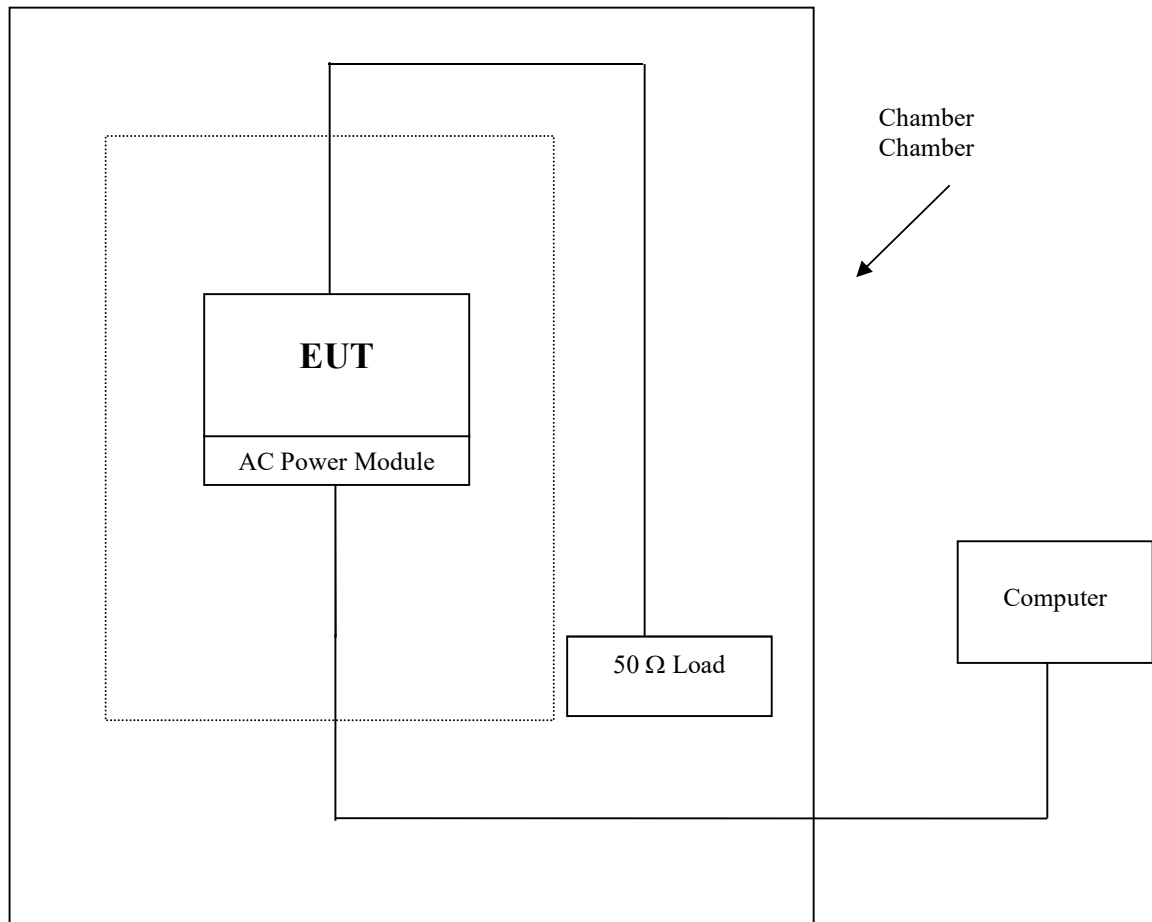
**Figure 2. Setup Diagram of Radiated Test**

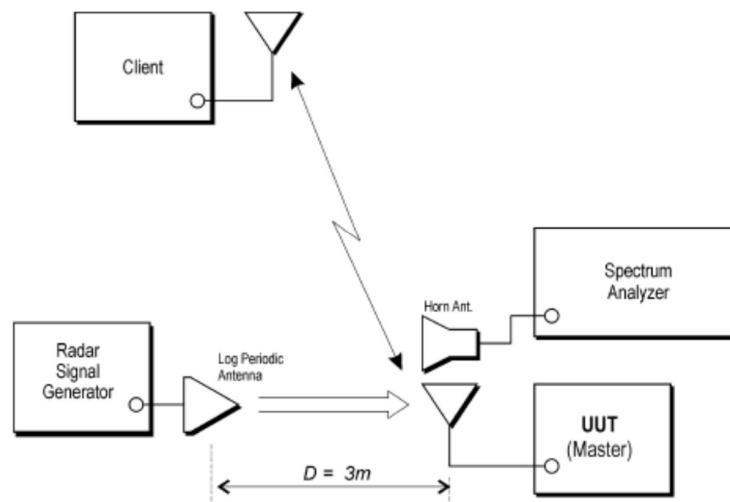
**Master with injection at the Master**

**Figure 3. The Setup Diagram of DFS Test**

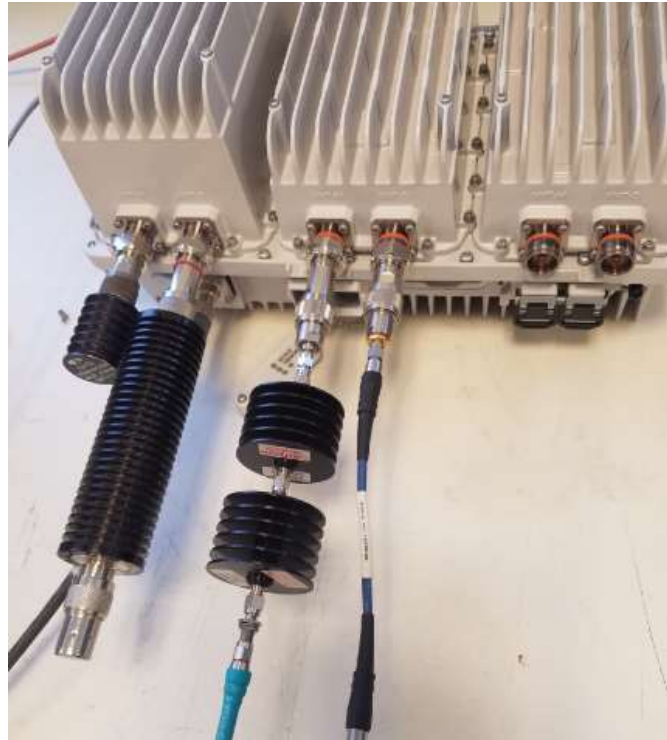
**Figure 4. Photo of RF Conducted Tests**

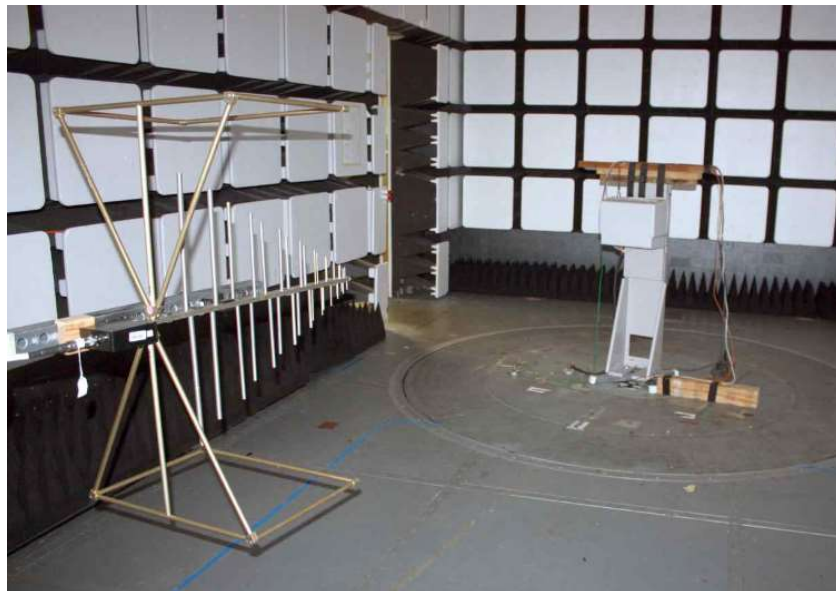
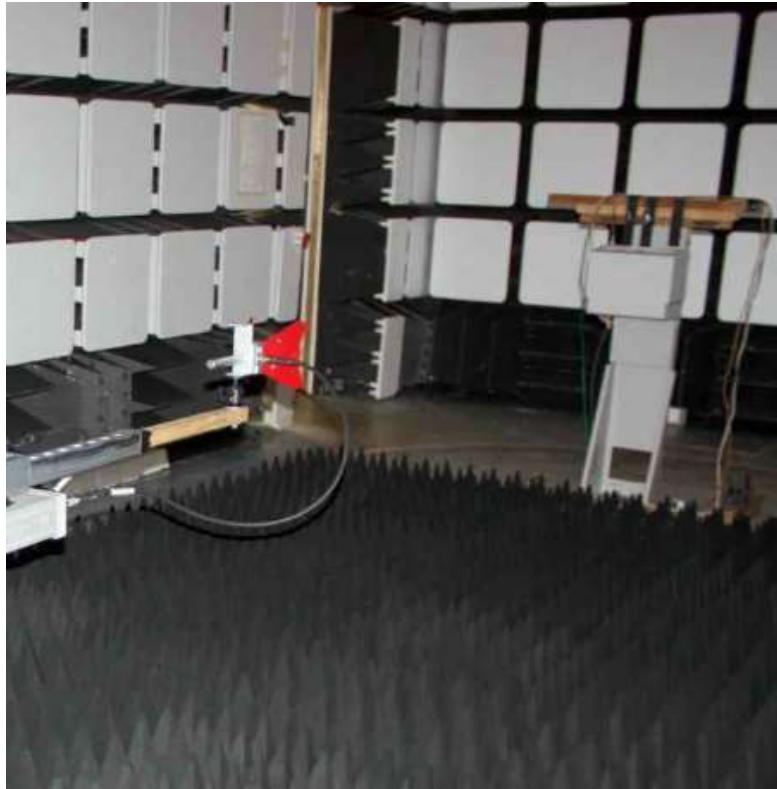
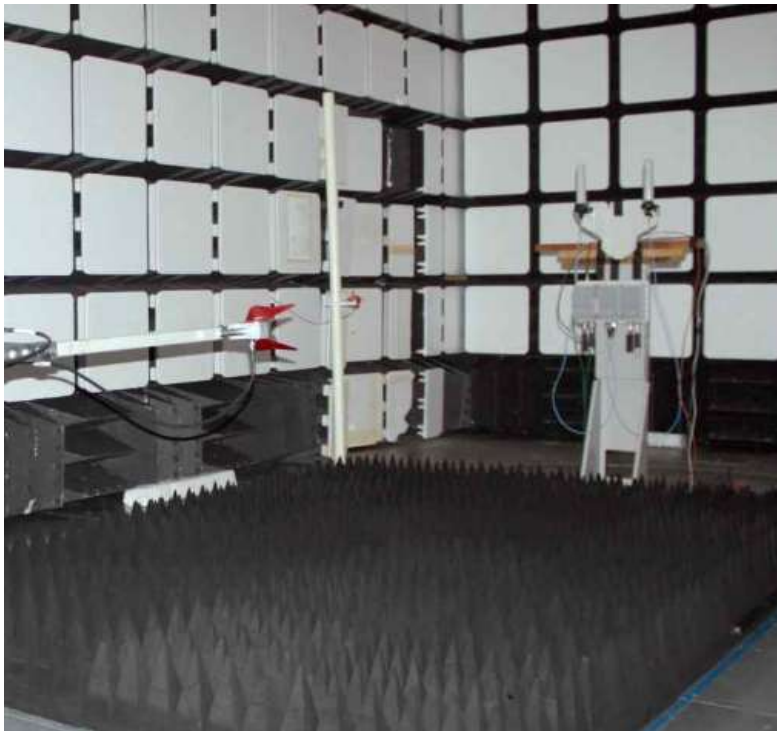
**Figure 5. Photos of Radiated Tests**

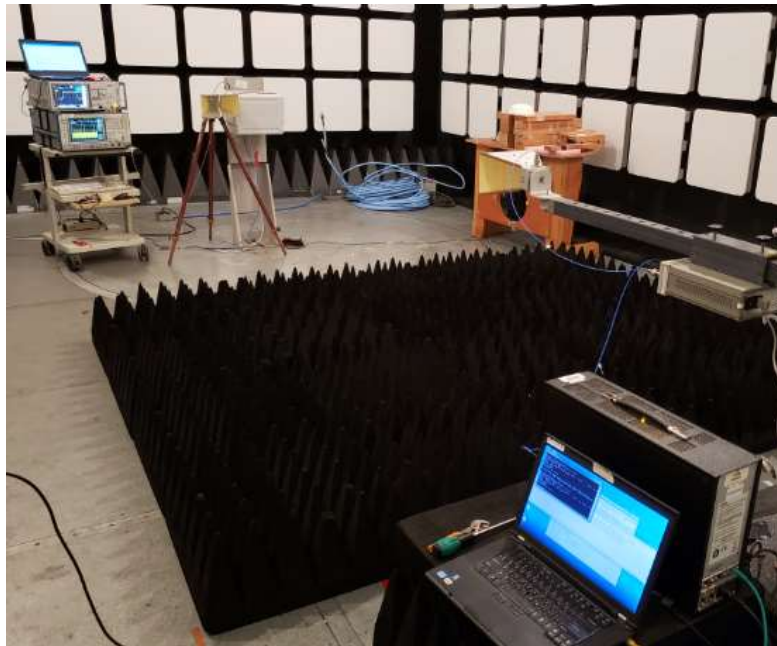
**Figure 6. Photos of DFS Tests**

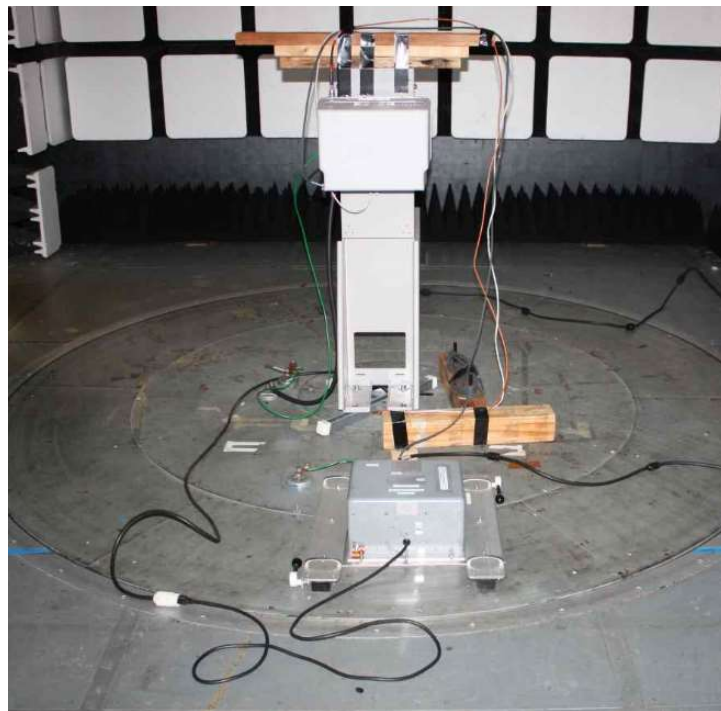
**Figure 7. Photo of AC Power Line Conducted Test**
