# Test Report

No: U142199E2

Designation of equipment under test: Sea Angel SA14

Type of test: Environmental test:  
- Thermal Shock  
- IP X7

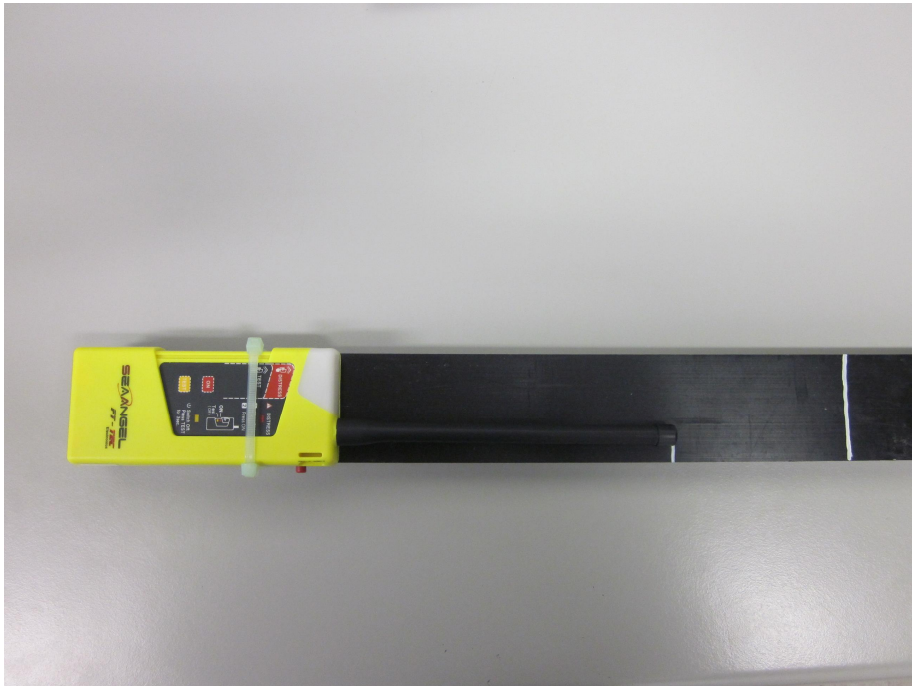
**Picture 1: Test set-up Thermal Shock**

The EUT shall be placed in an atmosphere of  $+70\text{ °C} \pm 3\text{ °C}$  for 1 h. It shall then be immersed in water at  $+25\text{ °C} \pm 3\text{ °C}$  to a depth of  $100\text{ mm} \pm 5\text{ mm}$ , measured from the highest point of the EUT to the surface of the water, for a period of 1 h. At the end of the test the EUT shall be subjected to a performance check, and shall then be examined for damage and for unwanted ingress of water. Following examination, the EUT shall be resealed in accordance with the manufacturer's instructions. Alternatively, if there are no external signs of unwanted ingress of water, an internal examination of the EUT, which involves disturbance to seals, may be carried out after all environmental tests have been completed.

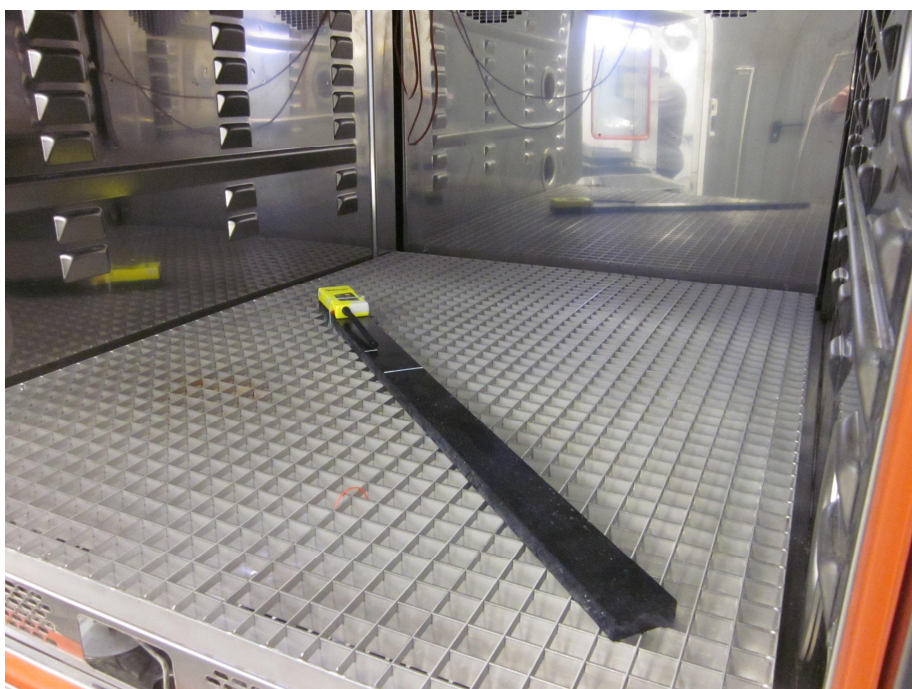
**Picture 2: Test set-up Thermal Shock**

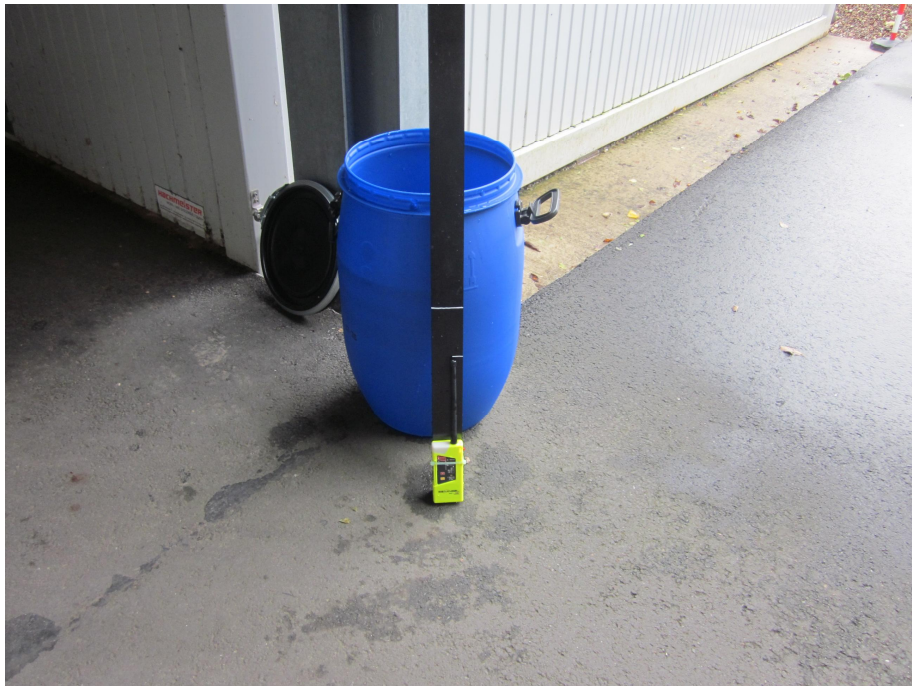
**Picture 5: After Thermal Shock**

| DUT | Temp. | Test duration | Visual damages | Performance check during the test | Requirements fulfilled |
|---|---|---|---|---|---|
| 142199_310608 | + 70 °C | 1 h | No | No | Yes |
| | + 25°C water | 1 h | No | Yes | Yes |

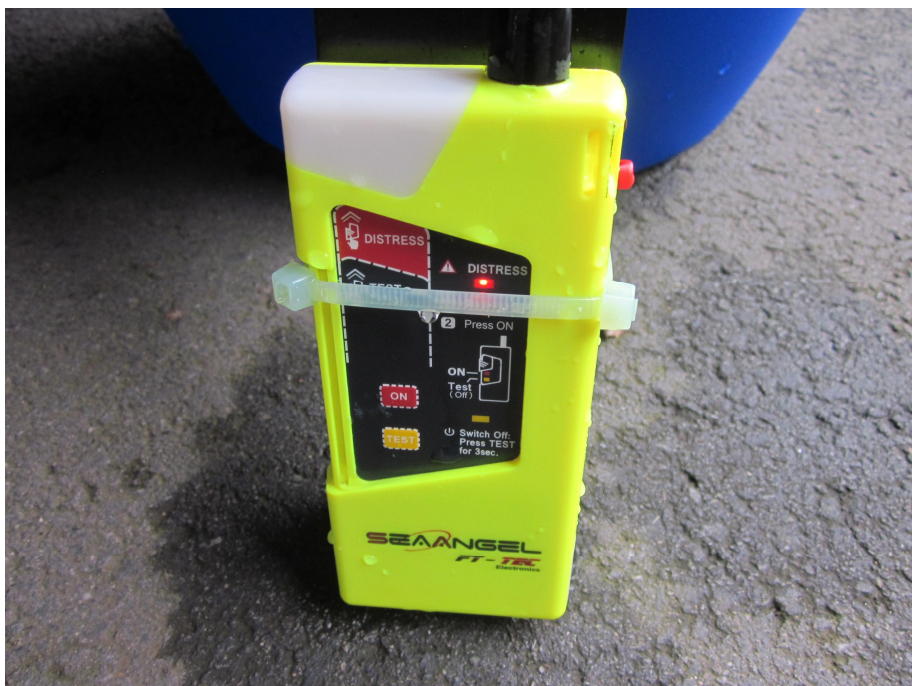
**Picture 6: After Thermal Shock**
