## Appendix G: Conducted Spurious Emission

### Test Result

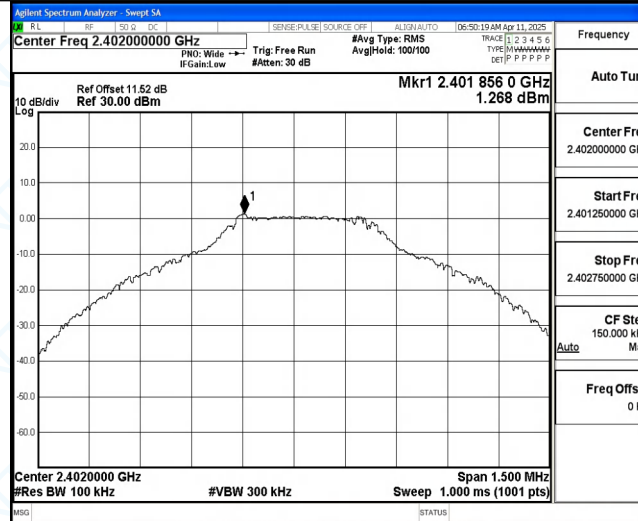
DH5\_Ant1\_2402\_0~Reference

| TestMode | Antenna | Freq(MHz) | FreqRange [MHz] | RefLevel [dBm] | Result [dBm] | Limit [dBm] | Verdict |
|---|---|---|---|---|---|---|---|
| DH5 | Ant1 | 2402 | Reference | 1.27 | 1.27 | --- | PASS |

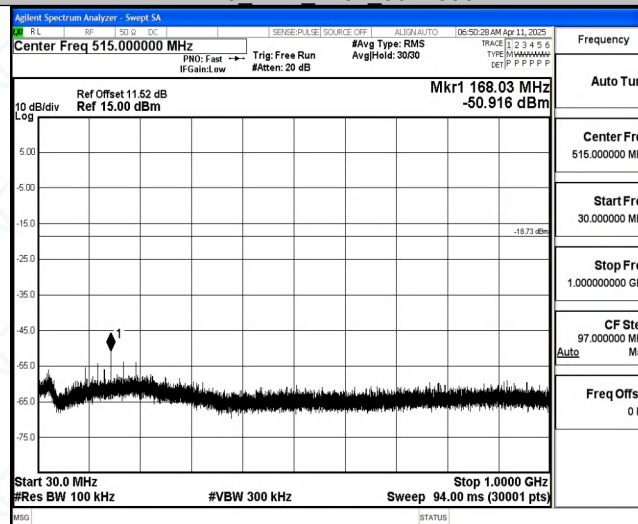
DH5\_Ant1\_2402\_30~1000

| TestMode | Antenna | Freq(MHz) | FreqRange [MHz] | RefLevel [dBm] | Result [dBm] | Limit [dBm] | Verdict |
|---|---|---|---|---|---|---|---|
| | | | 30~1000 | 1.27 | -50.92 | $\leq -18.73$ | PASS |

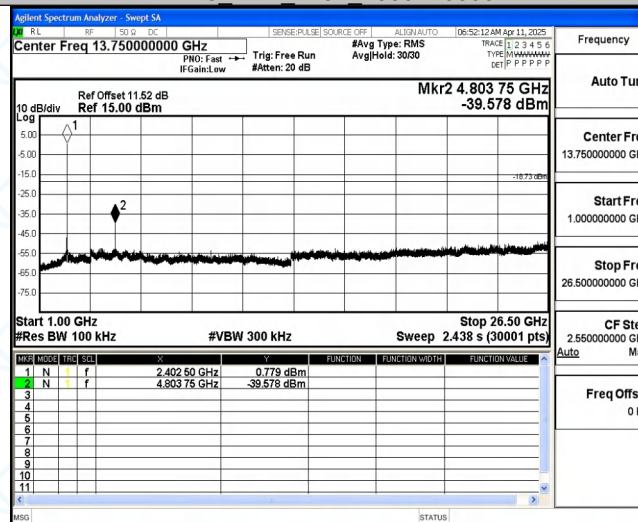
DH5\_Ant1\_2402\_1000~26500

| TestMode | Antenna | Freq(MHz) | FreqRange [MHz] | RefLevel [dBm] | Result [dBm] | Limit [dBm] | Verdict |
|---|---|---|---|---|---|---|---|
| | | | 1000~26500 | 1.27 | -39.58 | $\leq -18.73$ | PASS |

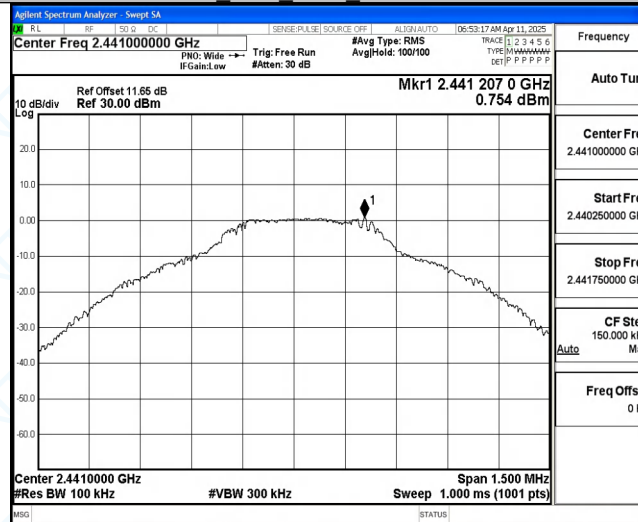
## DH5\_Ant1\_2441\_0~Reference

| TestMode | Antenna | Freq(MHz) | FreqRange [MHz] | RefLevel [dBm] | Result [dBm] | Limit [dBm] | Verdict |
|---|---|---|---|---|---|---|---|
| | | 2441 | Reference | 0.75 | 0.75 | --- | PASS |

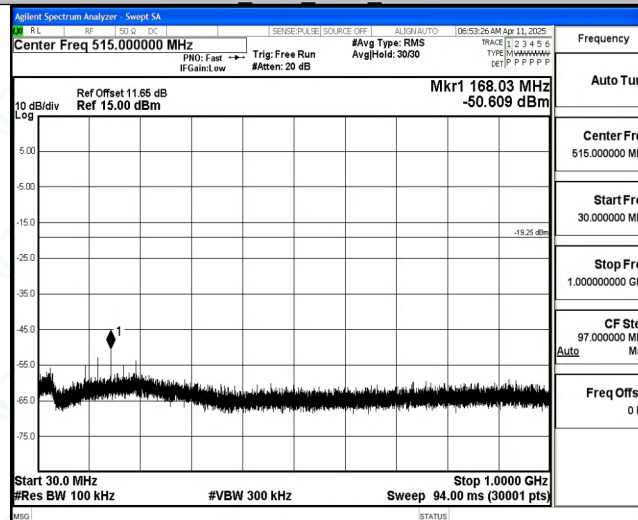
## DH5\_Ant1\_2441\_30~1000

| TestMode | Antenna | Freq(MHz) | FreqRange [MHz] | RefLevel [dBm] | Result [dBm] | Limit [dBm] | Verdict |
|---|---|---|---|---|---|---|---|
| | | | 30~1000 | 0.75 | -50.61 | $\leq -19.25$ | PASS |

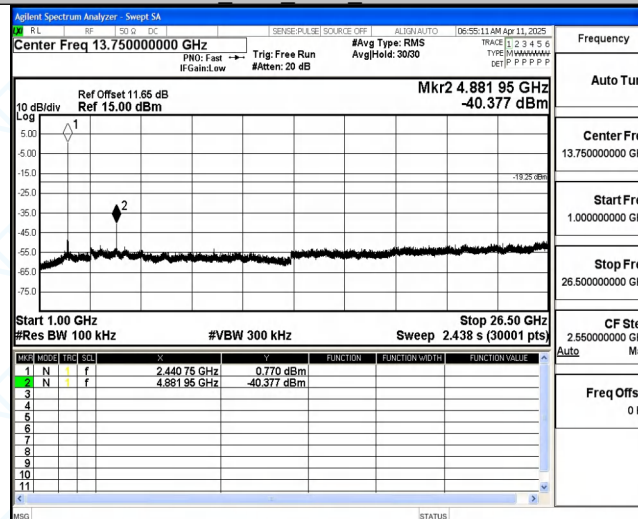
## DH5\_Ant1\_2441\_1000~26500

| TestMode | Antenna | Freq(MHz) | FreqRange [MHz] | RefLevel [dBm] | Result [dBm] | Limit [dBm] | Verdict |
|---|---|---|---|---|---|---|---|
| | | | 1000~26500 | 0.75 | -40.38 | $\leq -19.25$ | PASS |

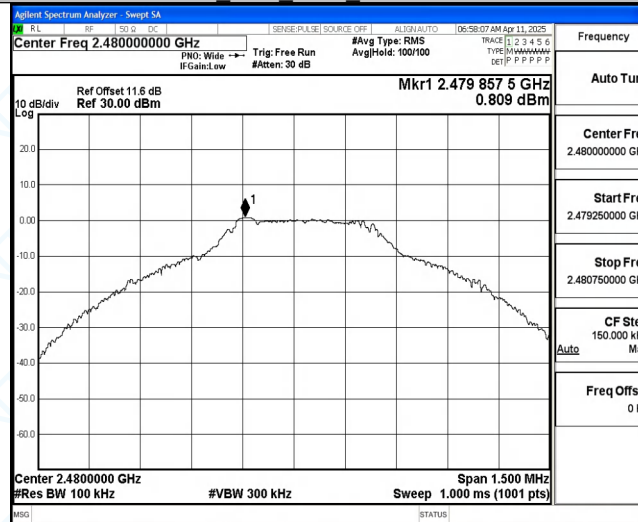
## DH5\_Ant1\_2480\_0~Reference

| TestMode | Antenna | Freq(MHz) | FreqRange [MHz] | RefLevel [dBm] | Result [dBm] | Limit [dBm] | Verdict |
|---|---|---|---|---|---|---|---|
| | | 2480 | Reference | 0.81 | 0.81 | --- | PASS |

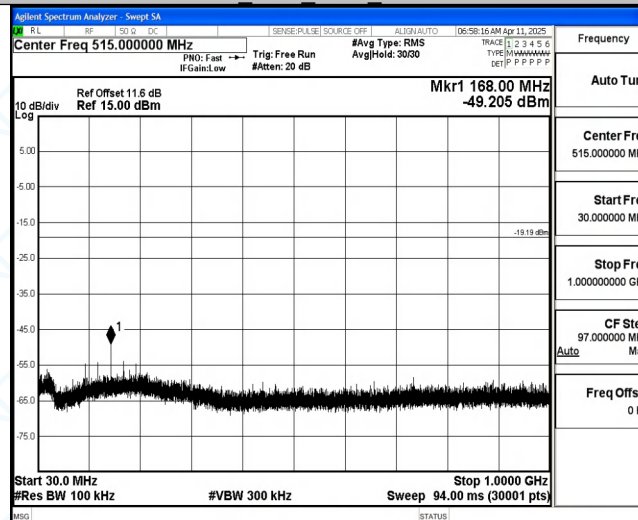
## DH5\_Ant1\_2480\_30~1000

| TestMode | Antenna | Freq(MHz) | FreqRange [MHz] | RefLevel [dBm] | Result [dBm] | Limit [dBm] | Verdict |
|---|---|---|---|---|---|---|---|
| | | | 30~1000 | 0.81 | -49.21 | $\leq -19.19$ | PASS |

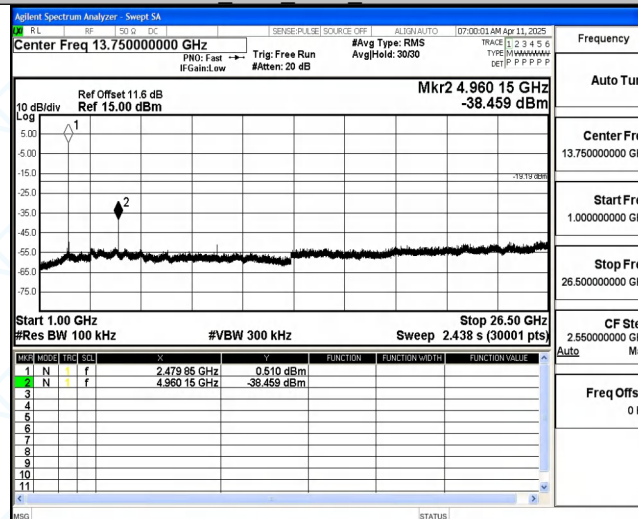
## DH5\_Ant1\_2480\_1000~26500

| TestMode | Antenna | Freq(MHz) | FreqRange [MHz] | RefLevel [dBm] | Result [dBm] | Limit [dBm] | Verdict |
|---|---|---|---|---|---|---|---|
| | | | 1000~26500 | 0.81 | -38.46 | $\leq -19.19$ | PASS |

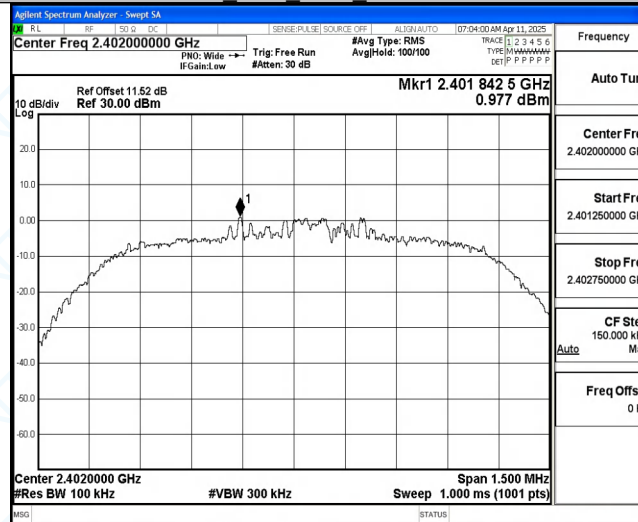
## 2DH5 Ant1 2402 0~Reference

| TestMode | Antenna | Freq(MHz) | FreqRange [MHz] | RefLevel [dBm] | Result [dBm] | Limit [dBm] | Verdict |
|---|---|---|---|---|---|---|---|
| 2DH5 | Ant1 | 2402 | Reference | 0.98 | 0.98 | --- | PASS |

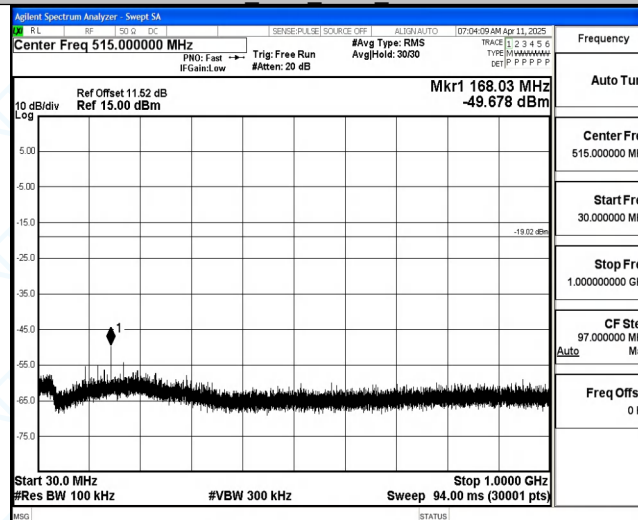
## 2DH5 Ant1 2402 30~1000

| TestMode | Antenna | Freq(MHz) | FreqRange [MHz] | RefLevel [dBm] | Result [dBm] | Limit [dBm] | Verdict |
|---|---|---|---|---|---|---|---|
| | | | 30~1000 | 0.98 | -49.68 | $\leq -19.02$ | PASS |

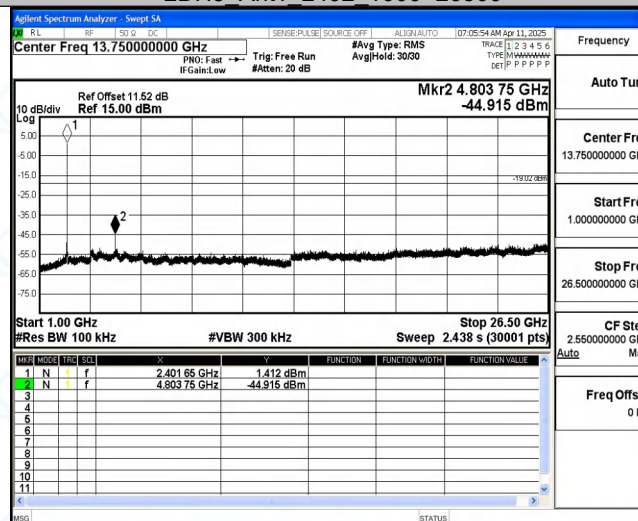
## 2DH5 Ant1 2402 1000~26500

| TestMode | Antenna | Freq(MHz) | FreqRange [MHz] | RefLevel [dBm] | Result [dBm] | Limit [dBm] | Verdict |
|---|---|---|---|---|---|---|---|
| | | | 1000~26500 | 0.98 | -44.92 | $\leq -19.02$ | PASS |

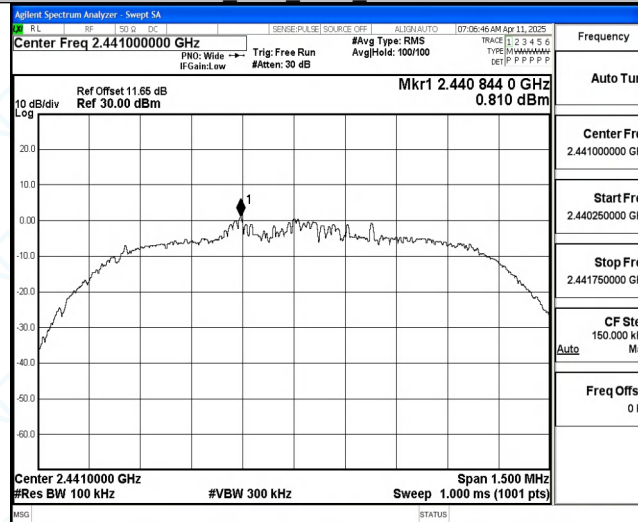
## 2DH5 Ant1 2441 0~Reference

| TestMode | Antenna | Freq(MHz) | FreqRange [MHz] | RefLevel [dBm] | Result [dBm] | Limit [dBm] | Verdict |
|---|---|---|---|---|---|---|---|
| | | 2441 | Reference | 0.81 | 0.81 | --- | PASS |

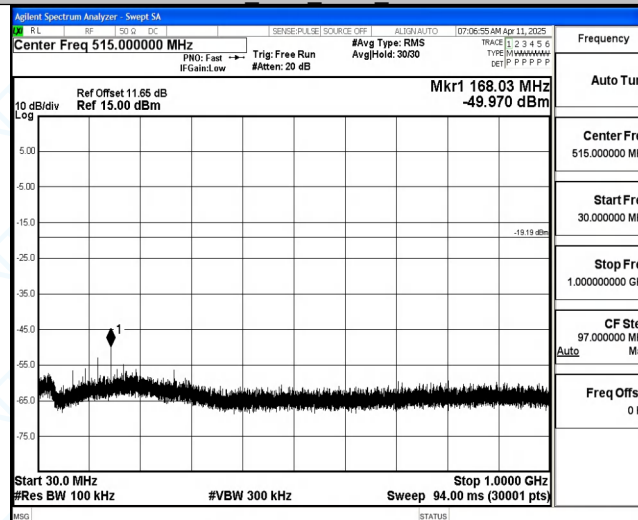
## 2DH5 Ant1 2441 30~1000

| TestMode | Antenna | Freq(MHz) | FreqRange [MHz] | RefLevel [dBm] | Result [dBm] | Limit [dBm] | Verdict |
|---|---|---|---|---|---|---|---|
| | | | 30~1000 | 0.81 | -49.97 | $\leq -19.19$ | PASS |

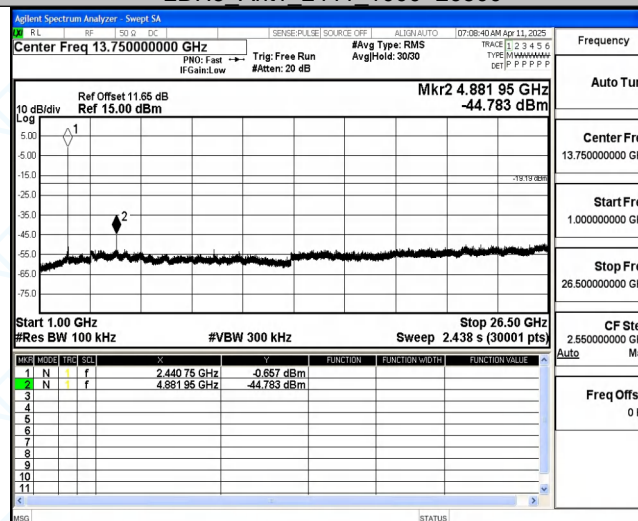
## 2DH5 Ant1 2441 1000~26500

| TestMode | Antenna | Freq(MHz) | FreqRange [MHz] | RefLevel [dBm] | Result [dBm] | Limit [dBm] | Verdict |
|---|---|---|---|---|---|---|---|
| | | | 1000~26500 | 0.81 | -44.78 | $\leq -19.19$ | PASS |

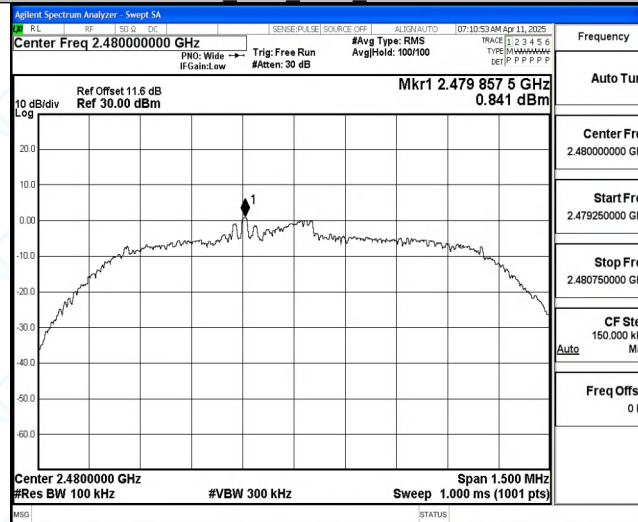
## 2DH5 Ant1 2480 0~Reference

| TestMode | Antenna | Freq(MHz) | FreqRange [MHz] | RefLevel [dBm] | Result [dBm] | Limit [dBm] | Verdict |
|---|---|---|---|---|---|---|---|
| | | 2480 | Reference | 0.84 | 0.84 | --- | PASS |

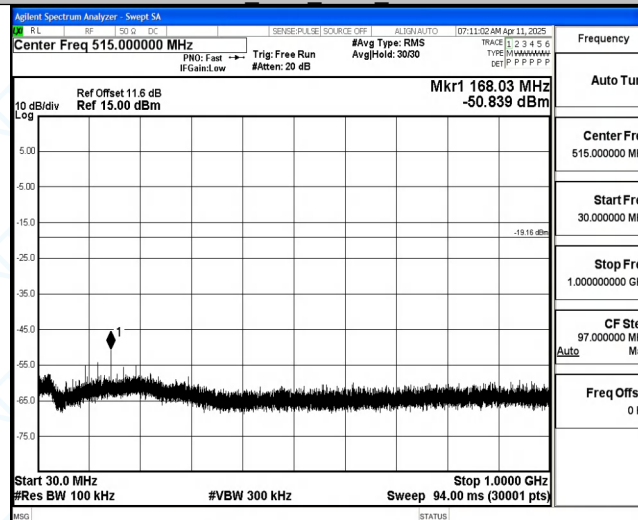
## 2DH5 Ant1 2480 30~1000

| TestMode | Antenna | Freq(MHz) | FreqRange [MHz] | RefLevel [dBm] | Result [dBm] | Limit [dBm] | Verdict |
|---|---|---|---|---|---|---|---|
| | | | 30~1000 | 0.84 | -50.84 | $\leq -19.16$ | PASS |

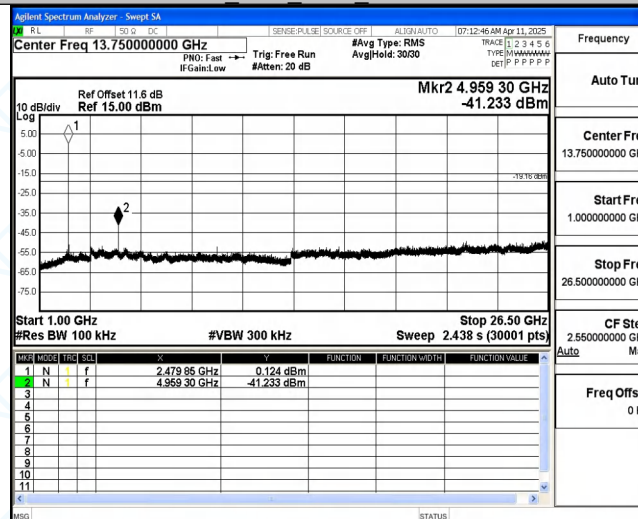
## 2DH5 Ant1 2480 1000~26500

| TestMode | Antenna | Freq(MHz) | FreqRange [MHz] | RefLevel [dBm] | Result [dBm] | Limit [dBm] | Verdict |
|---|---|---|---|---|---|---|---|
| | | | 1000~26500 | 0.84 | -41.23 | $\leq -19.16$ | PASS |

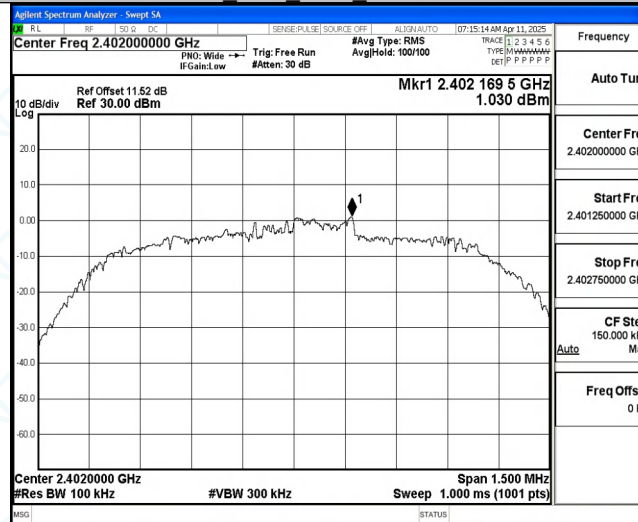
## 3DH5\_Ant1\_2402\_0~Reference

| TestMode | Antenna | Freq(MHz) | FreqRange [MHz] | RefLevel [dBm] | Result [dBm] | Limit [dBm] | Verdict |
|---|---|---|---|---|---|---|---|
| 3DH5 | Ant1 | 2402 | Reference | 1.03 | 1.03 | --- | PASS |

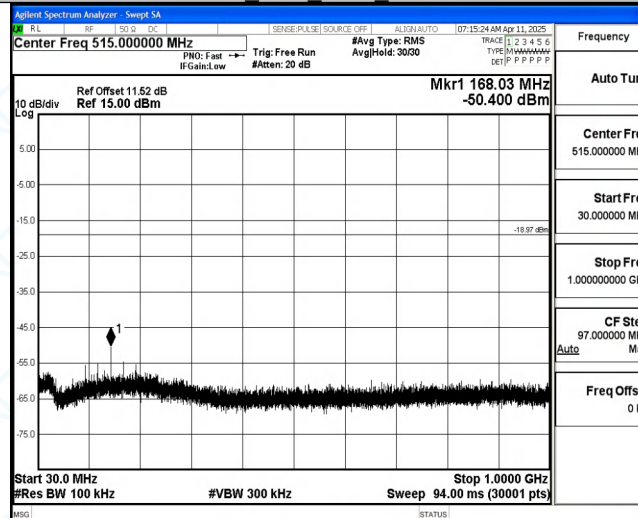
## 3DH5\_Ant1\_2402\_30~1000

| TestMode | Antenna | Freq(MHz) | FreqRange [MHz] | RefLevel [dBm] | Result [dBm] | Limit [dBm] | Verdict |
|---|---|---|---|---|---|---|---|
| | | | 30~1000 | 1.03 | -50.4 | $\leq -18.97$ | PASS |

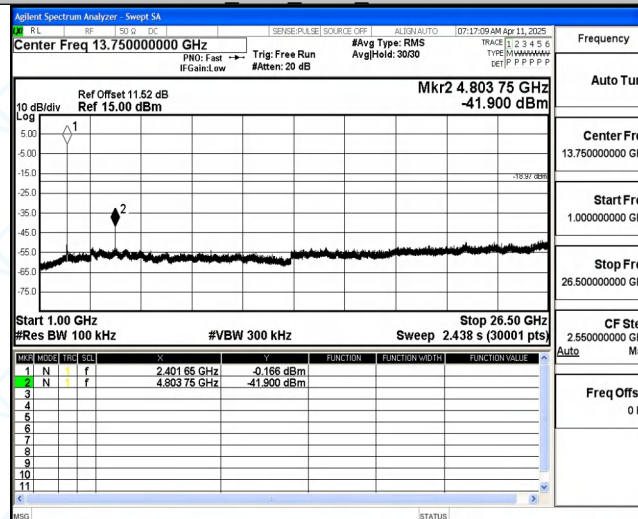
## 3DH5\_Ant1\_2402\_1000~26500

| TestMode | Antenna | Freq(MHz) | FreqRange [MHz] | RefLevel [dBm] | Result [dBm] | Limit [dBm] | Verdict |
|---|---|---|---|---|---|---|---|
| | | | 1000~26500 | 1.03 | -41.9 | $\leq -18.97$ | PASS |

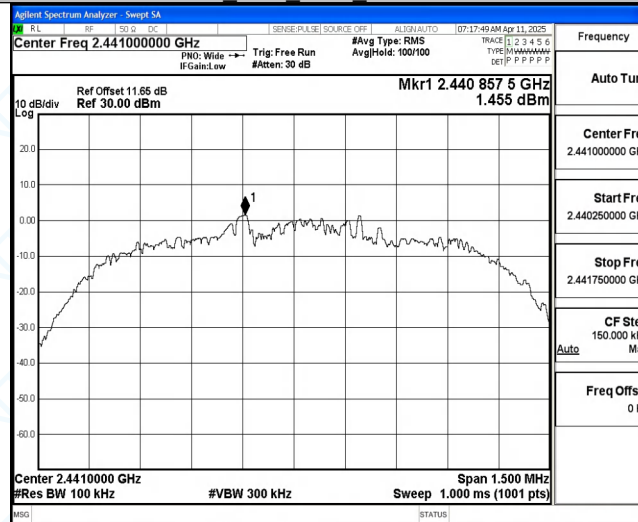
## 3DH5 Ant1 2441 0~Reference

| TestMode | Antenna | Freq(MHz) | FreqRange [MHz] | RefLevel [dBm] | Result [dBm] | Limit [dBm] | Verdict |
|---|---|---|---|---|---|---|---|
| | | 2441 | Reference | 1.46 | 1.46 | --- | PASS |

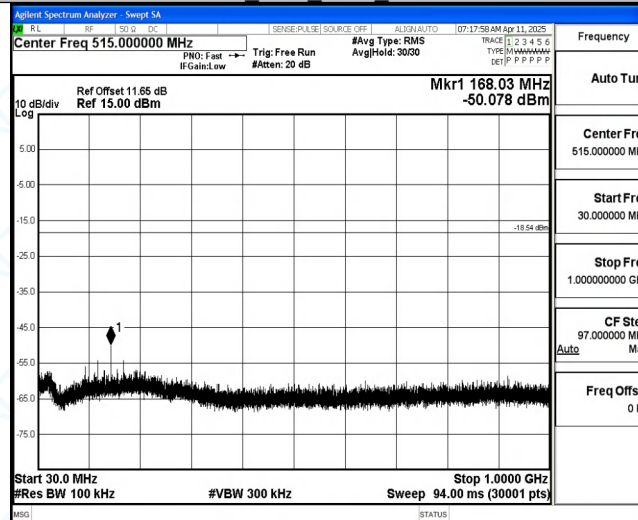
## 3DH5 Ant1 2441 30~1000

| TestMode | Antenna | Freq(MHz) | FreqRange [MHz] | RefLevel [dBm] | Result [dBm] | Limit [dBm] | Verdict |
|---|---|---|---|---|---|---|---|
| | | | 30~1000 | 1.46 | -50.08 | $\leq -18.54$ | PASS |

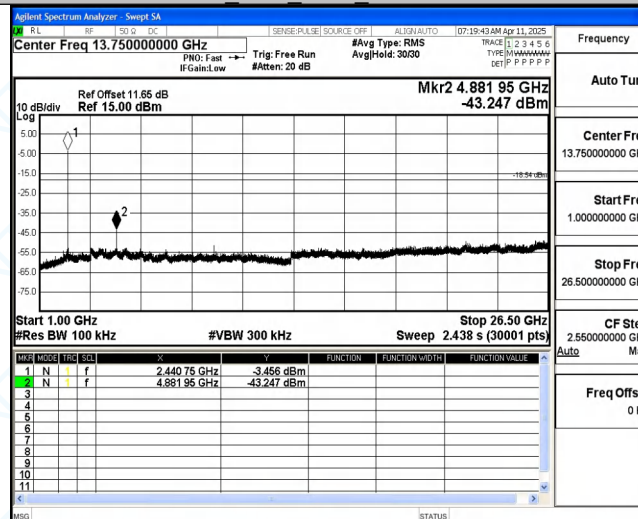
## 3DH5 Ant1 2441 1000~26500

| TestMode | Antenna | Freq(MHz) | FreqRange [MHz] | RefLevel [dBm] | Result [dBm] | Limit [dBm] | Verdict |
|---|---|---|---|---|---|---|---|
| | | | 1000~26500 | 1.46 | -43.25 | $\leq -18.54$ | PASS |

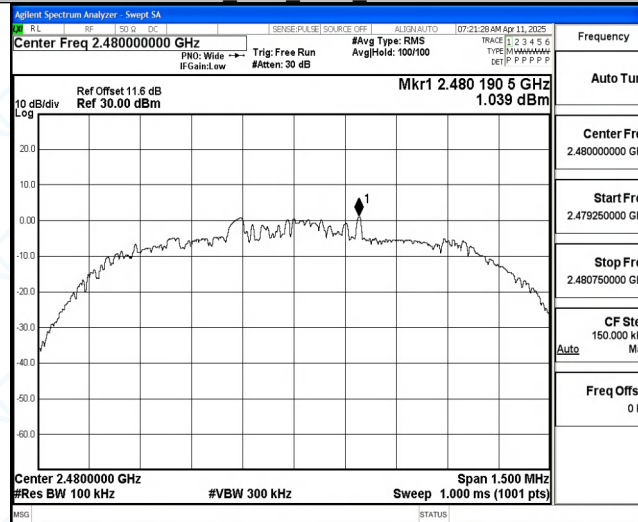
## 3DH5 Ant1 2480 0~Reference

| TestMode | Antenna | Freq(MHz) | FreqRange [MHz] | RefLevel [dBm] | Result [dBm] | Limit [dBm] | Verdict |
|---|---|---|---|---|---|---|---|
| | | 2480 | Reference | 1.04 | 1.04 | --- | PASS |

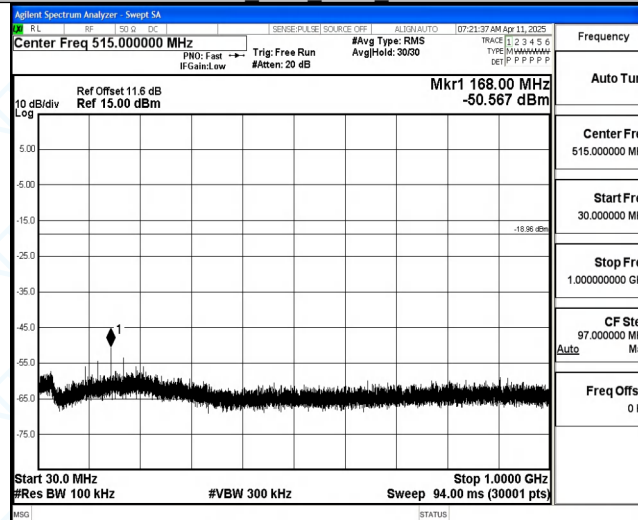
## 3DH5 Ant1 2480 30~1000

| TestMode | Antenna | Freq(MHz) | FreqRange [MHz] | RefLevel [dBm] | Result [dBm] | Limit [dBm] | Verdict |
|---|---|---|---|---|---|---|---|
| | | | 30~1000 | 1.04 | -50.57 | $\leq -18.96$ | PASS |

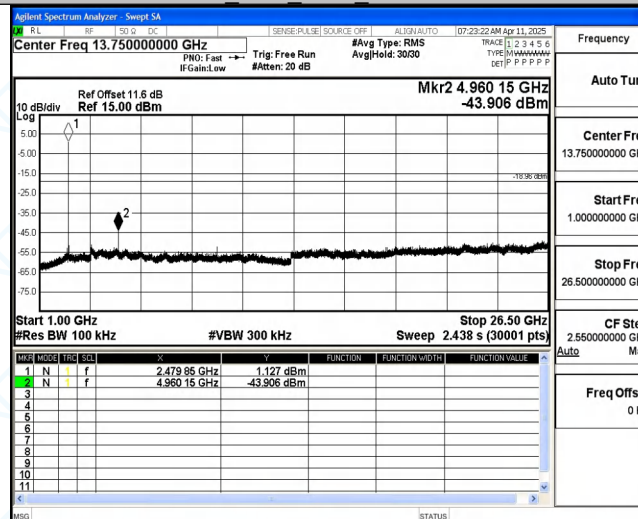
## 3DH5 Ant1 2480 1000~26500

| TestMode | Antenna | Freq(MHz) | FreqRange [MHz] | RefLevel [dBm] | Result [dBm] | Limit [dBm] | Verdict |
|---|---|---|---|---|---|---|---|
| | | | 1000~26500 | 1.04 | -43.91 | $\leq -18.96$ | PASS |
