## 7.7 Carrier Frequencies Separation

## 7.8 Number of Hopping Channel

## 7.9 Dwell Time

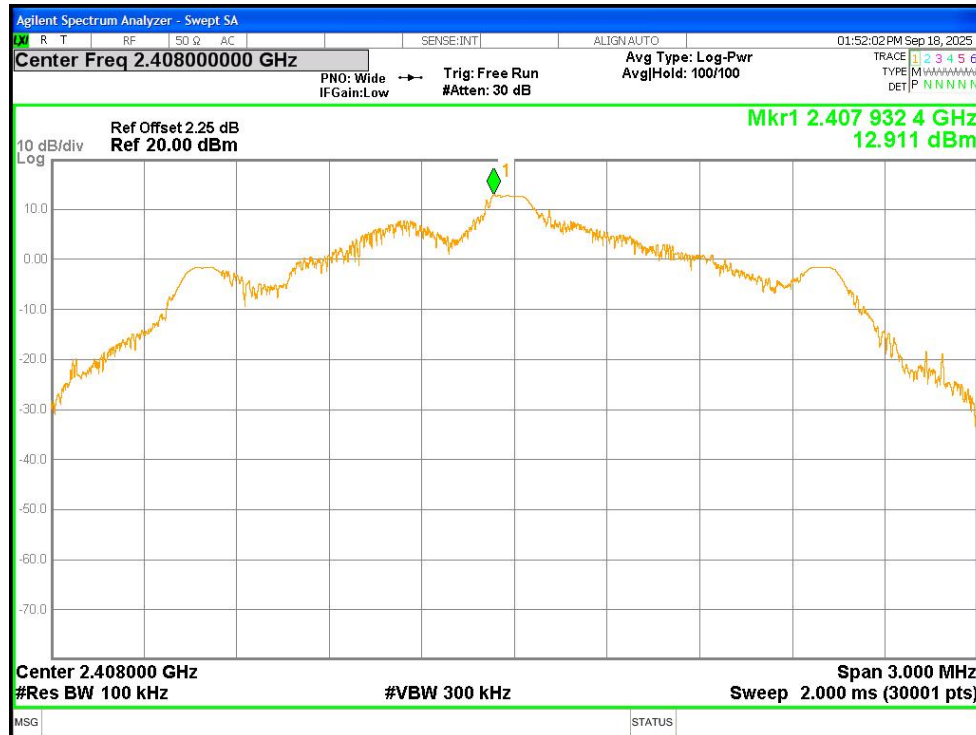
Tx. Spurious NVNT 1-DH1 2408MHz Ant1 Ref

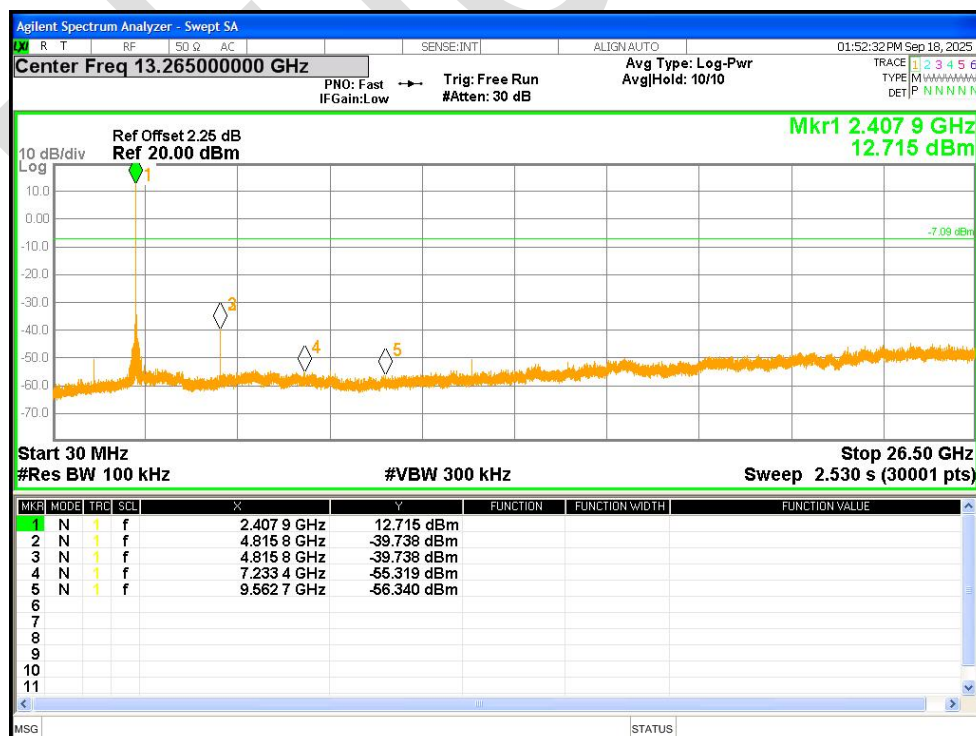
Tx. Spurious NVNT 1-DH1 2408MHz Ant1 Emission

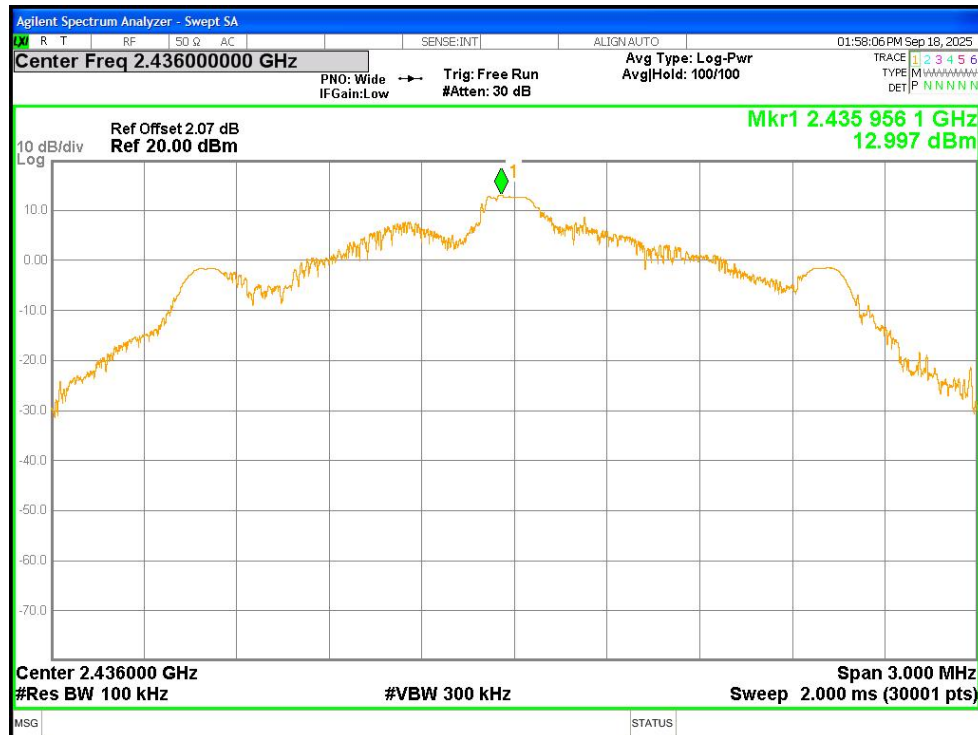
Tx. Spurious NVNT 1-DH1 2436MHz Ant1 Ref

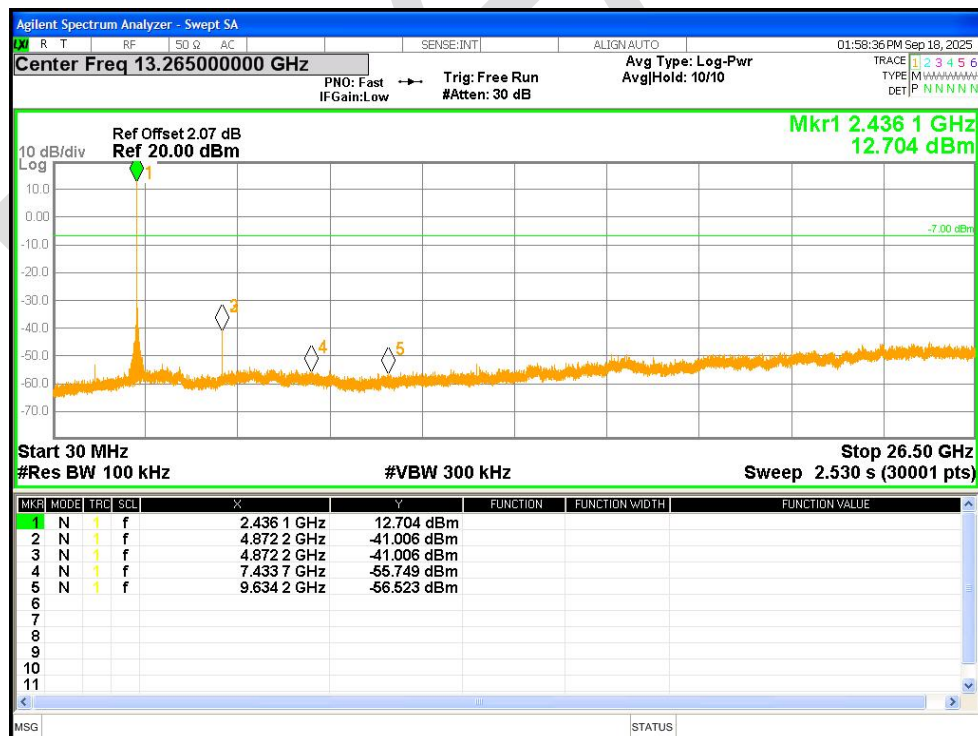
Tx. Spurious NVNT 1-DH1 2436MHz Ant1 Emission

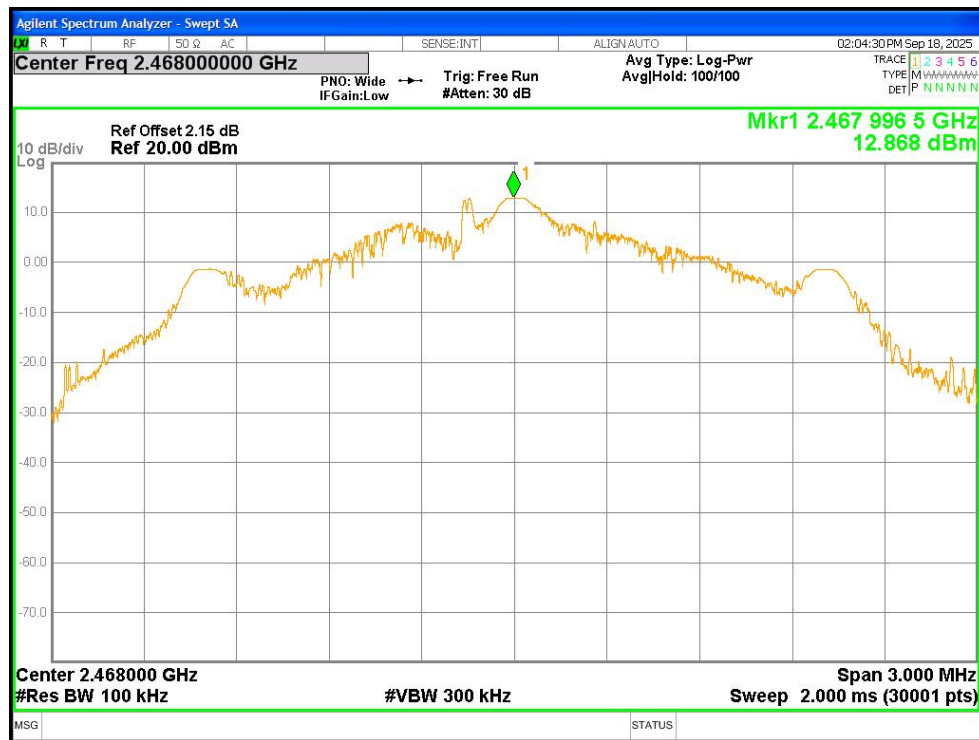
Tx. Spurious NVNT 1-DH1 2468MHz Ant1 Ref

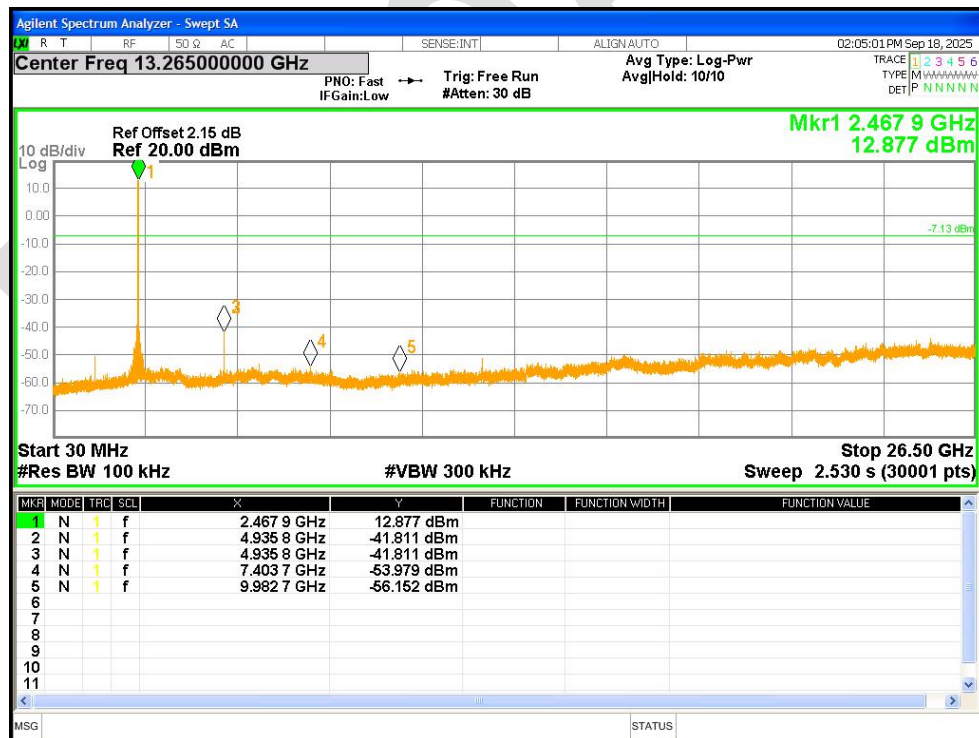
Tx. Spurious NVNT 1-DH1 2468MHz Ant1 Emission

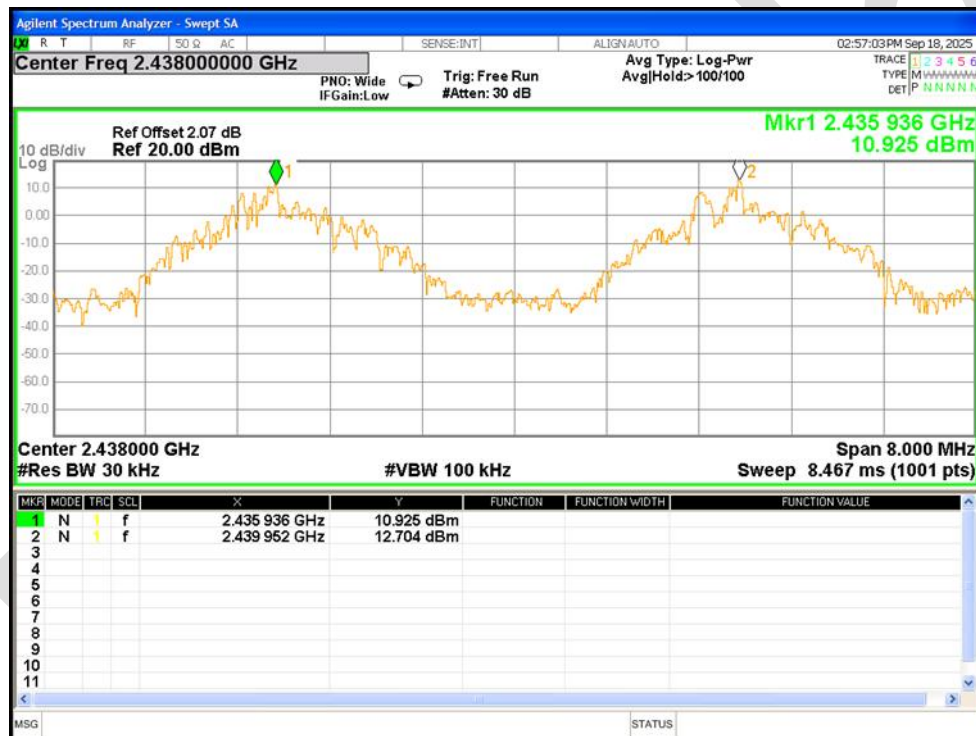
| Condition | Mode | Antenna | Hopping Freq1 (MHz) | Hopping Freq2 (MHz) | HFS (MHz) | Limit (MHz) | Verdict |
|---|---|---|---|---|---|---|---|
| NVNT | 2.4G | Ant1 | 2435.936 | 2439.952 | 4.016 | 1.403 | Pass |

CFS NVNT 2.4G 2441MHz Ant1

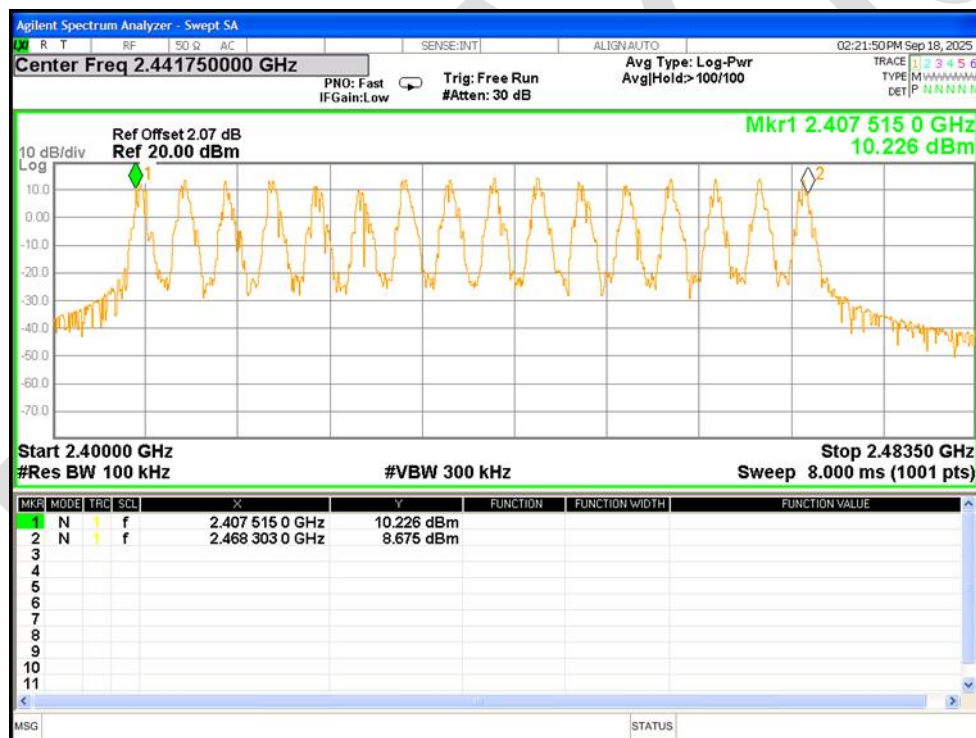
| Condition | Mode | Antenna | Hopping Number | Limit | Verdict |
|---|---|---|---|---|---|
| NVNT | 2.4G | Ant1 | 16 | 15 | Pass |

Hopping No. NVNT 2.4G 2441MHz Ant1

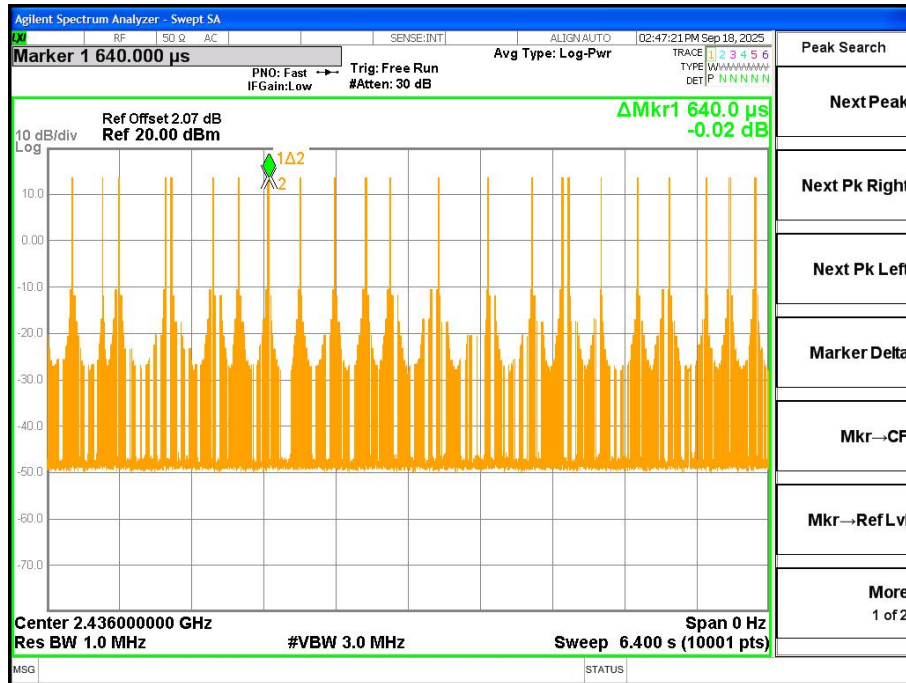
| Condition | Mode | Frequency<br>(MHz) | Antenna | Pulse Time<br>(ms) | Total Dwell Time<br>(ms) | Burst<br>Count | Period Time<br>(ms) | Limit<br>(ms) | Verdict |
|---|---|---|---|---|---|---|---|---|---|
| NVNT | 2.4G | 2436 | Ant1 | 0.64 | 14.72 | 23 | 6400 | 400 | Pass |

Dwell NVNT 2.4G 2436MHz Ant1 Accumulated Pulse

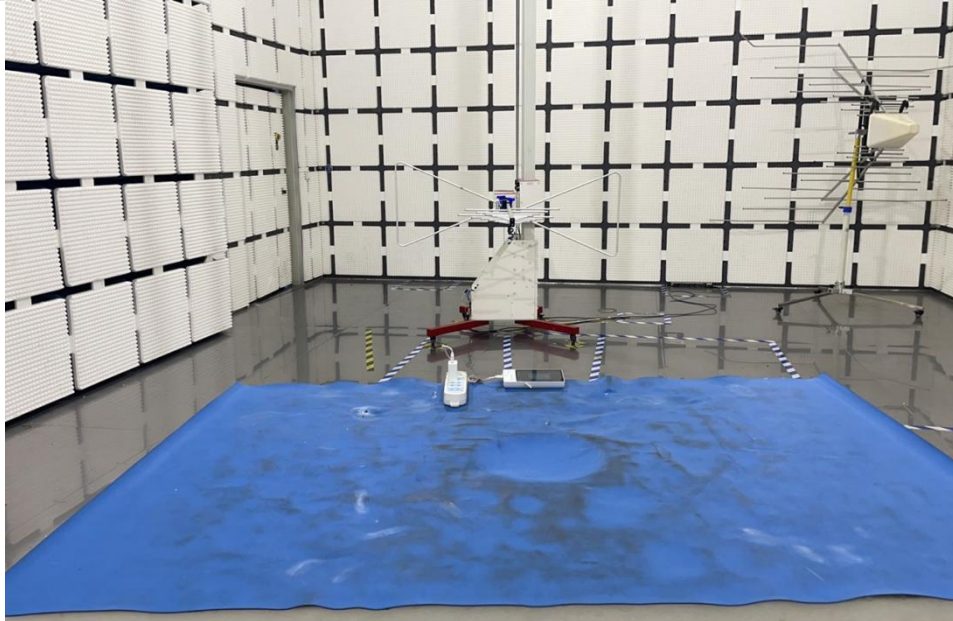
Radiated Emissions (30MHz-1GHz)

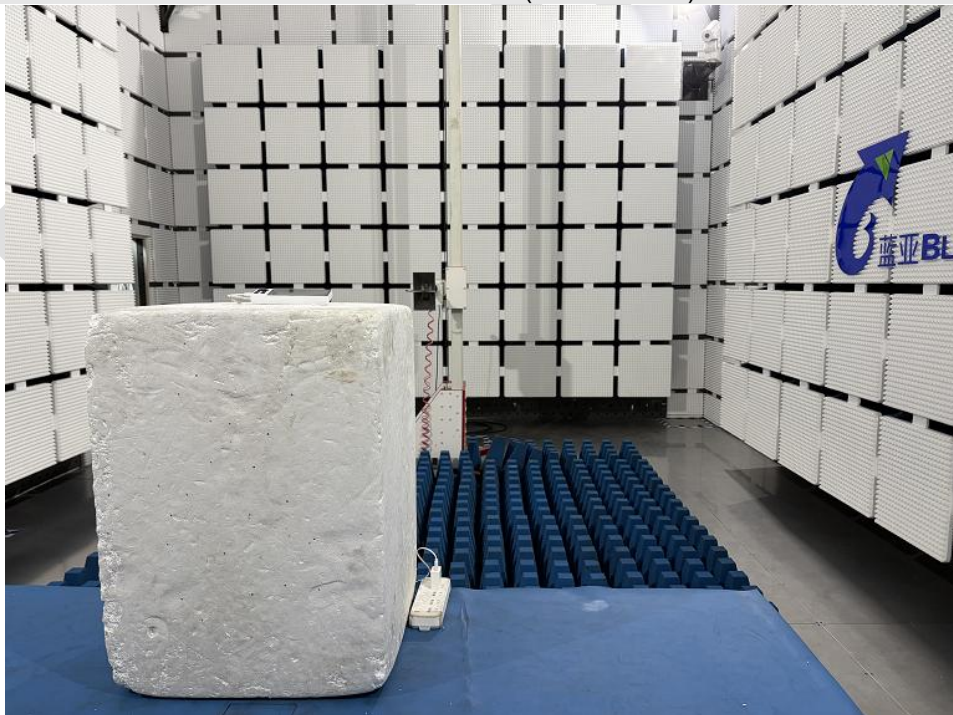
Radiated Emissions (above 1GHz)

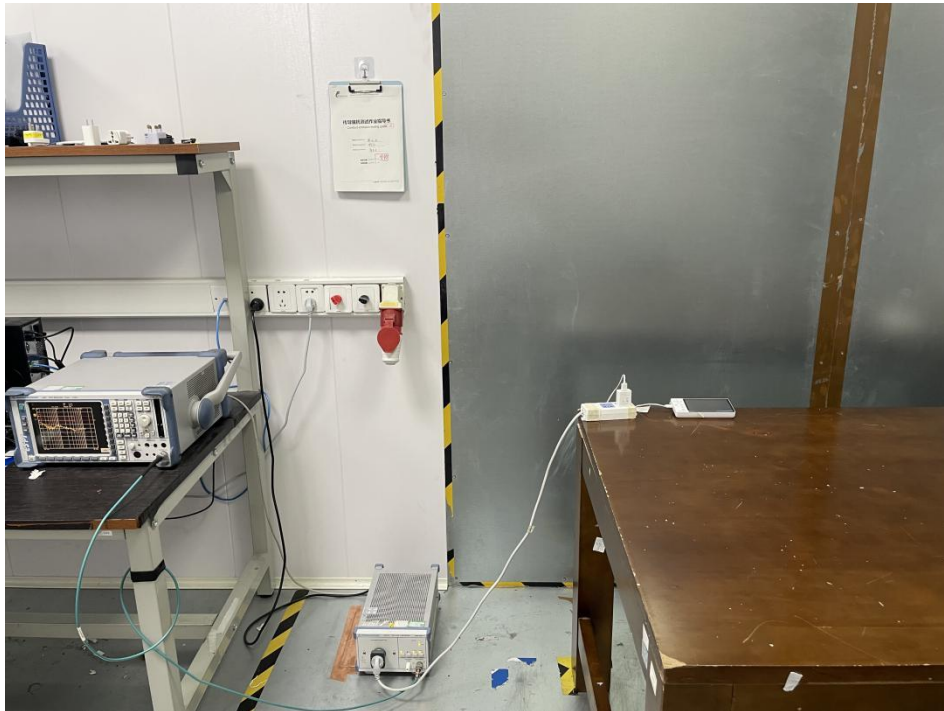
Conducted emissions at AC power line (150kHz-30MHz)
