Test plots

## 5.10 Spurious RF Conducted Emissions

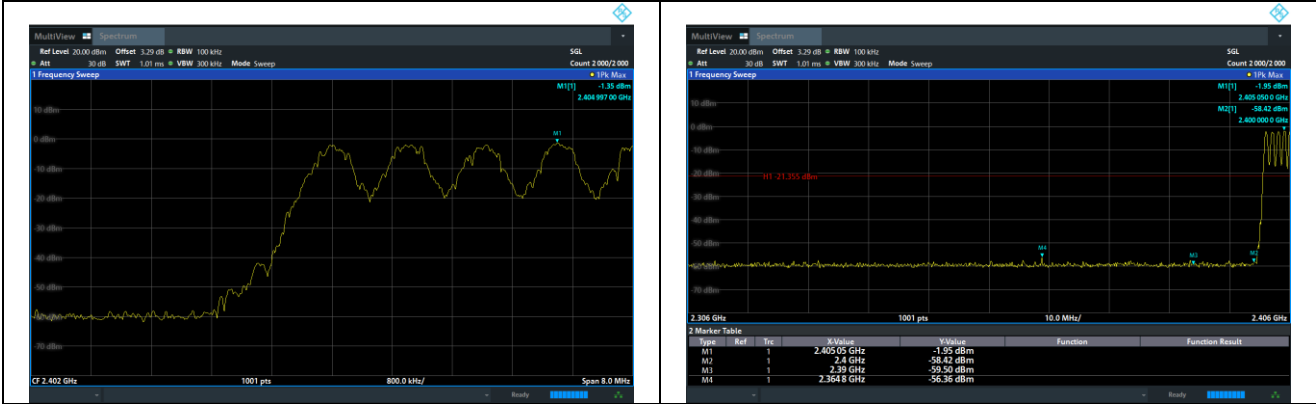
GFSK: Band Edge, Left Side

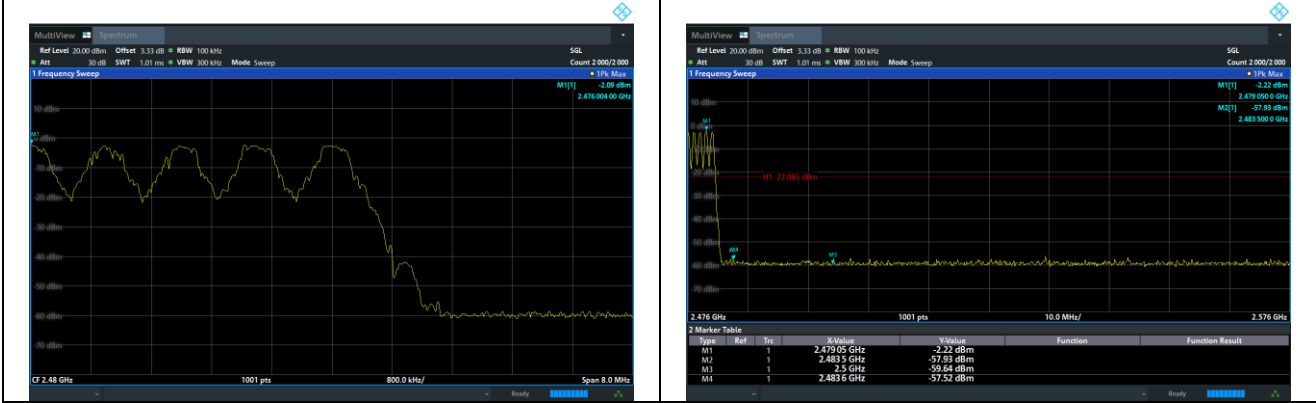
GFSK: Band Edge, Right Side

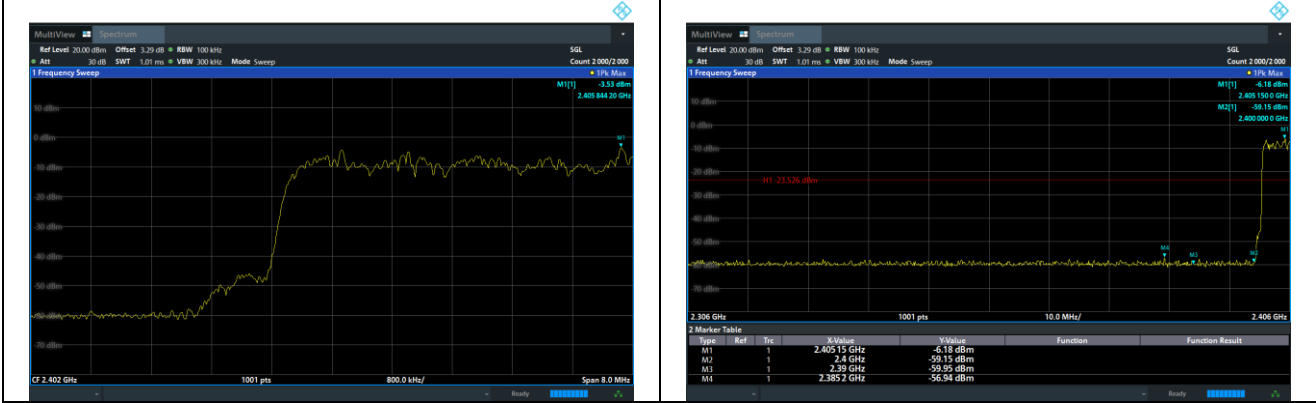
$\pi/4$ -DQPSK: Band Edge, Left Side

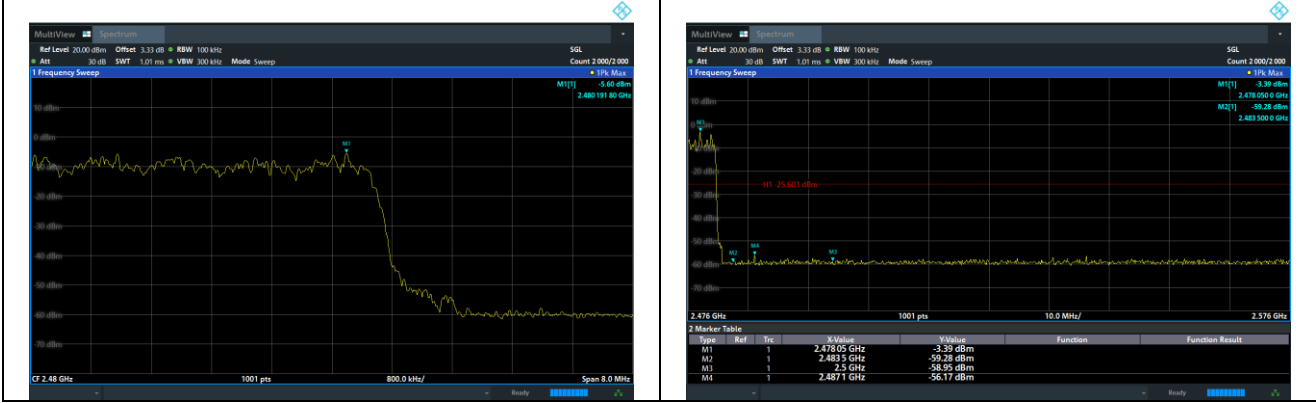
$\pi/4$ -DQPSK: Band Edge, Right Side

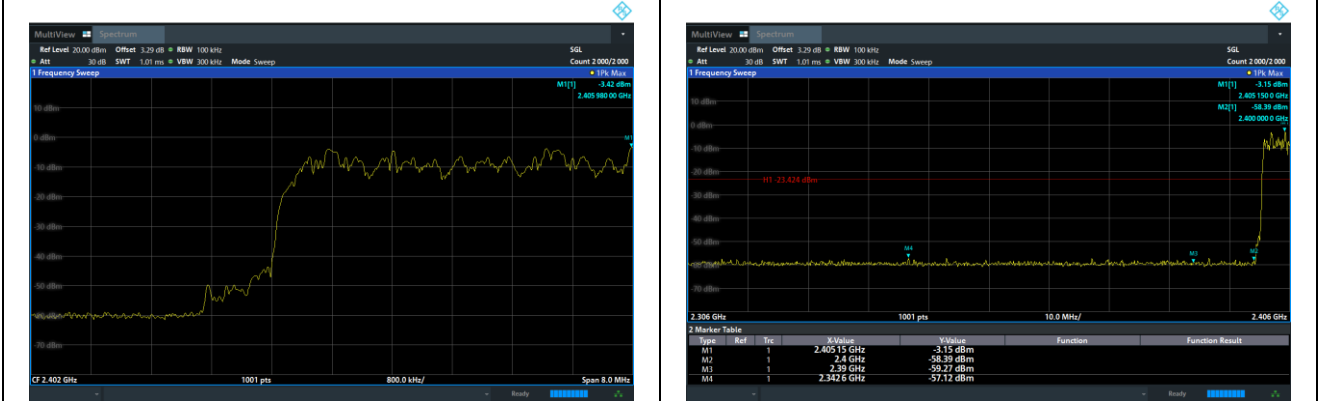
8DPSK: Band Edge, Left Side

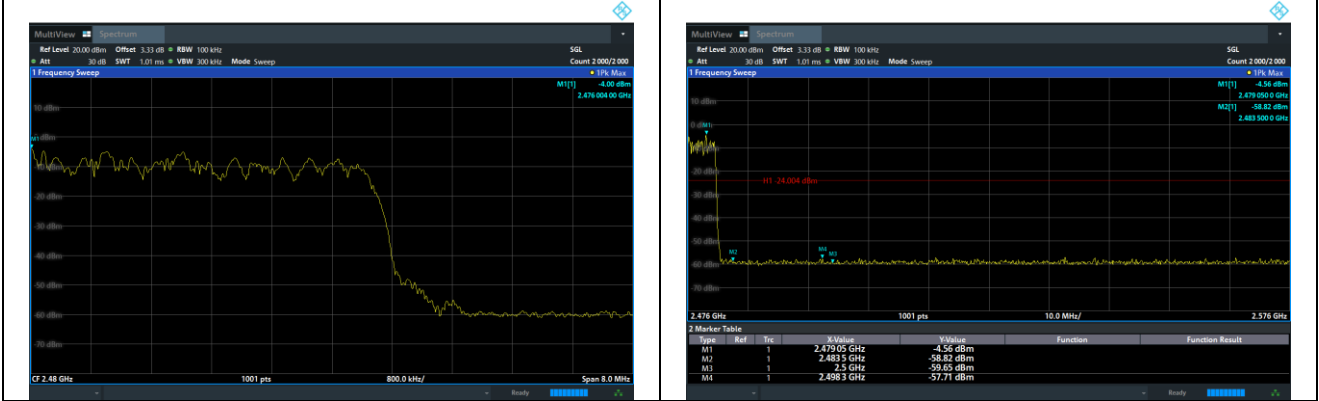
8DPSK: Band Edge, Right Side

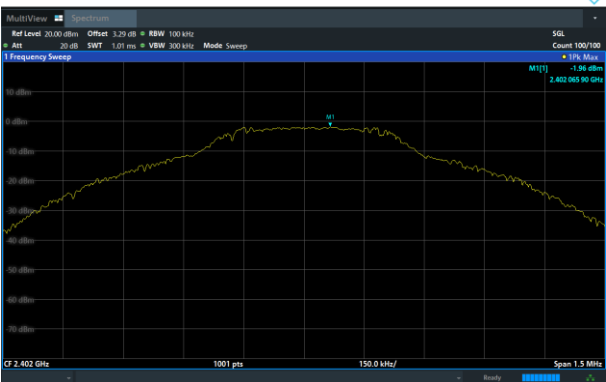
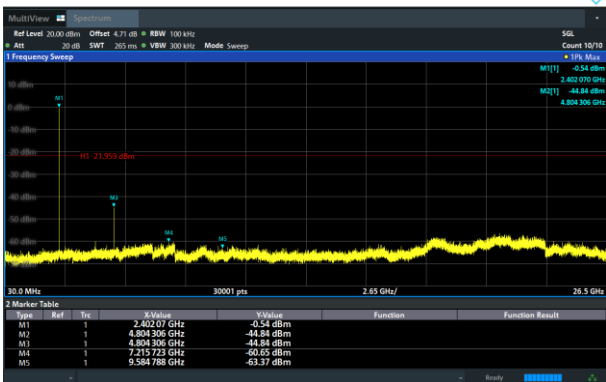
GFSK on Channel 00

1: The measurement frequency range is from 9kHz to the 10th harmonic of the fundamental frequency. The lowest, middle and highest channels are tested to verify the spurious emissions and band edge measurement data.

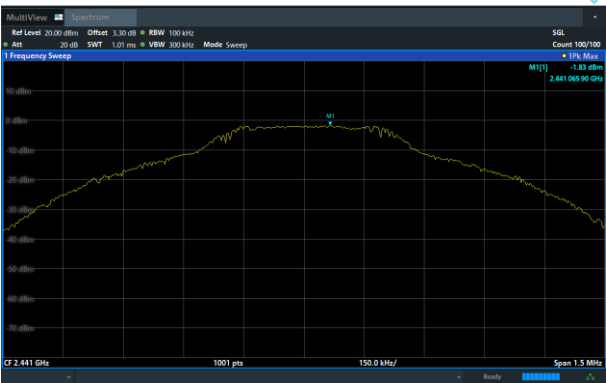
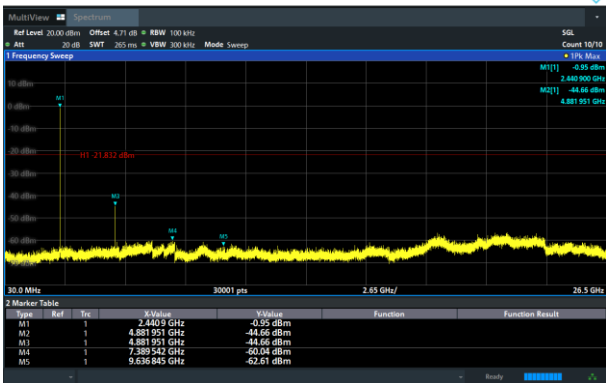
GFSK on Channel 39

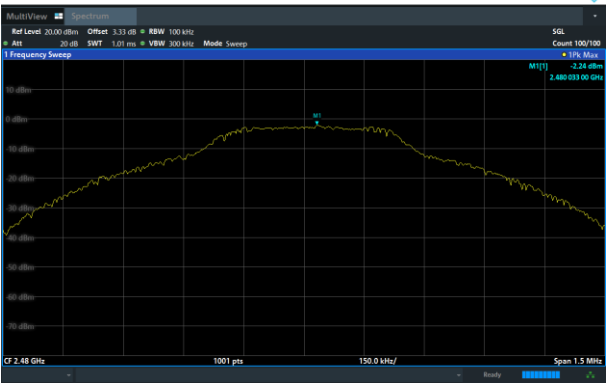
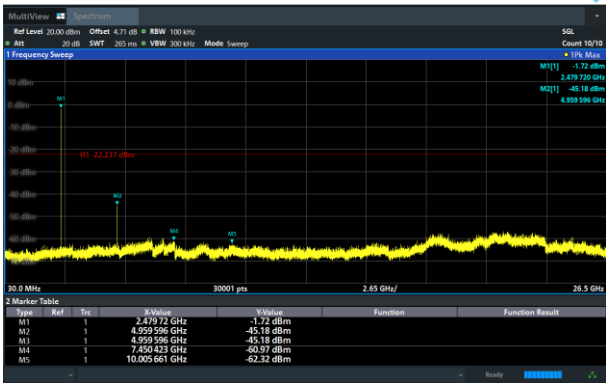
GFSK on Channel 78

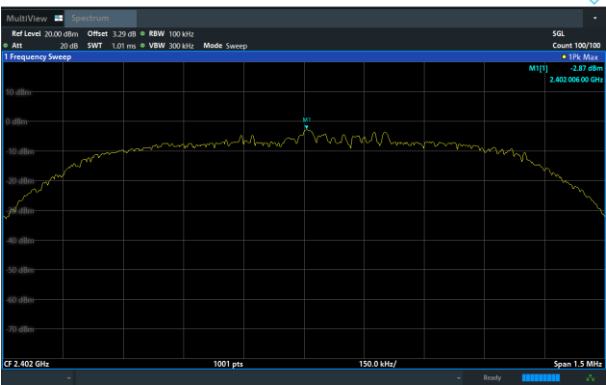
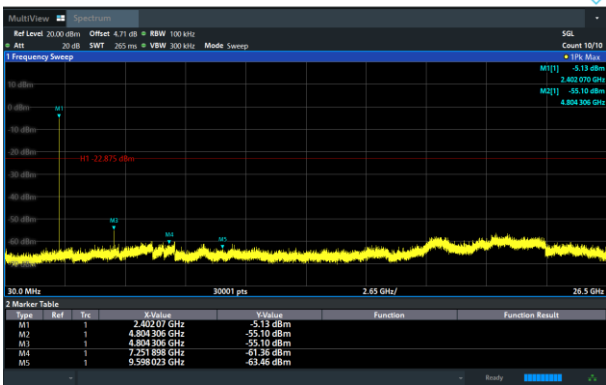
$\pi/4$ -DQPSK on Channel 00

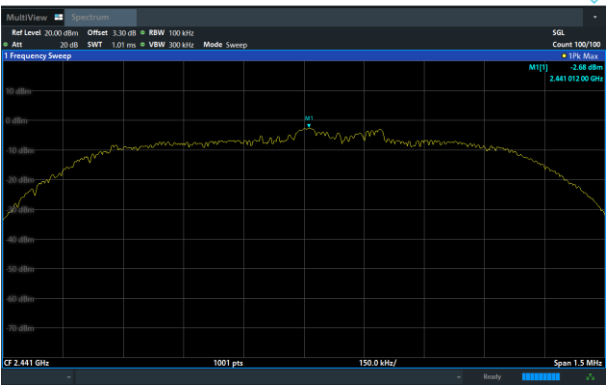
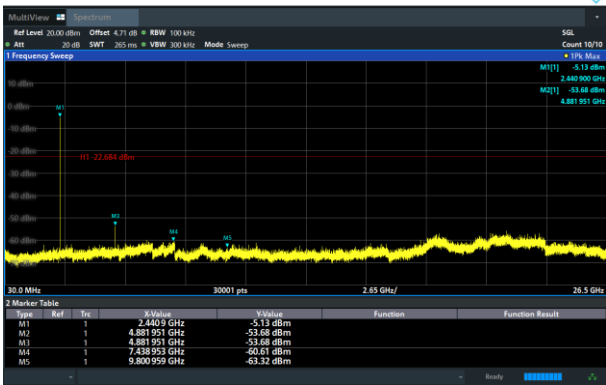
$\pi/4$ -DQPSK on Channel 39

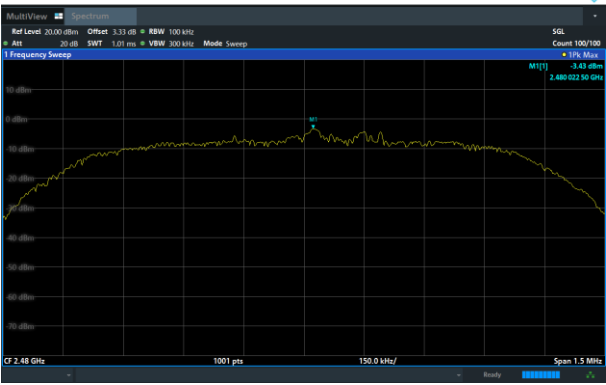
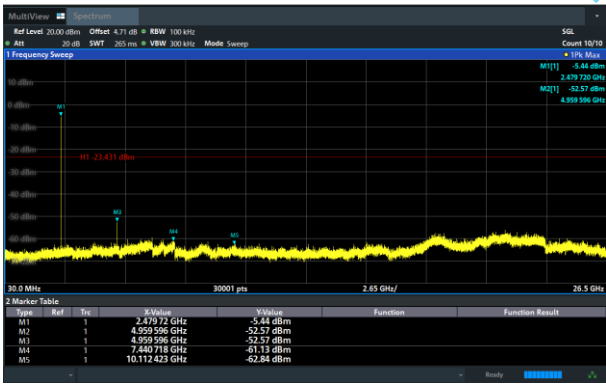
$\pi/4$ -DQPSK on Channel 78

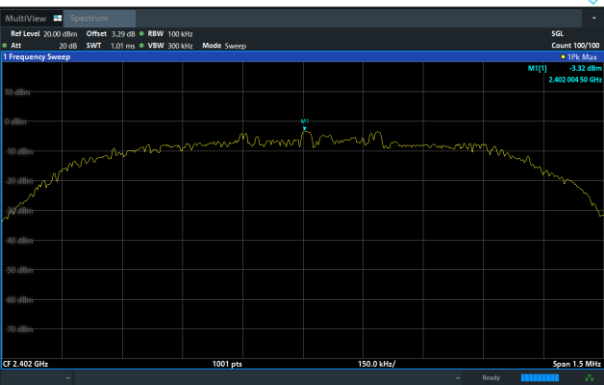
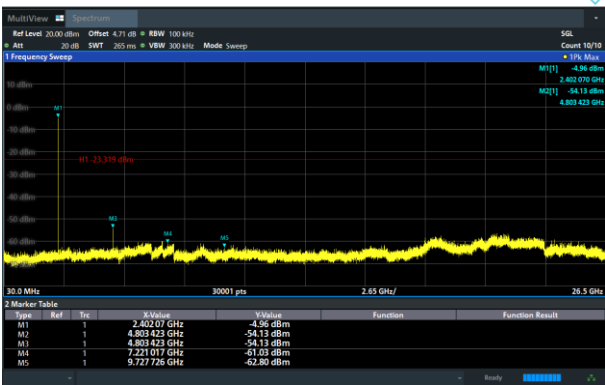
8DPSK on Channel 00

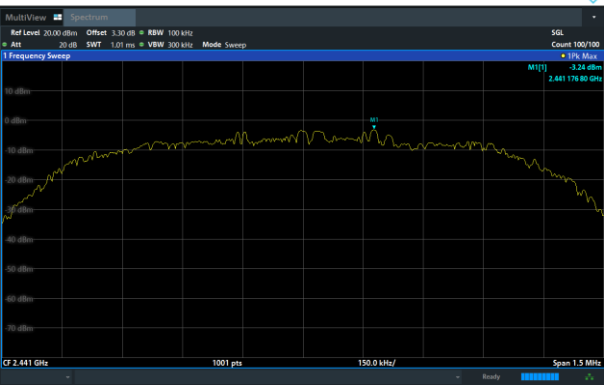
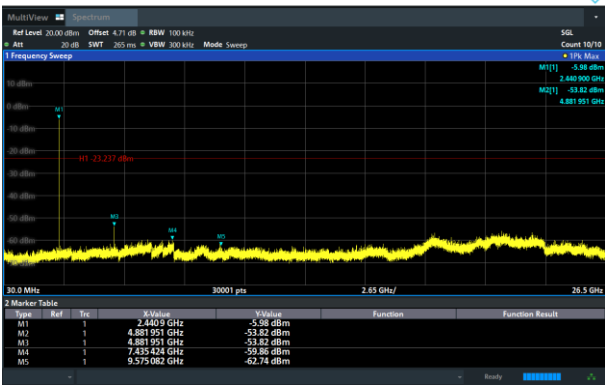
8DPSK on Channel 39

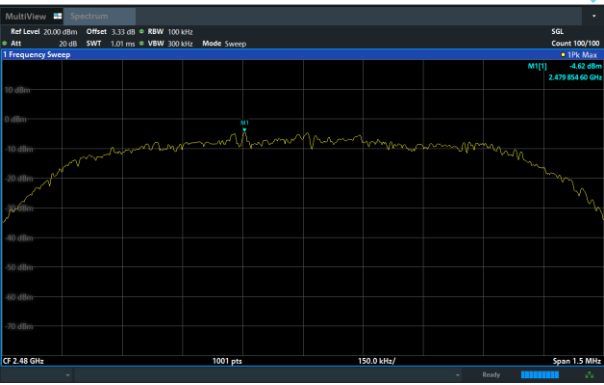
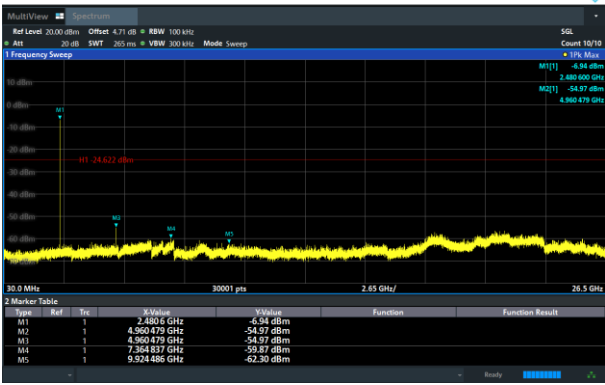
8DPSK on Channel 78
