# Photo Report on Test Setups

**Report Reference:** MDE\_HARMAN\_1607\_FCC\_Photo\_Setups

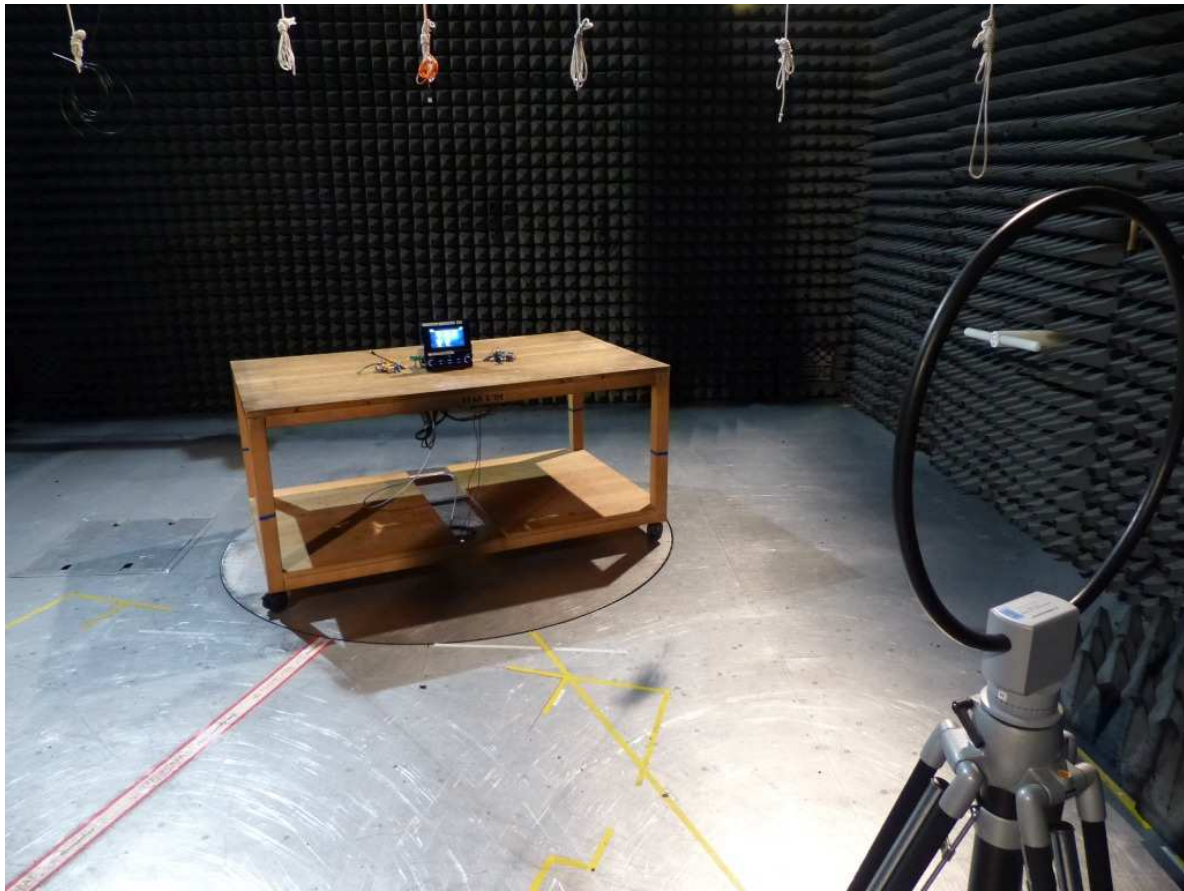
**Photo 1:** Test setup for radiated measurements (Enclosure, below 30 MHz, intentional radiator §15, ANSI C63.10)

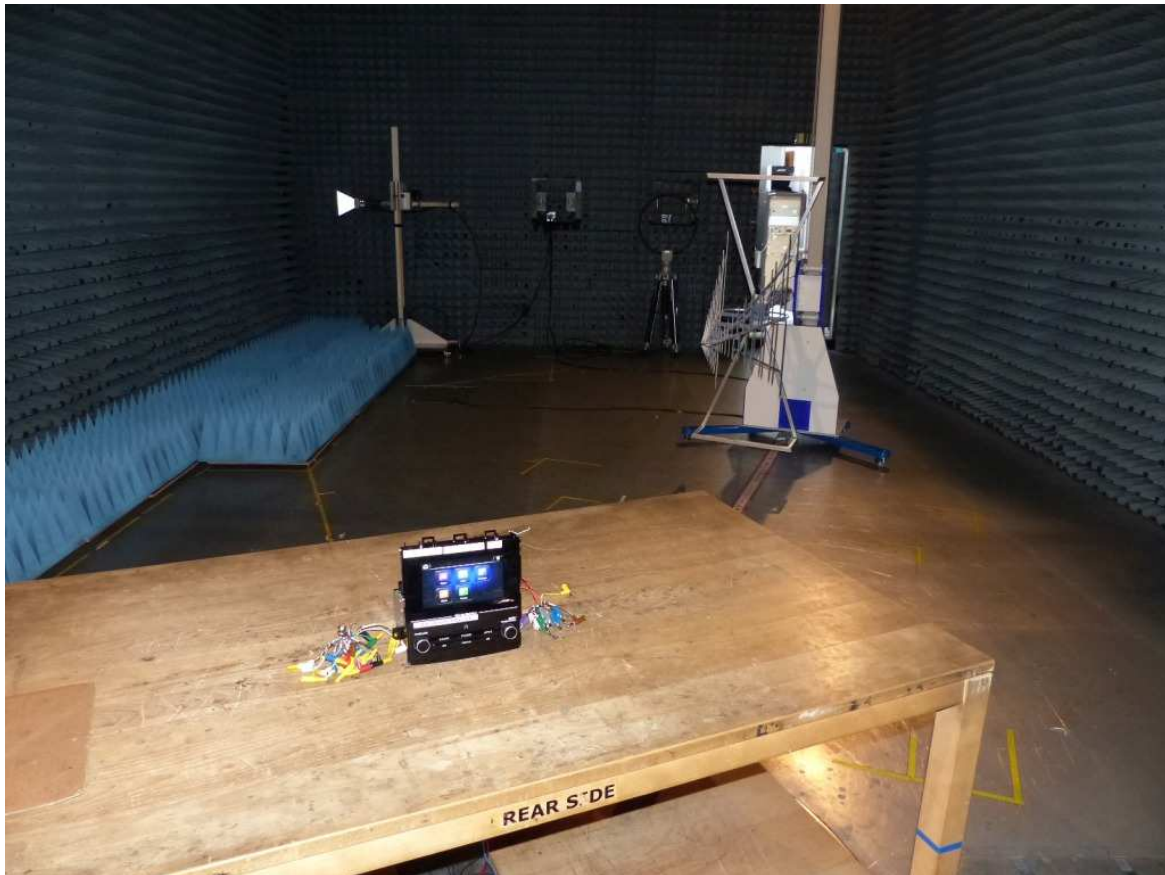
**Photo 2:** Test setup for radiated measurements (Enclosure, semi-anechoic chamber, 30 MHz to 1 GHz, intentional radiator §15, ANSI C63.10)

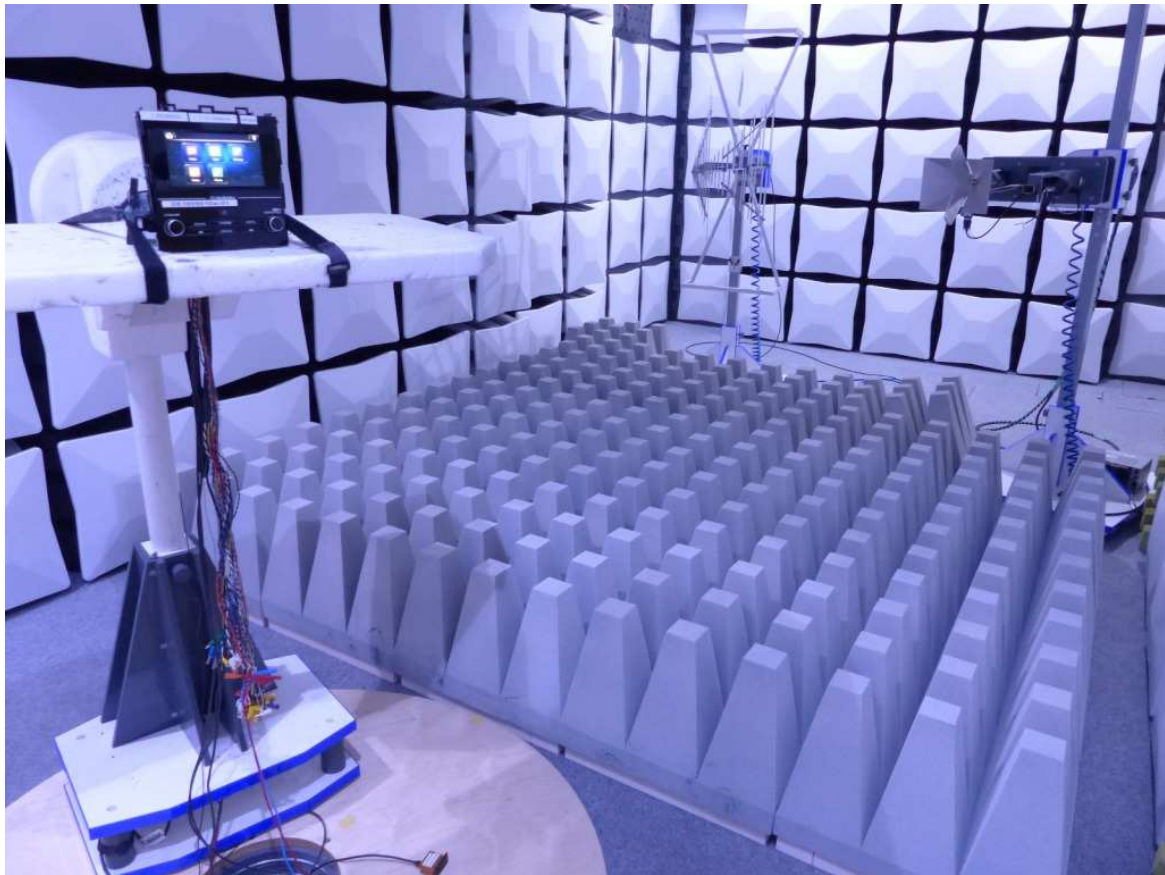
**Photo 3:** Test setup for radiated measurements (Enclosure, fully-anechoic chamber, 1-25 GHz intentional radiator §15, ANSI C63.10)
