# Radiated Emission Measurement

Condition : FCC\_part 15 RE-Class C\_Above 1GHz\_PK

EUT : W6M22310-23012

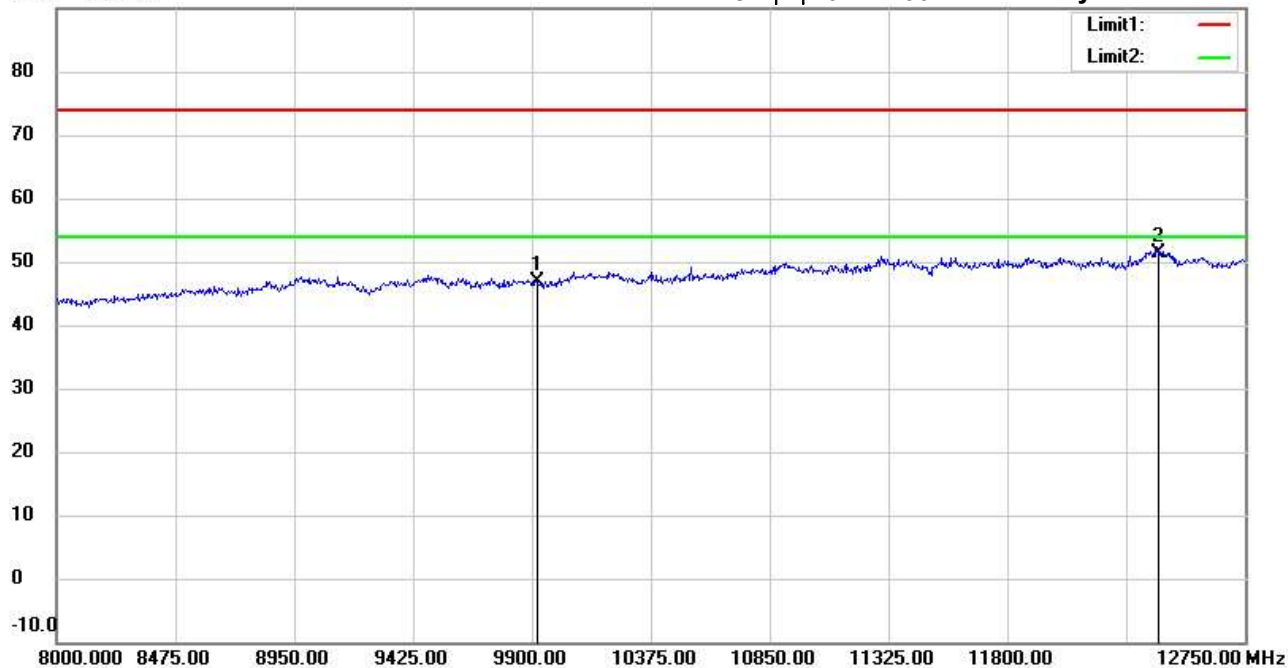
Data : #8

Test Mode : TX 2480 MHz

Polarization: Vertical

| Mk. | Frequency (MHz) | Reading (dBuV) | Detector | Corr. factor (dB/m) | Result (dBuV/m) | Limit (dBuV/m) | Ant.Pos (cm) | Tab.Pos (deg.) | Margin (dB) | Comment |
|---|---|---|---|---|---|---|---|---|---|---|
| | 9920.000 | 32.76 | peak | 14.00 | 46.76 | 74.00 | 150 | 52 | -27.24 | |
| * | 12400.000 | 33.75 | peak | 17.55 | 51.30 | 74.00 | 150 | 57 | -22.70 | |
