## Appendix B: photographs of test setup

Reference to the test report no. BLA-EMC-202512-A0401

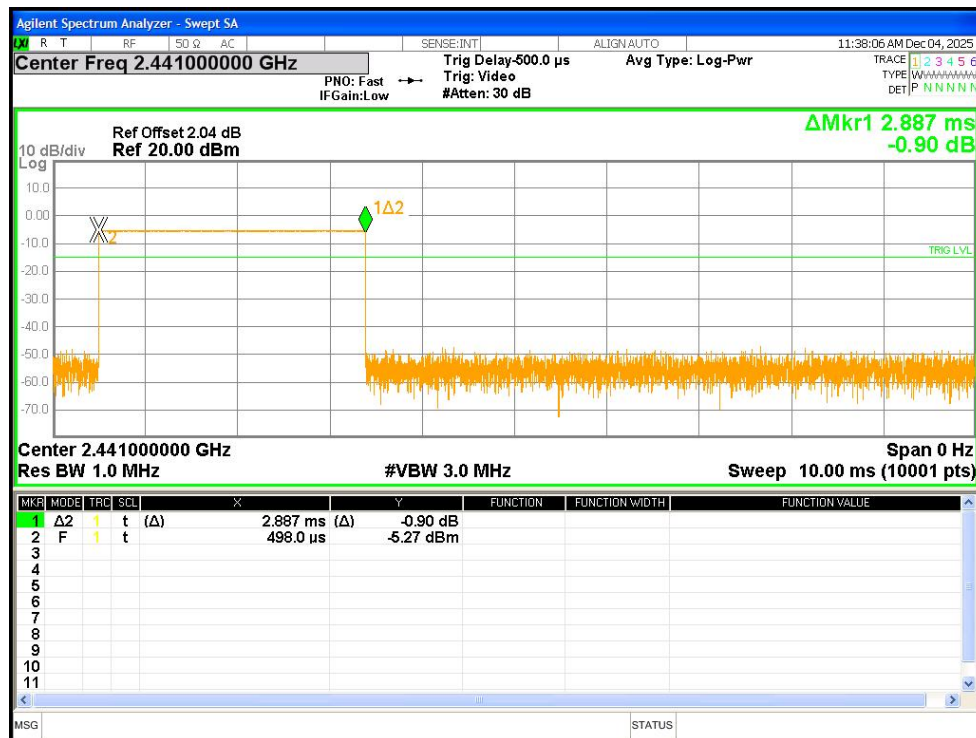
Dwell NVNT 1-DH5 2441MHz Ant1 Accumulated

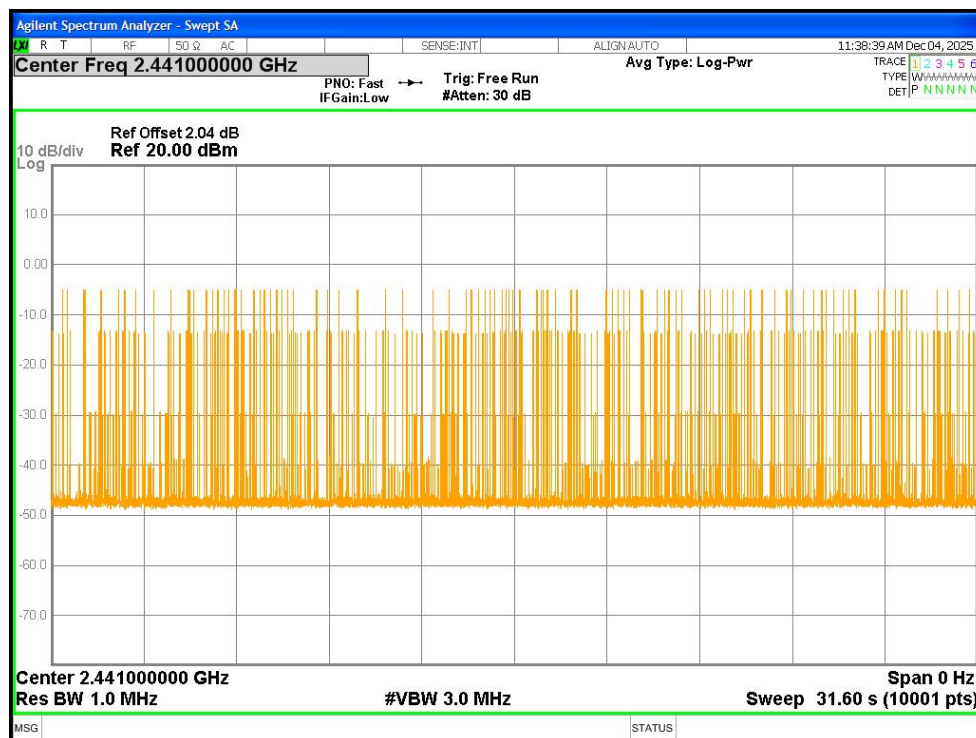
Dwell NVNT 2-DH1 2441MHz Ant1 One Burst

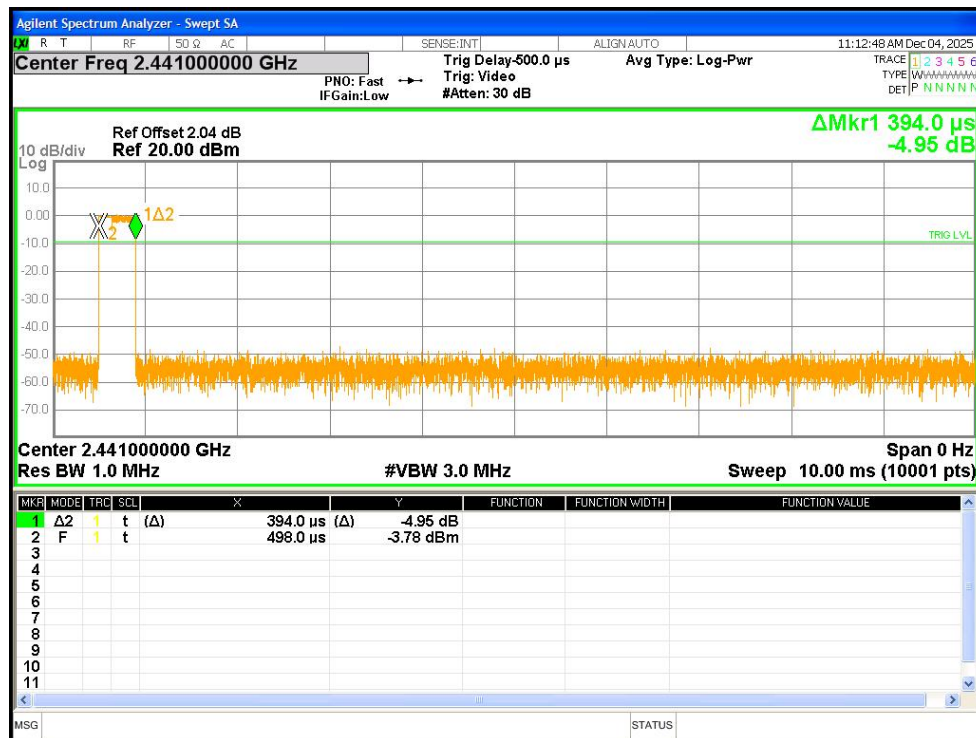
Dwell NVNT 2-DH1 2441MHz Ant1 Accumulated

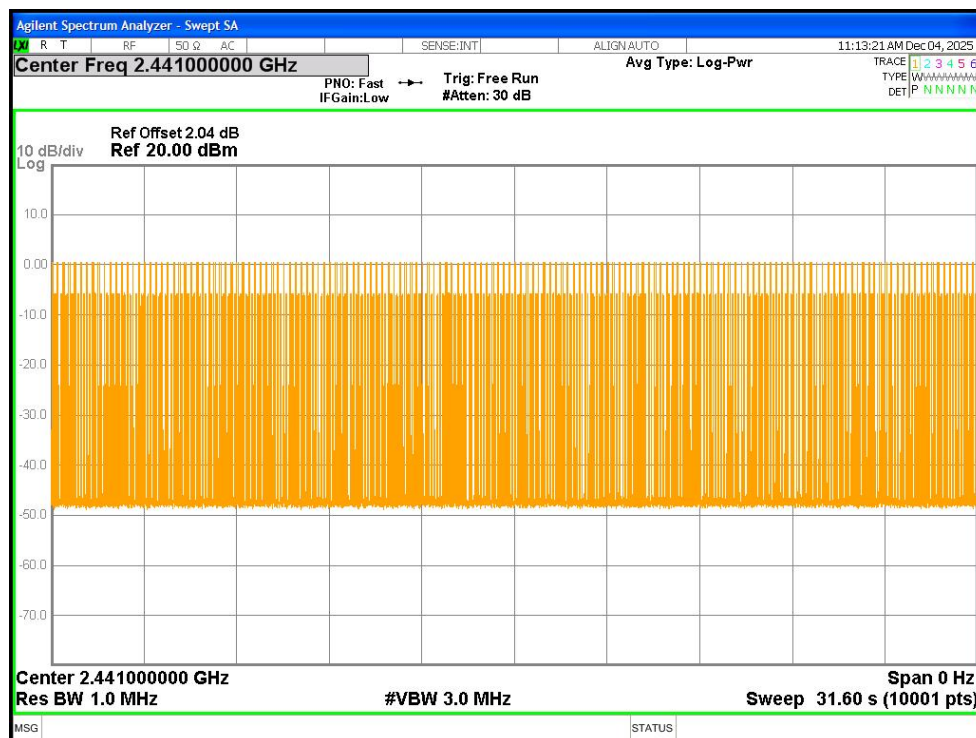
Dwell NVNT 2-DH3 2441MHz Ant1 One Burst

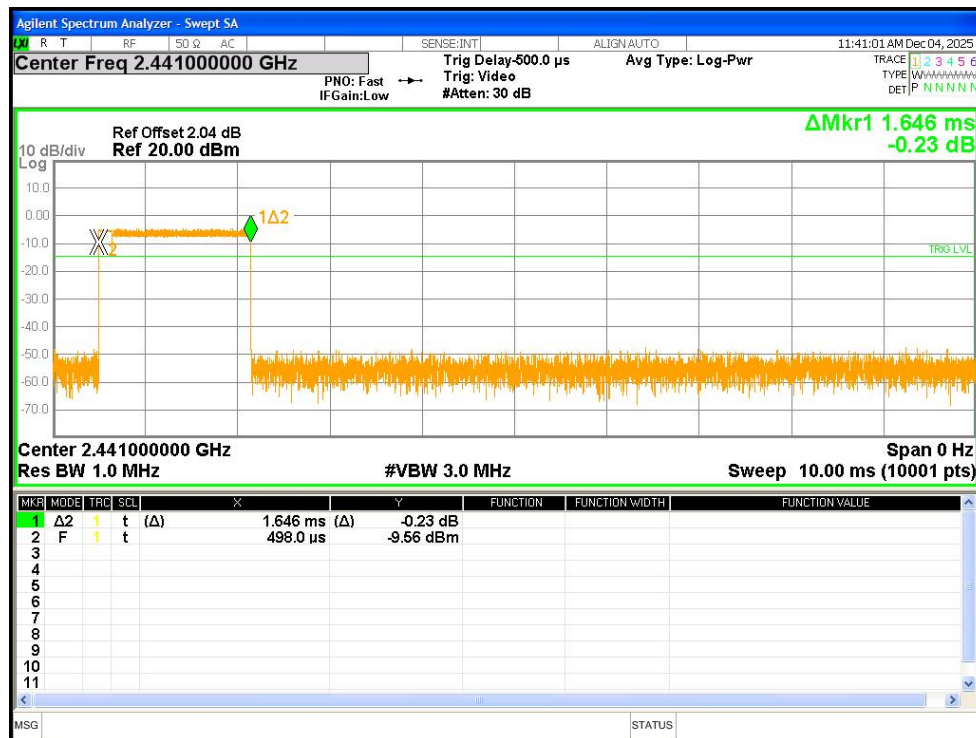
Dwell NVNT 2-DH3 2441MHz Ant1 Accumulated

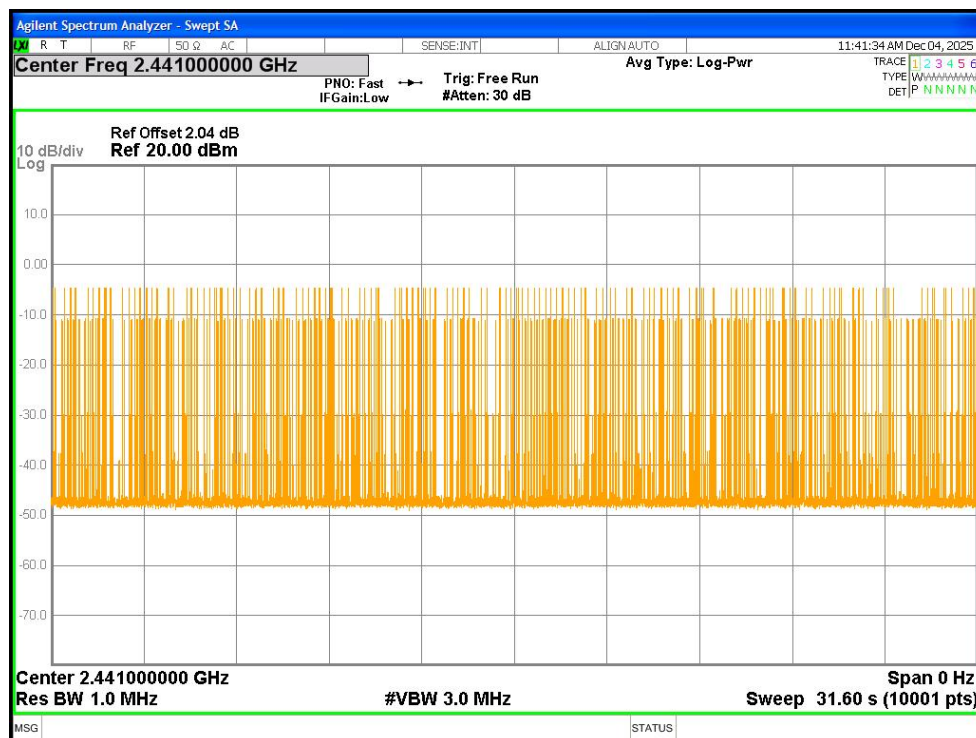
Dwell NVNT 2-DH5 2441MHz Ant1 One Burst

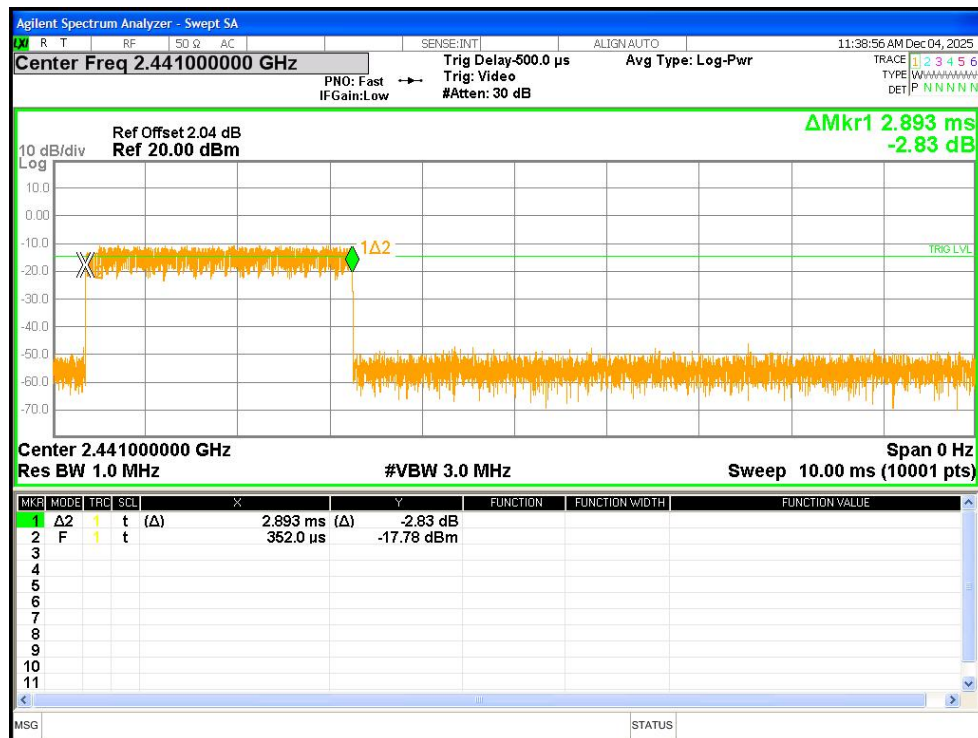
Dwell NVNT 2-DH5 2441MHz Ant1 Accumulated

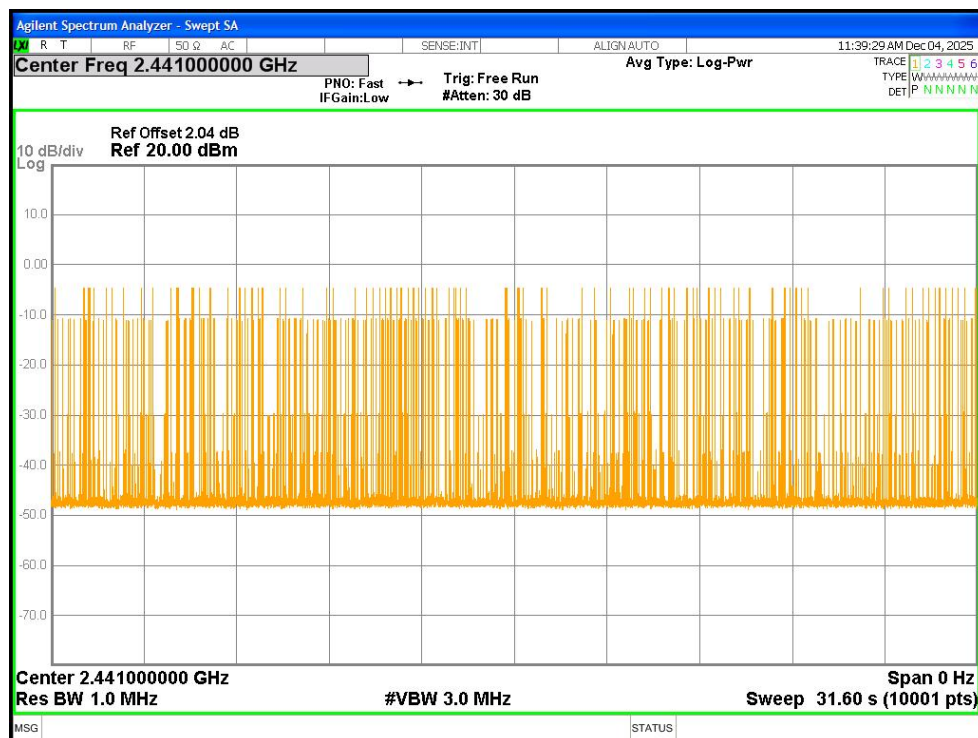
Dwell NVNT 3-DH1 2441MHz Ant1 One Burst

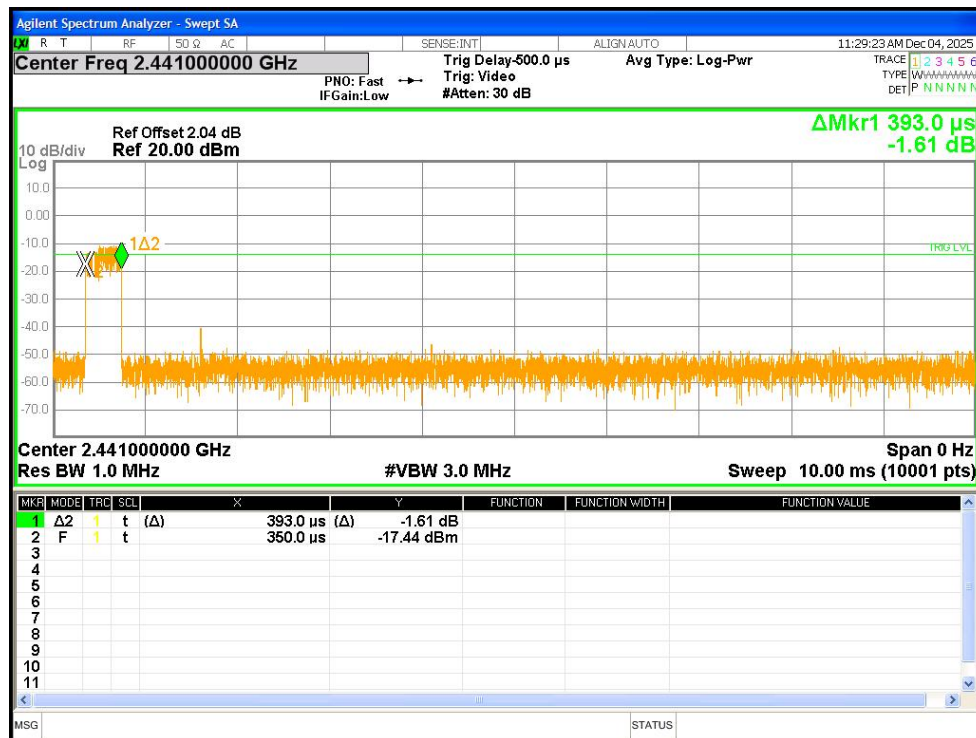
Dwell NVNT 3-DH1 2441MHz Ant1 Accumulated

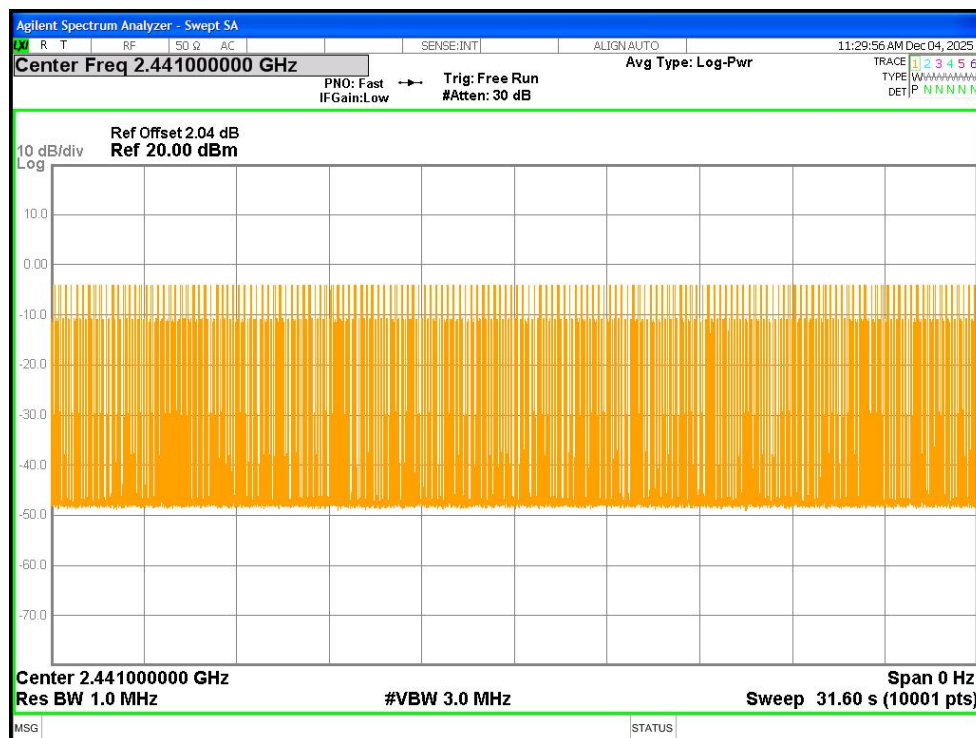
Dwell NVNT 3-DH3 2441MHz Ant1 One Burst

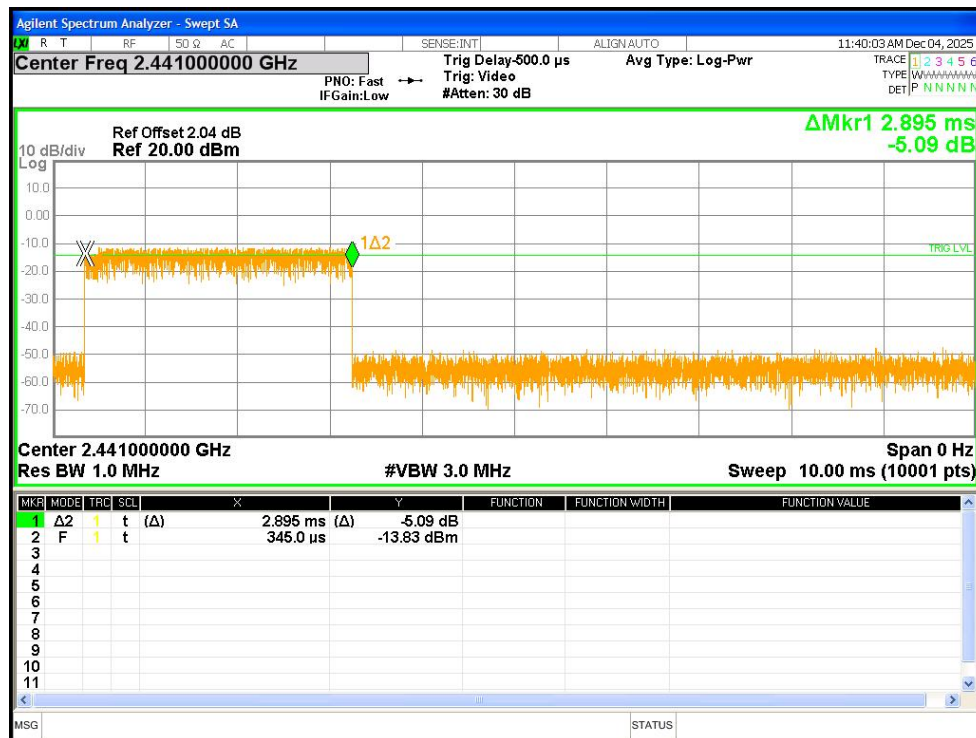
Dwell NVNT 3-DH5 2441MHz Ant1 Accumulated

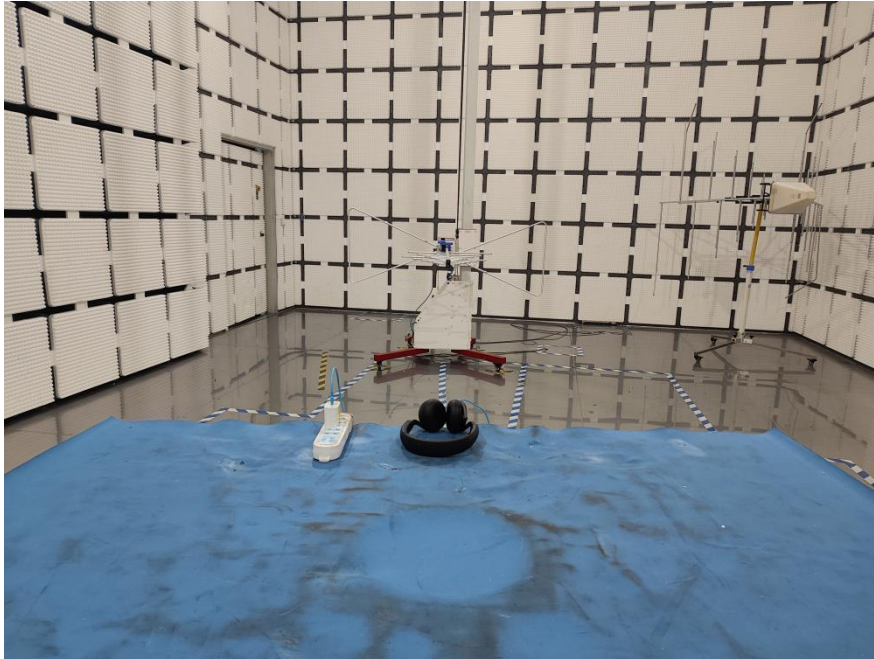
Radiated Emissions (30MHz-1GHz)

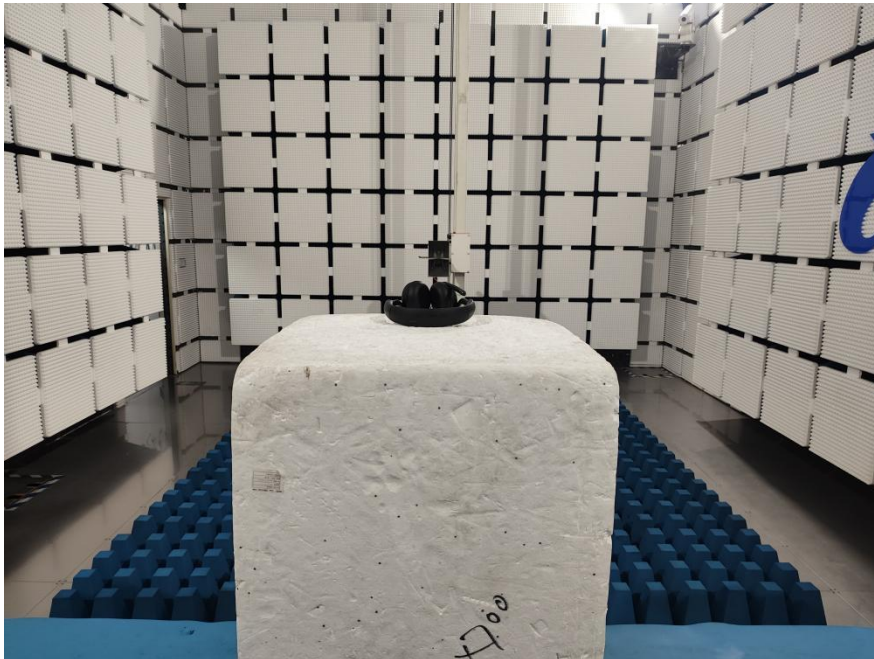
Radiated Emissions (above 1GHz)

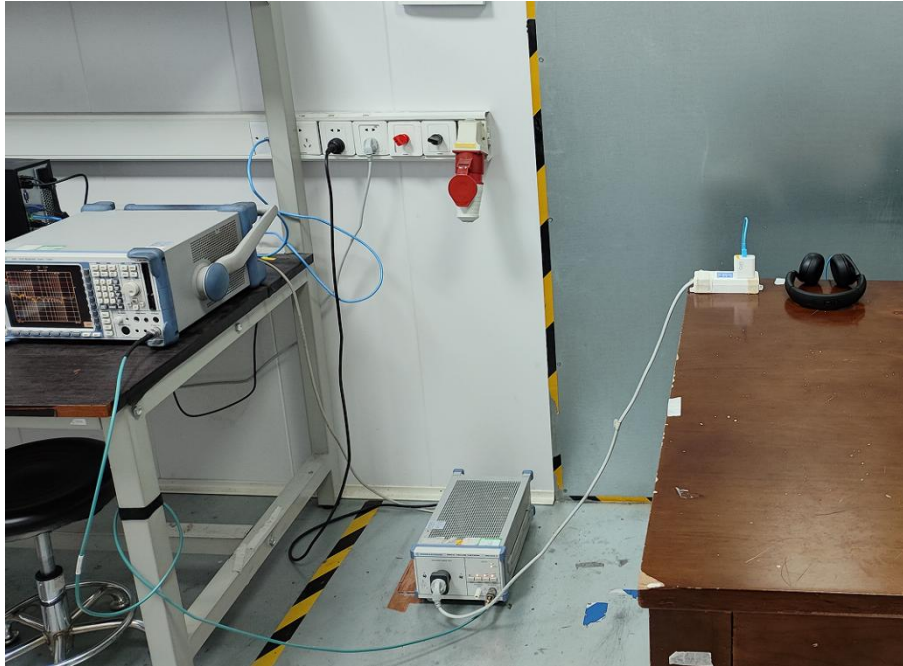
Conducted Emissions at Mains Terminals (150 kHz-30MHz)
