## Appendix B: photographs of test setup

## Appendix C: photographs of EUT

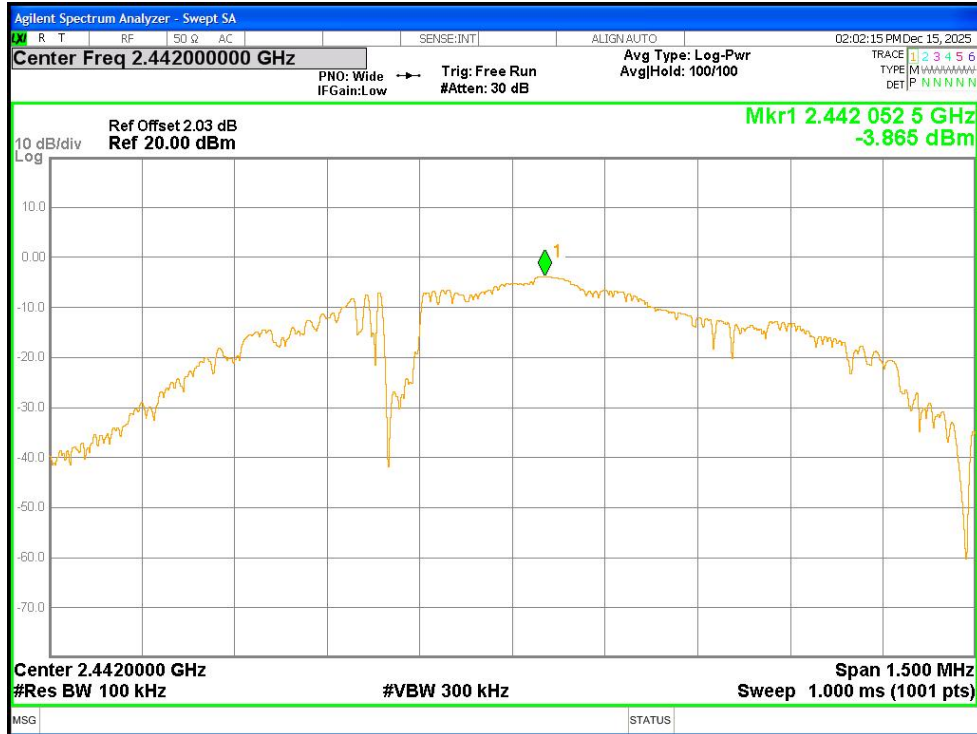
Tx. Spurious NVNT BLE 1M 2442MHz Ant1 Ref

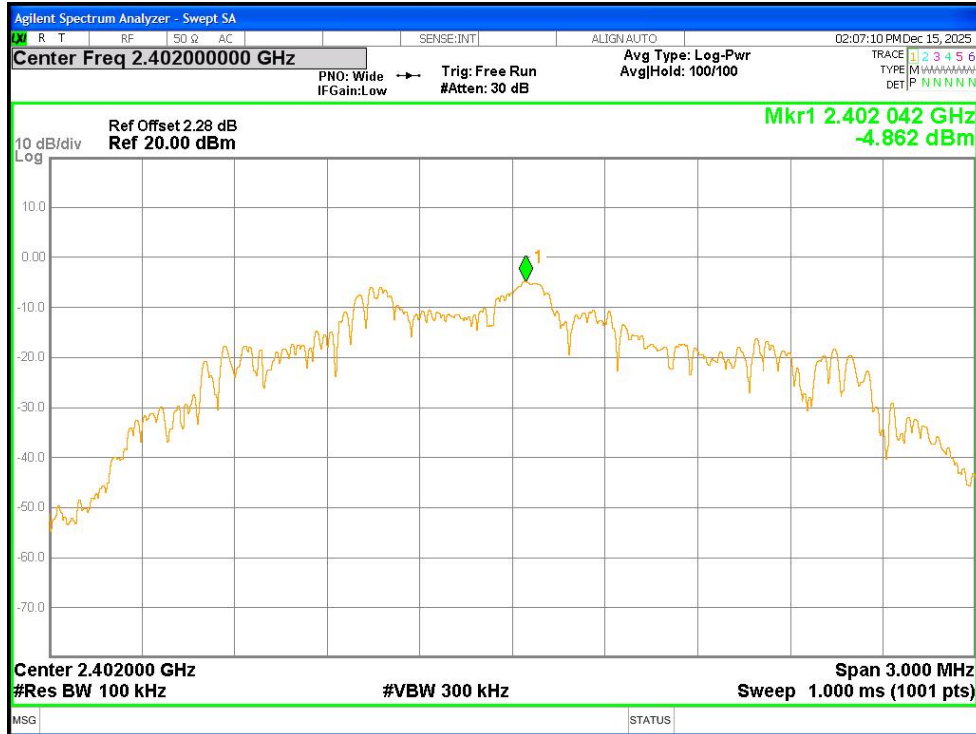
Tx. Spurious NVNT BLE 2M 2402MHz Ant1 Ref

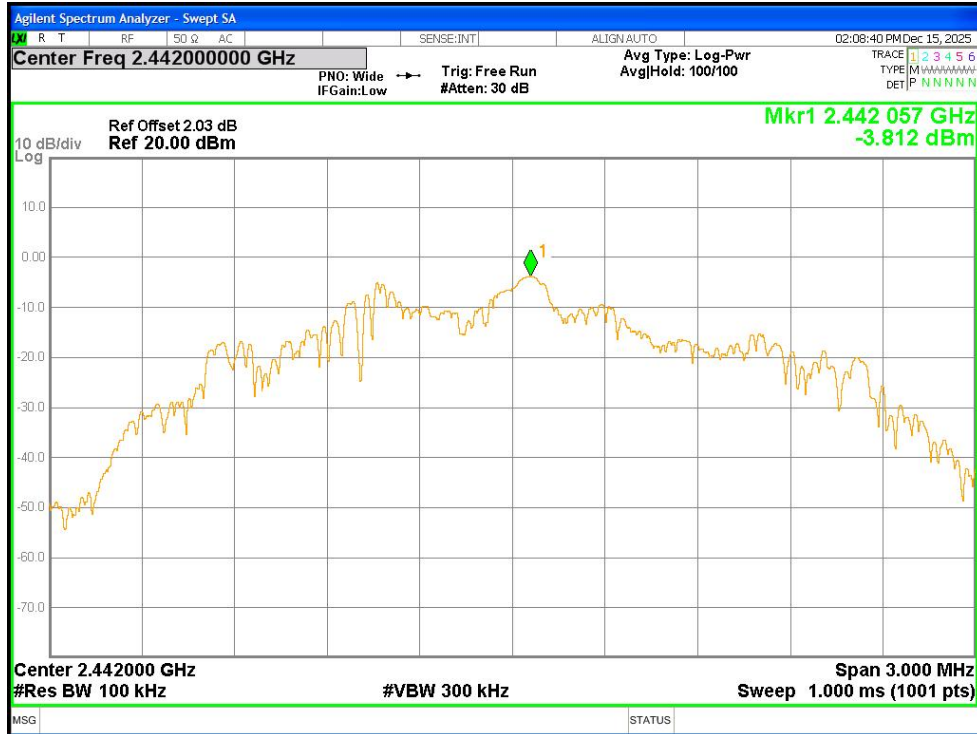
Tx. Spurious NVNT BLE 2M 2442MHz Ant1 Ref

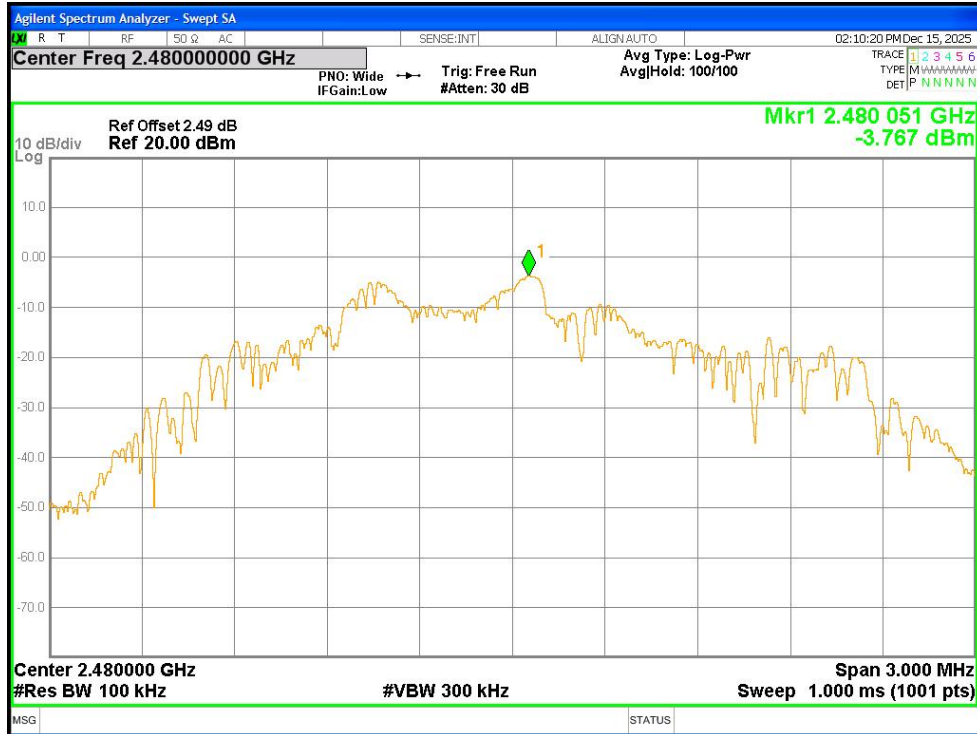
Tx. Spurious NVNT BLE 2M 2480MHz Ant1 Ref

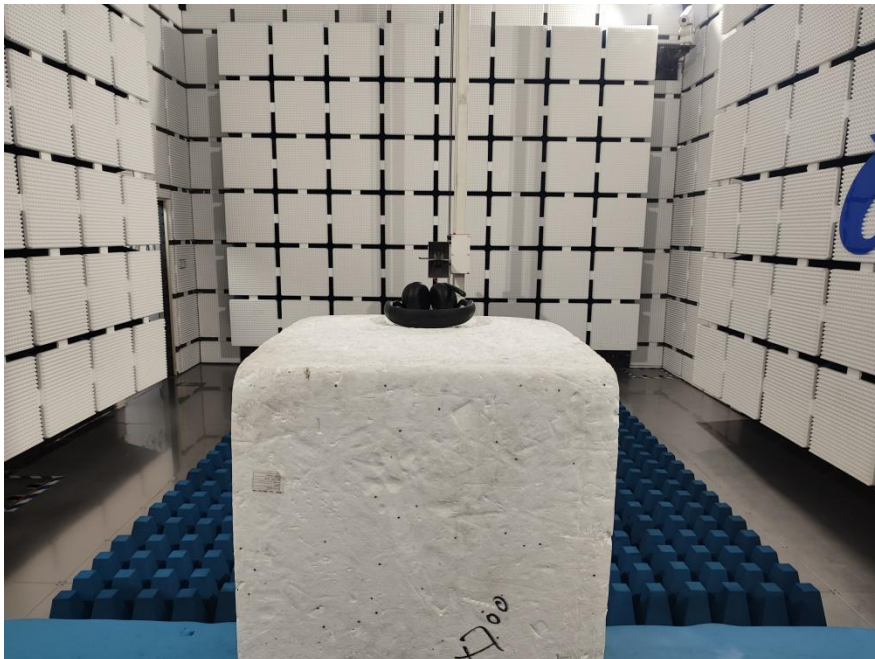
Radiated Emissions (above 1GHz)

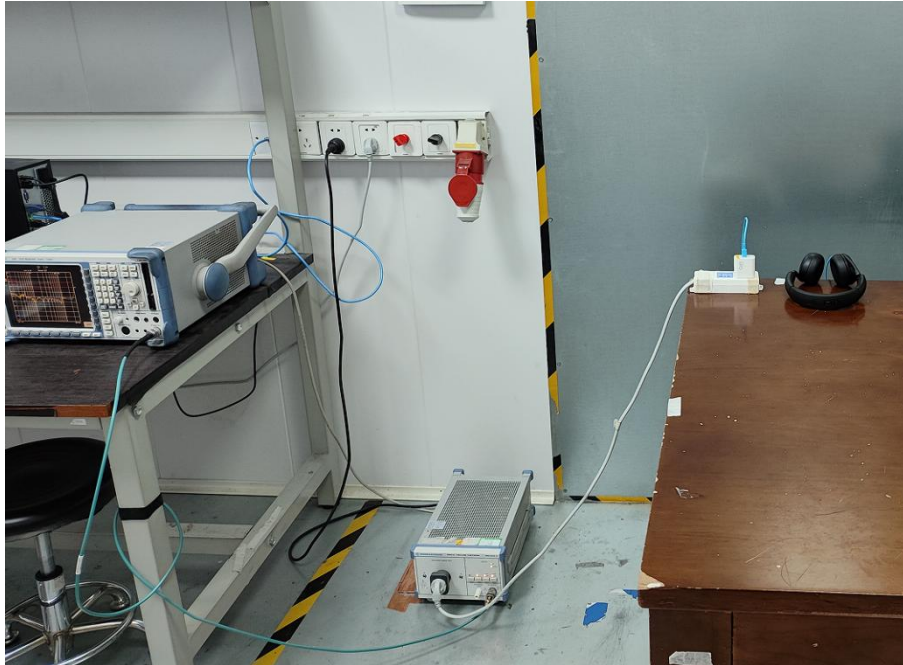
Conducted Emissions at Mains Terminals (150 kHz-30MHz)
