## Spurious Emissions at Antenna Terminal

### FCC Part 22H

#### B26\_2, Normal

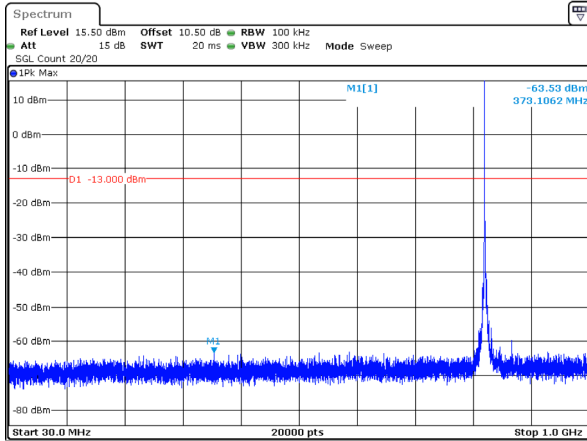
##### 1.4MHz\_Low\_QPSK\_1@0(30MHz~1GHz)

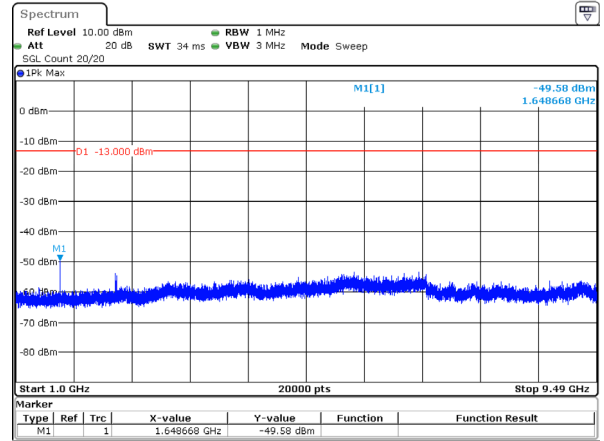
##### 1.4MHz\_Low\_QPSK\_1@0(1GHz~9.49GHz)

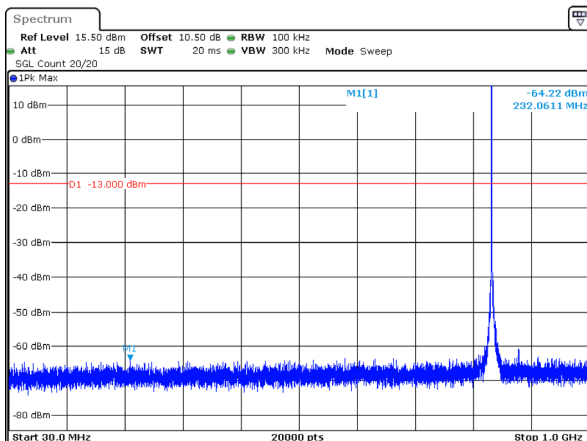
##### 1.4MHz\_Middle\_QPSK\_1@0(30MHz~1GHz)

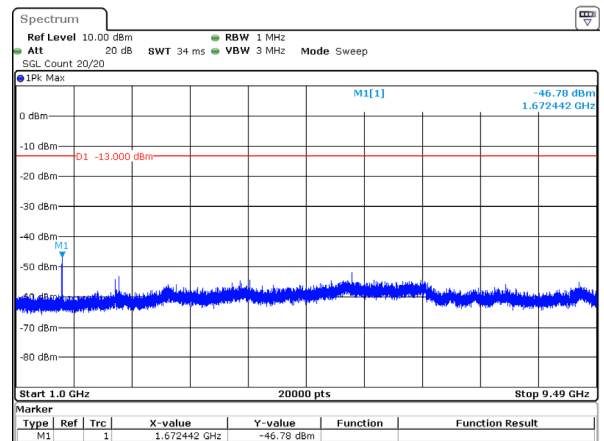
##### 1.4MHz\_Middle\_QPSK\_1@0(1GHz~9.49GHz)

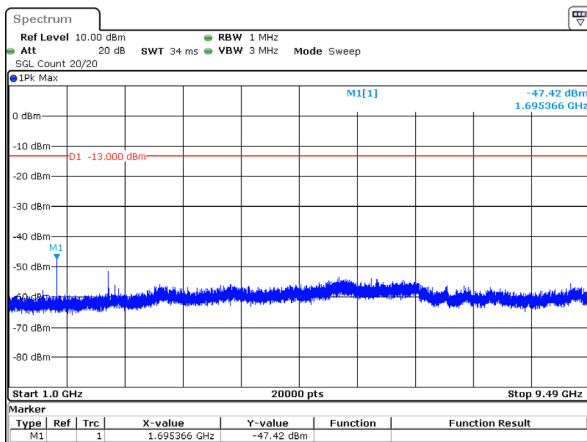
##### 1.4MHz\_High\_QPSK\_1@0(1GHz~9.49GHz)

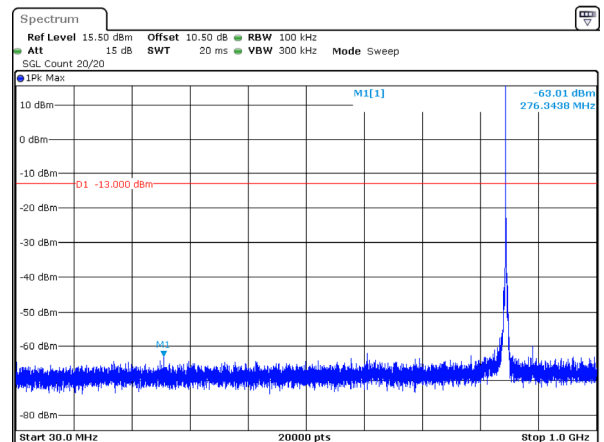
##### 1.4MHz\_High\_QPSK\_1@0(30MHz~1GHz)

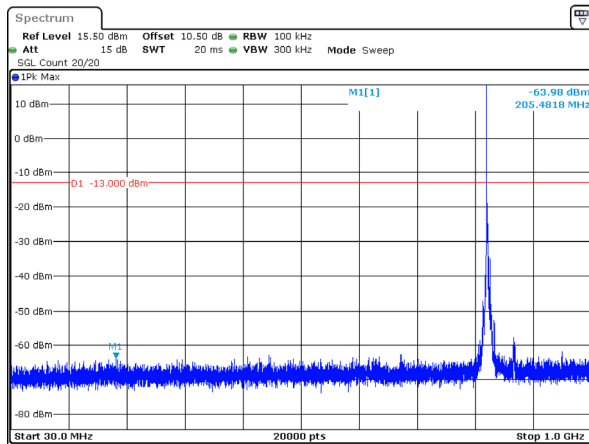
### 3MHz\_Low\_QPSK\_1@0(30MHz~1GHz)

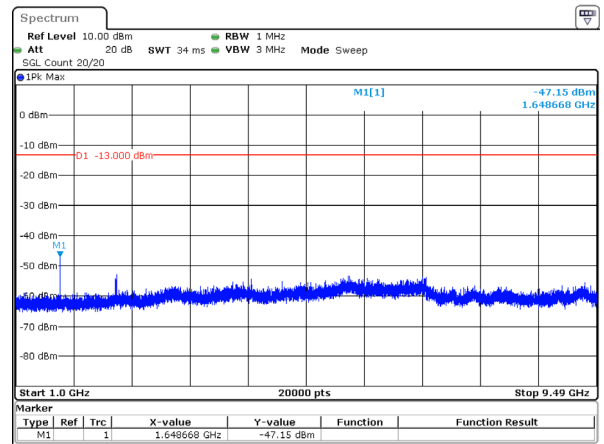
### 3MHz\_Low\_QPSK\_1@0(1GHz~9.49GHz)

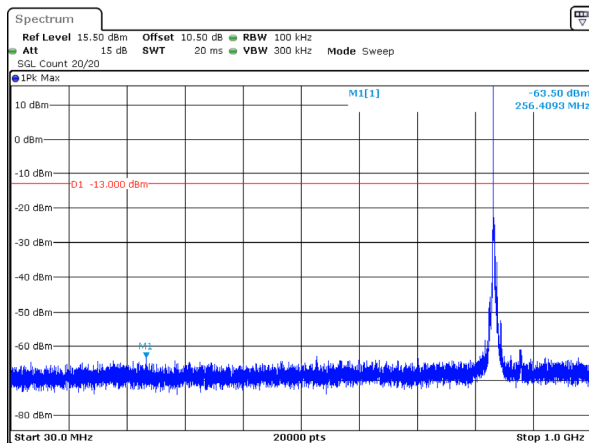
### 3MHz\_Middle\_QPSK\_1@0(30MHz~1GHz)

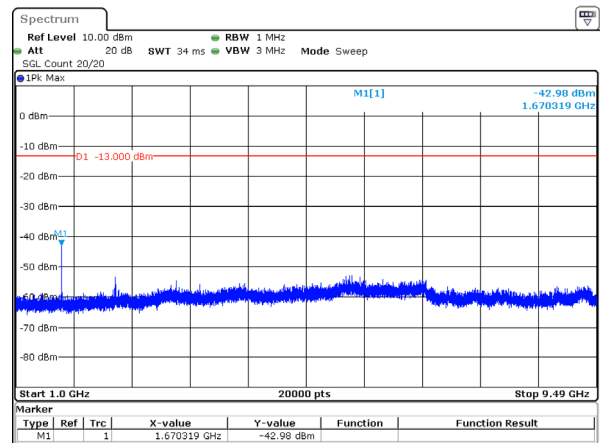
### 3MHz\_Middle\_QPSK\_1@0(1GHz~9.49GHz)

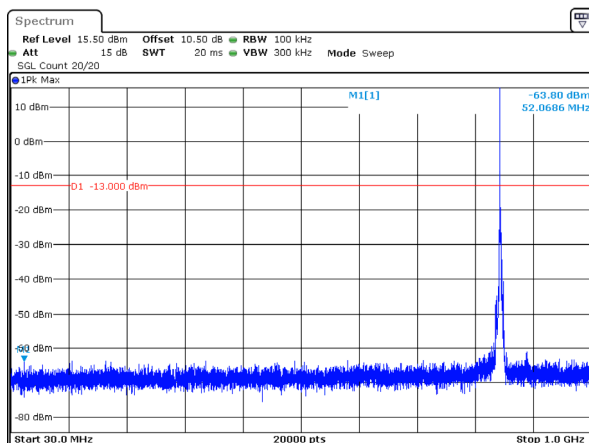
### 3MHz\_High\_QPSK\_1@0(30MHz~1GHz)

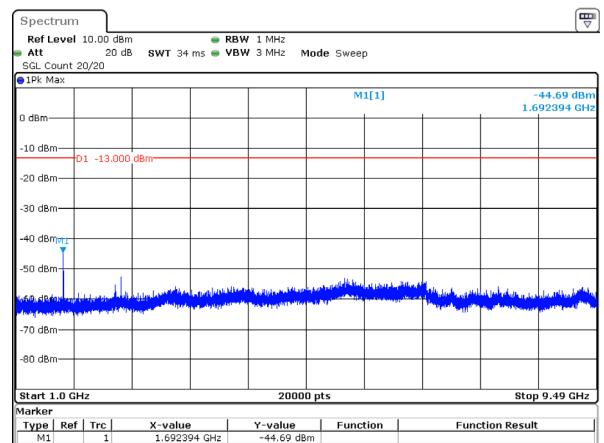
### 3MHz\_High\_QPSK\_1@0(1GHz~9.49GHz)

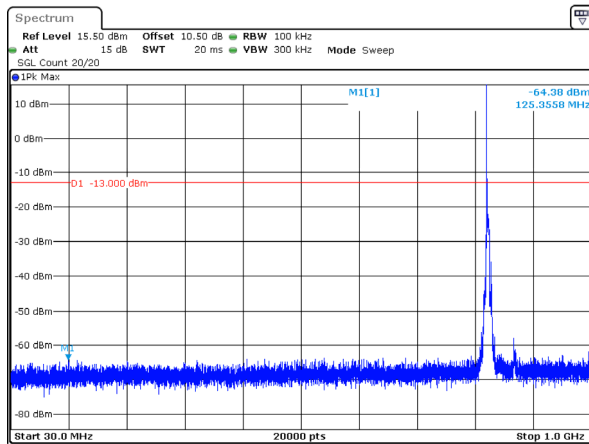
### 5MHz\_Low\_QPSK\_1@0(30MHz~1GHz)

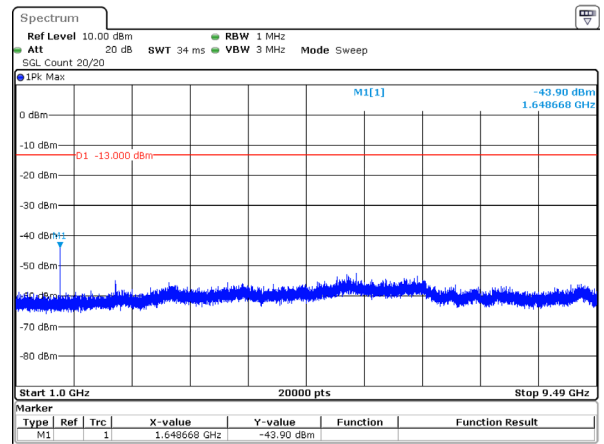
### 5MHz\_Low\_QPSK\_1@0(1GHz~9.49GHz)

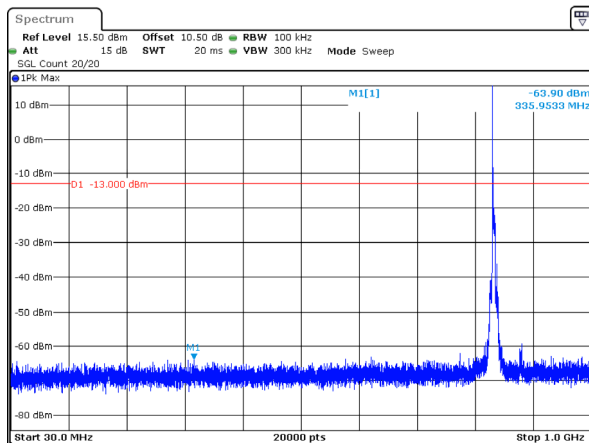
### 5MHz\_Middle\_QPSK\_1@0(30MHz~1GHz)

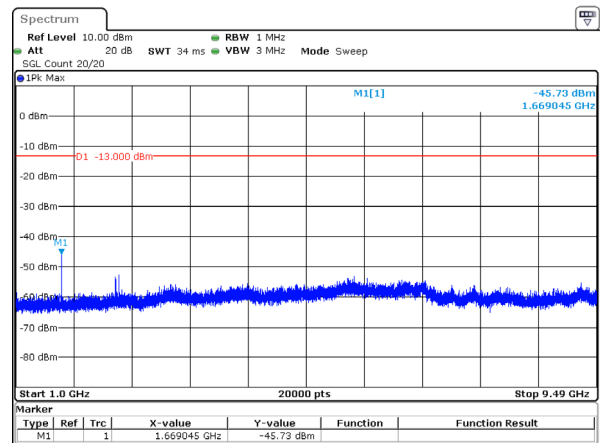
### 5MHz\_Middle\_QPSK\_1@0(1GHz~9.49GHz)

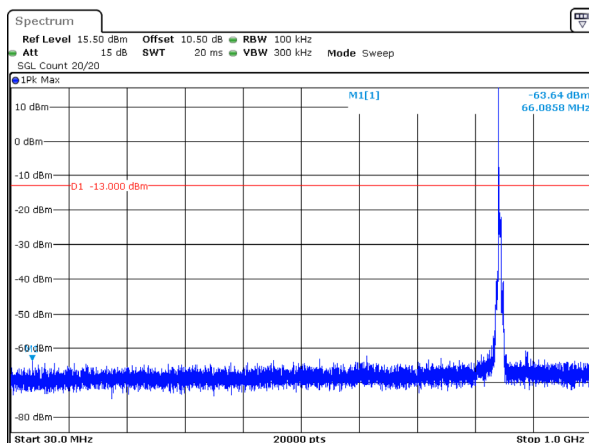
### 5MHz\_High\_QPSK\_1@0(30MHz~1GHz)

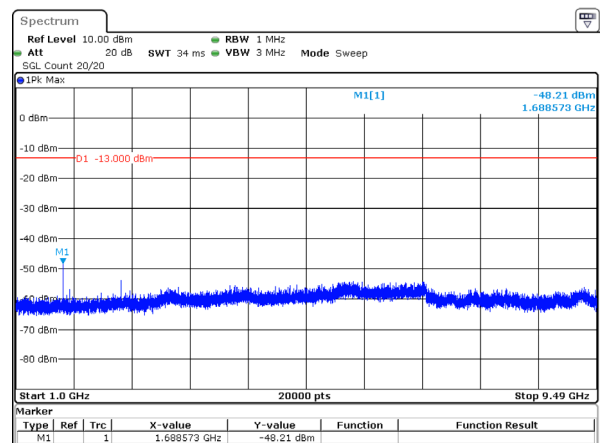
### 5MHz\_High\_QPSK\_1@0(1GHz~9.49GHz)

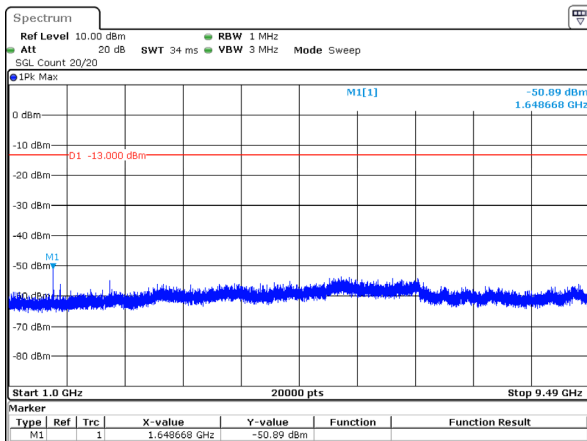
### 10MHz\_Low\_QPSK\_1@0(1GHz~9.49GHz)

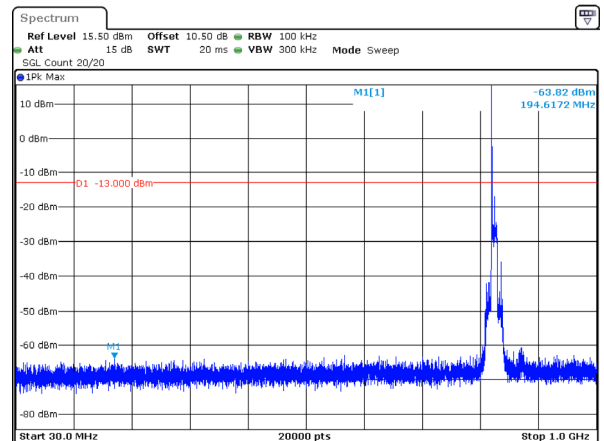
### 10MHz\_Low\_QPSK\_1@0(30MHz~1GHz)

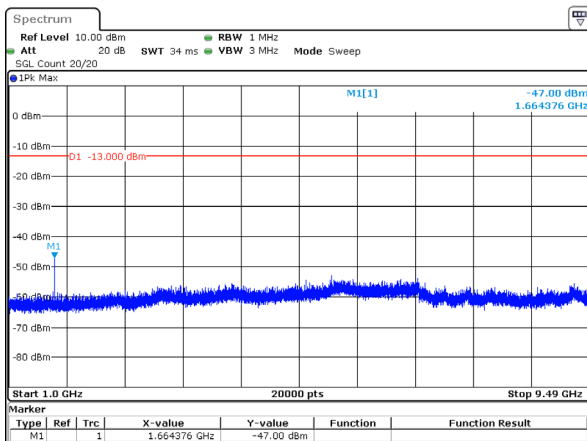
### 10MHz\_Middle\_QPSK\_1@0(1GHz~9.49GHz)

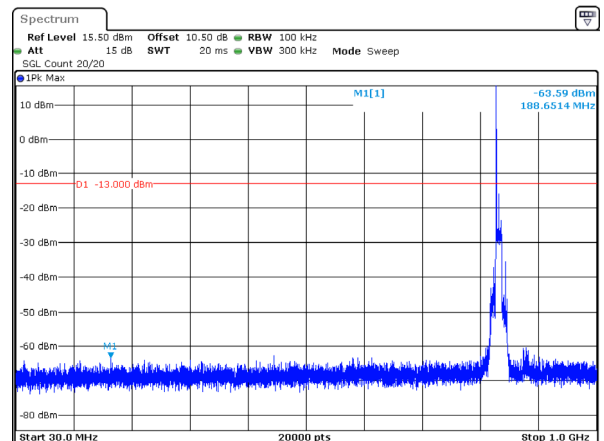
### 10MHz\_Middle\_QPSK\_1@0(30MHz~1GHz)

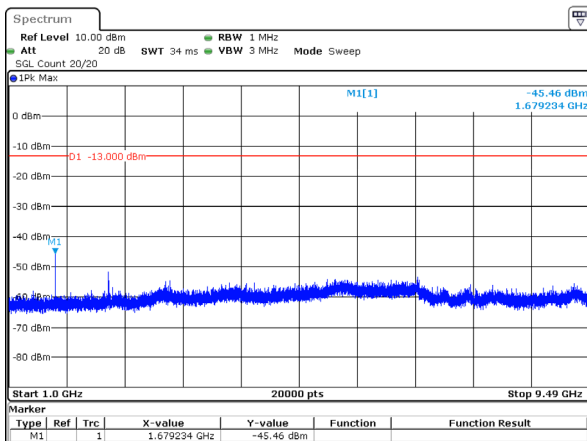
### 10MHz\_High\_QPSK\_1@0(1GHz~9.49GHz)

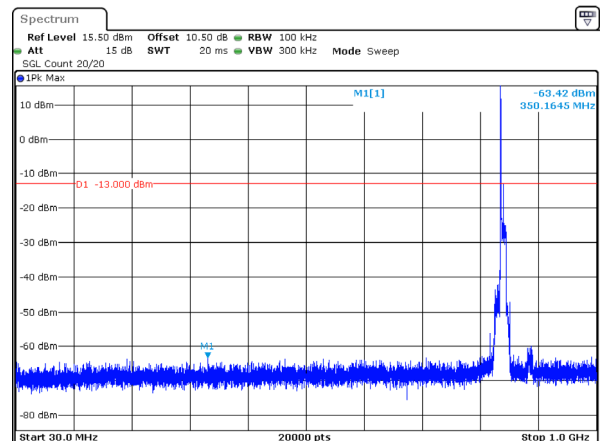
### 10MHz\_High\_QPSK\_1@0(30MHz~1GHz)

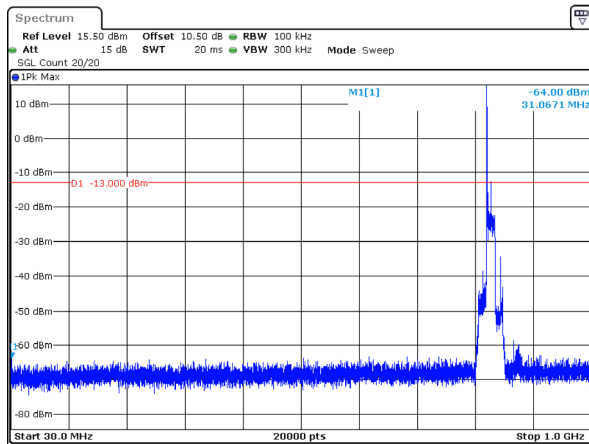
### 15MHz\_Low\_QPSK\_1@0(30MHz~1GHz)

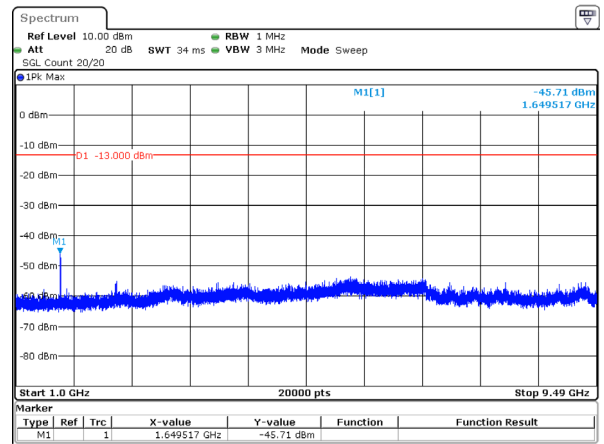
### 15MHz\_Low\_QPSK\_1@0(1GHz~9.49GHz)

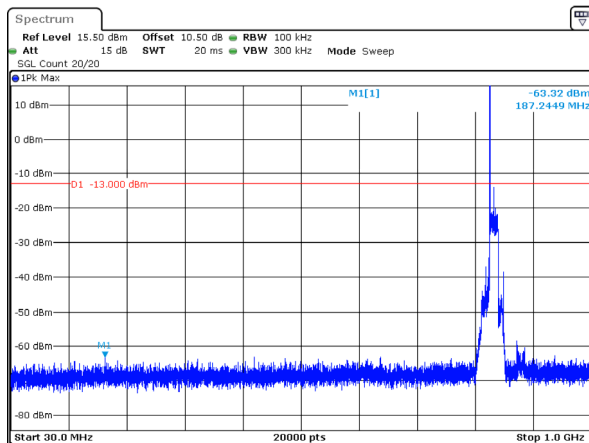
### 15MHz\_Middle\_QPSK\_1@0(30MHz~1GHz)

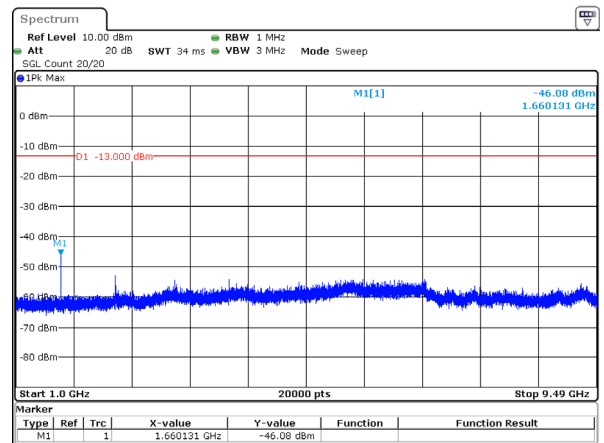
### 15MHz\_Middle\_QPSK\_1@0(1GHz~9.49GHz)

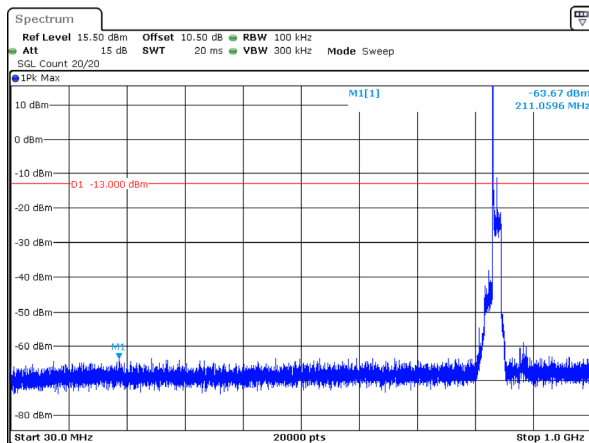
### 15MHz\_High\_QPSK\_1@0(30MHz~1GHz)

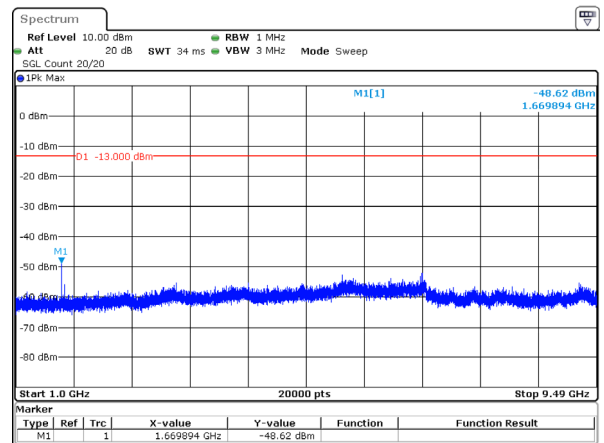
### 15MHz\_High\_QPSK\_1@0(1GHz~9.49GHz)
