## Occupied Bandwidth

### FCC Part 22H

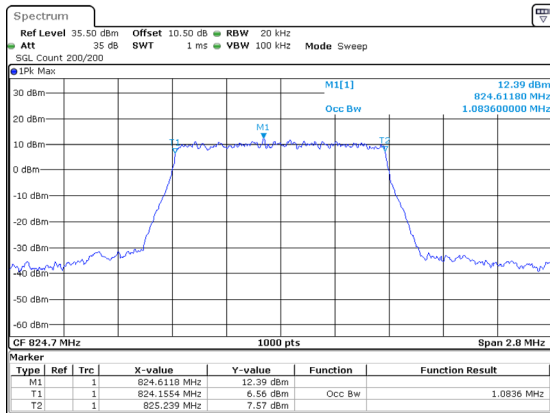
**1.4MHz\_Low\_QPSK\_6@0**

**Occupied Bandwidth**

| Mode | 99% OBW<br>(MHz) | EBW<br>(MHz) |
|---|---|---|
| 1.4MHz_Low_QPSK_6@0 | 1.084 | 1.275 |

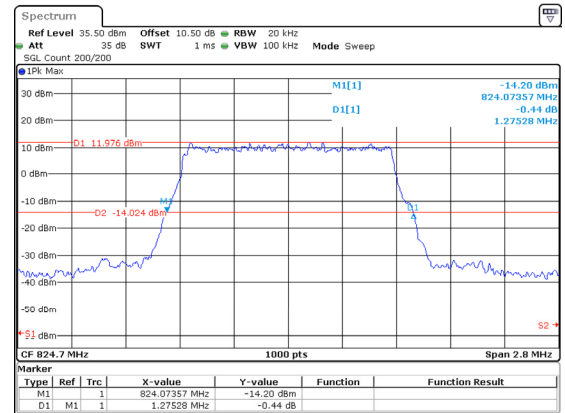
**26dB Bandwidth**

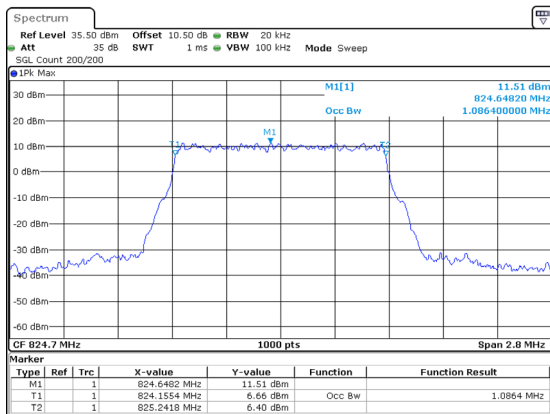
**1.4MHz\_Low\_16QAM\_6@0**

**Occupied Bandwidth**

| Mode | 99% OBW<br>(MHz) | EBW<br>(MHz) |
|---|---|---|
| 1.4MHz_Low_16QAM_6@0 | 1.086 | 1.281 |

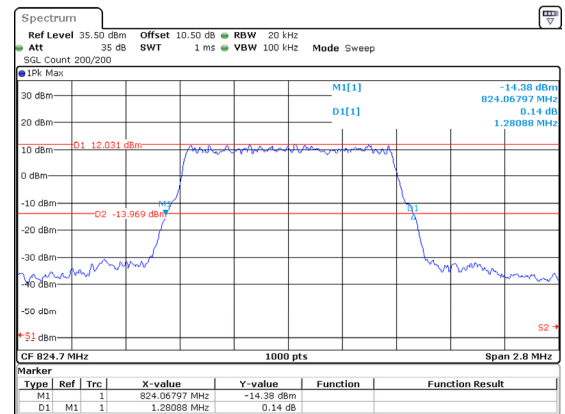
**26dB Bandwidth**

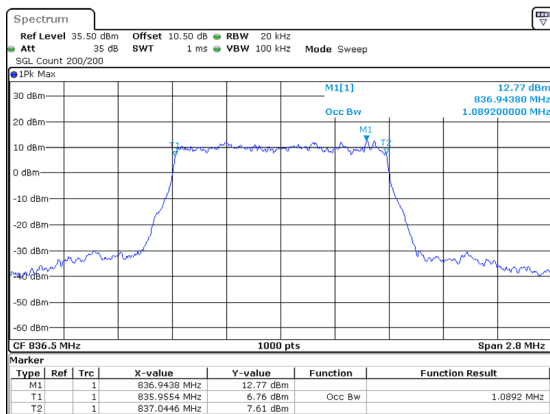
**1.4MHz\_Middle\_QPSK\_6@0**

**Occupied Bandwidth**

| Mode | 99% OBW<br>(MHz) | EBW<br>(MHz) |
|---|---|---|
| 1.4MHz_Middle_QPSK_6@0 | <b>1.089</b> | 1.244 |

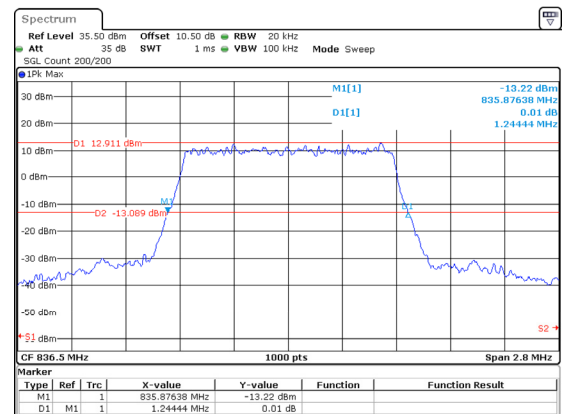
**26dB Bandwidth**

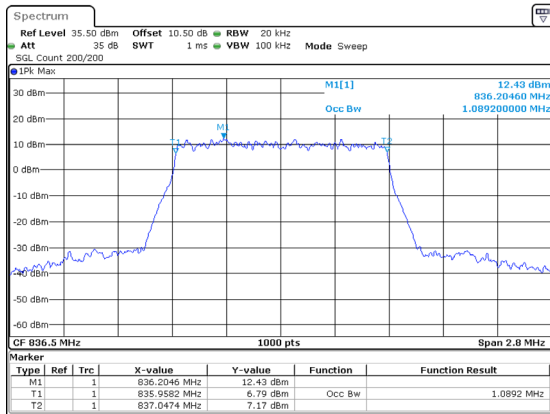
## 1.4MHz\_Middle\_16QAM\_6@0

### Occupied Bandwidth

| Mode | 99% OBW<br>(MHz) | EBW<br>(MHz) |
|---|---|---|
| 1.4MHz_Middle_16QAM_6@0 | <b>1.089</b> | 1.250 |

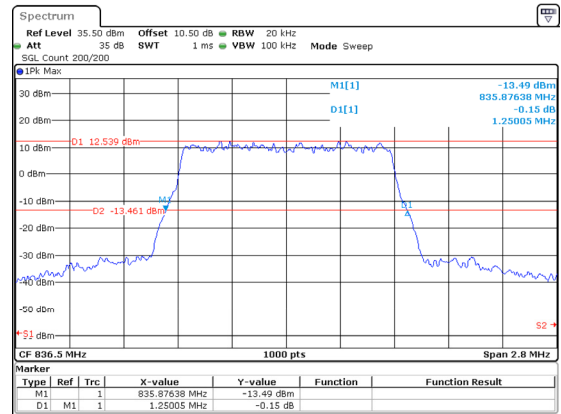
### 26dB Bandwidth

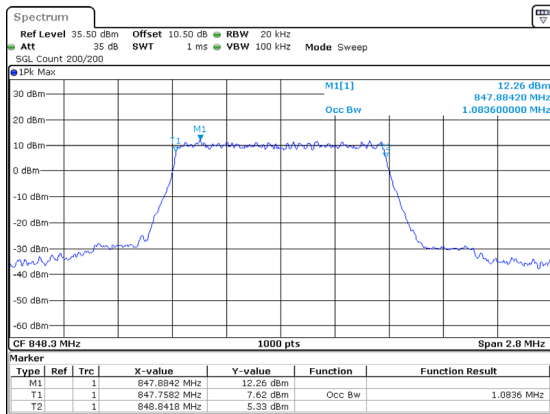
## 1.4MHz\_High\_QPSK\_6@0

### Occupied Bandwidth

| Mode | 99% OBW<br>(MHz) | EBW<br>(MHz) |
|---|---|---|
| 1.4MHz_High_QPSK_6@0 | 1.084 | 1.242 |

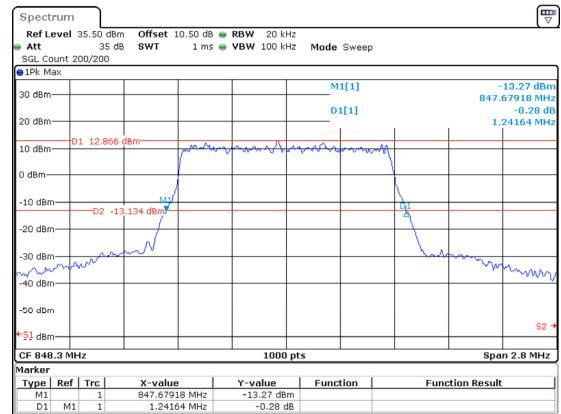
### 26dB Bandwidth

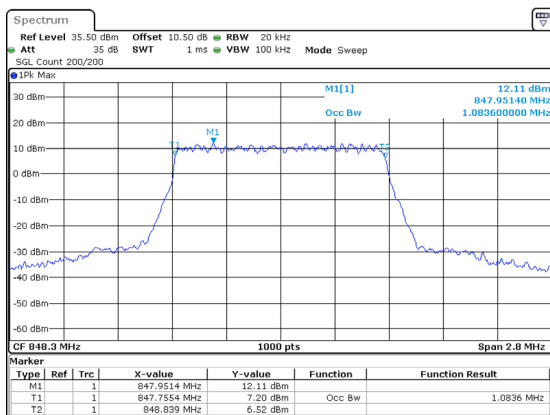
## 1.4MHz\_High\_16QAM\_6@0

### Occupied Bandwidth

| Mode | 99% OBW<br>(MHz) | EBW<br>(MHz) |
|---|---|---|
| 1.4MHz_High_16QAM_6@0 | 1.084 | 1.247 |

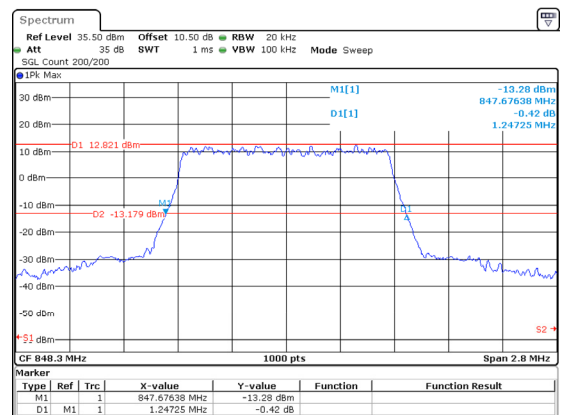
### 26dB Bandwidth

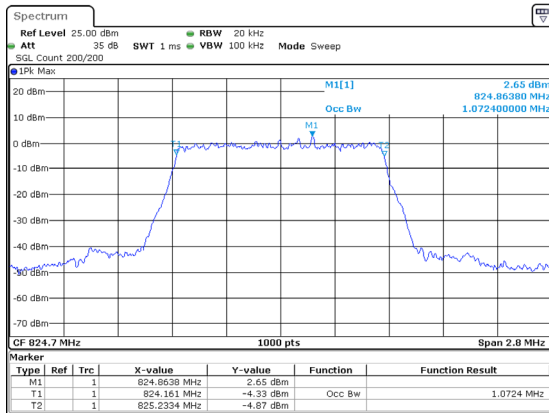
**1.4MHz\_Low\_QPSK\_6@0**

**Occupied Bandwidth**

| Mode | 99% OBW<br>(MHz) | EBW<br>(MHz) |
|---|---|---|
| 1.4MHz_Low_QPSK_6@0 | 1.072 | 1.228 |

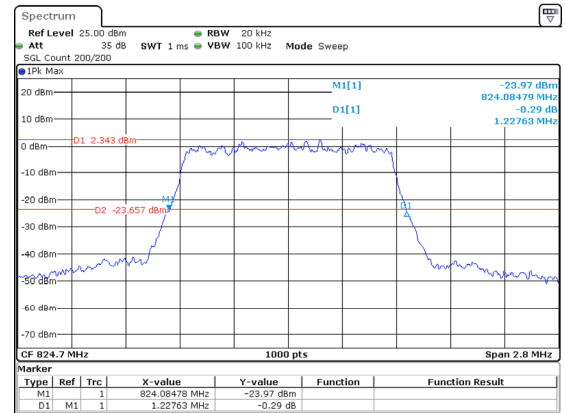
**26dB Bandwidth**

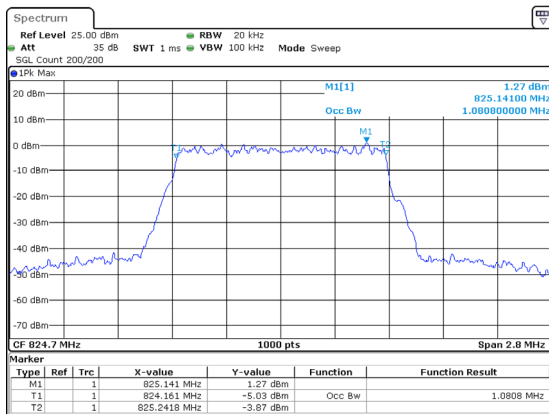
**1.4MHz\_Low\_16QAM\_6@0**

**Occupied Bandwidth**

| Mode | 99% OBW<br>(MHz) | EBW<br>(MHz) |
|---|---|---|
| 1.4MHz_Low_16QAM_6@0 | 1.081 | 1.264 |

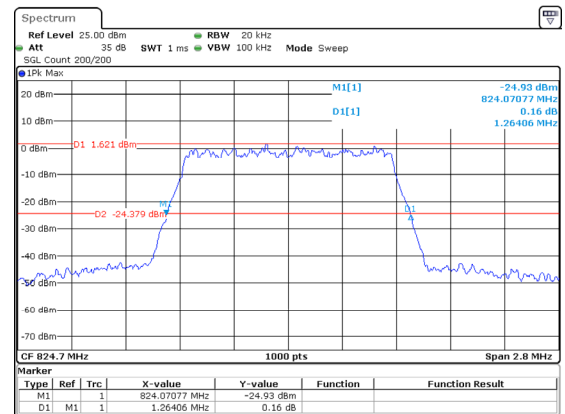
**26dB Bandwidth**

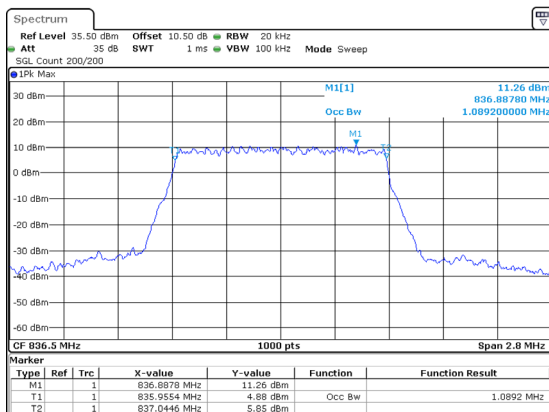
**1.4MHz\_Middle\_QPSK\_6@0**

**Occupied Bandwidth**

| Mode | 99% OBW<br>(MHz) | EBW<br>(MHz) |
|---|---|---|
| 1.4MHz_Middle_QPSK_6@0 | <b>1.089</b> | 1.253 |

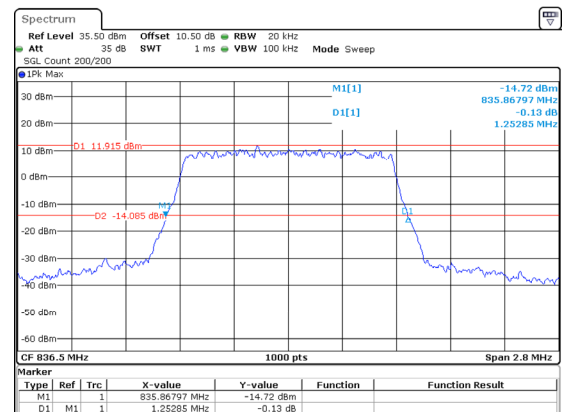
**26dB Bandwidth**

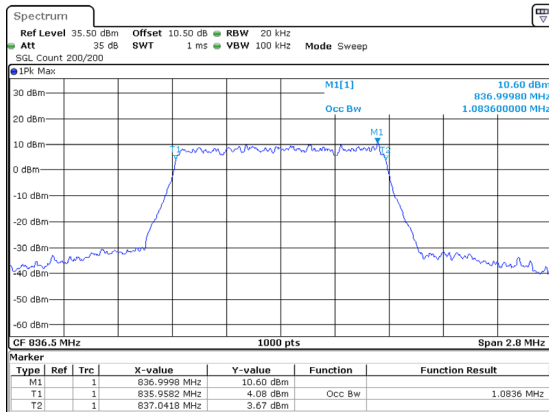
## 1.4MHz\_Middle\_16QAM\_6@0

### Occupied Bandwidth

| Mode | 99% OBW<br>(MHz) | EBW<br>(MHz) |
|---|---|---|
| 1.4MHz_Middle_16QAM_6@0 | <b>1.084</b> | 1.247 |

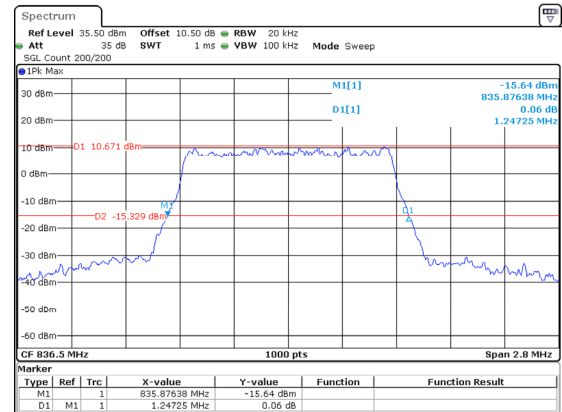
### 26dB Bandwidth

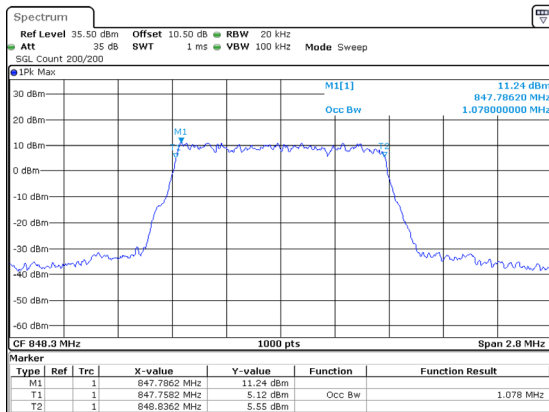
## 1.4MHz\_High\_QPSK\_6@0

### Occupied Bandwidth

| Mode | 99% OBW<br>(MHz) | EBW<br>(MHz) |
|---|---|---|
| 1.4MHz_High_QPSK_6@0 | <b>1.078</b> | 1.242 |

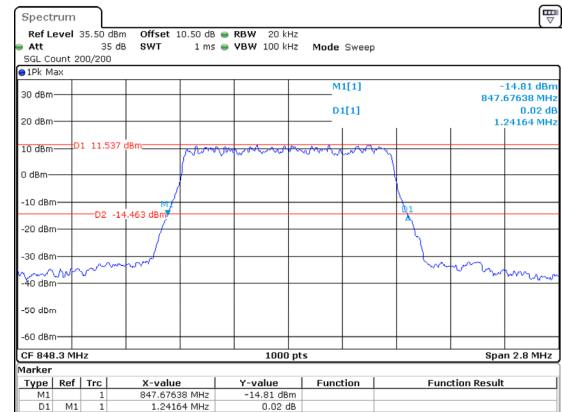
### 26dB Bandwidth

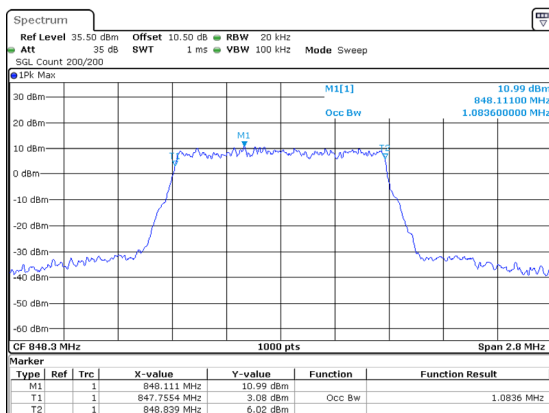
## 1.4MHz\_High\_16QAM\_6@0

### Occupied Bandwidth

| Mode | 99% OBW<br>(MHz) | EBW<br>(MHz) |
|---|---|---|
| 1.4MHz_High_16QAM_6@0 | <b>1.084</b> | 1.250 |

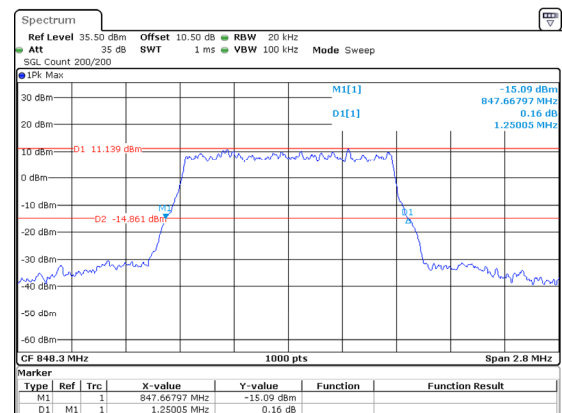
### 26dB Bandwidth
