## Annex 1: Measurement diagrams 23-1-0086301T004a-A1

| <b>Product:</b> | 1D Radar | | |
| <b>Model:</b> | iLDR-M-G5 | | |
| <b>Testing has been carried out in accordance with:</b> | FCC Regulations<br>Title 47 CFR, Chapter I, Subchapter D, Part 95<br>Subpart M<br>The 76-81 GHz Band Radar Service<br>§ 95.3367 76-81 GHz Band Radar Service radiated power limits<br>§ 95.3379 76-81 GHz Band Radar Service unwanted emissions limits | | |

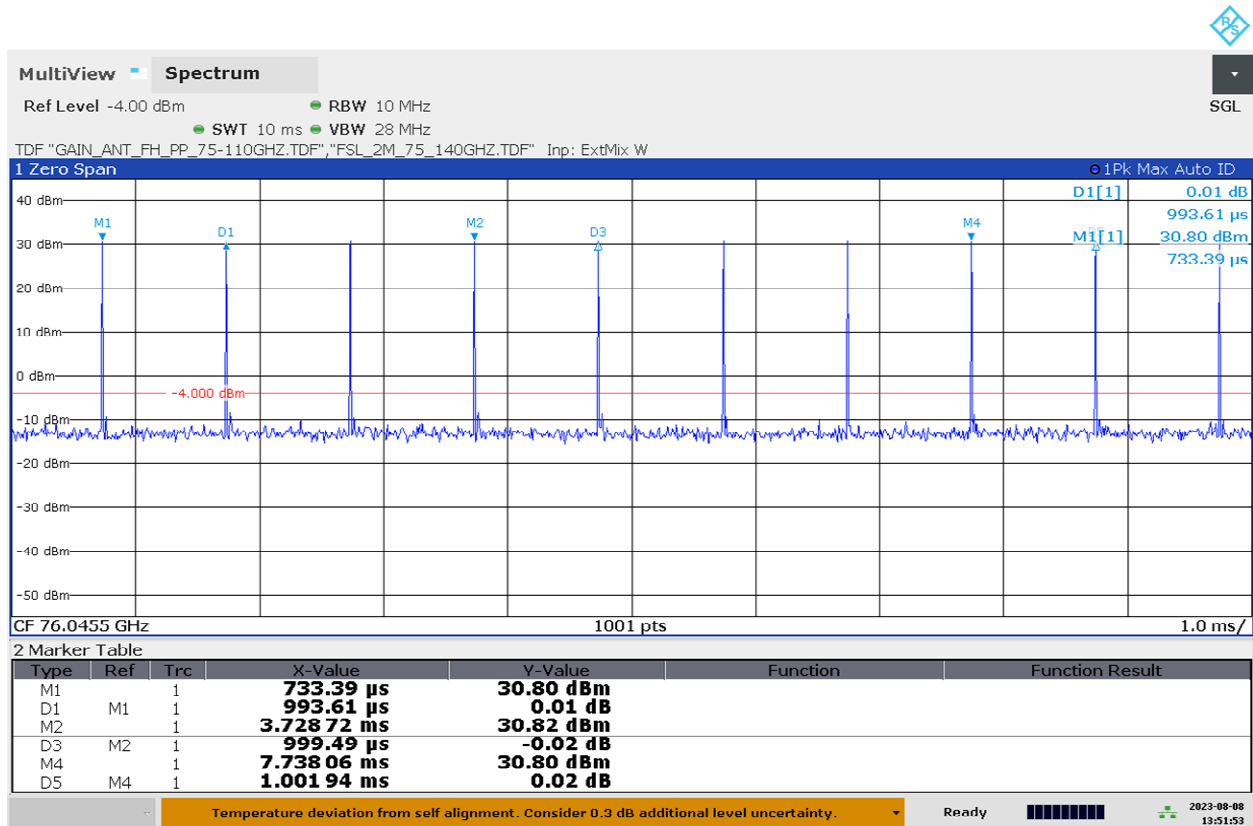
D105\_T01\_MT\_investigation\_fcc\_95M

Note: EUT Cycle Time: 1ms,

Declared by Customer is 1ms (verified), Only for information, not for assessment.

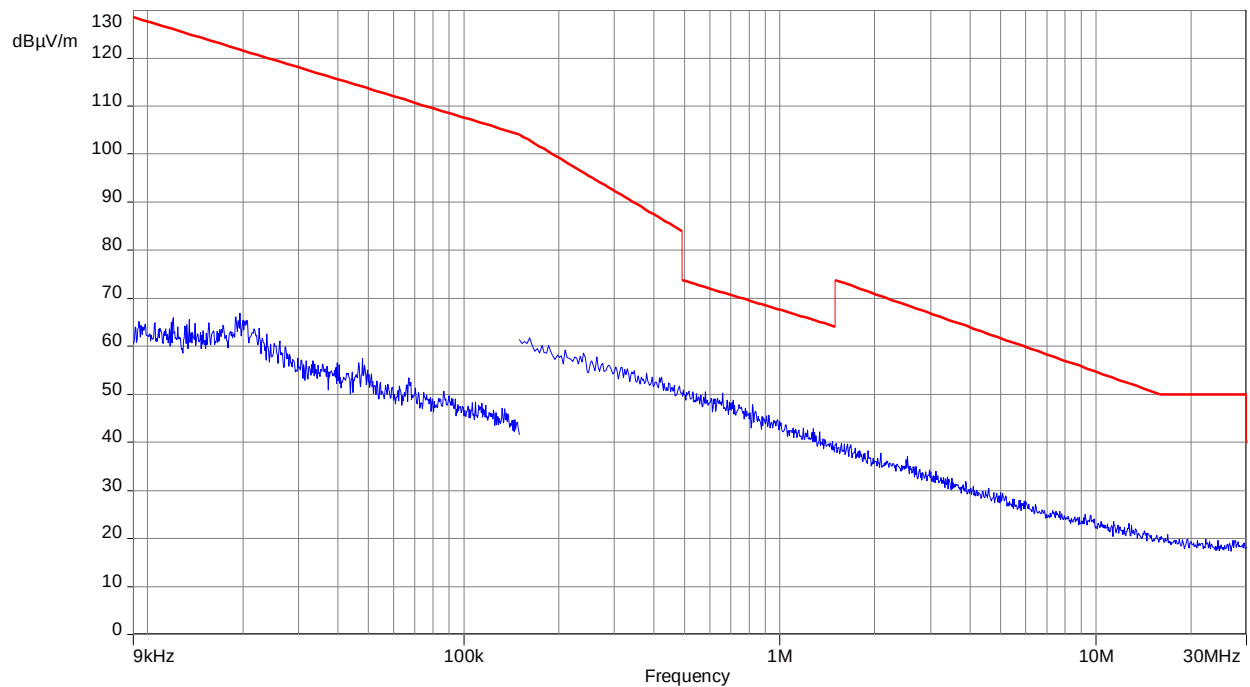
### 2-01\_B\_RSE\_TX\_RADAR\_76G - 81GHz\_TX SER magnetic (dBuV\_m)

Note: No critical Frequency found, Result: Passed.

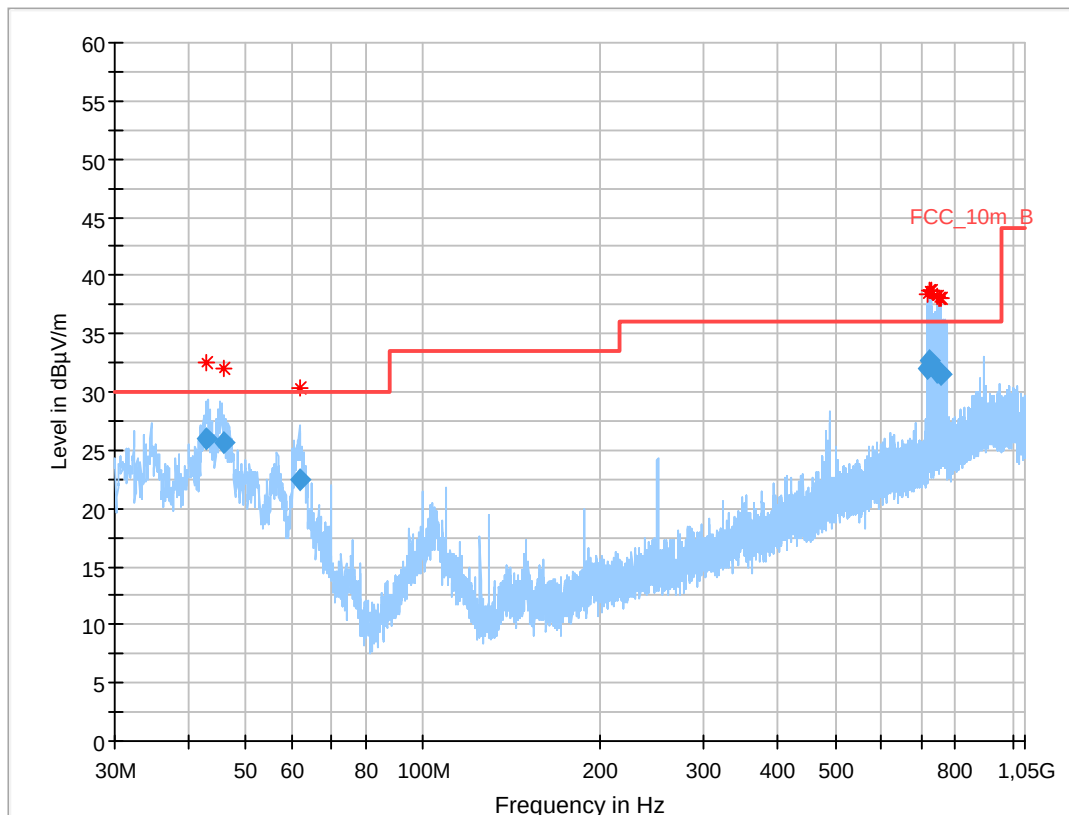
## Diagram 3.01\_RSE\_TX\_RADAR\_76G - 81GHz

| Test description: | FCC part 15 class B @ 10 m |
| Comment: | Ferrit hinter EUT, Schirm von EUT-Gehäuse getrennt |

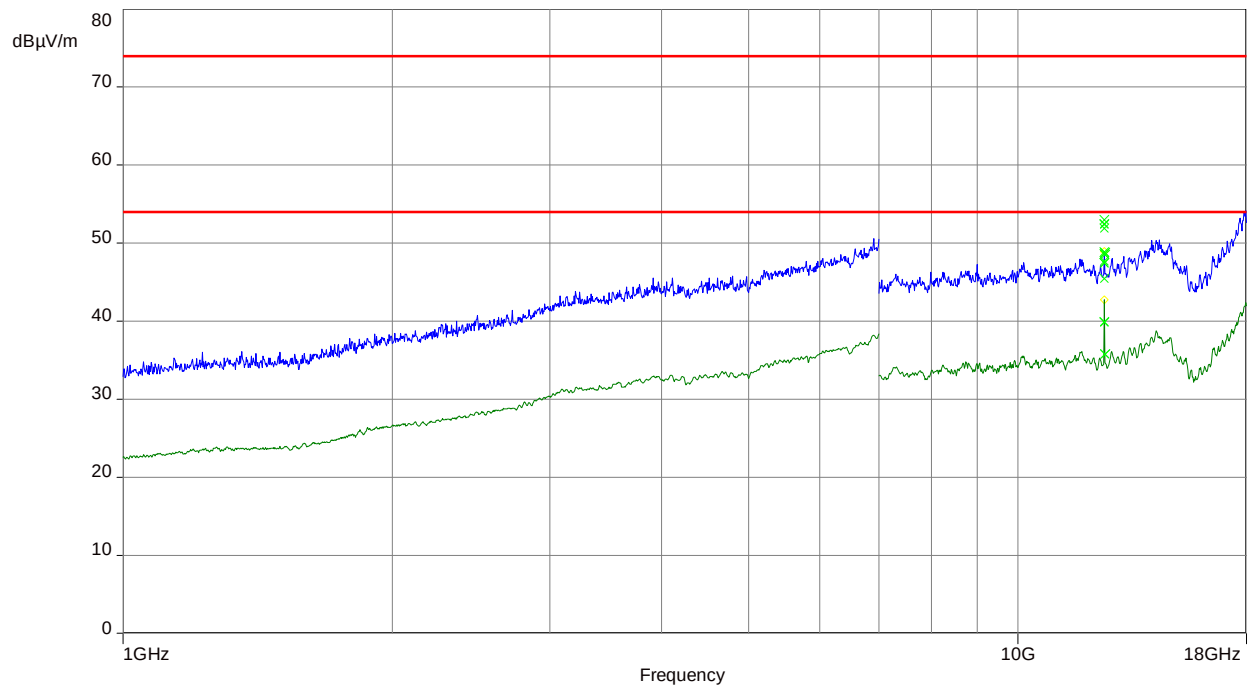
## Diagram D127\_B\_TX\_RSE\_1G\_18GHz\_TX SER (dBuV\_m)

Note-1: Max Peak: 53dBuV/m @ 12500GHz  
 Max Average: 47.7 dBuV/m @ 12500GHz

Note-2:  
 Limit line FCC: Peak: 74dBuV, Avg: 54dBuV, Result: Passed.

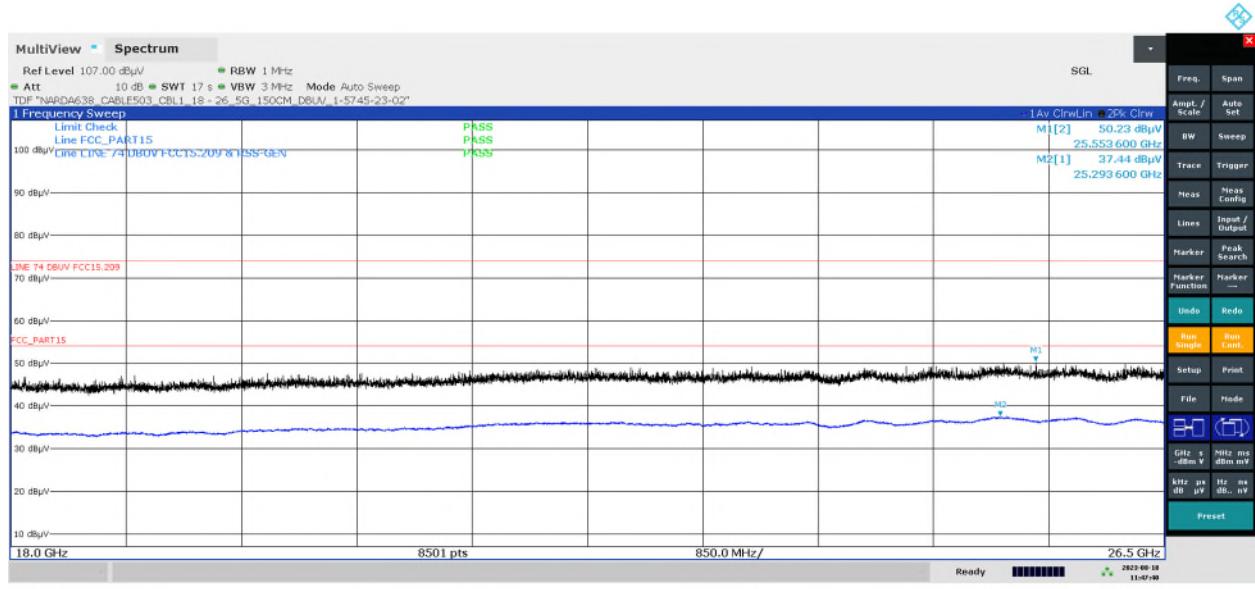
## D129\_01\_TX\_RSE\_18G\_26.5GHz\_Ant\_H

Note: no critical frequency found,  
Limit line FCC: Peak: 74dBμV, Avg: 54dBμV, Result: Passed.

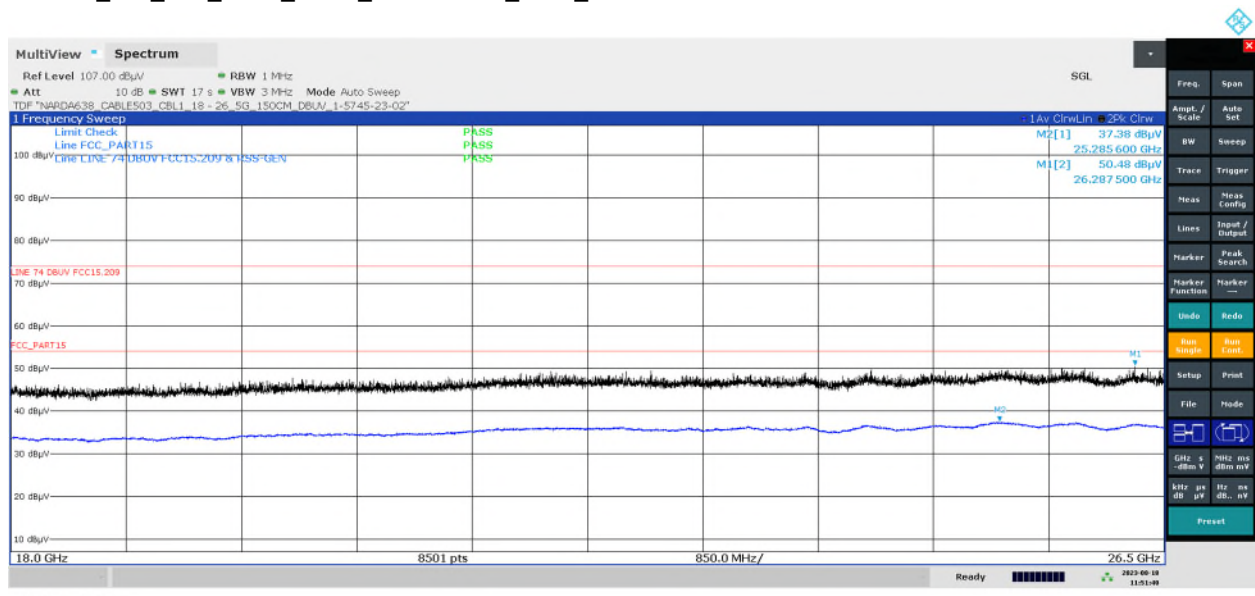
**D130\_01\_TX\_RSE\_18G\_26.5GHz\_Ant\_V**

Note: no critical frequency found,  
Limit line FCC: Peak: 74dBμV, Avg: 54dBμV, Result: Passed.

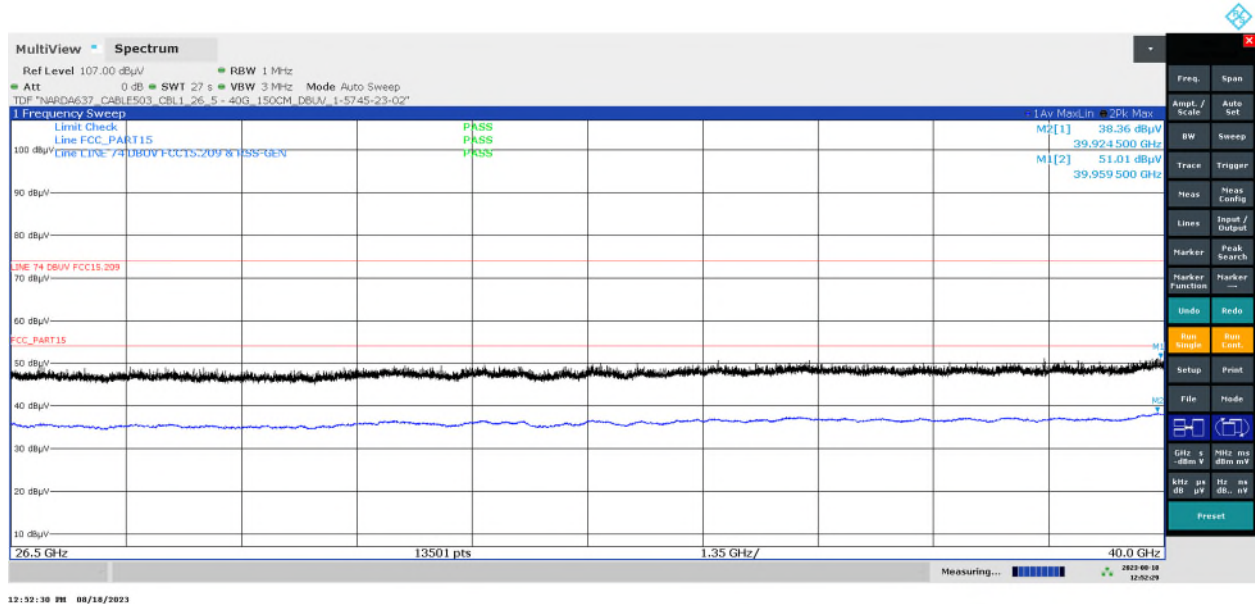
**D129\_02\_TX\_RSE\_26.5G\_40GHz\_Ant\_H\_V**

Note: no critical frequency found,  
Limit line FCC: Peak: 74dBμV, Avg: 54dBμV, Result: Passed.

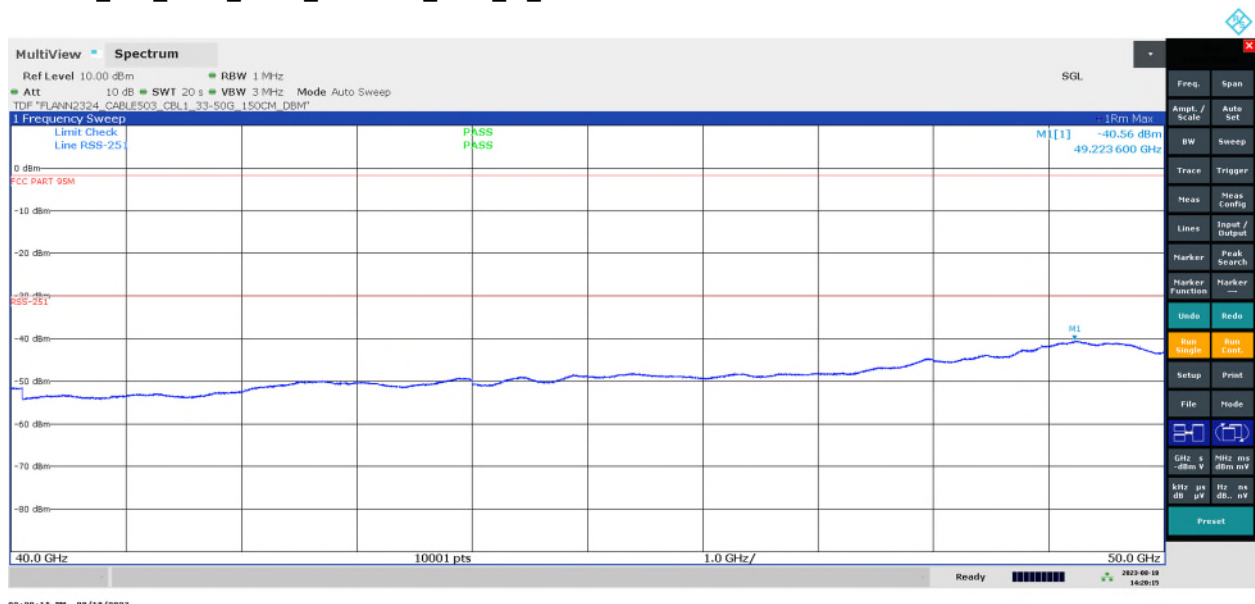
**D131\_TX\_RSE\_40G\_50GHz\_Ant\_V\_H**

Note: no critical frequency found, Limit line FCC: -1.7dBm, Result: Passed.

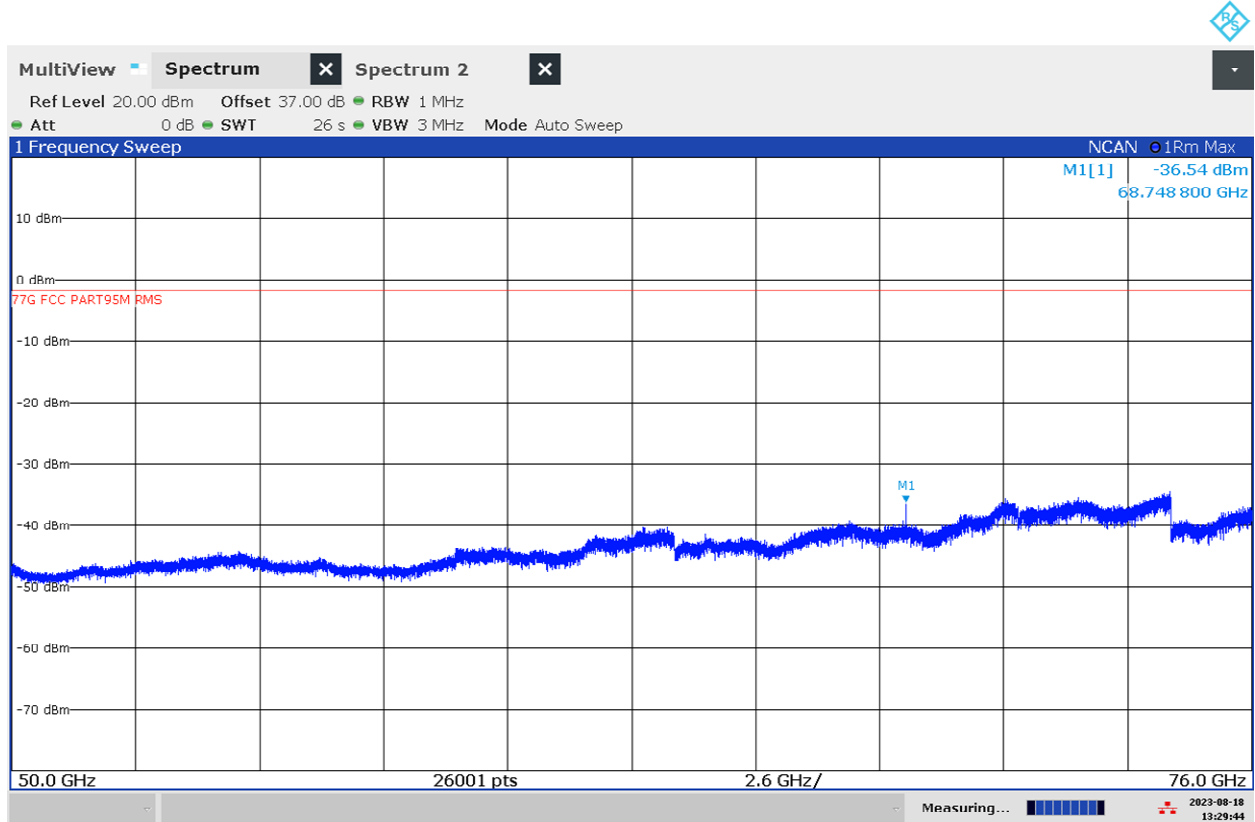
## D132\_TX\_RSE\_50G\_76GHz\_Ant\_V\_H

Note: Maximum Emission found - 36.54dBm at 68.749GHz  
Limit Line: -1.7dBm, Result: Passed.

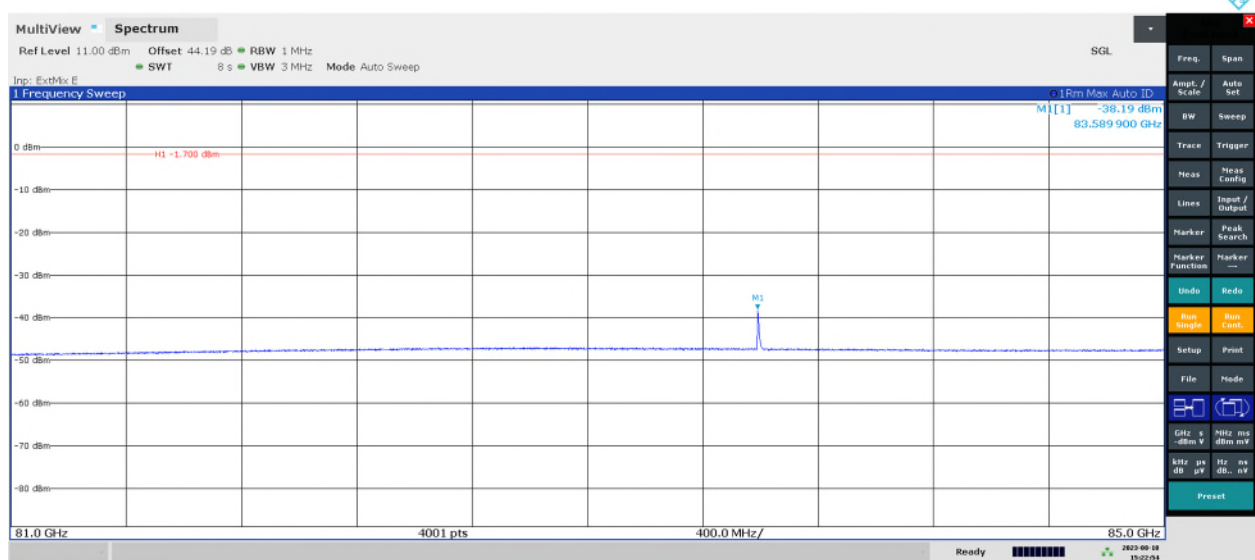
## D134\_01\_TX\_RSE\_81G\_85GHz\_Ant\_H\_V\_FCC

Note: No critical emission found, only ghost signal, since mixer products are used.  
Ghost signal verified, check diagram D134\_02, Limit Line: -1.7dBm, Result: Passed.

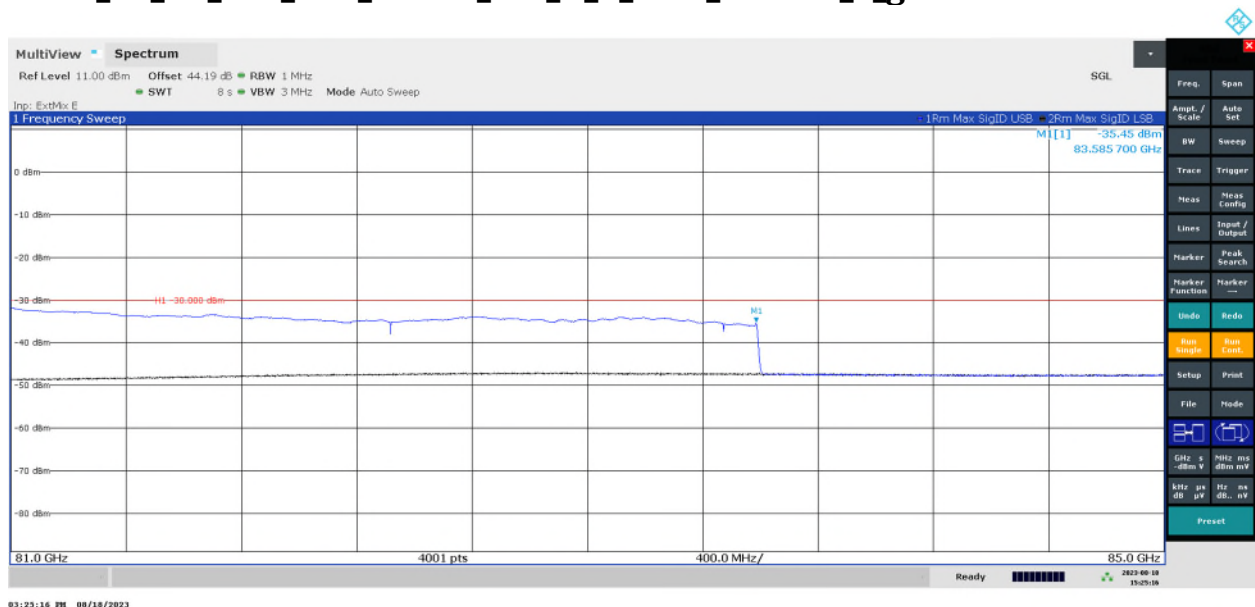
## D134\_02\_TX\_RSE\_81G\_85GHz\_Ant\_H\_V\_ISED\_marker\_1\_ghost

Note: no critical frequency found, only image signal.

Mixer Products are used, therefore there are some image/ghost signals.

Image/Ghost signal: signals which are not overlapping.

Real signal: signals which are overlapping.

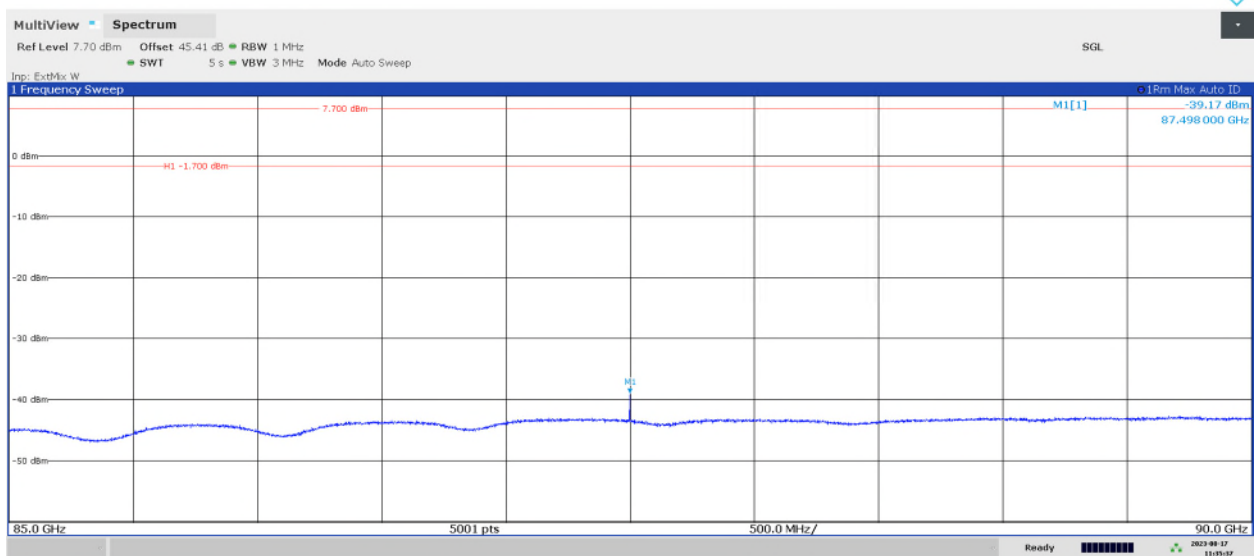
## D135\_TX\_RSE\_85G\_90GHz\_Ant\_V\_FCC

Note: no critical frequency found,  
 maximum emission found -39.17dBm@87.498GHz, Limit line: -1.7dBm, Result: Passed.

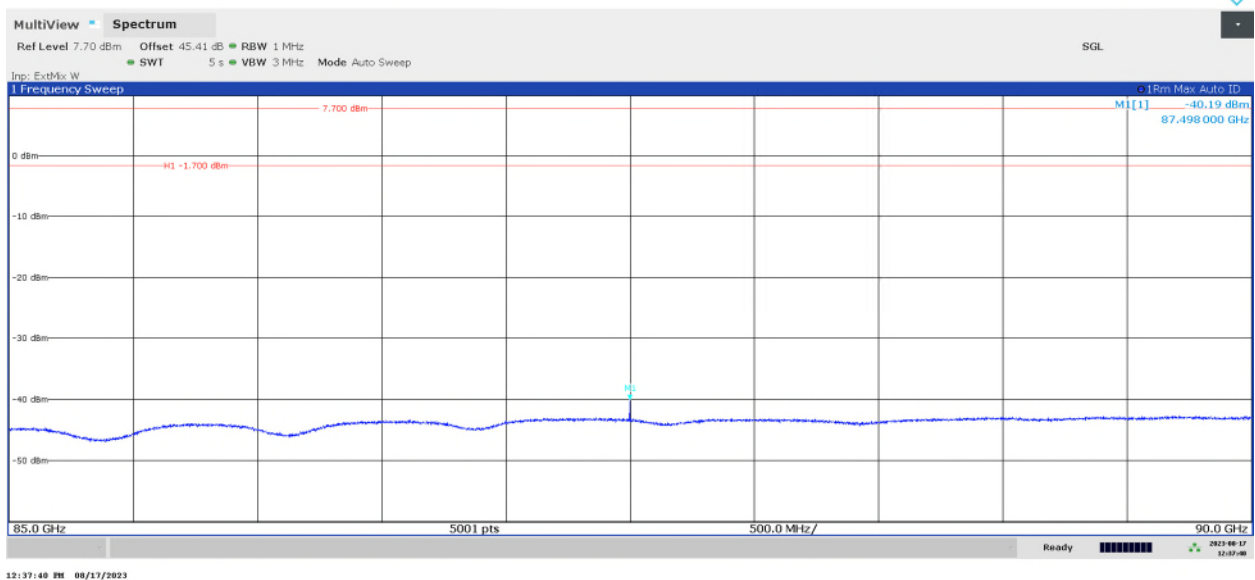
## D136\_TX\_RSE\_85G\_90GHz\_Ant\_H\_FCC

Note: no critical frequency found,  
 maximum emission found -40.19dBm@87.498GHz, Limit line: -1.7dBm, Result: Passed.

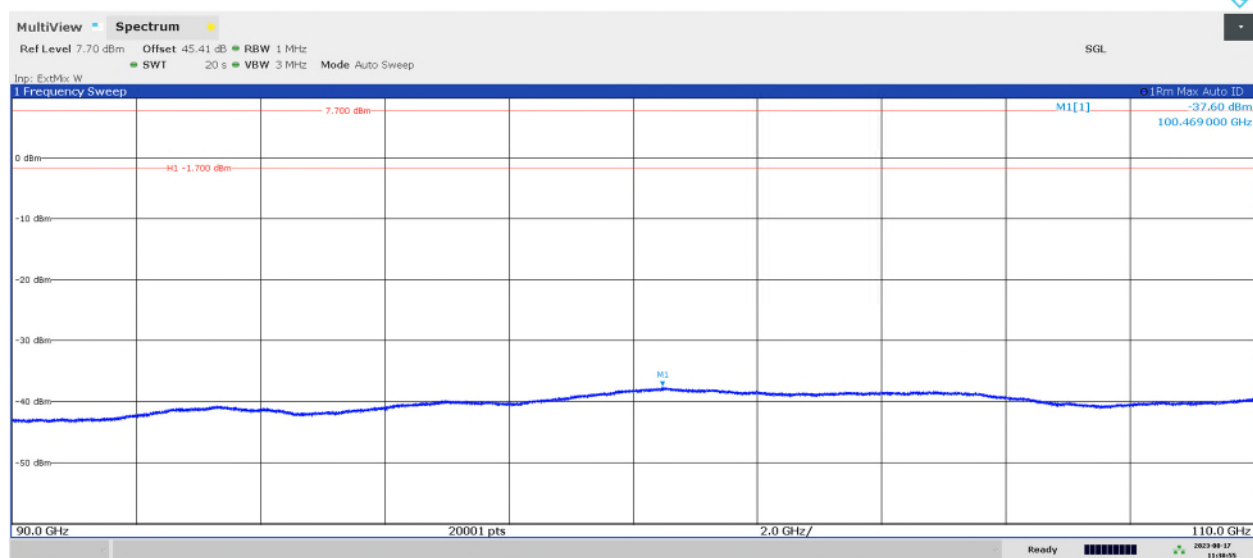
## D137\_TX\_RSE\_90G\_110GHz\_Ant\_V\_FCC

Note: no critical frequency found, Limit line: -1.7dBm, Result: Passed.

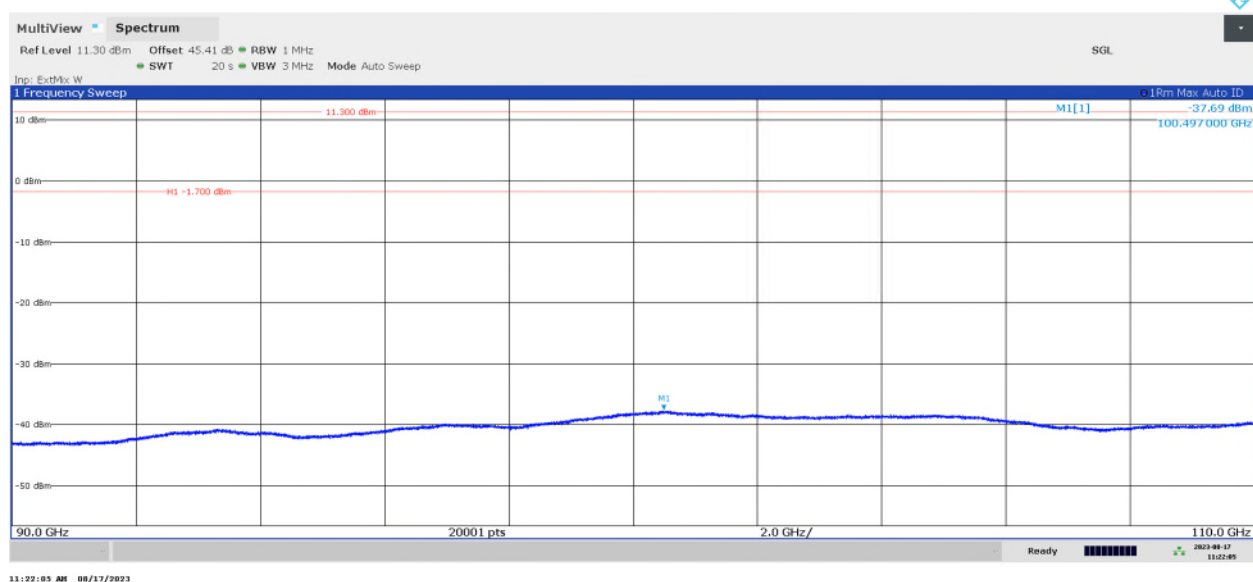
## D138\_TX\_RSE\_90G\_110GHz\_Ant\_H\_FCC

Note: no critical frequency found, Limit line: -1.7dBm, Result: Passed.

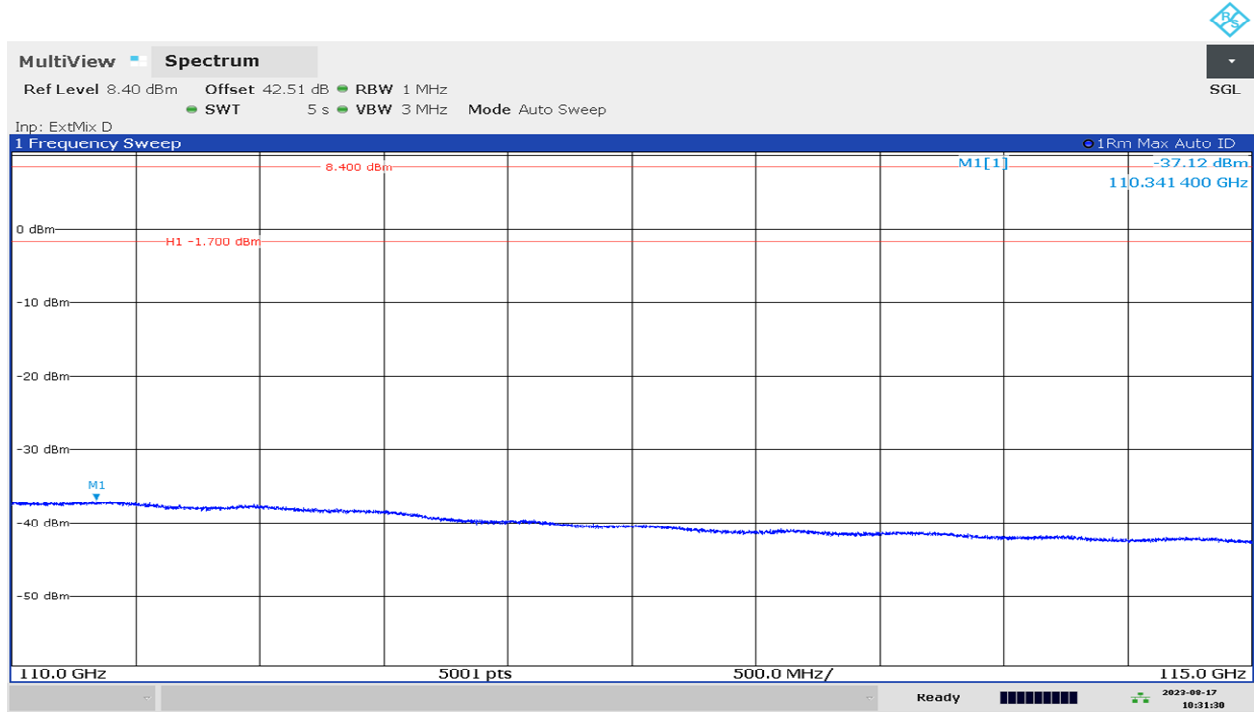
## D139\_TX\_RSE\_110G\_115GHz\_Ant\_V\_FCC

Note: no critical frequency found, Limit line: -1.7dBm, Result: Passed.

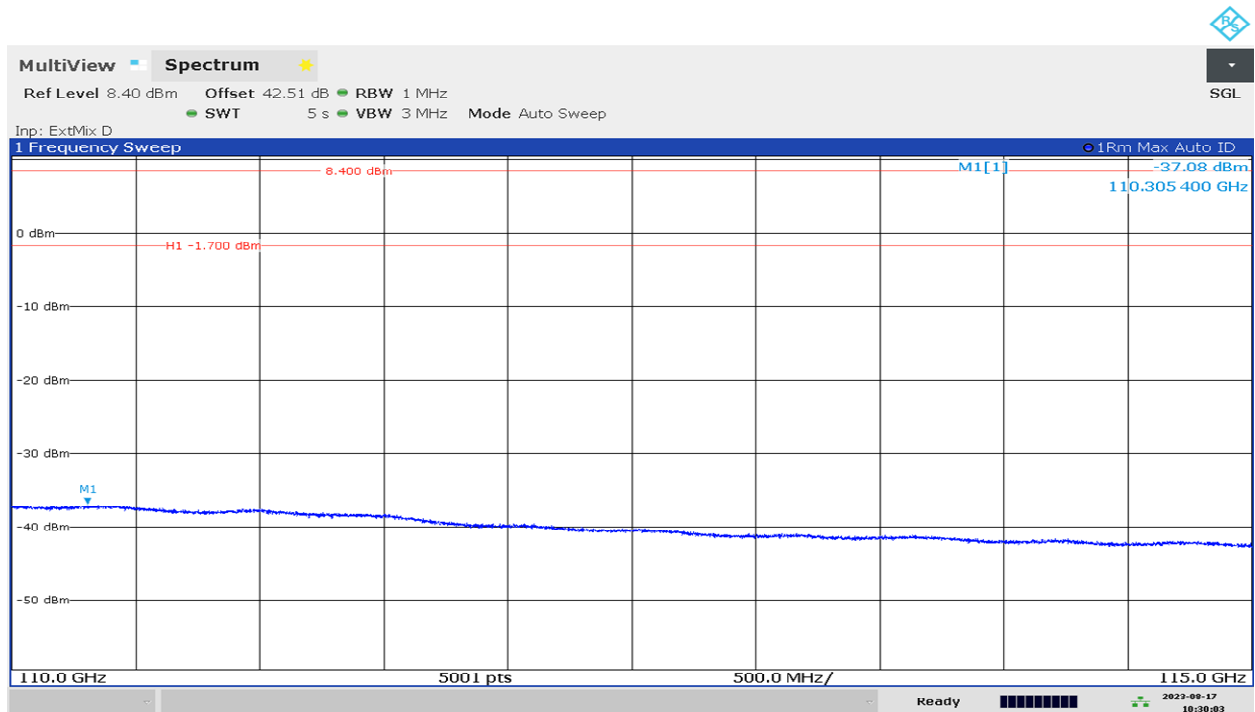
## D140\_TX\_RSE\_110G\_115GHz\_Ant\_H\_FCC

Note: no critical frequency found, Limit line: -1.7dBm, Result: Passed.

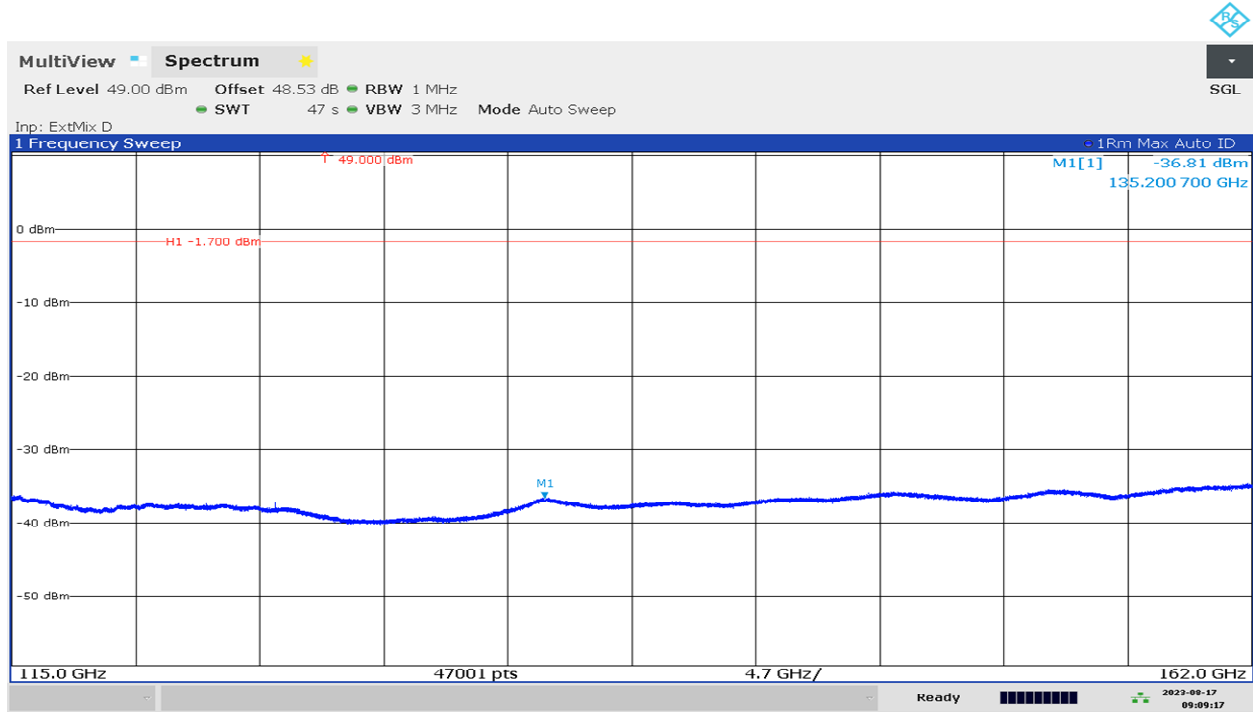
## D141\_TX\_RSE\_115G\_162GHz\_Ant\_V\_FCC

Note: no critical frequency found, Limit line: -1.7dBm, Result: Passed.

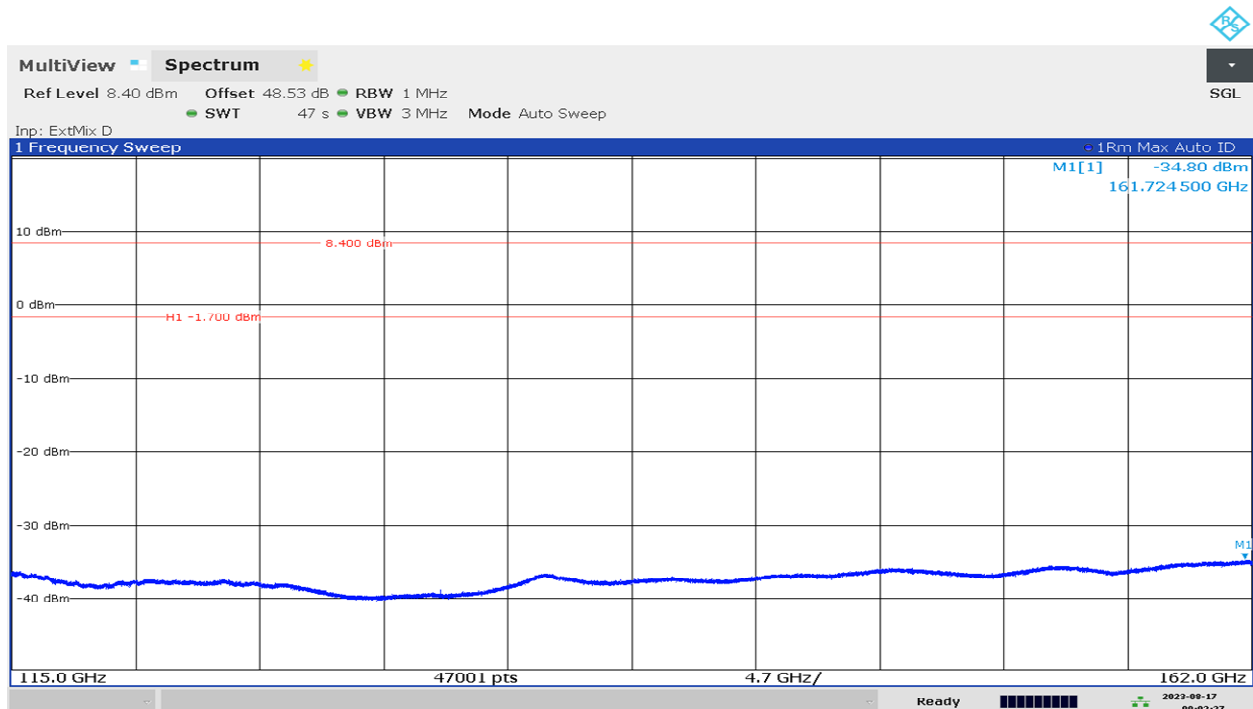
## D142\_TX\_RSE\_115G\_162GHz\_Ant\_H\_FCC

Note: no critical frequency found, Limit line: -1.7dBm, Result: Passed.

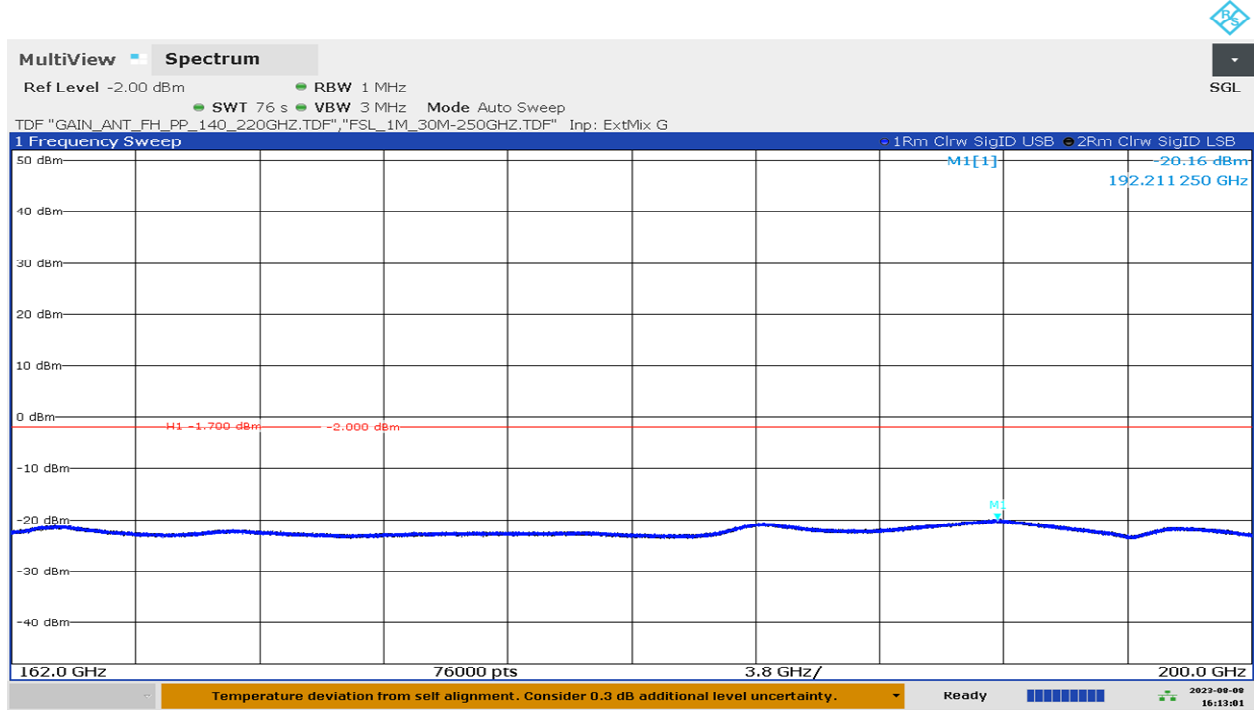
## D143\_01\_TX\_RSE\_162G\_200GHz\_Ant\_V

Note: no critical frequency found, Limit line: -1.7dBm, Result: Passed.

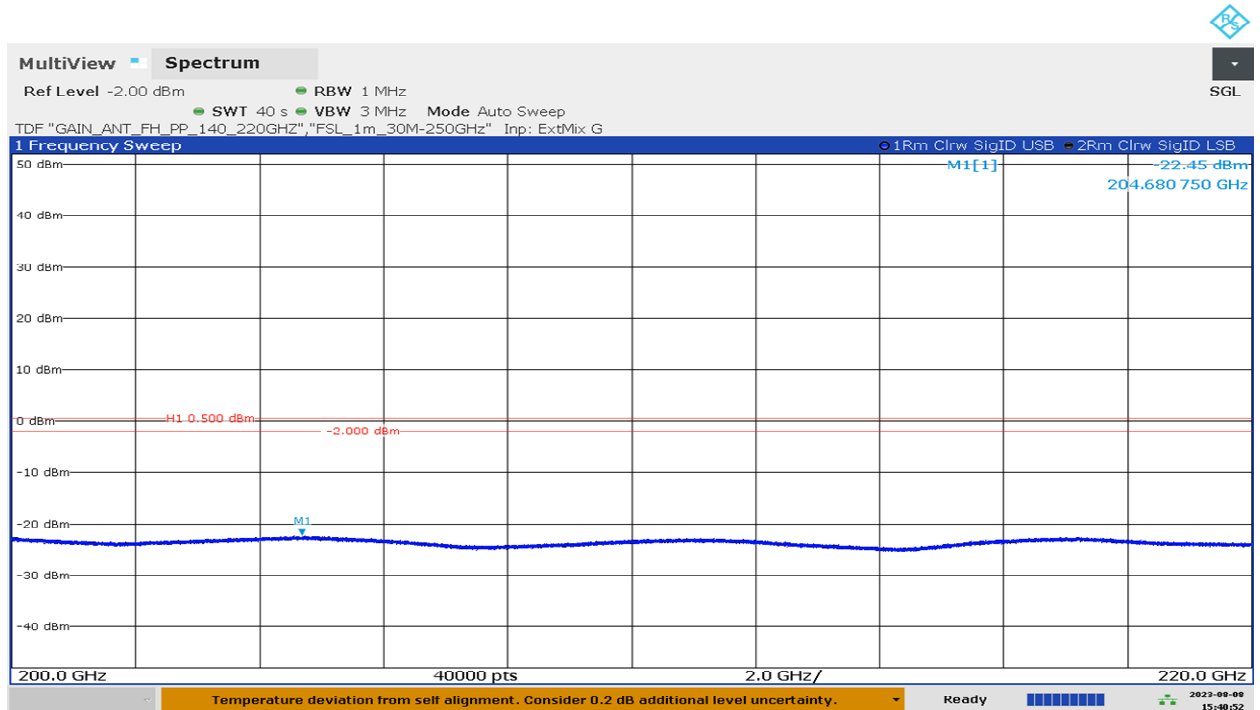
## D143\_02\_TX\_RSE\_200G\_220GHz\_Ant\_V

Note: no critical frequency found, Limit line: 0.5dBm, Result: Passed.

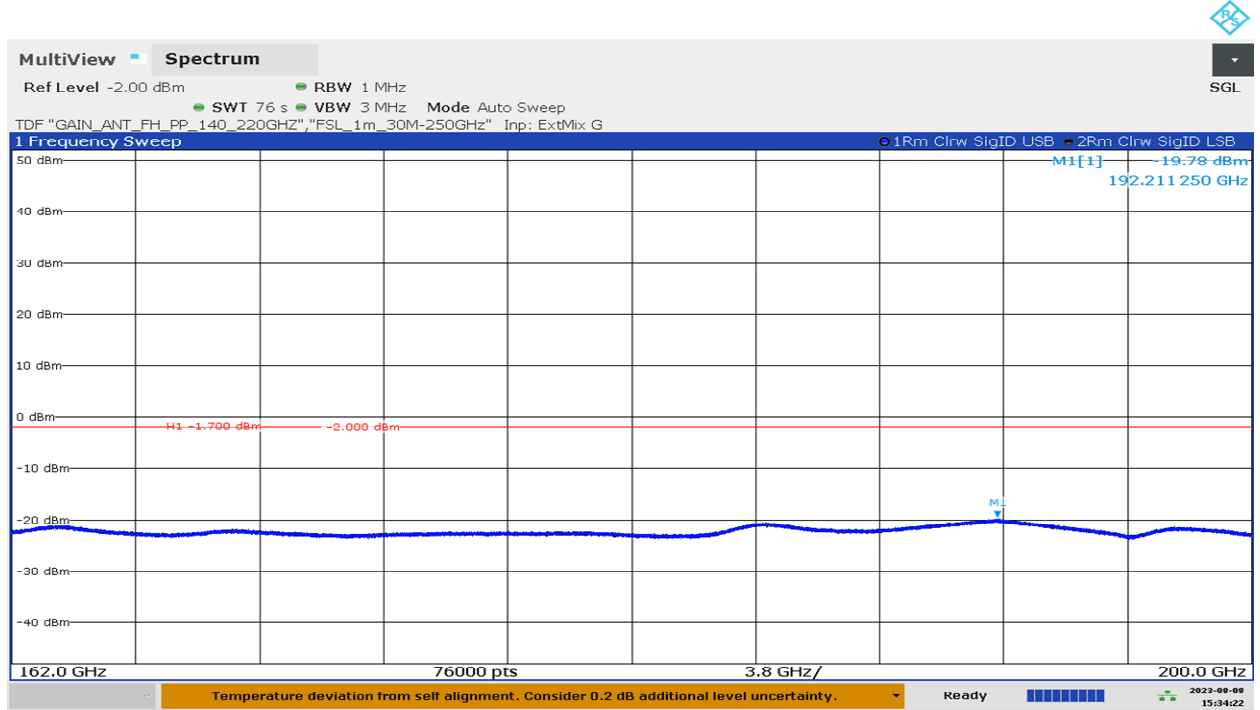
## D144\_01\_TX\_RSE\_162G\_200GHz\_Ant\_H

Note: no critical frequency found, Limit line: -1.7dBm, Result: Passed.

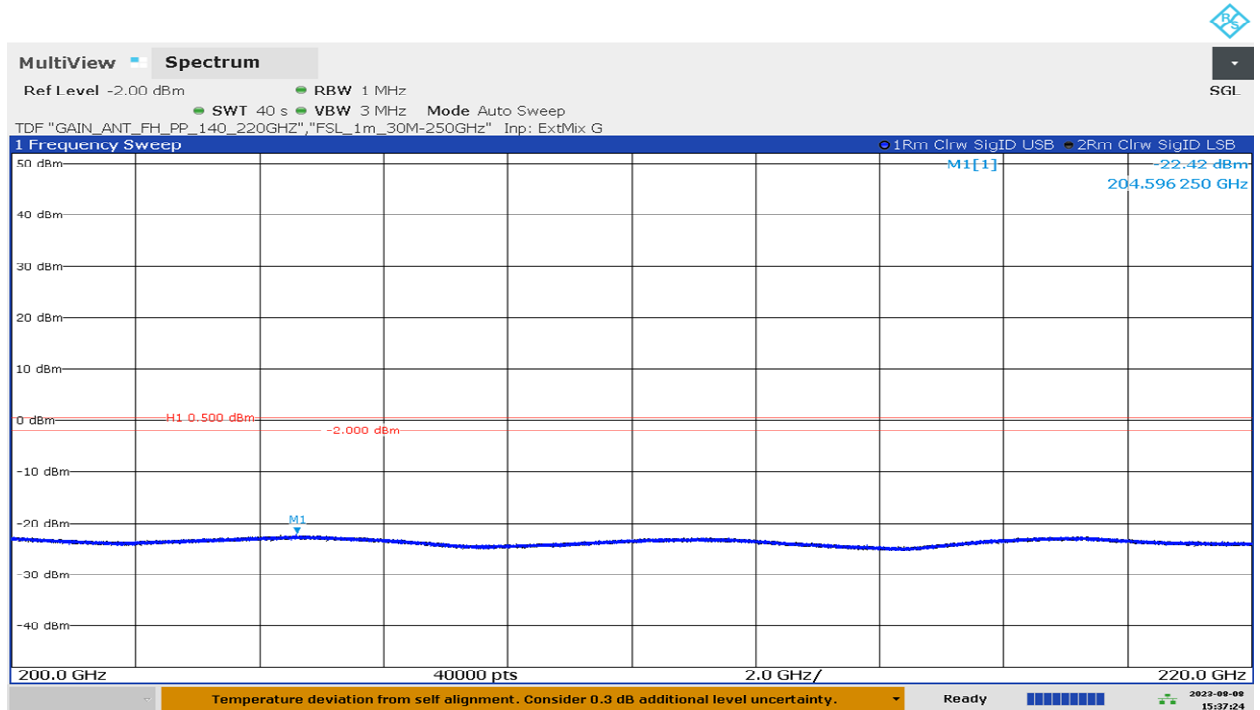
## D144\_02\_TX\_RSE\_200G\_220GHz\_Ant\_H

Note: no critical frequency found, Limit line: 0.5dBm, Result: Passed.

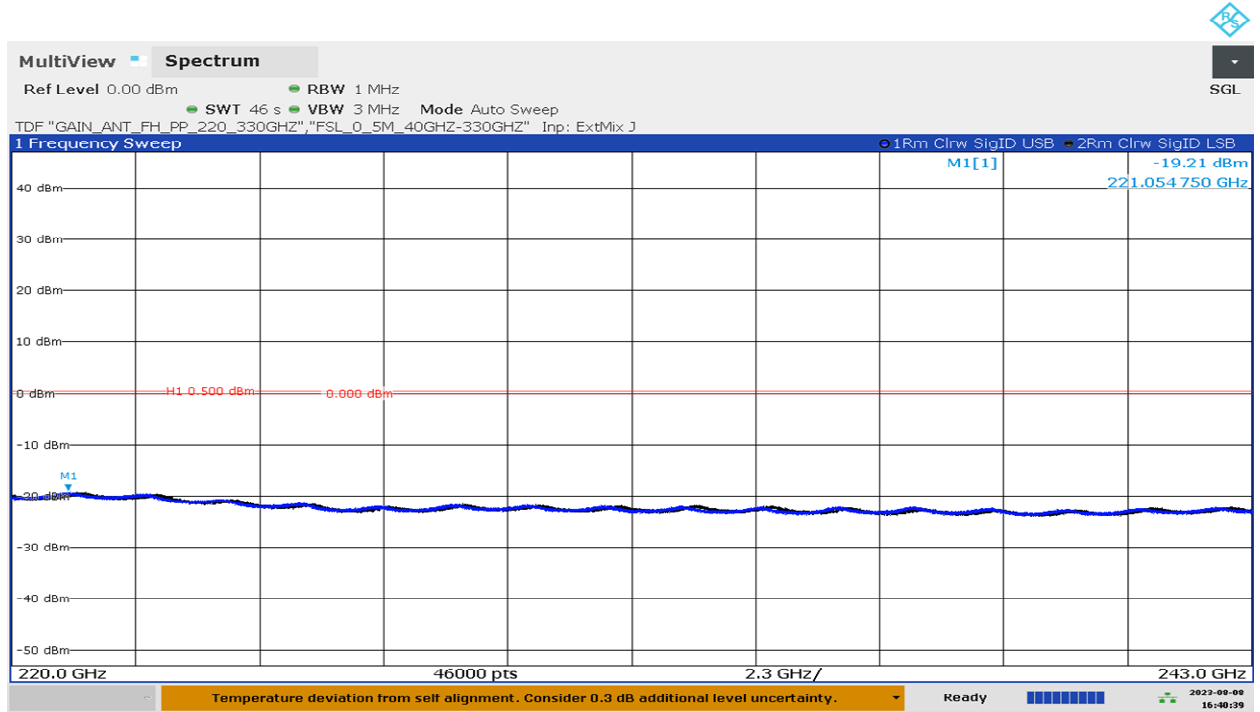
## D145\_TX\_RSE\_220G\_243GHz\_Ant\_V

Note: no critical frequency found, Limit line: 0.5dBm, Result: Passed.

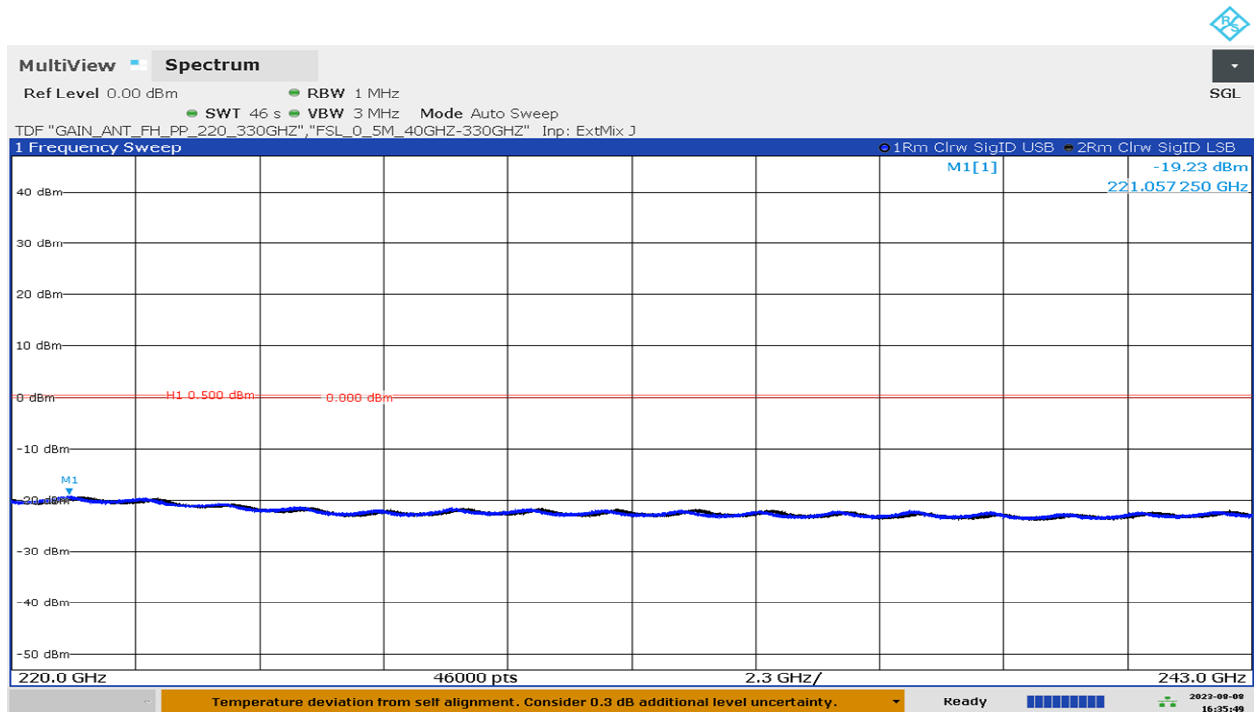
## D146\_T01\_TX\_RSE\_220G\_243GHz\_Ant\_H

Note: no critical frequency found, Limit line: 0.5dBm, Result: Passed.
