## Band Edge

## Conducted RF Spurious Emission

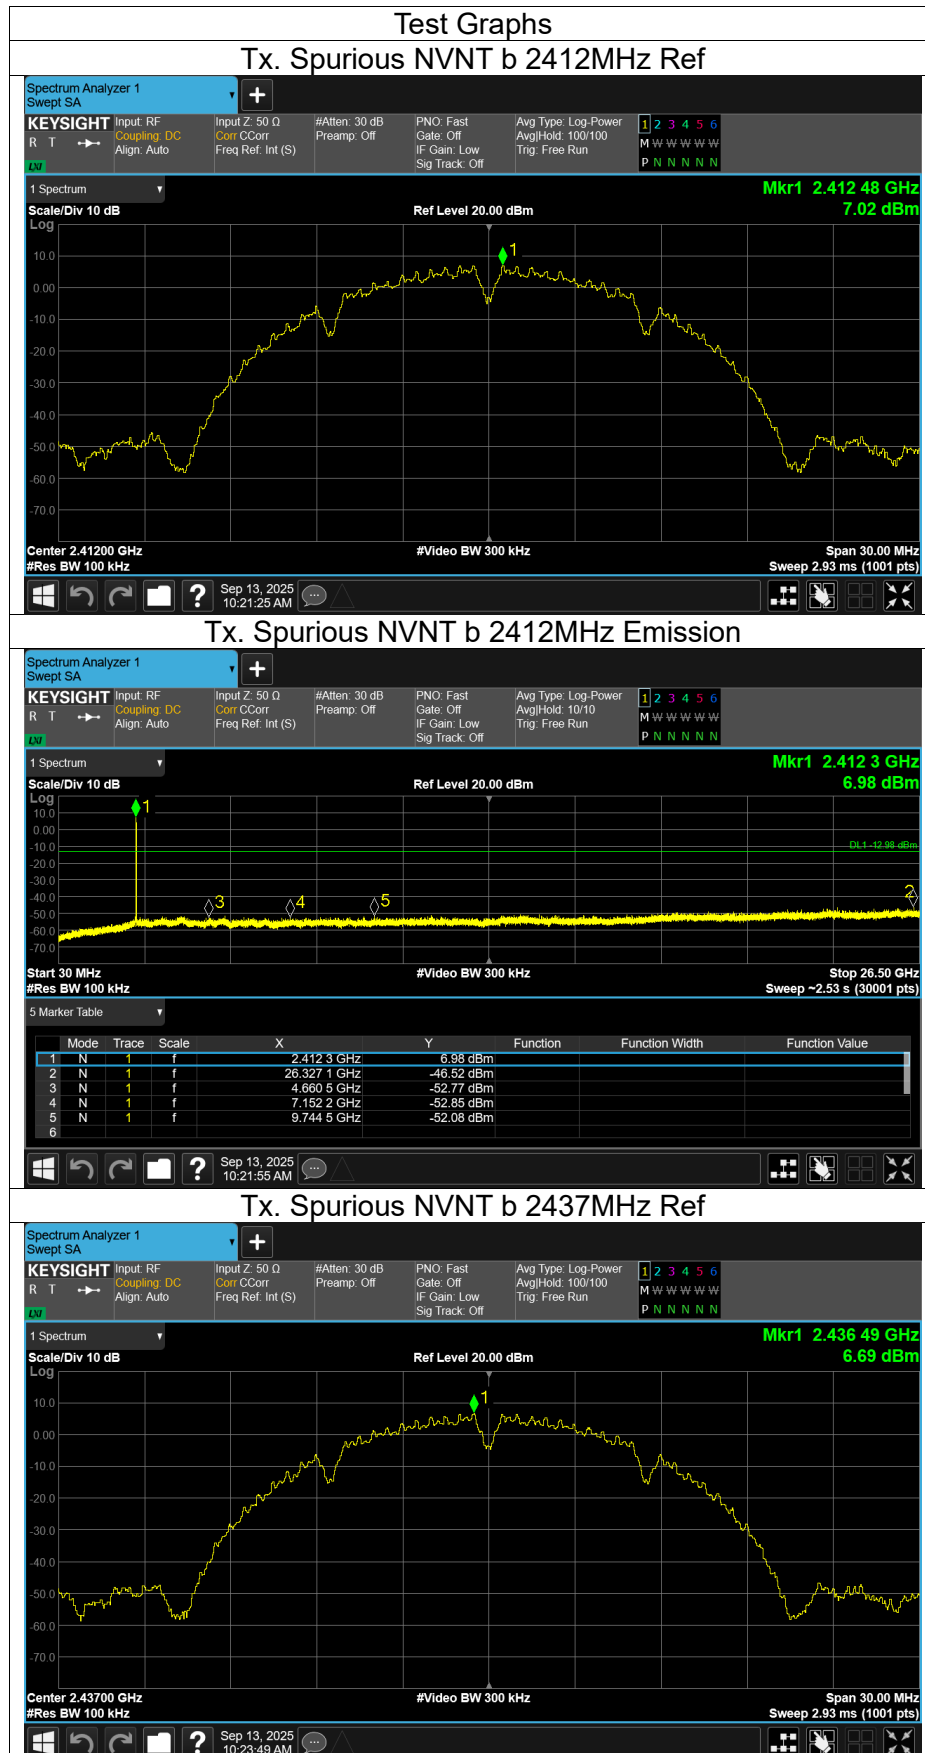
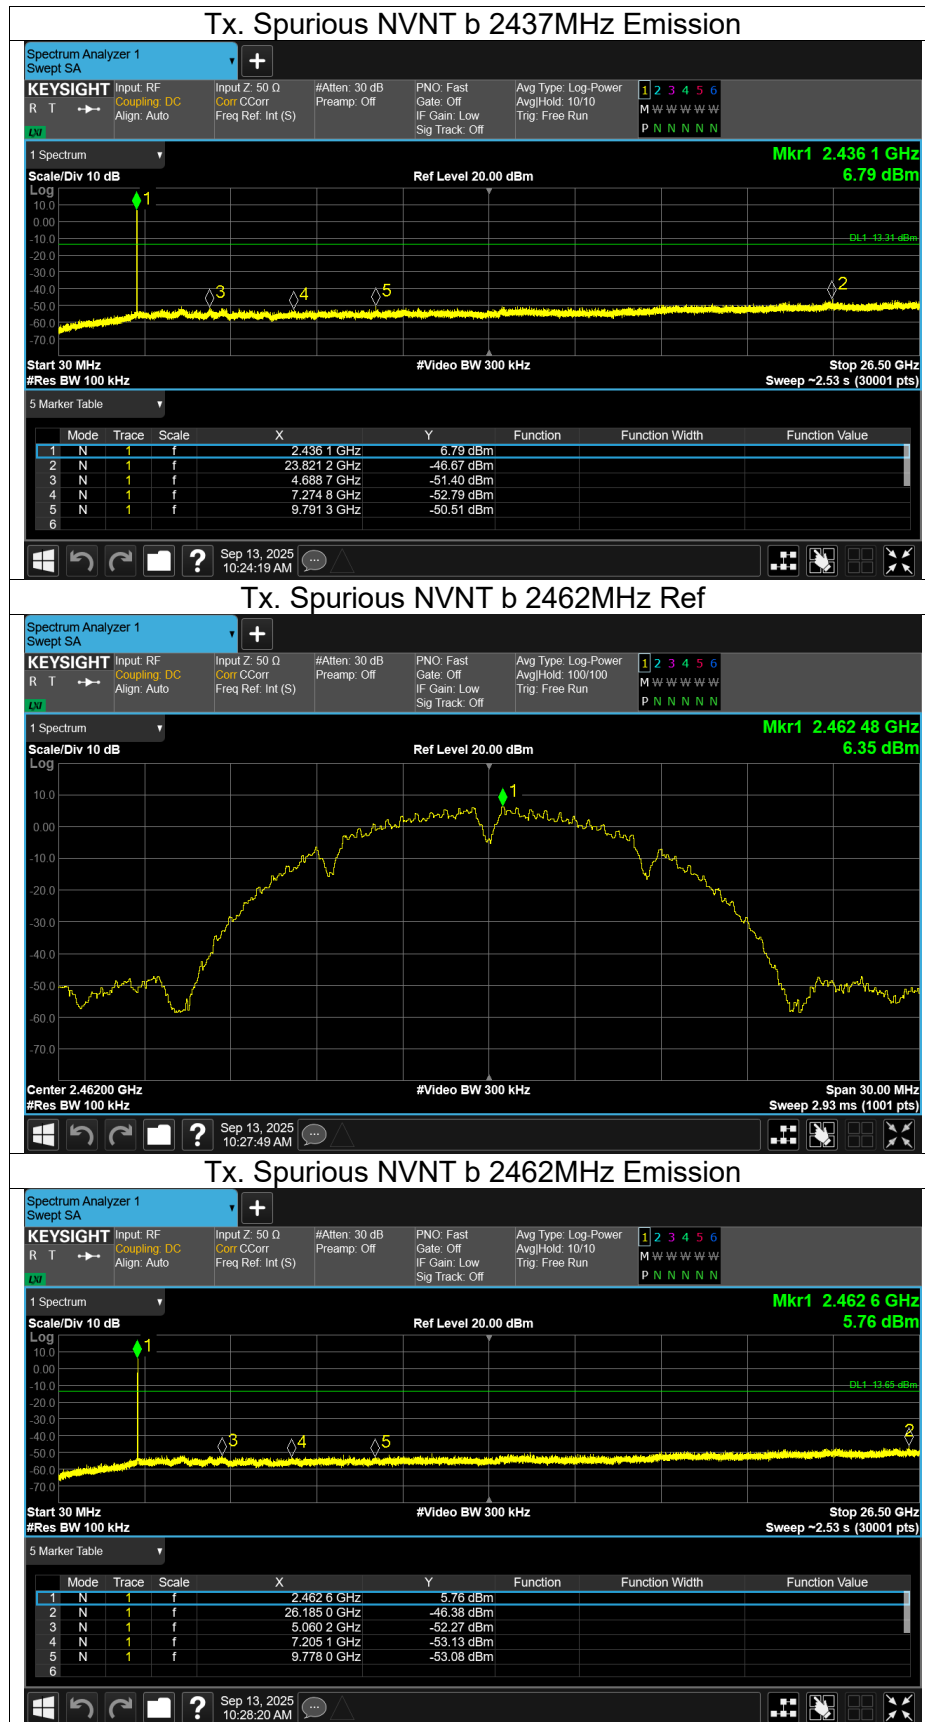
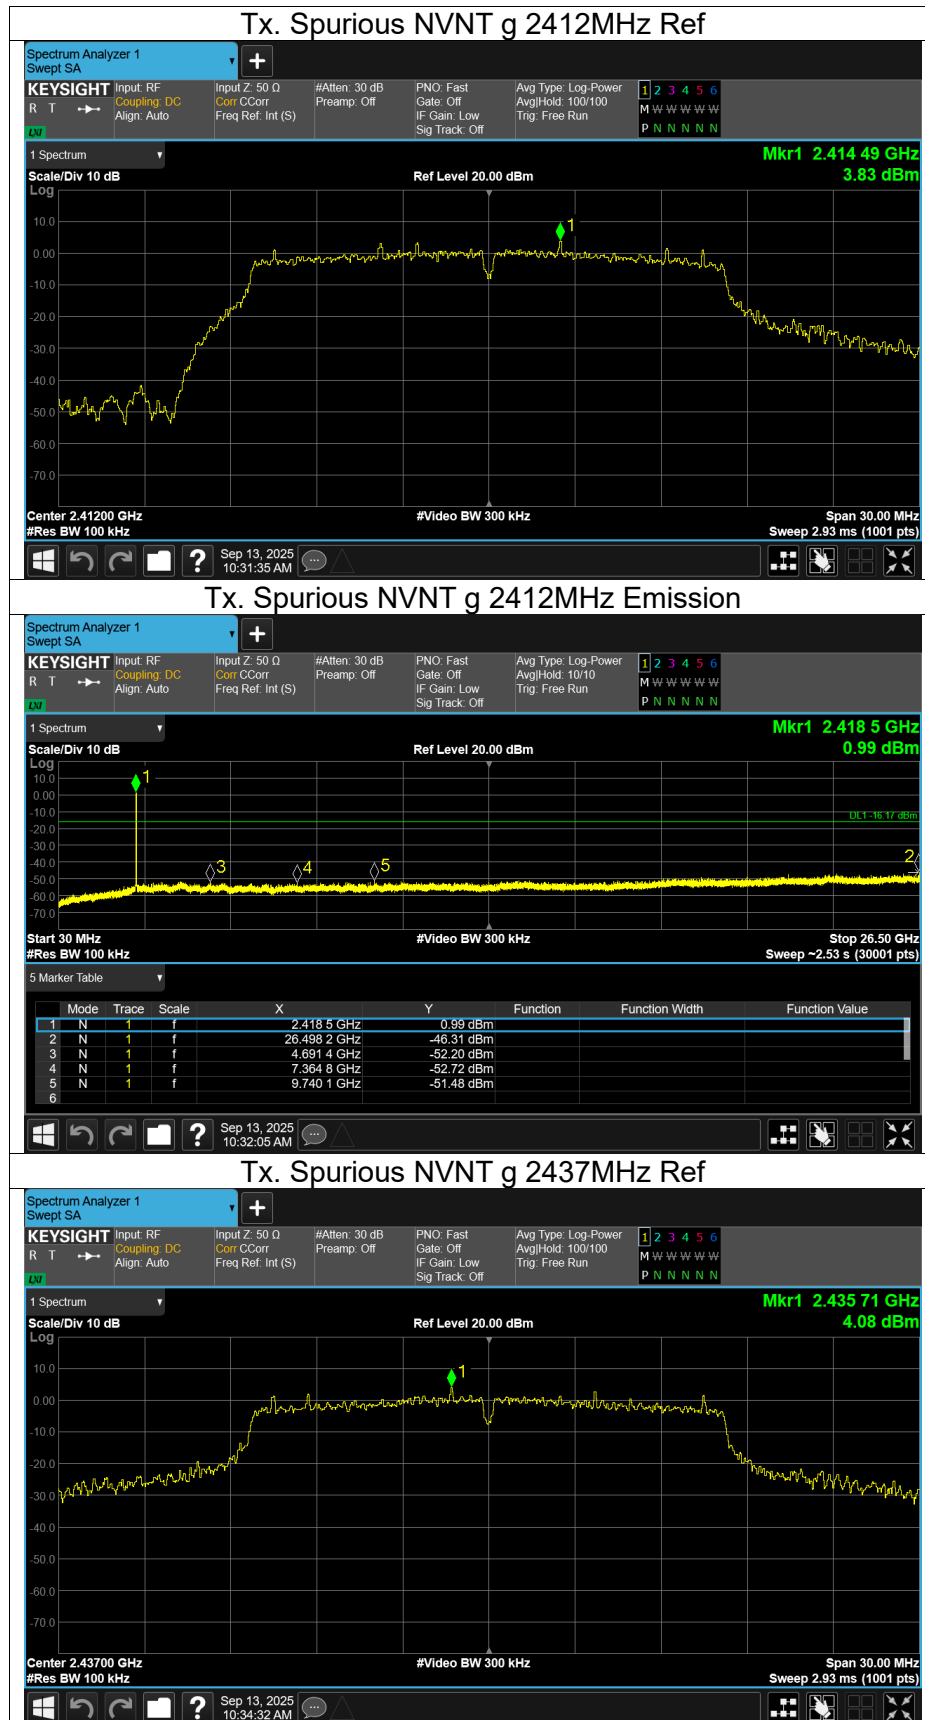
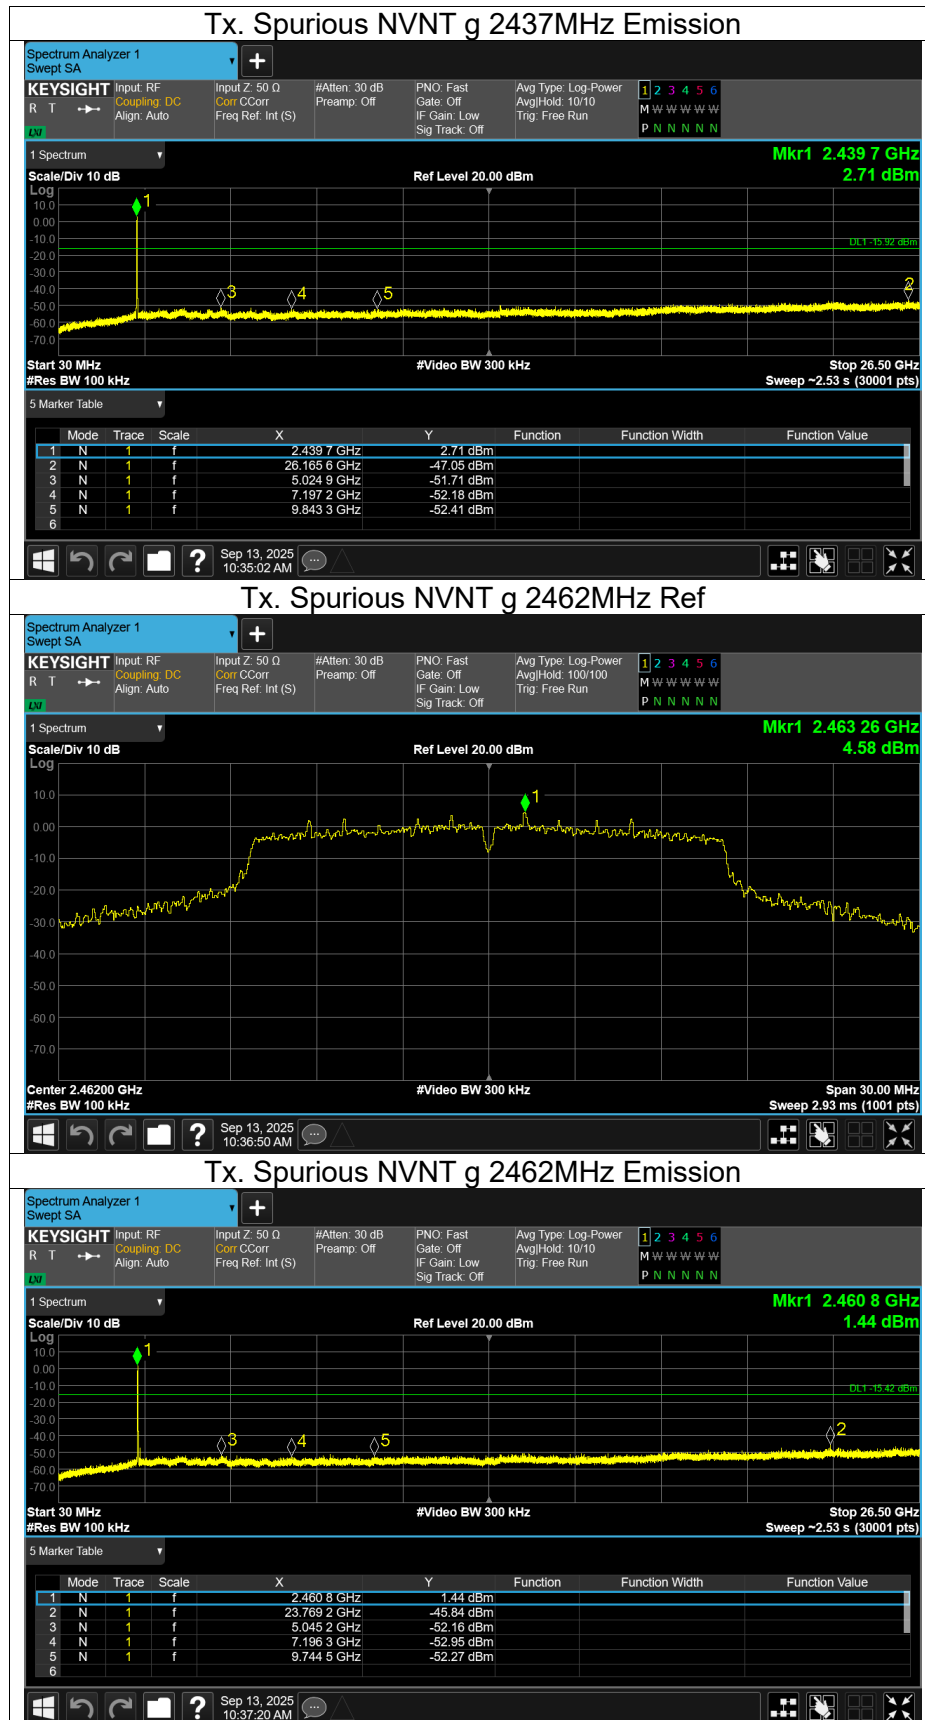
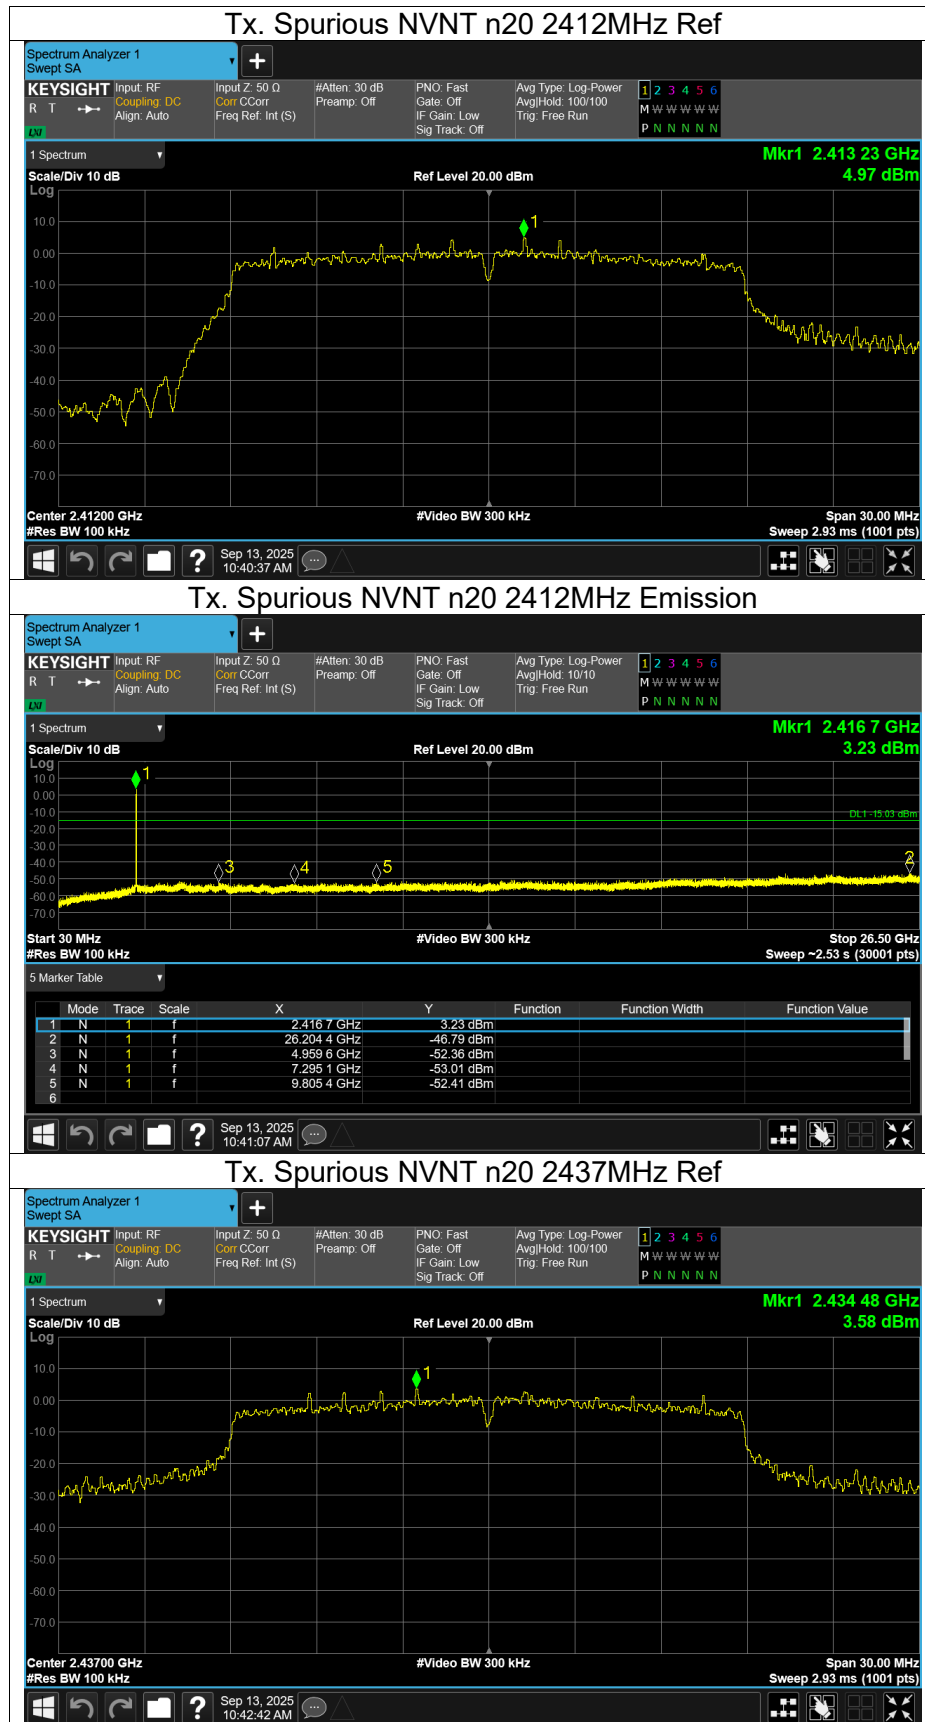
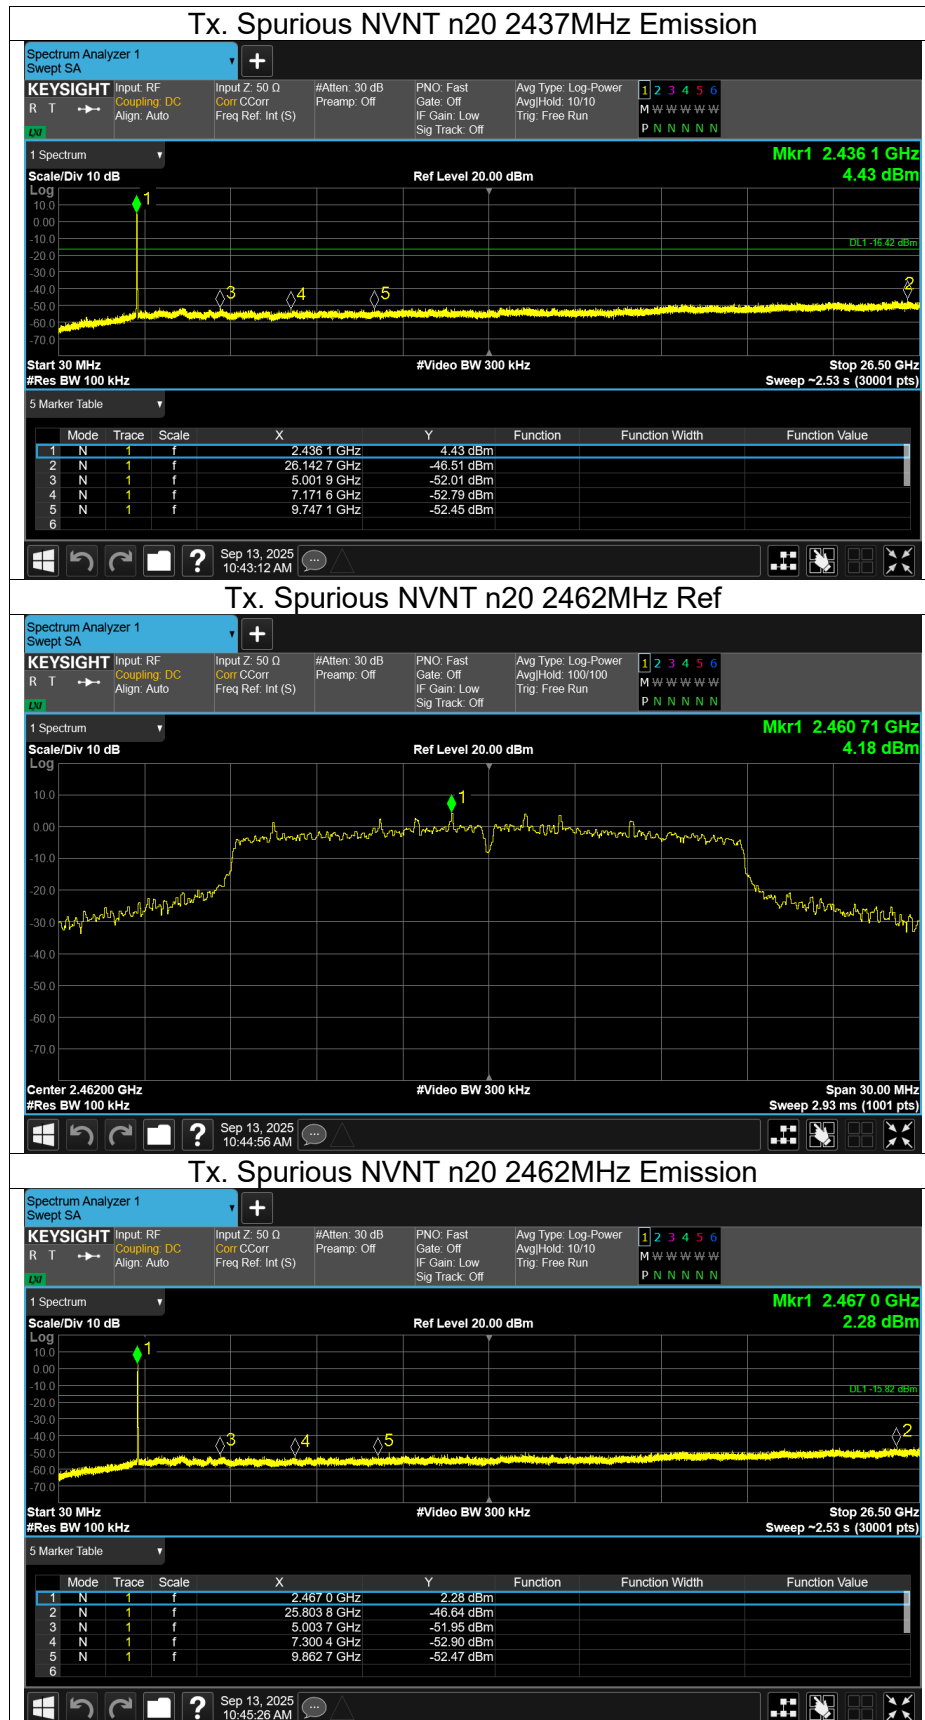
| Condition | Mode | Frequency (MHz) | Max Value (dBc) | Limit (dBc) | Verdict |
| NVNT | b | 2412 | -53.53 | -20 | Pass |
| NVNT | b | 2437 | -53.36 | -20 | Pass |
| NVNT | b | 2462 | -52.73 | -20 | Pass |
| NVNT | g | 2412 | -50.14 | -20 | Pass |
| NVNT | g | 2437 | -51.12 | -20 | Pass |
| NVNT | g | 2462 | -50.43 | -20 | Pass |
| NVNT | n20 | 2412 | -51.75 | -20 | Pass |
| NVNT | n20 | 2437 | -50.09 | -20 | Pass |
| NVNT | n20 | 2462 | -50.81 | -20 | Pass |
| NVNT | n40 | 2422 | -48.34 | -20 | Pass |
| NVNT | n40 | 2437 | -47.93 | -20 | Pass |
| NVNT | n40 | 2452 | -47.91 | -20 | Pass |
| NVNT | ax20 | 2412 | -50.76 | -20 | Pass |
| NVNT | ax20 | 2437 | -51.47 | -20 | Pass |
| NVNT | ax20 | 2462 | -51.11 | -20 | Pass |
| NVNT | ax40 | 2422 | -48.63 | -20 | Pass |
| NVNT | ax40 | 2437 | -47.75 | -20 | Pass |
| NVNT | ax40 | 2452 | -48.19 | -20 | Pass |
