## 10.6 APPENDIX: BAND EDGE MEASUREMENTS

## 10.7 APPENDIX: CONDUCTED SPURIOUS EMISSION

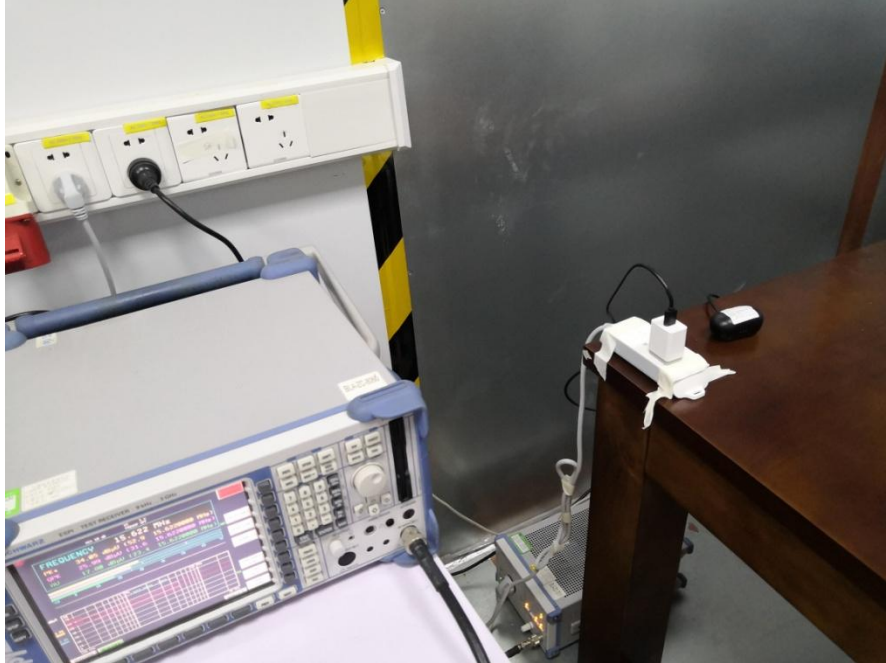
**Conducted Emissions at AC Power Line (150kHz-30MHz)**

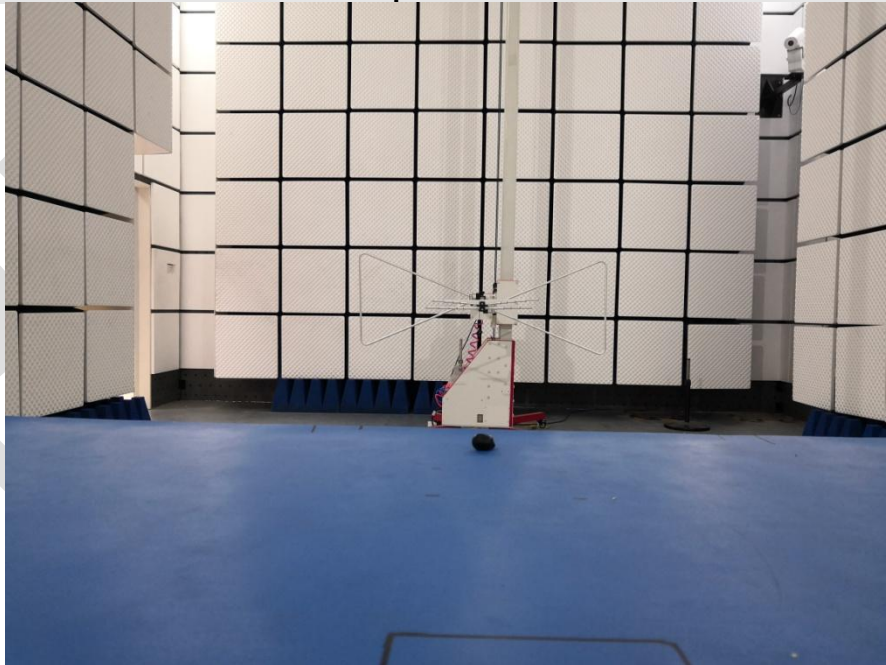
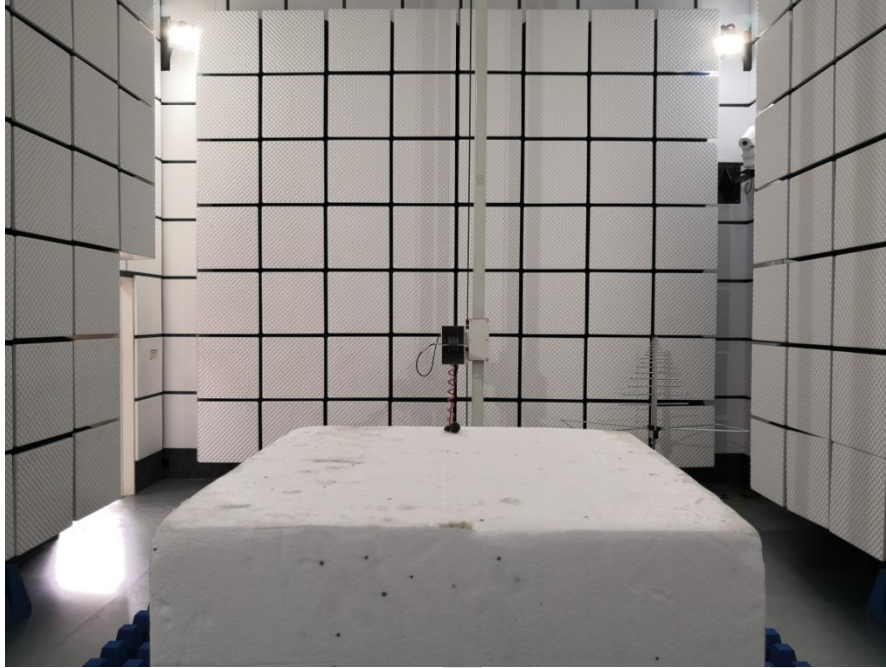
**Radiated Spurious Emissions**
