Conducted RF Spurious Emission

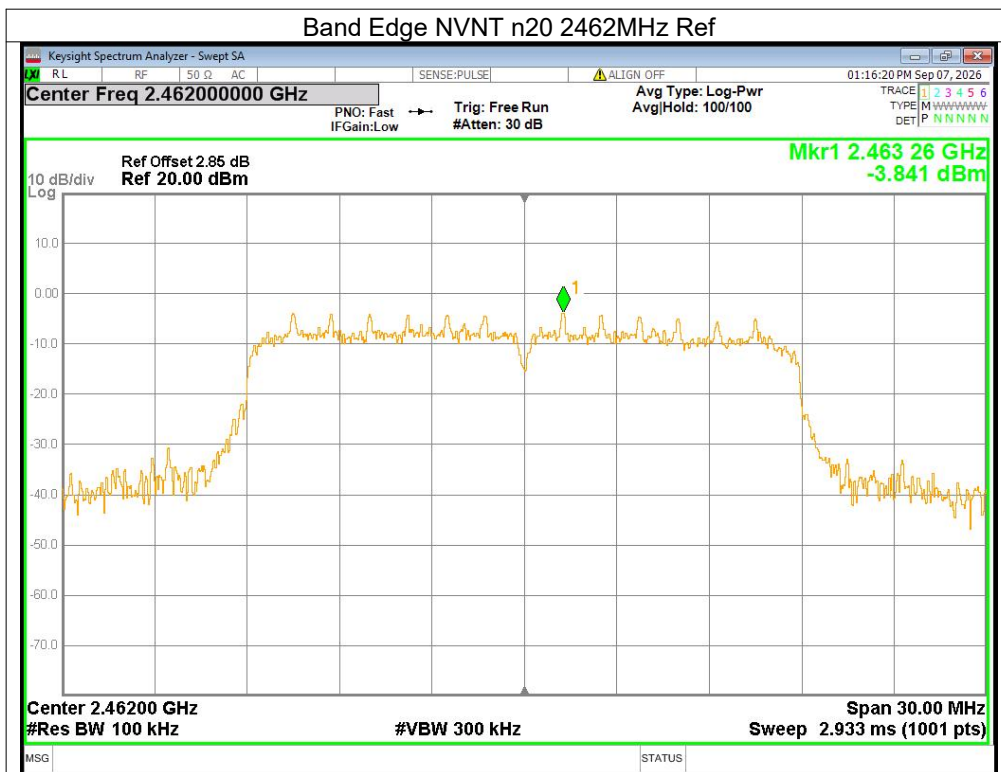
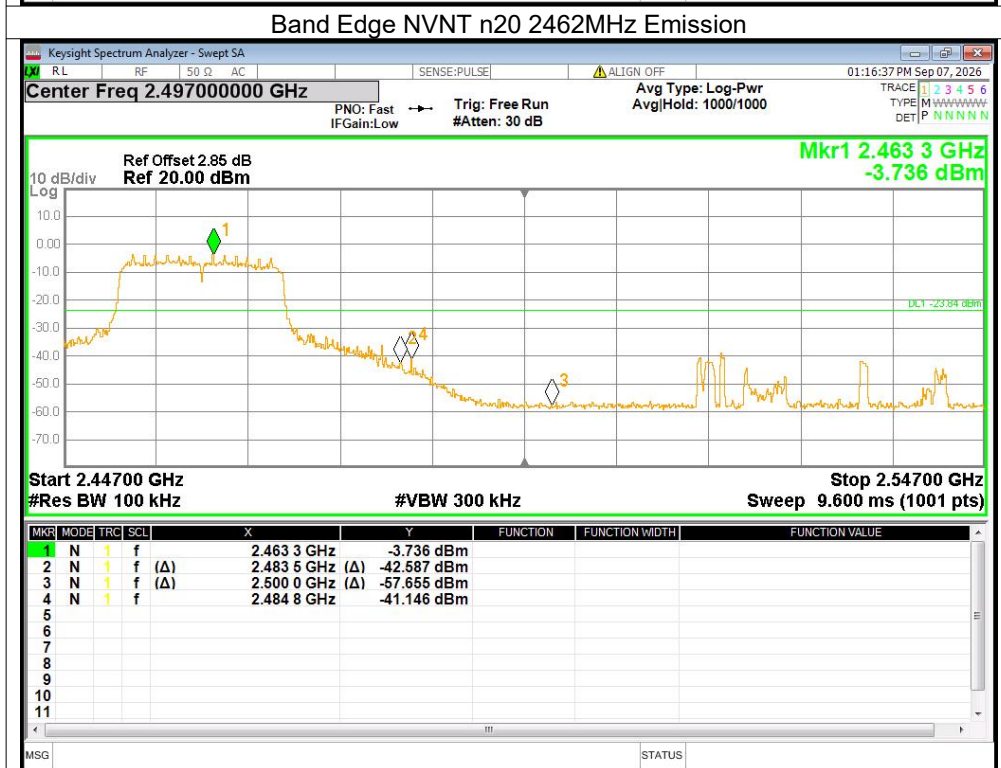
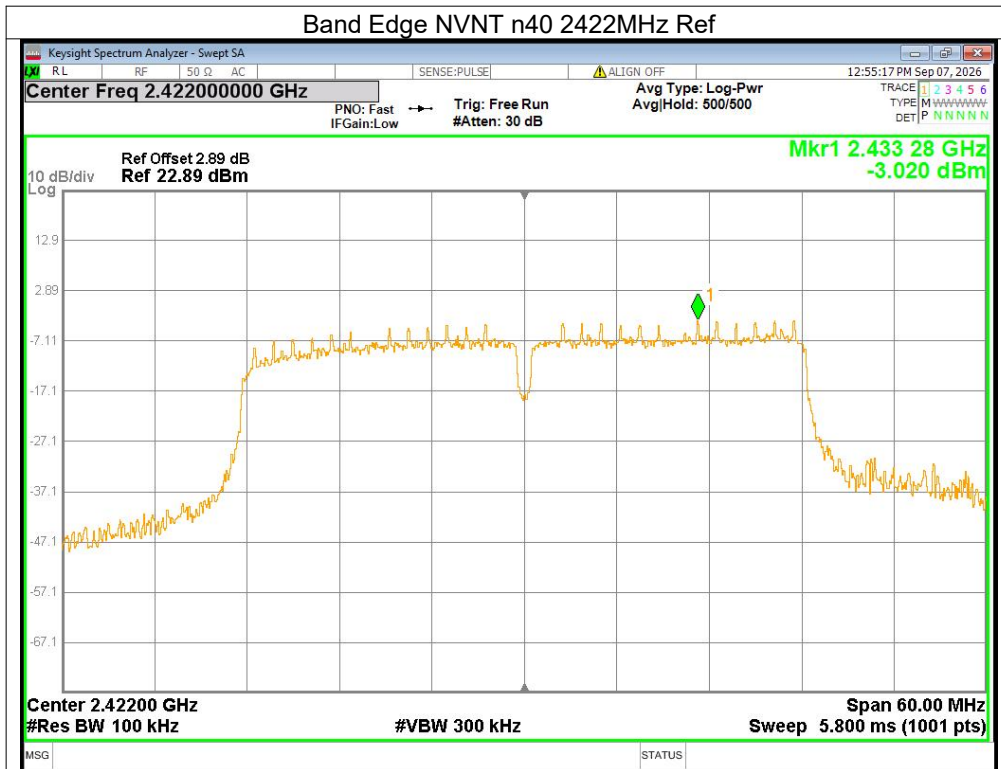
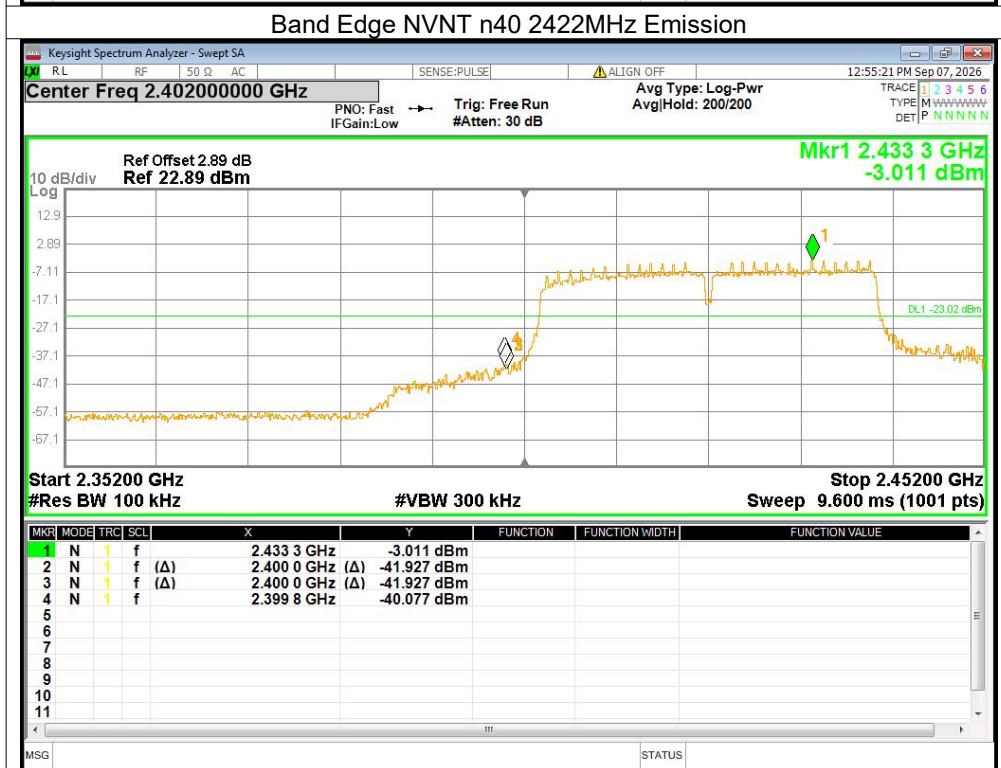
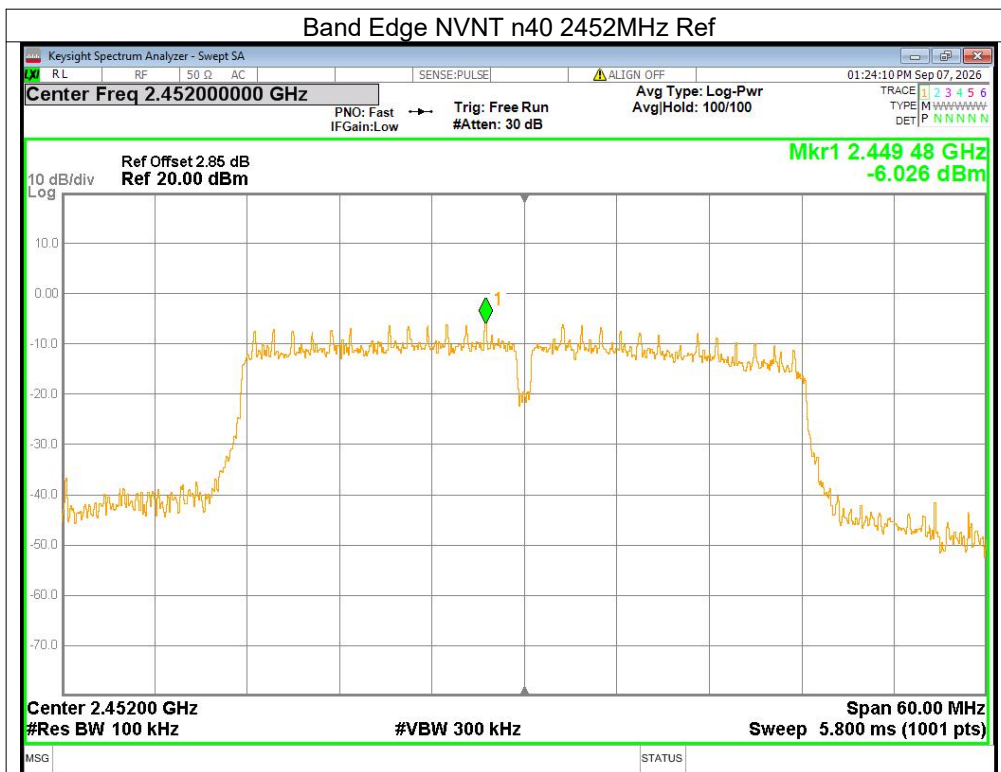
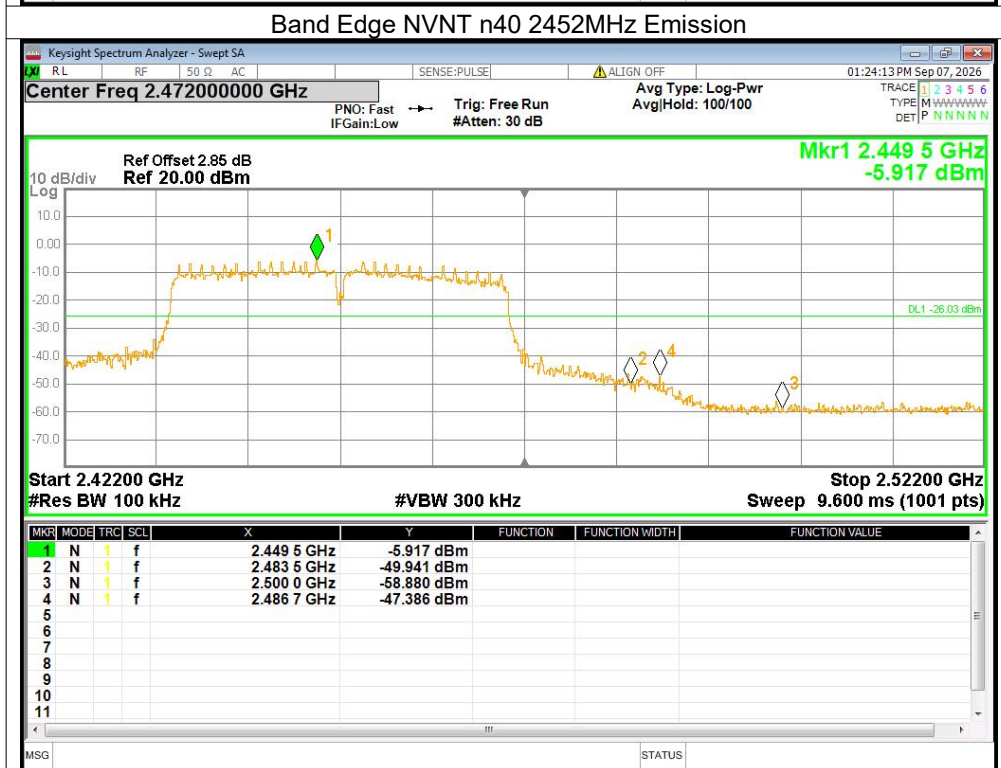
| Mode | Frequency (MHz) | Max Value (dBc) | Limit (dBc) | Verdict |
| b | 2412 | -48.78 | <=-20 | Pass |
| b | 2437 | -41.7 | <=-20 | Pass |
| b | 2462 | -44.65 | <=-20 | Pass |
| g | 2412 | -43.8 | <=-20 | Pass |
| g | 2437 | -44.01 | <=-20 | Pass |
| g | 2462 | -41.41 | <=-20 | Pass |
| n20 | 2412 | -43.7 | <=-20 | Pass |
| n20 | 2437 | -43.37 | <=-20 | Pass |
| n20 | 2462 | -40.45 | <=-20 | Pass |
| n40 | 2422 | -40.94 | <=-20 | Pass |
| n40 | 2437 | -41.88 | <=-20 | Pass |
| n40 | 2452 | -37.84 | <=-20 | Pass |
