# Radiated Emission Measurement

Condition : FCC\_part 15E RE\_Above 1GHz\_PK

EUT : W6M22311-23090

Test Mode : TX 802.11a CH44

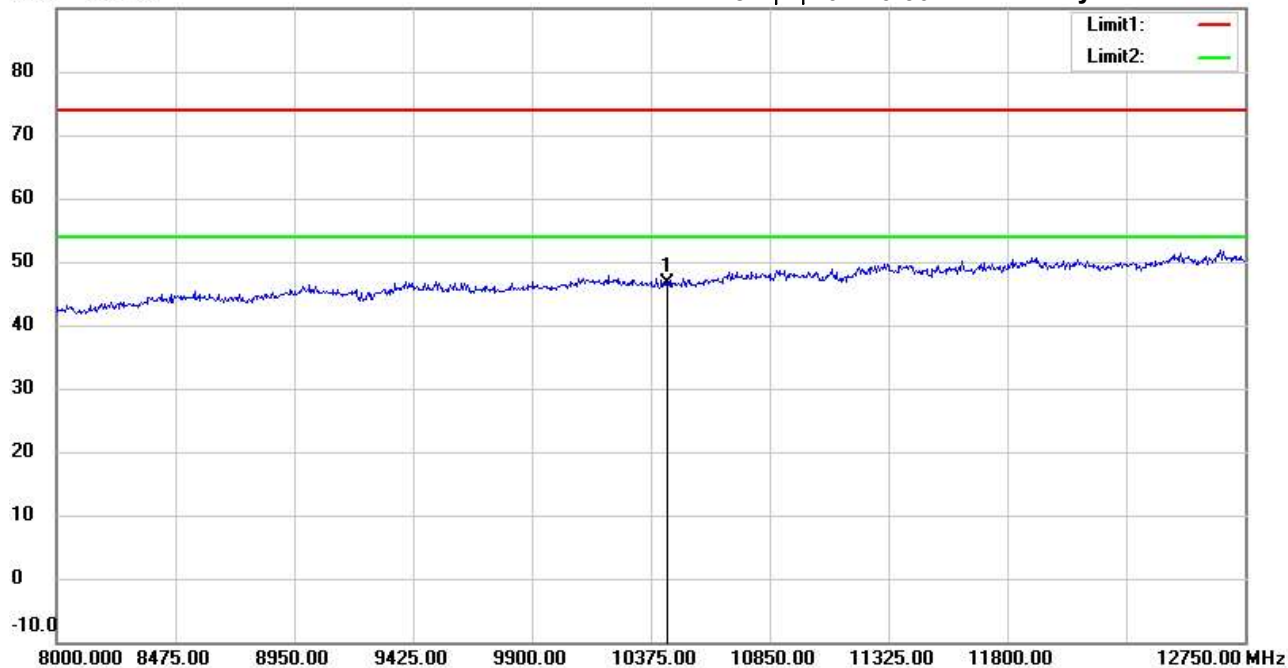
Data : #3

Condition : FCC\_part 15E RE\_Above 1GHz\_PK

Polarization: **Horizontal**

| Mk. | Frequency (MHz) | Reading (dBuV) | Detector | Corr. factor (dB/m) | Result (dBuV/m) | Limit (dBuV/m) | Ant.Pos (cm) | Tab.Pos (deg.) | Margin (dB) | Comment |
|---|---|---|---|---|---|---|---|---|---|---|
| * | 10440.000 | 32.54 | peak | 14.11 | 46.65 | 74.00 | 150 | 30 | -27.35 | |

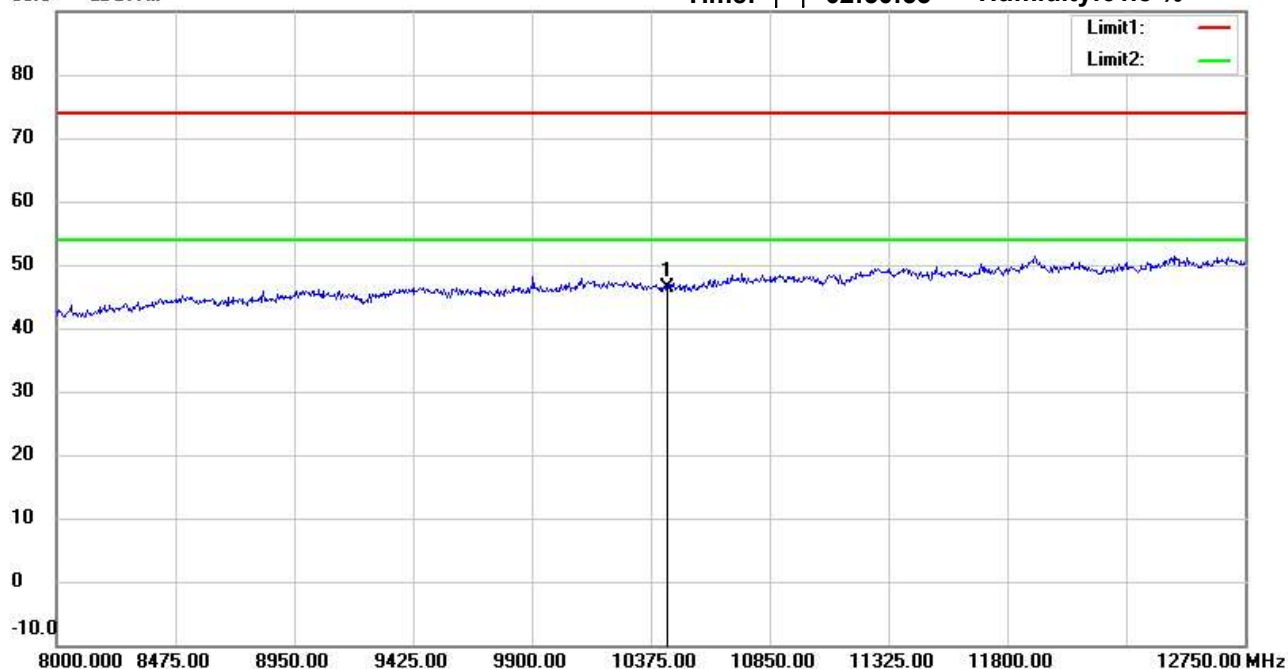
Data : #9

Condition : FCC\_part 15E RE\_Above 1GHz\_PK

Polarization: **Vertical**

| Mk. | Frequency (MHz) | Reading (dBuV) | Detector | Corr. factor (dB/m) | Result (dBuV/m) | Limit (dBuV/m) | Ant.Pos (cm) | Tab.Pos (deg.) | Margin (dB) | Comment |
|---|---|---|---|---|---|---|---|---|---|---|
| * | 10440.000 | 32.20 | peak | 14.11 | 46.31 | 74.00 | 150 | 132 | -27.69 | |

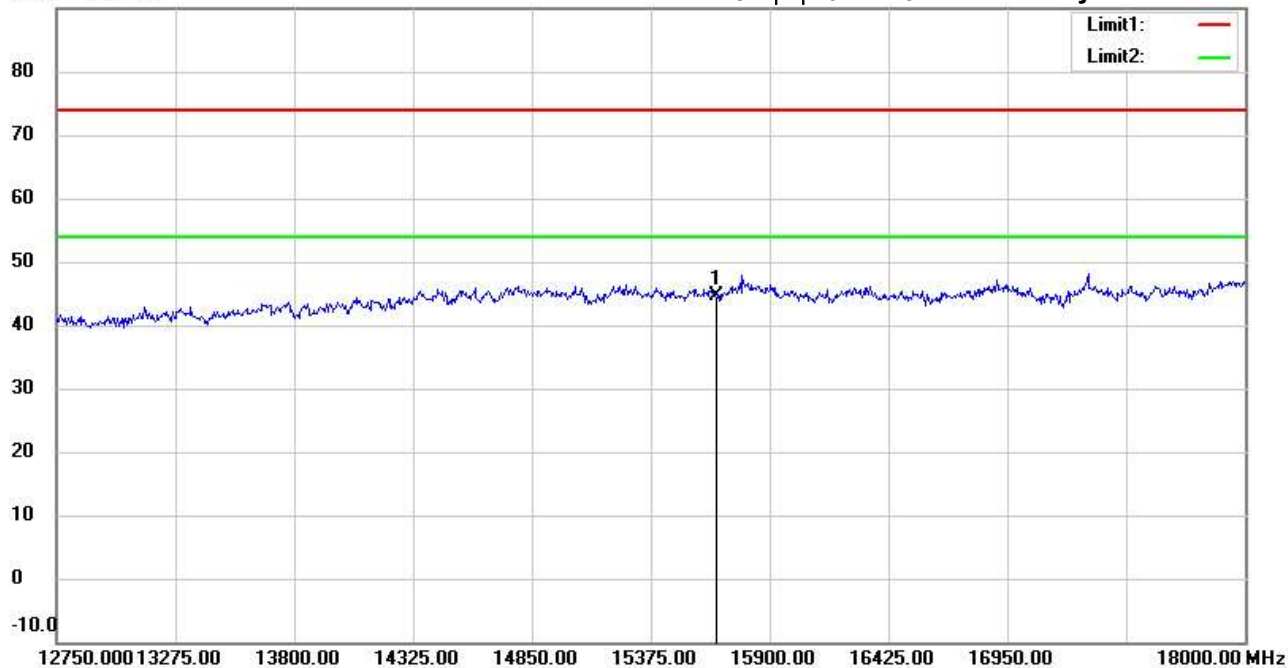
Data :#4

Condition : FCC\_part 15E RE\_Above 1GHz\_PK

Polarization: **Horizontal**

| Mk. | Frequency (MHz) | Reading (dBuV) | Detector | Corr. factor (dB/m) | Result (dBuV/m) | Limit (dBuV/m) | Ant.Pos (cm) | Tab.Pos (deg.) | Margin (dB) | Comment |
|---|---|---|---|---|---|---|---|---|---|---|
| * | 15660.000 | 21.53 | peak | 23.15 | 44.68 | 74.00 | 150 | 36 | -29.32 | |

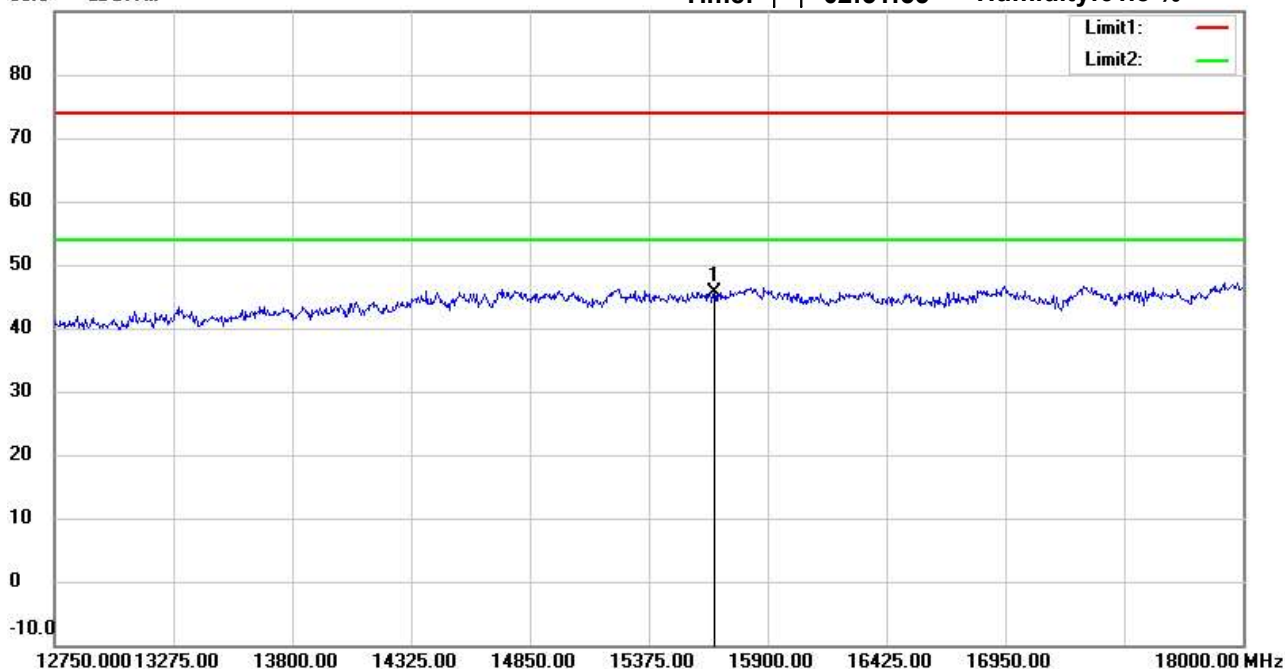
Data : #10

Condition : FCC\_part 15E RE\_Above 1GHz\_PK

Polarization: Vertical

| Mk. | Frequency (MHz) | Reading (dBuV) | Detector | Corr. factor (dB/m) | Result (dBuV/m) | Limit (dBuV/m) | Ant.Pos (cm) | Tab.Pos (deg.) | Margin (dB) | Comment |
|---|---|---|---|---|---|---|---|---|---|---|
| * | 15660.000 | 22.52 | peak | 23.15 | 45.67 | 74.00 | 150 | 288 | -28.33 | |

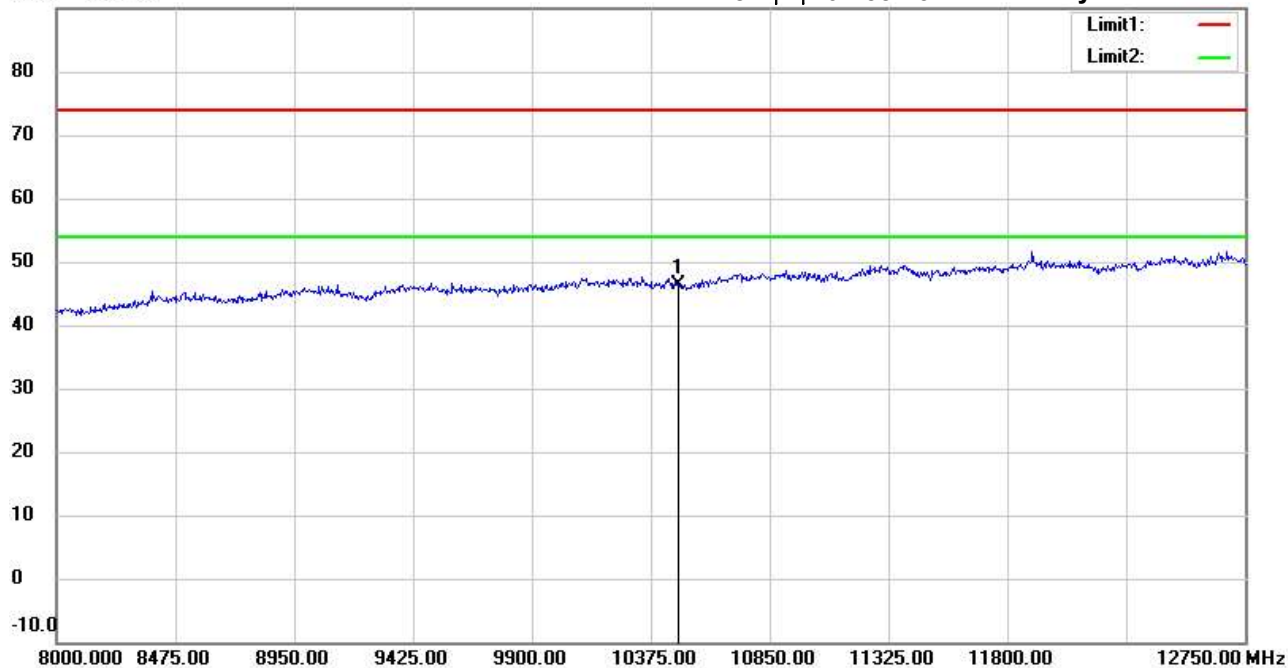
Data : #3

Condition : FCC\_part 15E RE\_Above 1GHz\_PK

Polarization: **Horizontal**

| Mk. | Frequency (MHz) | Reading (dBuV) | Detector | Corr. factor (dB/m) | Result (dBuV/m) | Limit (dBuV/m) | Ant.Pos (cm) | Tab.Pos (deg.) | Margin (dB) | Comment |
|---|---|---|---|---|---|---|---|---|---|---|
| * | 10480.000 | 32.23 | peak | 14.08 | 46.31 | 74.00 | 150 | 107 | -27.69 | |

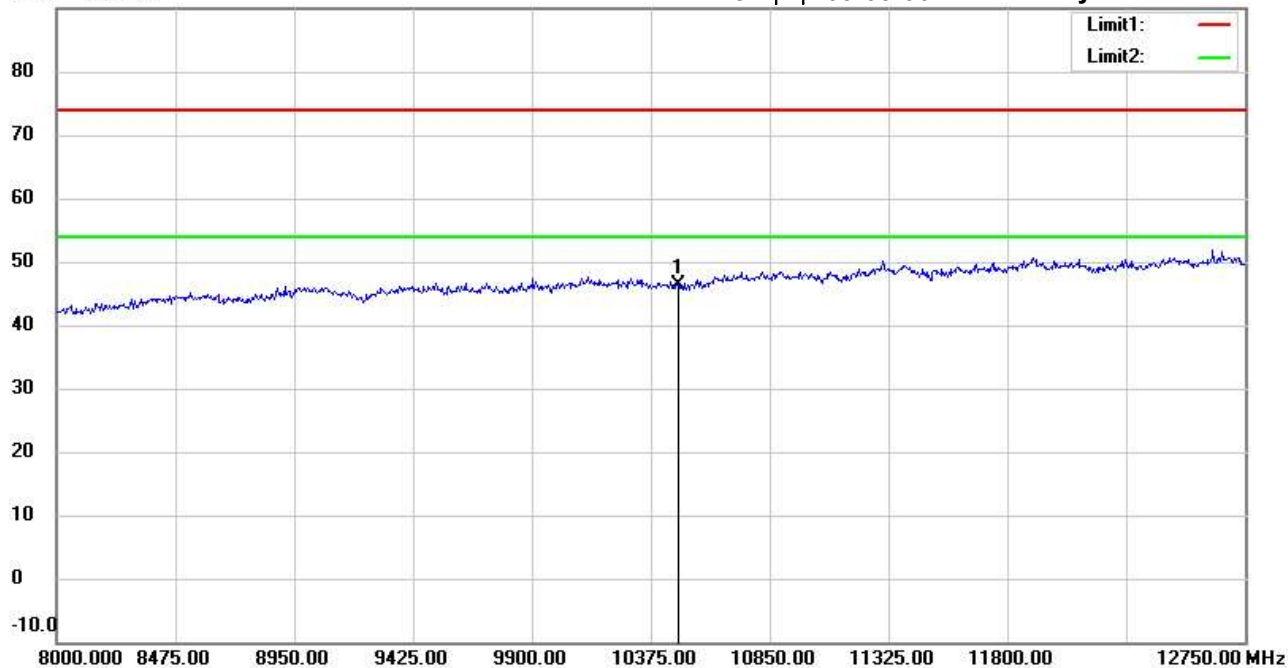
Data : #9

Condition : FCC\_part 15E RE\_Above 1GHz\_PK

Polarization: Vertical

| Mk. | Frequency (MHz) | Reading (dBuV) | Detector | Corr. factor (dB/m) | Result (dBuV/m) | Limit (dBuV/m) | Ant.Pos (cm) | Tab.Pos (deg.) | Margin (dB) | Comment |
|---|---|---|---|---|---|---|---|---|---|---|
| * | 10480.000 | 32.30 | peak | 14.08 | 46.38 | 74.00 | 150 | 306 | -27.62 | |

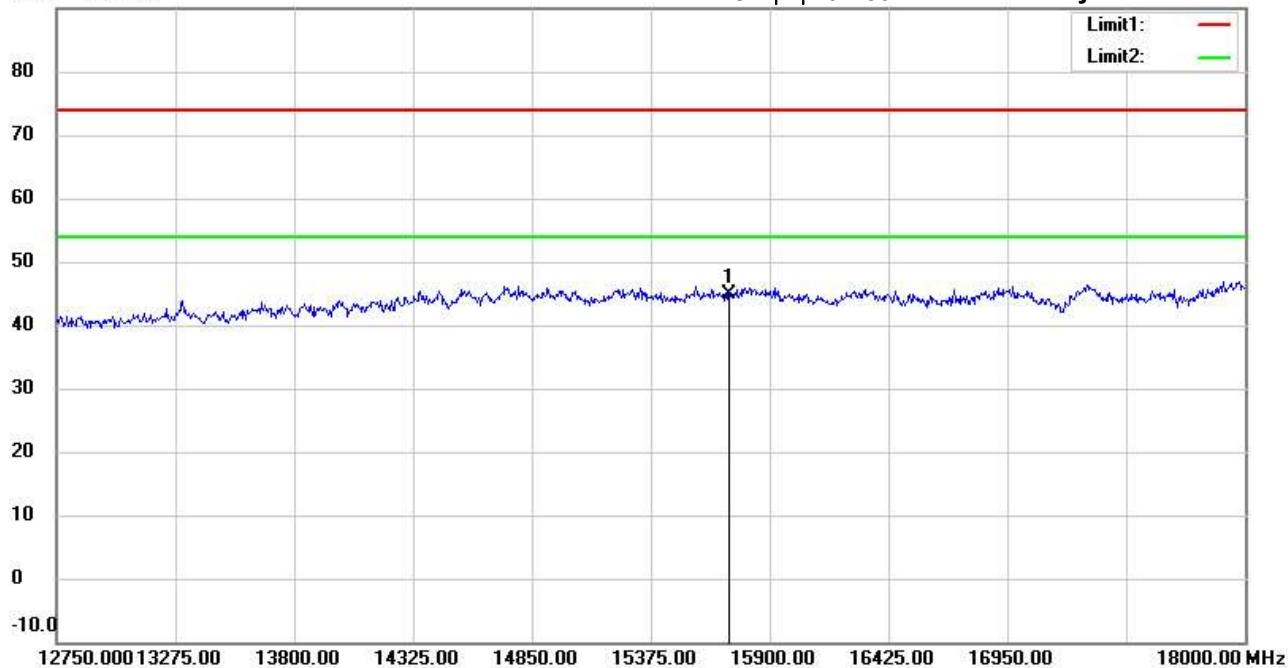
Data : #4

Condition : FCC\_part 15E RE\_Above 1GHz\_PK

Polarization: **Horizontal**

| Mk. | Frequency (MHz) | Reading (dBuV) | Detector | Corr. factor (dB/m) | Result (dBuV/m) | Limit (dBuV/m) | Ant.Pos (cm) | Tab.Pos (deg.) | Margin (dB) | Comment |
|---|---|---|---|---|---|---|---|---|---|---|
| * | 15720.000 | 21.72 | peak | 23.09 | 44.81 | 74.00 | 150 | 148 | -29.19 | |

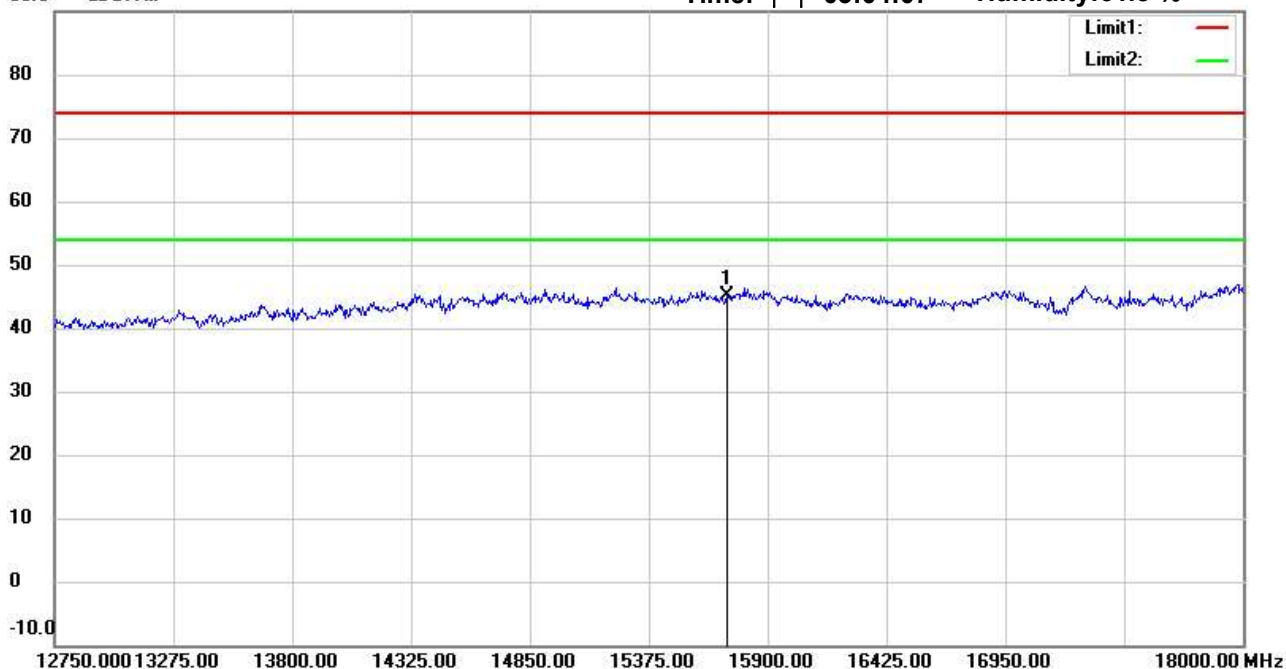
Data : #10

Condition : FCC\_part 15E RE\_Above 1GHz\_PK

Polarization: Vertical

| Mk. | Frequency (MHz) | Reading (dBuV) | Detector | Corr. factor (dB/m) | Result (dBuV/m) | Limit (dBuV/m) | Ant.Pos (cm) | Tab.Pos (deg.) | Margin (dB) | Comment |
|---|---|---|---|---|---|---|---|---|---|---|
| * | 15720.000 | 21.97 | peak | 23.09 | 45.06 | 74.00 | 150 | 285 | -28.94 | |
