# Radiated Emission Measurement

Condition : FCC\_part 15 RE-Class C\_Above 1GHz\_PK

EUT : W6M22311-23090

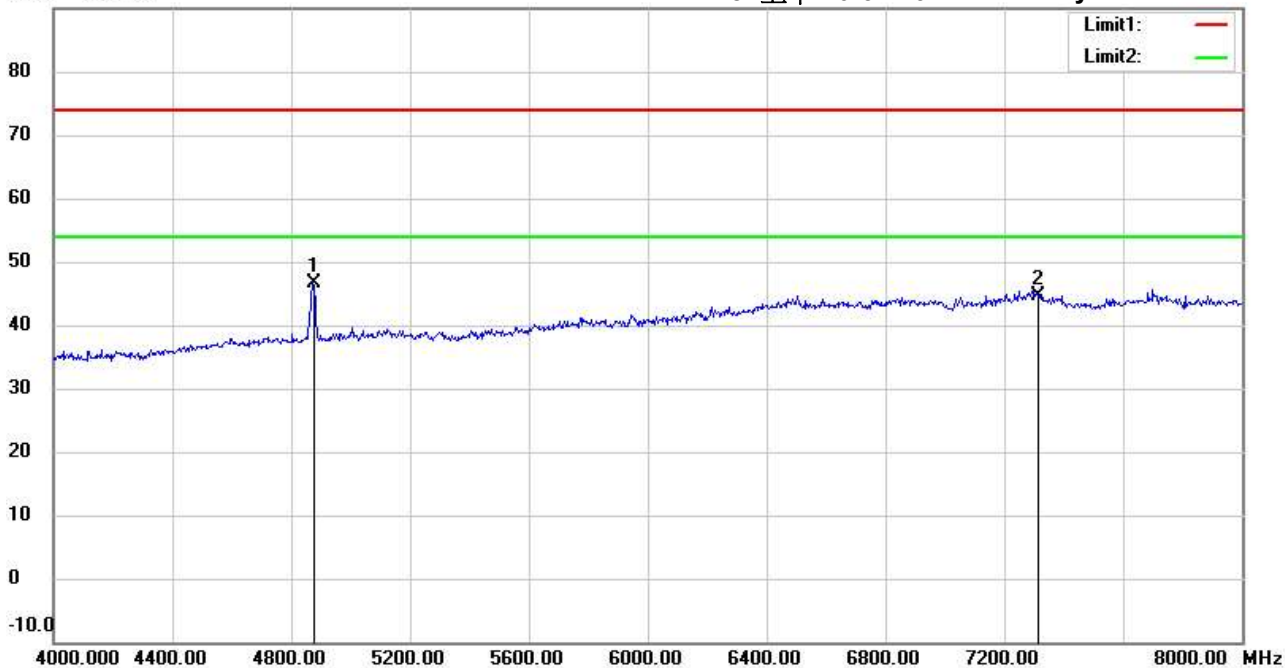
Test Mode : TX 802.11g CH6

Polarization: **Horizontal**

| Mk. | Frequency (MHz) | Reading (dBuV) | Detector | Corr. factor (dB/m) | Result (dBuV/m) | Limit (dBuV/m) | Ant.Pos (cm) | Tab.Pos (deg.) | Margin (dB) | Comment |
|---|---|---|---|---|---|---|---|---|---|---|
| * | 4874.000 | 41.51 | peak | 5.21 | 46.72 | 74.00 | 150 | 22 | -27.28 | |
| | 7311.000 | 32.98 | peak | 11.70 | 44.68 | 74.00 | 150 | 270 | -29.32 | |

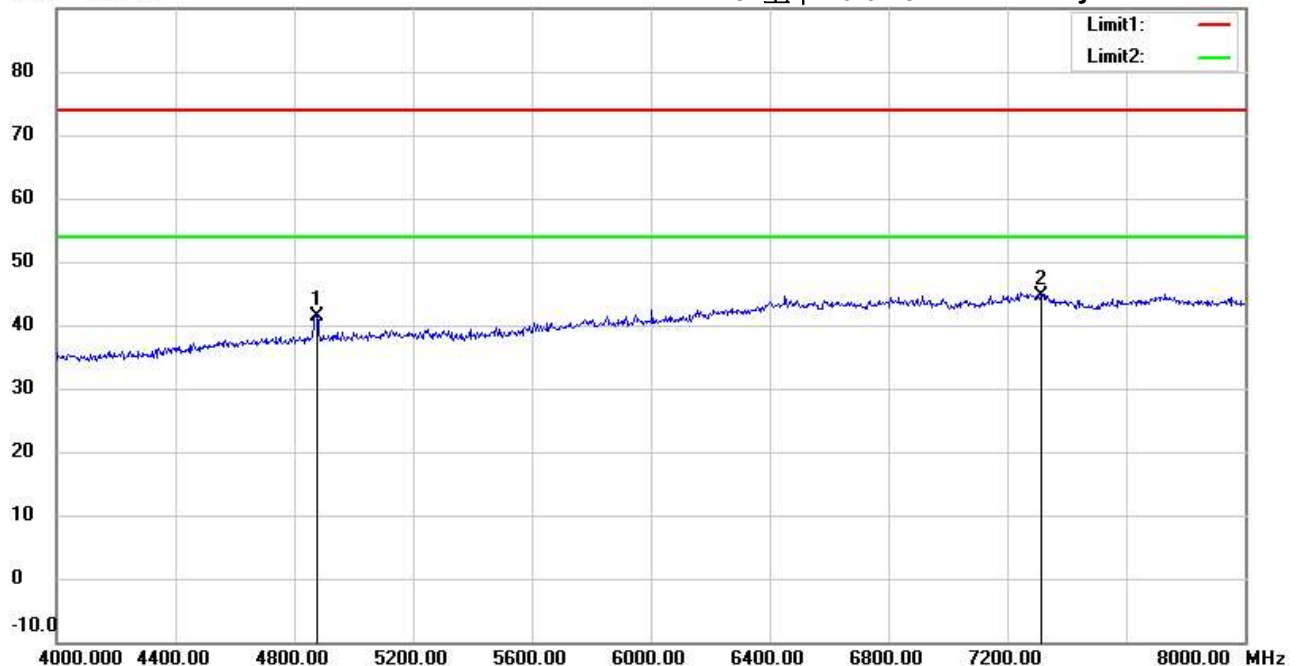
Test Mode : TX 802.11g CH6

Polarization: Vertical

| Mk. | Frequency (MHz) | Reading (dBuV) | Detector | Corr. factor (dB/m) | Result (dBuV/m) | Limit (dBuV/m) | Ant.Pos (cm) | Tab.Pos (deg.) | Margin (dB) | Comment |
|---|---|---|---|---|---|---|---|---|---|---|
| | 4876.000 | 36.22 | peak | 5.22 | 41.44 | 74.00 | 150 | 125 | -32.56 | |
| * | 7311.000 | 32.91 | peak | 11.70 | 44.61 | 74.00 | 150 | 130 | -29.39 | |

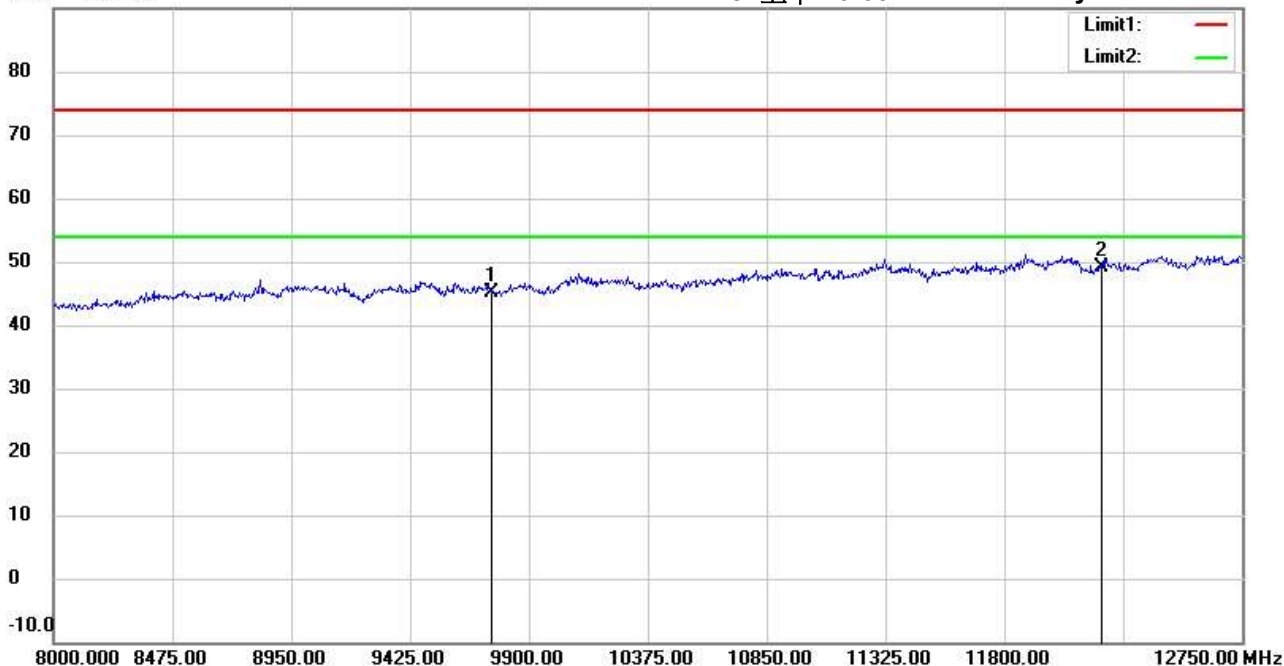
Test Mode : TX 802.11g CH6

Polarization: **Horizontal**

| Mk. | Frequency (MHz) | Reading (dBuV) | Detector | Corr. factor (dB/m) | Result (dBuV/m) | Limit (dBuV/m) | Ant.Pos (cm) | Tab.Pos (deg.) | Margin (dB) | Comment |
|---|---|---|---|---|---|---|---|---|---|---|
| | 9748.000 | 31.53 | peak | 13.70 | 45.23 | 74.00 | 150 | 21 | -28.77 | |
| * | 12185.000 | 32.22 | peak | 17.02 | 49.24 | 74.00 | 150 | 301 | -24.76 | |

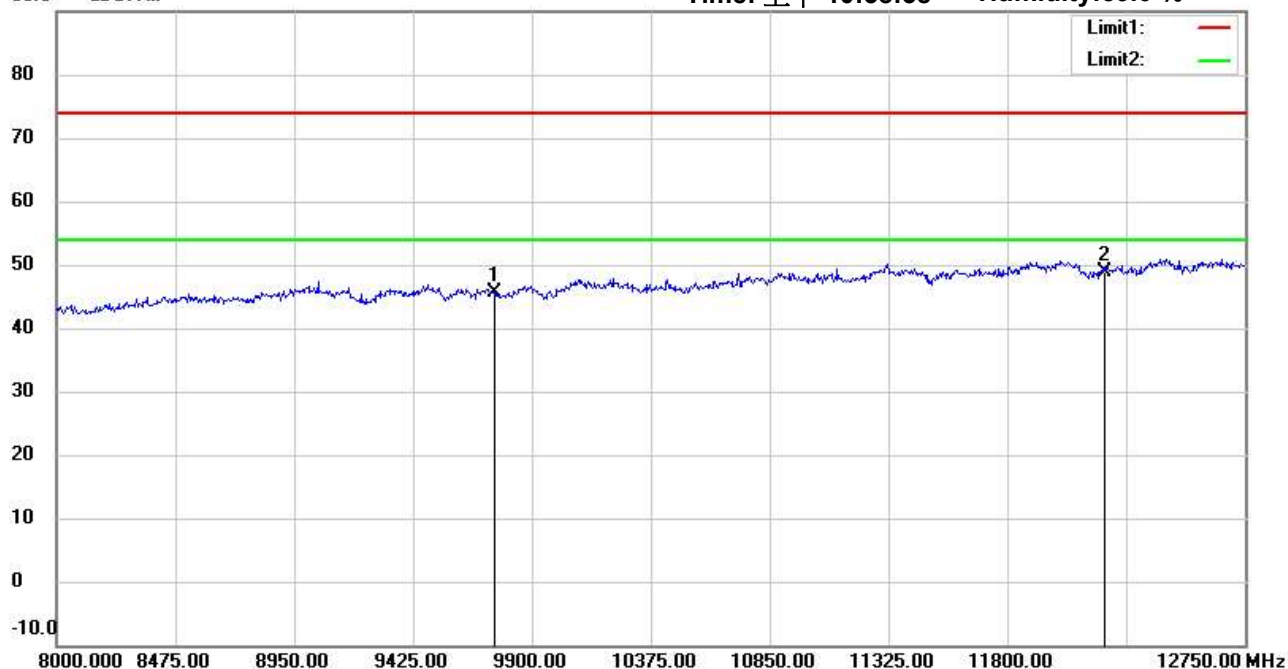
Test Mode : TX 802.11g CH6

Polarization: **Vertical**

| Mk. | Frequency (MHz) | Reading (dBuV) | Detector | Corr. factor (dB/m) | Result (dBuV/m) | Limit (dBuV/m) | Ant.Pos (cm) | Tab.Pos (deg.) | Margin (dB) | Comment |
|---|---|---|---|---|---|---|---|---|---|---|
| | 9748.000 | 32.02 | peak | 13.70 | 45.72 | 74.00 | 150 | 98 | -28.28 | |
| * | 12185.000 | 31.74 | peak | 17.02 | 48.76 | 74.00 | 150 | 81 | -25.24 | |

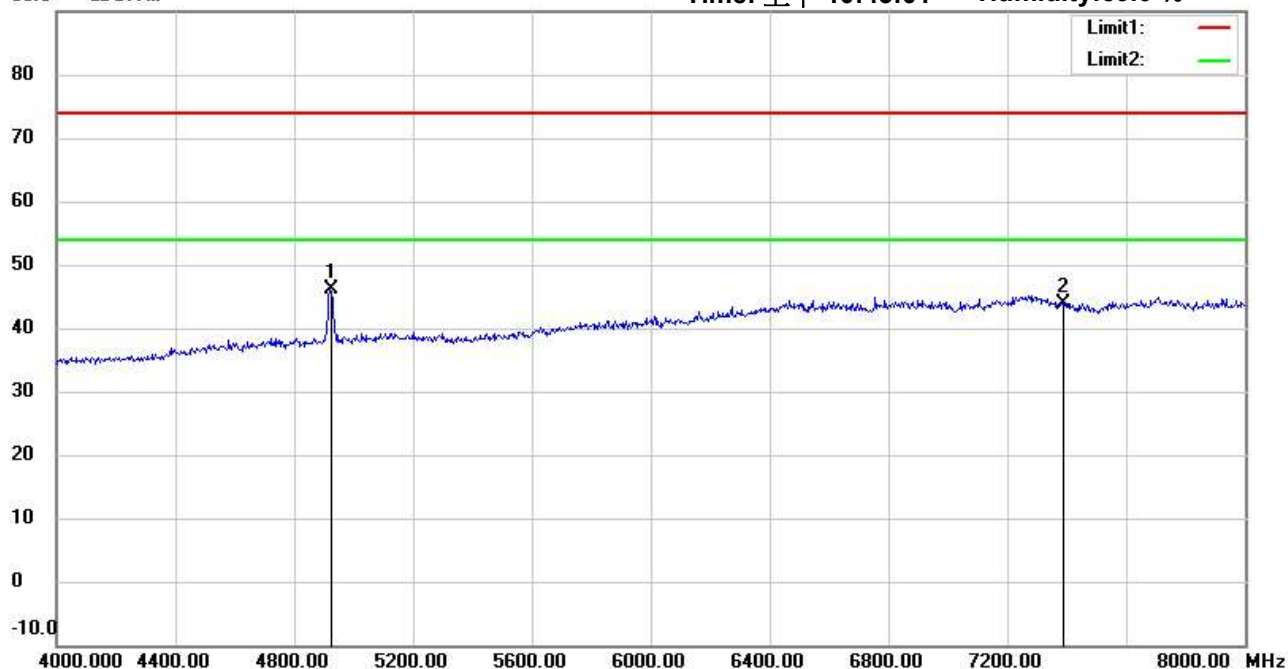
Test Mode : TX 802.11g CH11

Polarization: **Horizontal**

| Mk. | Frequency (MHz) | Reading (dBuV) | Detector | Corr. factor (dB/m) | Result (dBuV/m) | Limit (dBuV/m) | Ant.Pos (cm) | Tab.Pos (deg.) | Margin (dB) | Comment |
|---|---|---|---|---|---|---|---|---|---|---|
| * | 4922.000 | 40.80 | peak | 5.37 | 46.17 | 74.00 | 150 | 24 | -27.83 | |
| | 7386.000 | 32.53 | peak | 11.39 | 43.92 | 74.00 | 150 | 26 | -30.08 | |

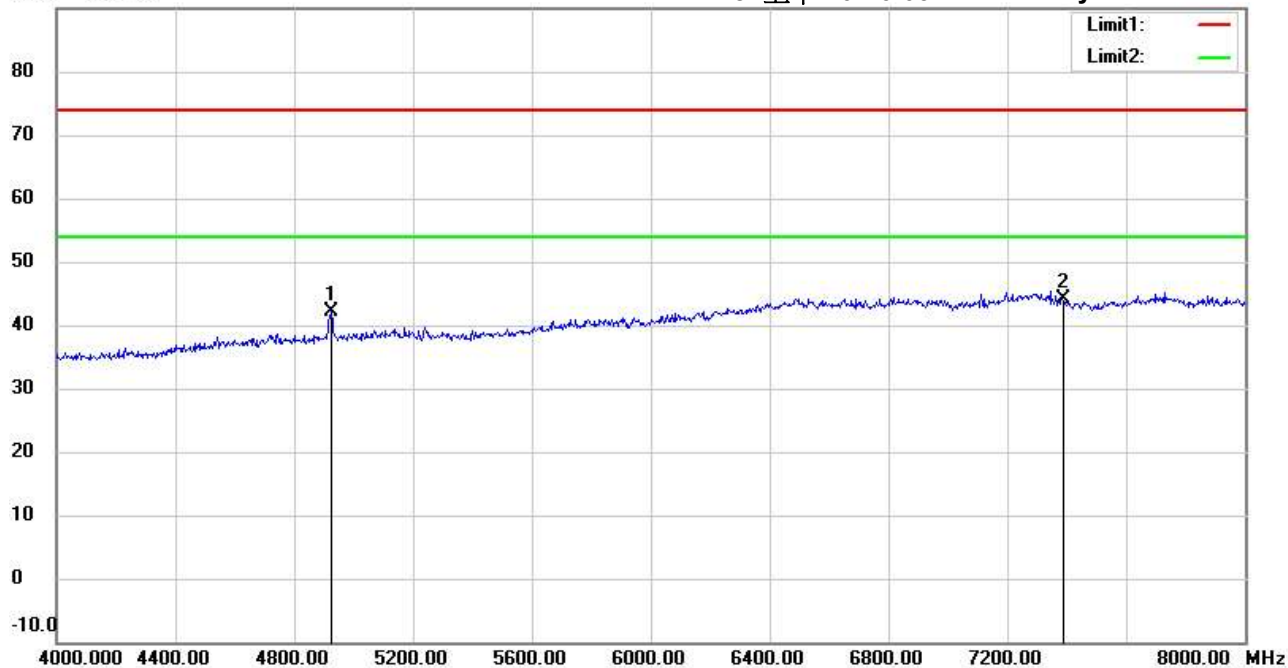
Test Mode : TX 802.11g CH11

Polarization: Vertical

| Mk. | Frequency (MHz) | Reading (dBuV) | Detector | Corr. factor (dB/m) | Result (dBuV/m) | Limit (dBuV/m) | Ant.Pos (cm) | Tab.Pos (deg.) | Margin (dB) | Comment |
|---|---|---|---|---|---|---|---|---|---|---|
| | 4924.000 | 36.69 | peak | 5.38 | 42.07 | 74.00 | 150 | 268 | -31.93 | |
| * | 7386.000 | 32.76 | peak | 11.39 | 44.15 | 74.00 | 150 | 216 | -29.85 | |

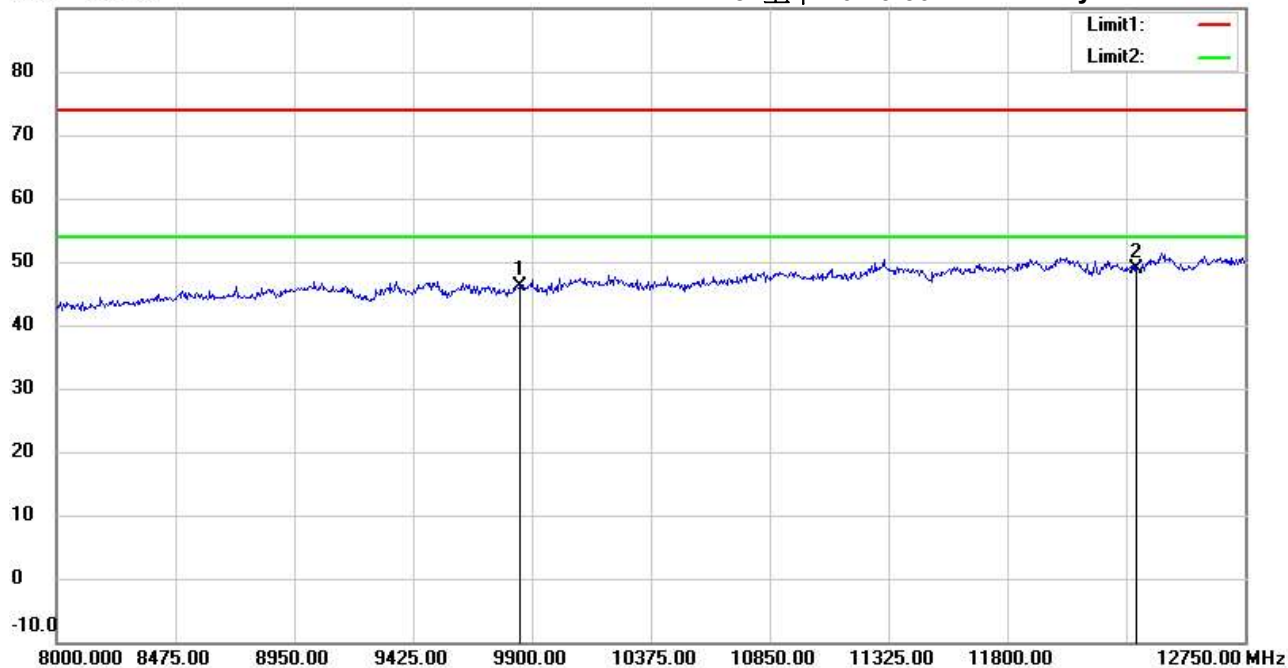
Test Mode : TX 802.11g CH11

Polarization: **Horizontal**

| Mk. | Frequency (MHz) | Reading (dBuV) | Detector | Corr. factor (dB/m) | Result (dBuV/m) | Limit (dBuV/m) | Ant.Pos (cm) | Tab.Pos (deg.) | Margin (dB) | Comment |
|---|---|---|---|---|---|---|---|---|---|---|
| | 9848.000 | 32.24 | peak | 13.97 | 46.21 | 74.00 | 150 | 254 | -27.79 | |
| * | 12310.000 | 32.28 | peak | 16.62 | 48.90 | 74.00 | 150 | 355 | -25.10 | |

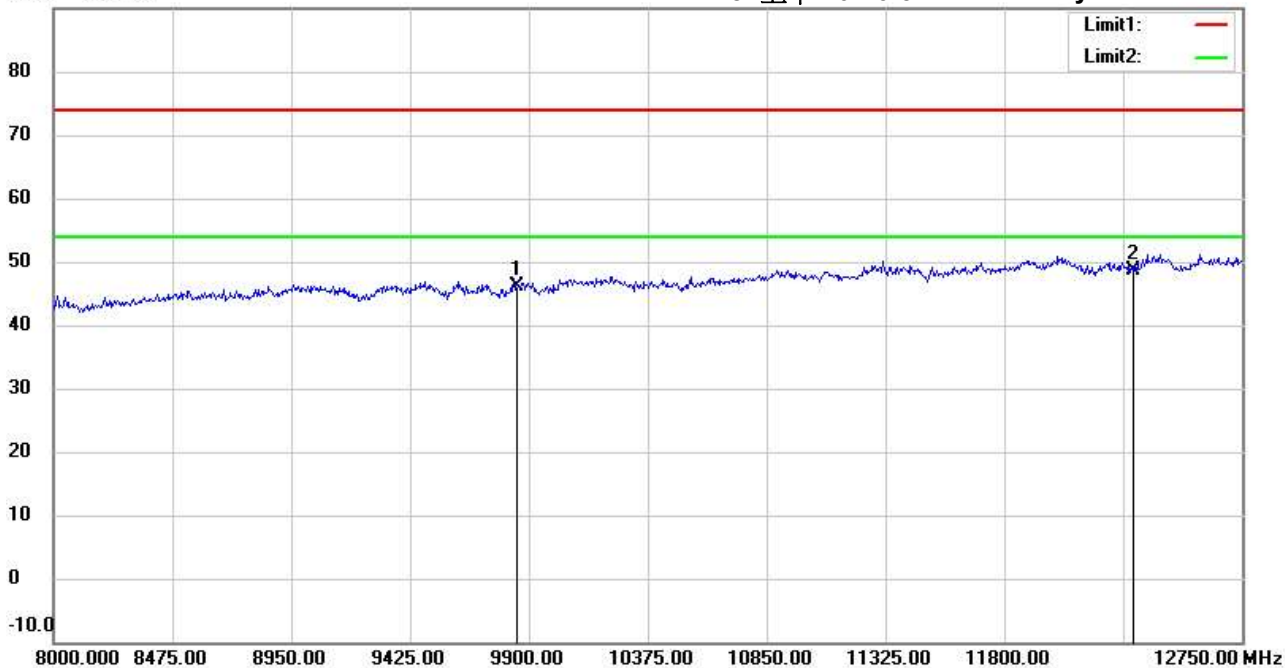
Test Mode : TX 802.11g CH11

Polarization: Vertical

| Mk. | Frequency (MHz) | Reading (dBuV) | Detector | Corr. factor (dB/m) | Result (dBuV/m) | Limit (dBuV/m) | Ant.Pos (cm) | Tab.Pos (deg.) | Margin (dB) | Comment |
|---|---|---|---|---|---|---|---|---|---|---|
| | 9848.000 | 32.22 | peak | 13.97 | 46.19 | 74.00 | 150 | 257 | -27.81 | |
| * | 12310.000 | 31.96 | peak | 16.62 | 48.58 | 74.00 | 150 | 51 | -25.42 | |

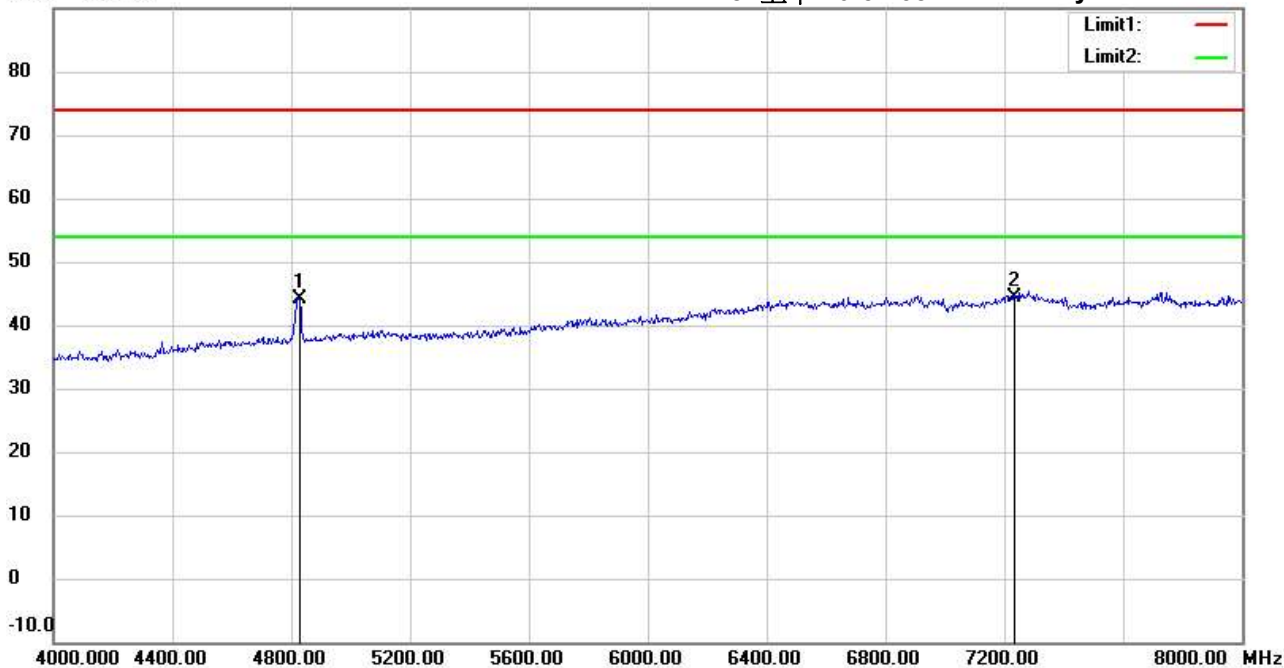
Test Mode : TX 802.11n20 CH1

Polarization: **Horizontal**

| Mk. | Frequency (MHz) | Reading (dBuV) | Detector | Corr. factor (dB/m) | Result (dBuV/m) | Limit (dBuV/m) | Ant.Pos (cm) | Tab.Pos (deg.) | Margin (dB) | Comment |
|---|---|---|---|---|---|---|---|---|---|---|
| | 4826.000 | 39.05 | peak | 5.09 | 44.14 | 74.00 | 150 | 30 | -29.86 | |
| * | 7236.000 | 32.84 | peak | 11.50 | 44.34 | 74.00 | 150 | 305 | -29.66 | |

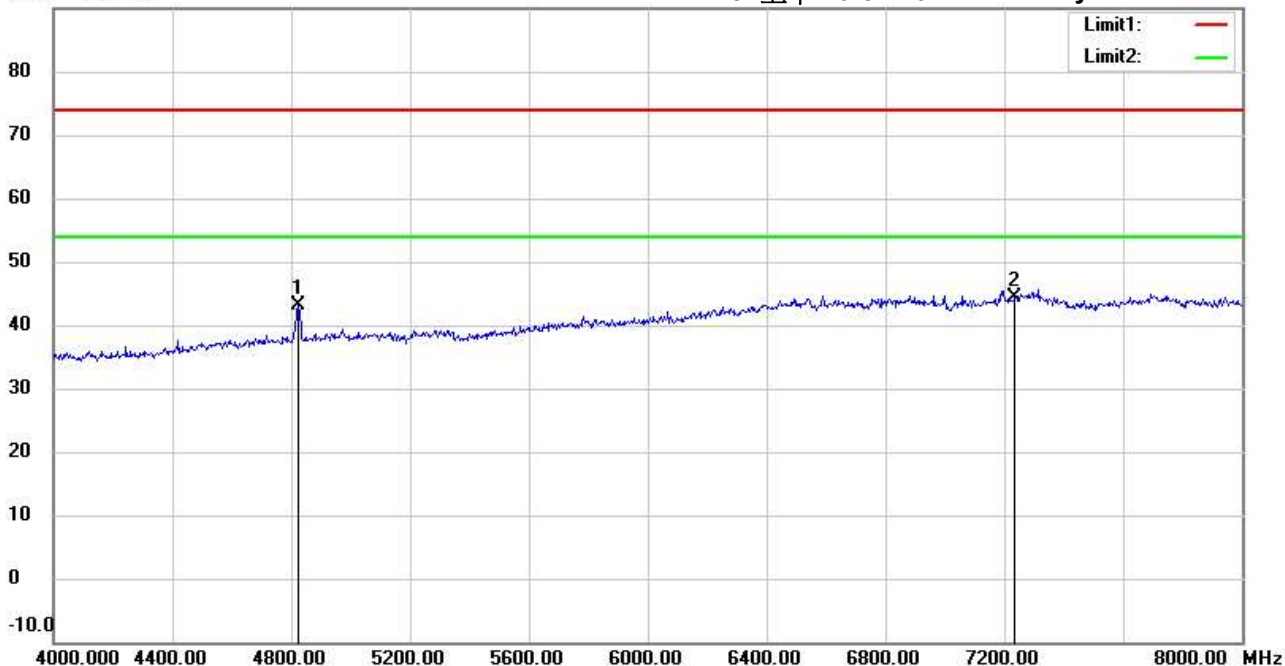
Test Mode : TX 802.11n20 CH1

Polarization: Vertical

| Mk. | Frequency (MHz) | Reading (dBuV) | Detector | Corr. factor (dB/m) | Result (dBuV/m) | Limit (dBuV/m) | Ant.Pos (cm) | Tab.Pos (deg.) | Margin (dB) | Comment |
|---|---|---|---|---|---|---|---|---|---|---|
| | 4824.000 | 38.04 | peak | 5.08 | 43.12 | 74.00 | 150 | 110 | -30.88 | |
| * | 7236.000 | 33.00 | peak | 11.50 | 44.50 | 74.00 | 150 | 333 | -29.50 | |

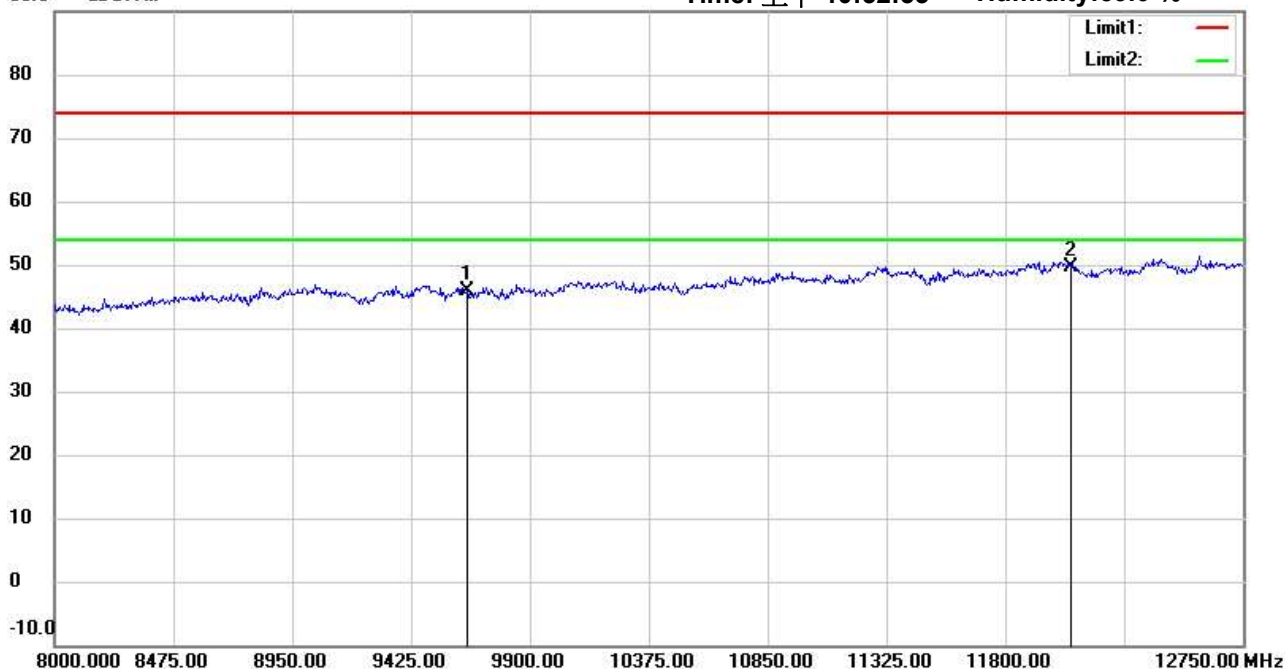
Test Mode : TX 802.11n20 CH1

Polarization: **Horizontal**

| Mk. | Frequency (MHz) | Reading (dBuV) | Detector | Corr. factor (dB/m) | Result (dBuV/m) | Limit (dBuV/m) | Ant.Pos (cm) | Tab.Pos (deg.) | Margin (dB) | Comment |
|---|---|---|---|---|---|---|---|---|---|---|
| | 9648.000 | 32.47 | peak | 13.44 | 45.91 | 74.00 | 150 | 32 | -28.09 | |
| * | 12060.000 | 32.65 | peak | 17.10 | 49.75 | 74.00 | 150 | 11 | -24.25 | |

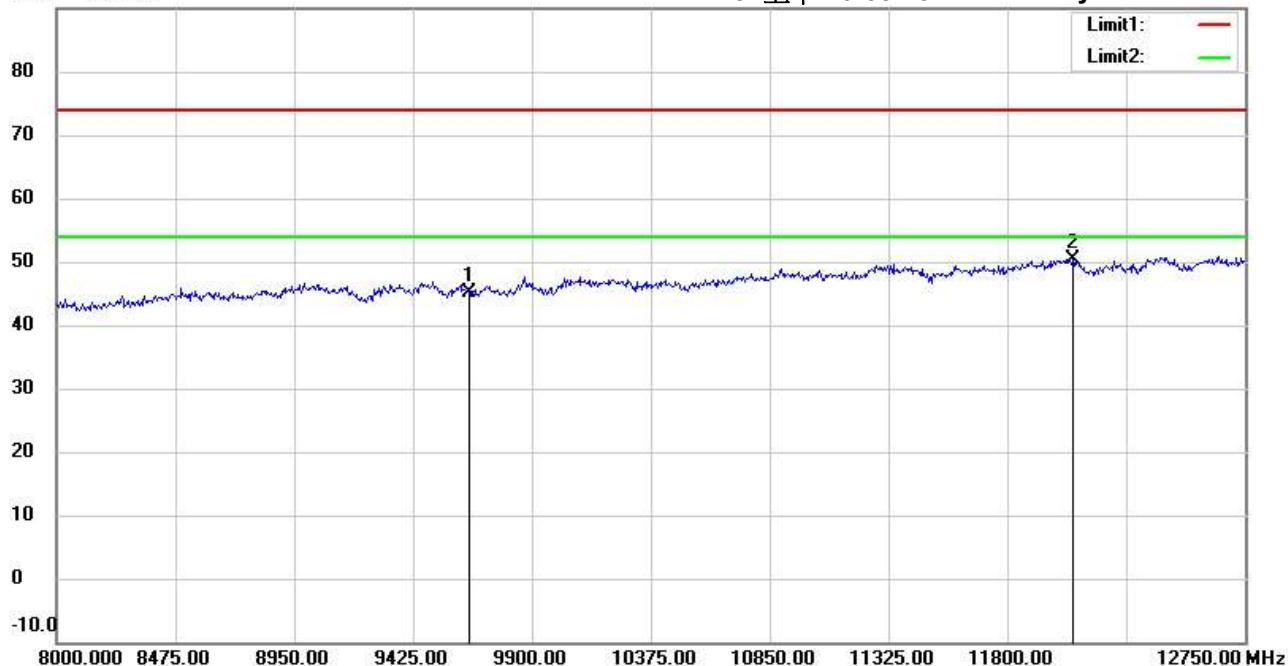
Test Mode : TX 802.11n20 CH1

Polarization: Vertical

| Mk. | Frequency (MHz) | Reading (dBuV) | Detector | Corr. factor (dB/m) | Result (dBuV/m) | Limit (dBuV/m) | Ant.Pos (cm) | Tab.Pos (deg.) | Margin (dB) | Comment |
|---|---|---|---|---|---|---|---|---|---|---|
| | 9648.000 | 31.67 | peak | 13.44 | 45.11 | 74.00 | 150 | 276 | -28.89 | |
| * | 12060.000 | 33.18 | peak | 17.10 | 50.28 | 74.00 | 150 | 350 | -23.72 | |
