## **RADIO TEST REPORT**

**Product** : **Payment Terminal**

**Model Name** : **M020**

**Test Regulation** : **FCC 47 CFR Part 15 Subpart C (Section 15.225)**

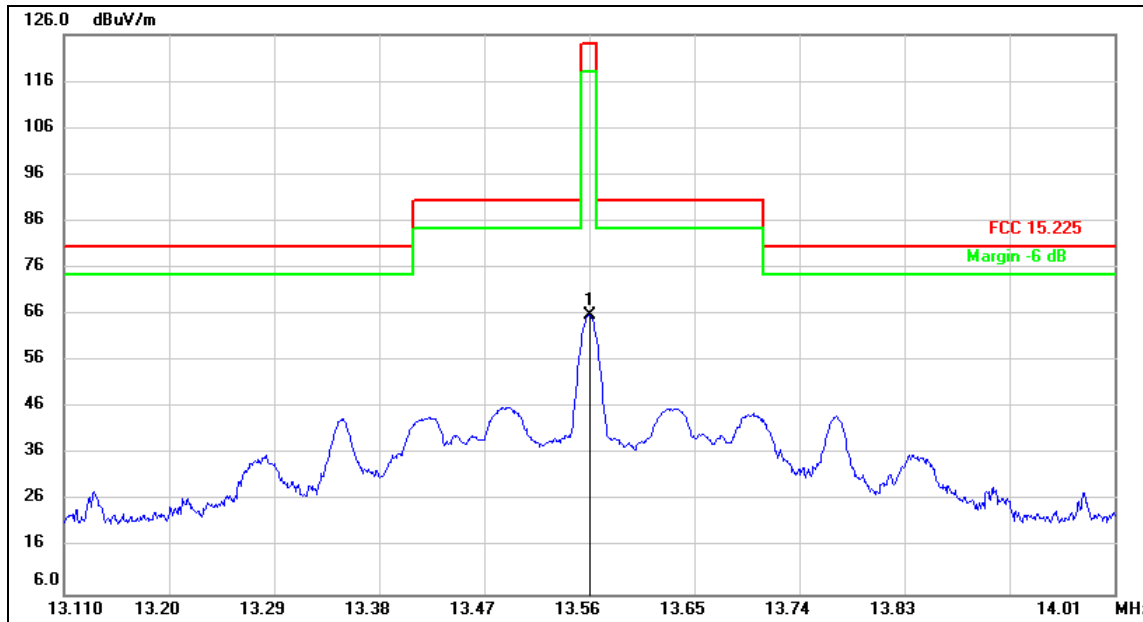
### Spectrum Mask 90 Degree

| No. | Frequency<br>(MHz) | Reading<br>(dBuV/m) | Correct<br>dB/m | Result<br>(dBuV/m) | Limit<br>(dBuV/m) | Margin<br>(dB) | Remark |
| 1 | 13.5601 | 54.35 | 11.45 | 65.80 | 124.00 | -58.20 | peak |

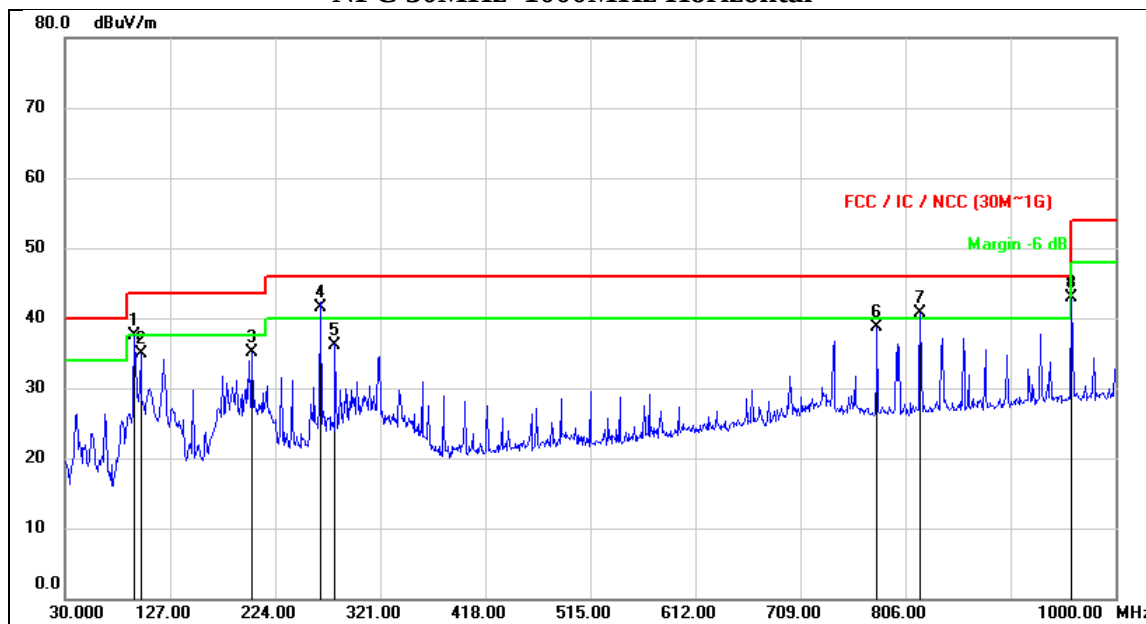
### NFC 30MHz~1000MHz Horizontal

| No. | Frequency<br>(MHz) | Reading<br>(dBuV/m) | Correct<br>dB/m | Result<br>(dBuV/m) | Limit<br>(dBuV/m) | Margin<br>(dB) | Remark |
| 1 | 94.8930 | 58.60 | -21.09 | 37.51 | 43.50 | -5.99 | peak |

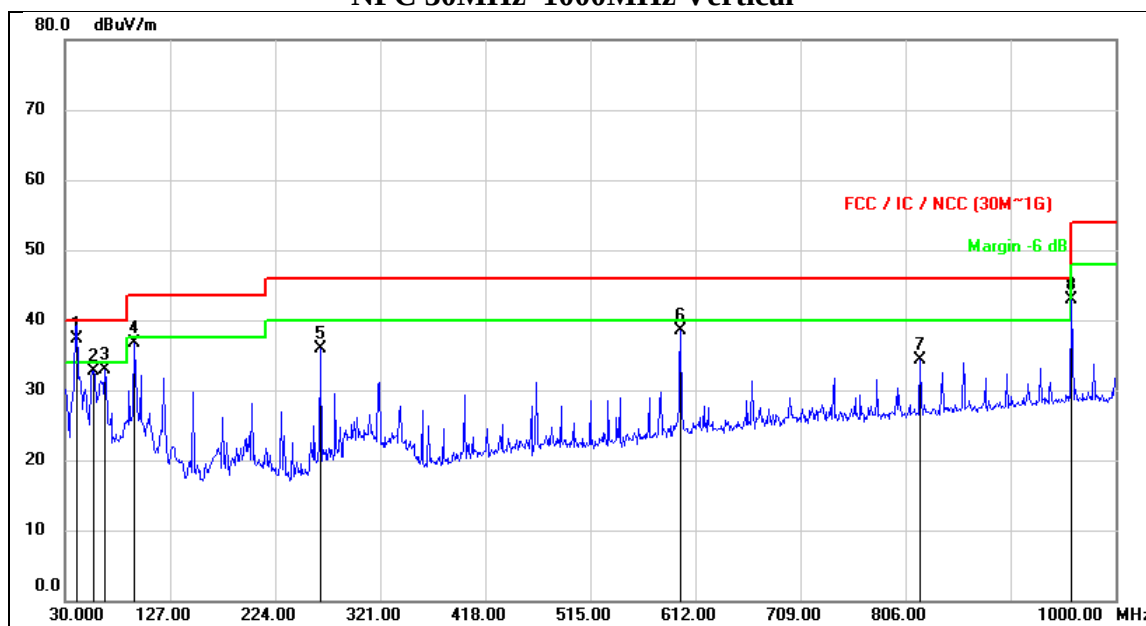
### NFC 30MHz~1000MHz Vertical

| No. | Frequency<br>(MHz) | Reading<br>(dBuV/m) | Correct<br>dB/m | Result<br>(dBuV/m) | Limit<br>(dBuV/m) | Margin<br>(dB) | Remark |
| 1 | 40.6699 | 52.95 | -15.72 | 37.23 | 40.00 | -2.77 | QP |

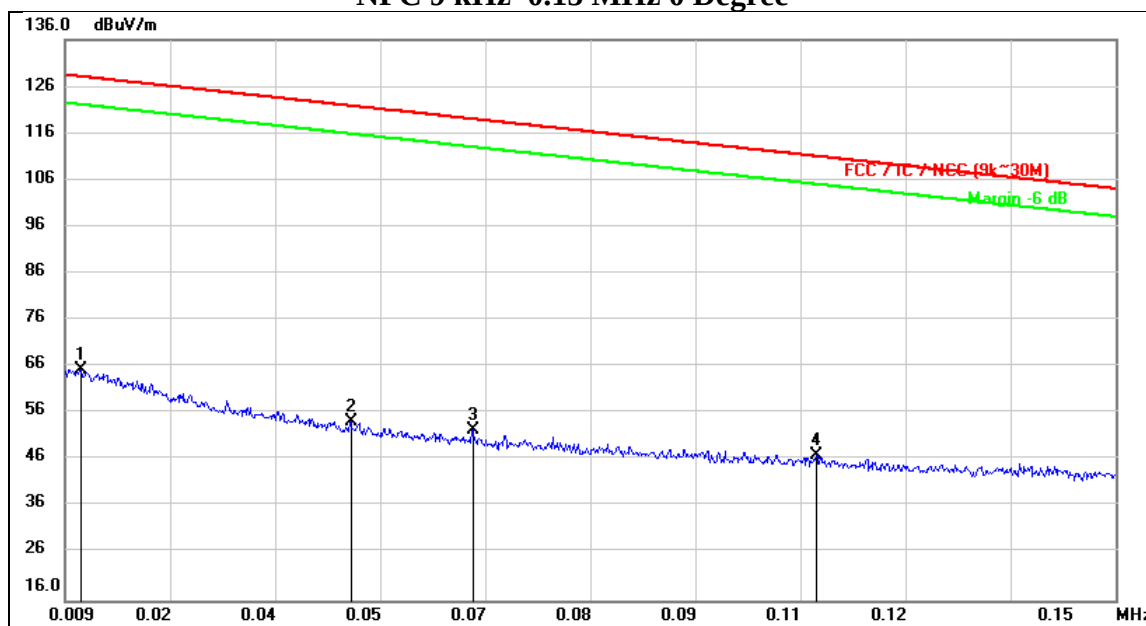
### NFC 9 kHz~0.15 MHz 0 Degree

| No. | Frequency (KHz) | Reading (dBuV/m) | Correct dB/m | Result (dBuV/m) | Limit (dBuV/m) | Margin (dB) | Remark |
| 1 | 0.0111 | 46.14 | 19.32 | 65.46 | 128.12 | -62.66 | peak |

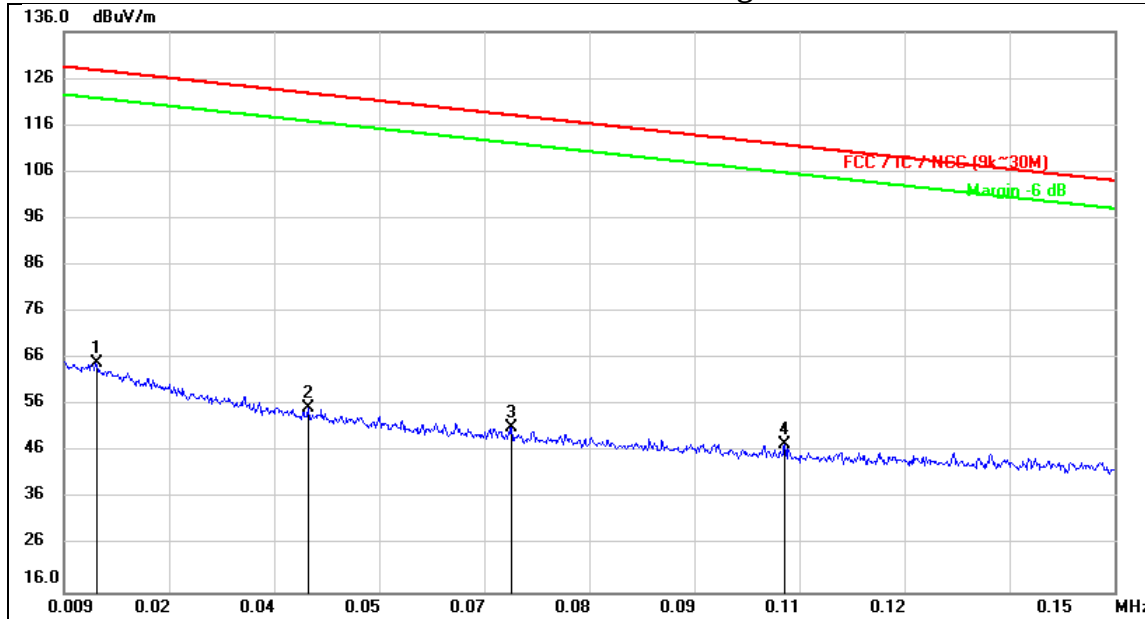
### NFC 9 kHz~0.15 MHz 90 Degree

| No. | Frequency<br>(KHz) | Reading<br>(dBuV/m) | Correct<br>dB/m | Result<br>(dBuV/m) | Limit<br>(dBuV/m) | Margin<br>(dB) | Remark |
| 1 | 0.0134 | 46.42 | 18.70 | 65.12 | 127.74 | -62.62 | peak |

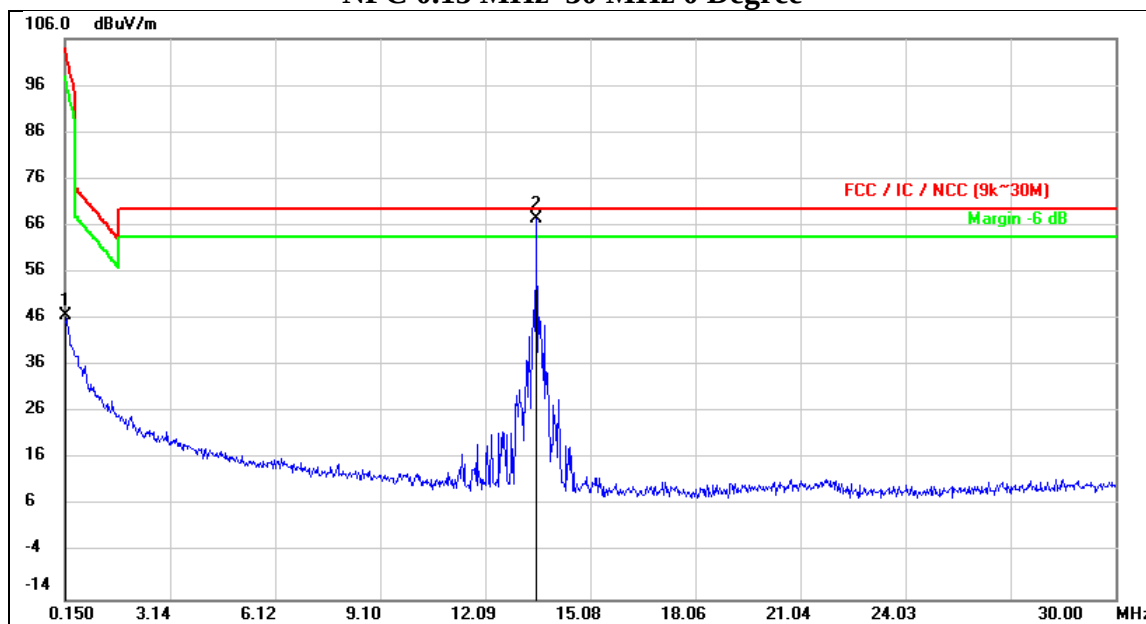
### NFC 0.15 MHz~30 MHz 0 Degree

| No. | Frequency<br>(MHz) | Reading<br>(dBuV/m) | Correct<br>dB/m | Result<br>(dBuV/m) | Limit<br>(dBuV/m) | Margin<br>(dB) | Remark |
| 1 | 0.1688 | 34.98 | 11.80 | 46.78 | 103.53 | -56.75 | peak |

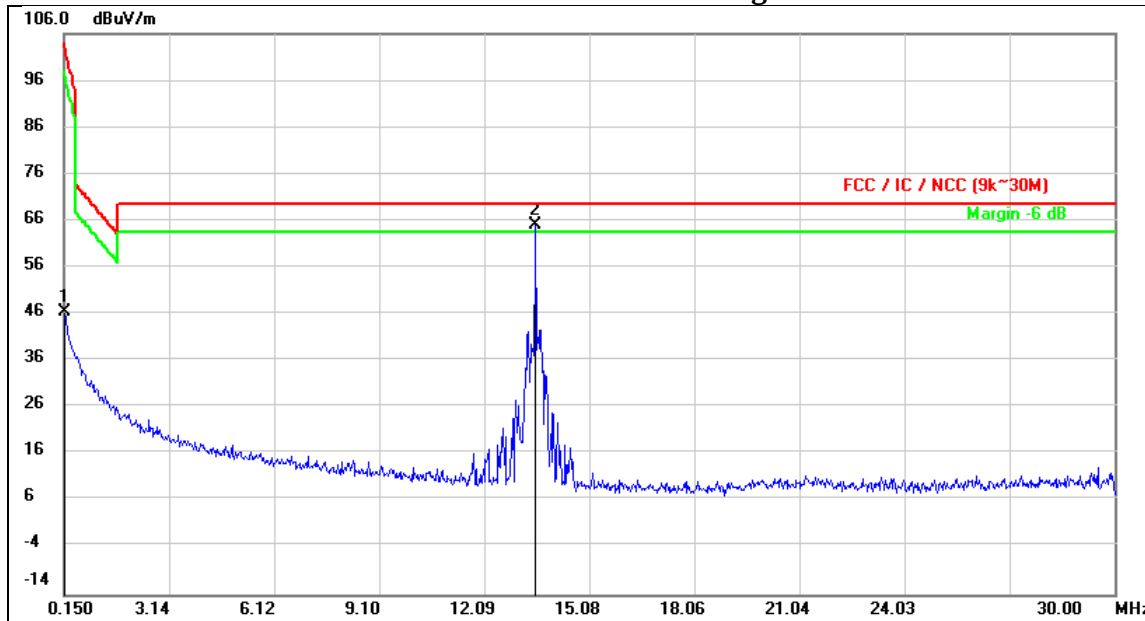
### NFC 0.15 MHz~30 MHz 90 Degree

| No. | Frequency<br>(MHz) | Reading<br>(dBuV/m) | Correct<br>dB/m | Result<br>(dBuV/m) | Limit<br>(dBuV/m) | Margin<br>(dB) | Remark |
| 1 | 0.1508 | 34.74 | 11.81 | 46.55 | 104.08 | -57.53 | peak |

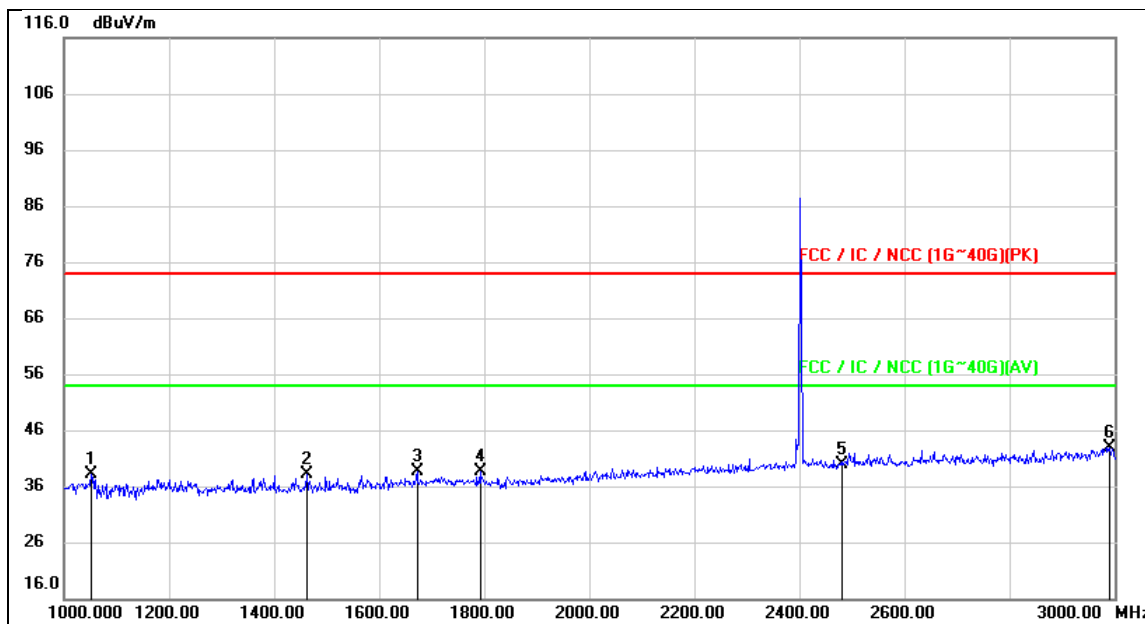
### Spurious Emission 1-3GHz Vertical

| No. | Frequency<br>(MHz) | Reading<br>(dBuV/m) | Correct<br>dB/m | Result<br>(dBuV/m) | Limit<br>(dBuV/m) | Margin<br>(dB) | Remark |
| 1 | 1053.600 | 51.20 | -12.97 | 38.23 | 74.00 | -35.77 | peak |

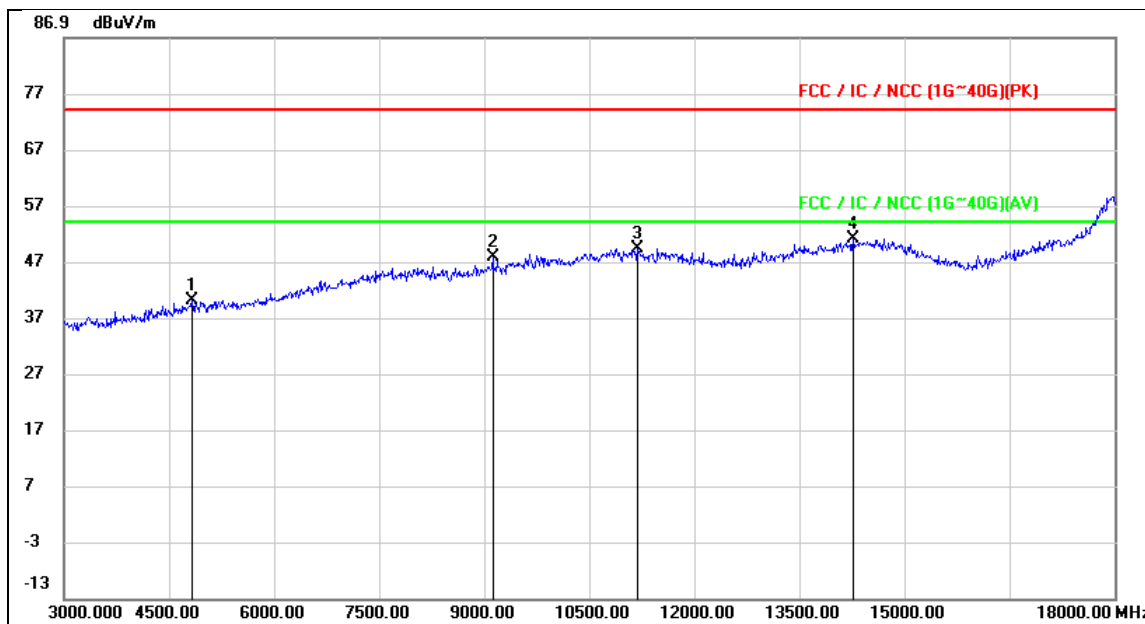
### Spurious Emission 3-18GHz Horizontal

| No. | Frequency<br>(MHz) | Reading<br>(dBuV/m) | Correct<br>dB/m | Result<br>(dBuV/m) | Limit<br>(dBuV/m) | Margin<br>(dB) | Remark |
| 1 | 4833.500 | 43.42 | -3.47 | 39.95 | 74.00 | -34.05 | peak |

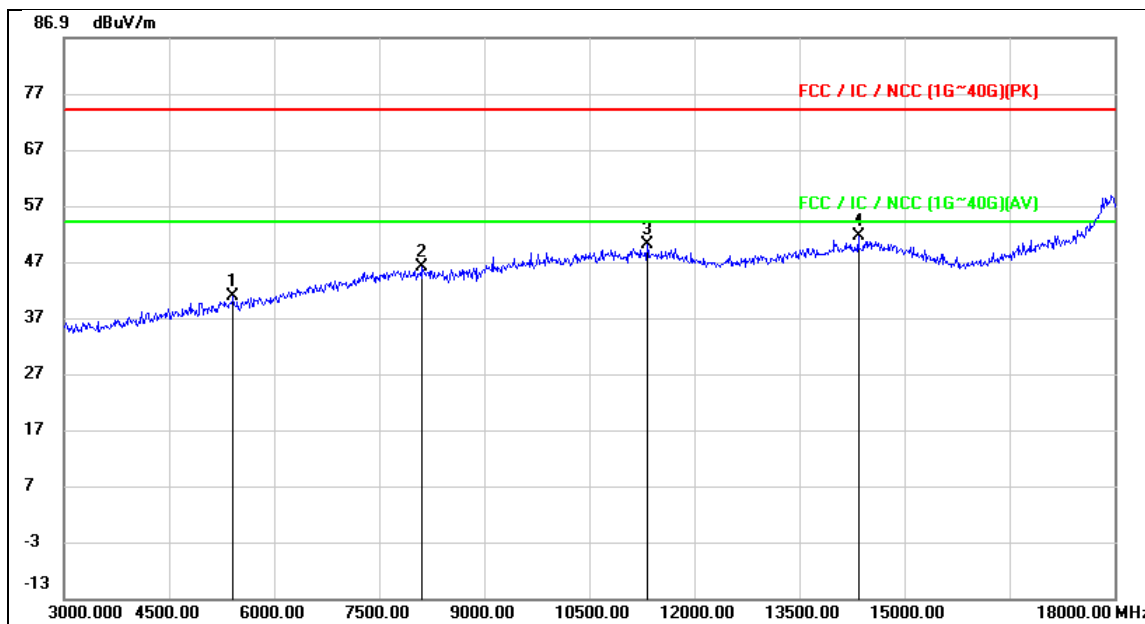
### Spurious Emission 3-18GHz Vertical

| No. | Frequency<br>(MHz) | Reading<br>(dBuV/m) | Correct<br>dB/m | Result<br>(dBuV/m) | Limit<br>(dBuV/m) | Margin<br>(dB) | Remark |
| 1 | 5422.000 | 43.45 | -2.76 | 40.69 | 74.00 | -33.31 | peak |

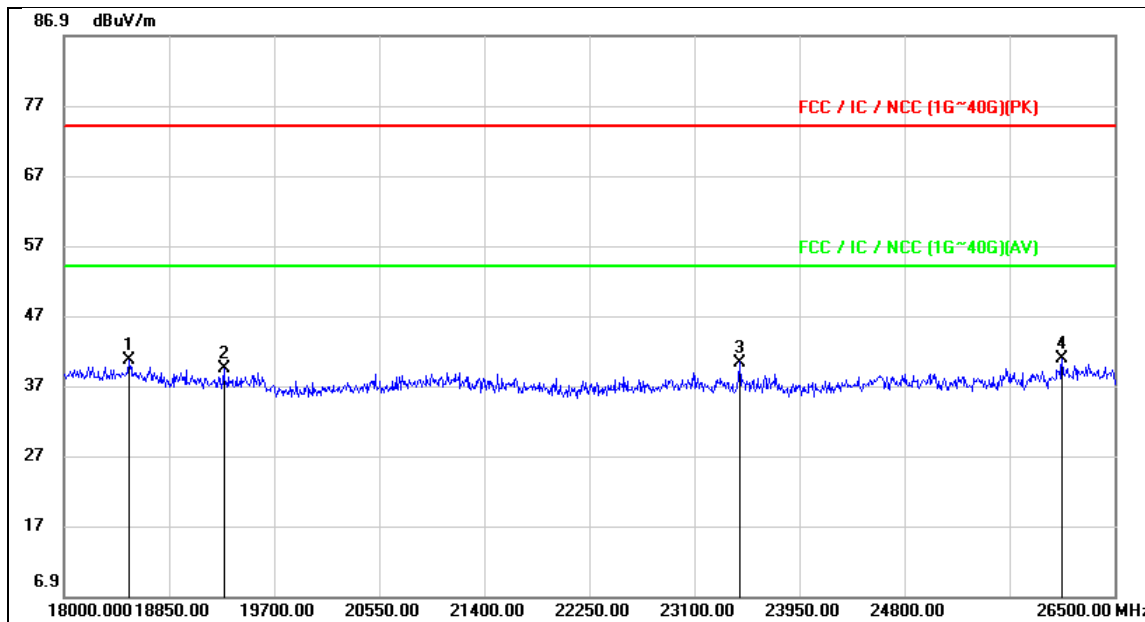
### Spurious Emission 18-25GHz Horizontal

| No. | Frequency<br>(MHz) | Reading<br>(dBuV/m) | Correct<br>dB/m | Result<br>(dBuV/m) | Limit<br>(dBuV/m) | Margin<br>(dB) | Remark |
| 1 | 18534.650 | 42.98 | -2.45 | 40.53 | 74.00 | -33.47 | peak |

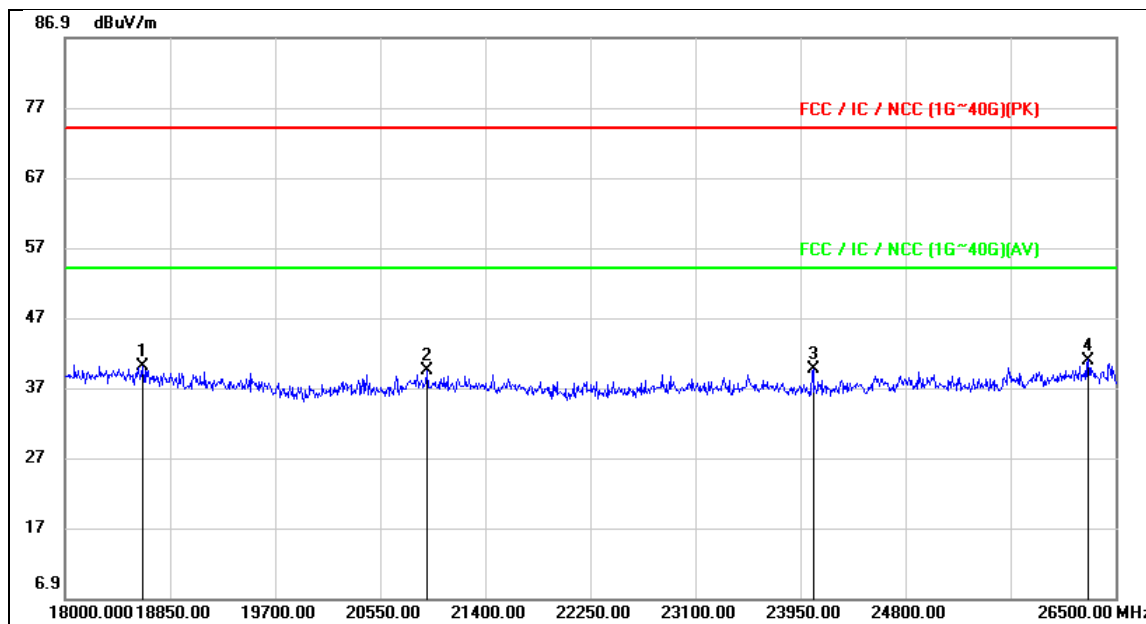
### Spurious Emission 18-25GHz Vertical

| No. | Frequency<br>(MHz) | Reading<br>(dBuV/m) | Correct<br>dB/m | Result<br>(dBuV/m) | Limit<br>(dBuV/m) | Margin<br>(dB) | Remark |
| 1 | 18631.833 | 42.51 | -2.54 | 39.97 | 74.00 | -34.03 | peak |

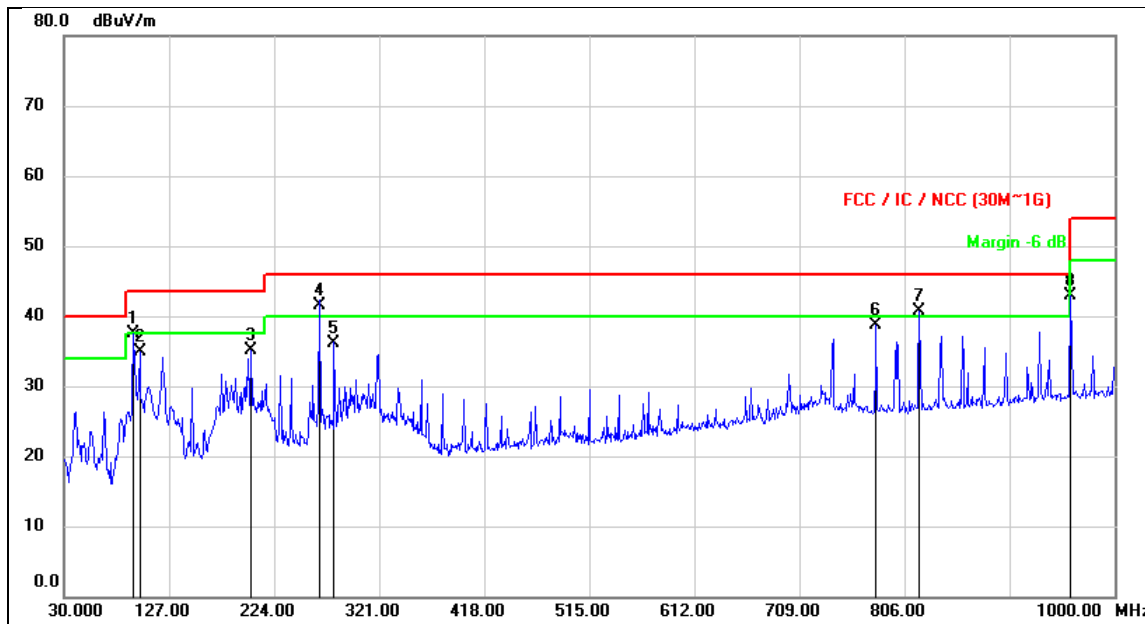
### Spurious Emission 30-1000MHz Horizontal

| No. | Frequency<br>(MHz) | Reading<br>(dBuV/m) | Correct<br>dB/m | Result<br>(dBuV/m) | Limit<br>(dBuV/m) | Margin<br>(dB) | Remark |
| 1 | 94.8930 | 58.60 | -21.09 | 37.51 | 43.50 | -5.99 | peak |

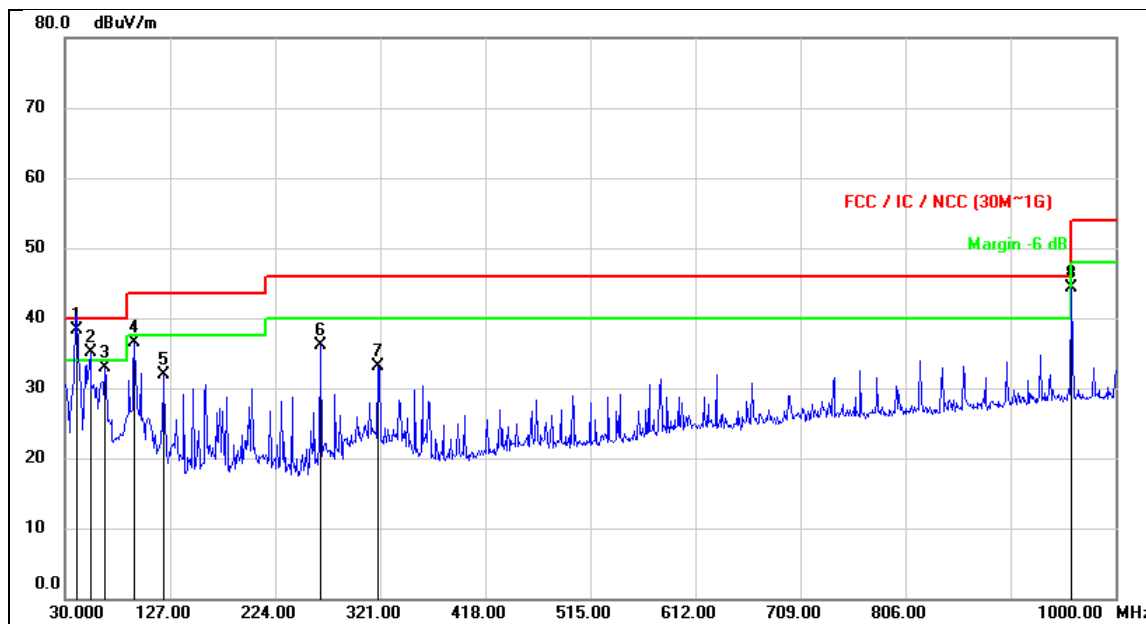
### Spurious Emission 30-1000MHz Vertical

| No. | Frequency (MHz) | Reading (dBuV/m) | Correct dB/m | Result (dBuV/m) | Limit (dBuV/m) | Margin (dB) | Remark |
| 1 | 40.6699 | 54.07 | -15.72 | 38.35 | 40.00 | -1.65 | QP |

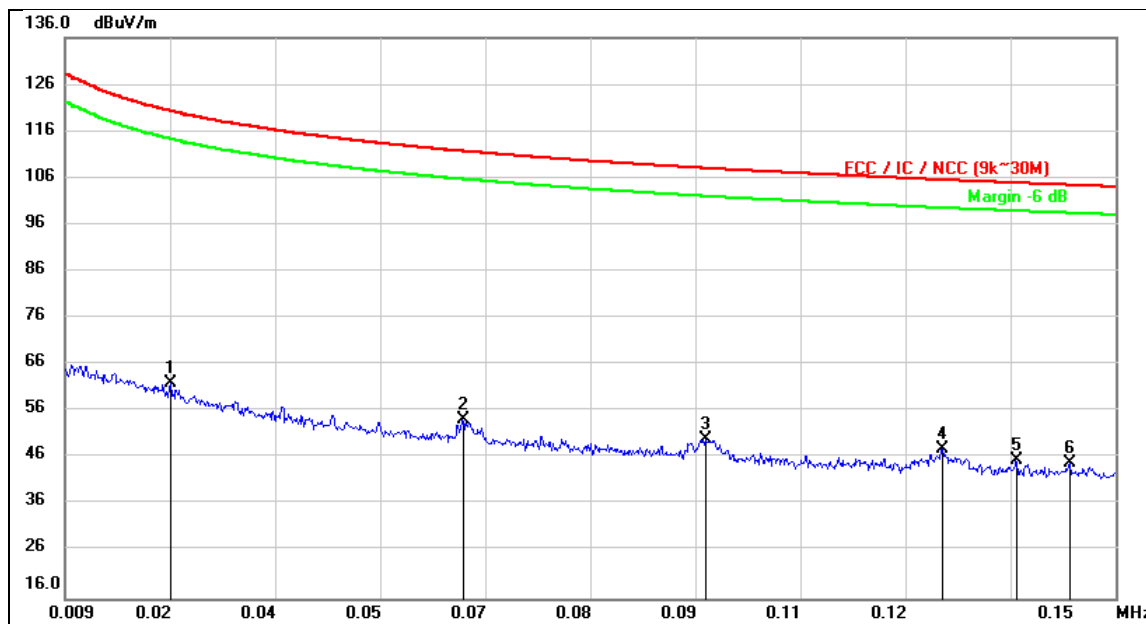
### Spurious Emission Worst case 9-150kHz 0°

| No. | Frequency (KHz) | Reading (dBuV/m) | Correct dB/m | Result (dBuV/m) | Limit (dBuV/m) | Margin (dB) | Remark |
| 1 | 0.0232 | 45.85 | 16.20 | 62.05 | 120.34 | -58.29 | peak |

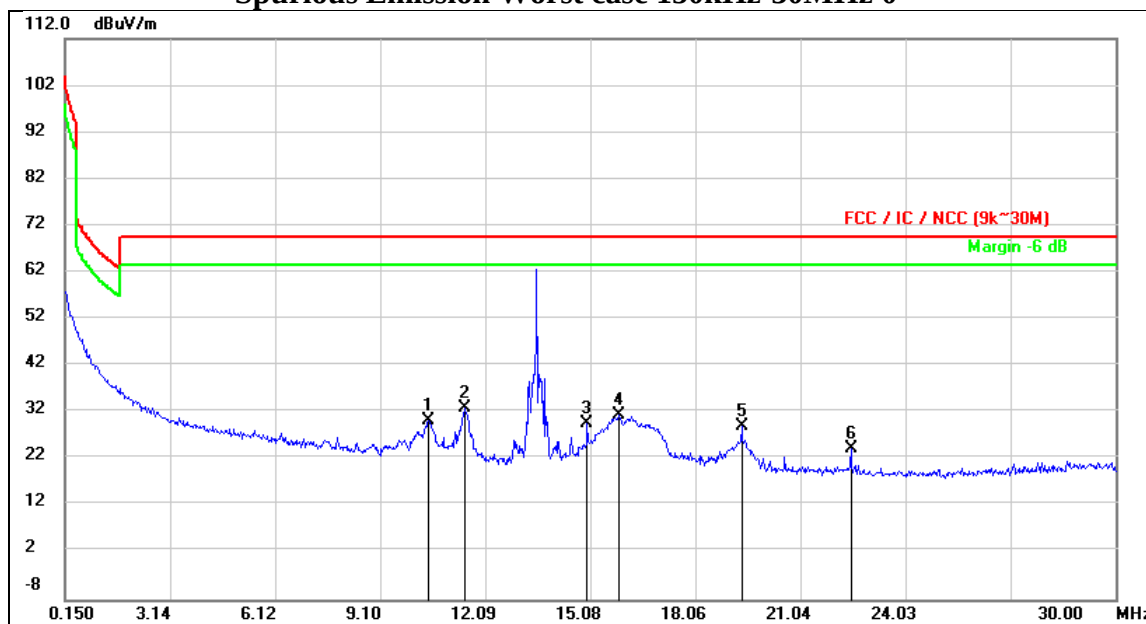
### Spurious Emission Worst case 150kHz-30MHz 0°

| No. | Frequency<br>(MHz) | Reading<br>(dBuV/m) | Correct<br>dB/m | Result<br>(dBuV/m) | Limit<br>(dBuV/m) | Margin<br>(dB) | Remark |
| 1 | 10.5079 | 18.58 | 11.64 | 30.22 | 69.54 | -39.32 | peak |

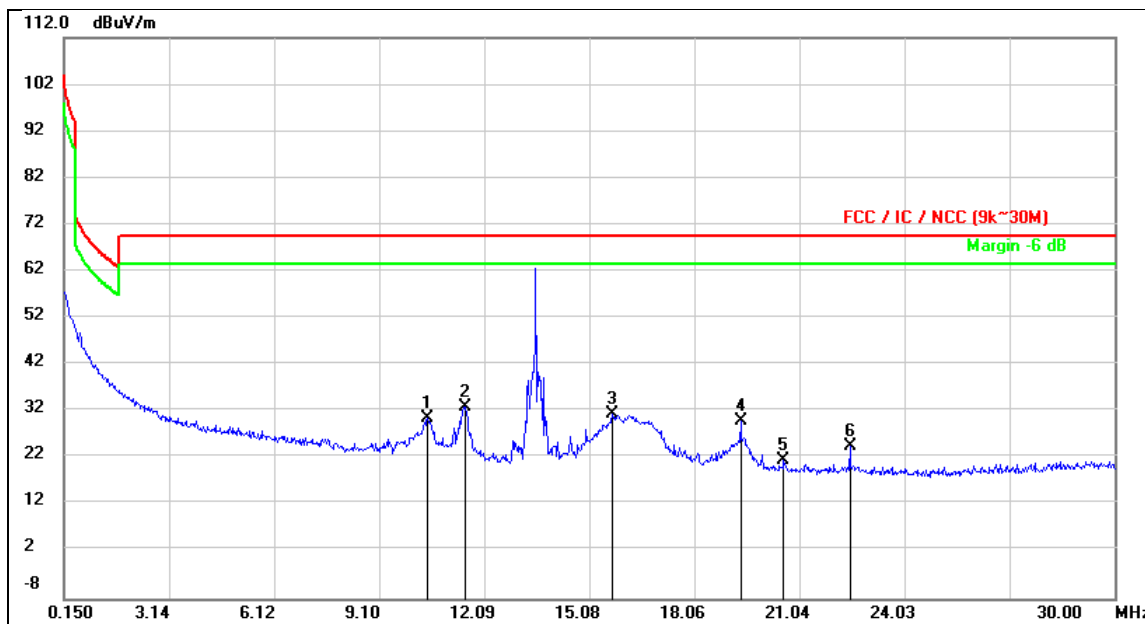
### Spurious Emission Worst case 150kHz-30MHz 90°

| No. | Frequency<br>(MHz) | Reading<br>(dBuV/m) | Correct<br>dB/m | Result<br>(dBuV/m) | Limit<br>(dBuV/m) | Margin<br>(dB) | Remark |
| 1 | 10.5000 | 18.98 | 11.64 | 30.62 | 69.54 | -38.92 | peak |

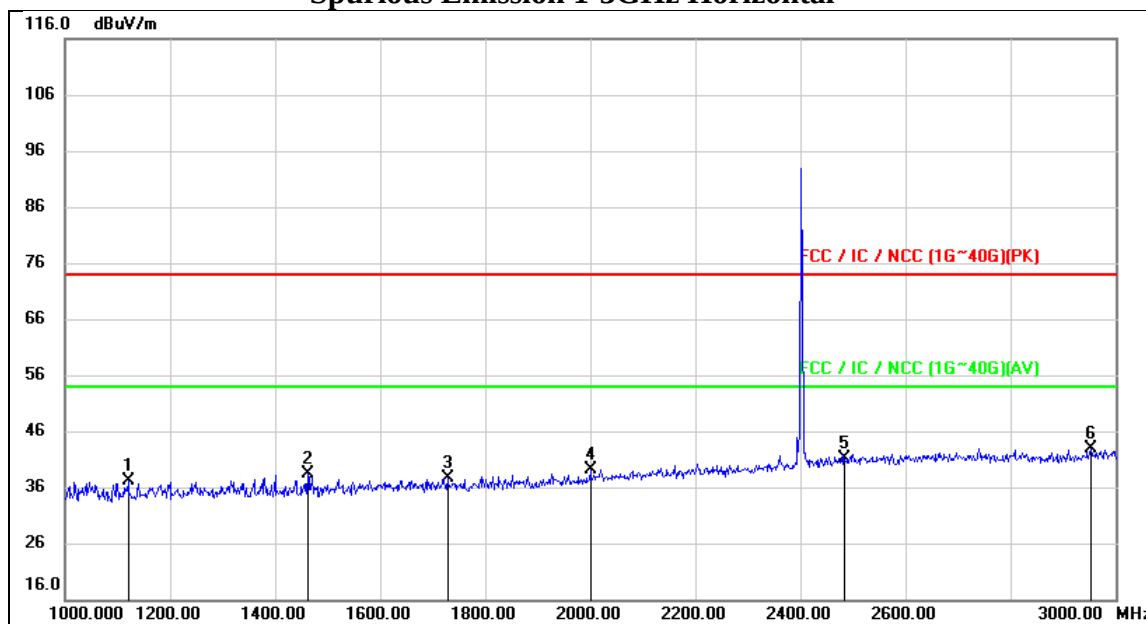
**Co-location (BT + NFC)  
Spurious Emission 1-3GHz Horizontal**

| No. | Frequency<br>(MHz) | Reading<br>(dBuV/m) | Correct<br>dB/m | Result<br>(dBuV/m) | Limit<br>(dBuV/m) | Margin<br>(dB) | Remark |
| 1 | 1120.467 | 49.75 | -12.72 | 37.03 | 74.00 | -36.97 | peak |

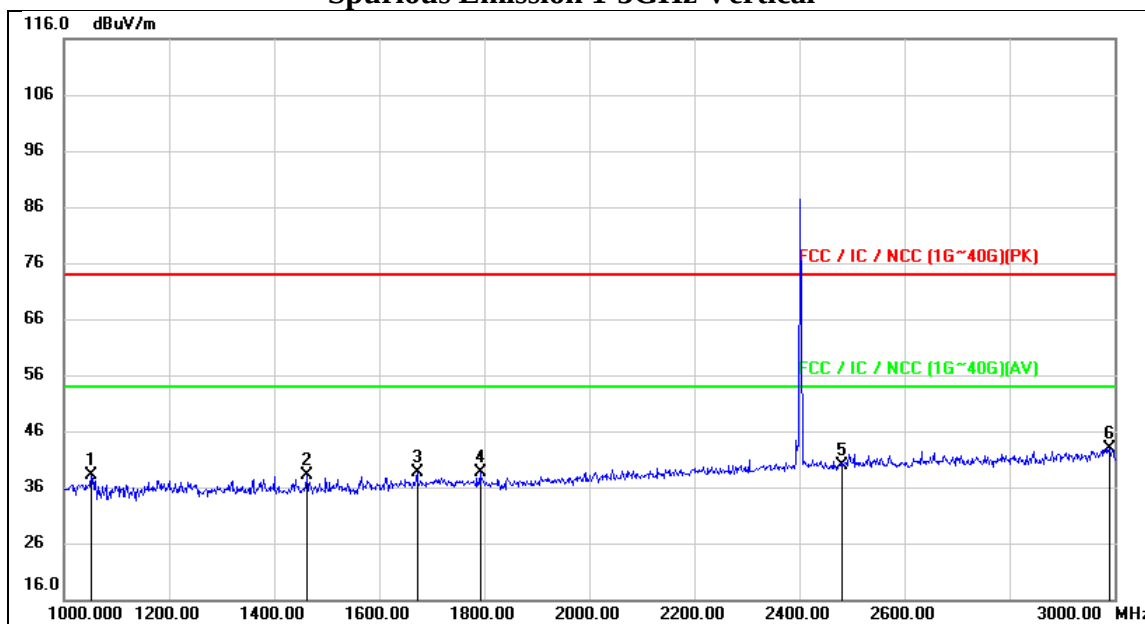
### Spurious Emission 1-3GHz Vertical

| No. | Frequency<br>(MHz) | Reading<br>(dBuV/m) | Correct<br>dB/m | Result<br>(dBuV/m) | Limit<br>(dBuV/m) | Margin<br>(dB) | Remark |
| 1 | 1053.600 | 51.20 | -12.97 | 38.23 | 74.00 | -35.77 | peak |

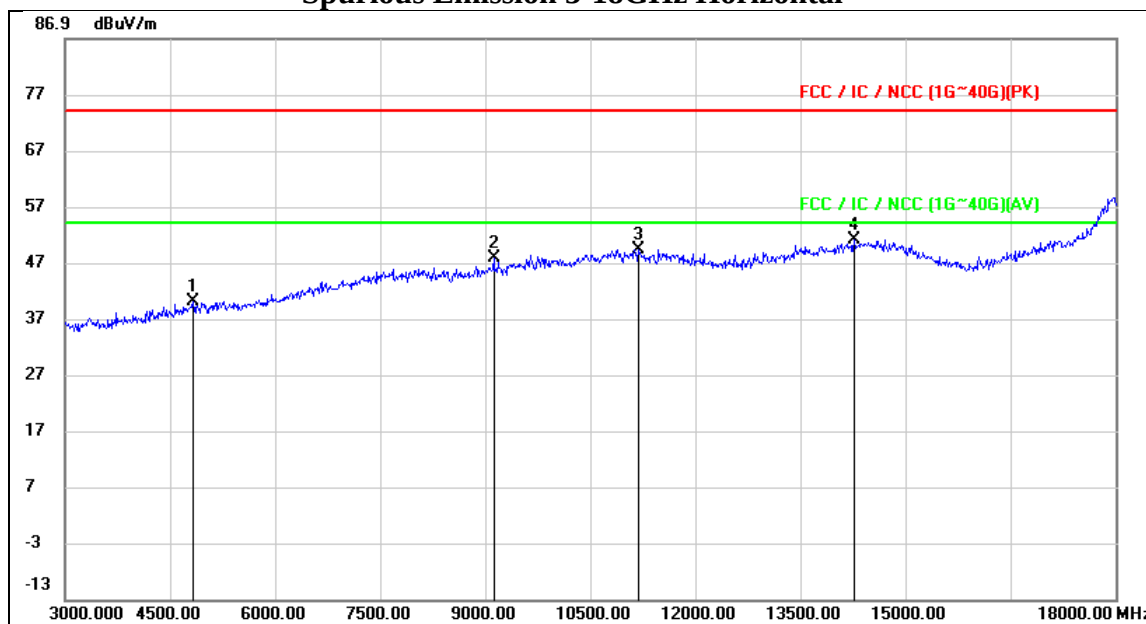
### Spurious Emission 3-18GHz Horizontal

| No. | Frequency<br>(MHz) | Reading<br>(dBuV/m) | Correct<br>dB/m | Result<br>(dBuV/m) | Limit<br>(dBuV/m) | Margin<br>(dB) | Remark |
| 1 | 4833.500 | 43.42 | -3.47 | 39.95 | 74.00 | -34.05 | peak |

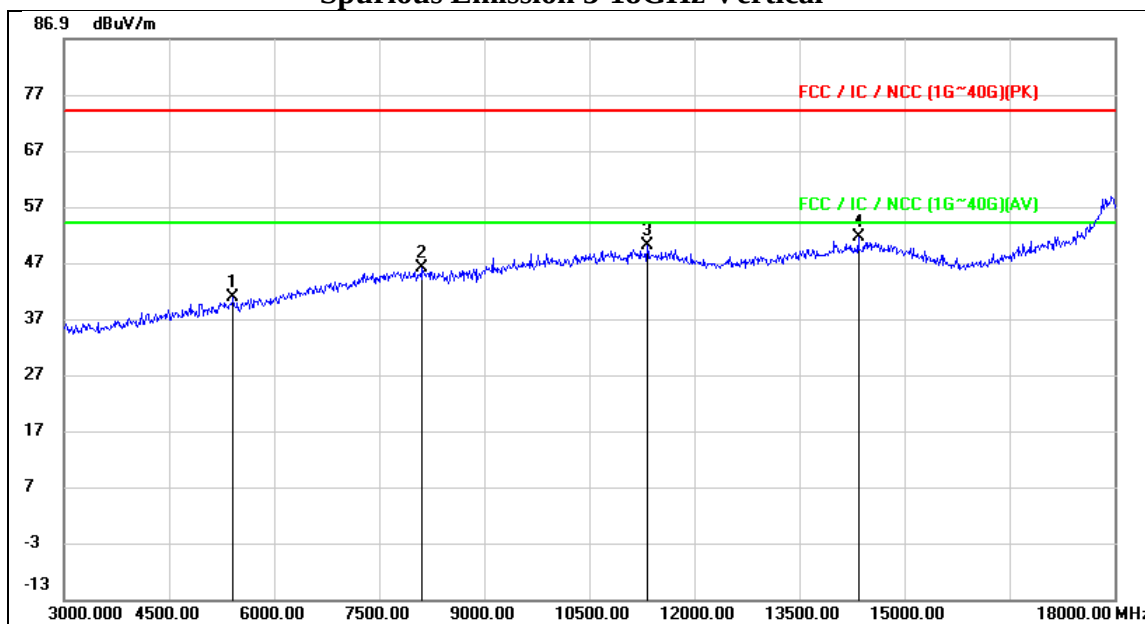
### Spurious Emission 3-18GHz Vertical

| No. | Frequency<br>(MHz) | Reading<br>(dBuV/m) | Correct<br>dB/m | Result<br>(dBuV/m) | Limit<br>(dBuV/m) | Margin<br>(dB) | Remark |
| 1 | 5422.000 | 43.45 | -2.76 | 40.69 | 74.00 | -33.31 | peak |

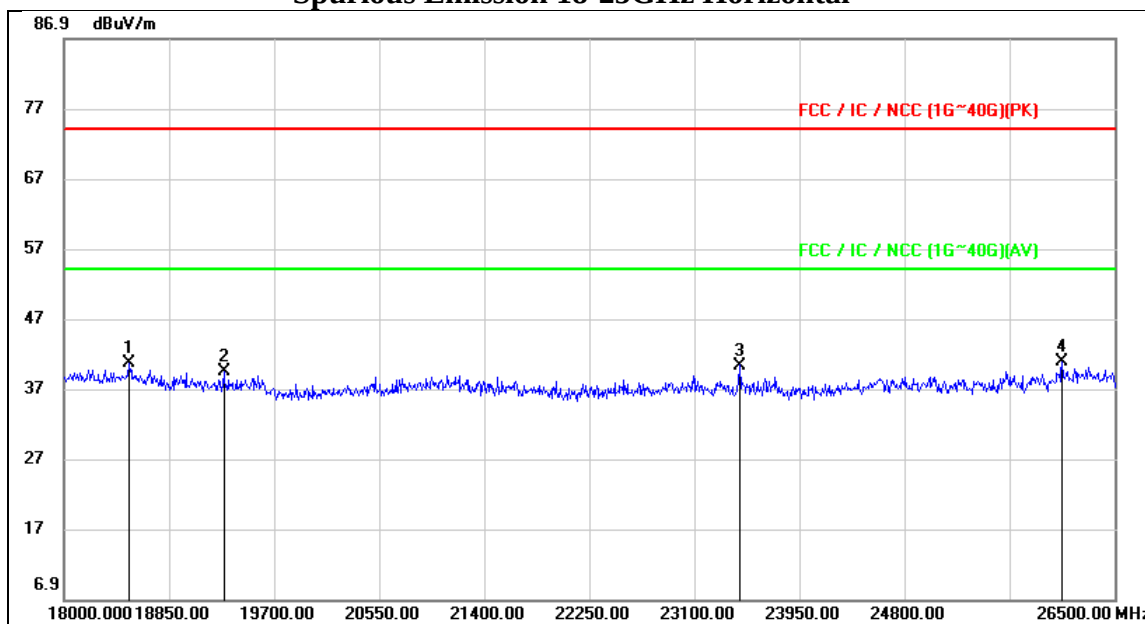
### Spurious Emission 18-25GHz Horizontal

| No. | Frequency<br>(MHz) | Reading<br>(dBuV/m) | Correct<br>dB/m | Result<br>(dBuV/m) | Limit<br>(dBuV/m) | Margin<br>(dB) | Remark |
| 1 | 18534.650 | 42.98 | -2.45 | 40.53 | 74.00 | -33.47 | peak |

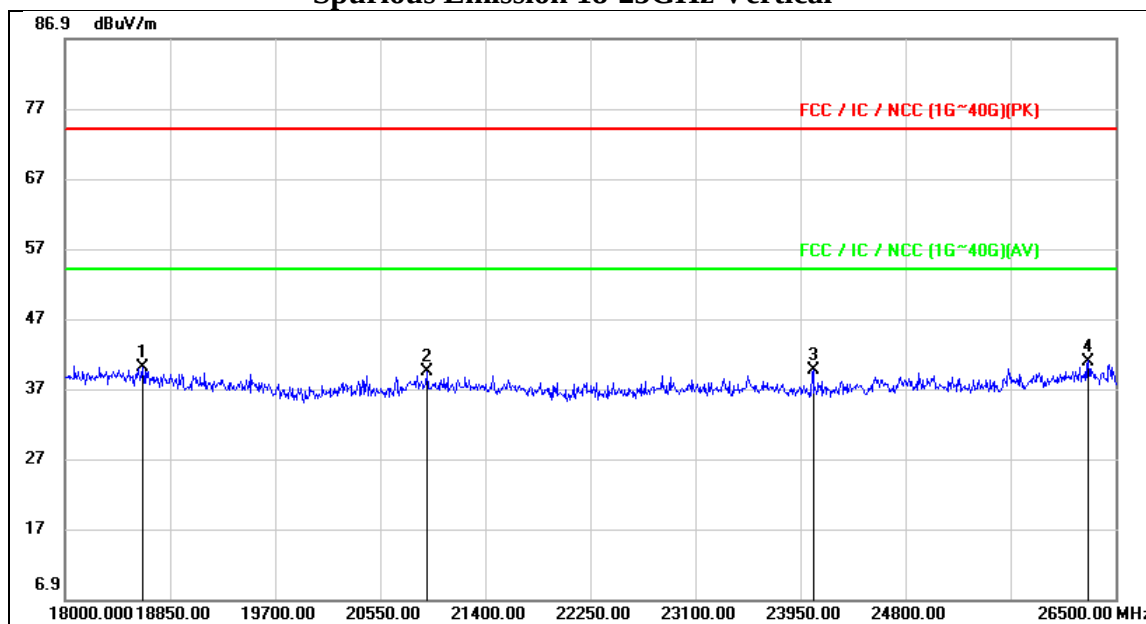
### Spurious Emission 18-25GHz Vertical

| No. | Frequency<br>(MHz) | Reading<br>(dBuV/m) | Correct<br>dB/m | Result<br>(dBuV/m) | Limit<br>(dBuV/m) | Margin<br>(dB) | Remark |
| 1 | 18631.833 | 42.51 | -2.54 | 39.97 | 74.00 | -34.03 | peak |

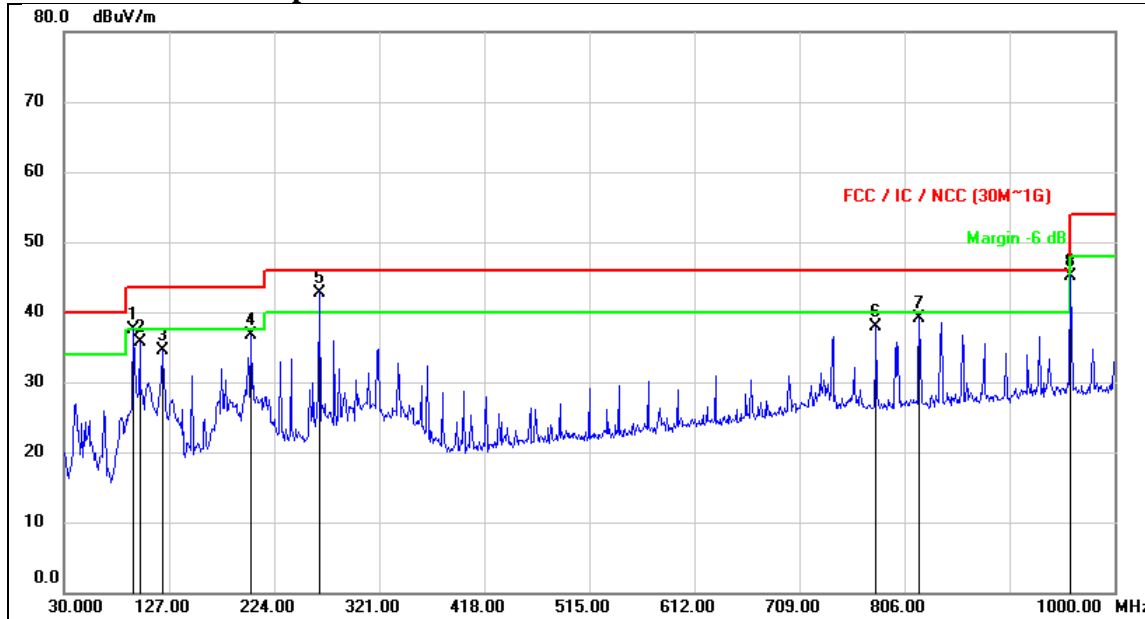
### Spurious Emission 30-1000MHz Horizontal

| No. | Frequency<br>(MHz) | Reading<br>(dBuV/m) | Correct<br>dB/m | Result<br>(dBuV/m) | Limit<br>(dBuV/m) | Margin<br>(dB) | Remark |
| 1 | 94.8930 | 58.60 | -21.09 | 37.51 | 43.50 | -5.99 | peak |

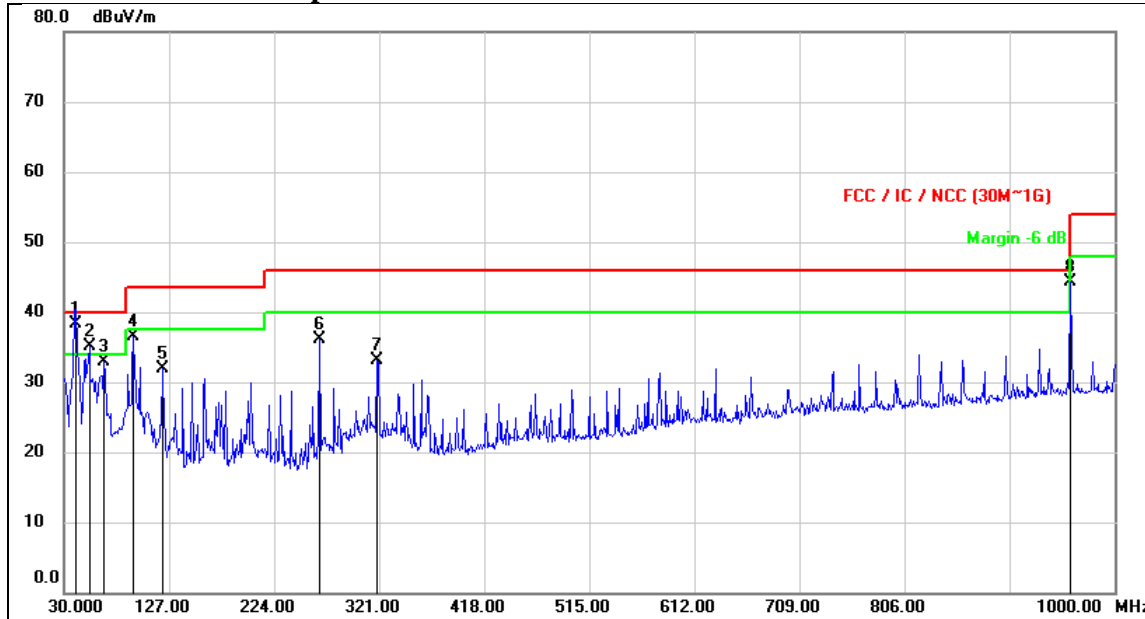
### Spurious Emission 30-1000MHz Vertical

| No. | Frequency<br>(MHz) | Reading<br>(dBuV/m) | Correct<br>dB/m | Result<br>(dBuV/m) | Limit<br>(dBuV/m) | Margin<br>(dB) | Remark |
| 1 | 40.6699 | 54.07 | -15.72 | 38.35 | 40.00 | -1.65 | QP |

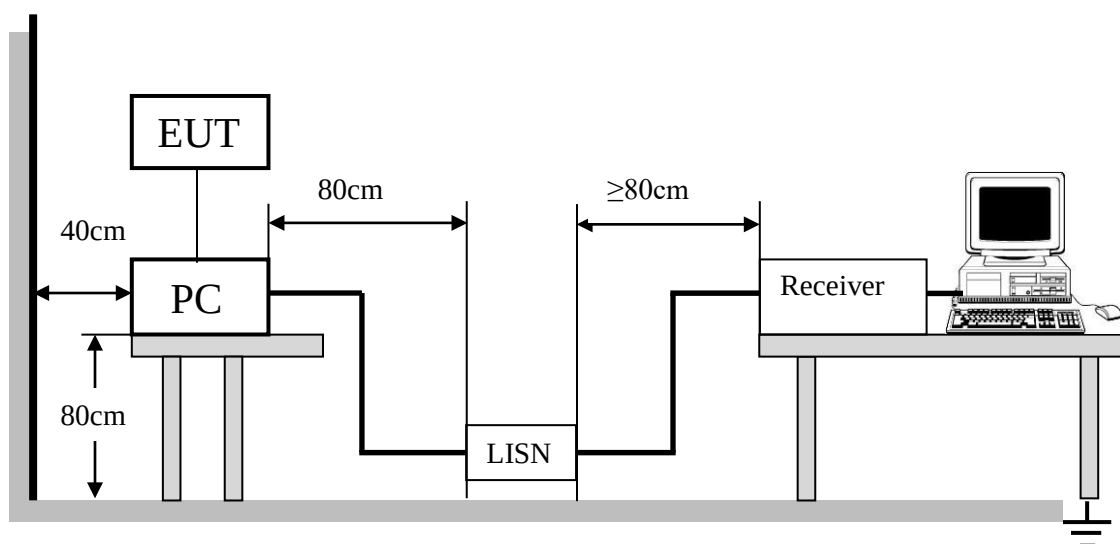
### Test Procedures

The EUT was put on a table of non-conducting material that was 80cm high. The vertical conducting wall of shielding was located 40cm to the rear of the EUT. The power line of the EUT was connected to the AC mains through a Artificial Mains Network (A.M.N.). A EMI Measurement Receiver (R&S Test Receiver ESR3) was used to test the emissions from both sides of AC line. According to the requirements in Section 6.2 of ANSI C63.10 - 2013. Conducted emissions from the EUT measured in the frequency range between 0.15 MHz and 30MHz using CISPR Quasi-Peak and average detector mode. The bandwidth of EMI test receiver was set at 9kHz.

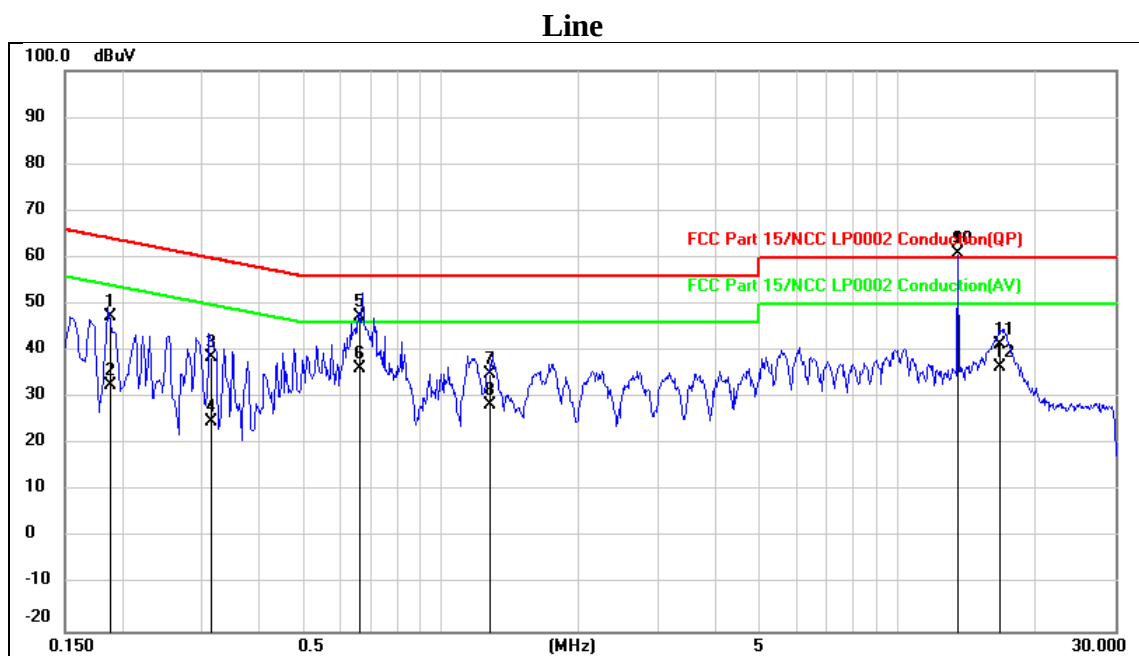
Perform the AC power-line conducted tests with the NFC antenna connected to determine compliance.

| No. | Frequency<br>(MHz) | Reading<br>(dBuV) | Correct<br>dB | Result<br>(dBuV) | Limit<br>(dBuV) | Margin<br>(dB) | Remark |
