## 5 Photographs of the Test Set-Up

**Prüfbericht - Nr.: 60383298 001**

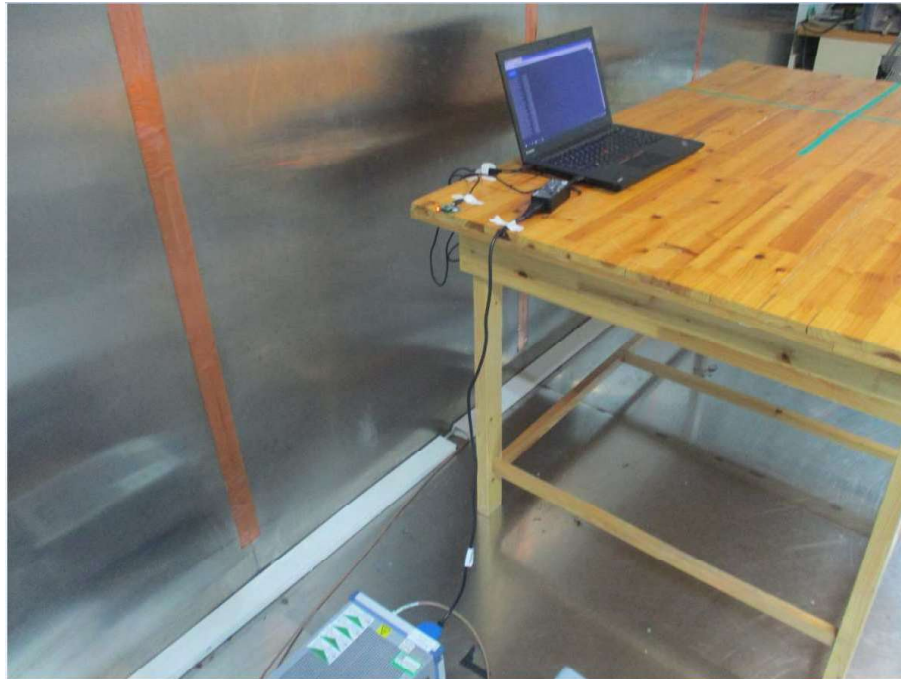
**Photograph 1: Set-up for measurement of conducted emission**

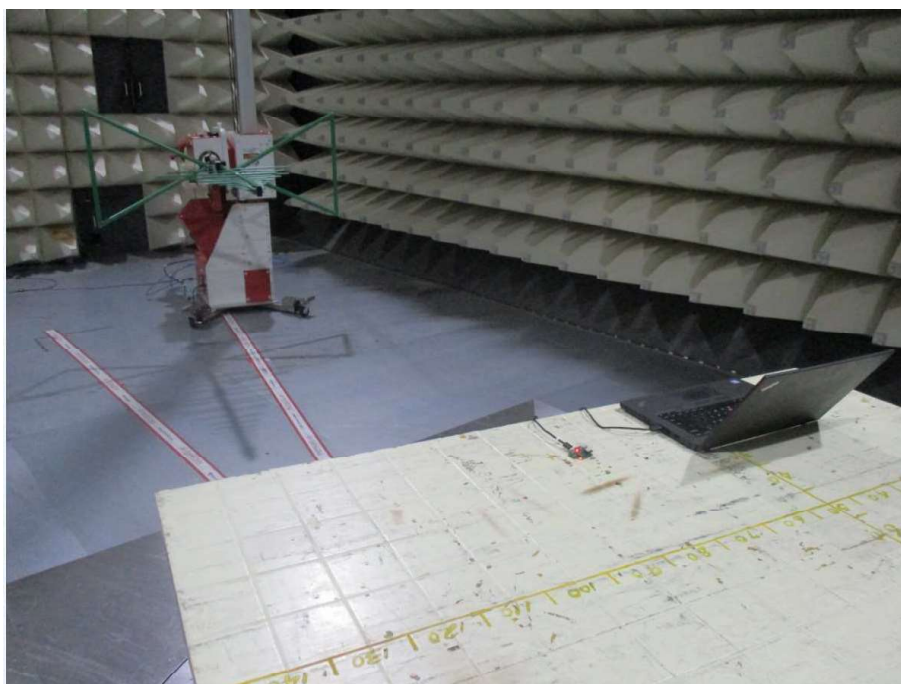
**Photograph 2: Set-up for measurement of radiated emission**

(30-1000 MHz)

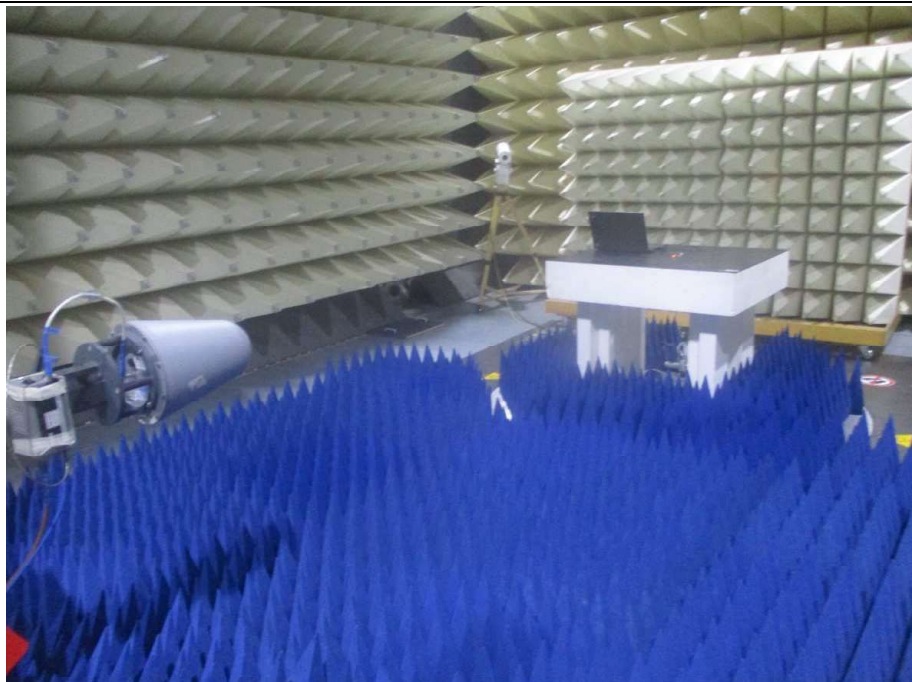
(1-12.5 GHz)
