## 10.7 APPENDIX: CONDUCTED SPURIOUS EMISSION

### Test Result

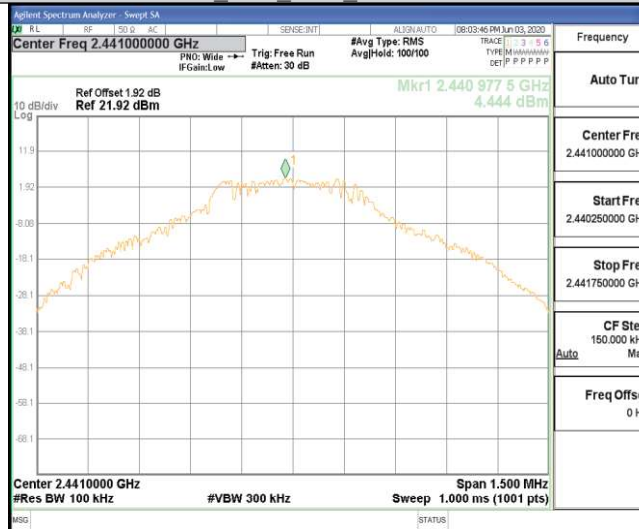
DH1\_Ant1\_2441\_0~Reference

| TestMode | Antenna | Channel | FreqRange [MHz] | RefLevel [dBm] | Result [dBm] | Limit [dBm] | Verdict |
|---|---|---|---|---|---|---|---|
| | | 2441 | Reference | 4.44 | 4.44 | --- | PASS |

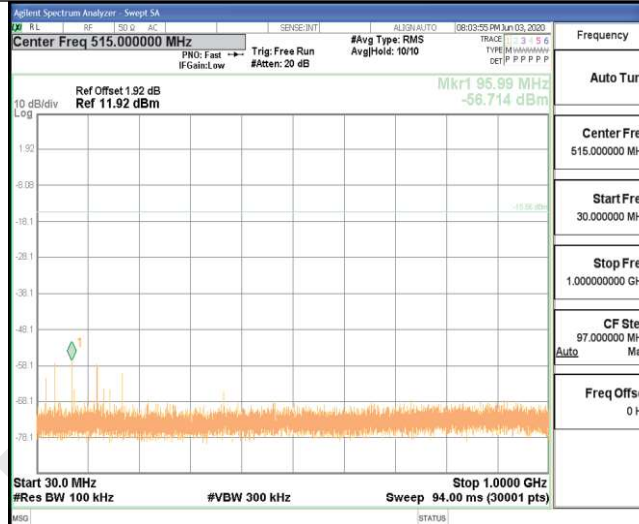
DH1\_Ant1\_2441\_30~1000

| TestMode | Antenna | Channel | FreqRange [MHz] | RefLevel [dBm] | Result [dBm] | Limit [dBm] | Verdict |
|---|---|---|---|---|---|---|---|
| | | | 30~1000 | 30~1000 | -56.714 | <=-15.556 | PASS |

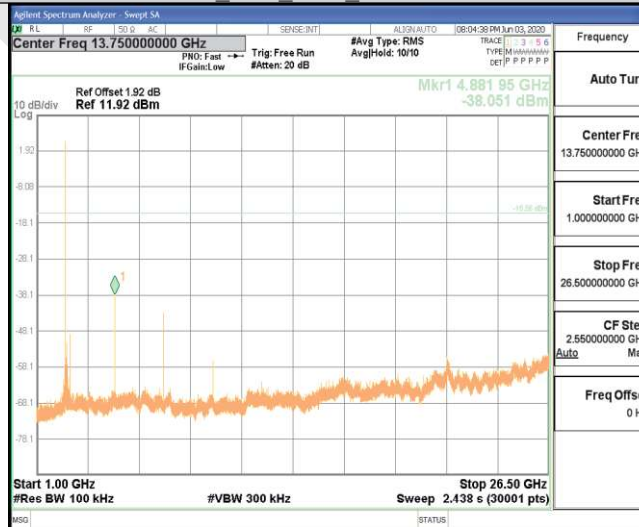
DH1\_Ant1\_2441\_1000~26500

| TestMode | Antenna | Channel | FreqRange [MHz] | RefLevel [dBm] | Result [dBm] | Limit [dBm] | Verdict |
|---|---|---|---|---|---|---|---|
| | | | 1000~26500 | 1000~26500 | -38.051 | <=-15.556 | PASS |

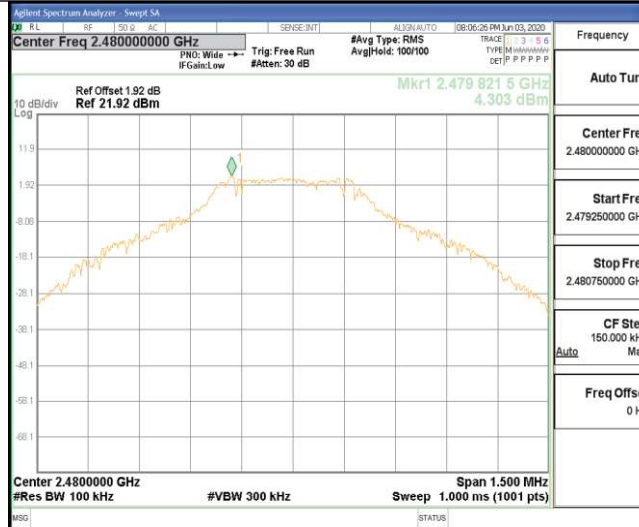
DH1\_Ant1\_2480\_0~Reference

| TestMode | Antenna | Channel | FreqRange [MHz] | RefLevel [dBm] | Result [dBm] | Limit [dBm] | Verdict |
|---|---|---|---|---|---|---|---|
| | | 2480 | Reference | 4.30 | 4.30 | --- | PASS |

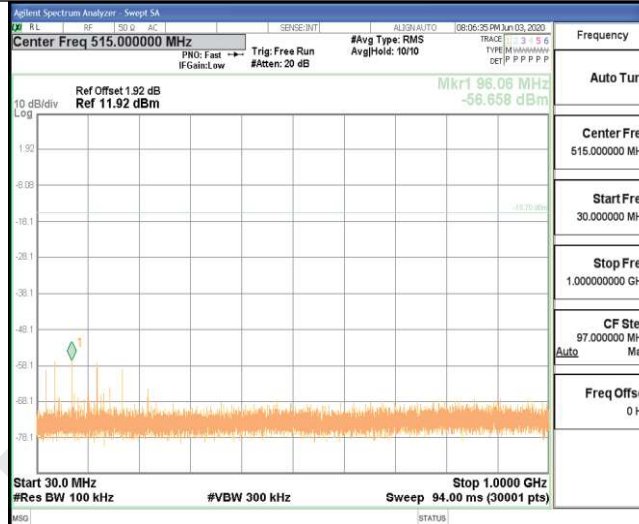
DH1\_Ant1\_2480\_30~1000

| TestMode | Antenna | Channel | FreqRange [MHz] | RefLevel [dBm] | Result [dBm] | Limit [dBm] | Verdict |
|---|---|---|---|---|---|---|---|
| | | | 30~1000 | 30~1000 | -56.658 | <=-15.697 | PASS |

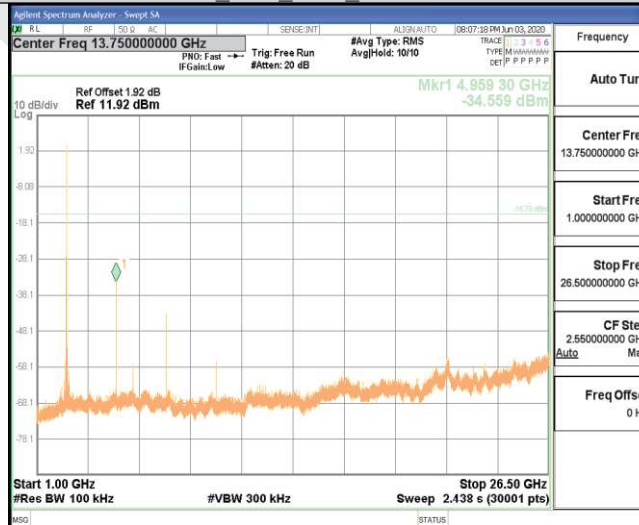
DH1\_Ant1\_2480\_1000~26500

| TestMode | Antenna | Channel | FreqRange [MHz] | RefLevel [dBm] | Result [dBm] | Limit [dBm] | Verdict |
|---|---|---|---|---|---|---|---|
| | | | 1000~26500 | 1000~26500 | -34.559 | <=-15.697 | PASS |

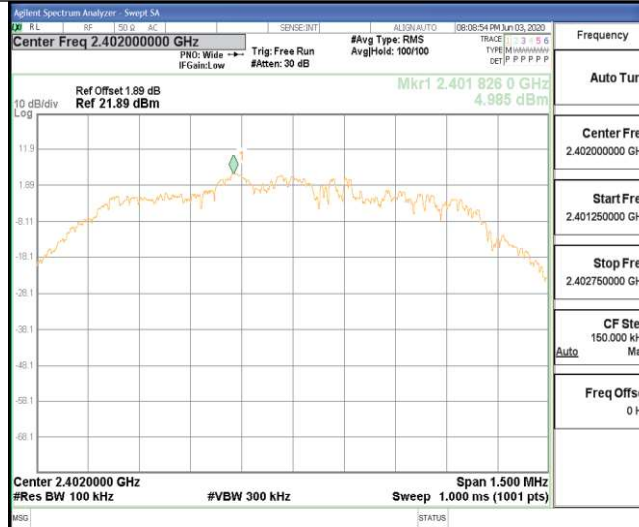
2DH1\_Ant1\_2402\_0~Reference

| TestMode | Antenna | Channel | FreqRange [MHz] | RefLevel [dBm] | Result [dBm] | Limit [dBm] | Verdict |
|---|---|---|---|---|---|---|---|
| 2DH1 | Ant1 | 2402 | Reference | 4.99 | 4.99 | --- | PASS |

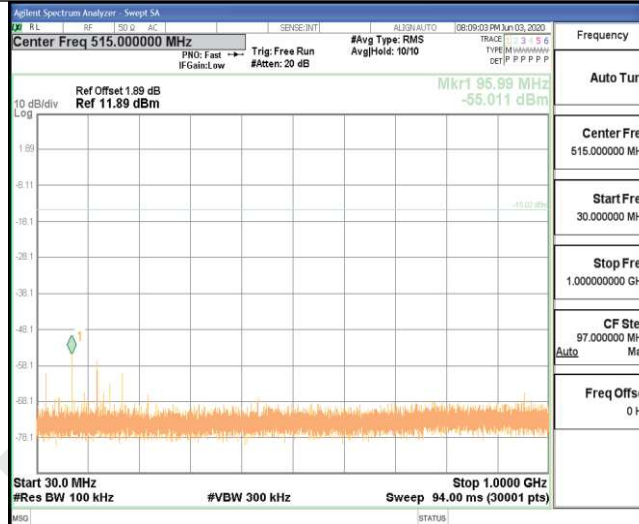
2DH1\_Ant1\_2402\_30~1000

| TestMode | Antenna | Channel | FreqRange [MHz] | RefLevel [dBm] | Result [dBm] | Limit [dBm] | Verdict |
|---|---|---|---|---|---|---|---|
| | | | 30~1000 | 30~1000 | -55.011 | <=-15.015 | PASS |

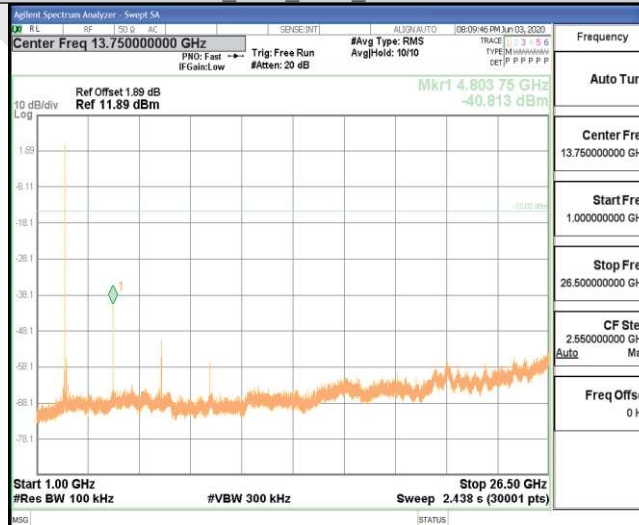
2DH1\_Ant1\_2402\_1000~26500

| TestMode | Antenna | Channel | FreqRange [MHz] | RefLevel [dBm] | Result [dBm] | Limit [dBm] | Verdict |
|---|---|---|---|---|---|---|---|
| | | | 1000~26500 | 1000~26500 | -40.813 | <=-15.015 | PASS |

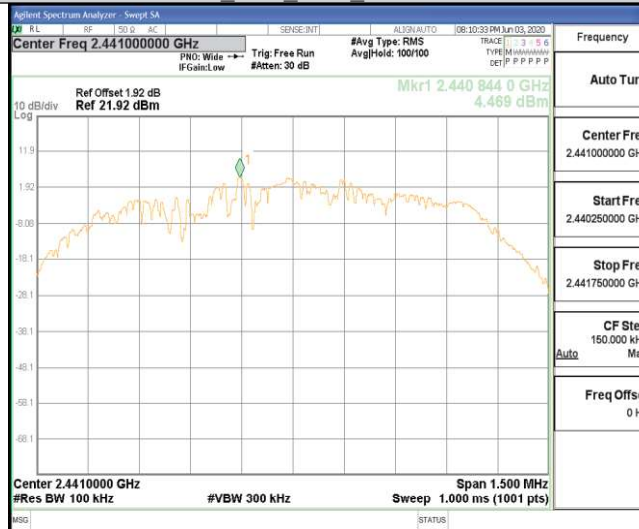
2DH1\_Ant1\_2441\_0~Reference

| TestMode | Antenna | Channel | FreqRange [MHz] | RefLevel [dBm] | Result [dBm] | Limit [dBm] | Verdict |
|---|---|---|---|---|---|---|---|
| | | 2441 | Reference | 4.47 | 4.47 | --- | PASS |

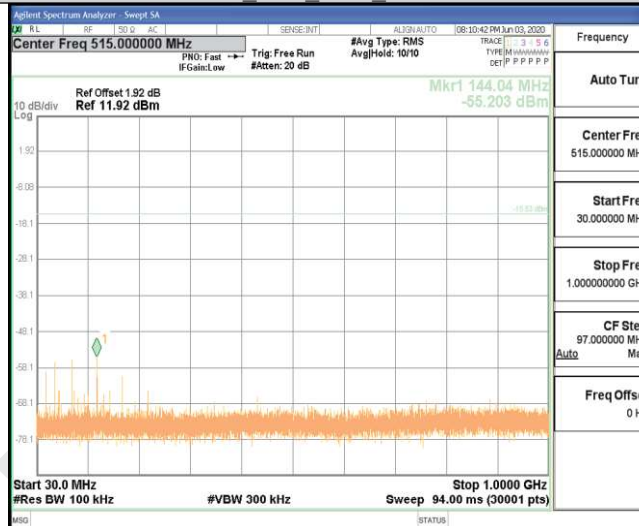
2DH1\_Ant1\_2441\_30~1000

| TestMode | Antenna | Channel | FreqRange [MHz] | RefLevel [dBm] | Result [dBm] | Limit [dBm] | Verdict |
|---|---|---|---|---|---|---|---|
| | | | 30~1000 | 30~1000 | -55.203 | <=-15.531 | PASS |

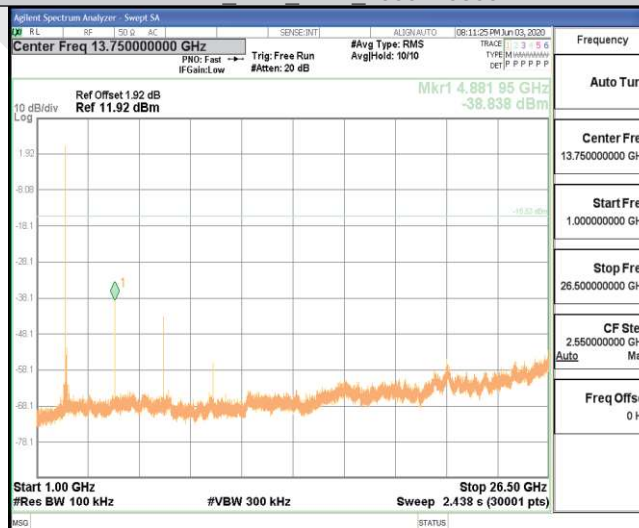
2DH1\_Ant1\_2441\_1000~26500

| TestMode | Antenna | Channel | FreqRange [MHz] | RefLevel [dBm] | Result [dBm] | Limit [dBm] | Verdict |
|---|---|---|---|---|---|---|---|
| | | | 1000~26500 | 1000~26500 | -38.838 | <=-15.531 | PASS |
