### **APPENDIX 3: Photographs of test setup**

#### **Radiated Emission**

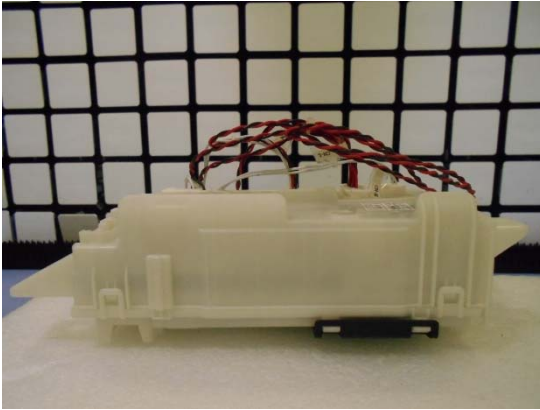
### Worst Case Position

ECU  
Below 30 MHz  
X-axis  
Above 30 MHz  
Horizontal: X-axis / Vertical: X-axis  
X-axis

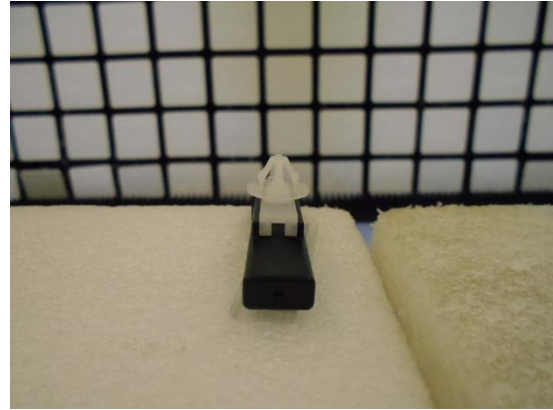
ANT  
Below 30 MHz  
X-axis  
Above 30 MHz  
Horizontal: X-axis / Vertical: X-axis  
X-axis

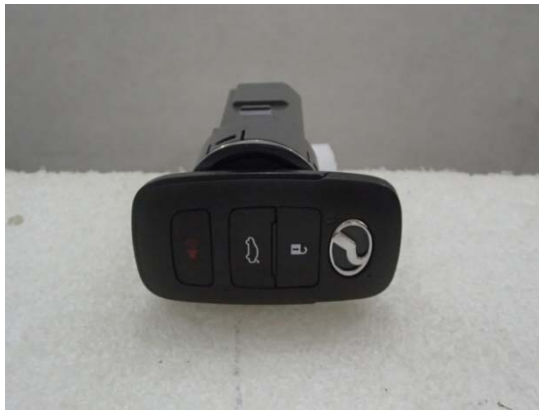
### **Immobilizer**

Below 30 MHz

X-axis

Above 30 MHz

Horizontal: X-axis / Vertical: X-axis

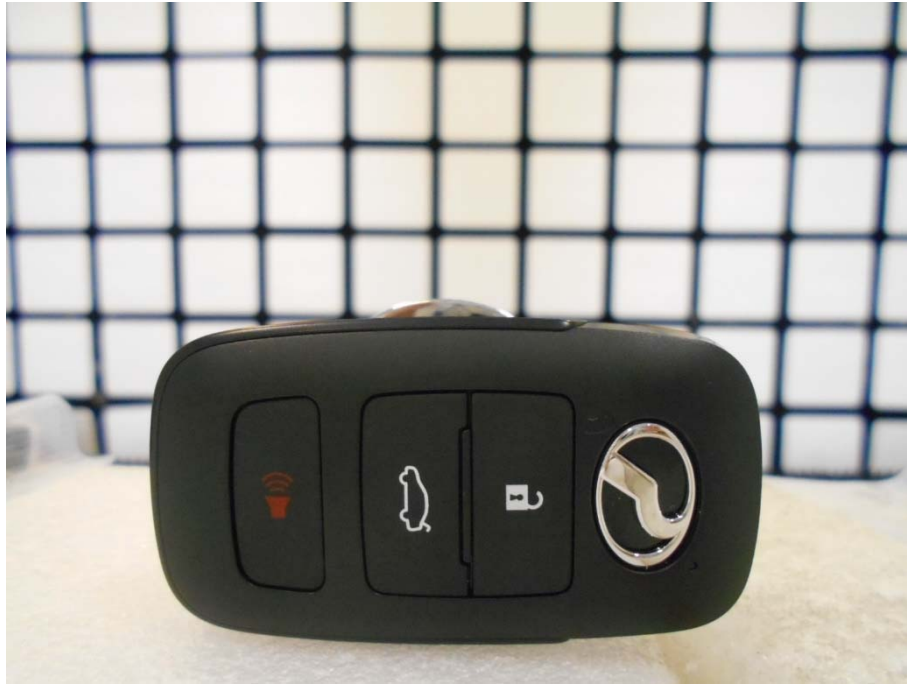
**Worst Case Position**

**With key (Worst)**

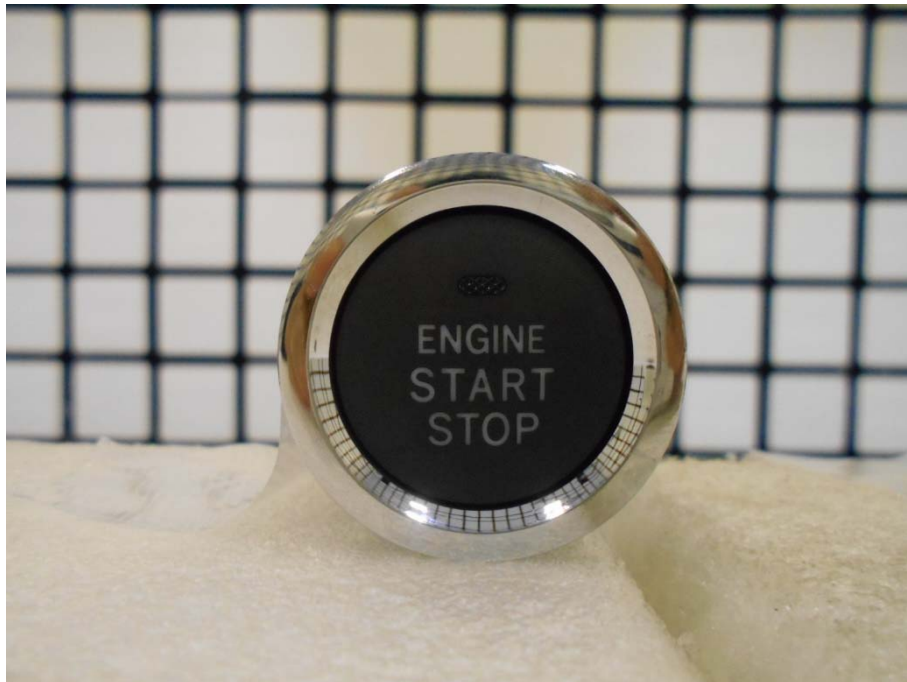
**Without key**
