## Appendix B: photographs of test setup

## Appendix C: photographs of EUT

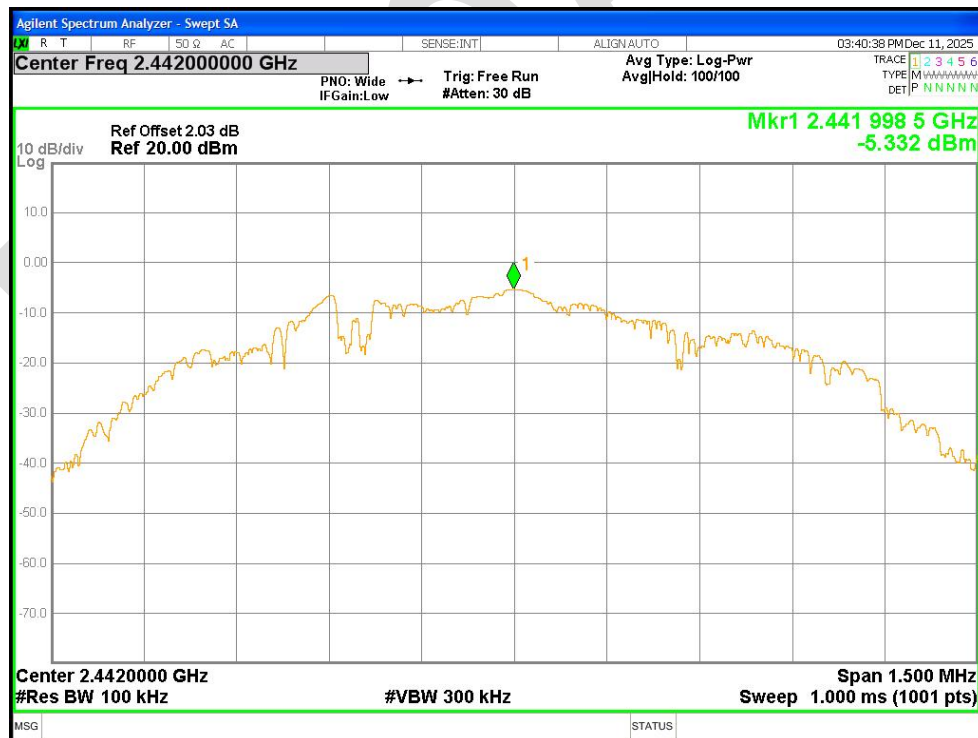
Tx. Spurious NVNT BLE 1M 2442MHz Ant1 Ref

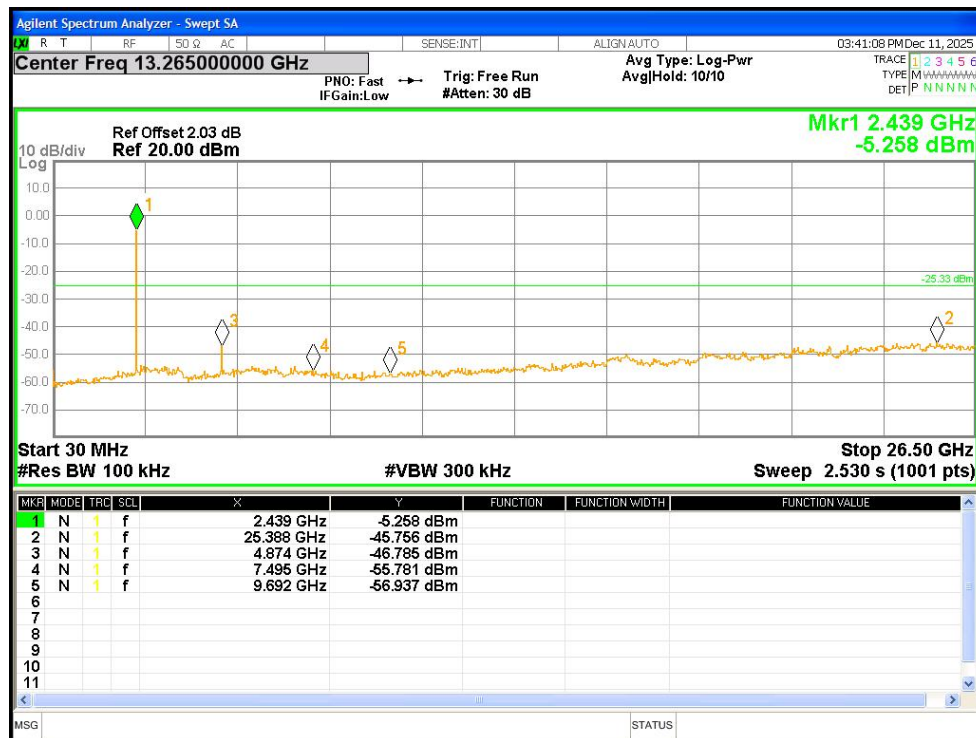
Tx. Spurious NVNT BLE 1M 2442MHz Ant1 Emission

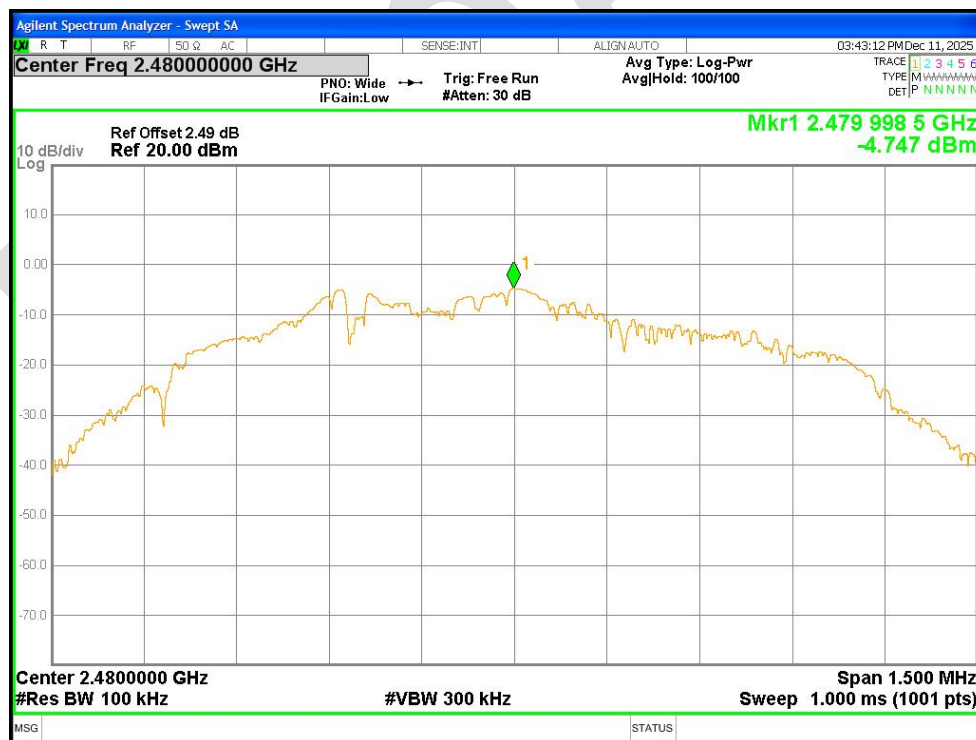
Tx. Spurious NVNT BLE 1M 2480MHz Ant1 Ref

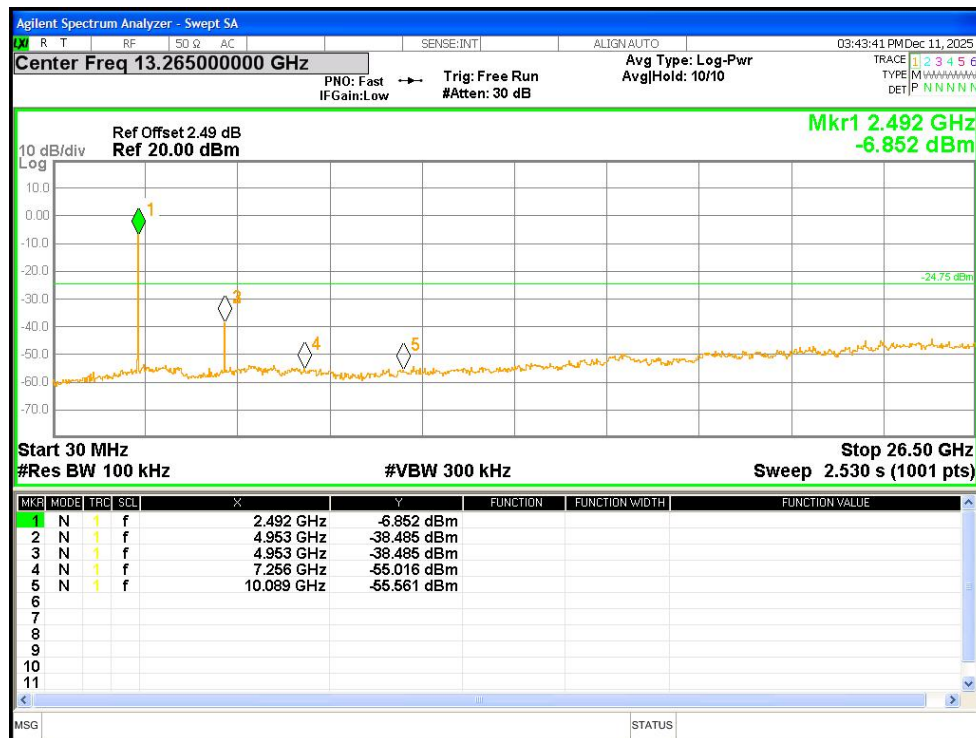
Tx. Spurious NVNT BLE 1M 2480MHz Ant1 Emission

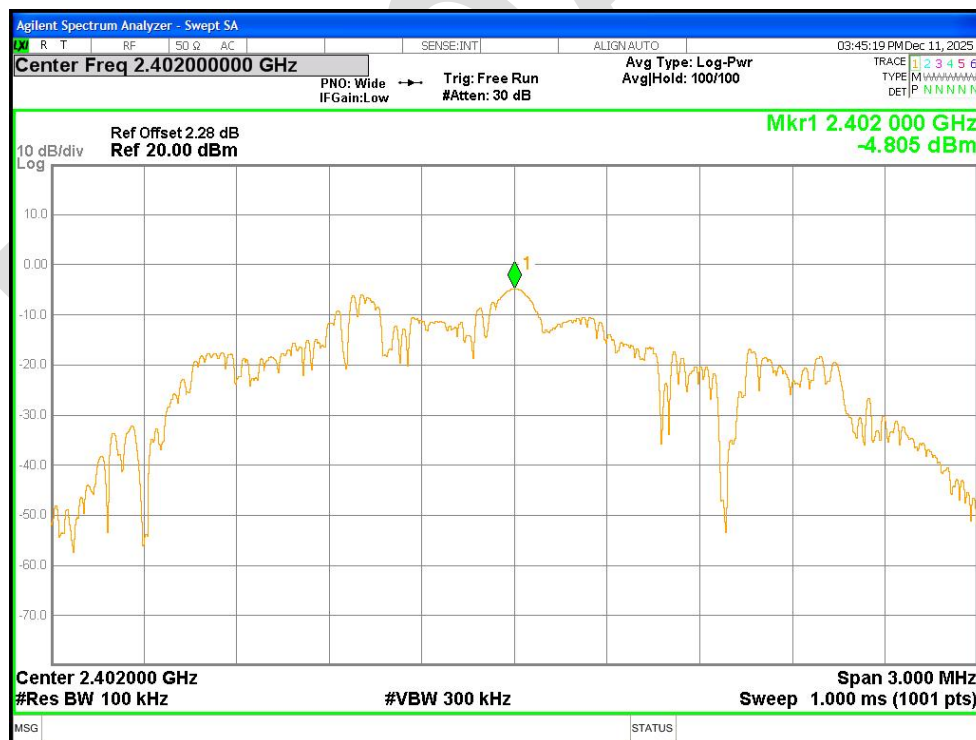
Tx. Spurious NVNT BLE 2M 2402MHz Ant1 Ref

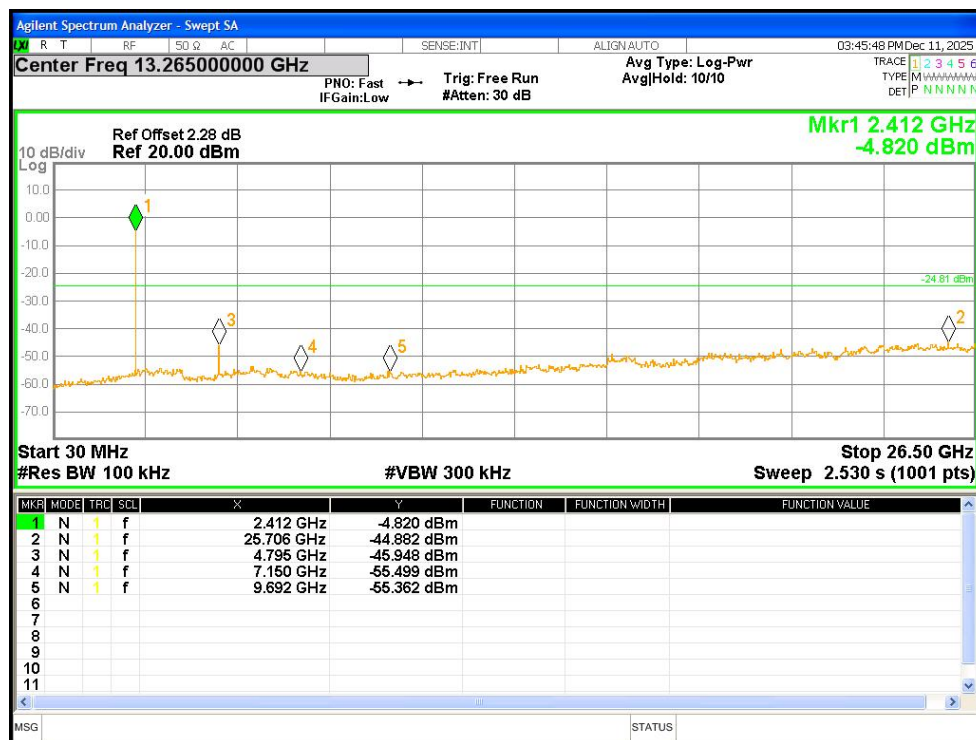
Tx. Spurious NVNT BLE 2M 2402MHz Ant1 Emission

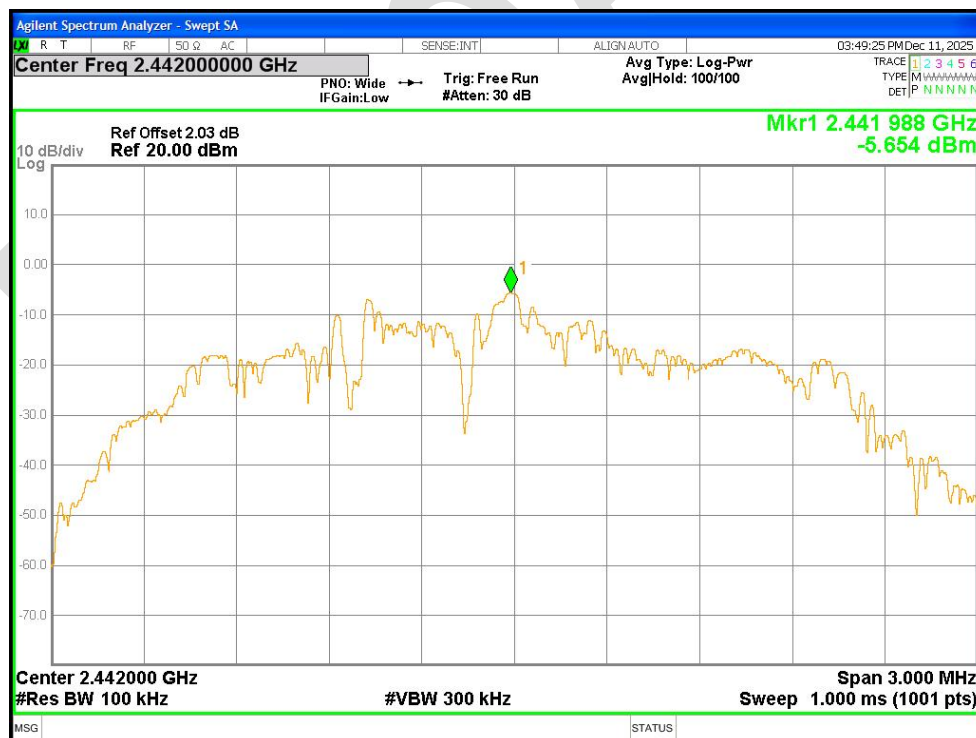
Tx. Spurious NVNT BLE 2M 2442MHz Ant1 Ref

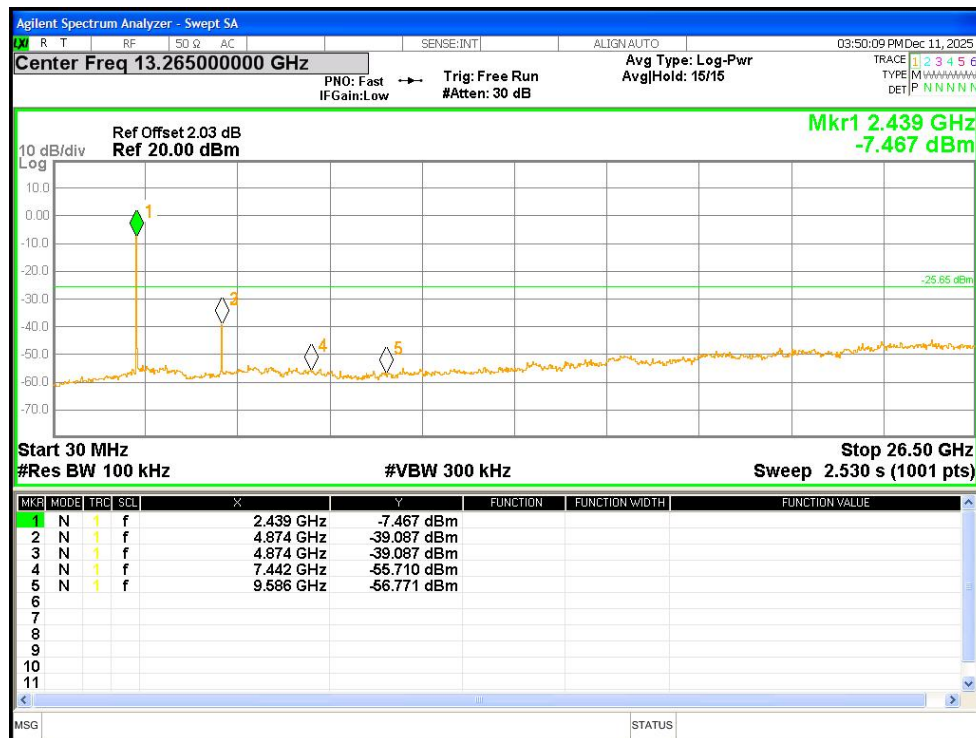
Tx. Spurious NVNT BLE 2M 2442MHz Ant1 Emission

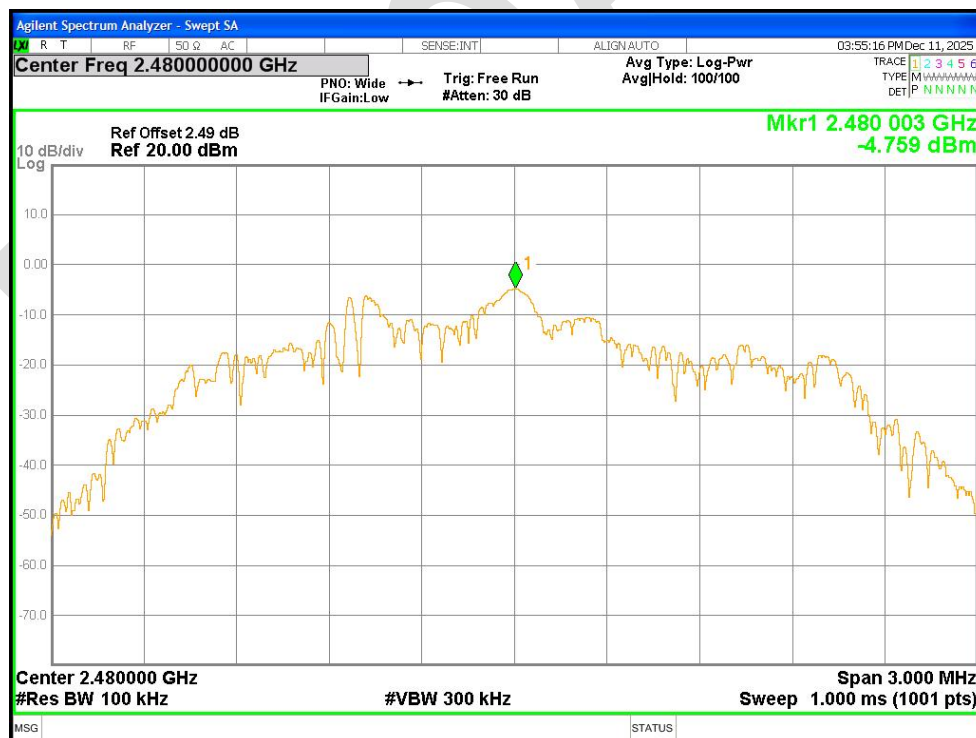
Tx. Spurious NVNT BLE 2M 2480MHz Ant1 Ref

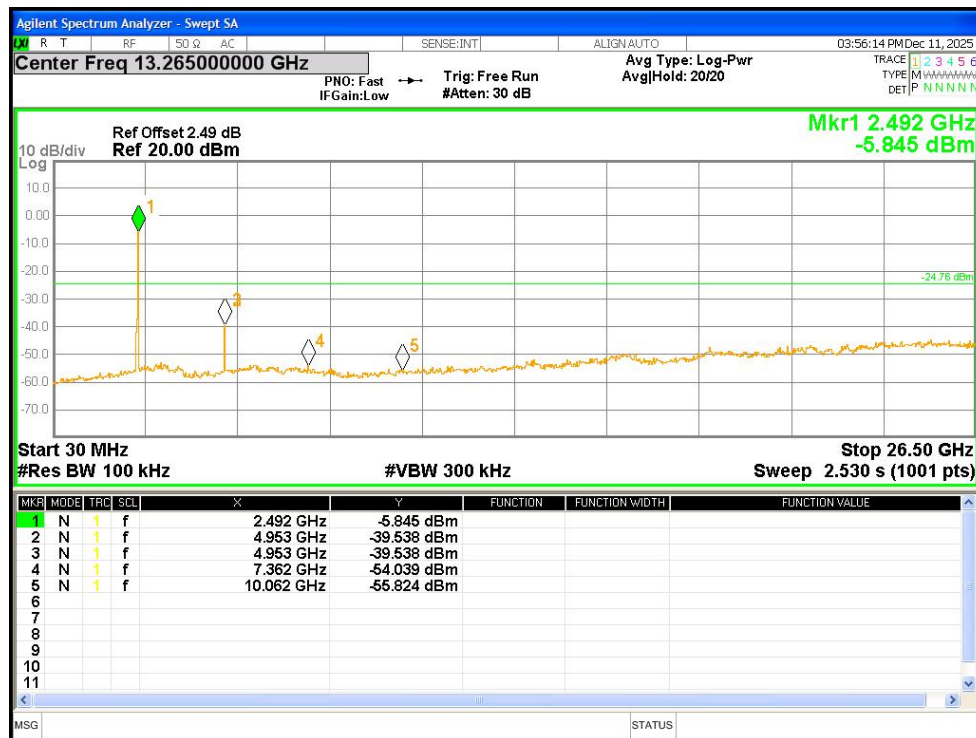
Tx. Spurious NVNT BLE 2M 2480MHz Ant1 Emission

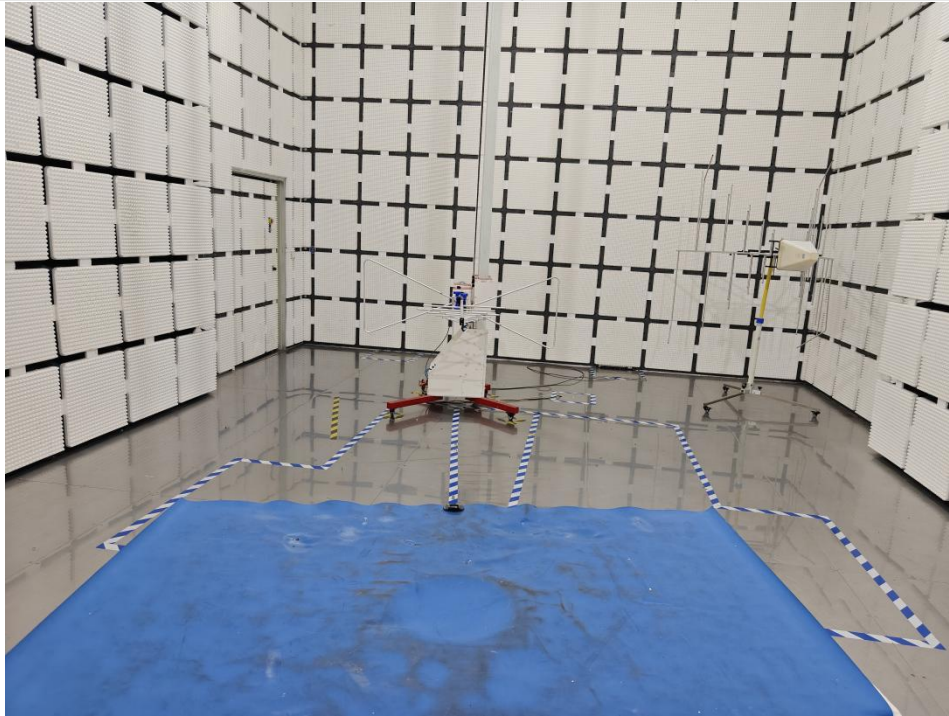
Radiated Emissions (30MHz-1GHz)

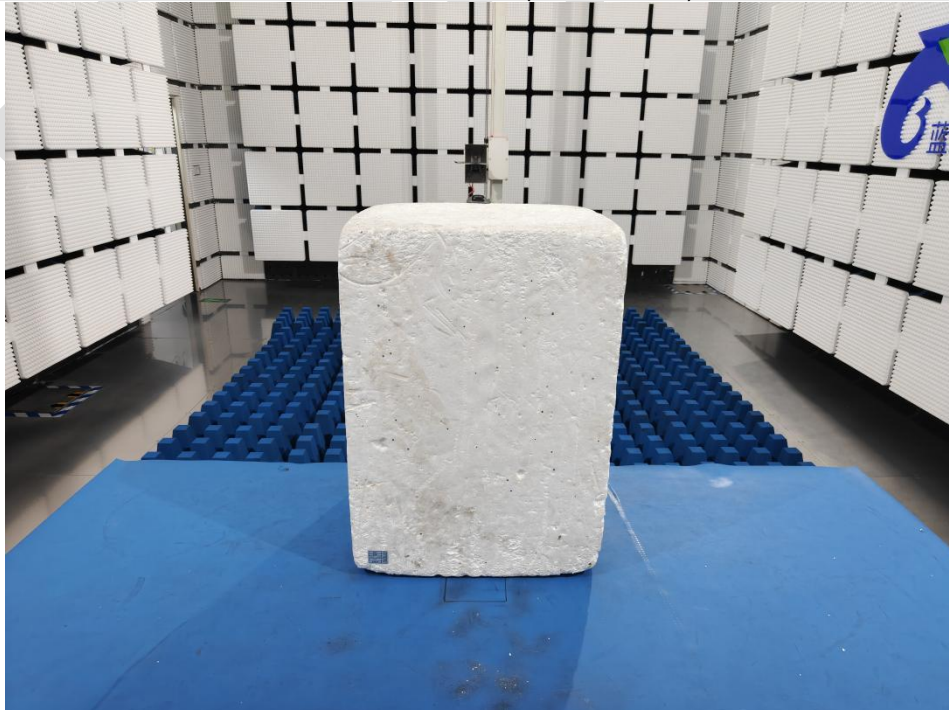
Radiated Emissions (above 1GHz)

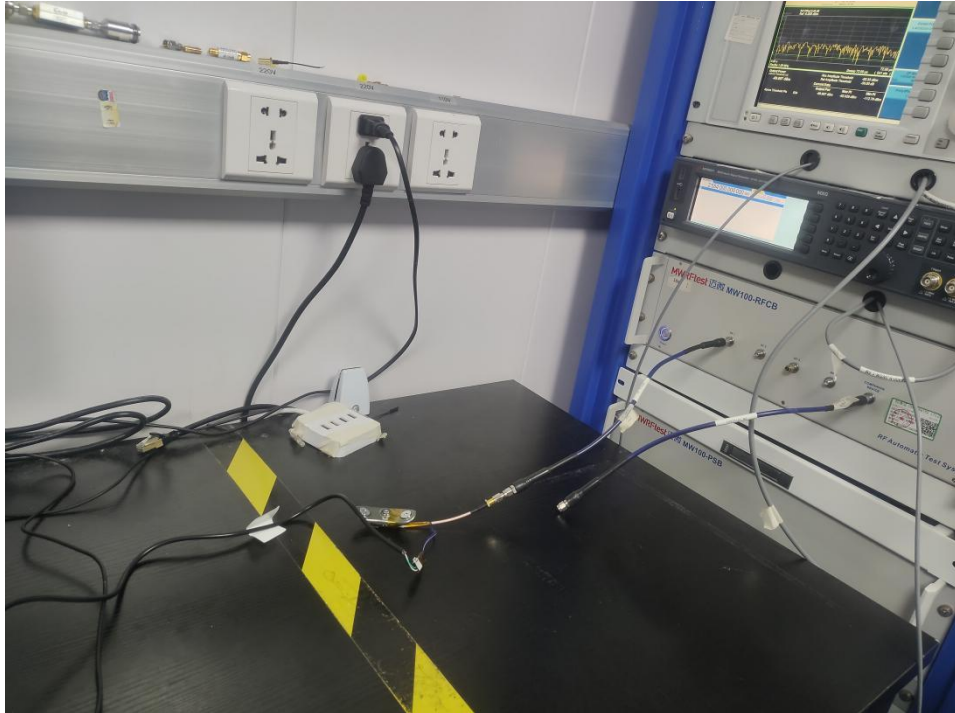
RF TEST
