## Appendix B: photographs of test setup

## Appendix C: photographs of EUT

Reference to the test report no. BLA-EMC-202601-A1001.

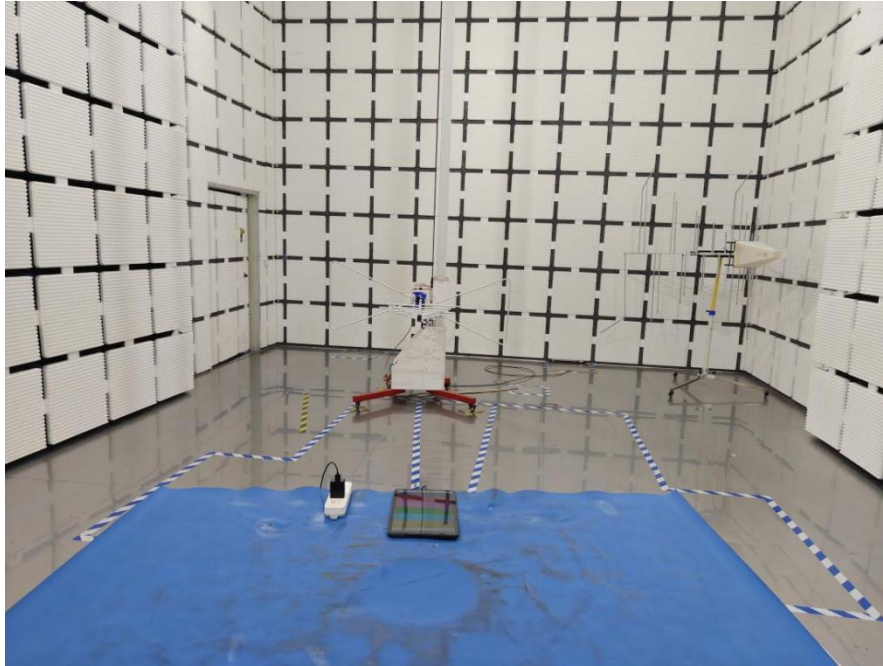
Radiated Emissions (30MHz-1GHz)

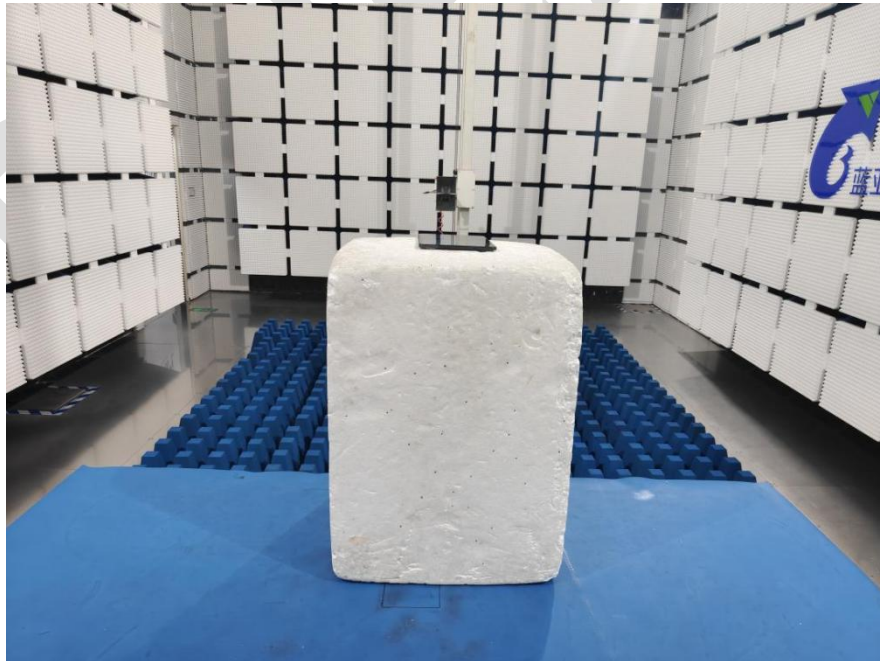
Radiated Emissions (above 1GHz)

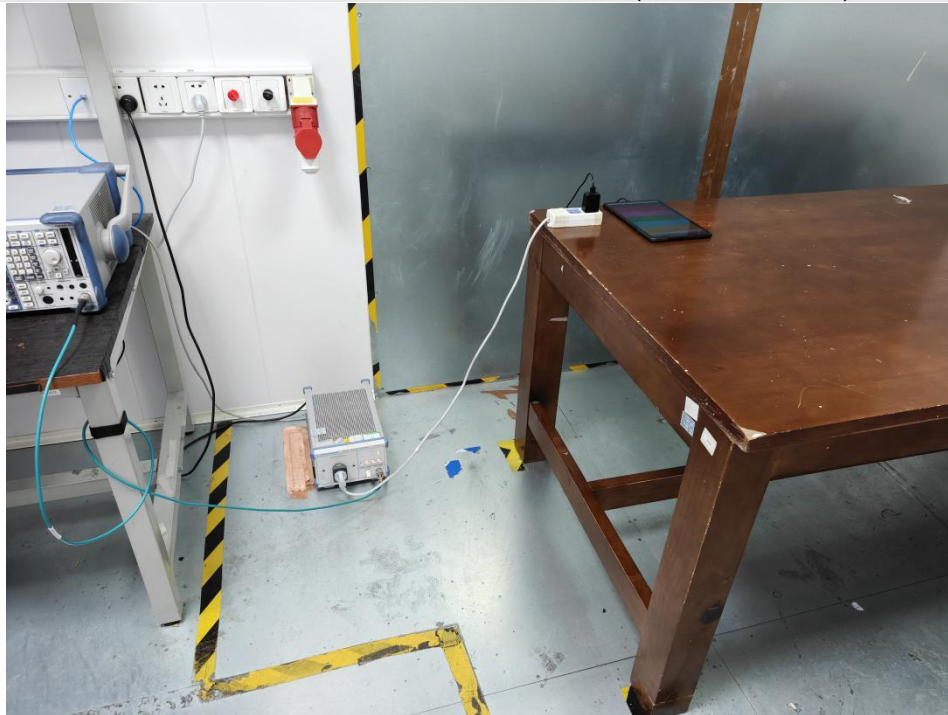
Conducted Emissions at Mains Terminals (150 kHz-30MHz)
