## Test Graphs

## Duty Cycle

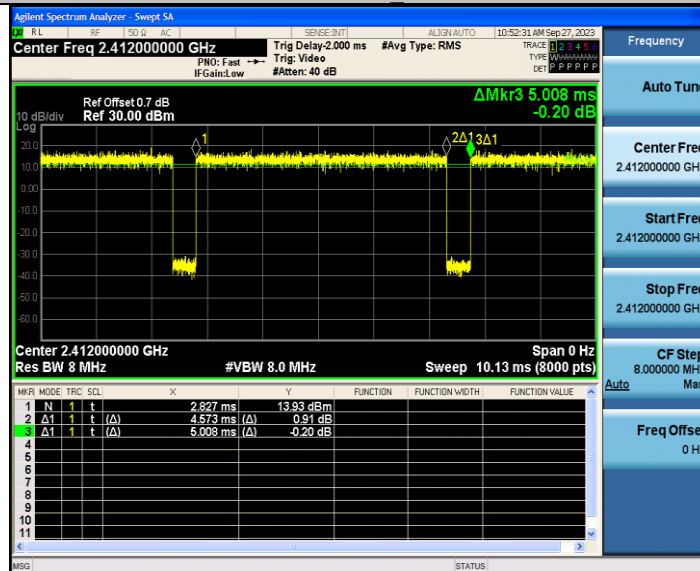
11N20SISO 2437

| Test Mode | Channel | Transmission Duration [ms] | Transmission Period [ms] | Duty Cycle [%] | Correction Factor [dB] |
|---|---|---|---|---|---|
| | 2437 | 4.57 | 5.01 | 91.32 | 0.39 |

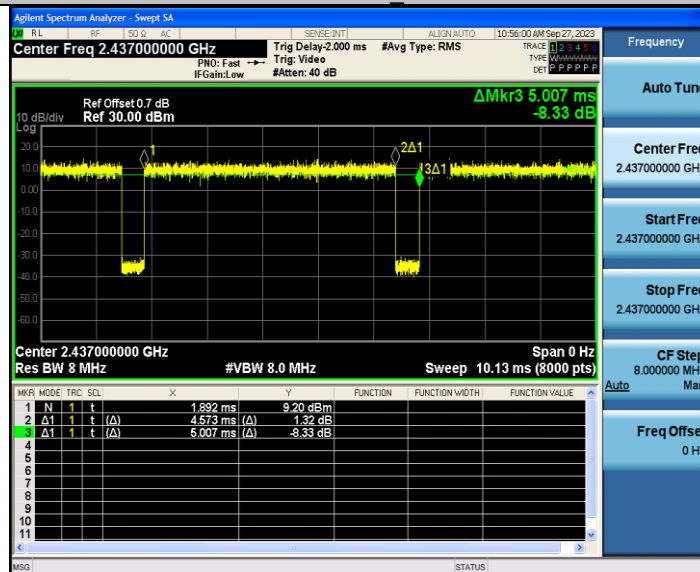
11N20SISO 2462

| Test Mode | Channel | Transmission Duration [ms] | Transmission Period [ms] | Duty Cycle [%] | Correction Factor [dB] |
|---|---|---|---|---|---|
| | 2462 | 4.57 | 4.99 | 91.65 | 0.38 |

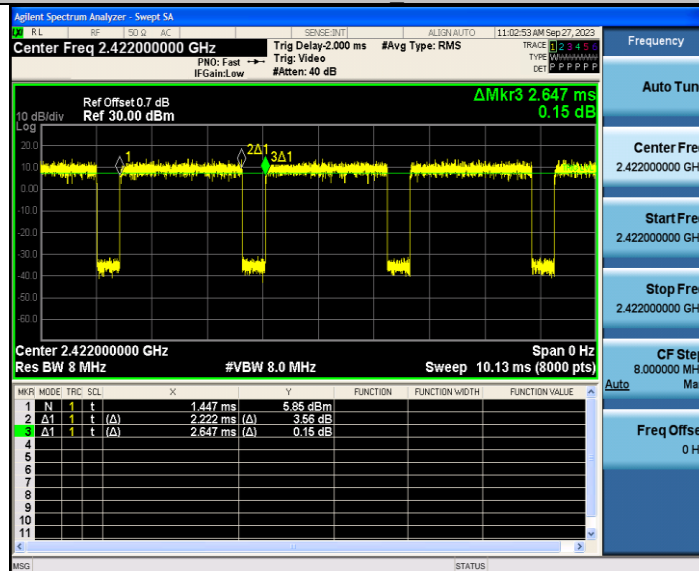
11N40SISO 2437

| Test Mode | Channel | Transmission Duration [ms] | Transmission Period [ms] | Duty Cycle [%] | Correction Factor [dB] |
|---|---|---|---|---|---|
| | 2437 | 2.22 | 2.67 | 83.41 | 0.79 |
