8733 Bluetooth chip:

8800 Bluetooth chip:

## 6 Photographs of the Test Setup

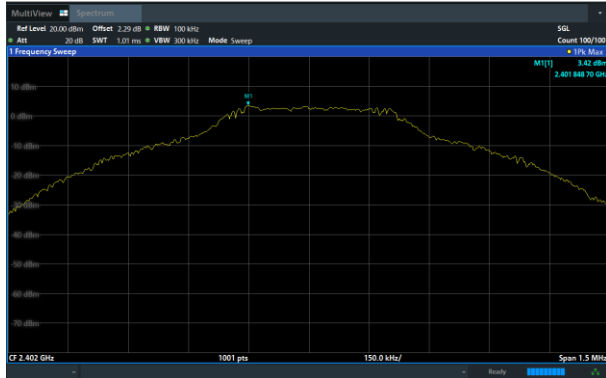
GFSK on Channel 00

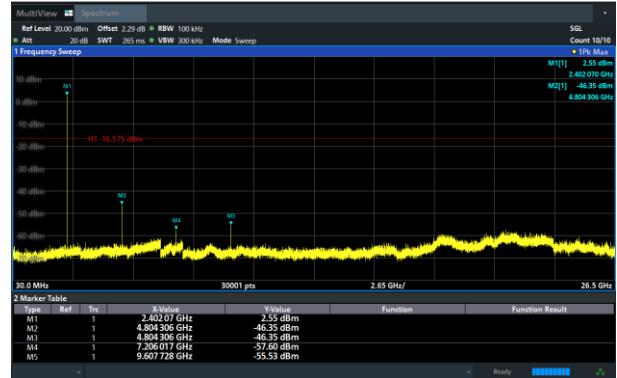
GFSK on Channel 00

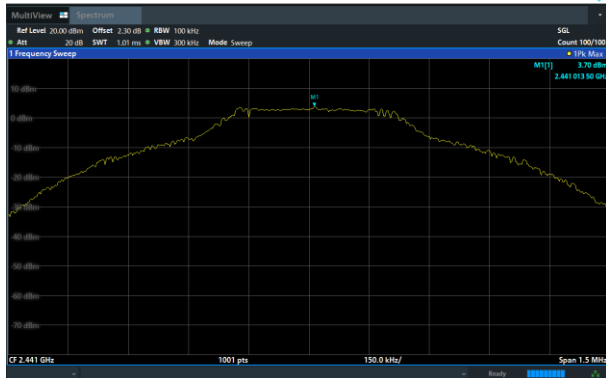
GFSK on Channel 39

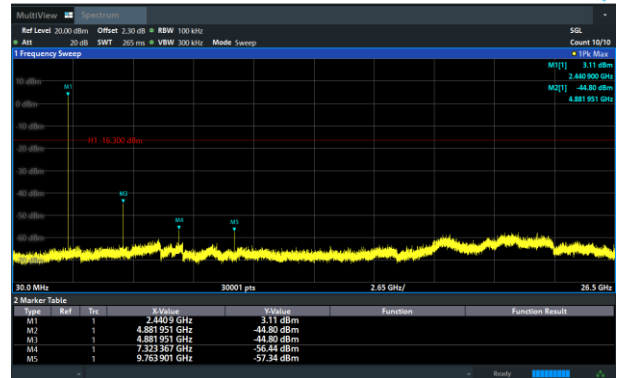
GFSK on Channel 39

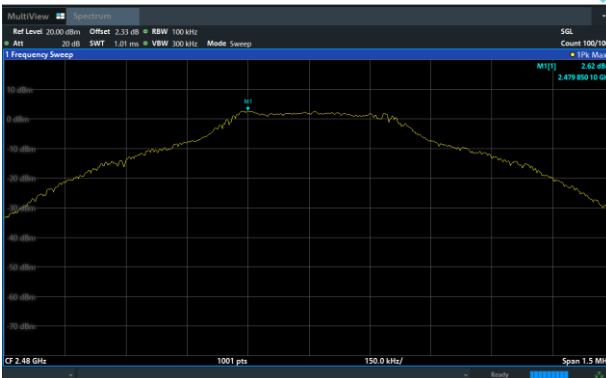
GFSK on Channel 78

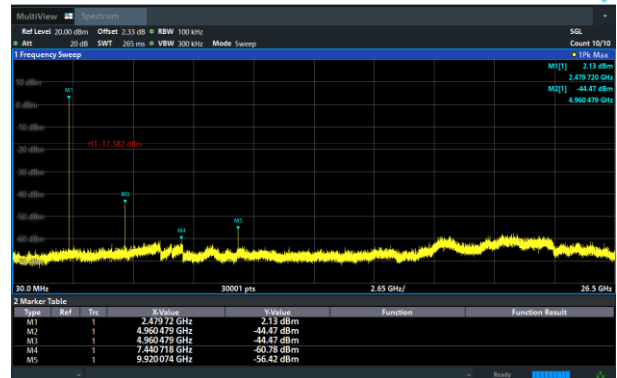
GFSK on Channel 78

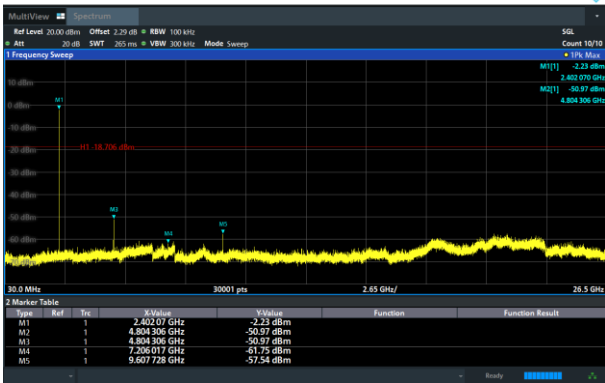
$\pi/4$ -DQPSK on Channel 00

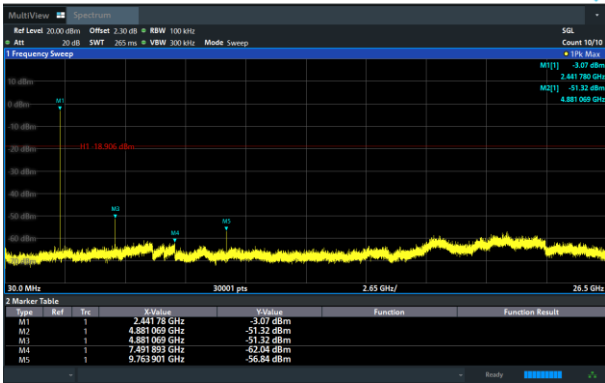
$\pi/4$ -DQPSK on Channel 39

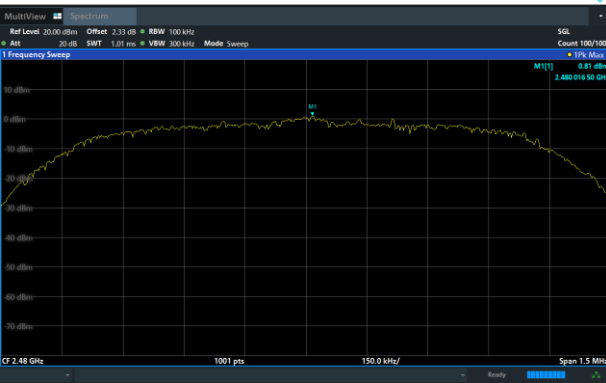
$\pi/4$ -DQPSK on Channel 78

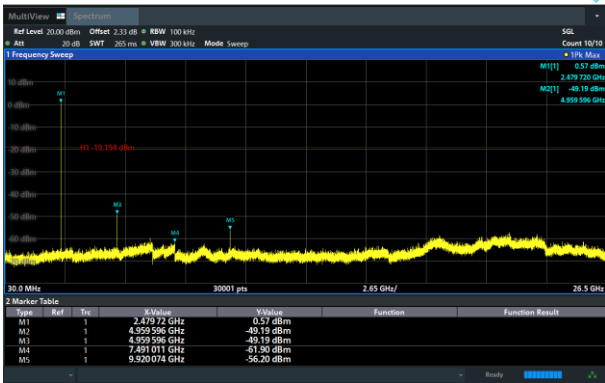
$\pi/4$ -DQPSK on Channel 78

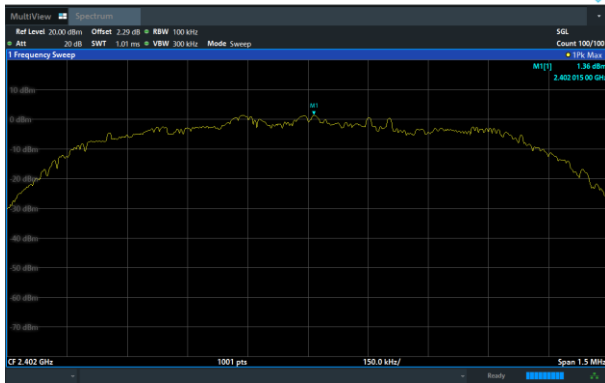
8DPSK on Channel 00

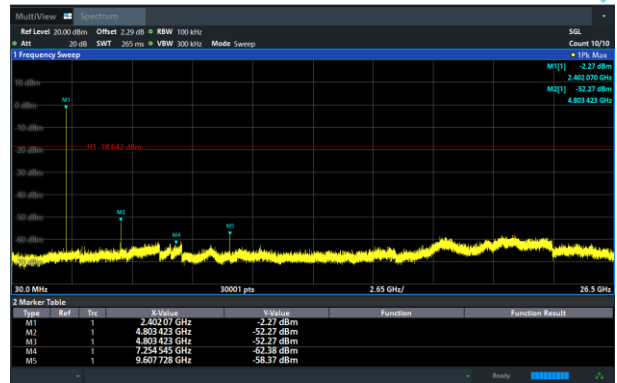
8DPSK on Channel 00

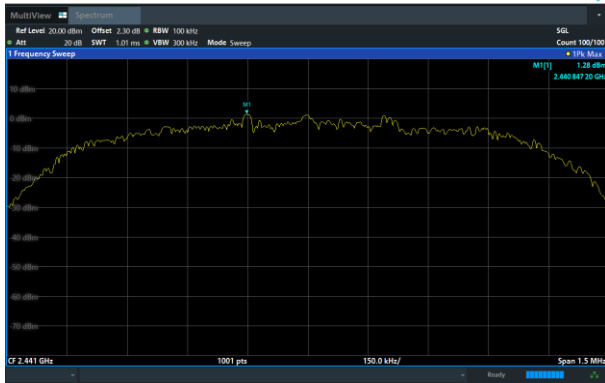
8DPSK on Channel 39

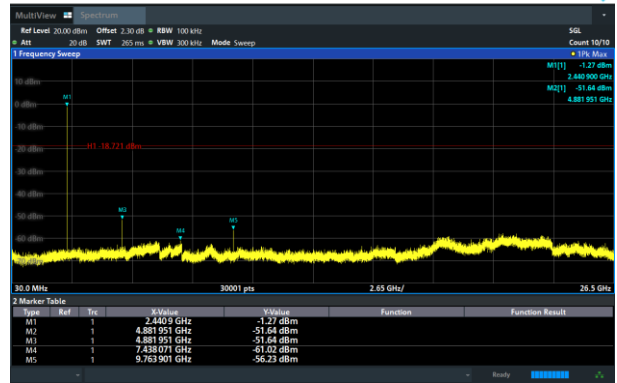
8DPSK on Channel 39

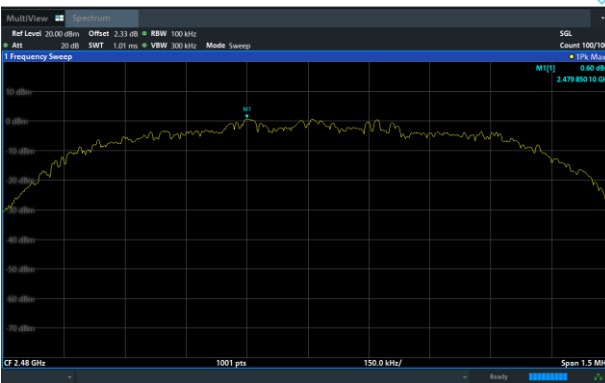
8DPSK on Channel 78

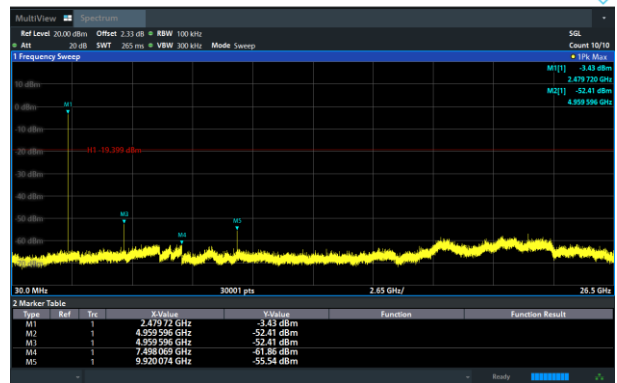
8DPSK on Channel 78

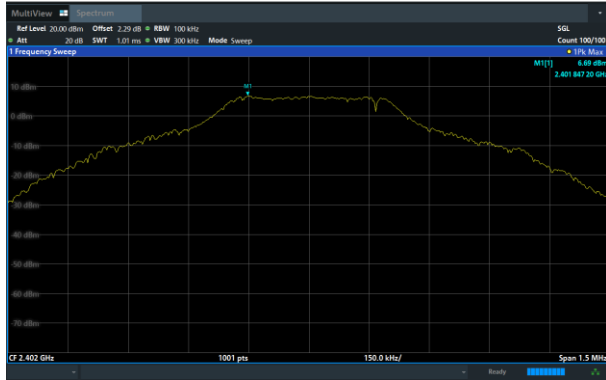
GFSK on Channel 00

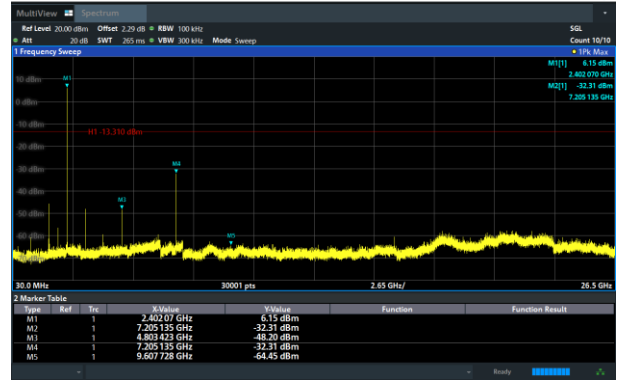
GFSK on Channel 00

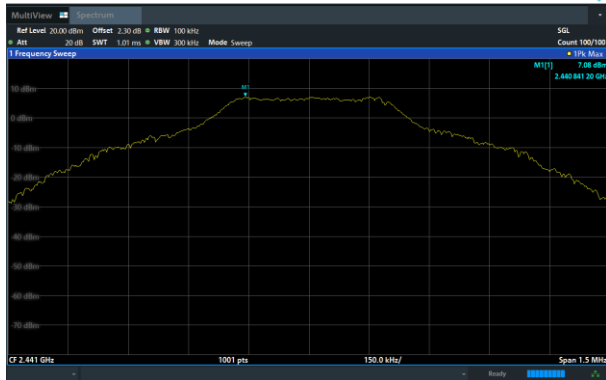
GFSK on Channel 39

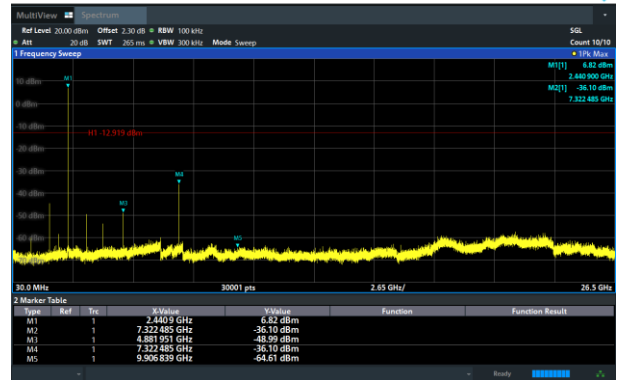
GFSK on Channel 39

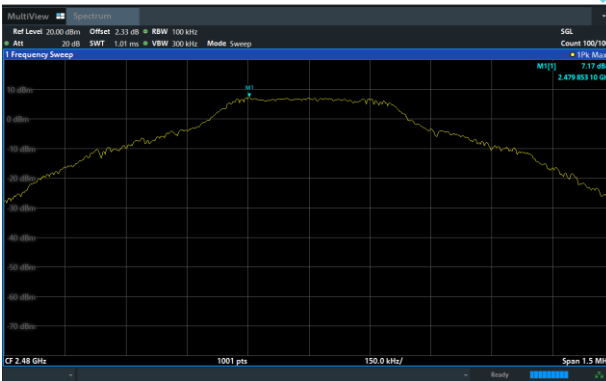
GFSK on Channel 78

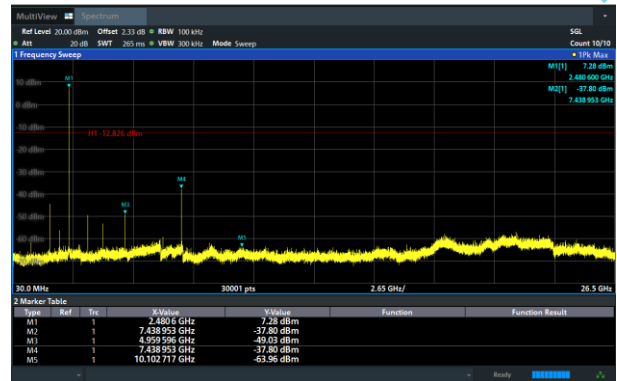
GFSK on Channel 78

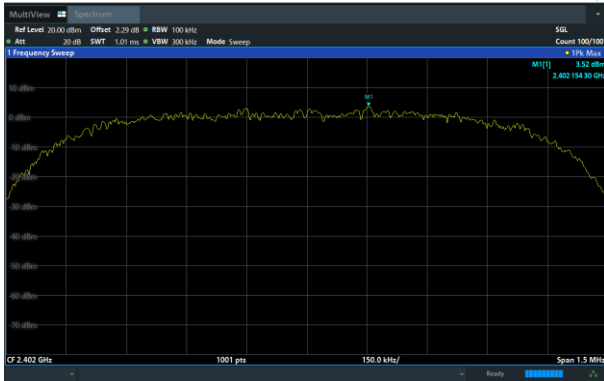
$\pi/4$ -DQPSK on Channel 00

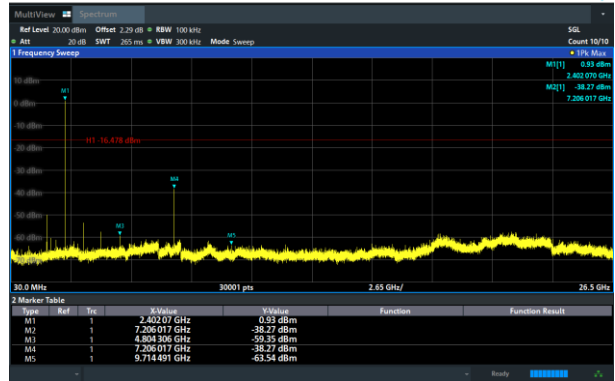
$\pi/4$ -DQPSK on Channel 00

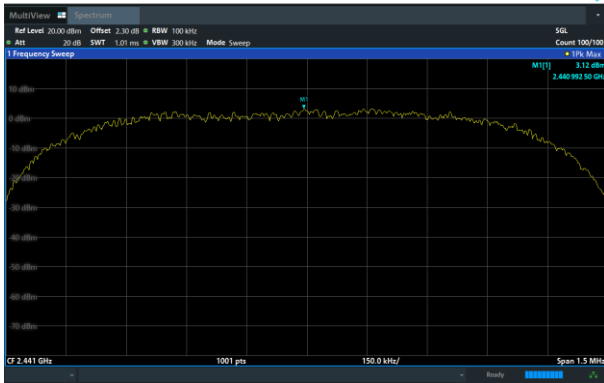
$\pi/4$ -DQPSK on Channel 39

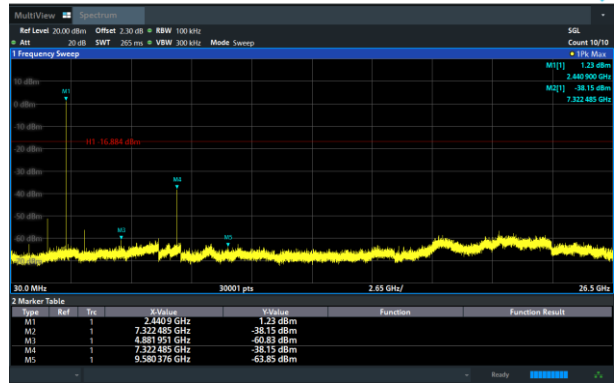
$\pi/4$ -DQPSK on Channel 39

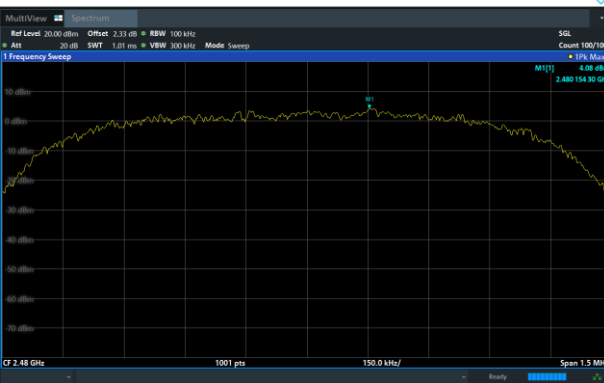
$\pi/4$ -DQPSK on Channel 78

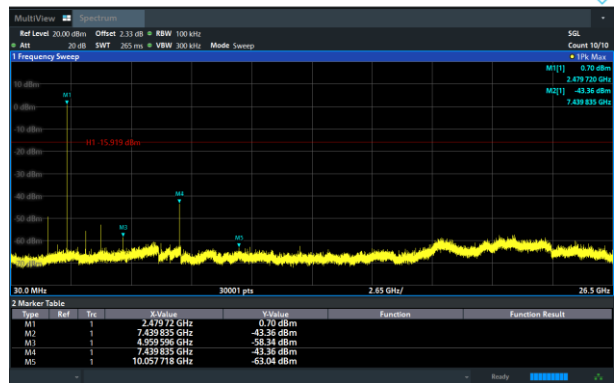
$\pi/4$ -DQPSK on Channel 78

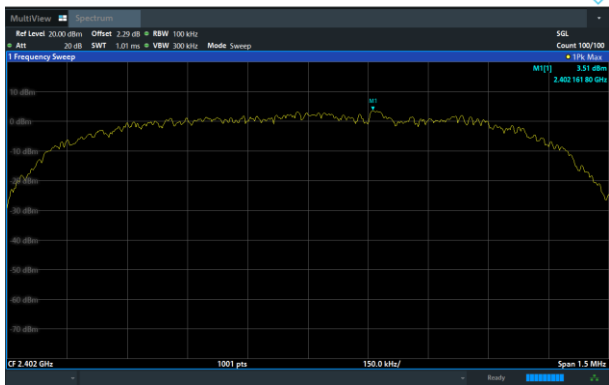
8DPSK on Channel 00

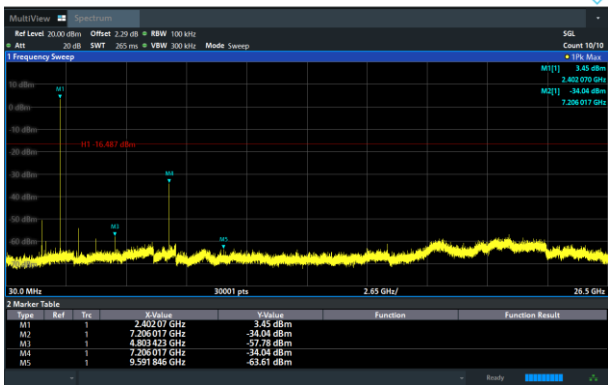
8DPSK on Channel 00

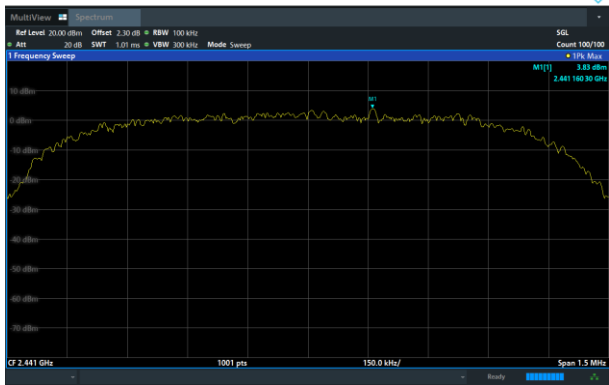
8DPSK on Channel 39

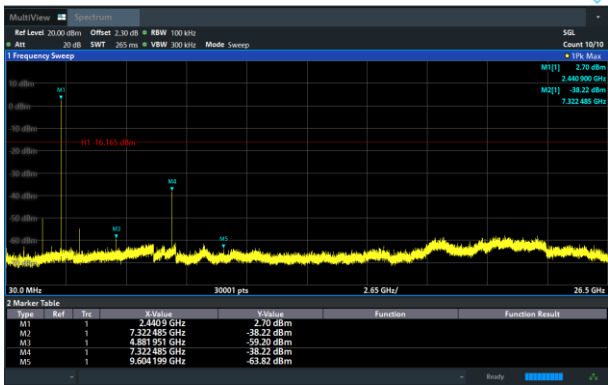
8DPSK on Channel 39

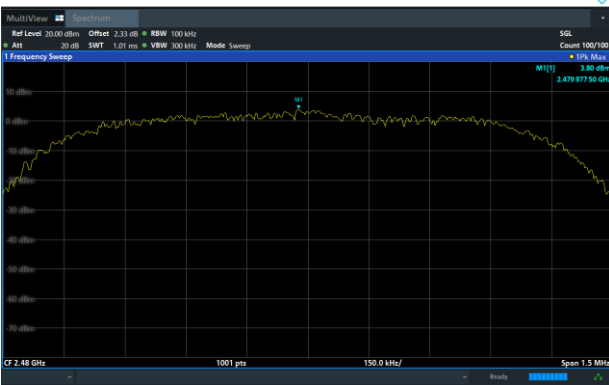
8DPSK on Channel 78

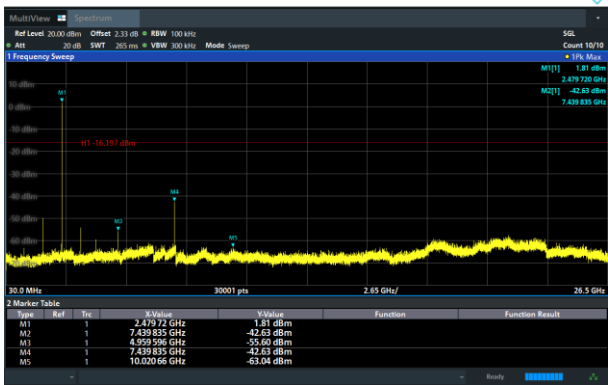
8DPSK on Channel 78

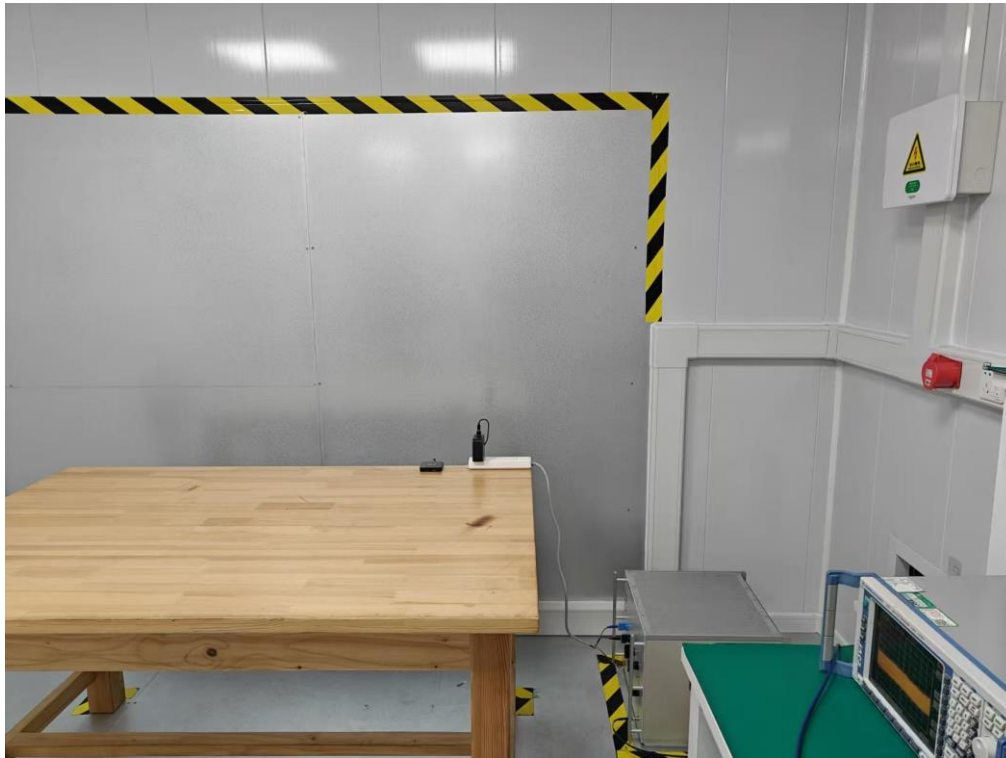
Conducted emission
