## Appendix G: Conducted Spurious Emission

### Test Result

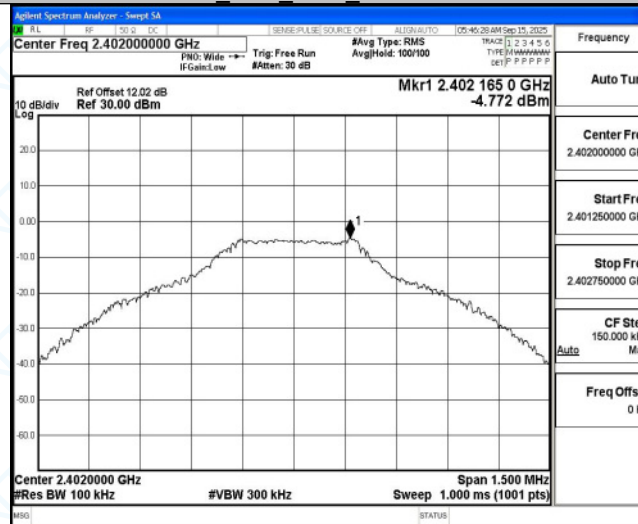
DH5\_Ant1\_2402\_0~Reference

| TestMode | Antenna | Freq(MHz) | FreqRange [MHz] | RefLevel [dBm] | Result [dBm] | Limit [dBm] | Verdict |
|---|---|---|---|---|---|---|---|
| DH5 | Ant1 | 2402 | Reference | -4.77 | -4.77 | --- | PASS |

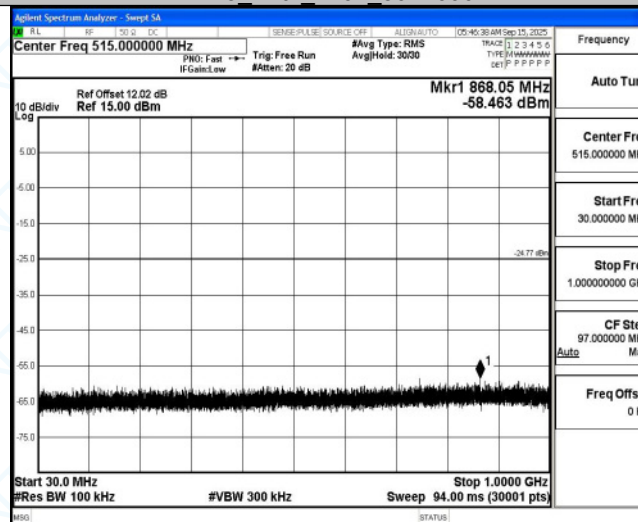
DH5\_Ant1\_2402\_30~1000

| TestMode | Antenna | Freq(MHz) | FreqRange [MHz] | RefLevel [dBm] | Result [dBm] | Limit [dBm] | Verdict |
|---|---|---|---|---|---|---|---|
| | | | 30~1000 | -4.77 | -58.46 | $\leq -24.77$ | PASS |

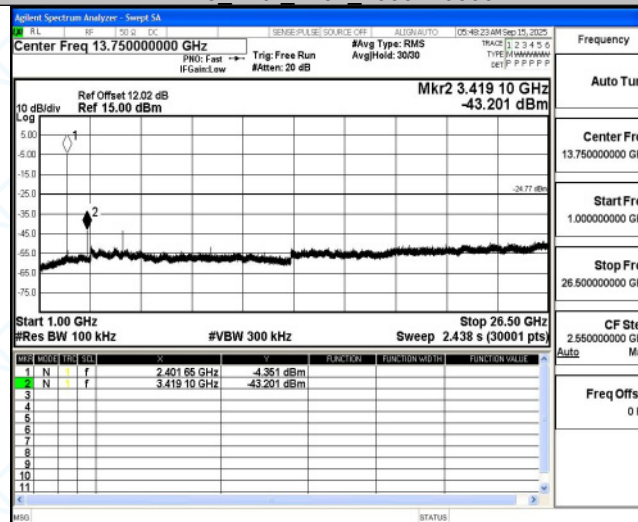
DH5\_Ant1\_2402\_1000~26500

| TestMode | Antenna | Freq(MHz) | FreqRange [MHz] | RefLevel [dBm] | Result [dBm] | Limit [dBm] | Verdict |
|---|---|---|---|---|---|---|---|
| | | | 1000~26500 | -4.77 | -43.2 | $\leq -24.77$ | PASS |

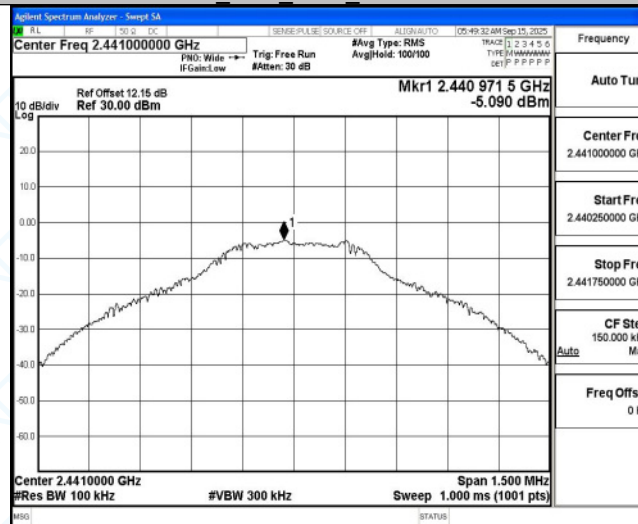
## DH5\_Ant1\_2441\_0~Reference

| TestMode | Antenna | Freq(MHz) | FreqRange [MHz] | RefLevel [dBm] | Result [dBm] | Limit [dBm] | Verdict |
|---|---|---|---|---|---|---|---|
| | | 2441 | Reference | -5.09 | -5.09 | --- | PASS |

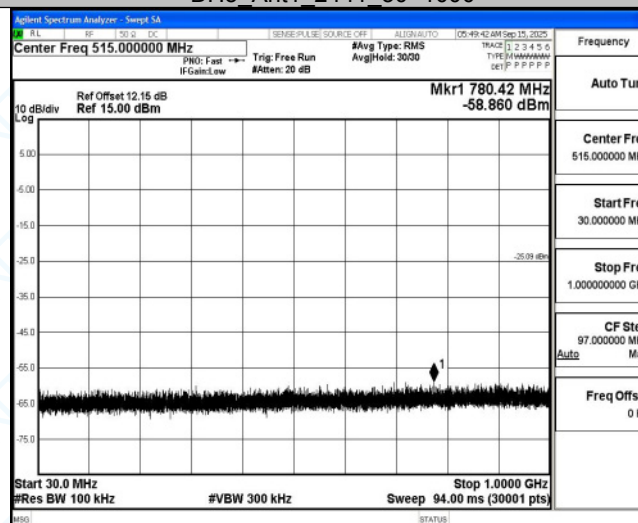
## DH5\_Ant1\_2441\_30~1000

| TestMode | Antenna | Freq(MHz) | FreqRange [MHz] | RefLevel [dBm] | Result [dBm] | Limit [dBm] | Verdict |
|---|---|---|---|---|---|---|---|
| | | | 30~1000 | -5.09 | -58.86 | $\leq -25.09$ | PASS |

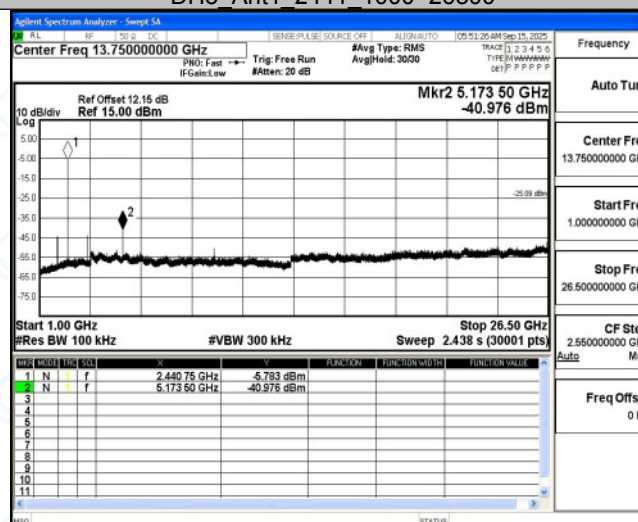
## DH5\_Ant1\_2441\_1000~26500

| TestMode | Antenna | Freq(MHz) | FreqRange [MHz] | RefLevel [dBm] | Result [dBm] | Limit [dBm] | Verdict |
|---|---|---|---|---|---|---|---|
| | | | 1000~26500 | -5.09 | -40.98 | $\leq -25.09$ | PASS |

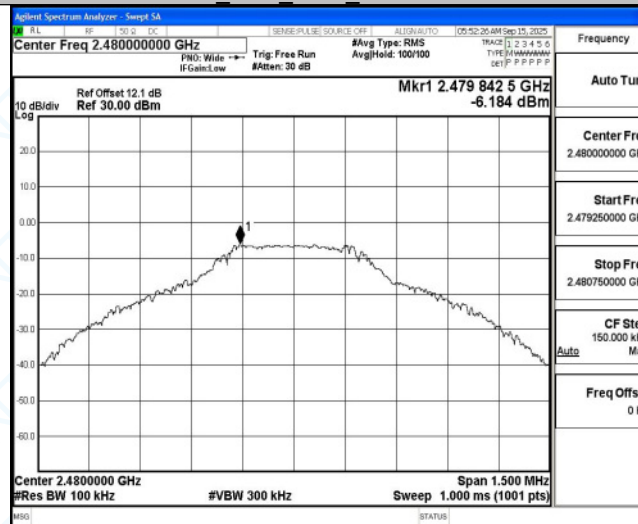
## DH5\_Ant1\_2480\_0~Reference

| TestMode | Antenna | Freq(MHz) | FreqRange [MHz] | RefLevel [dBm] | Result [dBm] | Limit [dBm] | Verdict |
|---|---|---|---|---|---|---|---|
| | | 2480 | Reference | -6.18 | -6.18 | --- | PASS |

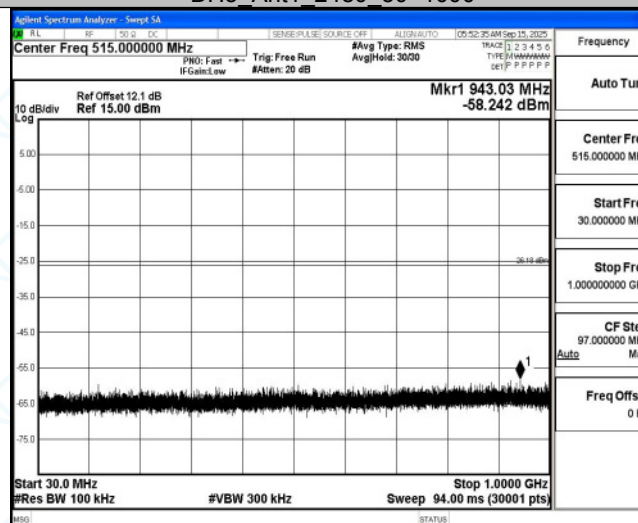
## DH5\_Ant1\_2480\_30~1000

| TestMode | Antenna | Freq(MHz) | FreqRange [MHz] | RefLevel [dBm] | Result [dBm] | Limit [dBm] | Verdict |
|---|---|---|---|---|---|---|---|
| | | | 30~1000 | -6.18 | -58.24 | $\leq -26.18$ | PASS |

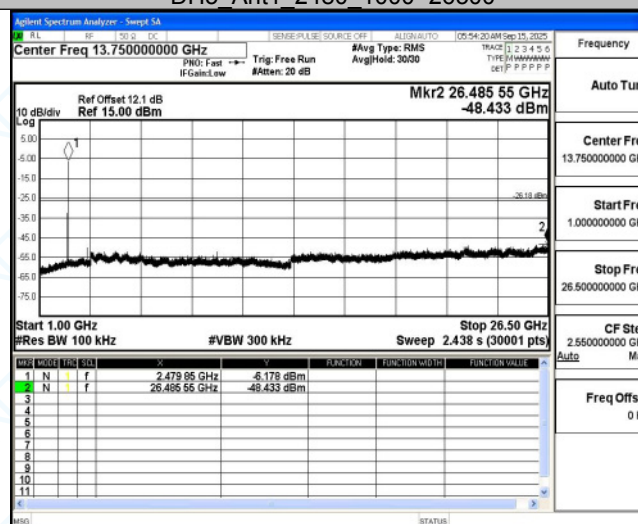
## DH5\_Ant1\_2480\_1000~26500

| TestMode | Antenna | Freq(MHz) | FreqRange [MHz] | RefLevel [dBm] | Result [dBm] | Limit [dBm] | Verdict |
|---|---|---|---|---|---|---|---|
| | | | 1000~26500 | -6.18 | -48.43 | $\leq -26.18$ | PASS |

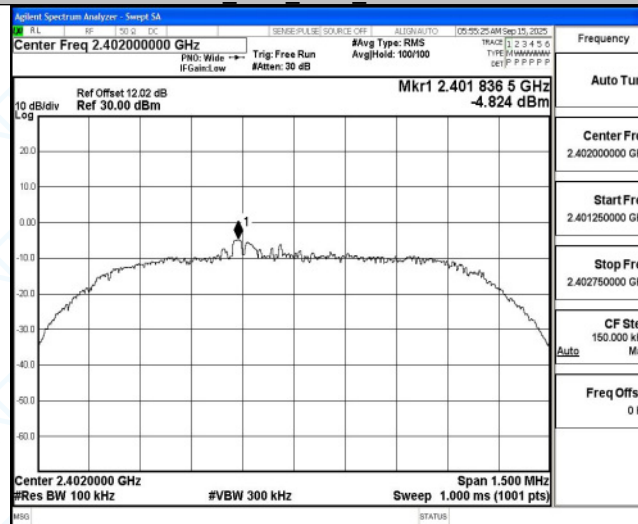
## 2DH5\_Ant1\_2402\_0~Reference

| TestMode | Antenna | Freq(MHz) | FreqRange [MHz] | RefLevel [dBm] | Result [dBm] | Limit [dBm] | Verdict |
|---|---|---|---|---|---|---|---|
| 2DH5 | Ant1 | 2402 | Reference | -4.82 | -4.82 | --- | PASS |

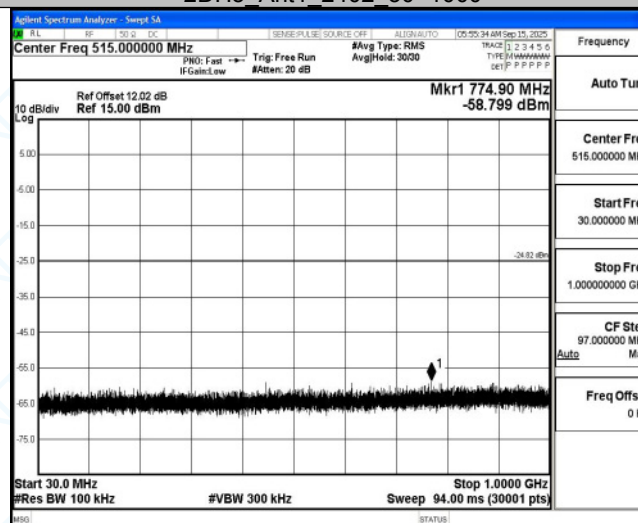
## 2DH5\_Ant1\_2402\_30~1000

| TestMode | Antenna | Freq(MHz) | FreqRange [MHz] | RefLevel [dBm] | Result [dBm] | Limit [dBm] | Verdict |
|---|---|---|---|---|---|---|---|
| | | | 30~1000 | -4.82 | -58.8 | $\leq -24.82$ | PASS |

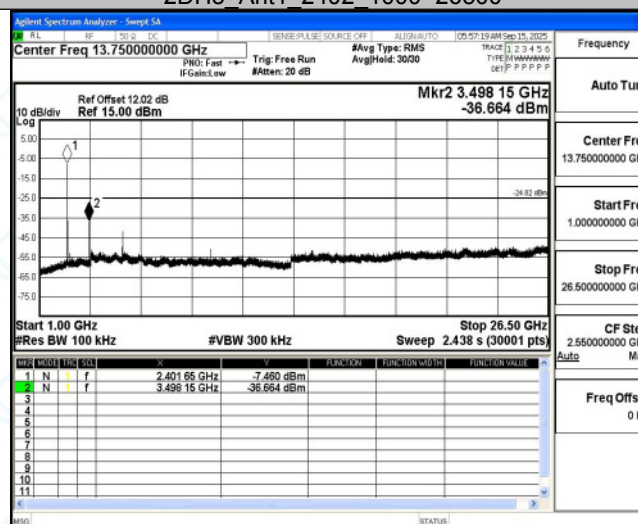
## 2DH5\_Ant1\_2402\_1000~26500

| TestMode | Antenna | Freq(MHz) | FreqRange [MHz] | RefLevel [dBm] | Result [dBm] | Limit [dBm] | Verdict |
|---|---|---|---|---|---|---|---|
| | | | 1000~26500 | -4.82 | -36.66 | $\leq -24.82$ | PASS |

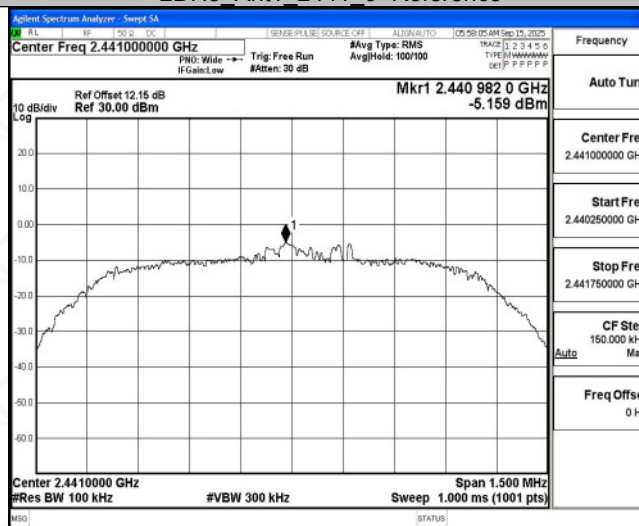
## 2DH5\_Ant1\_2441\_0~Reference

| TestMode | Antenna | Freq(MHz) | FreqRange [MHz] | RefLevel [dBm] | Result [dBm] | Limit [dBm] | Verdict |
|---|---|---|---|---|---|---|---|
| | | 2441 | Reference | -5.16 | -5.16 | --- | PASS |

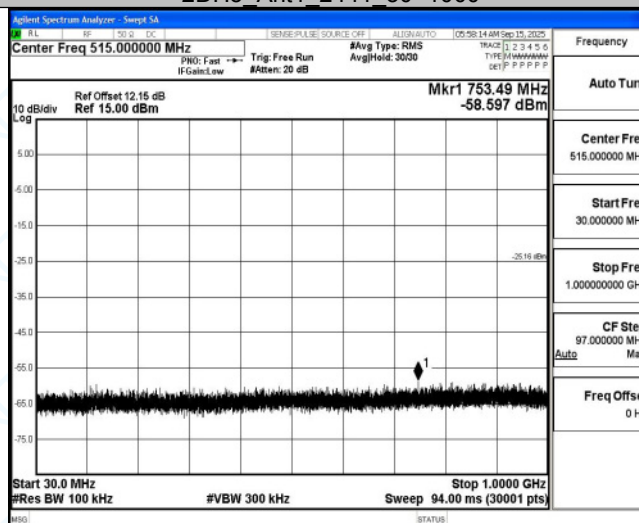
## 2DH5\_Ant1\_2441\_30~1000

| TestMode | Antenna | Freq(MHz) | FreqRange [MHz] | RefLevel [dBm] | Result [dBm] | Limit [dBm] | Verdict |
|---|---|---|---|---|---|---|---|
| | | | 30~1000 | -5.16 | -58.6 | $\leq -25.16$ | PASS |

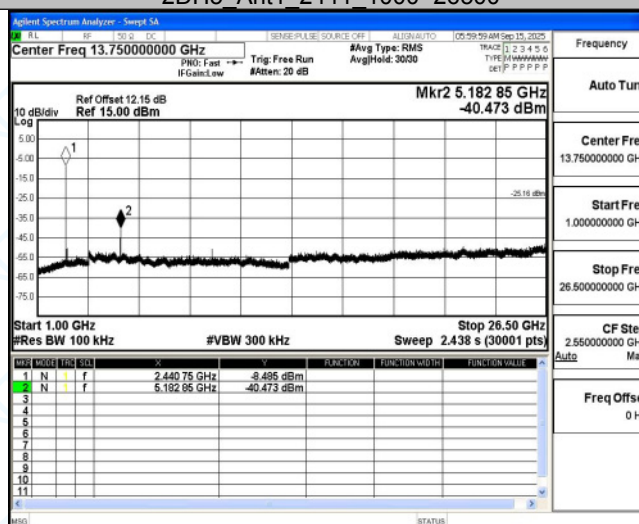
## 2DH5\_Ant1\_2441\_1000~26500

| TestMode | Antenna | Freq(MHz) | FreqRange [MHz] | RefLevel [dBm] | Result [dBm] | Limit [dBm] | Verdict |
|---|---|---|---|---|---|---|---|
| | | | 1000~26500 | -5.16 | -40.47 | $\leq -25.16$ | PASS |

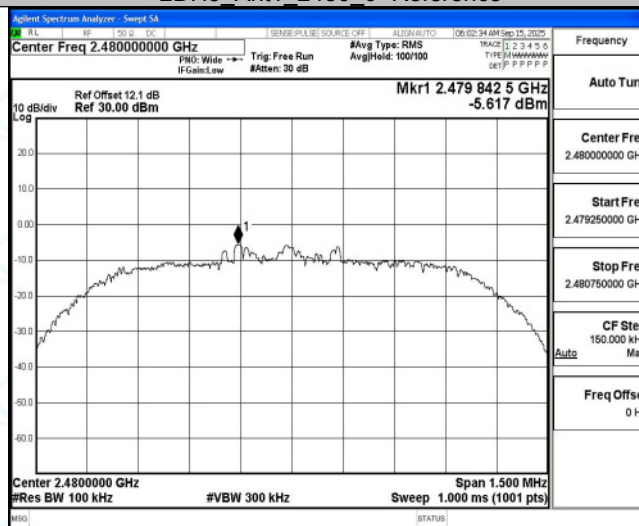
## 2DH5\_Ant1\_2480\_0~Reference

| TestMode | Antenna | Freq(MHz) | FreqRange [MHz] | RefLevel [dBm] | Result [dBm] | Limit [dBm] | Verdict |
|---|---|---|---|---|---|---|---|
| | | 2480 | Reference | -5.62 | -5.62 | --- | PASS |

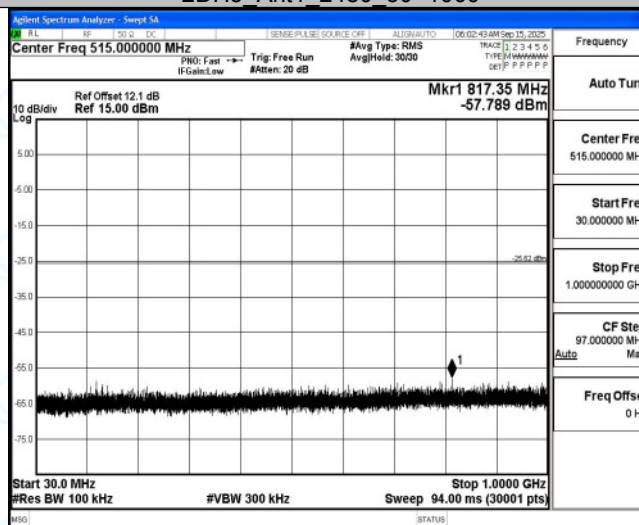
## 2DH5\_Ant1\_2480\_30~1000

| TestMode | Antenna | Freq(MHz) | FreqRange [MHz] | RefLevel [dBm] | Result [dBm] | Limit [dBm] | Verdict |
|---|---|---|---|---|---|---|---|
| | | | 30~1000 | -5.62 | -57.79 | $\leq -25.62$ | PASS |

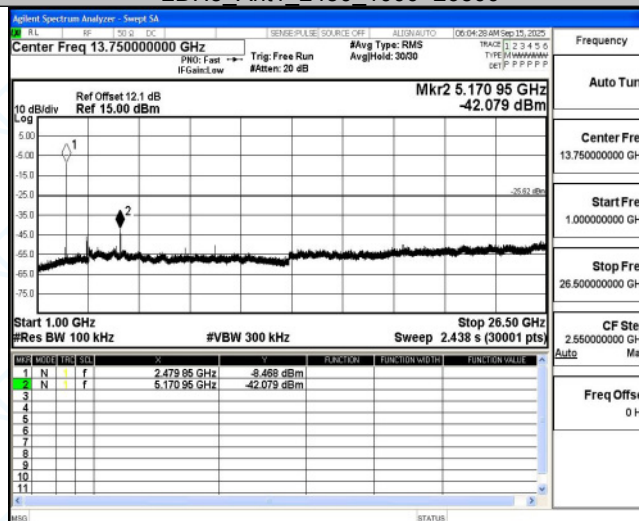
## 2DH5\_Ant1\_2480\_1000~26500

| TestMode | Antenna | Freq(MHz) | FreqRange [MHz] | RefLevel [dBm] | Result [dBm] | Limit [dBm] | Verdict |
|---|---|---|---|---|---|---|---|
| | | | 1000~26500 | -5.62 | -42.08 | $\leq -25.62$ | PASS |
