## Appendix B: Photographs of Test Setup

Product: Tablet PC

Model: X23Pro

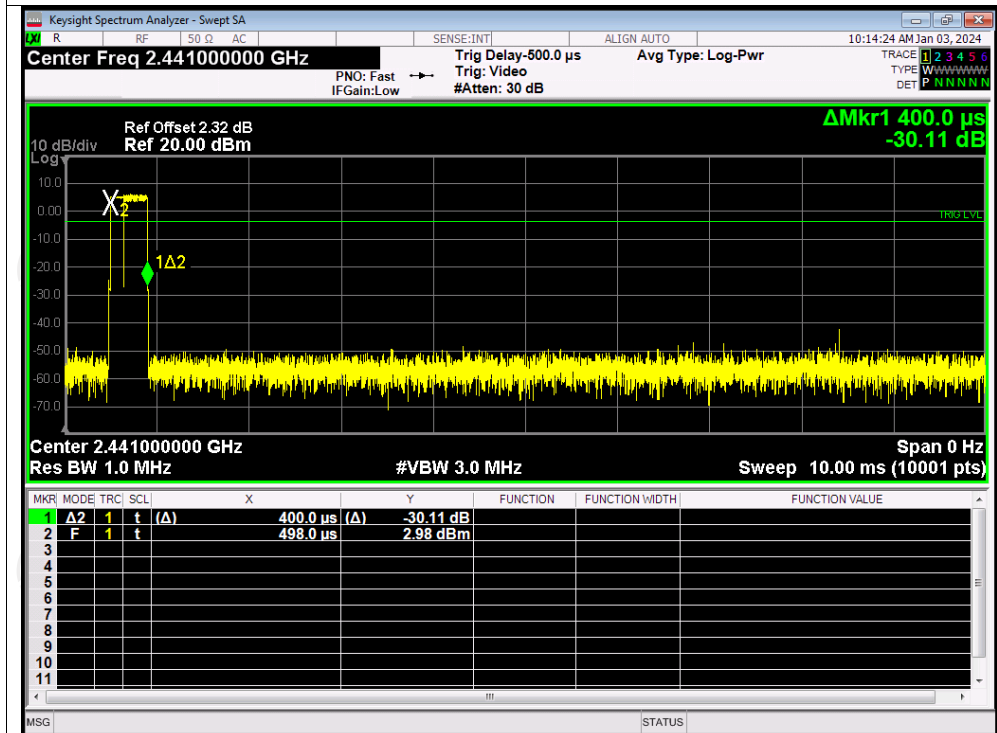
## Dwell NVNT 2-DH1 2441MHz One Burst

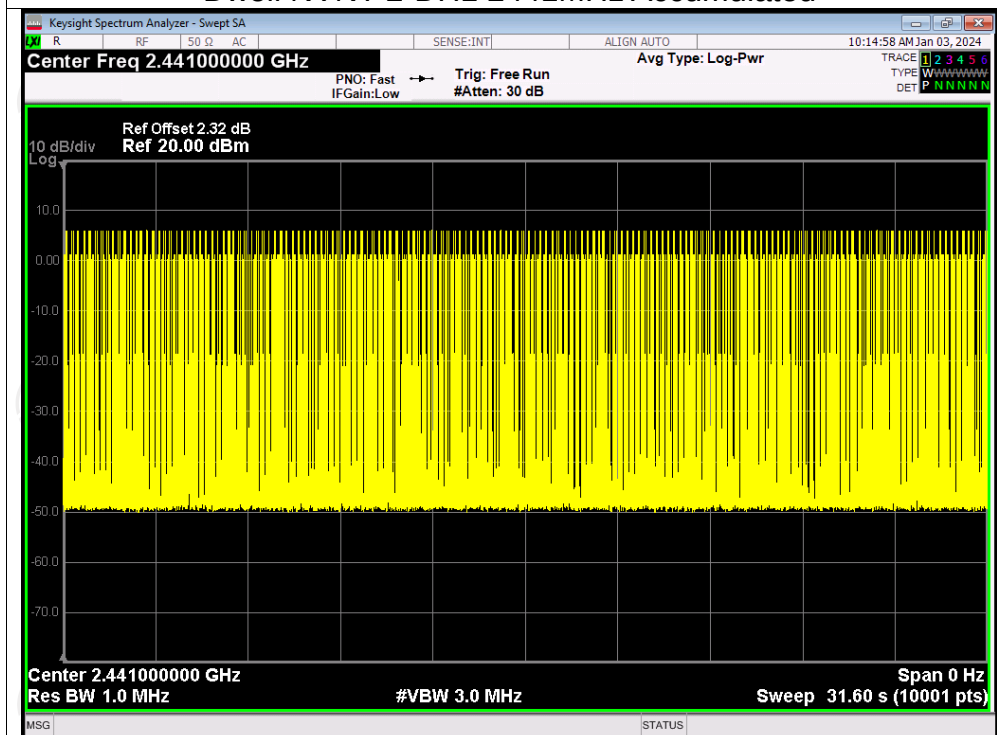
## Dwell NVNT 2-DH1 2441MHz Accumulated

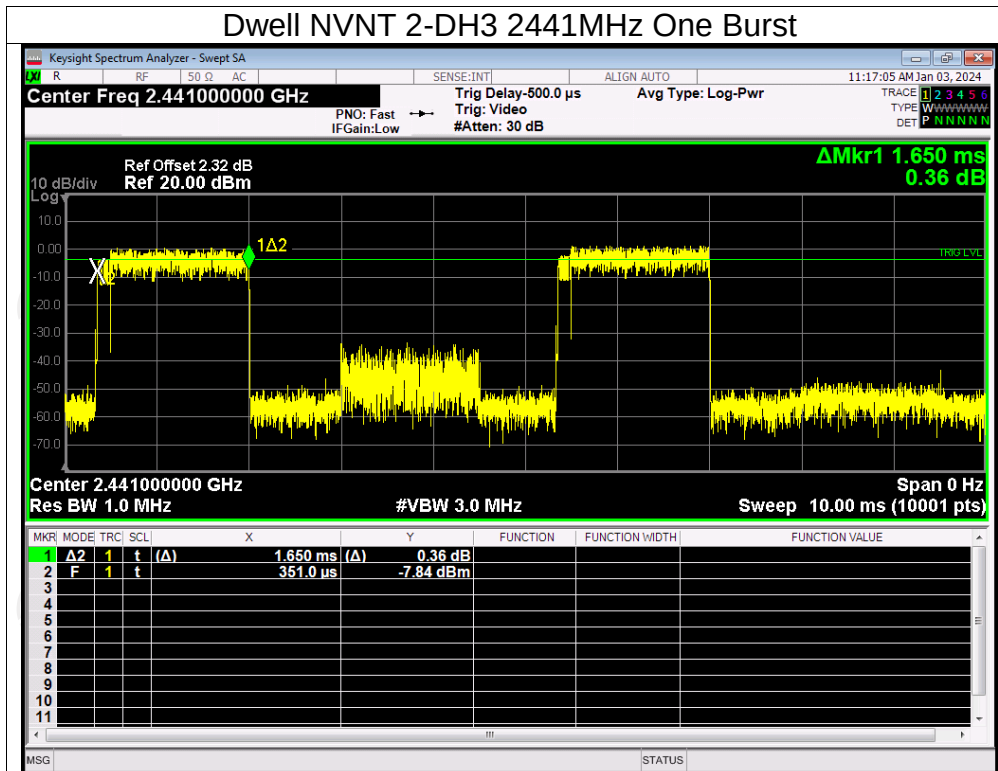
## Dwell NVNT 2-DH3 2441MHz One Burst

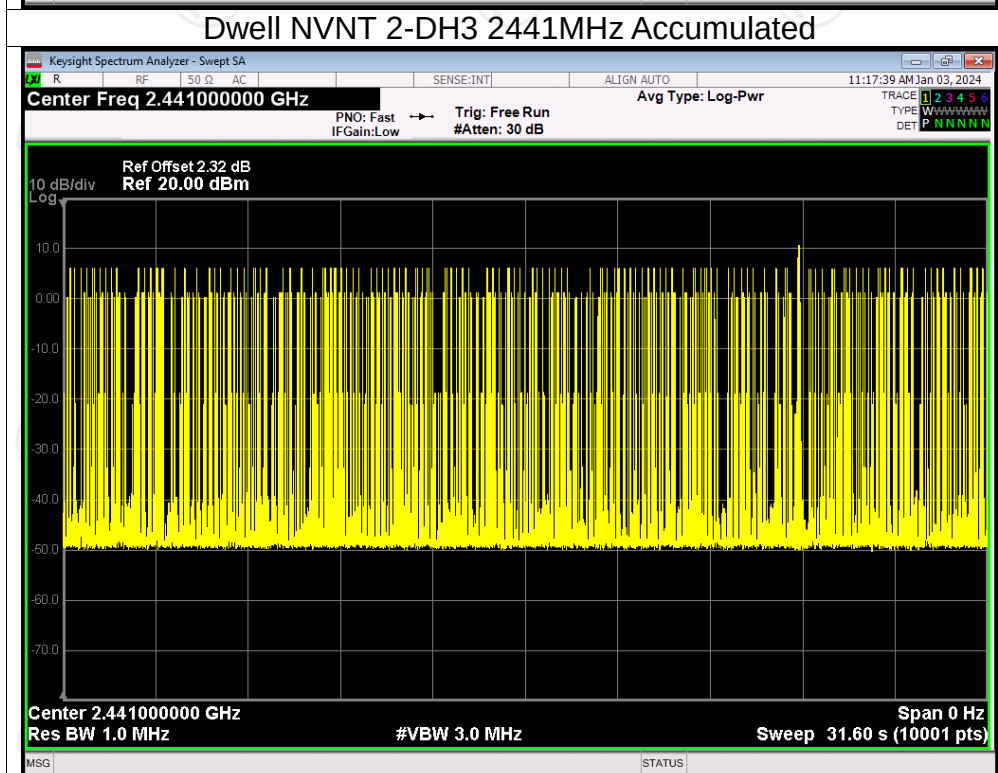
## Dwell NVNT 2-DH3 2441MHz Accumulated

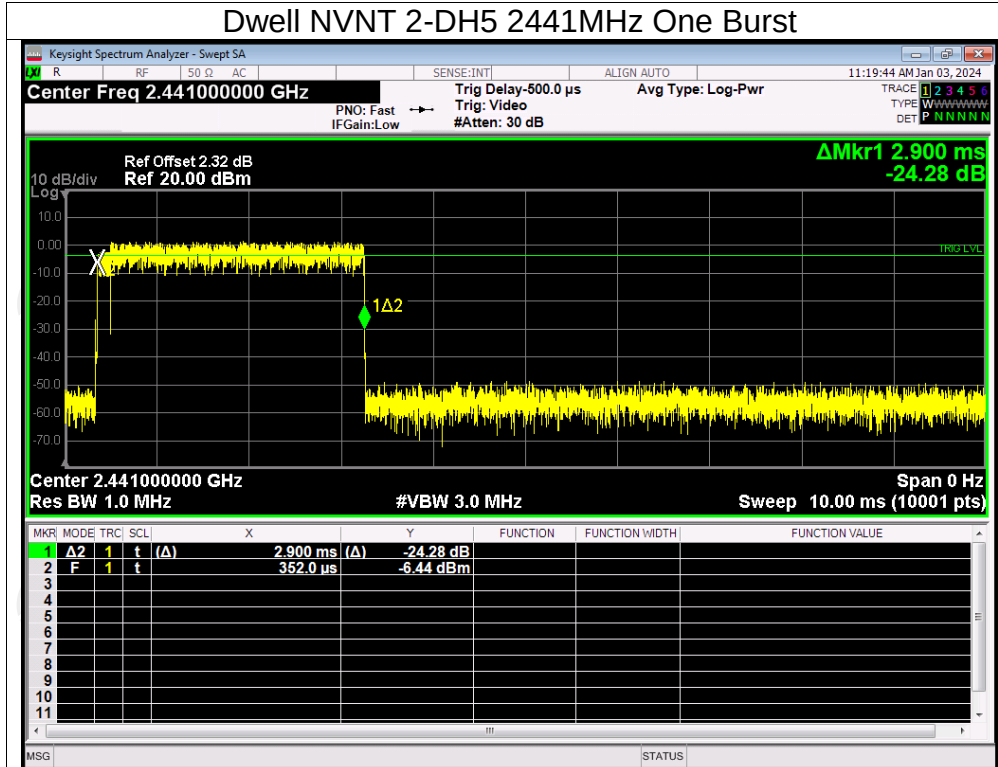
## Dwell NVNT 2-DH5 2441MHz One Burst

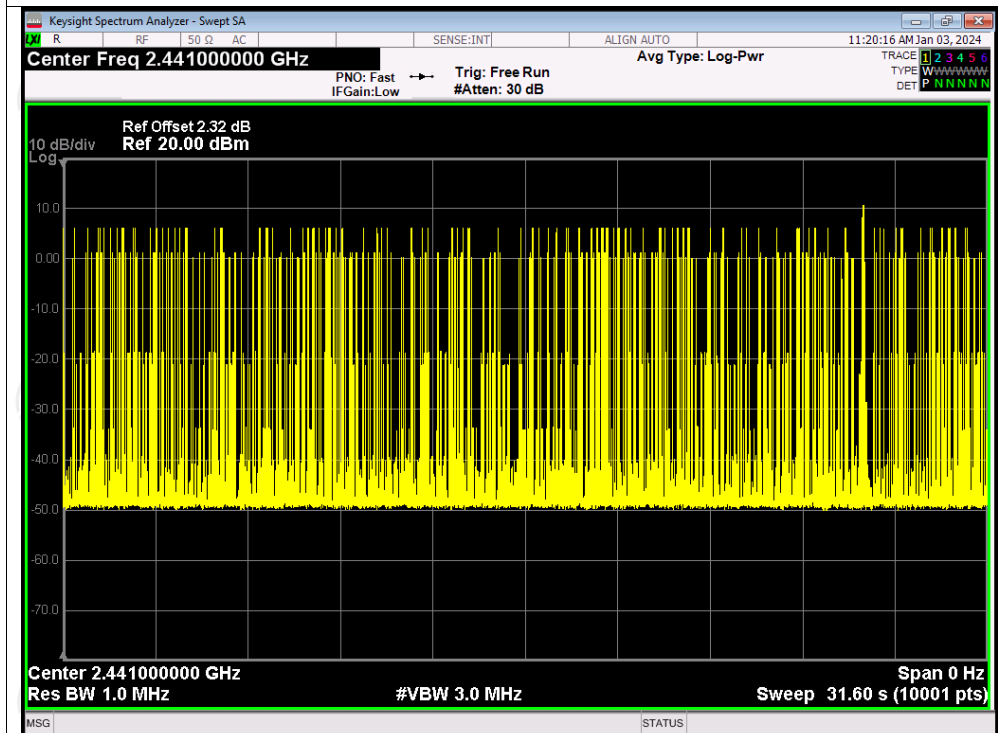
## Dwell NVNT 2-DH5 2441MHz Accumulated

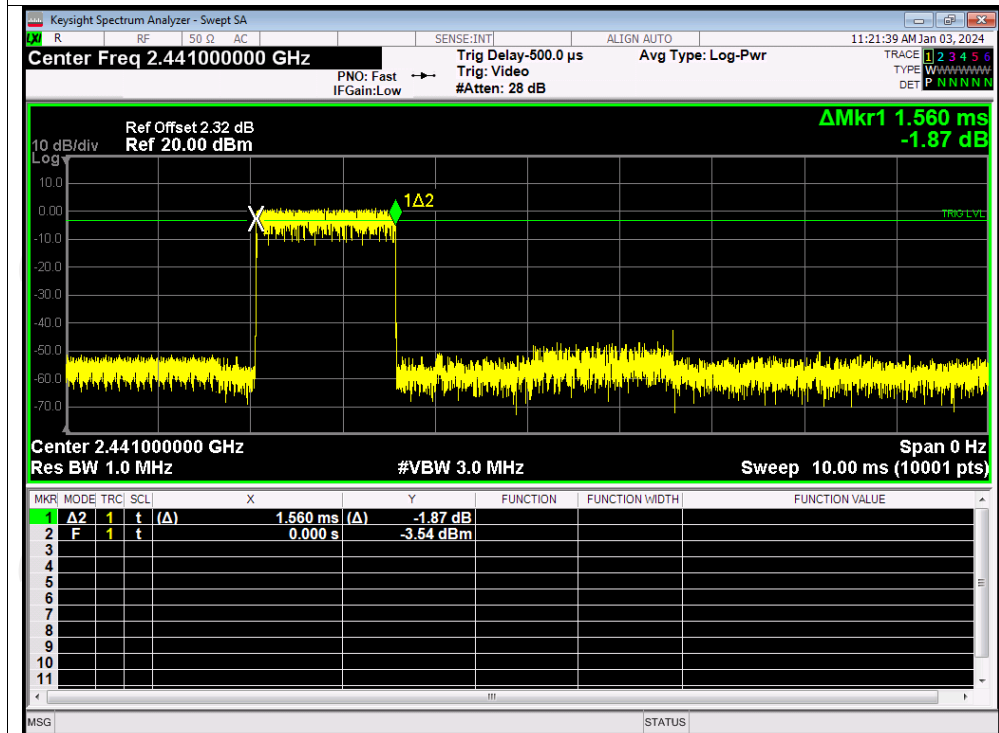
## Dwell NVNT 3-DH3 2441MHz One Burst

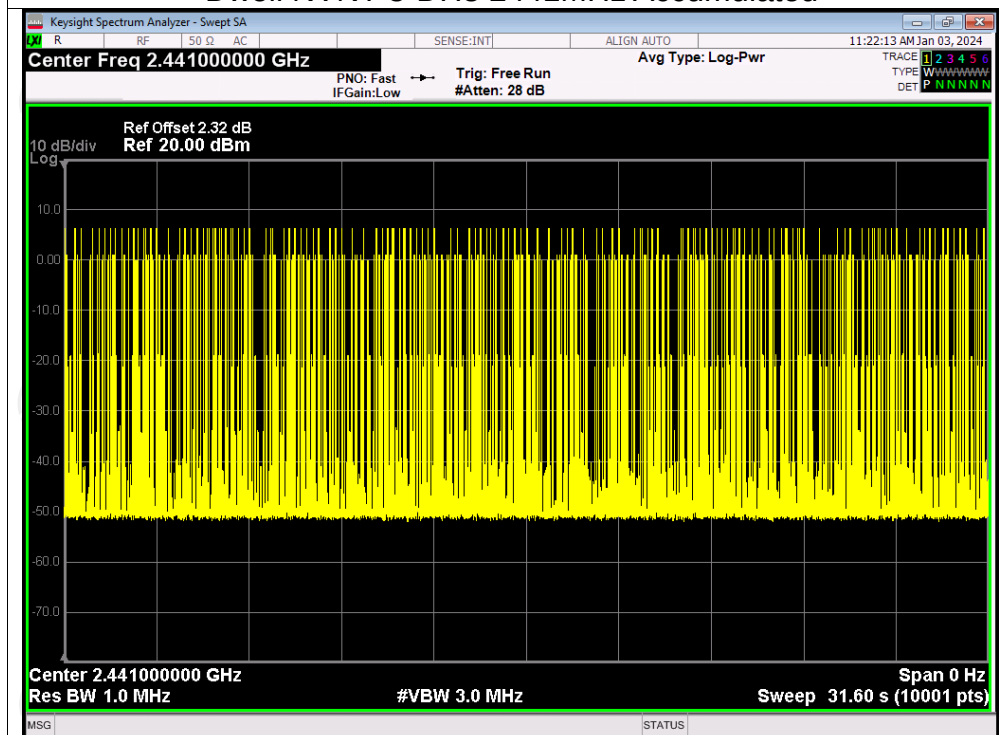
## Dwell NVNT 3-DH3 2441MHz Accumulated

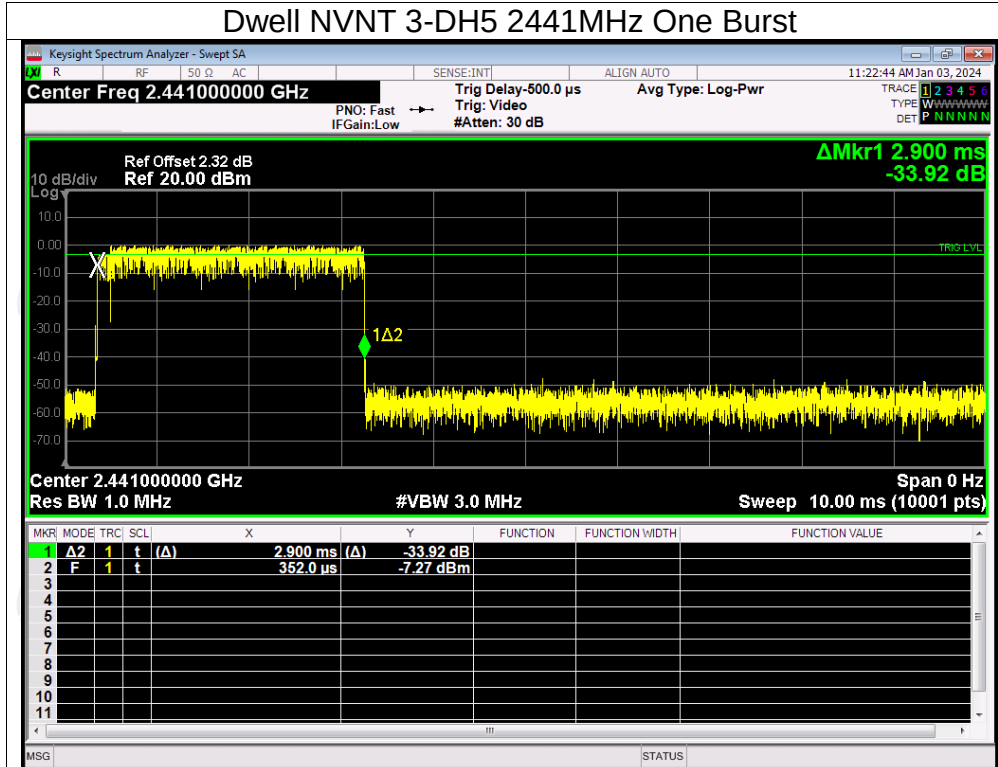
## Dwell NVNT 3-DH5 2441MHz One Burst

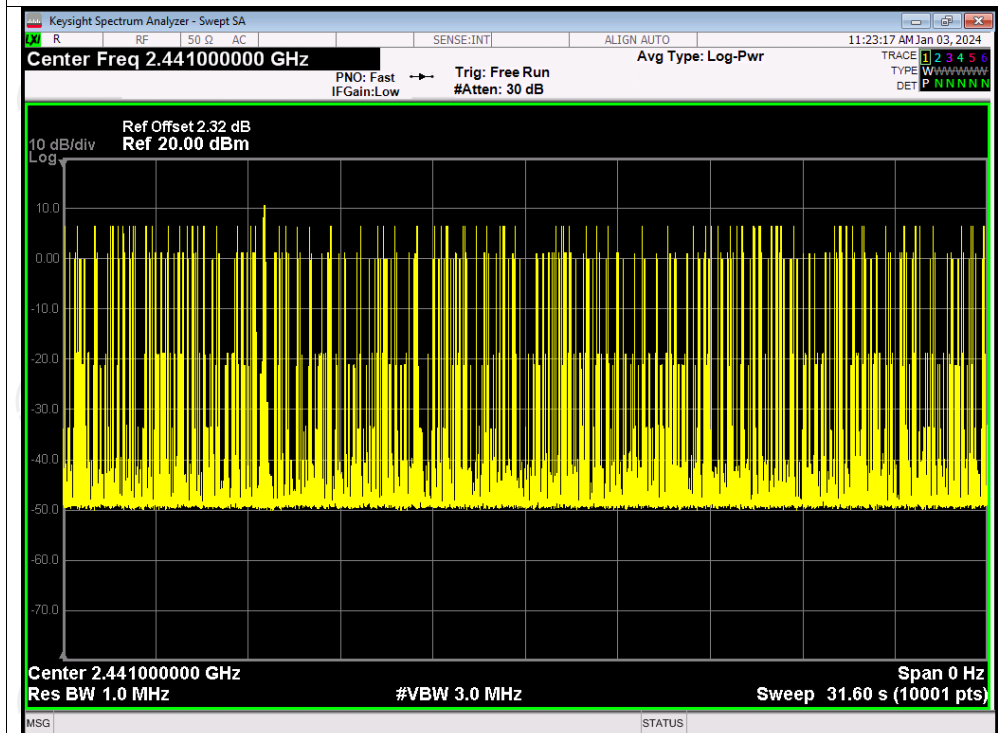
## Dwell NVNT 3-DH5 2441MHz Accumulated

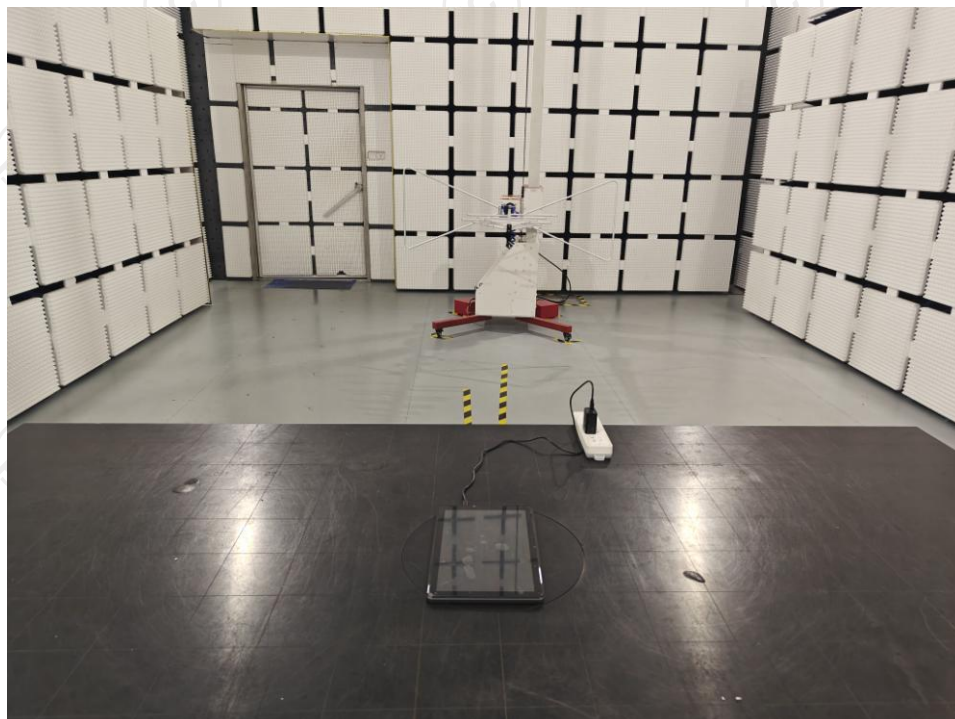
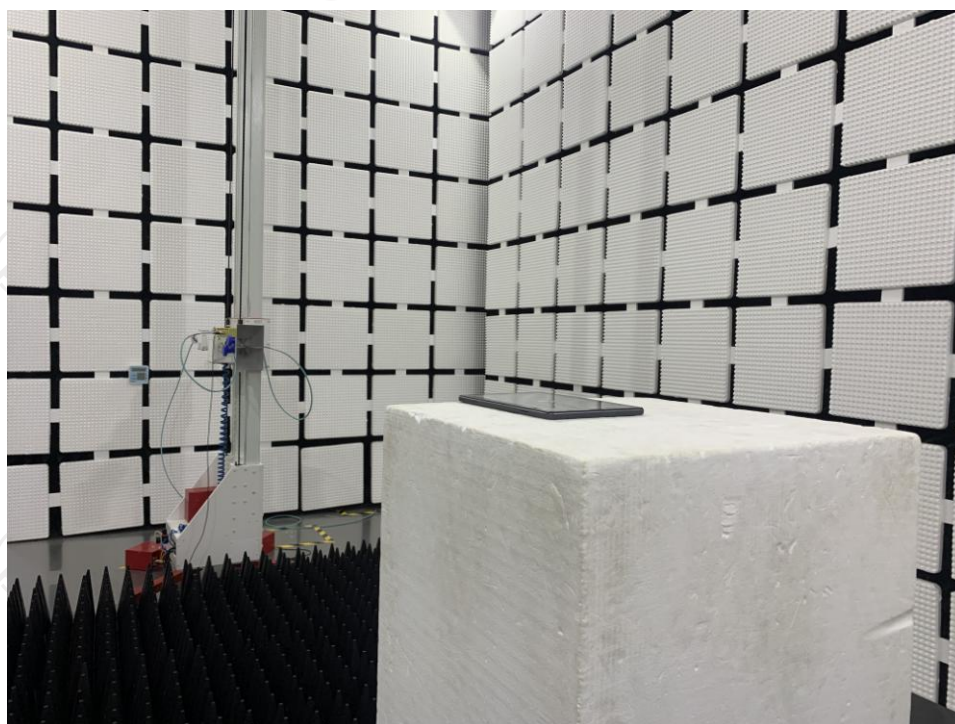
Radiated Emission

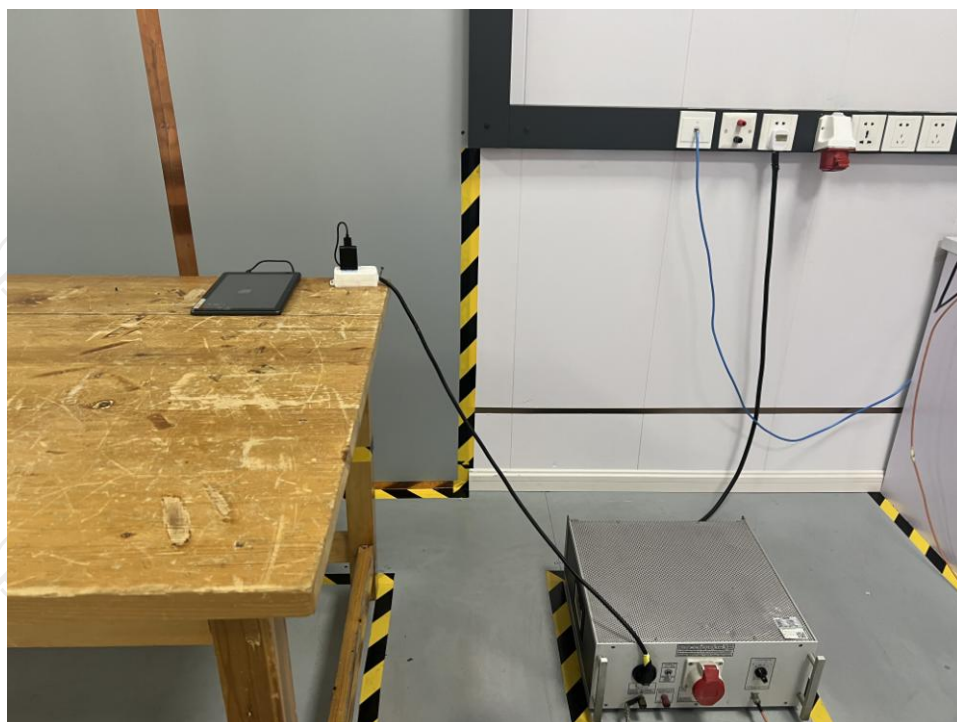
### Conducted Emission

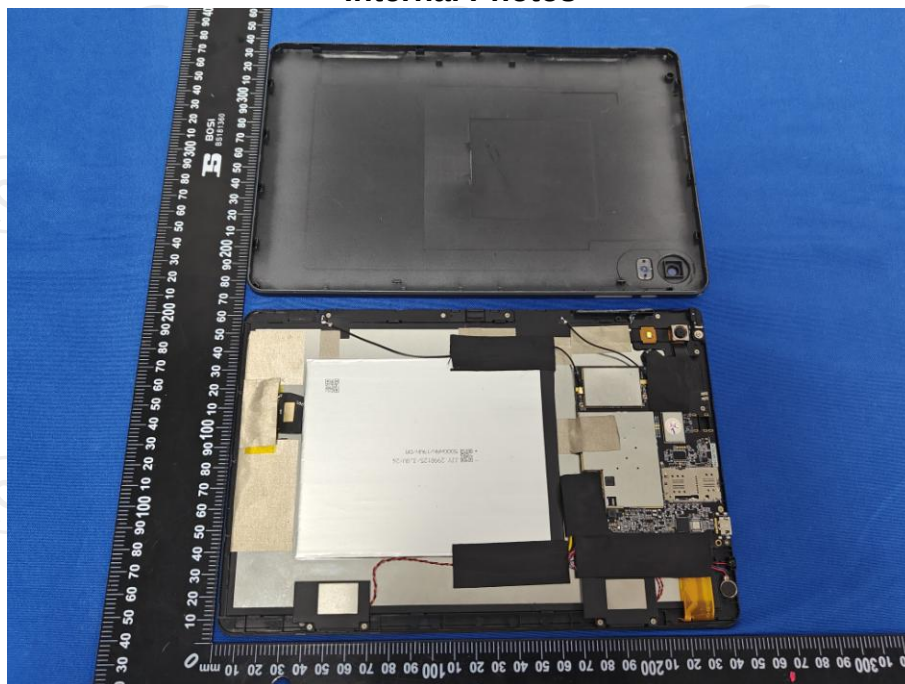
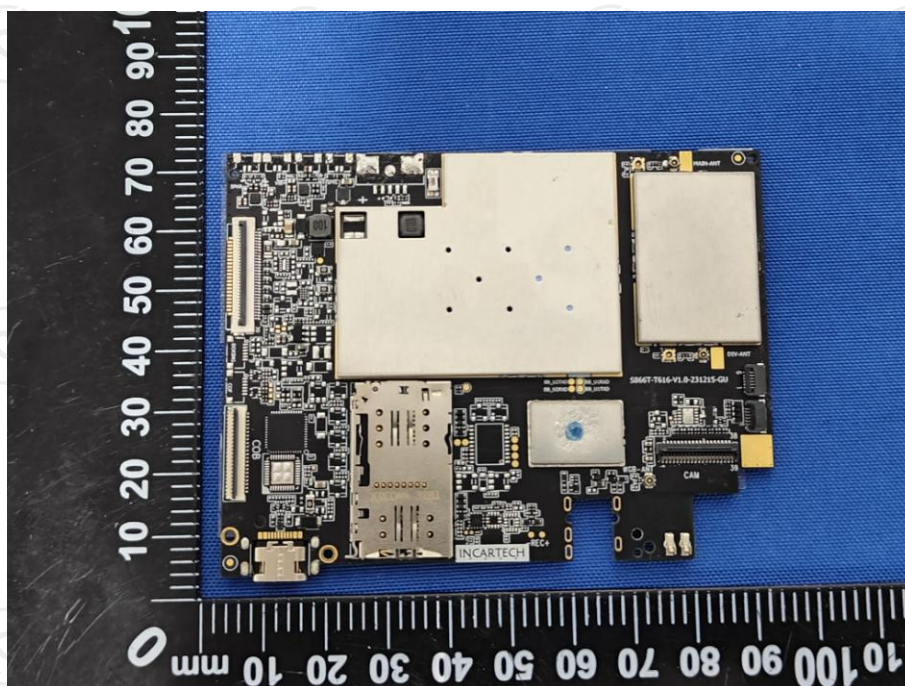
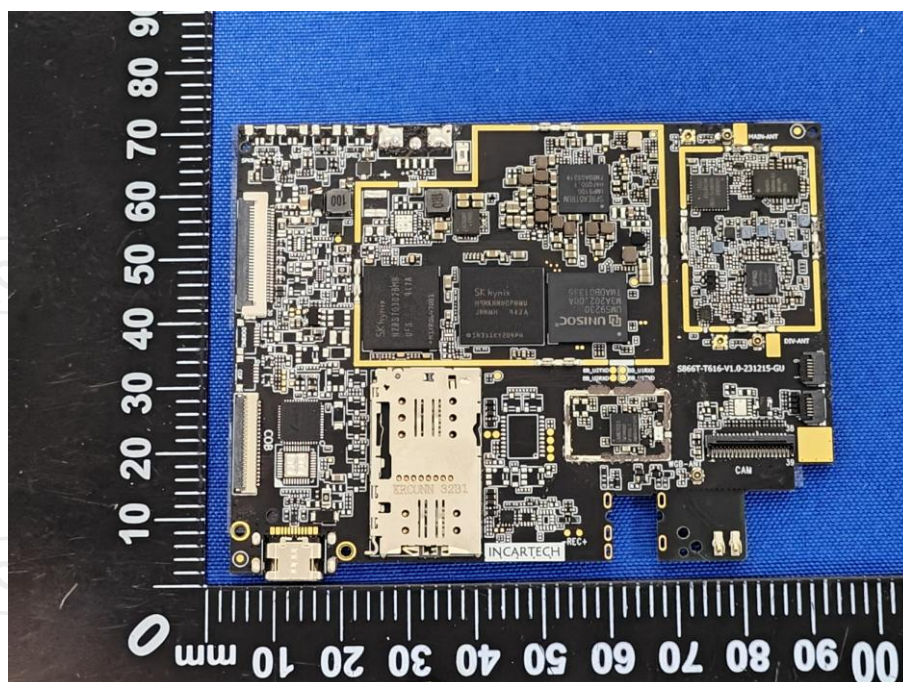
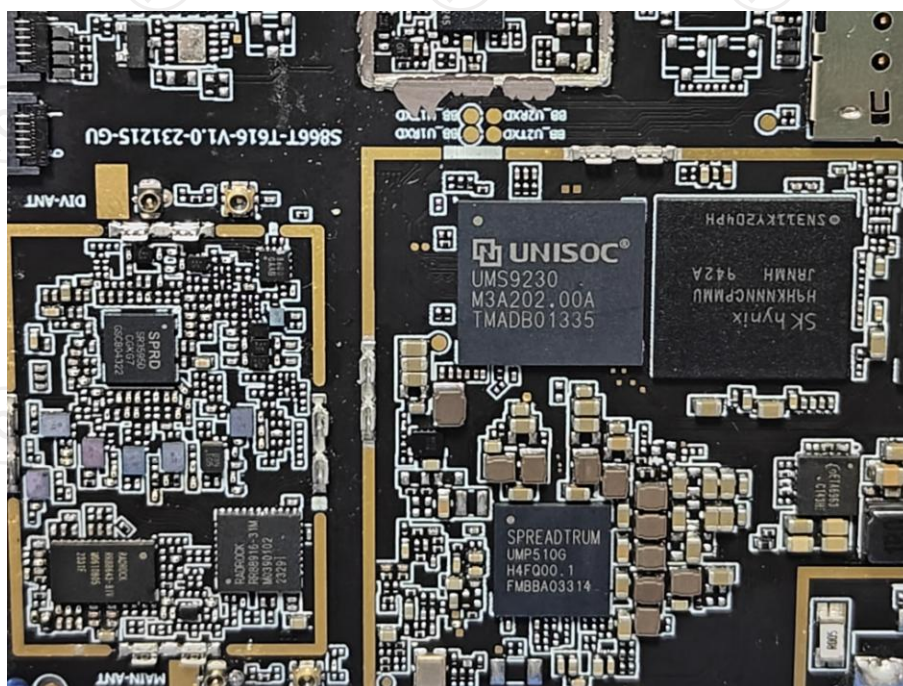
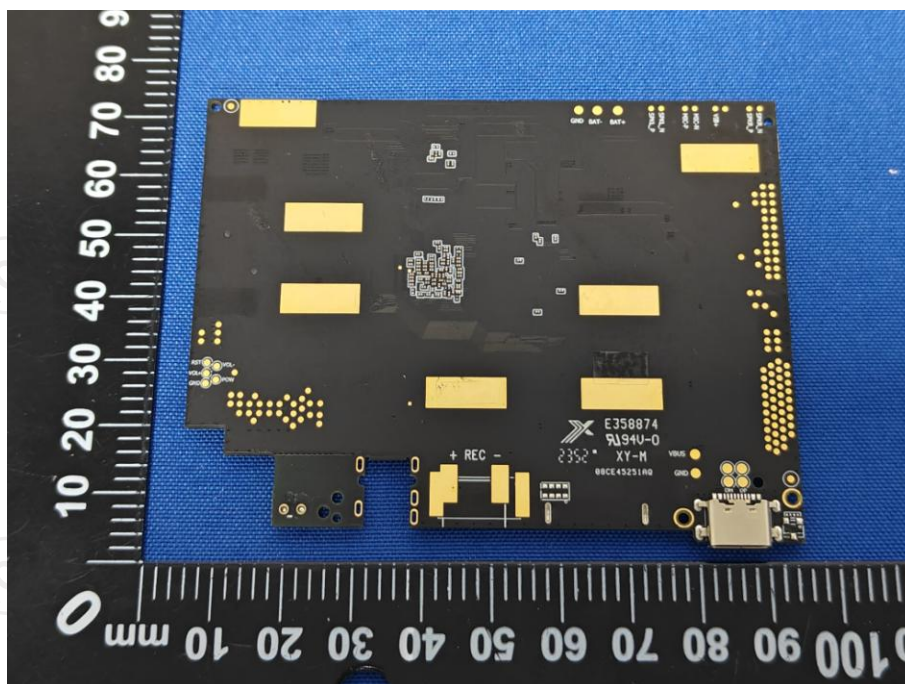
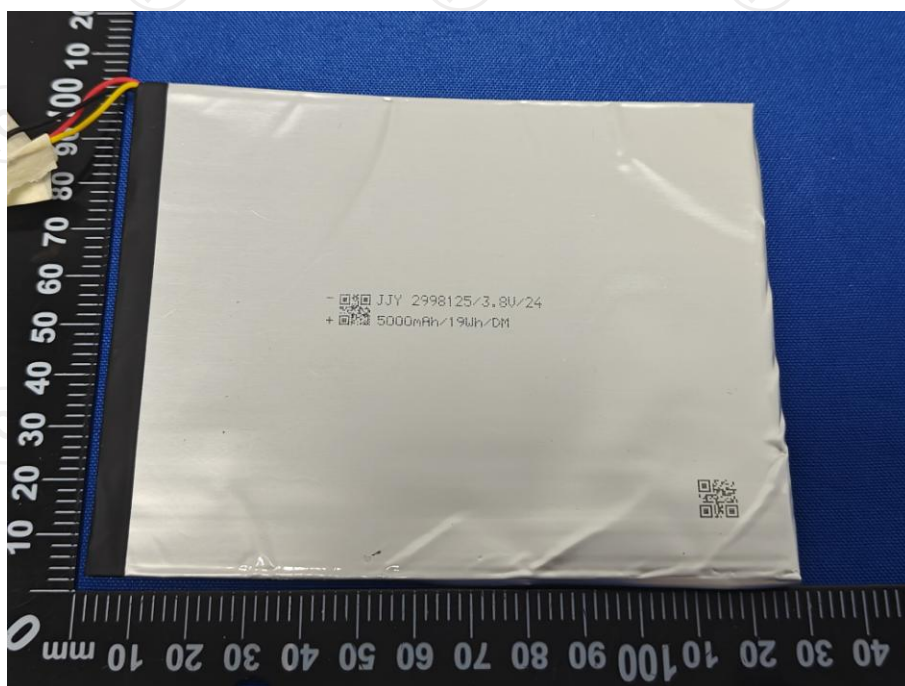
**Product: Tablet PC**  
**Model: X23Pro**  
**Internal Photos**
