## Appendix F: Conducted Spurious Emission

### Test Result

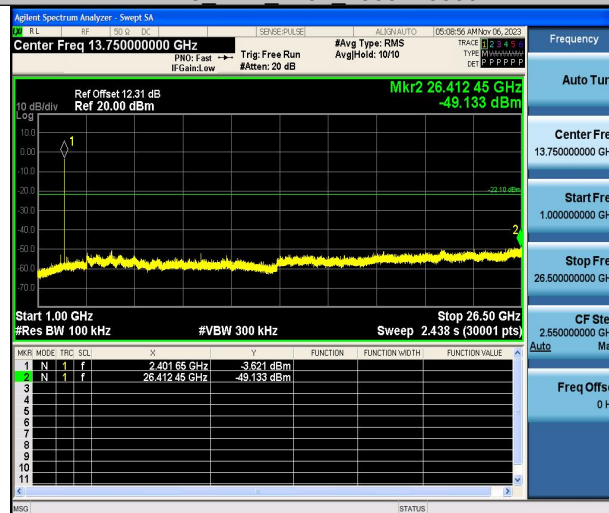
DH5\_Ant1\_2402\_1000~26500

| Test Mode | Antenna | Freq(MHz) | Freq Range [MHz] | RefLevel [dBm] | Result [dBm] | Limit [dBm] | Verdict |
|---|---|---|---|---|---|---|---|
| | | | 1000~26500 | -2.10 | -49.13 | $\leq -22.1$ | PASS |

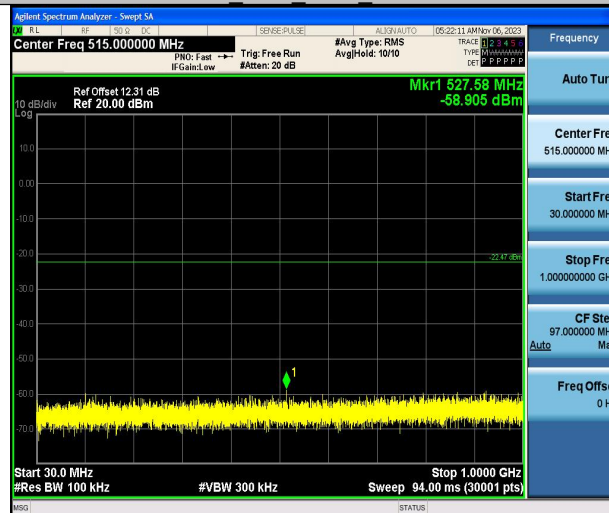
## 2DH5\_Ant1\_2402\_30~1000

| Test Mode | Antenna | Freq(MHz) | Freq Range [MHz] | RefLevel [dBm] | Result [dBm] | Limit [dBm] | Verdict |
|---|---|---|---|---|---|---|---|
| | | | 30~1000 | -2.47 | -58.91 | $\leq -22.47$ | PASS |

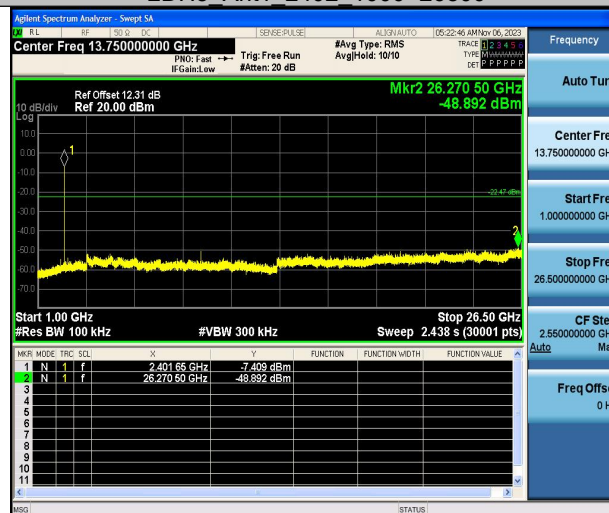
## 2DH5\_Ant1\_2402\_1000~26500

| Test Mode | Antenna | Freq(MHz) | Freq Range [MHz] | RefLevel [dBm] | Result [dBm] | Limit [dBm] | Verdict |
|---|---|---|---|---|---|---|---|
| | | | 1000~26500 | -2.47 | -48.89 | $\leq -22.47$ | PASS |

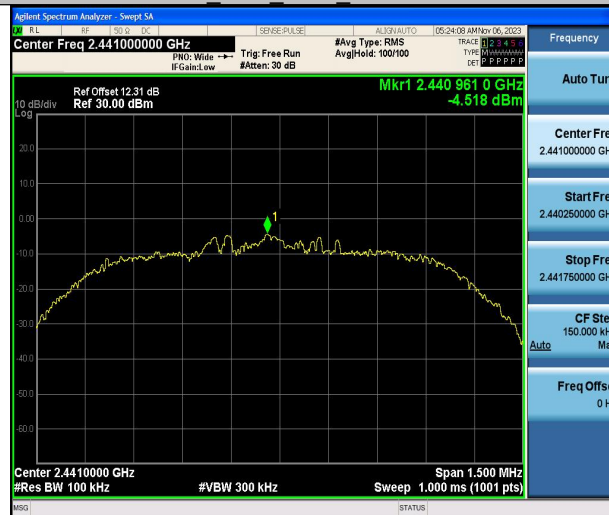
## 2DH5 Ant1 2441 0~Reference

| Test Mode | Antenna | Freq(MHz) | Freq Range [MHz] | RefLevel [dBm] | Result [dBm] | Limit [dBm] | Verdict |
|---|---|---|---|---|---|---|---|
| | | 2441 | Reference | -4.52 | -4.52 | --- | PASS |

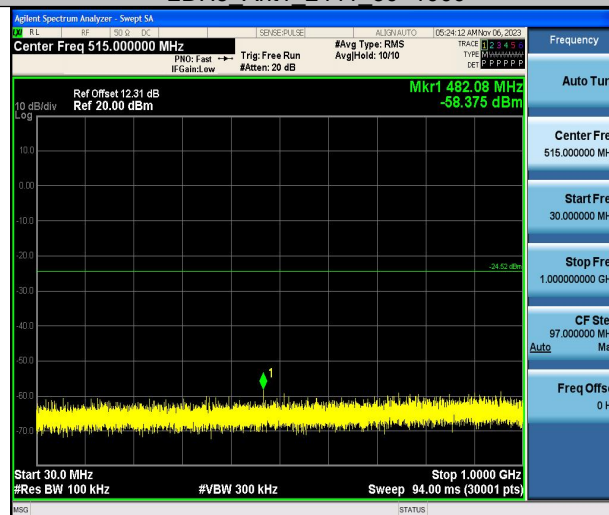
## 2DH5 Ant1 2441 30~1000

| Test Mode | Antenna | Freq(MHz) | Freq Range [MHz] | RefLevel [dBm] | Result [dBm] | Limit [dBm] | Verdict |
|---|---|---|---|---|---|---|---|
| | | | 30~1000 | -4.52 | -58.38 | $\leq -24.52$ | PASS |

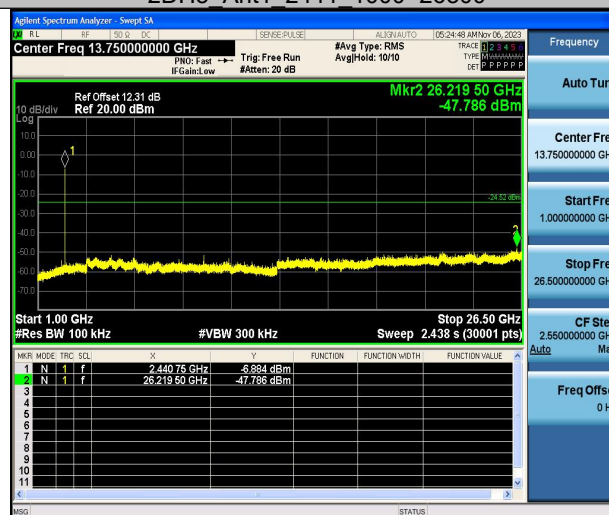
## 2DH5 Ant1 2441 1000~26500

| Test Mode | Antenna | Freq(MHz) | Freq Range [MHz] | RefLevel [dBm] | Result [dBm] | Limit [dBm] | Verdict |
|---|---|---|---|---|---|---|---|
| | | | 1000~26500 | -4.52 | -47.79 | $\leq -24.52$ | PASS |

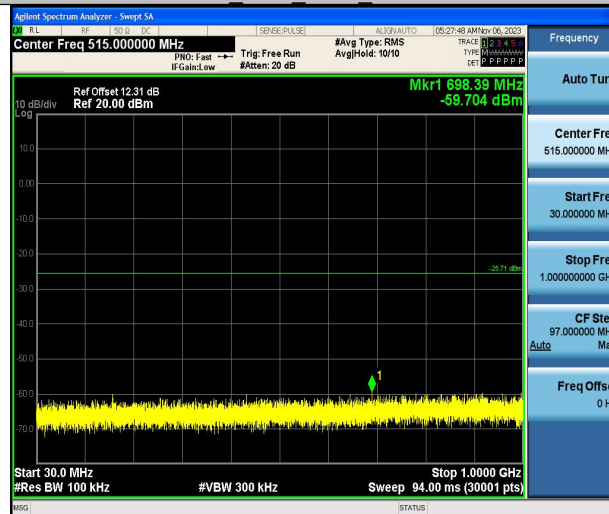
## 2DH5 Ant1 2480 30~1000

| Test Mode | Antenna | Freq(MHz) | Freq Range [MHz] | RefLevel [dBm] | Result [dBm] | Limit [dBm] | Verdict |
|---|---|---|---|---|---|---|---|
| | | | 30~1000 | -5.71 | -59.7 | $\leq -25.71$ | PASS |

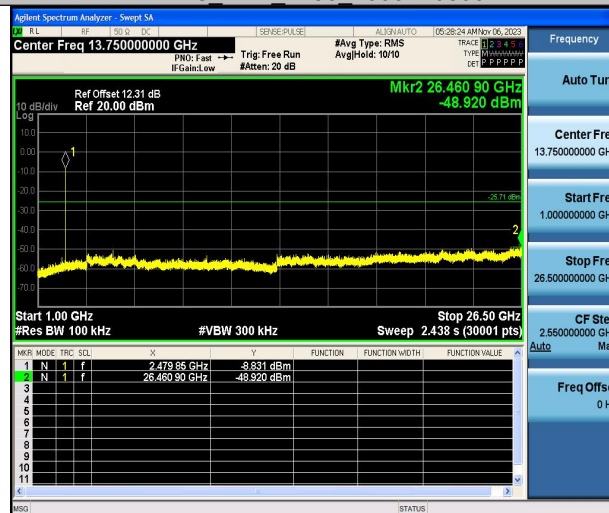
## 2DH5 Ant1 2480 1000~26500

| Test Mode | Antenna | Freq(MHz) | Freq Range [MHz] | RefLevel [dBm] | Result [dBm] | Limit [dBm] | Verdict |
|---|---|---|---|---|---|---|---|
| | | | 1000~26500 | -5.71 | -48.92 | $\leq -25.71$ | PASS |
