## Appendix B: photographs of test setup

## Appendix C: photographs of EUT

Reference to the test report no. BLA-EMC-202503-A7701

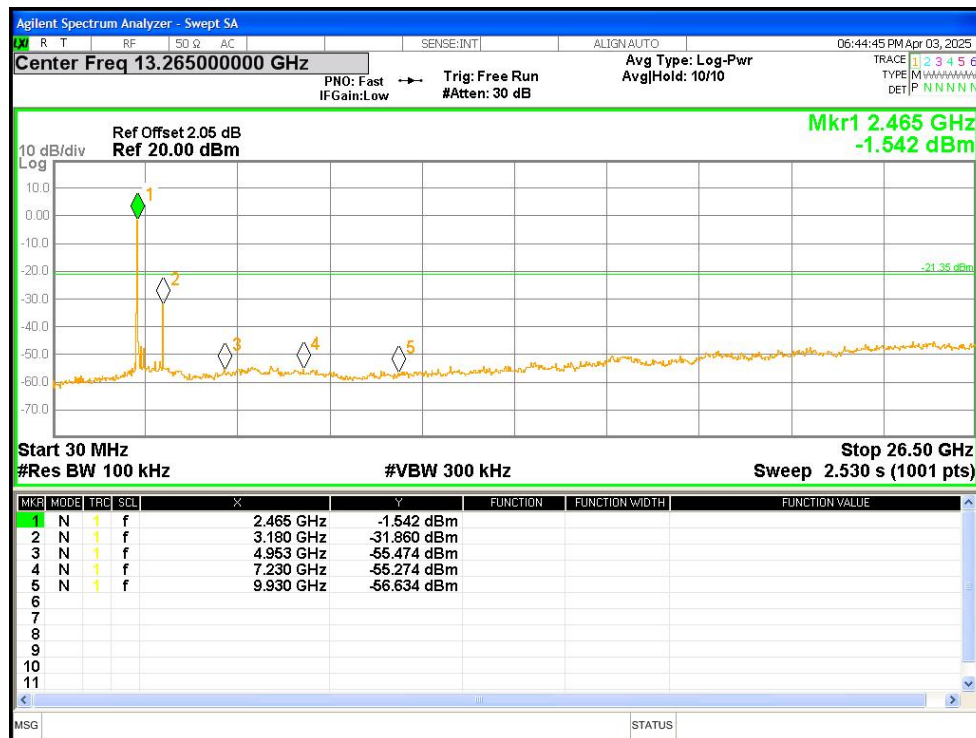
Tx. Spurious NVNT n40 2422MHz Ant1 Ref

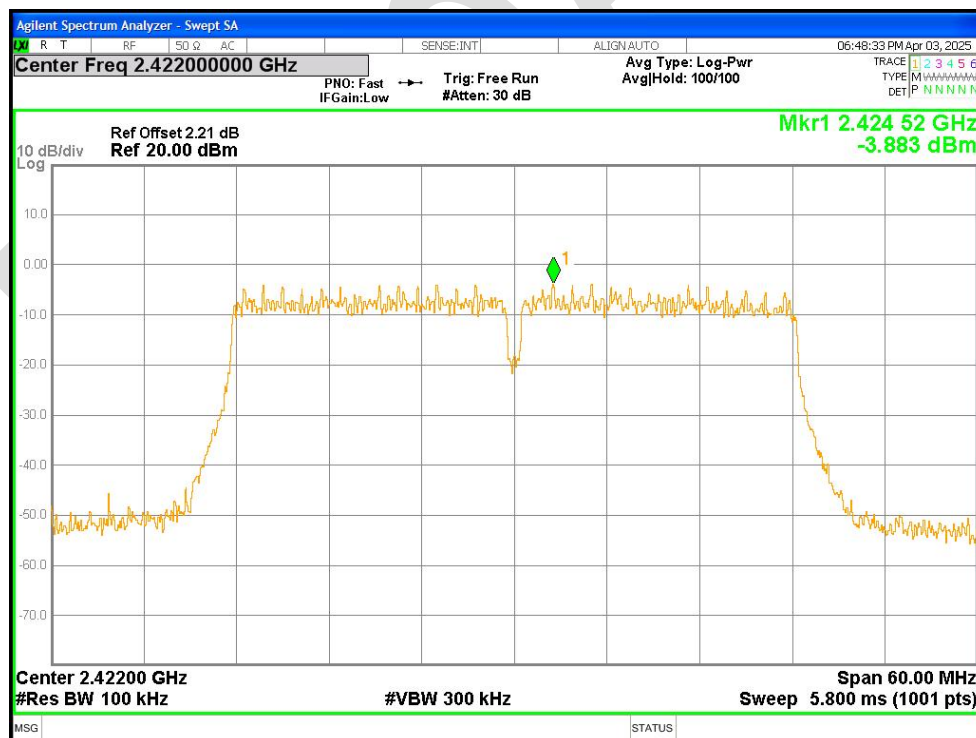
Tx. Spurious NVNT n40 2422MHz Ant1 Emission

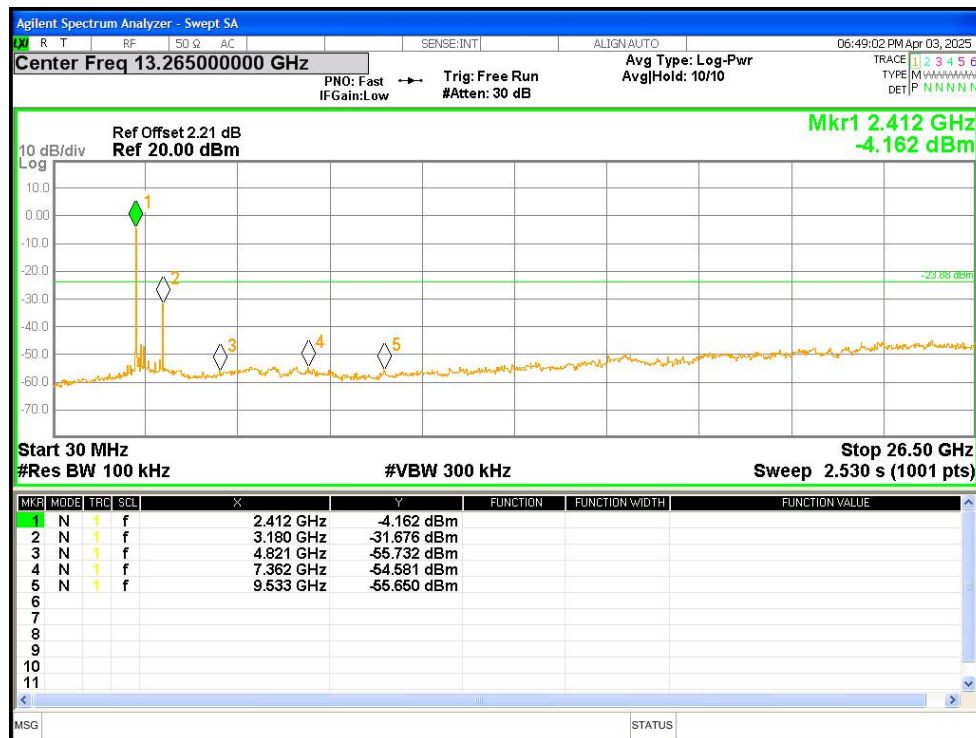
Tx. Spurious NVNT n40 2437MHz Ant1 Ref

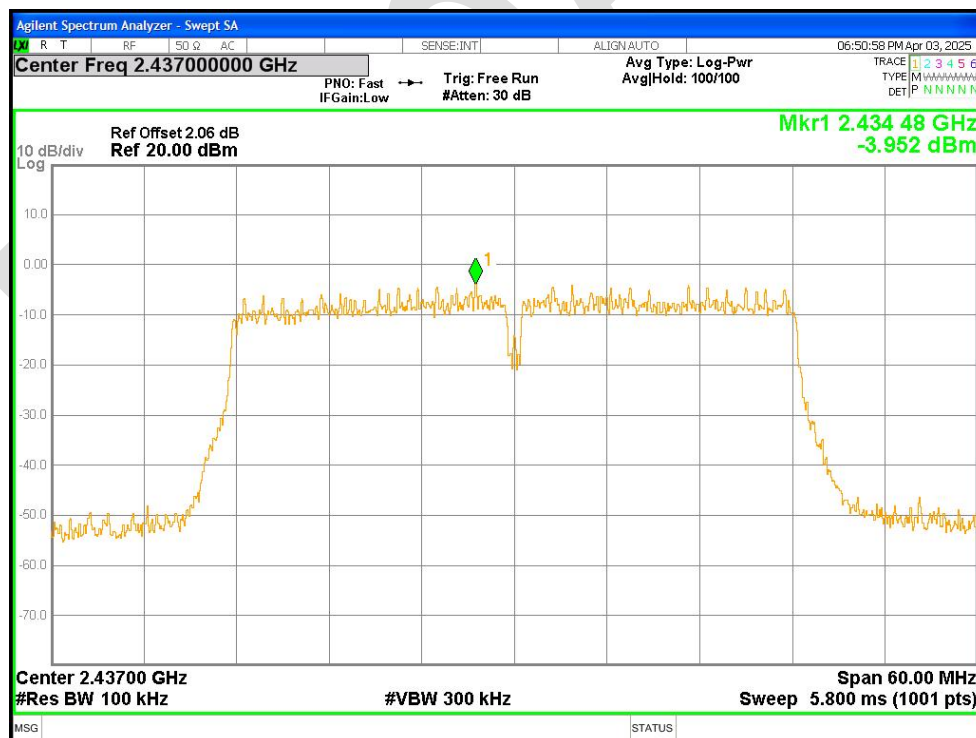
Tx. Spurious NVNT n40 2437MHz Ant1 Emission

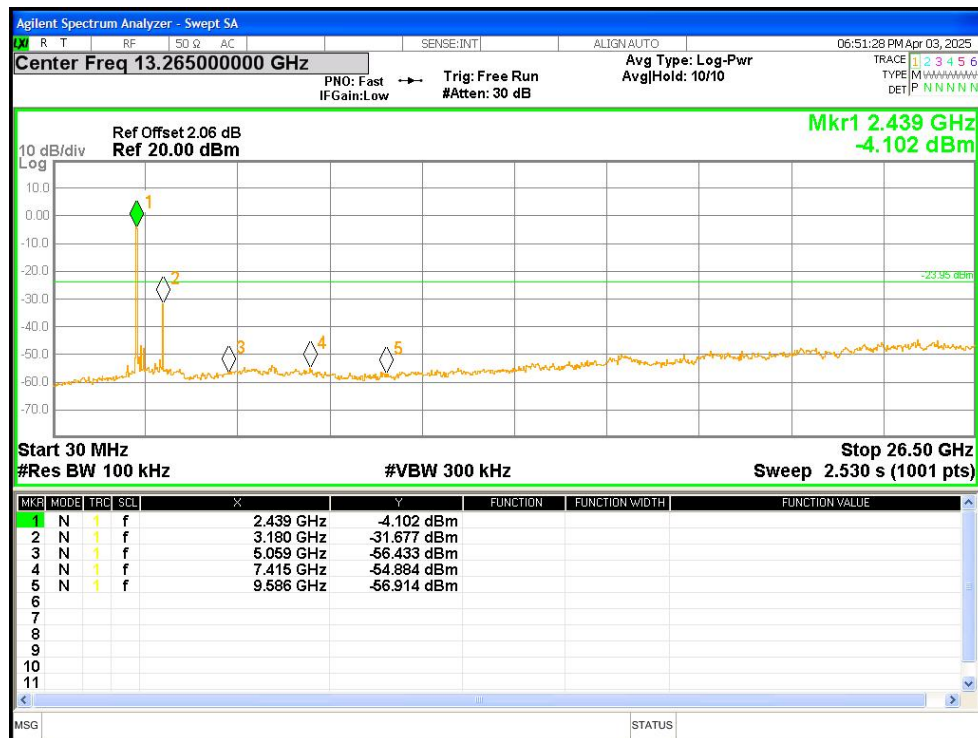
Tx. Spurious NVNT n40 2452MHz Ant1 Ref

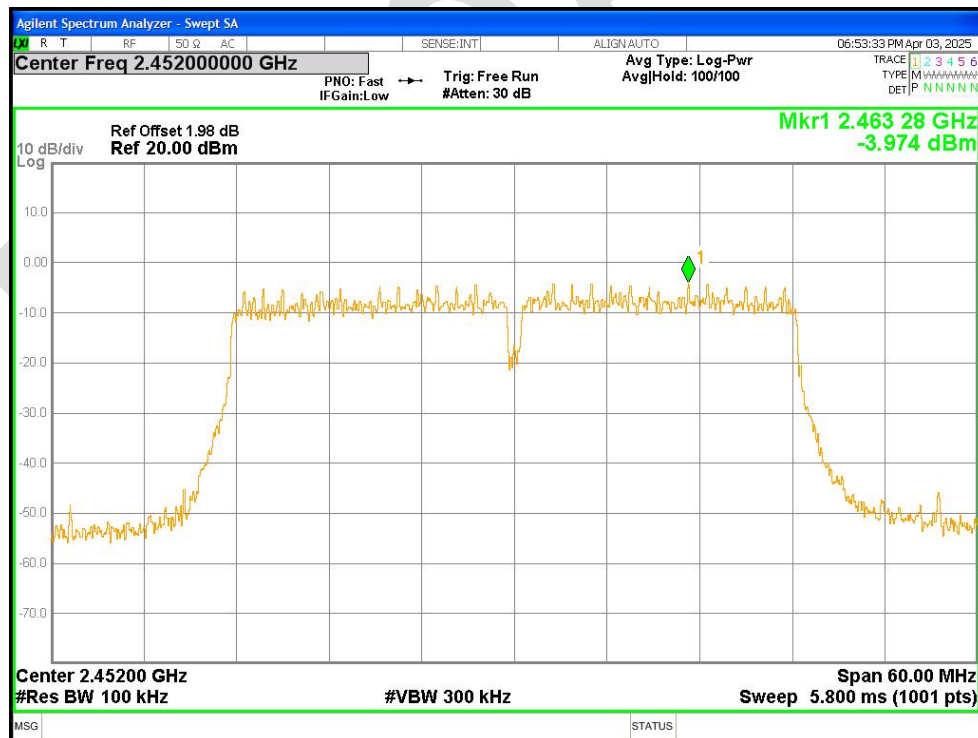
Tx. Spurious NVNT n40 2452MHz Ant1 Emission

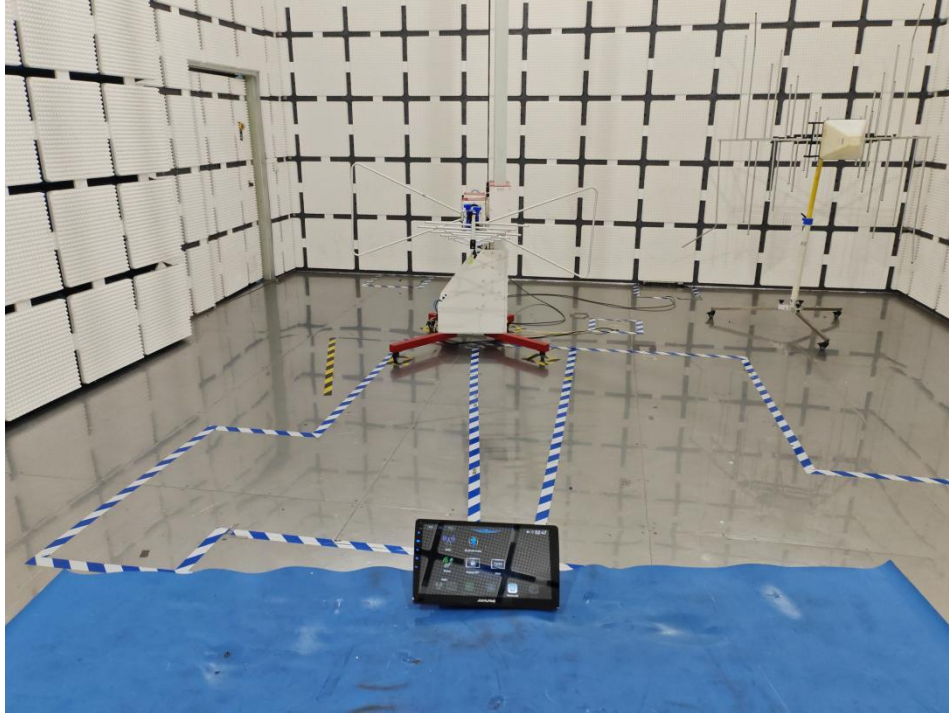
Radiated Emissions (30MHz-1GHz)

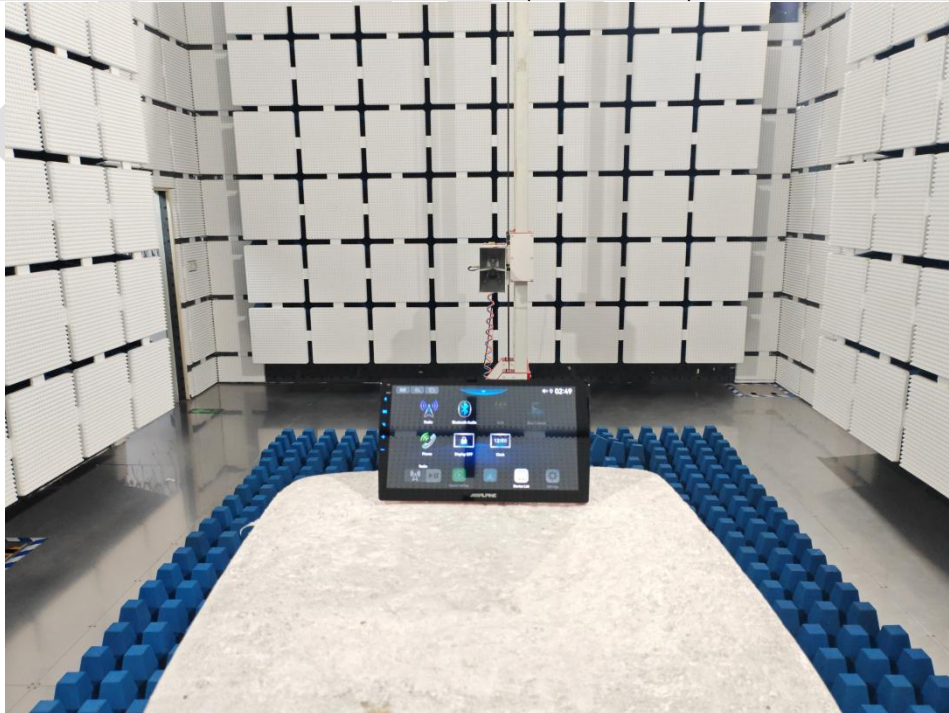
Radiated Emissions (above 1GHz)
