Appendix E: Number of hopping channels

## Appendix F: Band edge measurements

## Appendix G: Conducted Spurious Emission

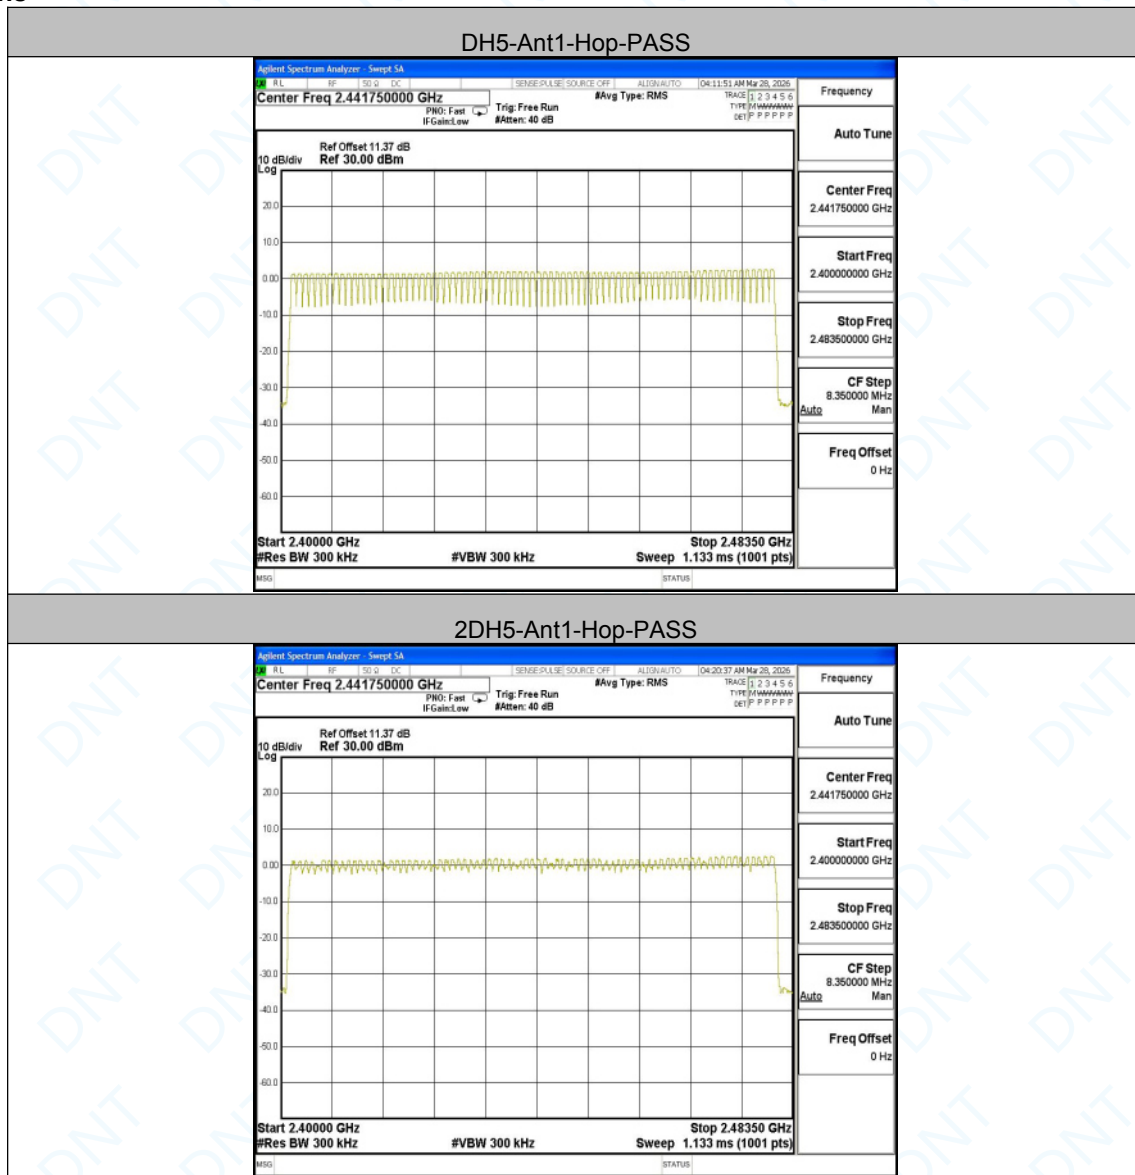
## Test Graphs

| TestMode | Antenna | Frequency[MHz] | Result[Num] | Limit[Num] | Verdict |
| DH5 | Ant1 | Hop | 79 | ≥15 | PASS |
| 2DH5 | Ant1 | Hop | 79 | ≥15 | PASS |

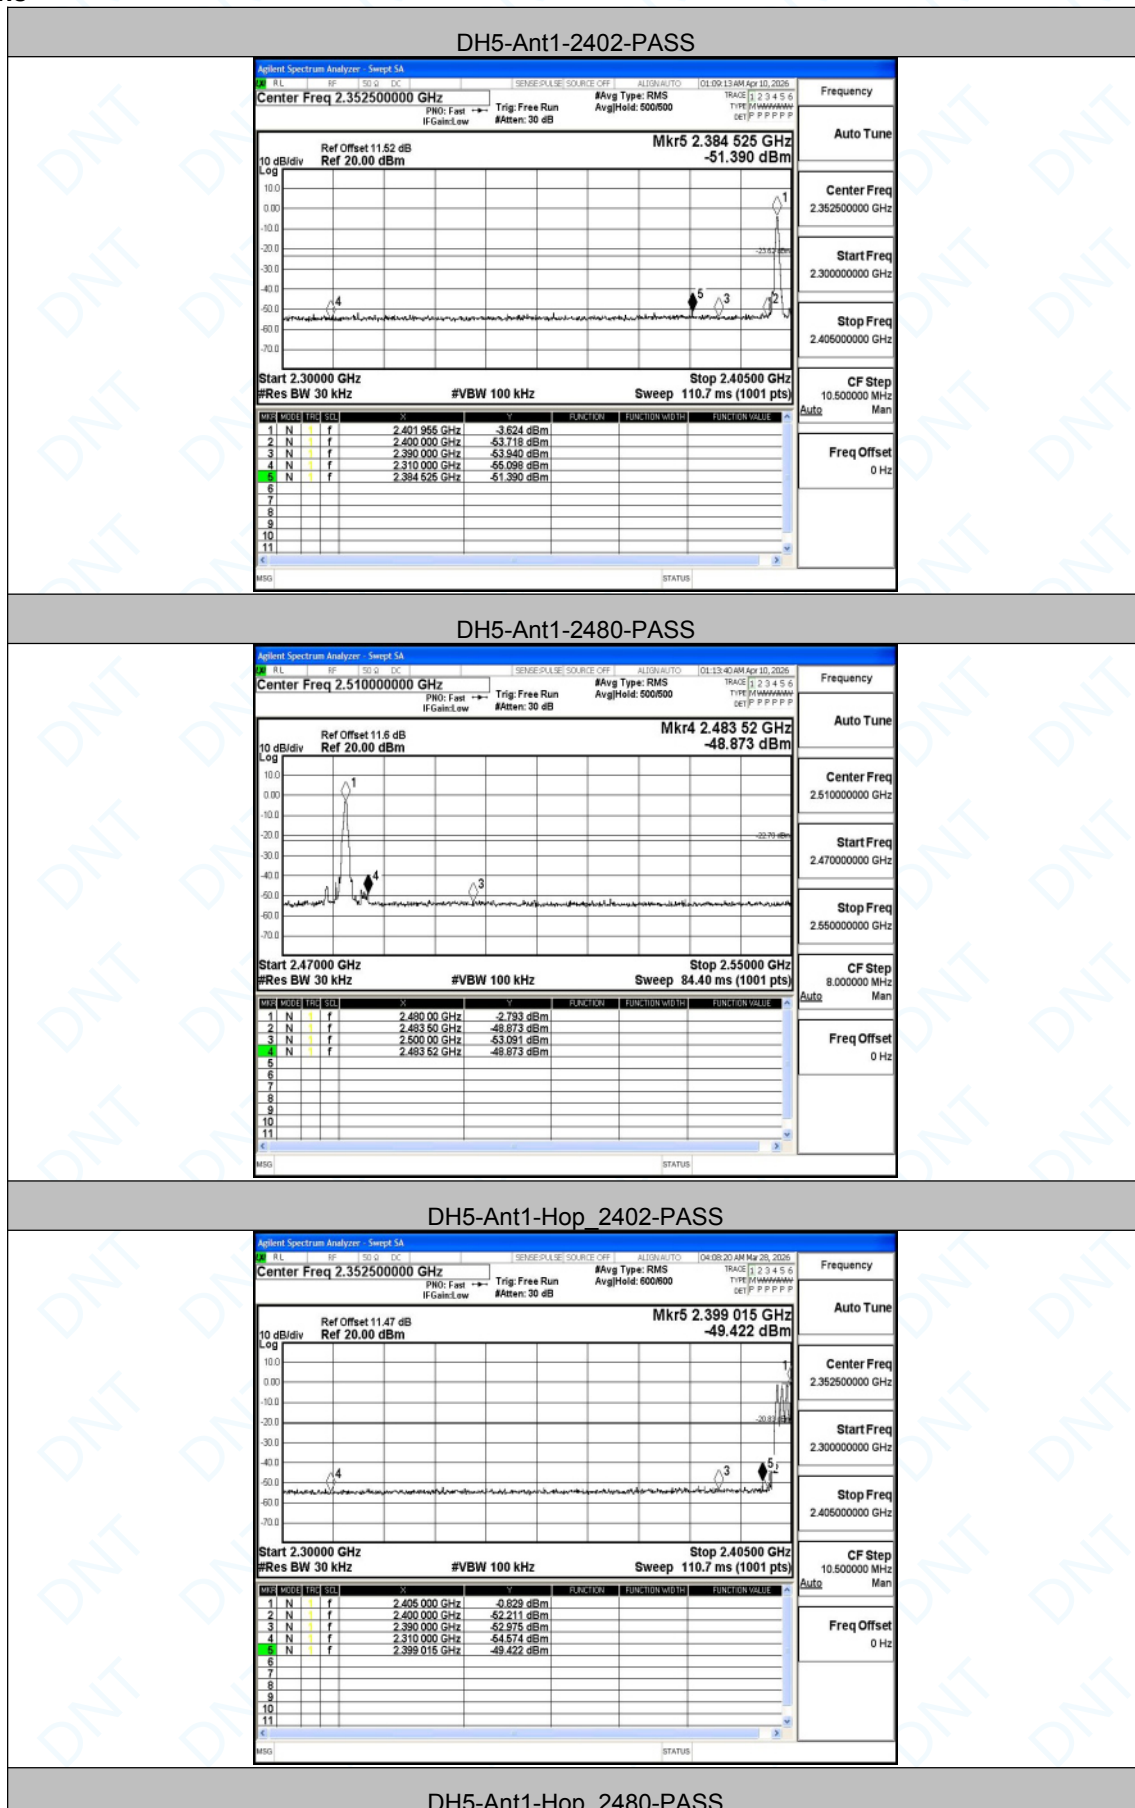
## Test Graphs

| TestMode | Antenna | ChName | Frequency[MHz] | RefLevel [dBm] | Result [dBm] | Limit [dBm] | Verdict |
| DH5 | Ant1 | Low | 2402 | -3.62 | -51.39 | $\leq -23.62$ | PASS |
| DH5 | Ant1 | High | 2480 | -2.79 | -48.87 | $\leq -22.79$ | PASS |
| DH5 | Ant1 | Low | Hop_2402 | -0.83 | -49.42 | $\leq -20.83$ | PASS |
| DH5 | Ant1 | High | Hop_2480 | 0.02 | -47.91 | $\leq -19.98$ | PASS |

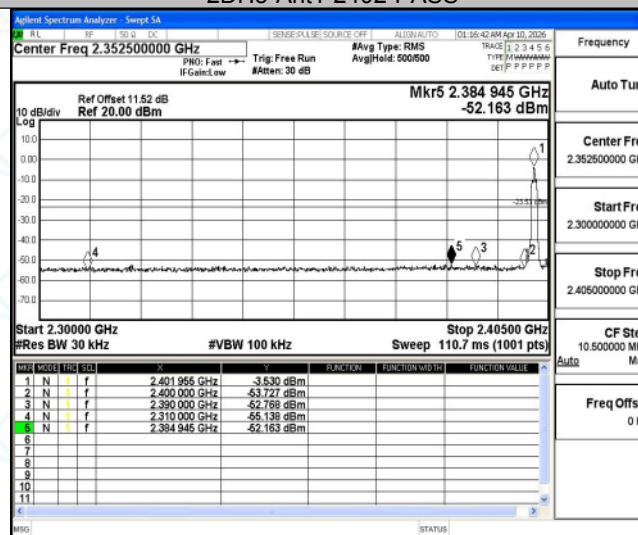
## 2DH5-Ant1-2402-PASS

| TestMode | Antenna | ChName | Frequency[MHz] | RefLevel [dBm] | Result [dBm] | Limit [dBm] | Verdict |
|---|---|---|---|---|---|---|---|
| 2DH5 | Ant1 | Low | 2402 | -3.53 | -52.16 | $\leq -23.53$ | PASS |

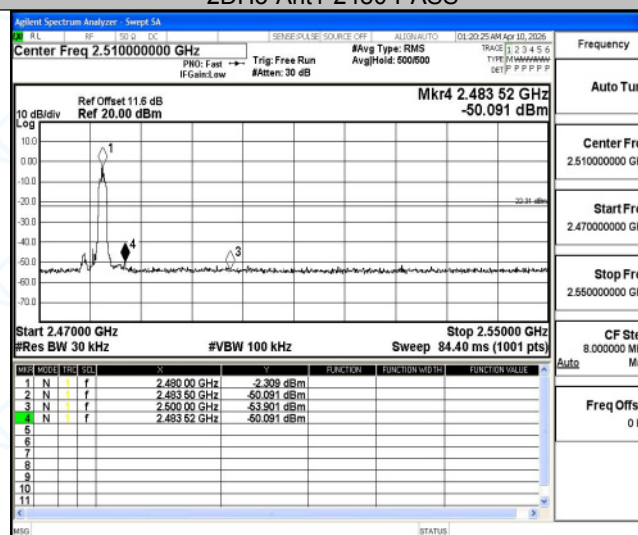
## 2DH5-Ant1-2480-PASS

| TestMode | Antenna | ChName | Frequency[MHz] | RefLevel [dBm] | Result [dBm] | Limit [dBm] | Verdict |
|---|---|---|---|---|---|---|---|
| 2DH5 | Ant1 | High | 2480 | -2.31 | -50.09 | $\leq -22.31$ | PASS |

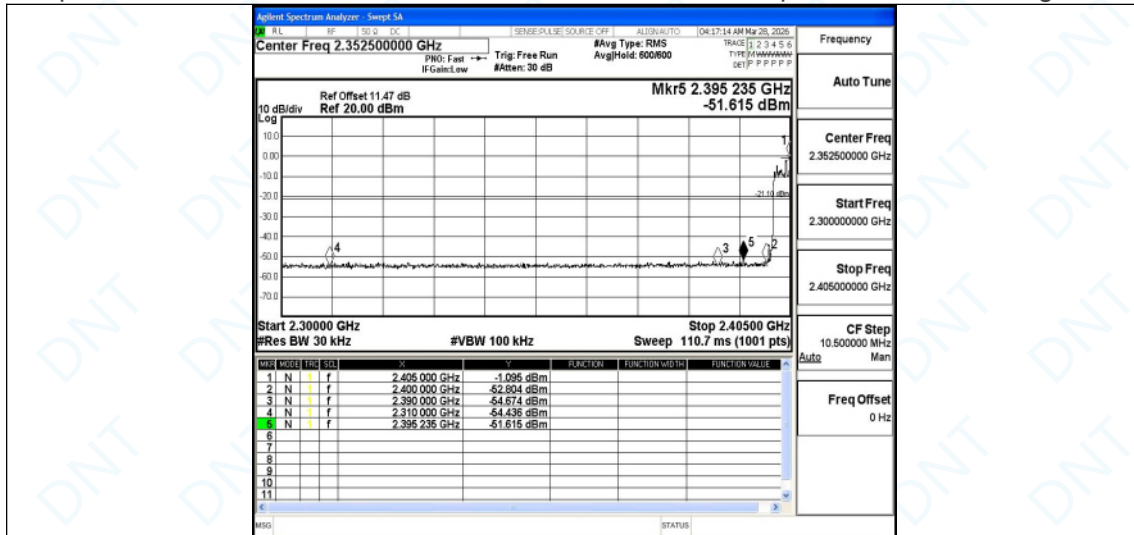
## 2DH5-Ant1-Hop\_2402-PASS

| TestMode | Antenna | ChName | Frequency[MHz] | RefLevel [dBm] | Result [dBm] | Limit [dBm] | Verdict |
|---|---|---|---|---|---|---|---|
| 2DH5 | Ant1 | Low | Hop_2402 | -1.10 | -51.62 | $\leq -21.1$ | PASS |

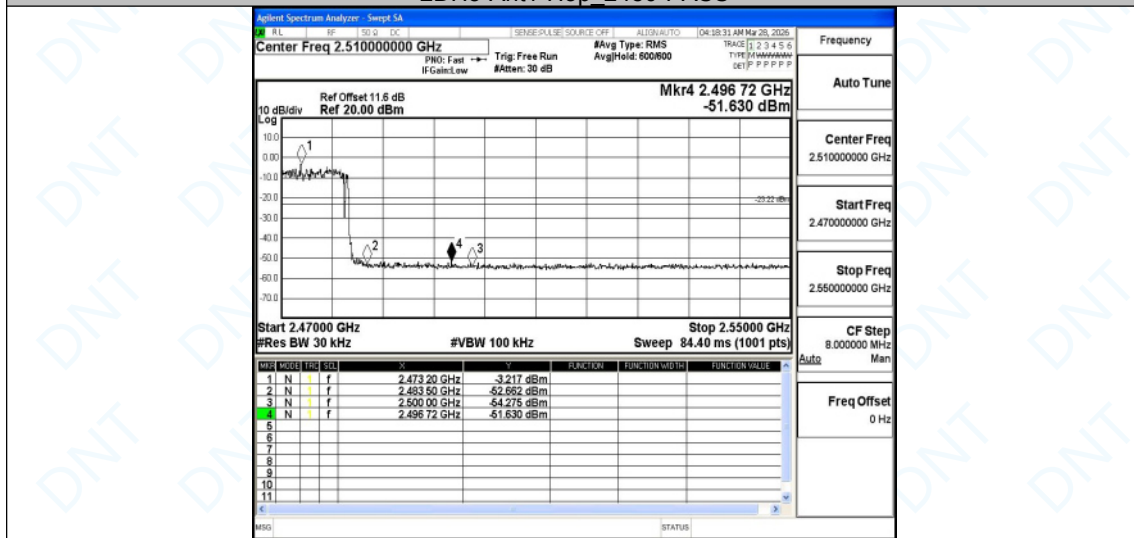
## 2DH5-Ant1-Hop 2480-PASS

| TestMode | Antenna | ChName | Frequency[MHz] | RefLevel [dBm] | Result [dBm] | Limit [dBm] | Verdict |
|---|---|---|---|---|---|---|---|
| 2DH5 | Ant1 | High | Hop_2480 | -3.22 | -51.63 | $\leq -23.22$ | PASS |

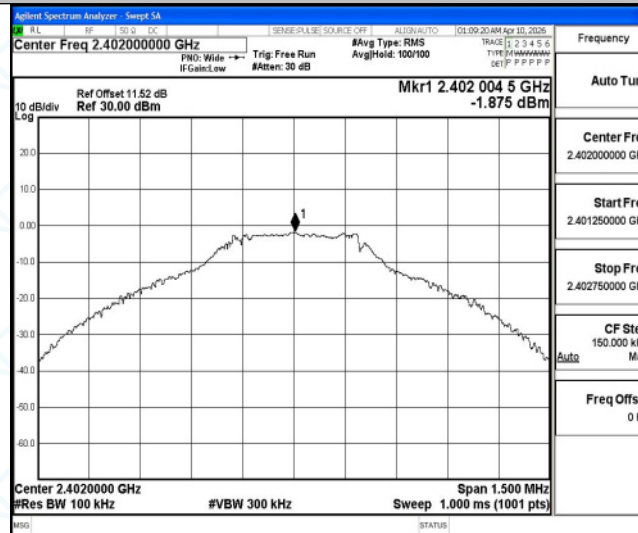
DH5-Ant1-2402-0~Reference-PASS

| TestMode | Antenna | Frequency[MHz] | FreqRange [MHz] | RefLevel [dBm] | Result [dBm] | Limit [dBm] | Verdict |
|---|---|---|---|---|---|---|---|
| DH5 | Ant1 | 2402 | 0~Reference | -1.88 | -1.88 | --- | PASS |

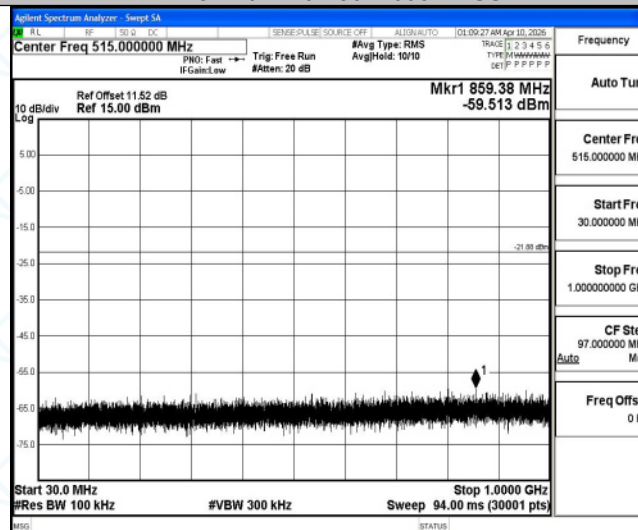
DH5-Ant1-2402-30~1000-PASS

| TestMode | Antenna | Frequency[MHz] | FreqRange [MHz] | RefLevel [dBm] | Result [dBm] | Limit [dBm] | Verdict |
|---|---|---|---|---|---|---|---|
| DH5 | Ant1 | 2402 | 30~1000 | -1.88 | -59.51 | ≤-21.88 | PASS |

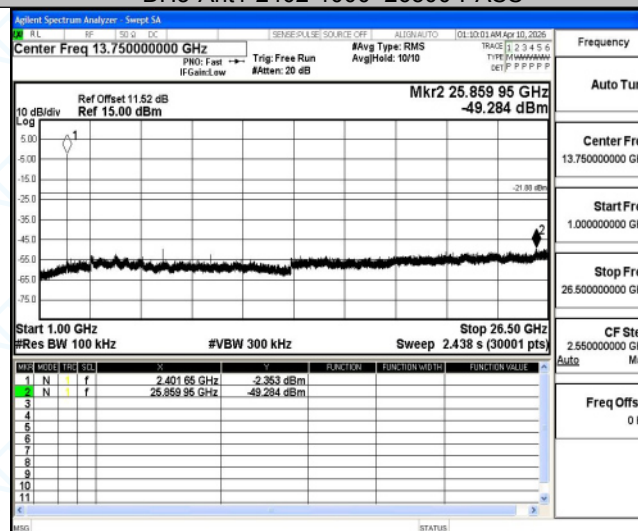
DH5-Ant1-2402-1000~26500-PASS

| TestMode | Antenna | Frequency[MHz] | FreqRange [MHz] | RefLevel [dBm] | Result [dBm] | Limit [dBm] | Verdict |
|---|---|---|---|---|---|---|---|
| DH5 | Ant1 | 2402 | 1000~26500 | -1.88 | -49.28 | ≤-21.88 | PASS |

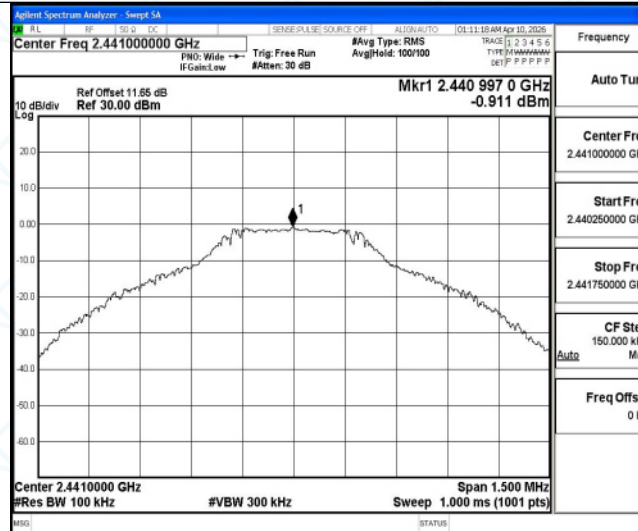
DH5-Ant1-2441-0~Reference-PASS

| TestMode | Antenna | Frequency[MHz] | FreqRange [MHz] | RefLevel [dBm] | Result [dBm] | Limit [dBm] | Verdict |
|---|---|---|---|---|---|---|---|
| DH5 | Ant1 | 2441 | 0~Reference | -0.91 | -0.91 | --- | PASS |

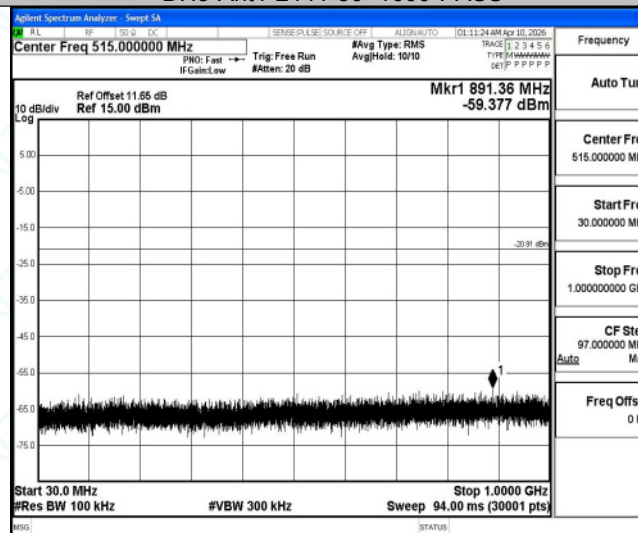
## DH5-Ant1-2441-30~1000-PASS

| TestMode | Antenna | Frequency[MHz] | FreqRange [MHz] | RefLevel [dBm] | Result [dBm] | Limit [dBm] | Verdict |
|---|---|---|---|---|---|---|---|
| DH5 | Ant1 | 2441 | 30~1000 | -0.91 | -59.38 | ≤-20.91 | PASS |

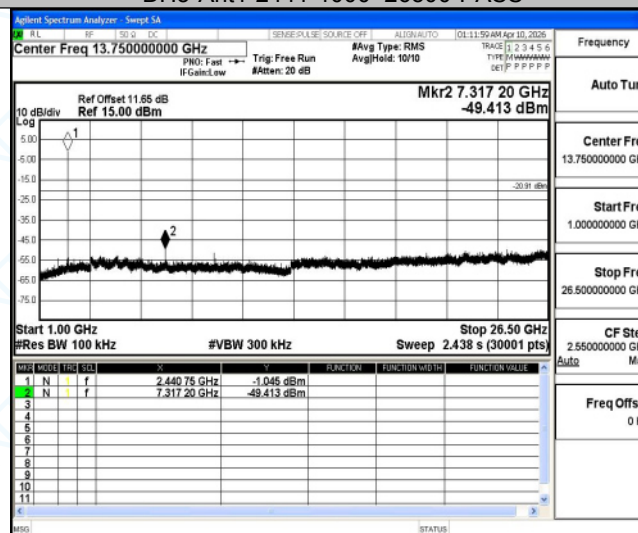
## DH5-Ant1-2441-1000~26500-PASS

| TestMode | Antenna | Frequency[MHz] | FreqRange [MHz] | RefLevel [dBm] | Result [dBm] | Limit [dBm] | Verdict |
|---|---|---|---|---|---|---|---|
| DH5 | Ant1 | 2441 | 1000~26500 | -0.91 | -49.41 | ≤-20.91 | PASS |

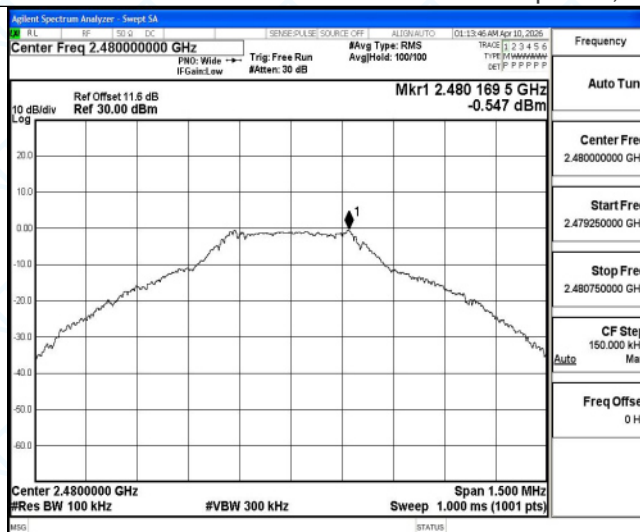
## DH5-Ant1-2480-0~Reference-PASS

| TestMode | Antenna | Frequency[MHz] | FreqRange [MHz] | RefLevel [dBm] | Result [dBm] | Limit [dBm] | Verdict |
|---|---|---|---|---|---|---|---|
| DH5 | Ant1 | 2480 | 0~Reference | -0.55 | -0.55 | --- | PASS |

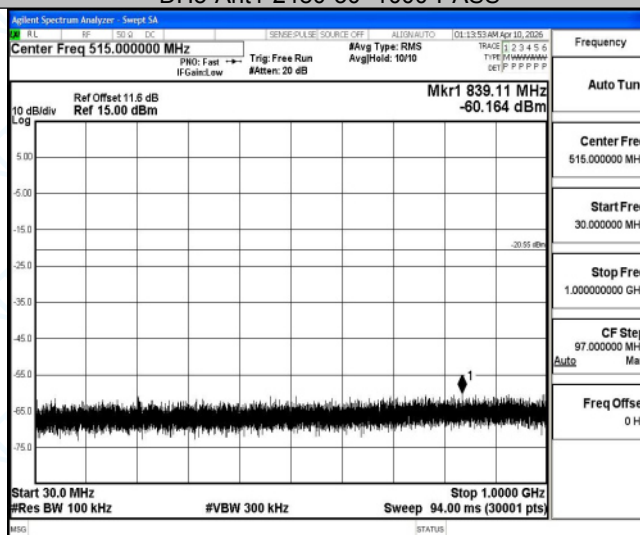
## DH5-Ant1-2480-30~1000-PASS

| TestMode | Antenna | Frequency[MHz] | FreqRange [MHz] | RefLevel [dBm] | Result [dBm] | Limit [dBm] | Verdict |
|---|---|---|---|---|---|---|---|
| DH5 | Ant1 | 2480 | 30~1000 | -0.55 | -60.16 | ≤-20.55 | PASS |

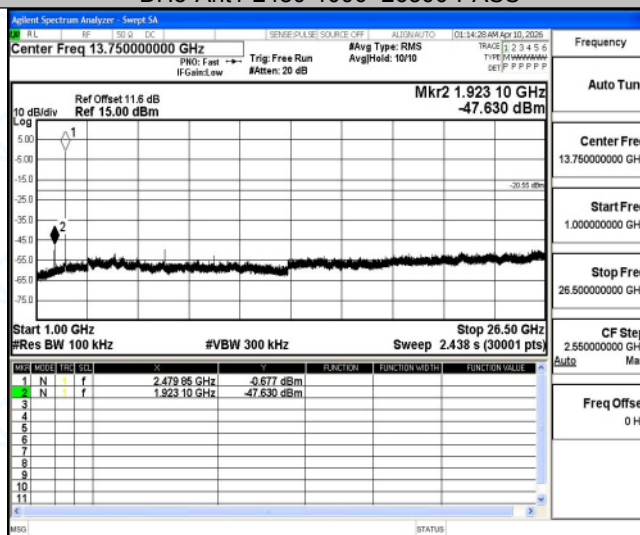
## DH5-Ant1-2480-1000~26500-PASS

| TestMode | Antenna | Frequency[MHz] | FreqRange [MHz] | RefLevel [dBm] | Result [dBm] | Limit [dBm] | Verdict |
|---|---|---|---|---|---|---|---|
| DH5 | Ant1 | 2480 | 1000~26500 | -0.55 | -47.63 | ≤-20.55 | PASS |

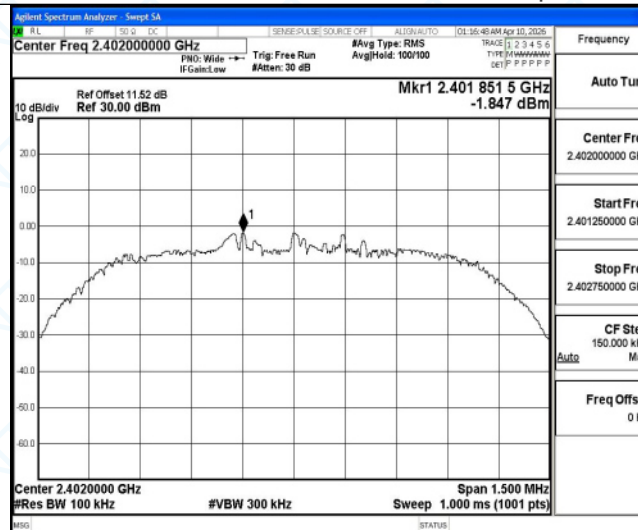
## 2DH5-Ant1-2402-0~Reference-PASS

| TestMode | Antenna | Frequency[MHz] | FreqRange [MHz] | RefLevel [dBm] | Result [dBm] | Limit [dBm] | Verdict |
|---|---|---|---|---|---|---|---|
| 2DH5 | Ant1 | 2402 | 0~Reference | -1.85 | -1.85 | --- | PASS |

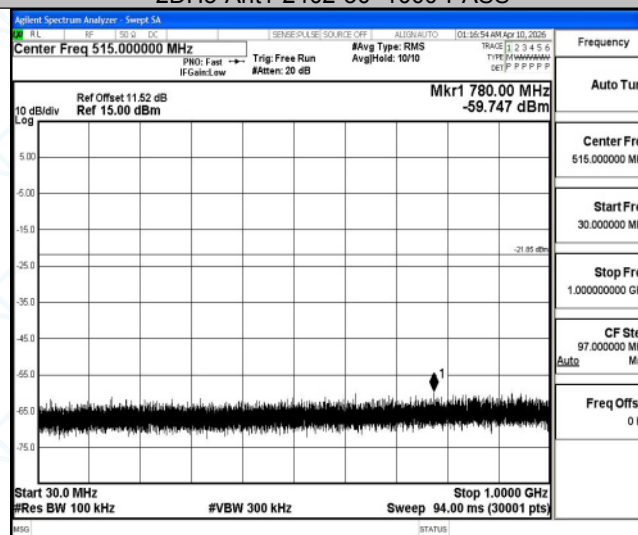
2DH5-Ant1-2402-30~1000-PASS

| TestMode | Antenna | Frequency[MHz] | FreqRange [MHz] | RefLevel [dBm] | Result [dBm] | Limit [dBm] | Verdict |
|---|---|---|---|---|---|---|---|
| 2DH5 | Ant1 | 2402 | 30~1000 | -1.85 | -59.75 | ≤-21.85 | PASS |

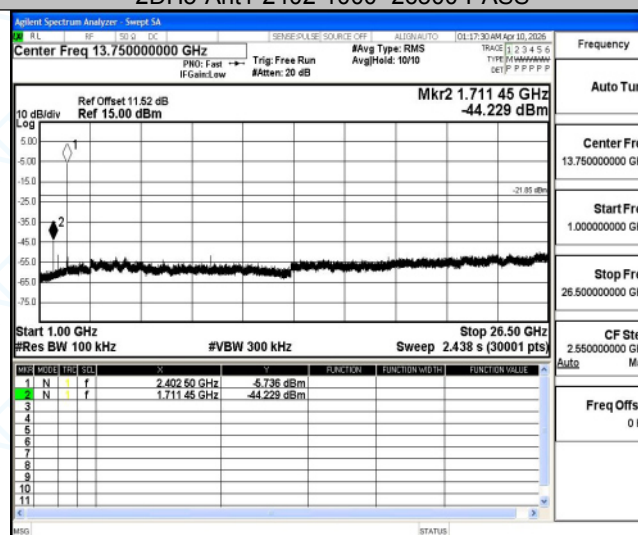
2DH5-Ant1-2402-1000~26500-PASS

| TestMode | Antenna | Frequency[MHz] | FreqRange [MHz] | RefLevel [dBm] | Result [dBm] | Limit [dBm] | Verdict |
|---|---|---|---|---|---|---|---|
| 2DH5 | Ant1 | 2402 | 1000~26500 | -1.85 | -44.23 | ≤-21.85 | PASS |

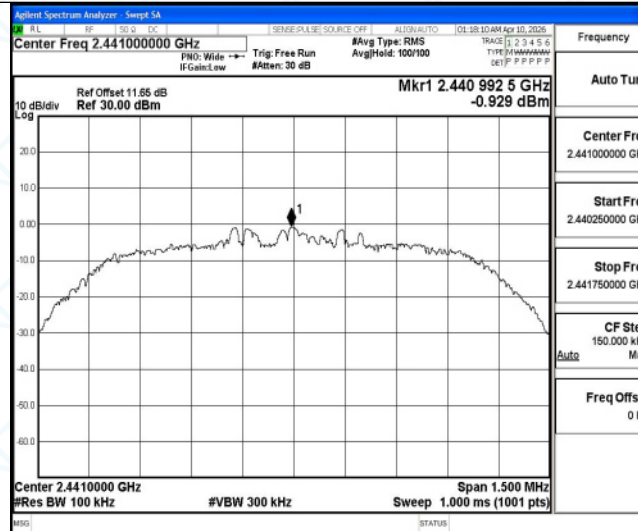
2DH5-Ant1-2441-0~Reference-PASS

| TestMode | Antenna | Frequency[MHz] | FreqRange [MHz] | RefLevel [dBm] | Result [dBm] | Limit [dBm] | Verdict |
|---|---|---|---|---|---|---|---|
| 2DH5 | Ant1 | 2441 | 0~Reference | -0.93 | -0.93 | --- | PASS |

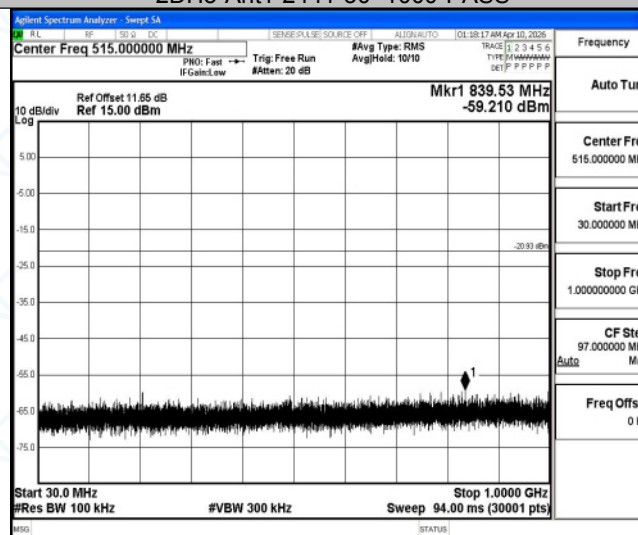
2DH5-Ant1-2441-30~1000-PASS

| TestMode | Antenna | Frequency[MHz] | FreqRange [MHz] | RefLevel [dBm] | Result [dBm] | Limit [dBm] | Verdict |
|---|---|---|---|---|---|---|---|
| 2DH5 | Ant1 | 2441 | 30~1000 | -0.93 | -59.21 | ≤-20.93 | PASS |

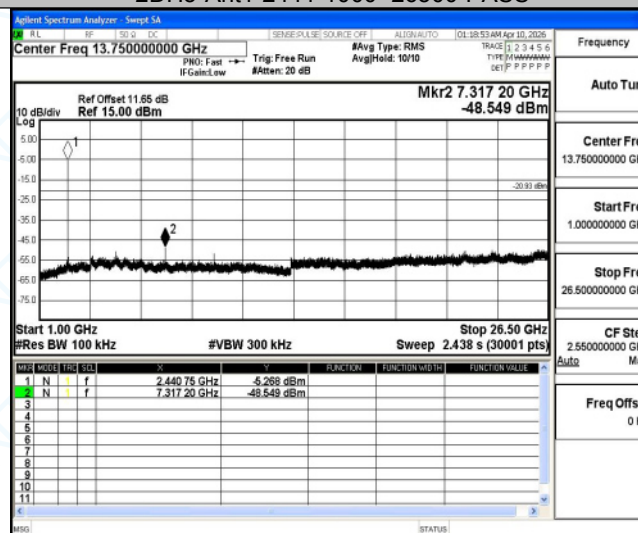
2DH5-Ant1-2441-1000~26500-PASS

| TestMode | Antenna | Frequency[MHz] | FreqRange [MHz] | RefLevel [dBm] | Result [dBm] | Limit [dBm] | Verdict |
|---|---|---|---|---|---|---|---|
| 2DH5 | Ant1 | 2441 | 1000~26500 | -0.93 | -48.55 | ≤-20.93 | PASS |

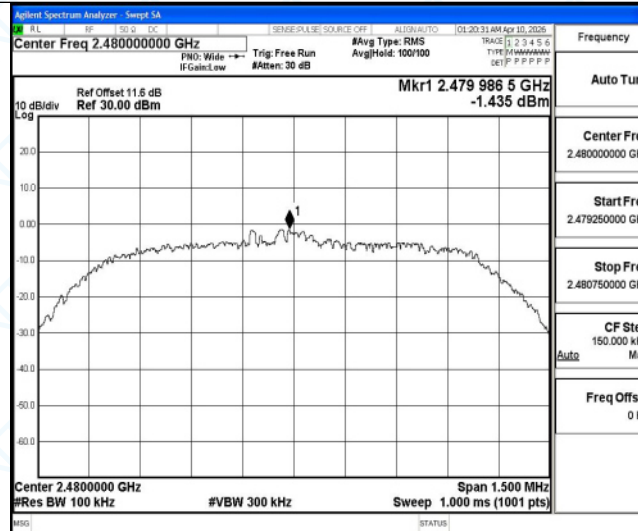
2DH5-Ant1-2480-0~Reference-PASS

| TestMode | Antenna | Frequency[MHz] | FreqRange [MHz] | RefLevel [dBm] | Result [dBm] | Limit [dBm] | Verdict |
|---|---|---|---|---|---|---|---|
| 2DH5 | Ant1 | 2480 | 0~Reference | -1.44 | -1.44 | --- | PASS |

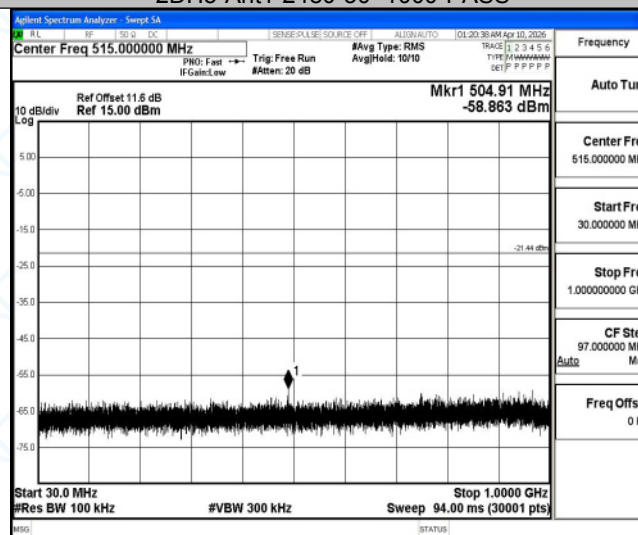
## 2DH5-Ant1-2480-30~1000-PASS

| TestMode | Antenna | Frequency[MHz] | FreqRange [MHz] | RefLevel [dBm] | Result [dBm] | Limit [dBm] | Verdict |
|---|---|---|---|---|---|---|---|
| 2DH5 | Ant1 | 2480 | 30~1000 | -1.44 | -58.86 | ≤-21.44 | PASS |

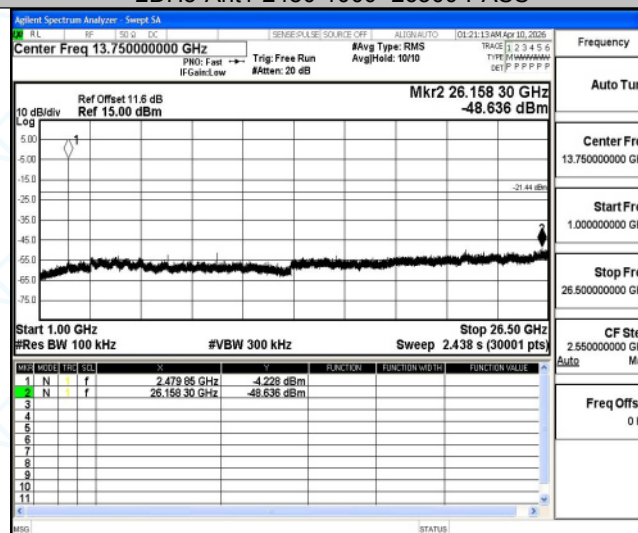
## 2DH5-Ant1-2480-1000~26500-PASS

| TestMode | Antenna | Frequency[MHz] | FreqRange [MHz] | RefLevel [dBm] | Result [dBm] | Limit [dBm] | Verdict |
|---|---|---|---|---|---|---|---|
| 2DH5 | Ant1 | 2480 | 1000~26500 | -1.44 | -48.64 | ≤-21.44 | PASS |
