CA\_7C\_SISO\_NTNV\_CC1:20 CC2:10MHz\_CC1:64QAM CC2:64QAM\_CC1:2510 CC2:2524.4MHz\_CC1: 1@0 CC2: 1@0

**Radiolink Testing (Shenzhen) Co., Ltd.**

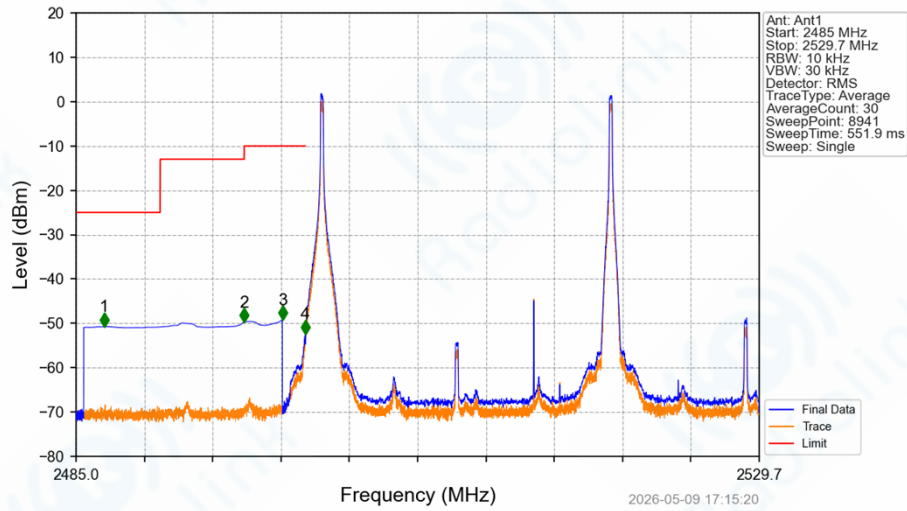
| Start (MHz) | Stop (MHz) | RBW (MHz) | Method | Marker No. | Freq (MHz) | Level (dBm) | Limit (dBm) | Result |
| 2485 | 2490.5 | 1 | CHP | 1 | 2486.830 | -50.71 | -25 | Pass |
| 2490.5 | 2496 | 1 | CHP | 2 | 2496.000 | -49.78 | -13 | Pass |
| 2496 | 2499 | 1 | CHP | 3 | 2498.500 | -49.10 | -10 | Pass |
| 2499 | 2500 | 0.02 | CHP | 4 | 2499.990 | -52.35 | -10 | Pass |
| 2500 | 2529.7 | 0.02 | CHP | / | / | / | / | / |

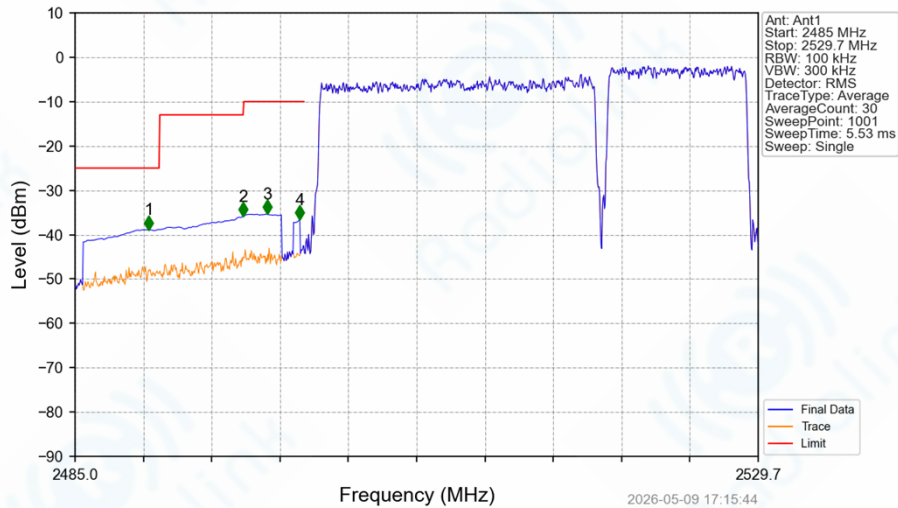
CA\_7C\_SISO\_NTNV\_CC1:20 CC2:10MHz\_CC1:64QAM CC2:64QAM\_CC1:2510 CC2:2524.4MHz\_CC1: 100@0 CC2: 50@0

| Start (MHz) | Stop (MHz) | RBW (MHz) | Method | Marker No. | Freq (MHz) | Level (dBm) | Limit (dBm) | Result |
| 2485 | 2490.5 | 1 | CHP | 1 | 2489.828 | -38.85 | -25 | Pass |
| 2490.5 | 2496 | 1 | CHP | 2 | 2495.996 | -35.85 | -13 | Pass |
| 2496 | 2499 | 1 | CHP | 3 | 2497.561 | -35.38 | -10 | Pass |
| 2499 | 2500 | 0.582 | CHP | 4 | 2499.706 | -36.64 | -10 | Pass |
| 2500 | 2529.7 | 0.1 | / | / | / | / | / | / |

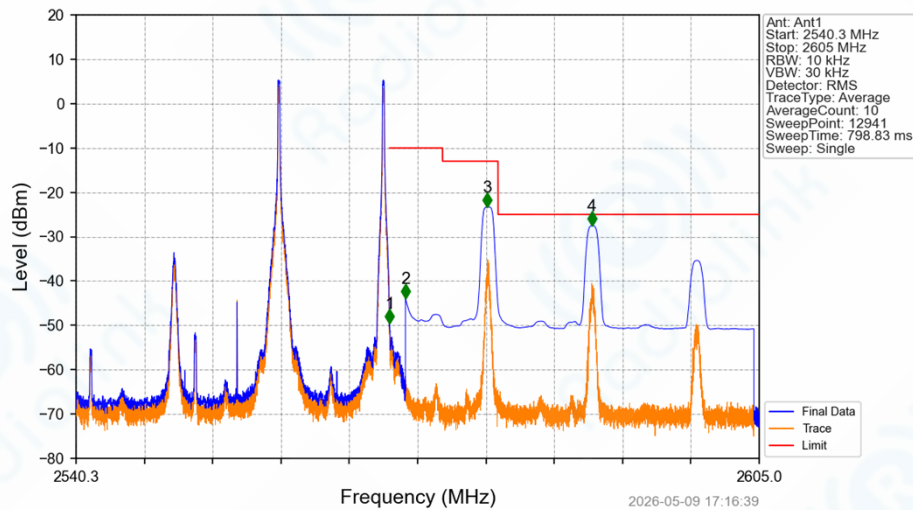
CA\_7C\_SISO\_NTNV\_CC1:20 CC2:10MHz\_CC1:64QAM CC2:64QAM\_CC1:2550.6 CC2:2565MHz\_CC1: 1@99 CC2:  
1@49

| Start (MHz) | Stop (MHz) | RBW (MHz) | Method | Marker No. | Freq (MHz) | Level (dBm) | Limit (dBm) | Result |
| 2540.3 | 2570 | 0.02 | CHP | / | / | / | / | / |
| 2570 | 2571 | 0.02 | CHP | 1 | 2570.010 | -49.55 | -10 | Pass |
| 2571 | 2575 | 1 | CHP | 2 | 2571.500 | -43.93 | -10 | Pass |
| 2575 | 2580.263 | 1 | CHP | 3 | 2579.235 | -23.30 | -13 | Pass |
| 2580.263 | 2605 | 1 | CHP | 4 | 2589.165 | -27.54 | -25 | Pass |

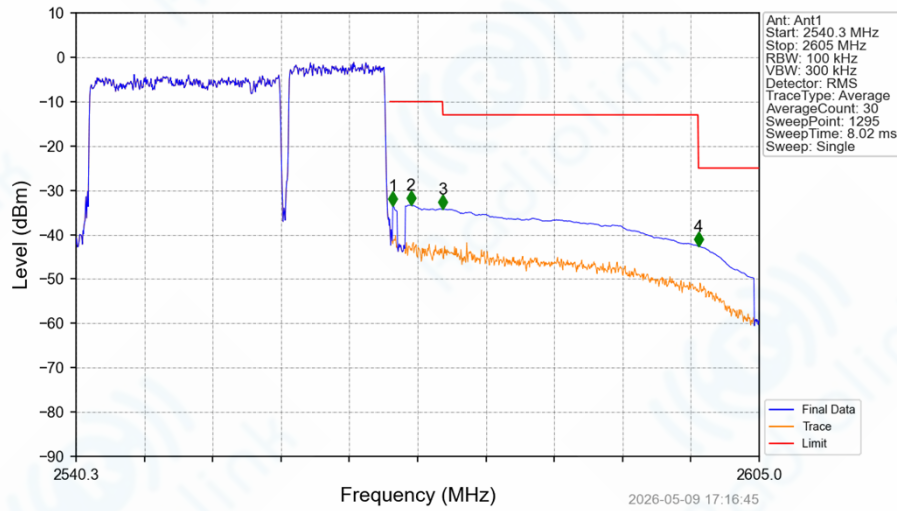
CA\_7C\_SISO\_NTNV\_CC1:20 CC2:10MHz\_CC1:64QAM CC2:64QAM\_CC1:2550.6 CC2:2565MHz\_CC1: 100@0 CC2: 50@0

| Start (MHz) | Stop (MHz) | RBW (MHz) | Method | Marker No. | Freq (MHz) | Level (dBm) | Limit (dBm) | Result |
| 2540.3 | 2570 | 0.1 | / | / | / | / | / | / |
| 2570 | 2571 | 0.585 | CHP | 1 | 2570.300 | -33.44 | -10 | Pass |
| 2571 | 2575 | 1 | CHP | 2 | 2572.000 | -33.31 | -10 | Pass |
| 2575 | 2599.237 | 1 | CHP | 3 | 2575.050 | -34.28 | -13 | Pass |
| 2599.237 | 2605 | 1 | CHP | 4 | 2599.250 | -42.62 | -25 | Pass |

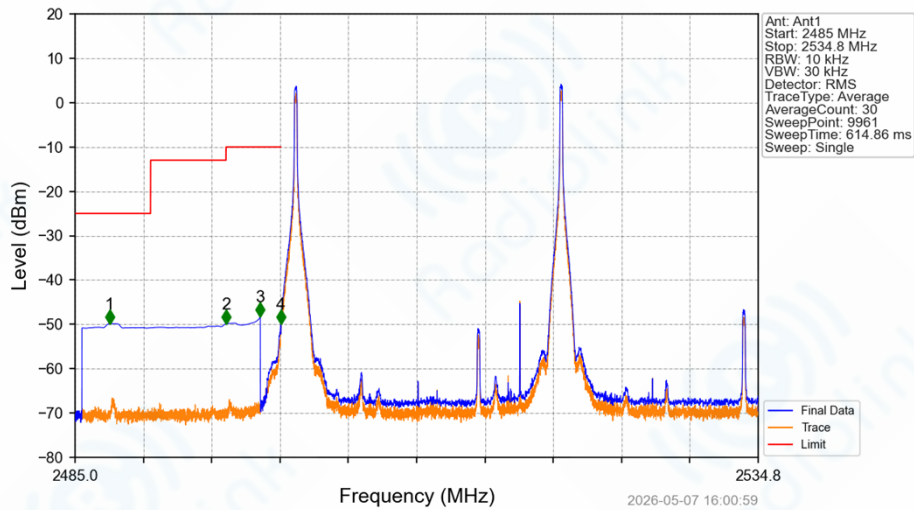
CA\_7C\_SISO\_NTNV\_CC1:20\_CC2:15MHz\_CC1:QPSK\_CC2:QPSK\_CC1:2510\_CC2:2527.1MHz\_CC1: 1@0\_CC2: 1@0

| Start (MHz) | Stop (MHz) | RBW (MHz) | Method | Marker No. | Freq (MHz) | Level (dBm) | Limit (dBm) | Result |
| 2485 | 2490.5 | 1 | CHP | 1 | 2487.510 | -49.83 | -25 | Pass |
| 2490.5 | 2496 | 1 | CHP | 2 | 2496.000 | -49.95 | -13 | Pass |
| 2496 | 2499 | 1 | CHP | 3 | 2498.500 | -48.32 | -10 | Pass |
| 2499 | 2500 | 0.02 | CHP | 4 | 2499.990 | -49.92 | -10 | Pass |
| 2500 | 2534.8 | 0.02 | CHP | / | / | / | / | / |

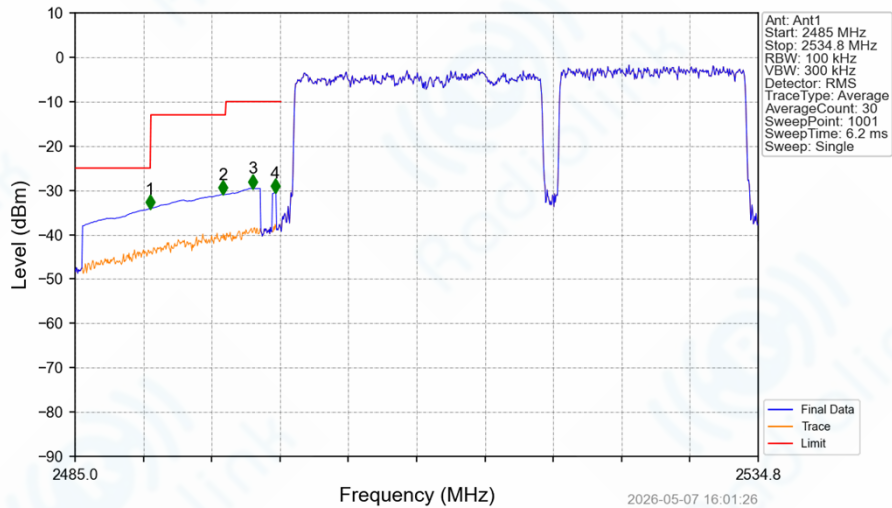
CA\_7C\_SISO\_NTNV\_CC1:20 CC2:15MHz\_CC1:QPSK CC2:QPSK\_CC1:2510 CC2:2527.1MHz\_CC1: 100@0 CC2: 75@0

| Start (MHz) | Stop (MHz) | RBW (MHz) | Method | Marker No. | Freq (MHz) | Level (dBm) | Limit (dBm) | Result |
| 2485 | 2490.5 | 1 | CHP | 1 | 2490.478 | -34.15 | -25 | Pass |
| 2490.5 | 2496 | 1 | CHP | 2 | 2495.757 | -30.88 | -13 | Pass |
| 2496 | 2499 | 1 | CHP | 3 | 2497.948 | -29.56 | -10 | Pass |
| 2499 | 2500 | 0.706 | CHP | 4 | 2499.591 | -30.51 | -10 | Pass |
| 2500 | 2534.8 | 0.1 | / | / | / | / | / | / |
