**Radiolink Testing (Shenzhen) Co., Ltd.**

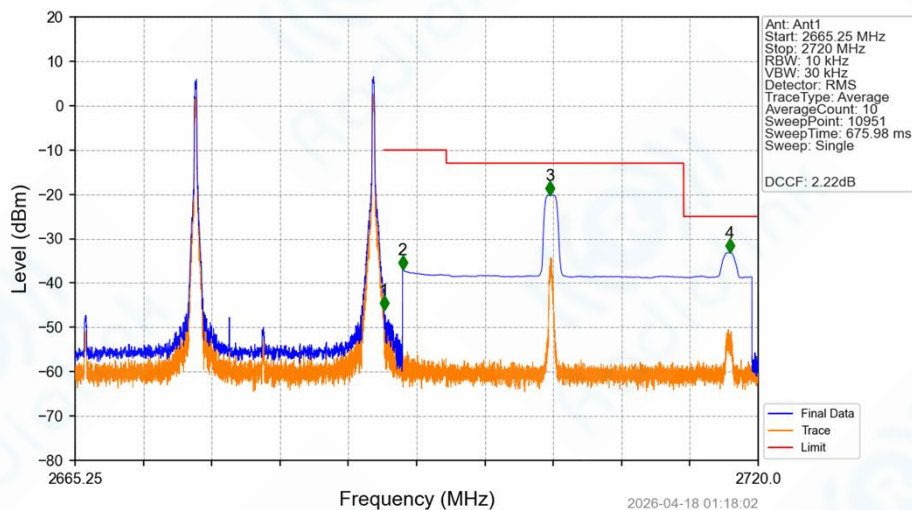
CA\_41C\_SISO\_NTNV\_CC1:10 CC2:15MHz\_CC1:QPSK CC2:QPSK\_CC1:2670.5 CC2:2682.5MHz\_CC1: 1@49 CC2:  
1@74

| Start (MHz) | Stop (MHz) | RBW (MHz) | Method | Marker No. | Freq (MHz) | Level (dBm) | Limit (dBm) | Result |
|---|---|---|---|---|---|---|---|---|
| 2690 | 2691 | 0.02 | CHP | 1 | 2690.010 | -46.03 | -10 | Pass |
| 2691 | 2695 | 1 | CHP | 2 | 2691.500 | -37.01 | -10 | Pass |
| 2695 | 2714.023 | 1 | CHP | 3 | 2703.325 | -20.21 | -13 | Pass |
| 2714.023 | 2720 | 1 | CHP | 4 | 2717.705 | -33.17 | -25 | Pass |

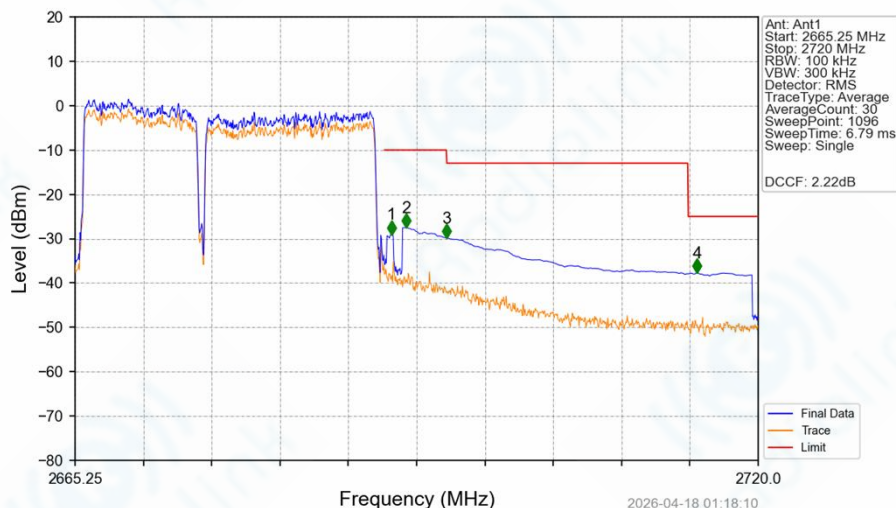
CA\_41C\_SISO\_NTNV\_CC1:10 CC2:15MHz\_CC1:QPSK CC2:QPSK\_CC1:2670.5 CC2:2682.5MHz\_CC1: 50@0 CC2: 75@0

| Start (MHz) | Stop (MHz) | RBW (MHz) | Method | Marker No. | Freq (MHz) | Level (dBm) | Limit (dBm) | Result |
|---|---|---|---|---|---|---|---|---|
| 2690 | 2691 | 0.487 | CHP | 1 | 2690.600 | -29.03 | -10 | Pass |
| 2691 | 2695 | 1 | CHP | 2 | 2691.800 | -27.47 | -10 | Pass |
| 2695 | 2714.353 | 1 | CHP | 3 | 2695.050 | -29.81 | -13 | Pass |
| 2714.353 | 2720 | 1 | CHP | 4 | 2715.100 | -37.66 | -25 | Pass |

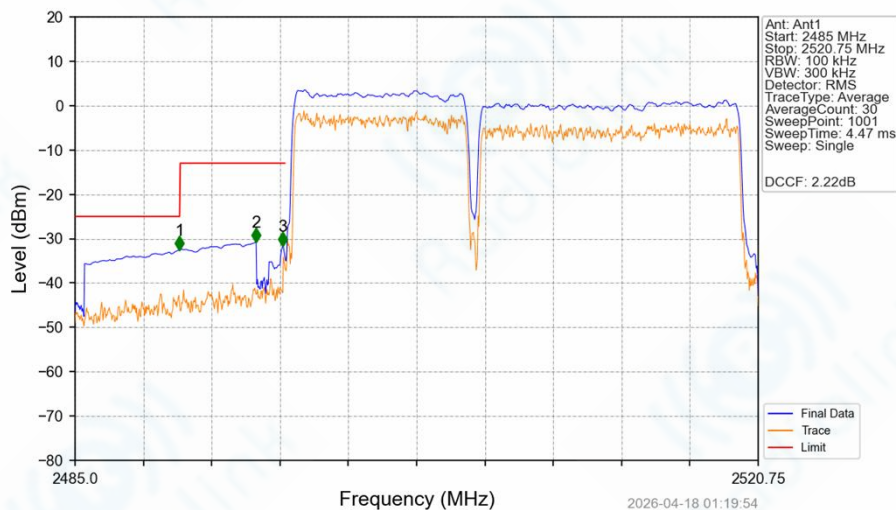
CA\_41C\_SISO\_NTNV\_CC1:10 CC2:15MHz\_CC1:16QAM CC2:16QAM\_CC1:2501 CC2:2513MHz\_CC1: 50@0 CC2: 75@0

| Start (MHz) | Stop (MHz) | RBW (MHz) | Method | Marker No. | Freq (MHz) | Level (dBm) | Limit (dBm) | Result |
|---|---|---|---|---|---|---|---|---|
| 2485 | 2490.5 | 1 | CHP | 1 | 2490.470 | -32.53 | -25 | Pass |
| 2490.5 | 2495 | 1 | CHP | 2 | 2494.474 | -30.85 | -13 | Pass |
| 2495 | 2496 | 0.25 | CHP | 3 | 2495.868 | -31.73 | -13 | Pass |

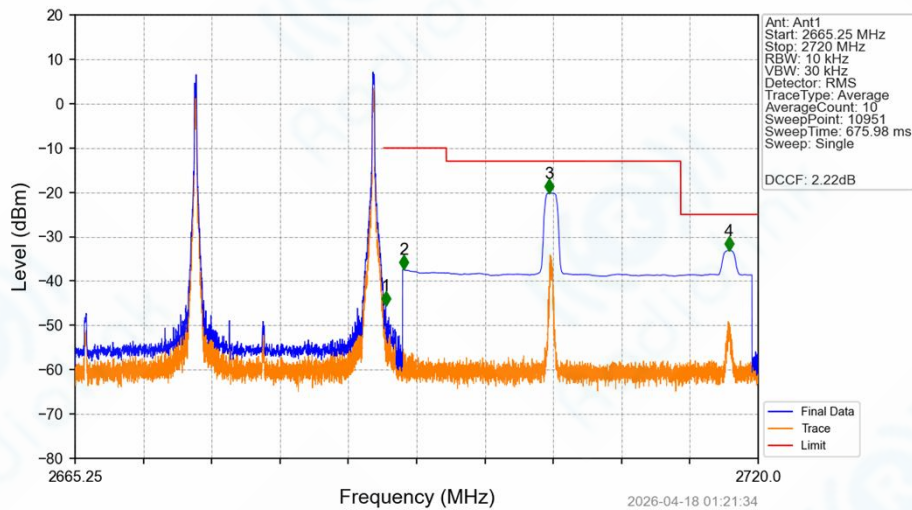
CA\_41C\_SISO\_NTNV\_CC1:10 CC2:15MHz\_CC1:16QAM CC2:16QAM\_CC1:2670.5 CC2:2682.5MHz\_CC1: 1@49 CC2: 1@74

| Start (MHz) | Stop (MHz) | RBW (MHz) | Method | Marker No. | Freq (MHz) | Level (dBm) | Limit (dBm) | Result |
|---|---|---|---|---|---|---|---|---|
| 2690 | 2691 | 0.02 | CHP | 1 | 2690.140 | -45.47 | -10 | Pass |
| 2691 | 2695 | 1 | CHP | 2 | 2691.605 | -37.39 | -10 | Pass |
| 2695 | 2713.787 | 1 | CHP | 3 | 2703.245 | -20.22 | -13 | Pass |
| 2713.787 | 2720 | 1 | CHP | 4 | 2717.640 | -33.14 | -25 | Pass |

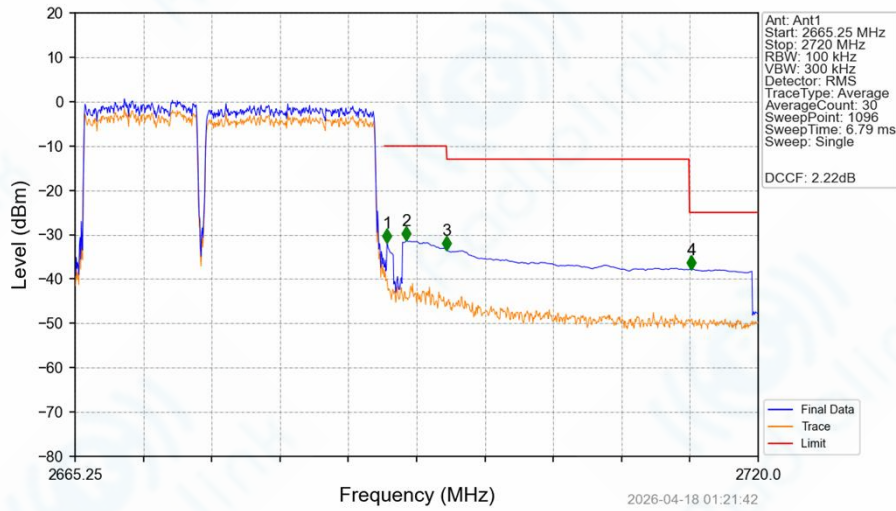
CA\_41C\_SISO\_NTNV\_CC1:10 CC2:15MHz\_CC1:16QAM CC2:16QAM\_CC1:2670.5 CC2:2682.5MHz\_CC1: 50@0 CC2: 75@0

| Start (MHz) | Stop (MHz) | RBW (MHz) | Method | Marker No. | Freq (MHz) | Level (dBm) | Limit (dBm) | Result |
|---|---|---|---|---|---|---|---|---|
| 2690 | 2691 | 0.489 | CHP | 1 | 2690.250 | -31.91 | -10 | Pass |
| 2691 | 2695 | 1 | CHP | 2 | 2691.800 | -31.39 | -10 | Pass |
| 2695 | 2714.458 | 1 | CHP | 3 | 2695.050 | -33.58 | -13 | Pass |
| 2714.458 | 2720 | 1 | CHP | 4 | 2714.650 | -37.80 | -25 | Pass |

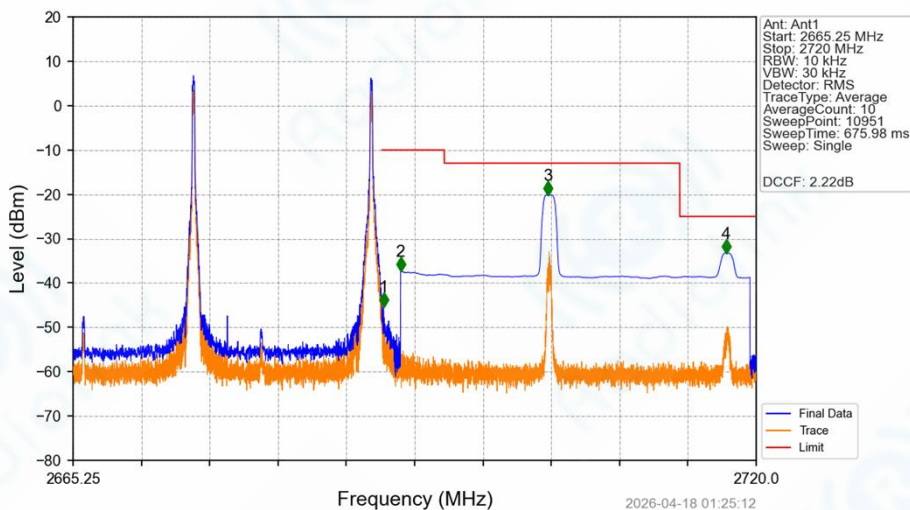
CA\_41C\_SISO\_NTNV\_CC1:10 CC2:15MHz\_CC1:64QAM CC2:64QAM\_CC1:2670.5 CC2:2682.5MHz\_CC1: 1@49 CC2: 1@74

| Start (MHz) | Stop (MHz) | RBW (MHz) | Method | Marker No. | Freq (MHz) | Level (dBm) | Limit (dBm) | Result |
|---|---|---|---|---|---|---|---|---|
| 2690 | 2691 | 0.02 | CHP | 1 | 2690.140 | -45.27 | -10 | Pass |
| 2691 | 2695 | 1 | CHP | 2 | 2691.500 | -37.29 | -10 | Pass |
| 2695 | 2713.87 | 1 | CHP | 3 | 2703.285 | -20.18 | -13 | Pass |
| 2713.87 | 2720 | 1 | CHP | 4 | 2717.580 | -33.23 | -25 | Pass |

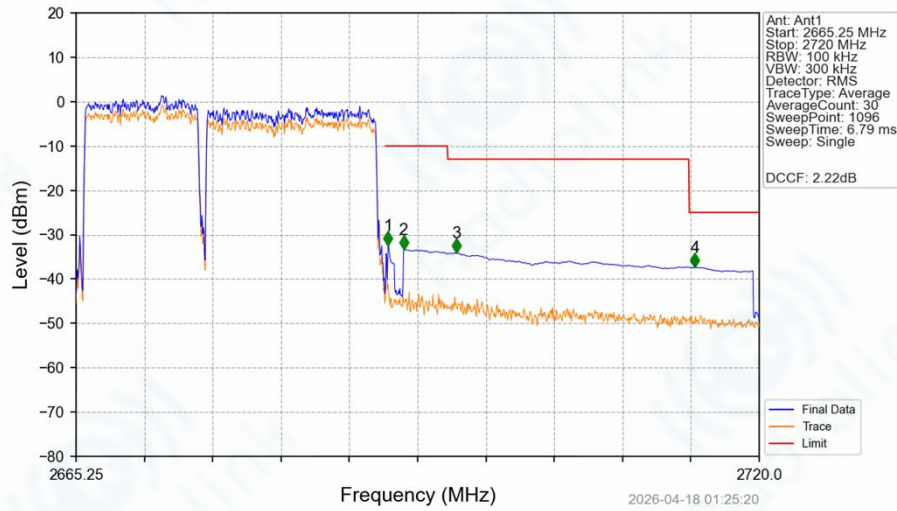
CA\_41C\_SISO\_NTNV\_CC1:10 CC2:15MHz\_CC1:64QAM CC2:64QAM\_CC1:2670.5 CC2:2682.5MHz\_CC1: 50@0 CC2: 75@0

| Start (MHz) | Stop (MHz) | RBW (MHz) | Method | Marker No. | Freq (MHz) | Level (dBm) | Limit (dBm) | Result |
|---|---|---|---|---|---|---|---|---|
| 2690 | 2691 | 0.488 | CHP | 1 | 2690.250 | -32.32 | -10 | Pass |
| 2691 | 2695 | 1 | CHP | 2 | 2691.500 | -33.37 | -10 | Pass |
| 2695 | 2714.398 | 1 | CHP | 3 | 2695.700 | -34.12 | -13 | Pass |
| 2714.398 | 2720 | 1 | CHP | 4 | 2714.850 | -37.37 | -25 | Pass |

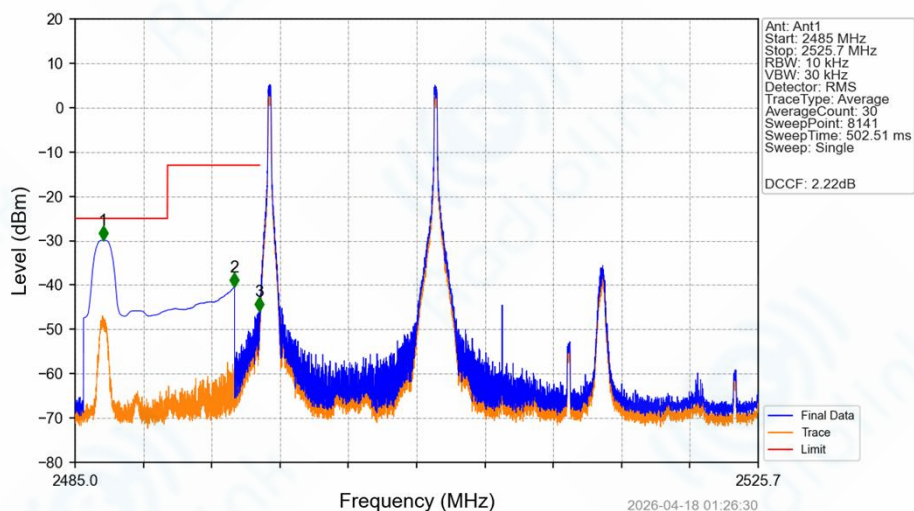
CA\_41C\_SISO\_NTNV\_CC1:10\_CC2:20MHz\_CC1:QPSK\_CC2:QPSK\_CC1:2501\_CC2:2515.4MHz\_CC1: 1@0 CC2: 1@0

| Start (MHz) | Stop (MHz) | RBW (MHz) | Method | Marker No. | Freq (MHz) | Level (dBm) | Limit (dBm) | Result |
|---|---|---|---|---|---|---|---|---|
| 2485 | 2490.5 | 1 | CHP | 1 | 2486.680 | -29.90 | -25 | Pass |
| 2490.5 | 2495 | 1 | CHP | 2 | 2494.495 | -40.41 | -13 | Pass |
| 2495 | 2496 | 0.01 | / | 3 | 2495.980 | -45.84 | -13 | Pass |

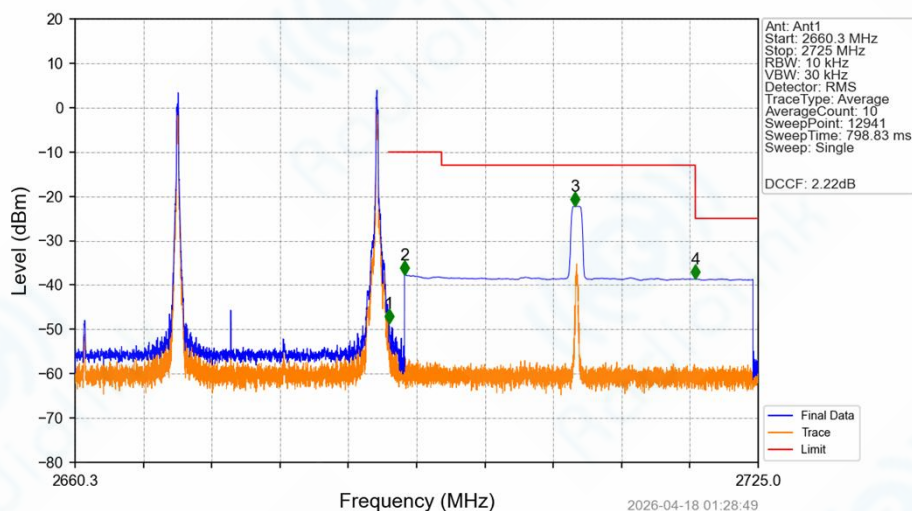
CA\_41C\_SISO\_NTNV\_CC1:10 CC2:20MHz\_CC1:QPSK CC2:QPSK\_CC1:2665.6 CC2:2680MHz\_CC1: 1@49 CC2: 1@99

| Start (MHz) | Stop (MHz) | RBW (MHz) | Method | Marker No. | Freq (MHz) | Level (dBm) | Limit (dBm) | Result |
|---|---|---|---|---|---|---|---|---|
| 2690 | 2691 | 0.02 | CHP | 1 | 2690.025 | -48.55 | -10 | Pass |
| 2691 | 2695 | 1 | CHP | 2 | 2691.510 | -37.64 | -10 | Pass |
| 2695 | 2719.041 | 1 | CHP | 3 | 2707.620 | -22.25 | -13 | Pass |
| 2719.041 | 2725 | 1 | CHP | 4 | 2719.055 | -38.61 | -25 | Pass |

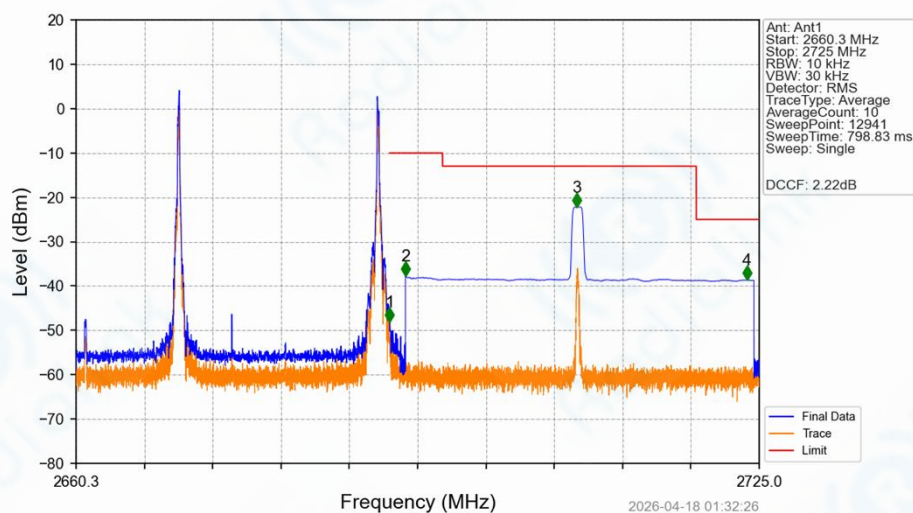
CA\_41C\_SISO\_NTNV\_CC1:10 CC2:20MHz\_CC1:16QAM CC2:16QAM\_CC1:2665.6 CC2:2680MHz\_CC1: 1@49 CC2: 1@99

| Start (MHz) | Stop (MHz) | RBW (MHz) | Method | Marker No. | Freq (MHz) | Level (dBm) | Limit (dBm) | Result |
|---|---|---|---|---|---|---|---|---|
| 2690 | 2691 | 0.02 | CHP | 1 | 2690.010 | -48.14 | -10 | Pass |
| 2691 | 2695 | 1 | CHP | 2 | 2691.500 | -37.71 | -10 | Pass |
| 2695 | 2719.038 | 1 | CHP | 3 | 2707.715 | -22.21 | -13 | Pass |
| 2719.038 | 2725 | 1 | CHP | 4 | 2723.850 | -38.61 | -25 | Pass |
