**Radiolink Testing (Shenzhen) Co., Ltd.**

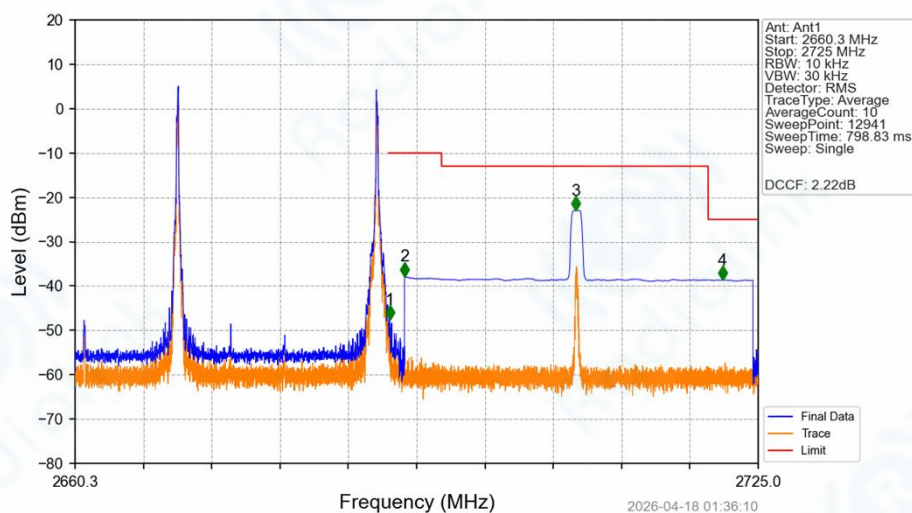
CA\_41C\_SISO\_NTNV\_CC1:10 CC2:20MHz\_CC1:64QAM CC2:64QAM\_CC1:2665.6 CC2:2680MHz\_CC1: 1@49 CC2: 1@99

| Start (MHz) | Stop (MHz) | RBW (MHz) | Method | Marker No. | Freq (MHz) | Level (dBm) | Limit (dBm) | Result |
| 2690 | 2691 | 0.02 | CHP | 1 | 2690.095 | -47.57 | -10 | Pass |
| 2691 | 2695 | 1 | CHP | 2 | 2691.500 | -37.78 | -10 | Pass |
| 2695 | 2720.256 | 1 | CHP | 3 | 2707.720 | -22.96 | -13 | Pass |
| 2720.256 | 2725 | 1 | CHP | 4 | 2721.600 | -38.58 | -25 | Pass |

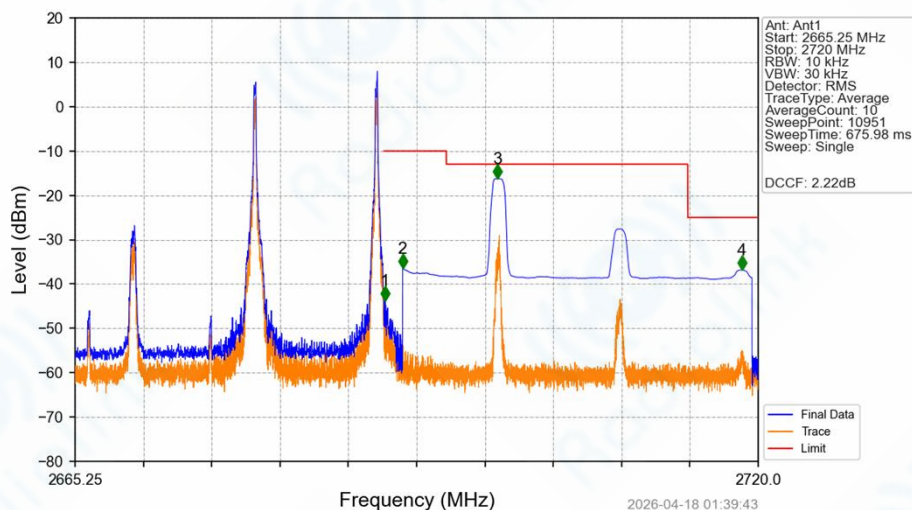
CA\_41C\_SISO\_NTNV\_CC1:15\_CC2:10MHz\_CC1:QPSK\_CC2:QPSK\_CC1:2673\_CC2:2685MHz\_CC1: 1@74\_CC2: 1@49

| Start (MHz) | Stop (MHz) | RBW (MHz) | Method | Marker No. | Freq (MHz) | Level (dBm) | Limit (dBm) | Result |
| 2690 | 2691 | 0.02 | CHP | 1 | 2690.095 | -43.71 | -10 | Pass |
| 2691 | 2695 | 1 | CHP | 2 | 2691.500 | -36.40 | -10 | Pass |
| 2695 | 2714.353 | 1 | CHP | 3 | 2699.115 | -16.26 | -13 | Pass |
| 2714.353 | 2720 | 1 | CHP | 4 | 2718.705 | -36.81 | -25 | Pass |

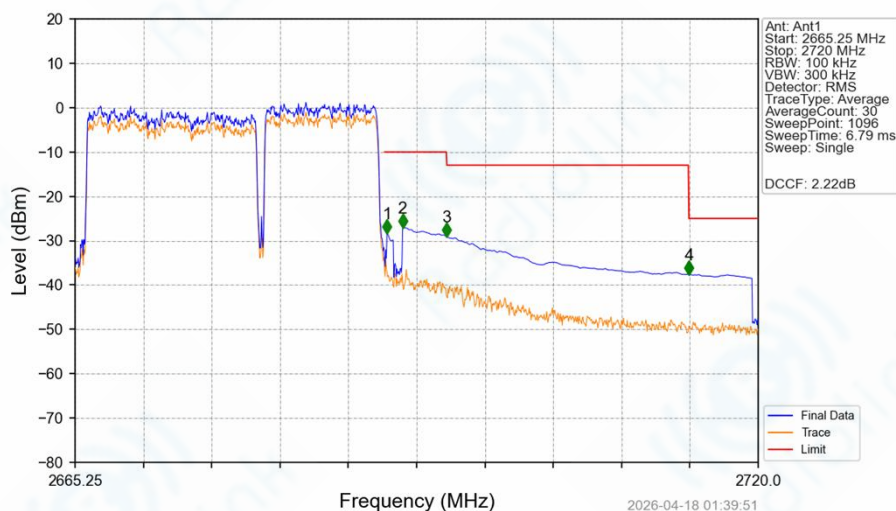
CA\_41C\_SISO\_NTNV\_CC1:15 CC2:10MHz\_CC1:QPSK CC2:QPSK\_CC1:2673 CC2:2685MHz\_CC1: 75@0 CC2: 50@0

| Start (MHz) | Stop (MHz) | RBW (MHz) | Method | Marker No. | Freq (MHz) | Level (dBm) | Limit (dBm) | Result |
| 2690 | 2691 | 0.489 | CHP | 1 | 2690.250 | -28.37 | -10 | Pass |
| 2691 | 2695 | 1 | CHP | 2 | 2691.500 | -27.07 | -10 | Pass |
| 2695 | 2714.428 | 1 | CHP | 3 | 2695.050 | -29.17 | -13 | Pass |
| 2714.428 | 2720 | 1 | CHP | 4 | 2714.450 | -37.61 | -25 | Pass |

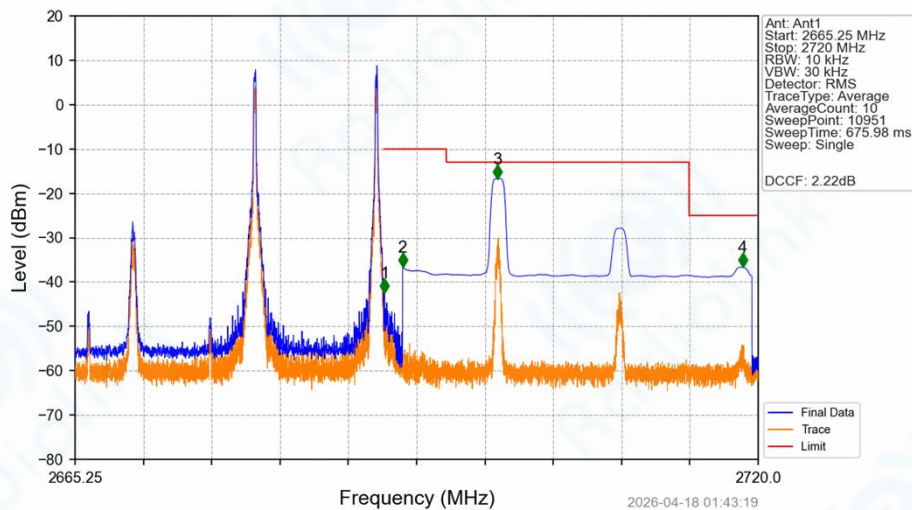
CA\_41C\_SISO\_NTNV\_CC1:15 CC2:10MHz\_CC1:16QAM CC2:16QAM\_CC1:2673 CC2:2685MHz\_CC1: 1@74 CC2: 1@49

| Start (MHz) | Stop (MHz) | RBW (MHz) | Method | Marker No. | Freq (MHz) | Level (dBm) | Limit (dBm) | Result |
| 2690 | 2691 | 0.02 | CHP | 1 | 2690.045 | -42.42 | -10 | Pass |
| 2691 | 2695 | 1 | CHP | 2 | 2691.500 | -36.63 | -10 | Pass |
| 2695 | 2714.458 | 1 | CHP | 3 | 2699.085 | -16.70 | -13 | Pass |
| 2714.458 | 2720 | 1 | CHP | 4 | 2718.740 | -36.66 | -25 | Pass |

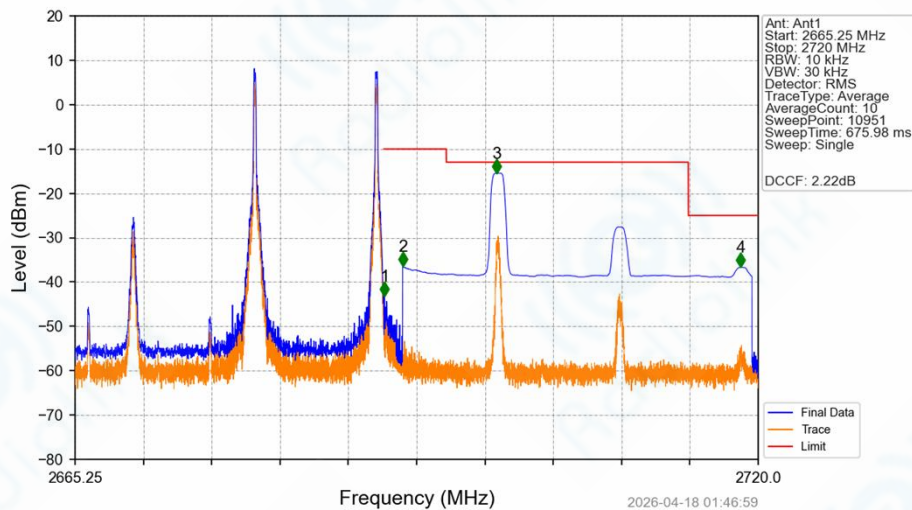
CA\_41C\_SISO\_NTNV\_CC1:15 CC2:10MHz\_CC1:64QAM CC2:64QAM\_CC1:2673 CC2:2685MHz\_CC1: 1@74 CC2: 1@49

| Start (MHz) | Stop (MHz) | RBW (MHz) | Method | Marker No. | Freq (MHz) | Level (dBm) | Limit (dBm) | Result |
| 2690 | 2691 | 0.02 | CHP | 1 | 2690.055 | -43.19 | -10 | Pass |
| 2691 | 2695 | 1 | CHP | 2 | 2691.505 | -36.36 | -10 | Pass |
| 2695 | 2714.398 | 1 | CHP | 3 | 2699.005 | -15.47 | -13 | Pass |
| 2714.398 | 2720 | 1 | CHP | 4 | 2718.595 | -36.67 | -25 | Pass |
