## n77a\_30kHz\_SISO\_NTNV\_10MHz\_DFT-s-OFDM\_QPSK\_3840MHz\_Edge\_1RB\_Left\_Ant1

**Radiolink Testing (Shenzhen) Co., Ltd.**

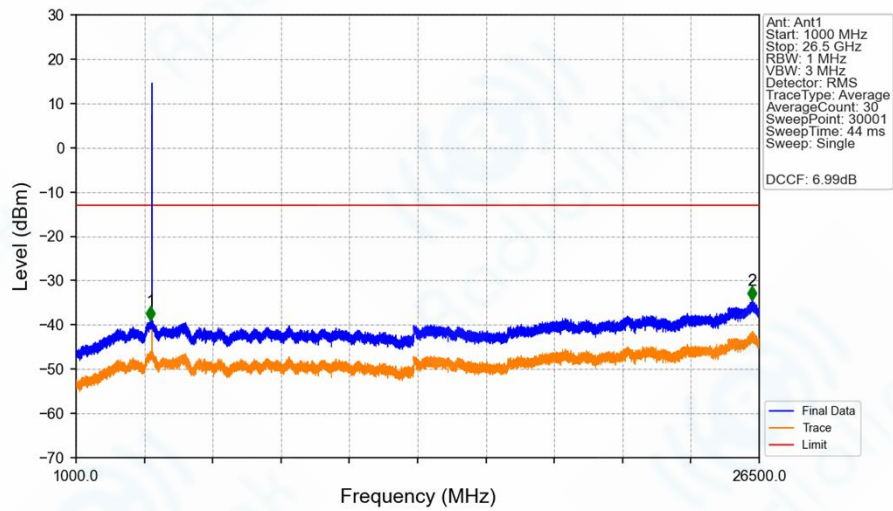
| Start (MHz) | Stop (MHz) | RBW (MHz) | Method | Marker No. | Freq (MHz) | Level (dBm) | Limit (dBm) | Result |
|---|---|---|---|---|---|---|---|---|
| 1000 | 3830 | 1 | / | 1 | 3785.450 | -38.95 | -13 | Pass |
| 3850 | 26500 | 1 | / | 2 | 26236.500 | -34.47 | -13 | Pass |

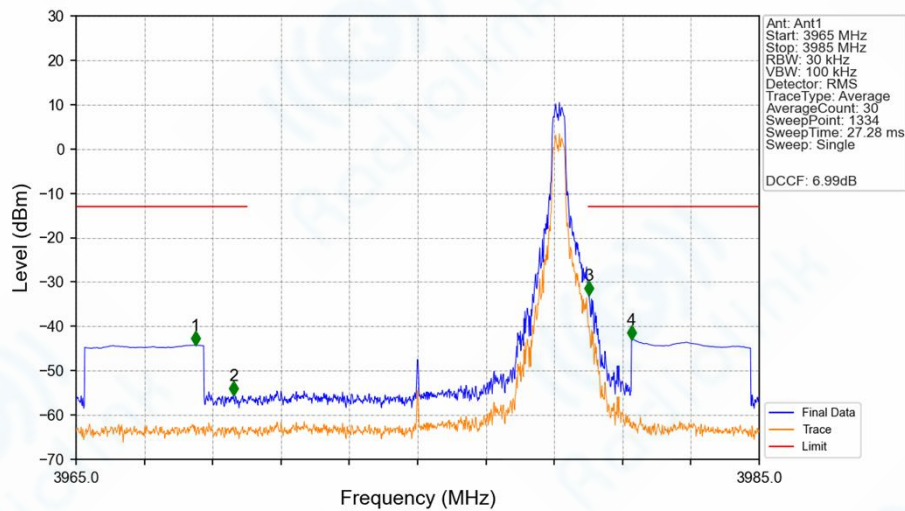
## n77a\_30kHz\_SISO\_NTNV\_10MHz\_DFT-s-OFDM\_QPSK\_3975MHz\_Edge\_1RB\_Right\_Ant1

| Start (MHz) | Stop (MHz) | RBW (MHz) | Method | Marker No. | Freq (MHz) | Level (dBm) | Limit (dBm) | Result |
|---|---|---|---|---|---|---|---|---|
| 3965 | 3969 | 0.5 | CHP | 1 | 3968.496 | -44.24 | -13 | Pass |
| 3969 | 3970 | 0.03 | / | 2 | 3969.606 | -55.58 | -13 | Pass |
| 3980 | 3981 | 0.03 | / | 3 | 3980.019 | -32.93 | -13 | Pass |
| 3981 | 3985 | 0.5 | CHP | 4 | 3981.264 | -42.92 | -13 | Pass |

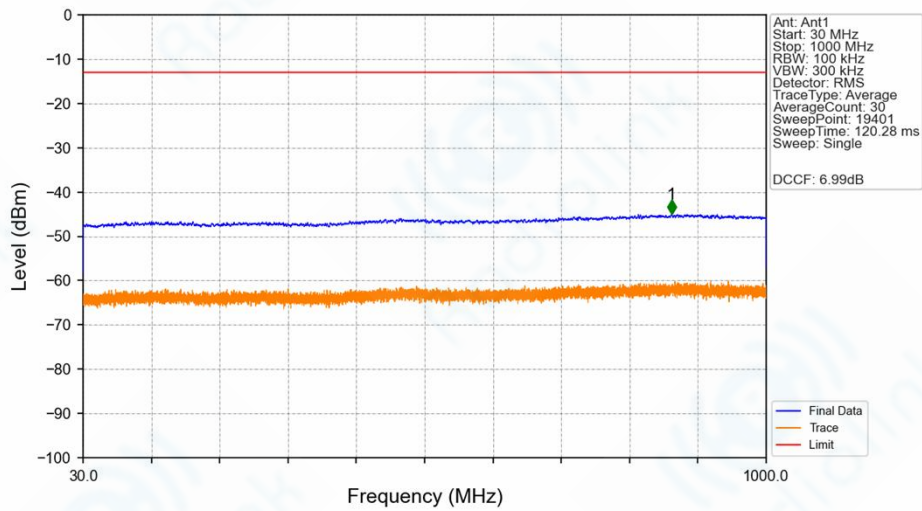
## n77a\_30kHz\_SISO\_NTNV\_10MHz\_DFT-s-OFDM\_QPSK\_3975MHz\_Edge\_1RB\_Right\_Ant1

| Start (MHz) | Stop (MHz) | RBW (MHz) | Method | Marker No. | Freq (MHz) | Level (dBm) | Limit (dBm) | Result |
|---|---|---|---|---|---|---|---|---|
| 30 | 1000 | 1 | CHP | 1 | 865.750 | -44.98 | -13 | Pass |

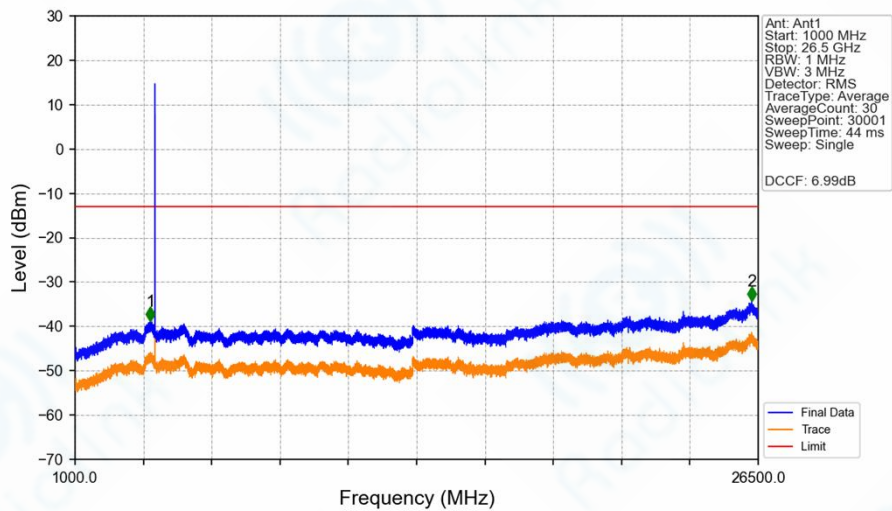
## n77a\_30kHz\_SISO\_NTNV\_10MHz\_DFT-s-OFDM\_QPSK\_3975MHz\_Edge\_1RB\_Right\_Ant1

| Start (MHz) | Stop (MHz) | RBW (MHz) | Method | Marker No. | Freq (MHz) | Level (dBm) | Limit (dBm) | Result |
|---|---|---|---|---|---|---|---|---|
| 1000 | 3965 | 1 | / | 1 | 3811.800 | -38.82 | -13 | Pass |
| 3985 | 26500 | 1 | / | 2 | 26252.650 | -34.33 | -13 | Pass |

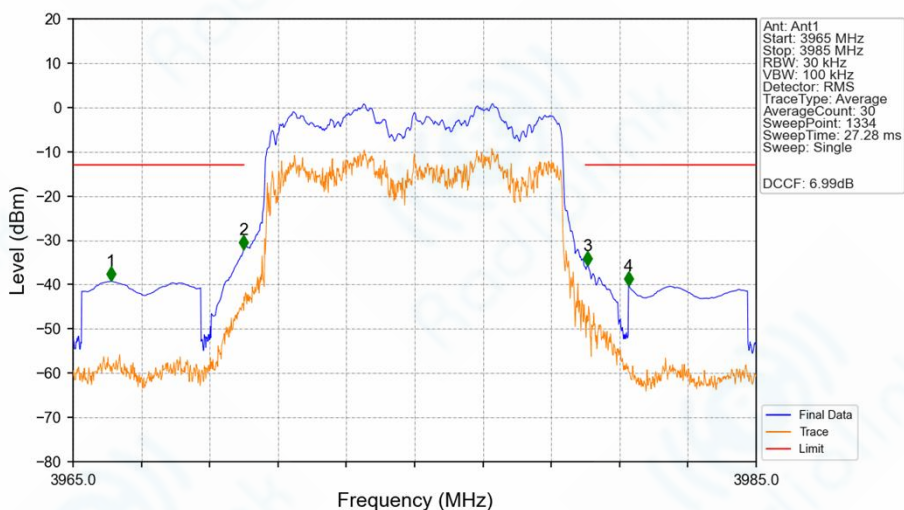
## n77a\_30kHz\_SISO\_NTNV\_10MHz\_DFT-s-OFDM\_QPSK\_3975MHz\_Outer\_Full\_Ant1

| Start (MHz) | Stop (MHz) | RBW (MHz) | Method | Marker No. | Freq (MHz) | Level (dBm) | Limit (dBm) | Result |
|---|---|---|---|---|---|---|---|---|
| 3965 | 3969 | 0.5 | CHP | 1 | 3966.110 | -39.14 | -13 | Pass |
| 3969 | 3970 | 0.09418 | CHP | 2 | 3969.996 | -32.02 | -13 | Pass |
| 3980 | 3981 | 0.09418 | CHP | 3 | 3980.064 | -35.63 | -13 | Pass |
| 3981 | 3985 | 0.5 | CHP | 4 | 3981.264 | -40.16 | -13 | Pass |

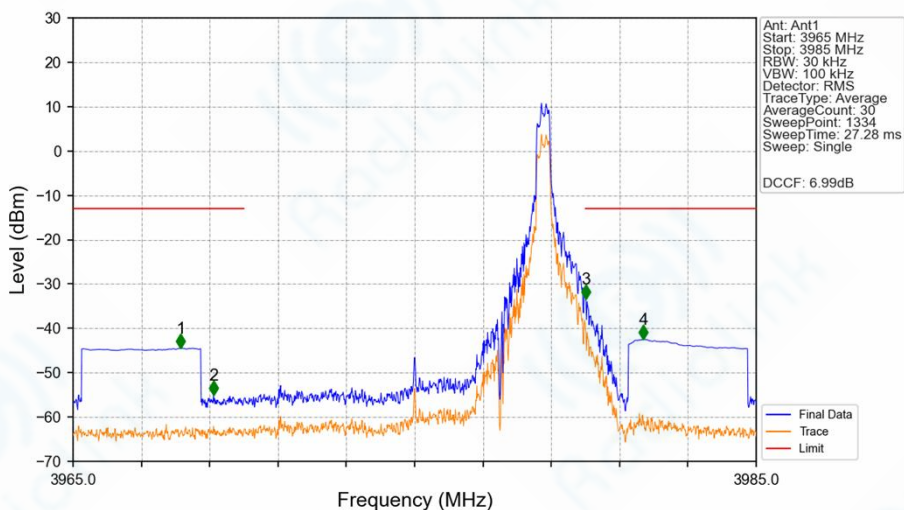
## n77a\_30kHz\_SISO\_NTNV\_10MHz\_DFT-s-OFDM\_QPSK\_3975MHz\_Inner\_1RB\_Right\_Ant1

| Start (MHz) | Stop (MHz) | RBW (MHz) | Method | Marker No. | Freq (MHz) | Level (dBm) | Limit (dBm) | Result |
|---|---|---|---|---|---|---|---|---|
| 3965 | 3969 | 0.5 | CHP | 1 | 3968.151 | -44.48 | -13 | Pass |
| 3969 | 3970 | 0.03 | / | 2 | 3969.111 | -55.08 | -13 | Pass |
| 3980 | 3981 | 0.03 | / | 3 | 3980.004 | -33.40 | -13 | Pass |
| 3981 | 3985 | 0.5 | CHP | 4 | 3981.699 | -42.46 | -13 | Pass |

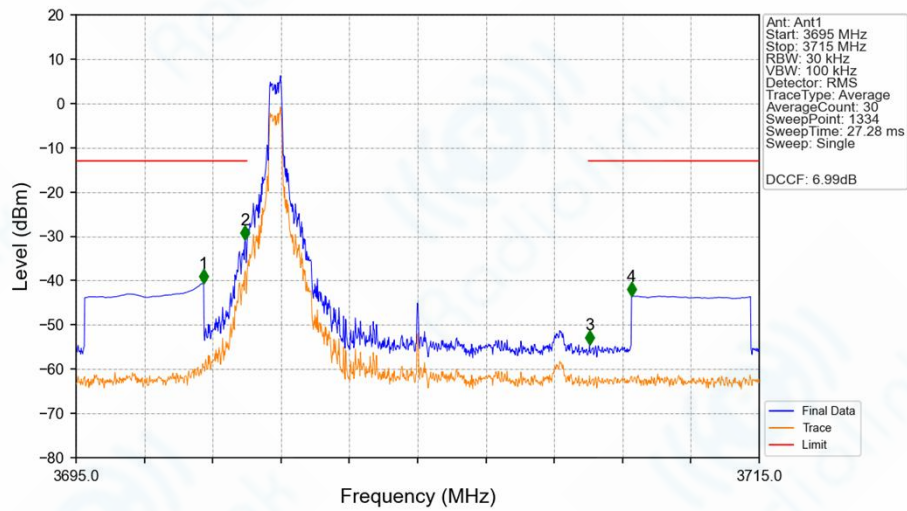
## n77a\_30kHz\_SISO\_NTNV\_10MHz\_CP-OFDM\_QPSK\_3705MHz\_Edge\_1RB\_Left\_Ant1

| Start (MHz) | Stop (MHz) | RBW (MHz) | Method | Marker No. | Freq (MHz) | Level (dBm) | Limit (dBm) | Result |
|---|---|---|---|---|---|---|---|---|
| 3695 | 3699 | 0.5 | CHP | 1 | 3698.736 | -40.55 | -13 | Pass |
| 3699 | 3700 | 0.03 | / | 2 | 3699.951 | -30.82 | -13 | Pass |
| 3710 | 3711 | 0.03 | / | 3 | 3710.034 | -54.45 | -13 | Pass |
| 3711 | 3715 | 0.5 | CHP | 4 | 3711.264 | -43.51 | -13 | Pass |

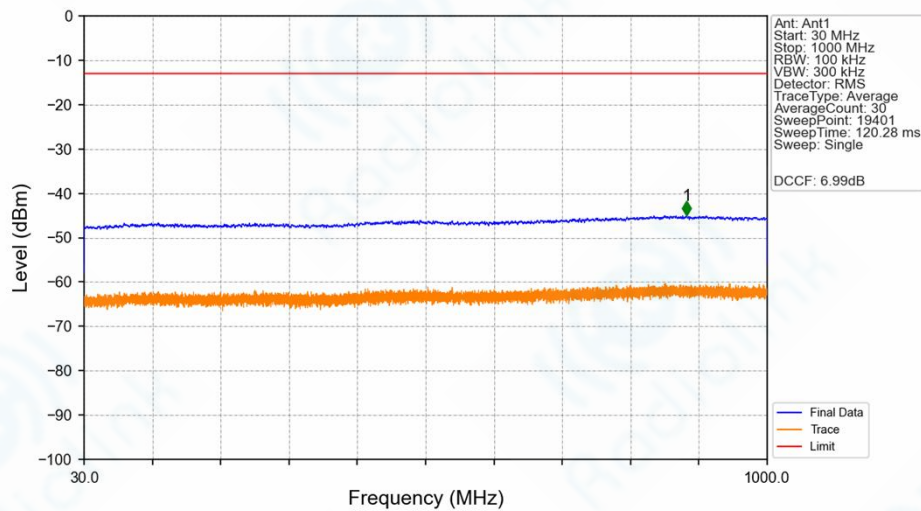
## n77a\_30kHz\_SISO\_NTNV\_10MHz\_CP-OFDM\_QPSK\_3705MHz\_Edge\_1RB\_Left\_Ant1

| Start (MHz) | Stop (MHz) | RBW (MHz) | Method | Marker No. | Freq (MHz) | Level (dBm) | Limit (dBm) | Result |
|---|---|---|---|---|---|---|---|---|
| 30 | 1000 | 1 | CHP | 1 | 885.650 | -44.99 | -13 | Pass |

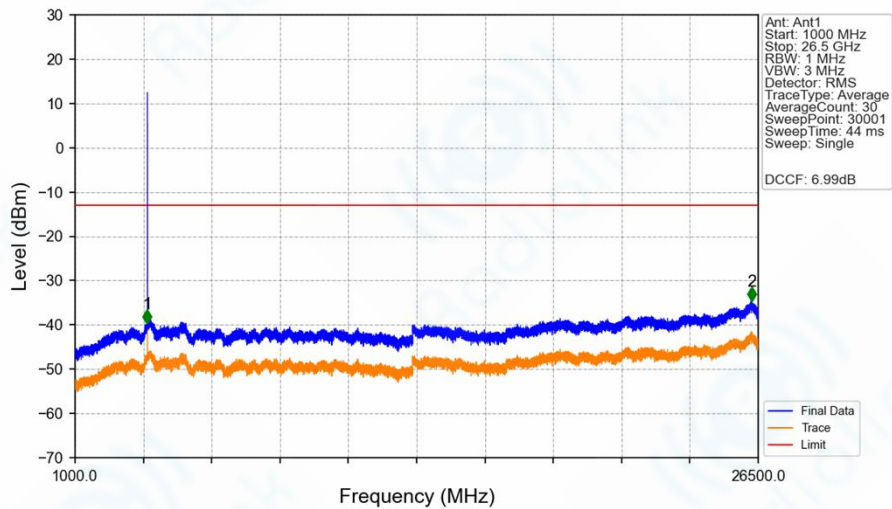
## n77a\_30kHz\_SISO\_NTNV\_10MHz\_CP-OFDM\_QPSK\_3705MHz\_Edge\_1RB\_Left\_Ant1

| Start (MHz) | Stop (MHz) | RBW (MHz) | Method | Marker No. | Freq (MHz) | Level (dBm) | Limit (dBm) | Result |
|---|---|---|---|---|---|---|---|---|
| 1000 | 3695 | 1 | / | 1 | 3691.950 | -39.74 | -13 | Pass |
| 3715 | 26500 | 1 | / | 2 | 26251.800 | -34.54 | -13 | Pass |

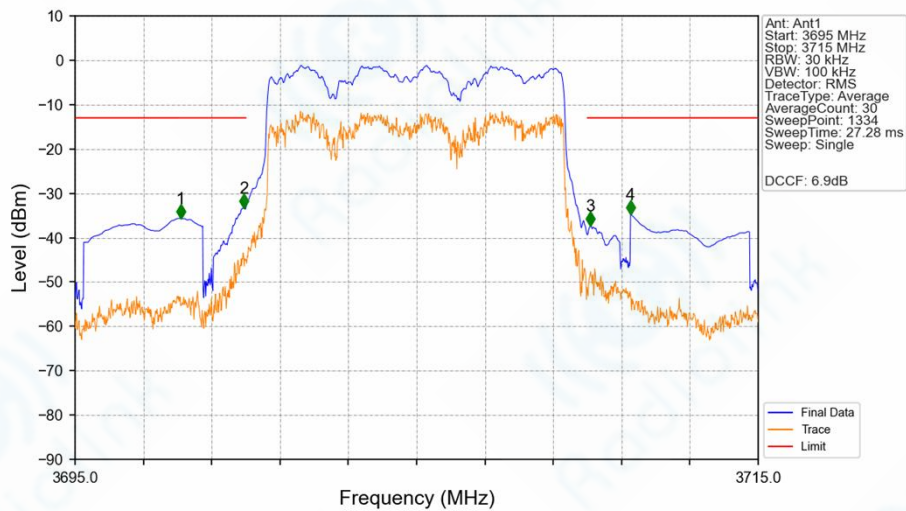
## n77a\_30kHz\_SISO\_NTNV\_10MHz\_CP-OFDM\_QPSK\_3705MHz\_Outer\_Full\_Ant1

| Start (MHz) | Stop (MHz) | RBW (MHz) | Method | Marker No. | Freq (MHz) | Level (dBm) | Limit (dBm) | Result |
|---|---|---|---|---|---|---|---|---|
| 3695 | 3699 | 0.5 | CHP | 1 | 3698.091 | -35.58 | -13 | Pass |
| 3699 | 3700 | 0.0962 | CHP | 2 | 3699.936 | -33.29 | -13 | Pass |
| 3710 | 3711 | 0.0962 | CHP | 3 | 3710.094 | -37.29 | -13 | Pass |
| 3711 | 3715 | 0.5 | CHP | 4 | 3711.264 | -34.68 | -13 | Pass |

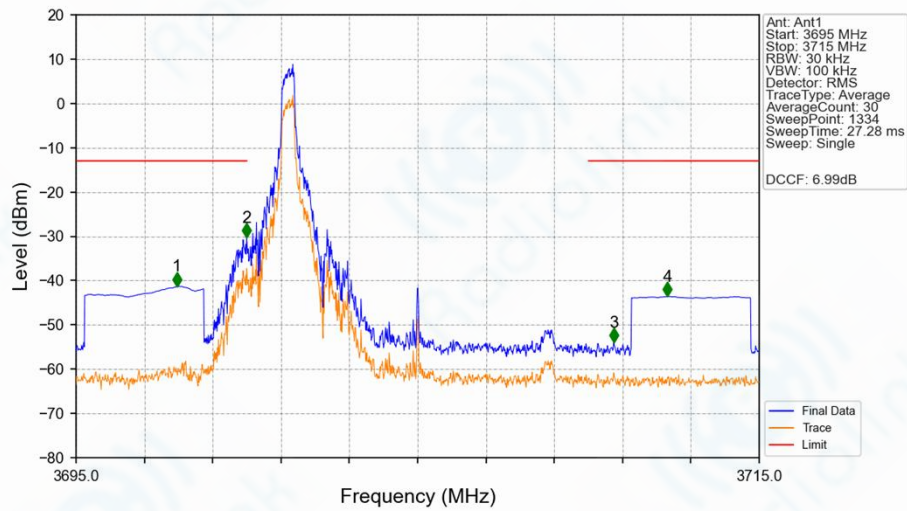
## n77a\_30kHz\_SISO\_NTNV\_10MHz\_CP-OFDM\_QPSK\_3705MHz\_Inner\_1RB\_Left\_Ant1

| Start (MHz) | Stop (MHz) | RBW (MHz) | Method | Marker No. | Freq (MHz) | Level (dBm) | Limit (dBm) | Result |
|---|---|---|---|---|---|---|---|---|
| 3695 | 3699 | 0.5 | CHP | 1 | 3697.956 | -41.24 | -13 | Pass |
| 3699 | 3700 | 0.03 | / | 2 | 3699.996 | -30.24 | -13 | Pass |
| 3710 | 3711 | 0.03 | / | 3 | 3710.739 | -53.84 | -13 | Pass |
| 3711 | 3715 | 0.5 | CHP | 4 | 3712.314 | -43.56 | -13 | Pass |

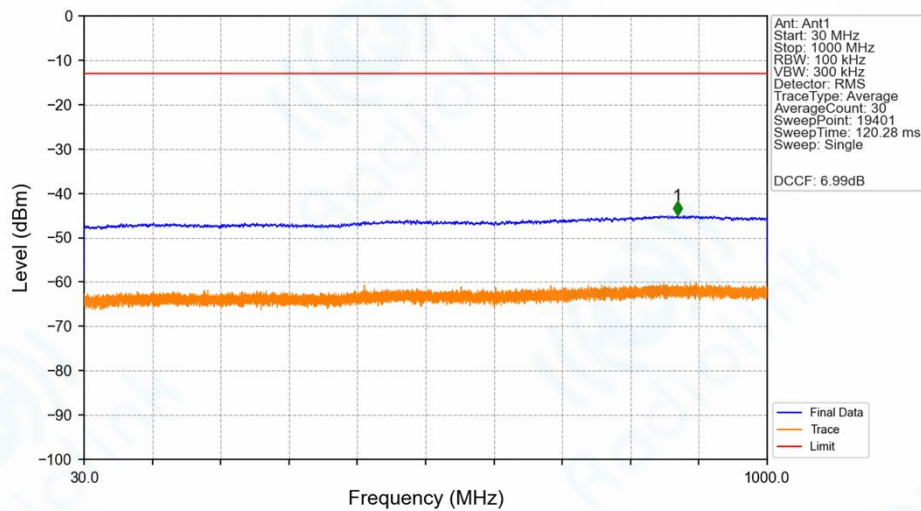
## n77a\_30kHz\_SISO\_NTNV\_10MHz\_CP-OFDM\_QPSK\_3840MHz\_Edge\_1RB\_Left\_Ant1

| Start (MHz) | Stop (MHz) | RBW (MHz) | Method | Marker No. | Freq (MHz) | Level (dBm) | Limit (dBm) | Result |
|---|---|---|---|---|---|---|---|---|
| 30 | 1000 | 1 | CHP | 1 | 872.500 | -45.02 | -13 | Pass |

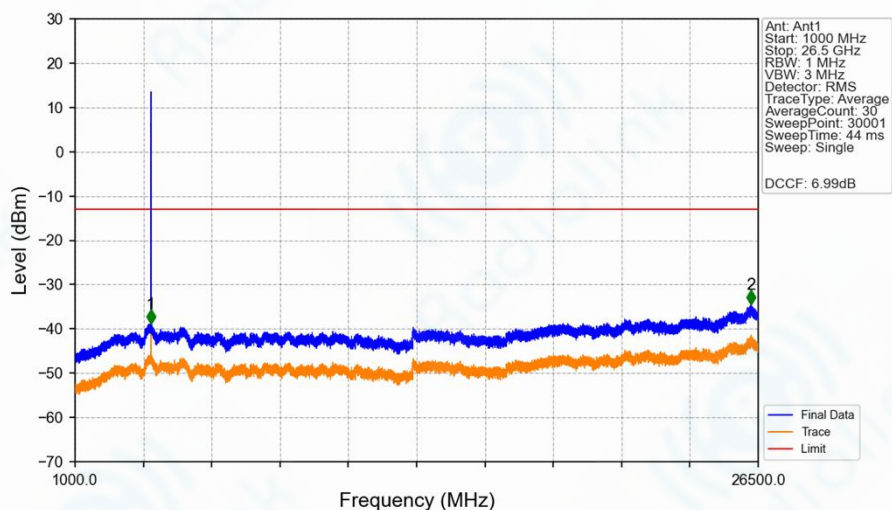
## n77a\_30kHz\_SISO\_NTNV\_10MHz\_CP-OFDM\_QPSK\_3840MHz\_Edge\_1RB\_Left\_Ant1

| Start (MHz) | Stop (MHz) | RBW (MHz) | Method | Marker No. | Freq (MHz) | Level (dBm) | Limit (dBm) | Result |
|---|---|---|---|---|---|---|---|---|
| 1000 | 3830 | 1 | / | 1 | 3825.400 | -38.75 | -13 | Pass |
| 3850 | 26500 | 1 | / | 2 | 26239.900 | -34.38 | -13 | Pass |

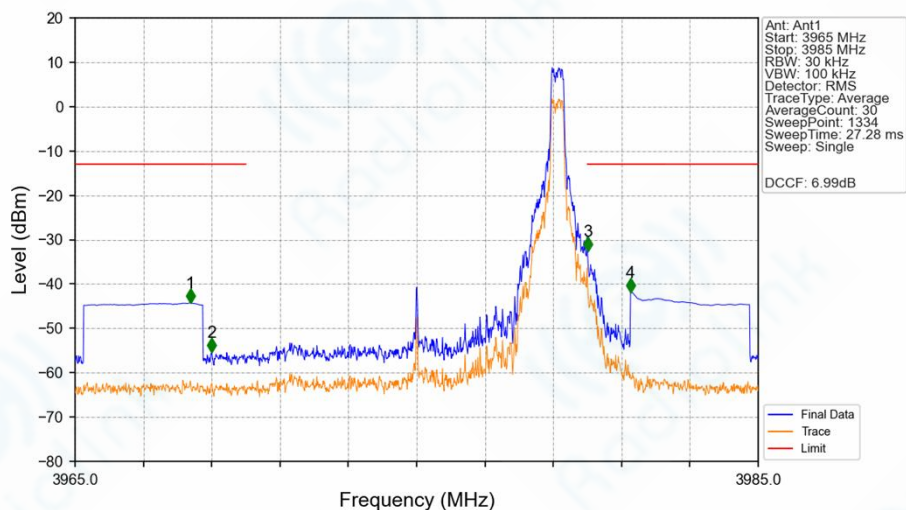
## n77a\_30kHz\_SISO\_NTNV\_10MHz\_CP-OFDM\_QPSK\_3975MHz\_Edge\_1RB\_Right\_Ant1

| Start (MHz) | Stop (MHz) | RBW (MHz) | Method | Marker No. | Freq (MHz) | Level (dBm) | Limit (dBm) | Result |
|---|---|---|---|---|---|---|---|---|
| 3965 | 3969 | 0.5 | CHP | 1 | 3968.376 | -44.26 | -13 | Pass |
| 3969 | 3970 | 0.03 | / | 2 | 3969.006 | -55.38 | -13 | Pass |
| 3980 | 3981 | 0.03 | / | 3 | 3980.004 | -32.56 | -13 | Pass |
| 3981 | 3985 | 0.5 | CHP | 4 | 3981.264 | -41.88 | -13 | Pass |

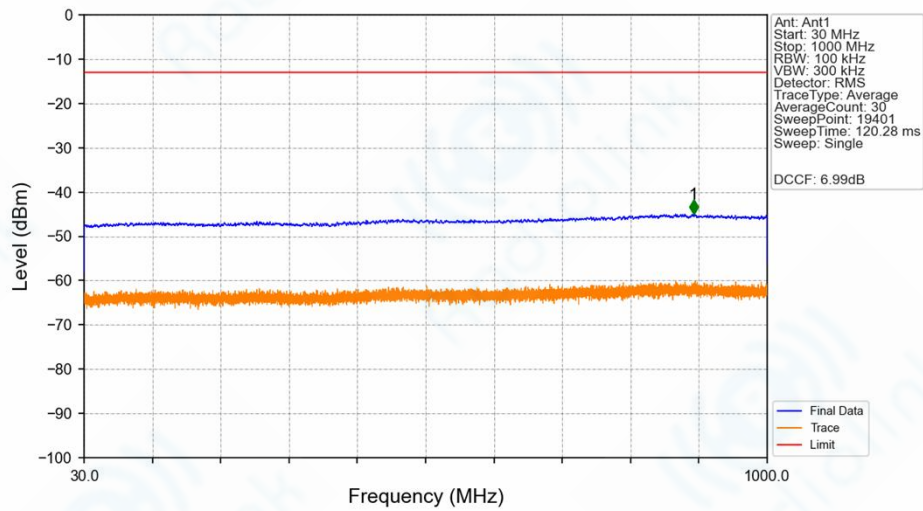
## n77a\_30kHz\_SISO\_NTNV\_10MHz\_CP-OFDM\_QPSK\_3975MHz\_Edge\_1RB\_Right\_Ant1

| Start (MHz) | Stop (MHz) | RBW (MHz) | Method | Marker No. | Freq (MHz) | Level (dBm) | Limit (dBm) | Result |
|---|---|---|---|---|---|---|---|---|
| 30 | 1000 | 1 | CHP | 1 | 895.350 | -44.93 | -13 | Pass |

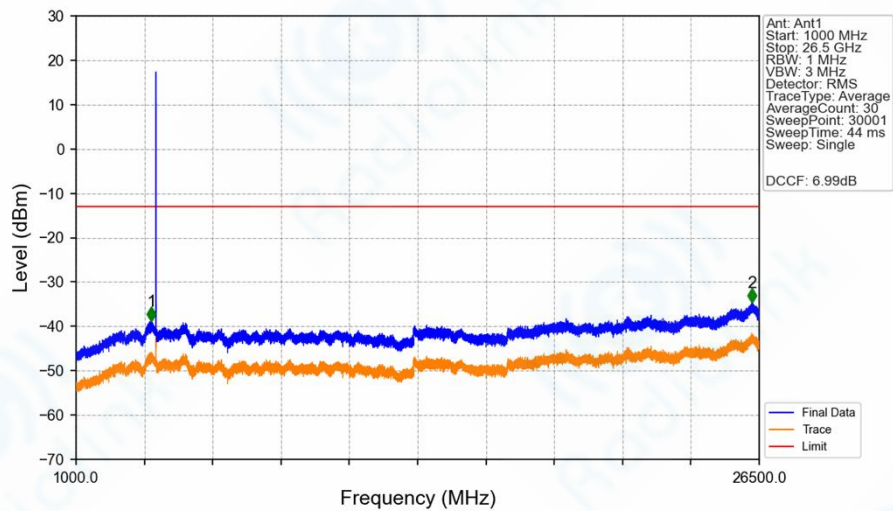
## n77a\_30kHz\_SISO\_NTNV\_10MHz\_CP-OFDM\_QPSK\_3975MHz\_Edge\_1RB\_Right\_Ant1

| Start (MHz) | Stop (MHz) | RBW (MHz) | Method | Marker No. | Freq (MHz) | Level (dBm) | Limit (dBm) | Result |
|---|---|---|---|---|---|---|---|---|
| 1000 | 3965 | 1 | / | 1 | 3810.100 | -38.82 | -13 | Pass |
| 3985 | 26500 | 1 | / | 2 | 26220.350 | -34.54 | -13 | Pass |

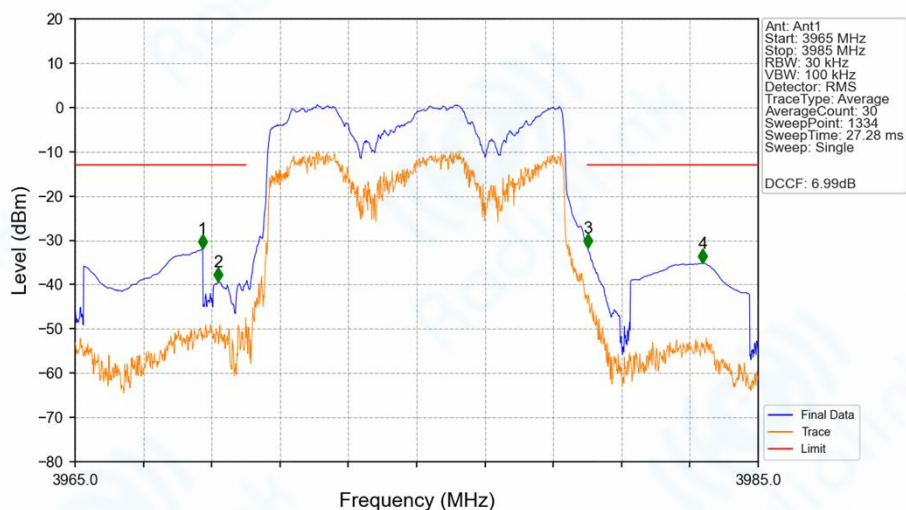
## n77a\_30kHz\_SISO\_NTNV\_10MHz\_CP-OFDM\_QPSK\_3975MHz\_Outer\_Full\_Ant1

| Start (MHz) | Stop (MHz) | RBW (MHz) | Method | Marker No. | Freq (MHz) | Level (dBm) | Limit (dBm) | Result |
|---|---|---|---|---|---|---|---|---|
| 3965 | 3969 | 0.5 | CHP | 1 | 3968.736 | -31.93 | -13 | Pass |
| 3969 | 3970 | 0.09581 | CHP | 2 | 3969.186 | -39.36 | -13 | Pass |
| 3980 | 3981 | 0.09581 | CHP | 3 | 3980.004 | -31.67 | -13 | Pass |
| 3981 | 3985 | 0.5 | CHP | 4 | 3983.380 | -35.09 | -13 | Pass |

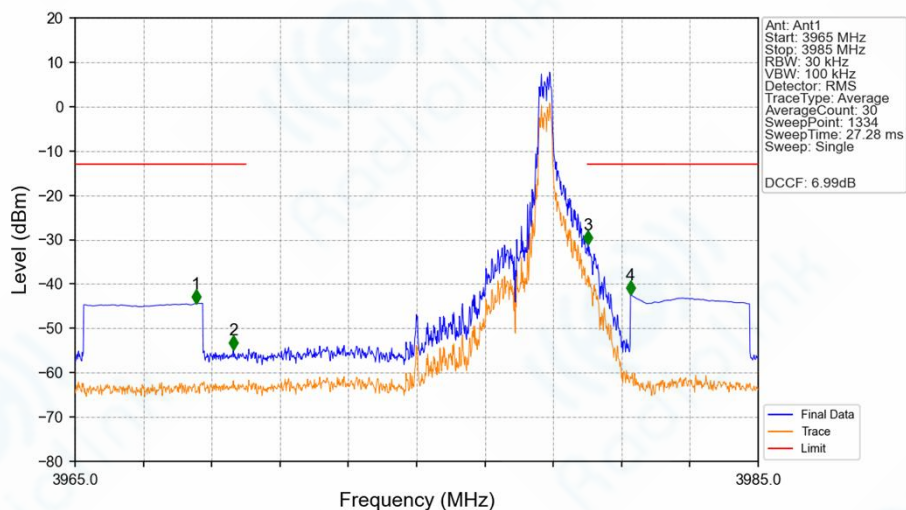
## n77a\_30kHz\_SISO\_NTNV\_10MHz\_CP-OFDM\_QPSK\_3975MHz\_Inner\_1RB\_Right\_Ant1

| Start (MHz) | Stop (MHz) | RBW (MHz) | Method | Marker No. | Freq (MHz) | Level (dBm) | Limit (dBm) | Result |
|---|---|---|---|---|---|---|---|---|
| 3965 | 3969 | 0.5 | CHP | 1 | 3968.541 | -44.36 | -13 | Pass |
| 3969 | 3970 | 0.03 | / | 2 | 3969.636 | -54.82 | -13 | Pass |
| 3980 | 3981 | 0.03 | / | 3 | 3980.019 | -31.09 | -13 | Pass |
| 3981 | 3985 | 0.5 | CHP | 4 | 3981.264 | -42.43 | -13 | Pass |

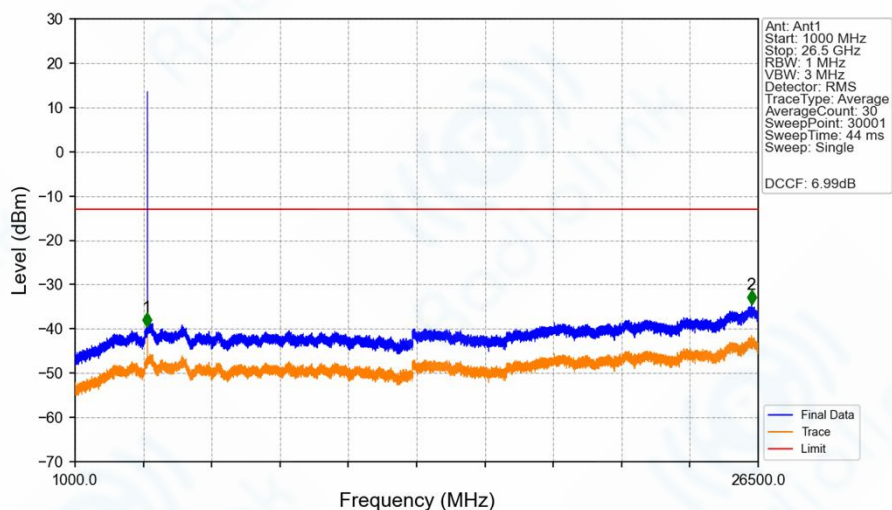
## n77a\_30kHz\_SISO\_NTNV\_20MHz\_DFT-s-OFDM PI/2 BPSK 3710.01MHz\_Edge\_1RB\_Left\_Ant1

| Start (MHz) | Stop (MHz) | RBW (MHz) | Method | Marker No. | Freq (MHz) | Level (dBm) | Limit (dBm) | Result |
|---|---|---|---|---|---|---|---|---|
| 1000 | 3695.01 | 1 | / | 1 | 3671.550 | -39.61 | -13 | Pass |
| 3725.01 | 26500 | 1 | / | 2 | 26244.150 | -34.46 | -13 | Pass |

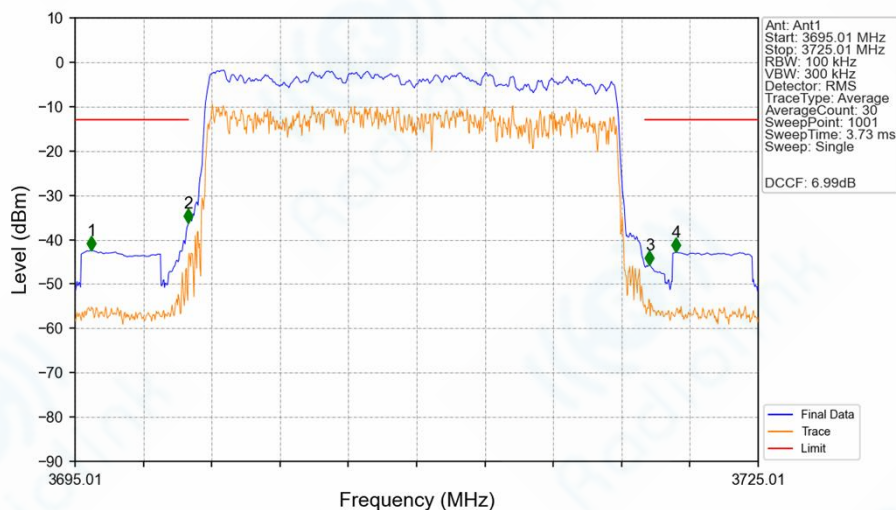
## n77a\_30kHz\_SISO\_NTNV\_20MHz\_DFT-s-OFDM PI/2 BPSK 3710.01MHz\_Outer\_Full\_Ant1

| Start (MHz) | Stop (MHz) | RBW (MHz) | Method | Marker No. | Freq (MHz) | Level (dBm) | Limit (dBm) | Result |
|---|---|---|---|---|---|---|---|---|
| 3695.01 | 3699.01 | 0.5 | CHP | 1 | 3695.730 | -42.40 | -13 | Pass |
| 3699.01 | 3700.01 | 0.18793 | CHP | 2 | 3699.990 | -36.21 | -13 | Pass |
| 3720.01 | 3721.01 | 0.18793 | CHP | 3 | 3720.240 | -45.68 | -13 | Pass |
| 3721.01 | 3725.01 | 0.5 | CHP | 4 | 3721.410 | -42.84 | -13 | Pass |

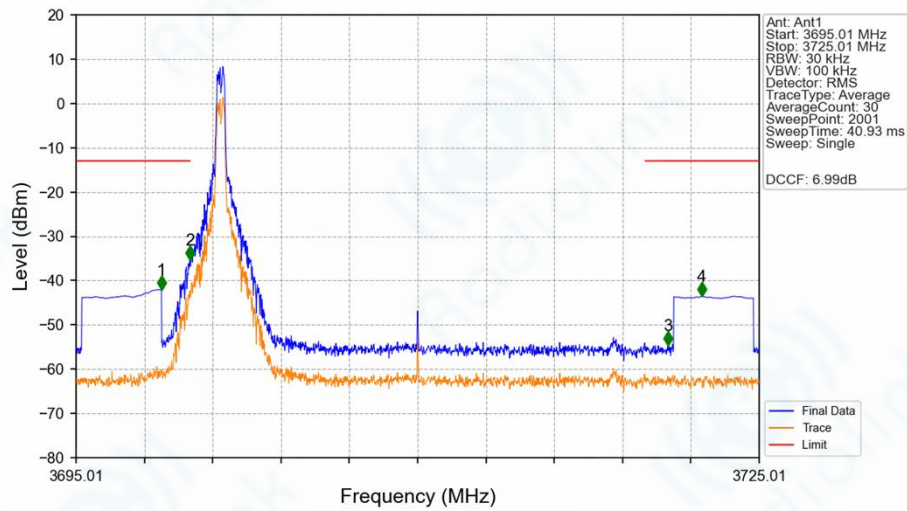
## n77a\_30kHz\_SISO\_NTNV\_20MHz\_DFT-s-OFDM PI/2 BPSK 3710.01MHz\_Inner\_1RB\_Left\_Ant1

| Start (MHz) | Stop (MHz) | RBW (MHz) | Method | Marker No. | Freq (MHz) | Level (dBm) | Limit (dBm) | Result |
|---|---|---|---|---|---|---|---|---|
| 3695.01 | 3699.01 | 0.5 | CHP | 1 | 3698.760 | -42.02 | -13 | Pass |
| 3699.01 | 3700.01 | 0.03 | / | 2 | 3700.005 | -35.38 | -13 | Pass |
| 3720.01 | 3721.01 | 0.03 | / | 3 | 3720.990 | -54.61 | -13 | Pass |
| 3721.01 | 3725.01 | 0.5 | CHP | 4 | 3722.475 | -43.55 | -13 | Pass |

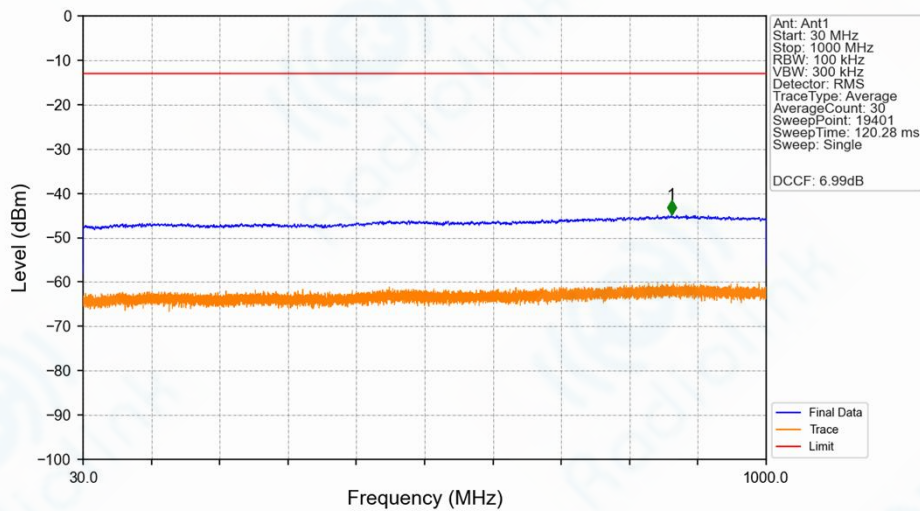
## n77a\_30kHz\_SISO\_NTNV\_20MHz\_DFT-s-OFDM PI/2 BPSK 3840MHz\_Edge\_1RB\_Left\_Ant1

| Start (MHz) | Stop (MHz) | RBW (MHz) | Method | Marker No. | Freq (MHz) | Level (dBm) | Limit (dBm) | Result |
|---|---|---|---|---|---|---|---|---|
| 30 | 1000 | 1 | CHP | 1 | 865.500 | -44.84 | -13 | Pass |

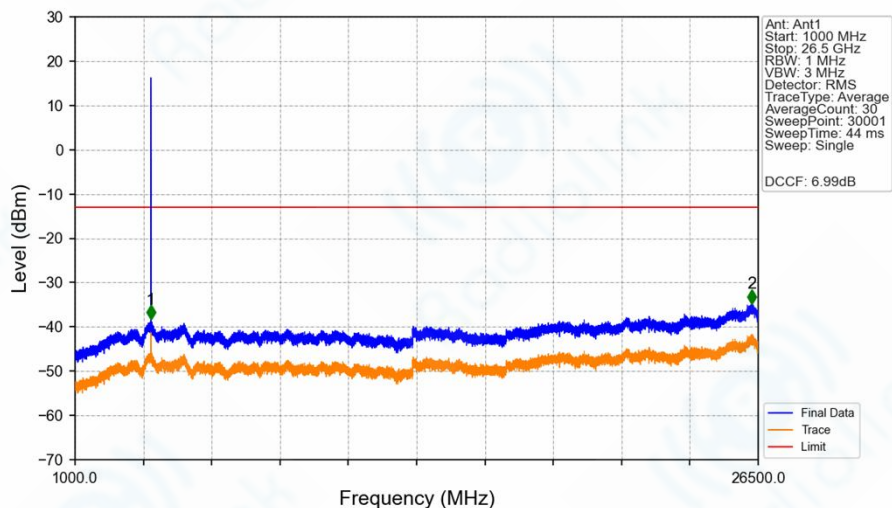
## n77a\_30kHz\_SISO\_NTNV\_20MHz\_DFT-s-OFDM\_PI/2\_BPSK\_3840MHz\_Edge\_1RB\_Left\_Ant1

| Start (MHz) | Stop (MHz) | RBW (MHz) | Method | Marker No. | Freq (MHz) | Level (dBm) | Limit (dBm) | Result |
|---|---|---|---|---|---|---|---|---|
| 1000 | 3825 | 1 | / | 1 | 3822.000 | -38.26 | -13 | Pass |
| 3855 | 26500 | 1 | / | 2 | 26250.950 | -34.70 | -13 | Pass |

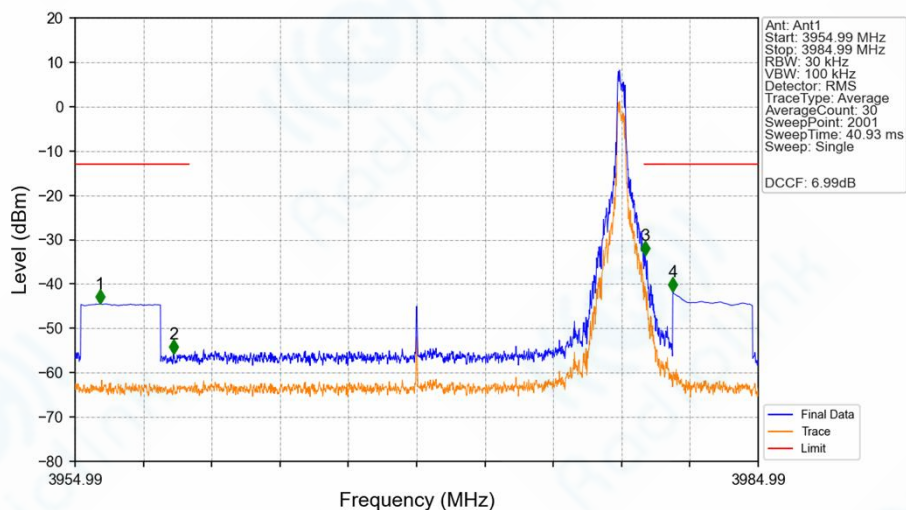
## n77a\_30kHz\_SISO\_NTNV\_20MHz\_DFT-s-OFDM\_PI/2\_BPSK\_3969.99MHz\_Edge\_1RB\_Right\_Ant1

| Start (MHz) | Stop (MHz) | RBW (MHz) | Method | Marker No. | Freq (MHz) | Level (dBm) | Limit (dBm) | Result |
|---|---|---|---|---|---|---|---|---|
| 3954.99 | 3958.99 | 0.5 | CHP | 1 | 3956.085 | -44.49 | -13 | Pass |
| 3958.99 | 3959.99 | 0.03 | / | 2 | 3959.310 | -55.75 | -13 | Pass |
| 3979.99 | 3980.99 | 0.03 | / | 3 | 3980.025 | -33.51 | -13 | Pass |
| 3980.99 | 3984.99 | 0.5 | CHP | 4 | 3981.240 | -41.72 | -13 | Pass |

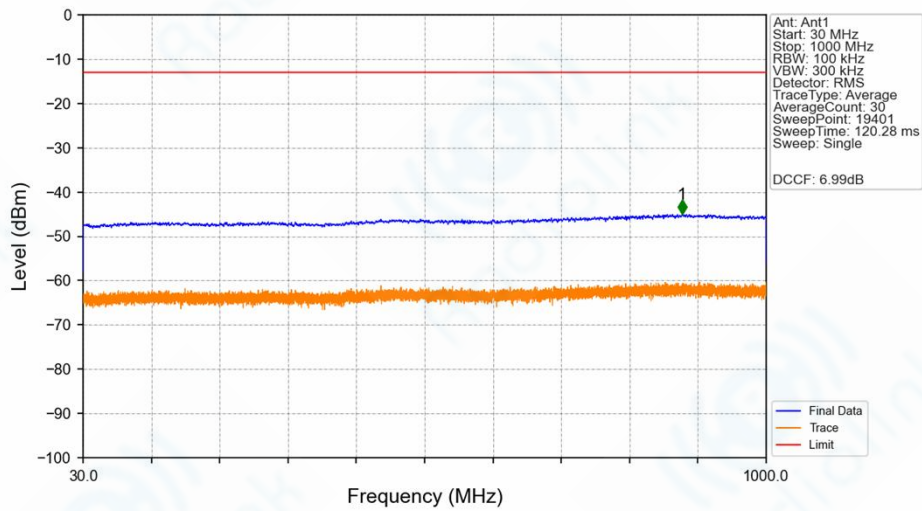
n77a\_30kHz\_SISO\_NTNV\_20MHz\_DFT-s-OFDM\_PI/2\_BPSK\_3969.99MHz\_Edge\_1RB\_Right\_Ant1

| Start (MHz) | Stop (MHz) | RBW (MHz) | Method | Marker No. | Freq (MHz) | Level (dBm) | Limit (dBm) | Result |
|---|---|---|---|---|---|---|---|---|
| 30 | 1000 | 1 | CHP | 1 | 880.600 | -44.98 | -13 | Pass |

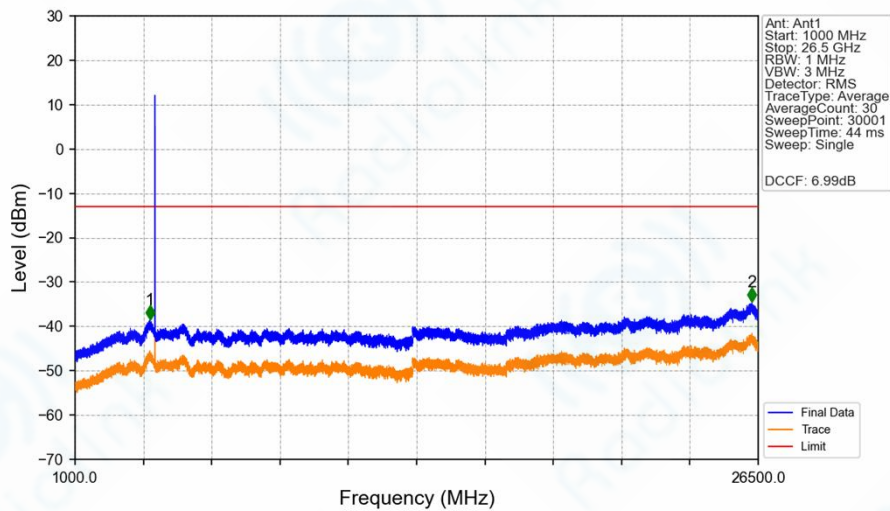
n77a\_30kHz\_SISO\_NTNV\_20MHz\_DFT-s-OFDM\_PI/2\_BPSK\_3969.99MHz\_Edge\_1RB\_Right\_Ant1

| Start (MHz) | Stop (MHz) | RBW (MHz) | Method | Marker No. | Freq (MHz) | Level (dBm) | Limit (dBm) | Result |
|---|---|---|---|---|---|---|---|---|
| 1000 | 3954.99 | 1 | / | 1 | 3794.800 | -38.48 | -13 | Pass |
| 3984.99 | 26500 | 1 | / | 2 | 26273.050 | -34.49 | -13 | Pass |

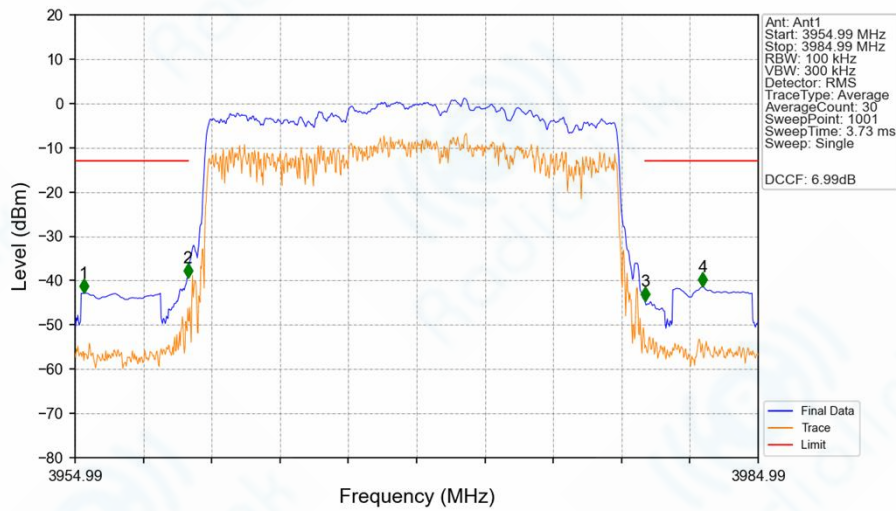
## n77a 30kHz\_SISO\_NTNV\_20MHz\_DFT-s-OFDM PI/2 BPSK\_3969.99MHz\_Outer\_Full\_Ant1

| Start (MHz) | Stop (MHz) | RBW (MHz) | Method | Marker No. | Freq (MHz) | Level (dBm) | Limit (dBm) | Result |
|---|---|---|---|---|---|---|---|---|
| 3954.99 | 3958.99 | 0.5 | CHP | 1 | 3955.380 | -42.81 | -13 | Pass |
| 3958.99 | 3959.99 | 0.18955 | CHP | 2 | 3959.940 | -39.28 | -13 | Pass |
| 3979.99 | 3980.99 | 0.18955 | CHP | 3 | 3980.010 | -44.59 | -13 | Pass |
| 3980.99 | 3984.99 | 0.5 | CHP | 4 | 3982.560 | -41.38 | -13 | Pass |

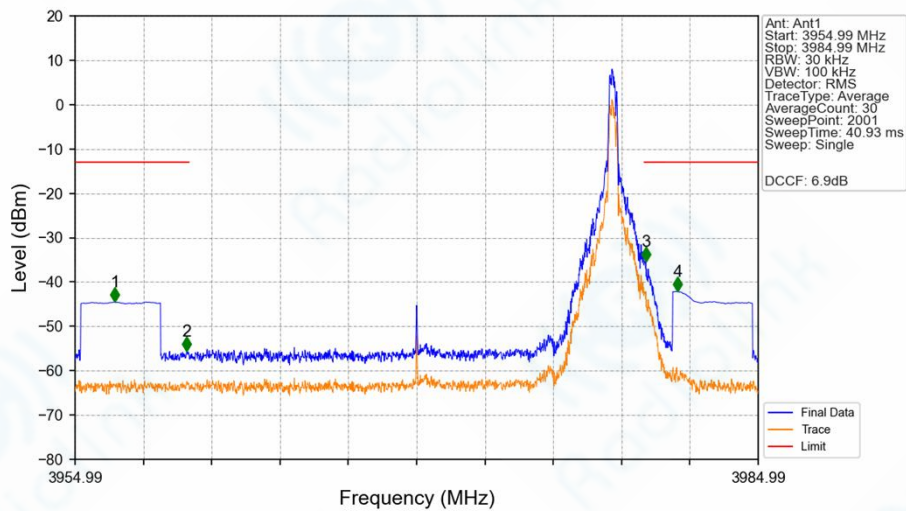
## n77a 30kHz\_SISO\_NTNV\_20MHz\_DFT-s-OFDM PI/2 BPSK\_3969.99MHz\_Inner\_1RB\_Right\_Ant1

| Start (MHz) | Stop (MHz) | RBW (MHz) | Method | Marker No. | Freq (MHz) | Level (dBm) | Limit (dBm) | Result |
|---|---|---|---|---|---|---|---|---|
| 3954.99 | 3958.99 | 0.5 | CHP | 1 | 3956.730 | -44.50 | -13 | Pass |
| 3958.99 | 3959.99 | 0.03 | / | 2 | 3959.895 | -55.55 | -13 | Pass |
| 3979.99 | 3980.99 | 0.03 | / | 3 | 3980.055 | -35.24 | -13 | Pass |
| 3980.99 | 3984.99 | 0.5 | CHP | 4 | 3981.450 | -42.08 | -13 | Pass |

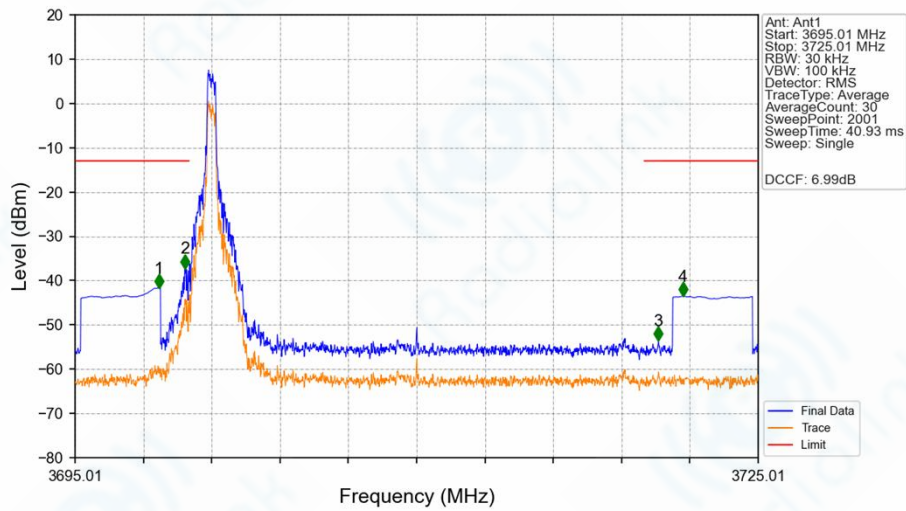
## n77a\_30kHz\_SISO\_NTNV\_20MHz\_DFT-s-OFDM\_QPSK\_3710.01MHz\_Edge\_1RB\_Left\_Ant1

| Start (MHz) | Stop (MHz) | RBW (MHz) | Method | Marker No. | Freq (MHz) | Level (dBm) | Limit (dBm) | Result |
|---|---|---|---|---|---|---|---|---|
| 3695.01 | 3699.01 | 0.5 | CHP | 1 | 3698.685 | -41.64 | -13 | Pass |
| 3699.01 | 3700.01 | 0.03 | / | 2 | 3699.840 | -37.23 | -13 | Pass |
| 3720.01 | 3721.01 | 0.03 | / | 3 | 3720.630 | -53.57 | -13 | Pass |
| 3721.01 | 3725.01 | 0.5 | CHP | 4 | 3721.695 | -43.50 | -13 | Pass |

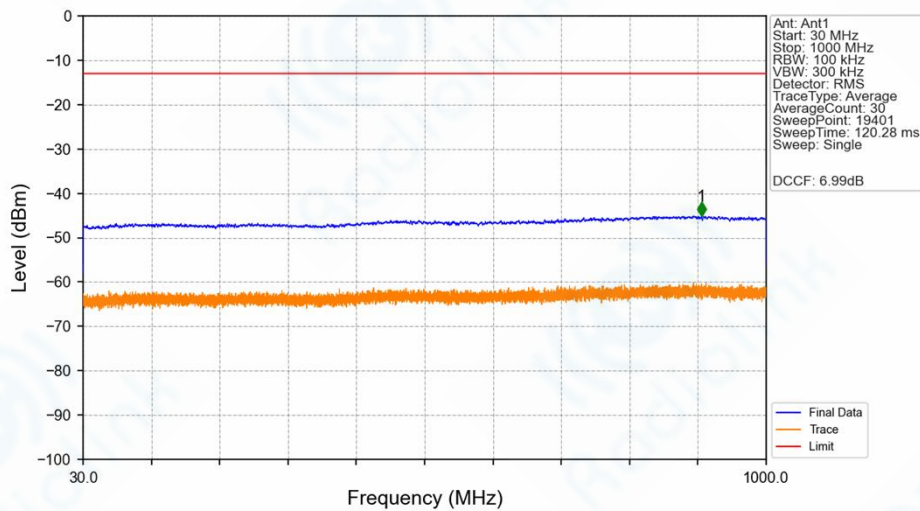
## n77a\_30kHz\_SISO\_NTNV\_20MHz\_DFT-s-OFDM\_QPSK\_3710.01MHz\_Edge\_1RB\_Left\_Ant1

| Start (MHz) | Stop (MHz) | RBW (MHz) | Method | Marker No. | Freq (MHz) | Level (dBm) | Limit (dBm) | Result |
|---|---|---|---|---|---|---|---|---|
| 30 | 1000 | 1 | CHP | 1 | 908.250 | -45.11 | -13 | Pass |

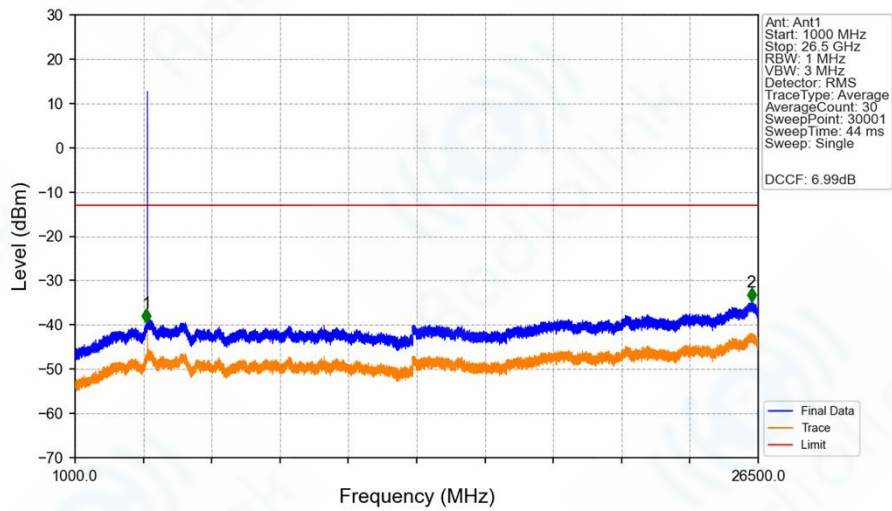
## n77a\_30kHz\_SISO\_NTNV\_20MHz\_DFT-s-OFDM\_QPSK\_3710.01MHz\_Edge\_1RB\_Left\_Ant1

| Start (MHz) | Stop (MHz) | RBW (MHz) | Method | Marker No. | Freq (MHz) | Level (dBm) | Limit (dBm) | Result |
|---|---|---|---|---|---|---|---|---|
| 1000 | 3695.01 | 1 | / | 1 | 3665.600 | -39.55 | -13 | Pass |
| 3725.01 | 26500 | 1 | / | 2 | 26248.400 | -34.87 | -13 | Pass |

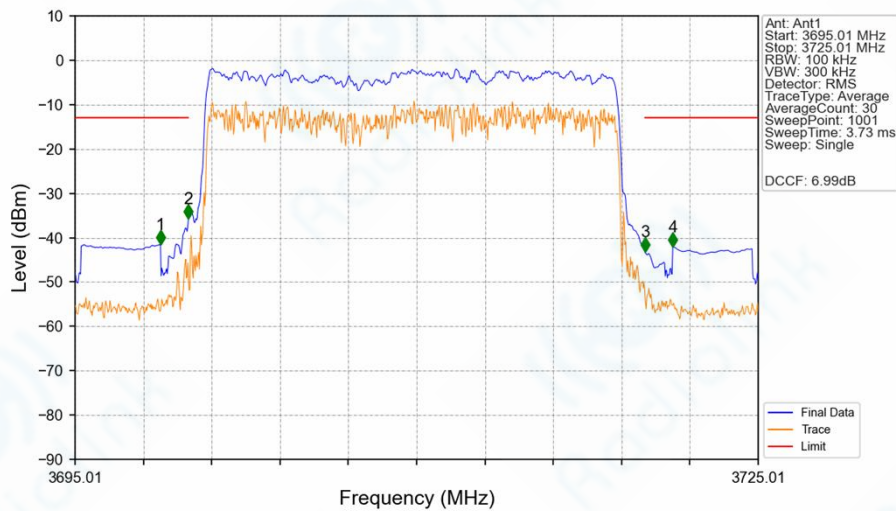
## n77a\_30kHz\_SISO\_NTNV\_20MHz\_DFT-s-OFDM\_QPSK\_3710.01MHz\_Outer\_Full\_Ant1

| Start (MHz) | Stop (MHz) | RBW (MHz) | Method | Marker No. | Freq (MHz) | Level (dBm) | Limit (dBm) | Result |
|---|---|---|---|---|---|---|---|---|
| 3695.01 | 3699.01 | 0.5 | CHP | 1 | 3698.760 | -41.47 | -13 | Pass |
| 3699.01 | 3700.01 | 0.1935 | CHP | 2 | 3699.990 | -35.61 | -13 | Pass |
| 3720.01 | 3721.01 | 0.1935 | CHP | 3 | 3720.030 | -43.14 | -13 | Pass |
| 3721.01 | 3725.01 | 0.5 | CHP | 4 | 3721.260 | -41.96 | -13 | Pass |

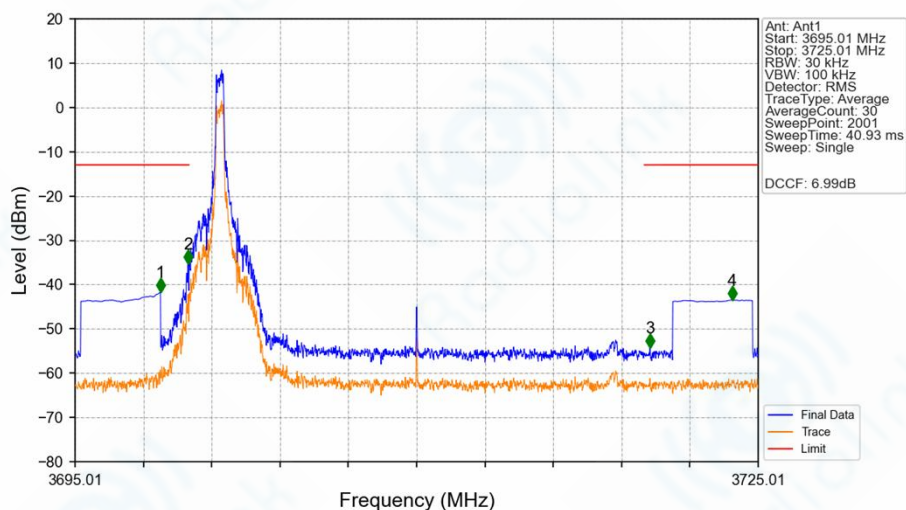
## n77a\_30kHz\_SISO\_NTNV\_20MHz\_DFT-s-OFDM\_QPSK\_3710.01MHz\_Inner\_1RB\_Left\_Ant1

| Start (MHz) | Stop (MHz) | RBW (MHz) | Method | Marker No. | Freq (MHz) | Level (dBm) | Limit (dBm) | Result |
|---|---|---|---|---|---|---|---|---|
| 3695.01 | 3699.01 | 0.5 | CHP | 1 | 3698.760 | -41.71 | -13 | Pass |
| 3699.01 | 3700.01 | 0.03 | / | 2 | 3699.975 | -35.24 | -13 | Pass |
| 3720.01 | 3721.01 | 0.03 | / | 3 | 3720.255 | -54.20 | -13 | Pass |
| 3721.01 | 3725.01 | 0.5 | CHP | 4 | 3723.870 | -43.46 | -13 | Pass |

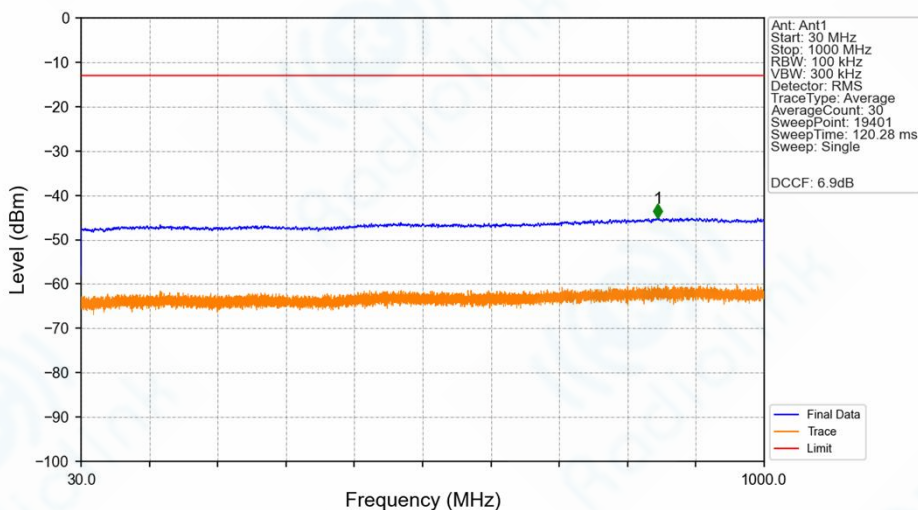
## n77a\_30kHz\_SISO\_NTNV\_20MHz\_DFT-s-OFDM\_QPSK\_3840MHz\_Edge\_1RB\_Left\_Ant1

| Start (MHz) | Stop (MHz) | RBW (MHz) | Method | Marker No. | Freq (MHz) | Level (dBm) | Limit (dBm) | Result |
|---|---|---|---|---|---|---|---|---|
| 30 | 1000 | 1 | CHP | 1 | 848.950 | -45.07 | -13 | Pass |

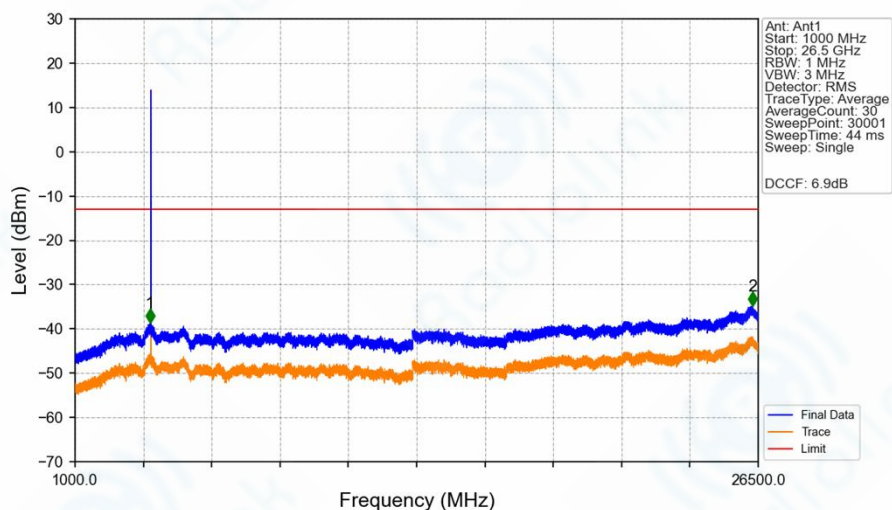
## n77a\_30kHz\_SISO\_NTNV\_20MHz\_DFT-s-OFDM\_QPSK\_3840MHz\_Edge\_1RB\_Left\_Ant1

| Start (MHz) | Stop (MHz) | RBW (MHz) | Method | Marker No. | Freq (MHz) | Level (dBm) | Limit (dBm) | Result |
|---|---|---|---|---|---|---|---|---|
| 1000 | 3825 | 1 | / | 1 | 3802.450 | -38.67 | -13 | Pass |
| 3855 | 26500 | 1 | / | 2 | 26279.850 | -34.87 | -13 | Pass |

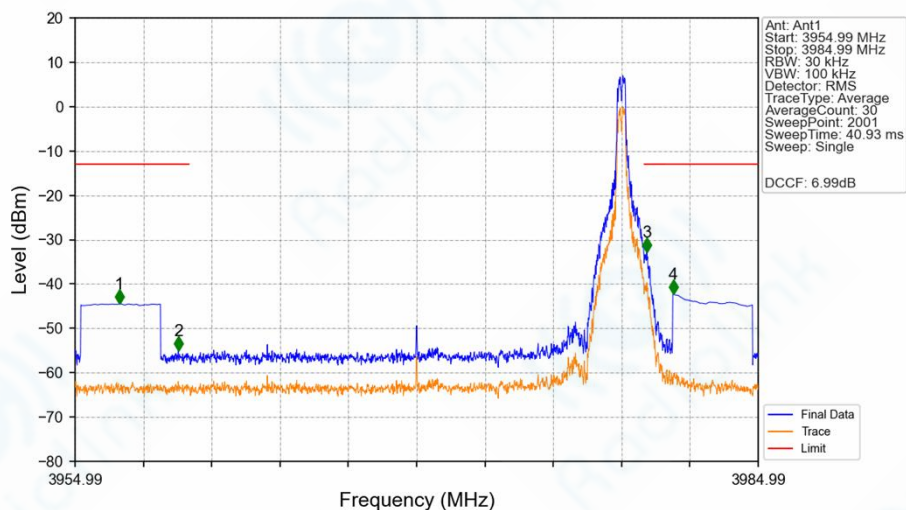
## n77a\_30kHz\_SISO\_NTNV\_20MHz\_DFT-s-OFDM\_QPSK\_3969.99MHz\_Edge\_1RB\_Right\_Ant1

| Start (MHz) | Stop (MHz) | RBW (MHz) | Method | Marker No. | Freq (MHz) | Level (dBm) | Limit (dBm) | Result |
|---|---|---|---|---|---|---|---|---|
| 3954.99 | 3958.99 | 0.5 | CHP | 1 | 3956.925 | -44.50 | -13 | Pass |
| 3958.99 | 3959.99 | 0.03 | / | 2 | 3959.520 | -54.96 | -13 | Pass |
| 3979.99 | 3980.99 | 0.03 | / | 3 | 3980.100 | -32.70 | -13 | Pass |
| 3980.99 | 3984.99 | 0.5 | CHP | 4 | 3981.255 | -42.25 | -13 | Pass |

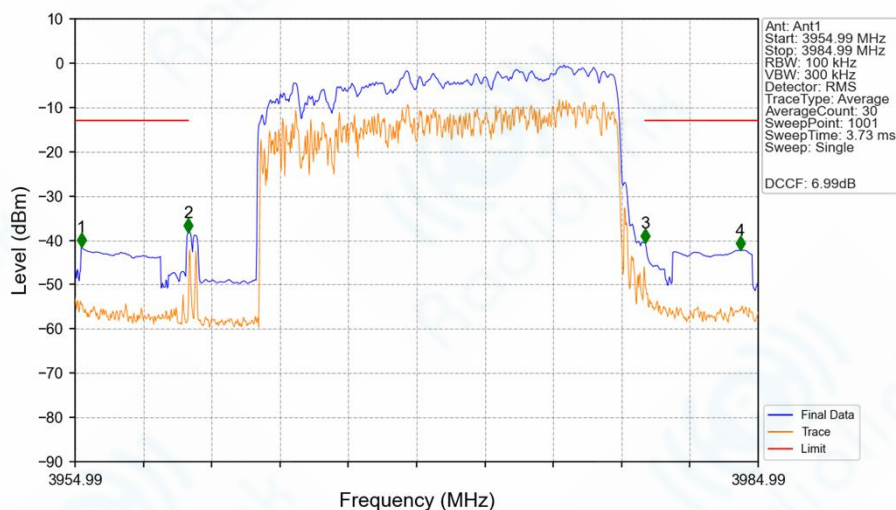
## n77a\_30kHz\_SISO\_NTNV\_20MHz\_DFT-s-OFDM\_QPSK\_3969.99MHz\_Outer\_Full\_Ant1

| Start (MHz) | Stop (MHz) | RBW (MHz) | Method | Marker No. | Freq (MHz) | Level (dBm) | Limit (dBm) | Result |
|---|---|---|---|---|---|---|---|---|
| 3954.99 | 3958.99 | 0.5 | CHP | 1 | 3955.260 | -41.56 | -13 | Pass |
| 3958.99 | 3959.99 | 0.18808 | CHP | 2 | 3959.970 | -38.27 | -13 | Pass |
| 3979.99 | 3980.99 | 0.18808 | CHP | 3 | 3980.010 | -40.50 | -13 | Pass |
| 3980.99 | 3984.99 | 0.5 | CHP | 4 | 3984.210 | -42.16 | -13 | Pass |

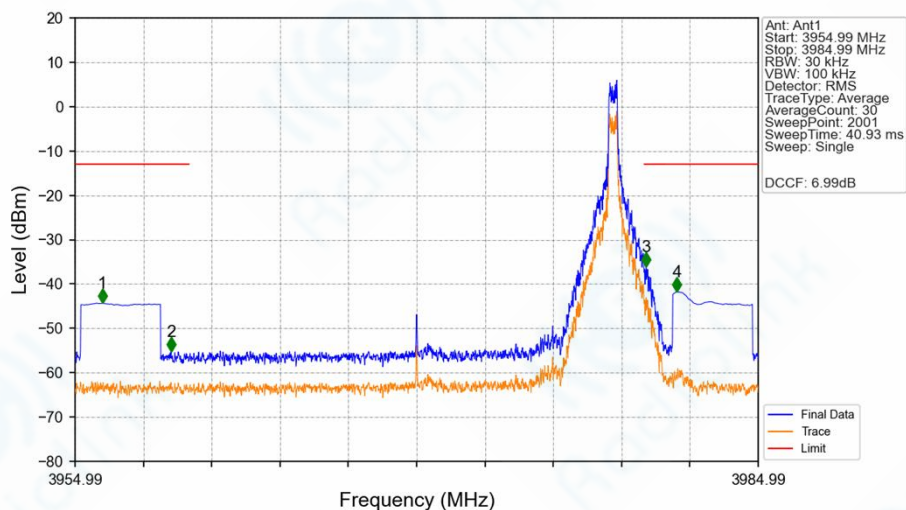
## n77a\_30kHz\_SISO\_NTNV\_20MHz\_DFT-s-OFDM\_QPSK\_3969.99MHz\_Inner\_1RB\_Right\_Ant1

| Start (MHz) | Stop (MHz) | RBW (MHz) | Method | Marker No. | Freq (MHz) | Level (dBm) | Limit (dBm) | Result |
|---|---|---|---|---|---|---|---|---|
| 3954.99 | 3958.99 | 0.5 | CHP | 1 | 3956.190 | -44.30 | -13 | Pass |
| 3958.99 | 3959.99 | 0.03 | / | 2 | 3959.205 | -55.21 | -13 | Pass |
| 3979.99 | 3980.99 | 0.03 | / | 3 | 3980.070 | -36.12 | -13 | Pass |

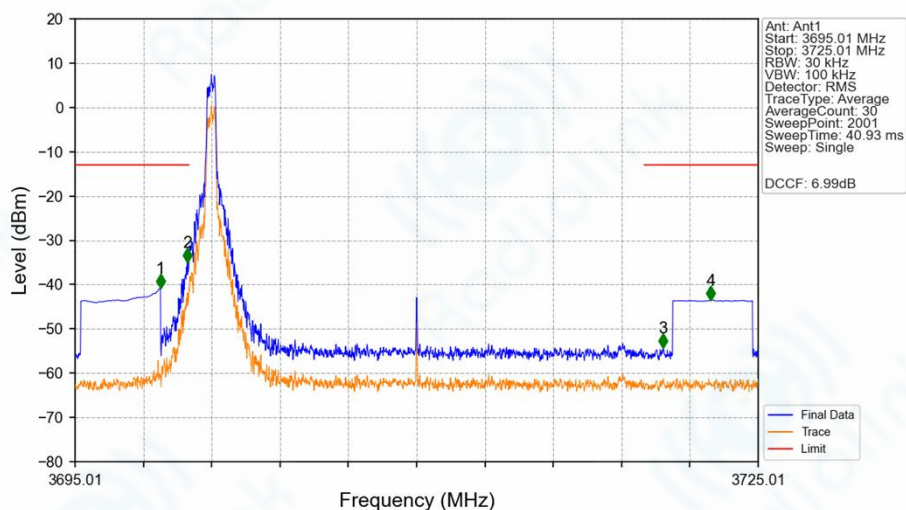
## n77a\_30kHz\_SISO\_NTNV\_20MHz\_CP-OFDM\_QPSK\_3710.01MHz\_Edge\_1RB\_Left\_Ant1

| Start (MHz) | Stop (MHz) | RBW (MHz) | Method | Marker No. | Freq (MHz) | Level (dBm) | Limit (dBm) | Result |
| 3695.01 | 3699.01 | 0.5 | CHP | 1 | 3698.760 | -40.84 | -13 | Pass |
| 3721.01 | 3725.01 | 0.5 | CHP | 4 | 3722.925 | -43.50 | -13 | Pass |
