## n77a\_30kHz\_SISO\_NTNV\_10MHz\_DFT-s-OFDM\_QPSK\_3840MHz\_Edge\_1RB\_Left\_Ant1

**Radiolink Testing (Shenzhen) Co., Ltd.**

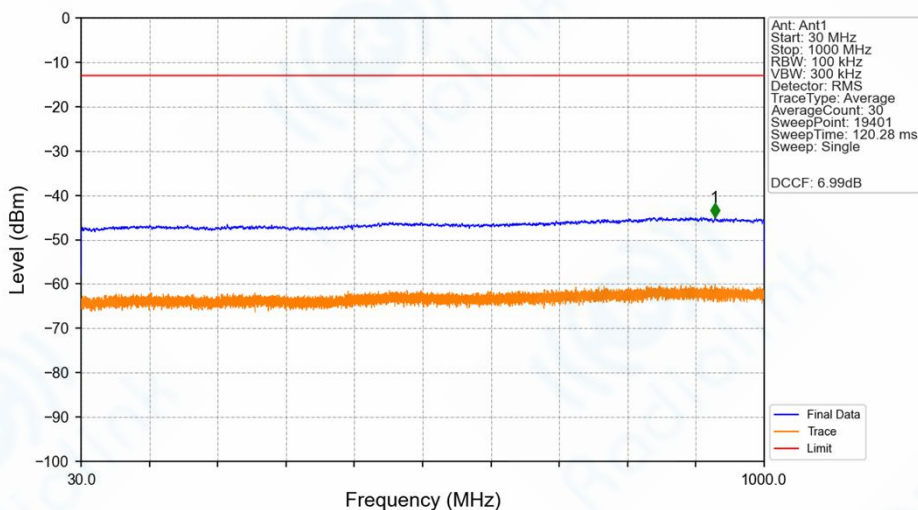
## n77a\_30kHz\_SISO\_NTNV\_20MHz\_CP-OFDM\_QPSK\_3710.01MHz\_Edge\_1RB\_Left\_Ant1

| Start (MHz) | Stop (MHz) | RBW (MHz) | Method | Marker No. | Freq (MHz) | Level (dBm) | Limit (dBm) | Result |
| 30 | 1000 | 1 | CHP | 1 | 930.100 | -44.96 | -13 | Pass |

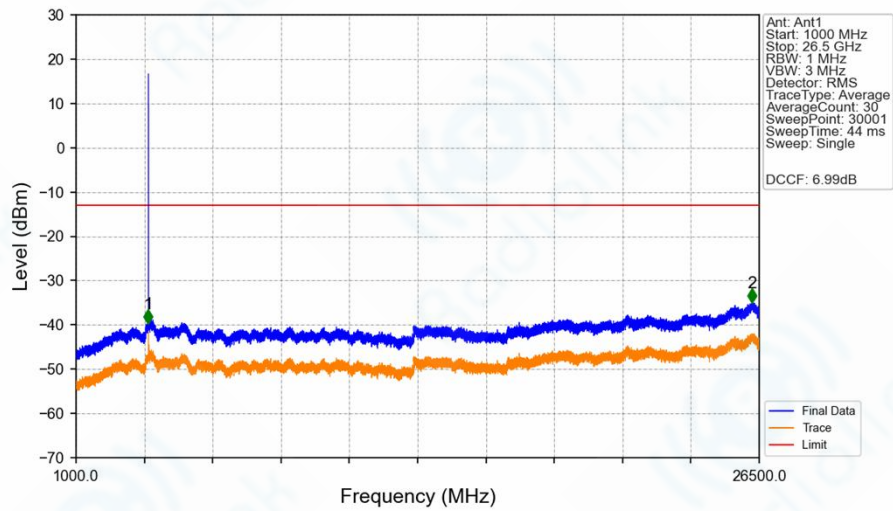
## n77a\_30kHz\_SISO\_NTNV\_20MHz\_CP-OFDM\_QPSK\_3710.01MHz\_Edge\_1RB\_Left\_Ant1

| Start (MHz) | Stop (MHz) | RBW (MHz) | Method | Marker No. | Freq (MHz) | Level (dBm) | Limit (dBm) | Result |
| 1000 | 3695.01 | 1 | / | 1 | 3688.550 | -39.68 | -13 | Pass |
| 3725.01 | 26500 | 1 | / | 2 | 26223.750 | -35.01 | -13 | Pass |

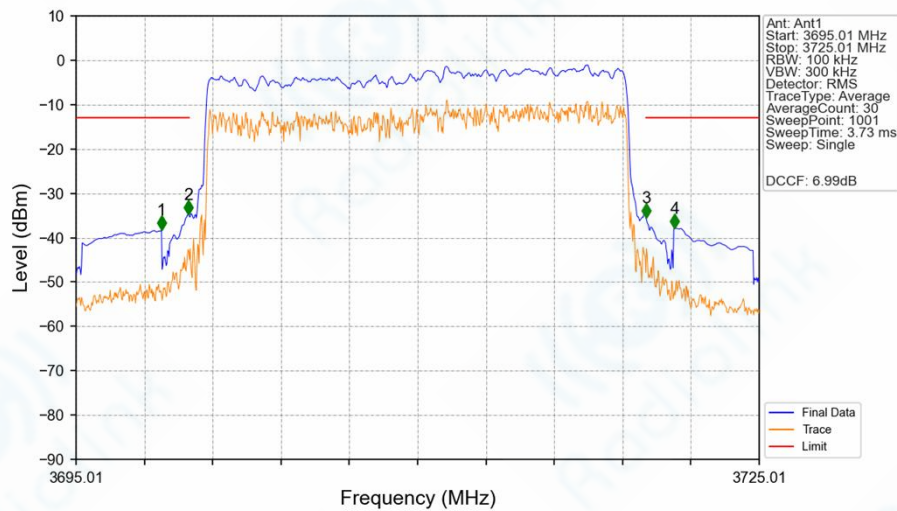
## n77a\_30kHz\_SISO\_NTNV\_20MHz\_CP-OFDM\_QPSK\_3710.01MHz\_Outer\_Full\_Ant1

| Start (MHz) | Stop (MHz) | RBW (MHz) | Method | Marker No. | Freq (MHz) | Level (dBm) | Limit (dBm) | Result |
| 3695.01 | 3699.01 | 0.5 | CHP | 1 | 3698.760 | -38.28 | -13 | Pass |
| 3721.01 | 3725.01 | 0.5 | CHP | 4 | 3721.290 | -37.92 | -13 | Pass |

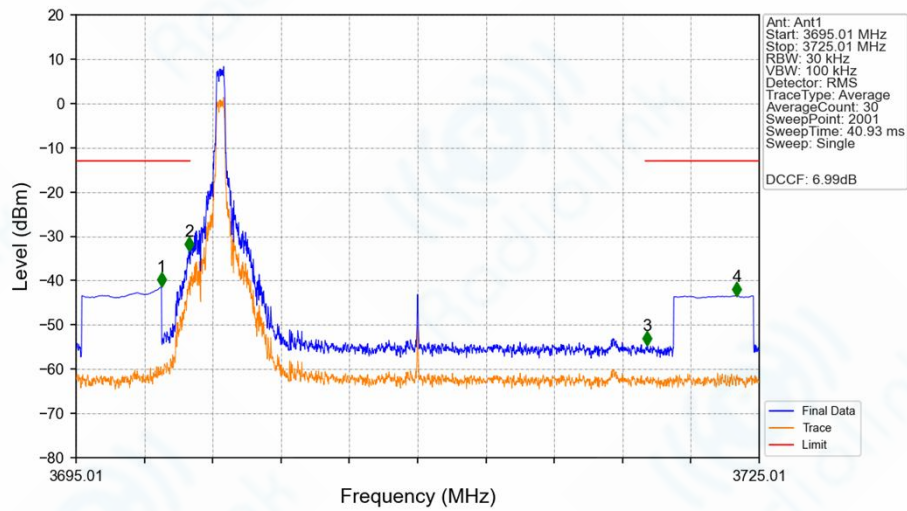
n77a\_30kHz\_SISO\_NTNV\_20MHz\_CP-OFDM\_QPSK\_3710.01MHz\_Inner\_1RB\_Left\_Ant1

| Start (MHz) | Stop (MHz) | RBW (MHz) | Method | Marker No. | Freq (MHz) | Level (dBm) | Limit (dBm) | Result |
| 3695.01 | 3699.01 | 0.5 | CHP | 1 | 3698.760 | -41.35 | -13 | Pass |
| 3721.01 | 3725.01 | 0.5 | CHP | 4 | 3724.020 | -43.43 | -13 | Pass |

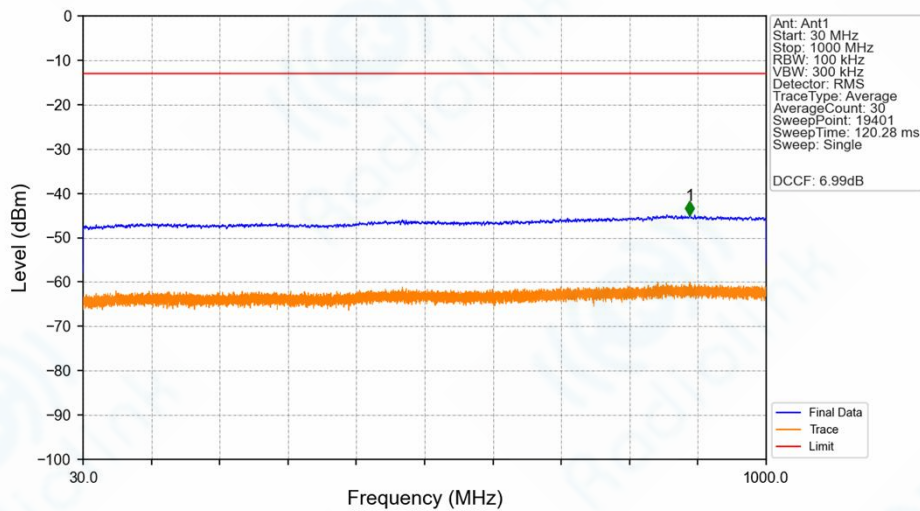
n77a\_30kHz\_SISO\_NTNV\_20MHz\_CP-OFDM\_QPSK\_3840MHz\_Edge\_1RB\_Left\_Ant1

| Start (MHz) | Stop (MHz) | RBW (MHz) | Method | Marker No. | Freq (MHz) | Level (dBm) | Limit (dBm) | Result |
| 30 | 1000 | 1 | CHP | 1 | 891.250 | -44.87 | -13 | Pass |

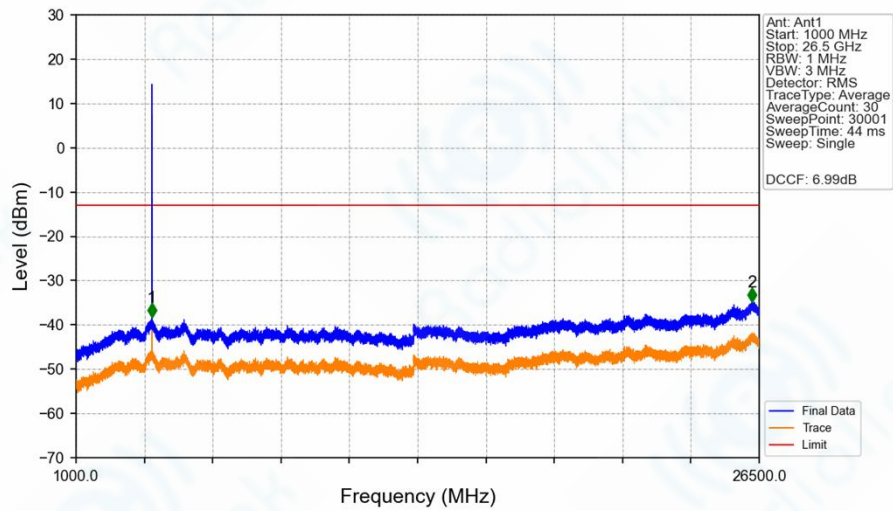
## n77a\_30kHz\_SISO\_NTNV\_20MHz\_CP-OFDM\_QPSK\_3840MHz\_Edge\_1RB\_Left\_Ant1

| Start (MHz) | Stop (MHz) | RBW (MHz) | Method | Marker No. | Freq (MHz) | Level (dBm) | Limit (dBm) | Result |
| 1000 | 3825 | 1 | / | 1 | 3823.700 | -38.20 | -13 | Pass |
| 3855 | 26500 | 1 | / | 2 | 26234.800 | -34.80 | -13 | Pass |

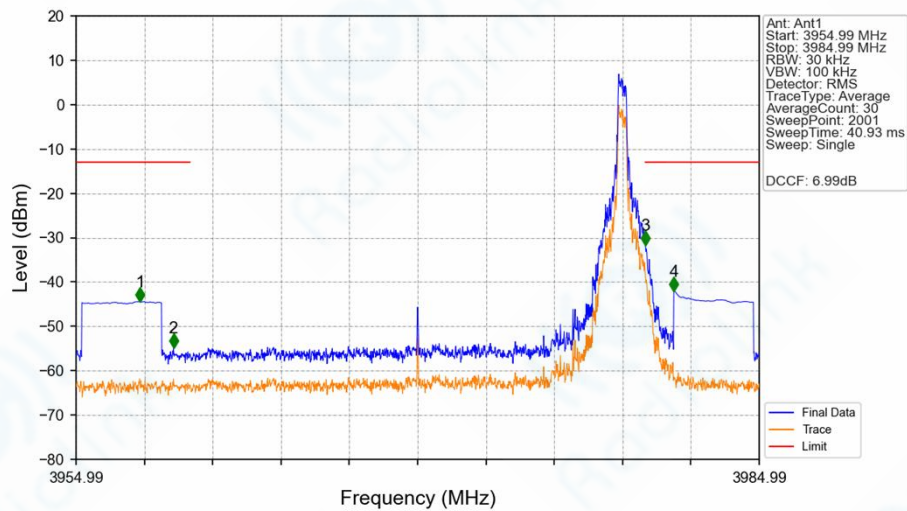
## n77a\_30kHz\_SISO\_NTNV\_20MHz\_CP-OFDM\_QPSK\_3969.99MHz\_Edge\_1RB\_Right\_Ant1

| Start (MHz) | Stop (MHz) | RBW (MHz) | Method | Marker No. | Freq (MHz) | Level (dBm) | Limit (dBm) | Result |
| 3954.99 | 3958.99 | 0.5 | CHP | 1 | 3957.795 | -44.38 | -13 | Pass |

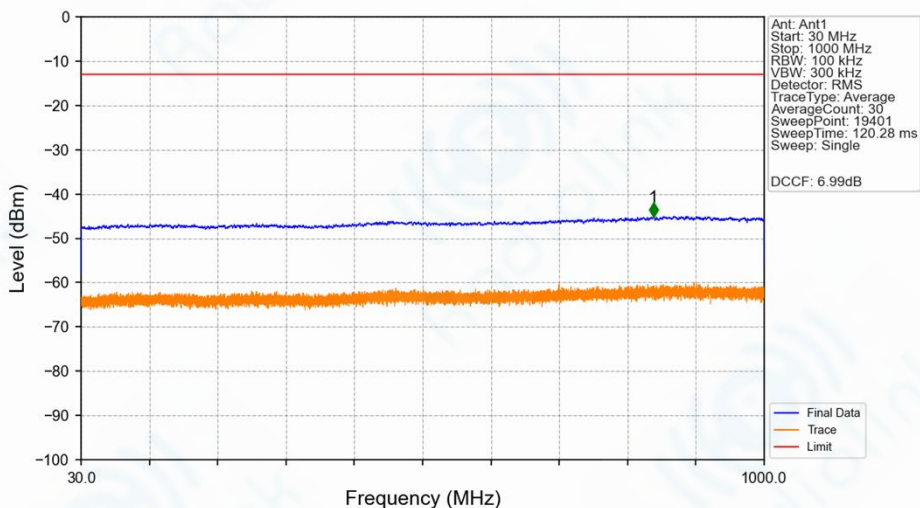
## n77a\_30kHz\_SISO\_NTNV\_20MHz\_CP-OFDM QPSK\_3969.99MHz\_Edge\_1RB\_Right\_Ant1

| Start (MHz) | Stop (MHz) | RBW (MHz) | Method | Marker No. | Freq (MHz) | Level (dBm) | Limit (dBm) | Result |
| 30 | 1000 | 1 | CHP | 1 | 842.450 | -45.05 | -13 | Pass |

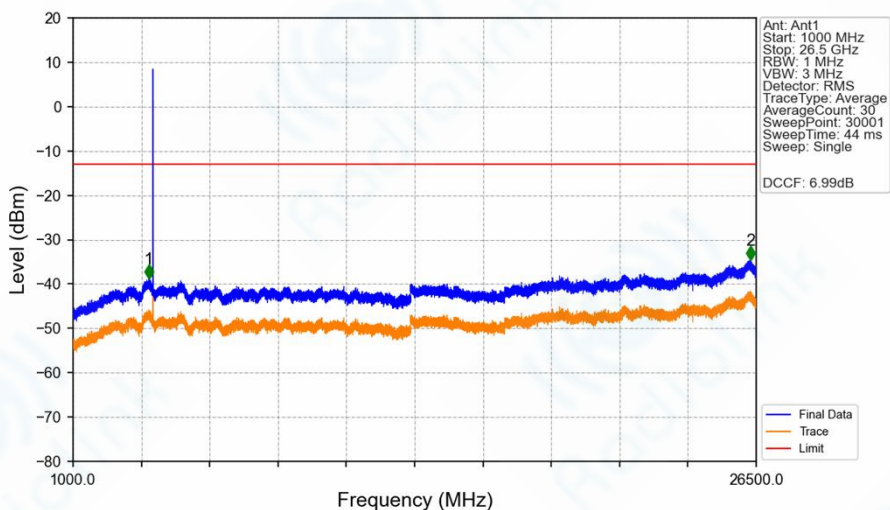
## n77a\_30kHz\_SISO\_NTNV\_20MHz\_CP-OFDM QPSK\_3969.99MHz\_Edge\_1RB\_Right\_Ant1

| Start (MHz) | Stop (MHz) | RBW (MHz) | Method | Marker No. | Freq (MHz) | Level (dBm) | Limit (dBm) | Result |
| 1000 | 3954.99 | 1 | / | 1 | 3818.600 | -38.83 | -13 | Pass |
| 3984.99 | 26500 | 1 | / | 2 | 26280.700 | -34.57 | -13 | Pass |

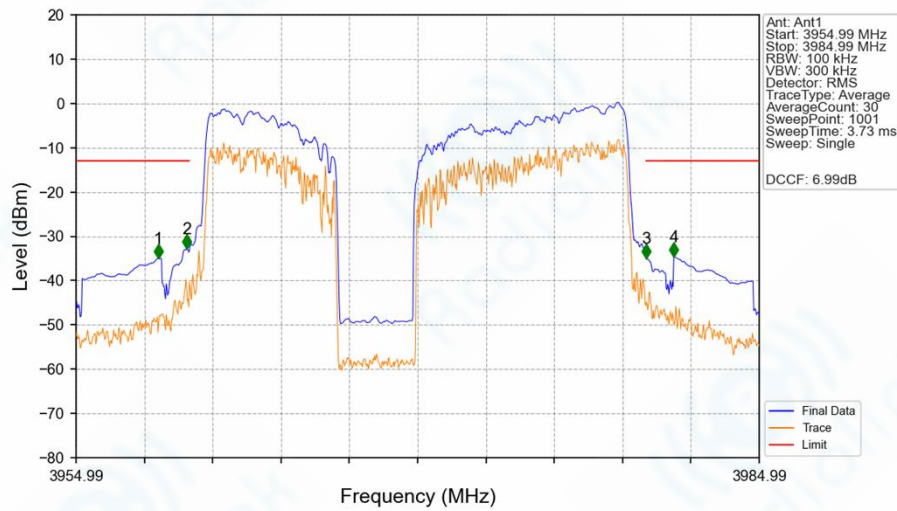
## n77a\_30kHz\_SISO\_NTNV\_20MHz\_CP-OFDM\_QPSK\_3969.99MHz\_Outer\_Full\_Ant1

| Start (MHz) | Stop (MHz) | RBW (MHz) | Method | Marker No. | Freq (MHz) | Level (dBm) | Limit (dBm) | Result |
| 3954.99 | 3958.99 | 0.5 | CHP | 1 | 3958.590 | -34.98 | -13 | Pass |
| 3980.99 | 3984.99 | 0.5 | CHP | 4 | 3981.240 | -34.63 | -13 | Pass |

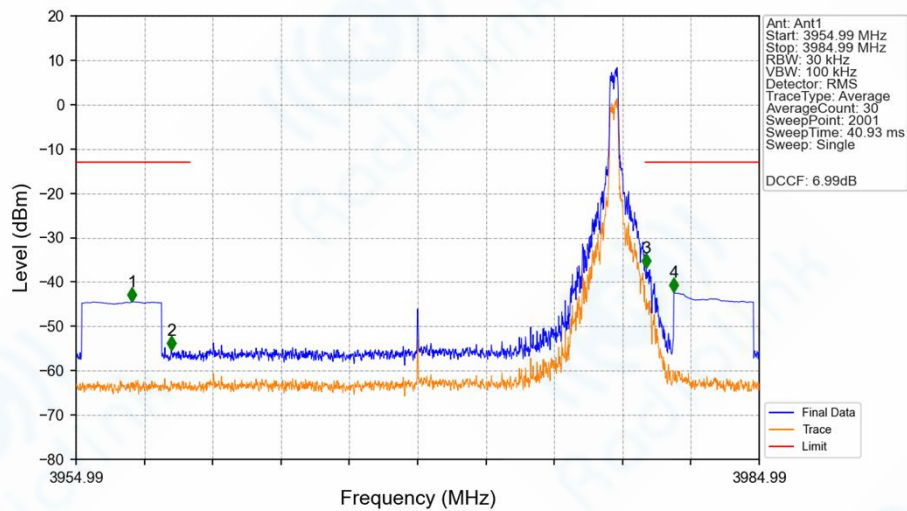
## n77a\_30kHz\_SISO\_NTNV\_20MHz\_CP-OFDM\_QPSK\_3969.99MHz\_Inner\_1RB\_Right\_Ant1

| Start (MHz) | Stop (MHz) | RBW (MHz) | Method | Marker No. | Freq (MHz) | Level (dBm) | Limit (dBm) | Result |
| 3954.99 | 3958.99 | 0.5 | CHP | 1 | 3957.450 | -44.44 | -13 | Pass |
