### 5.2.3 30\_S\_30M\_NTNV

**Radiolink Testing (Shenzhen) Co., Ltd.**

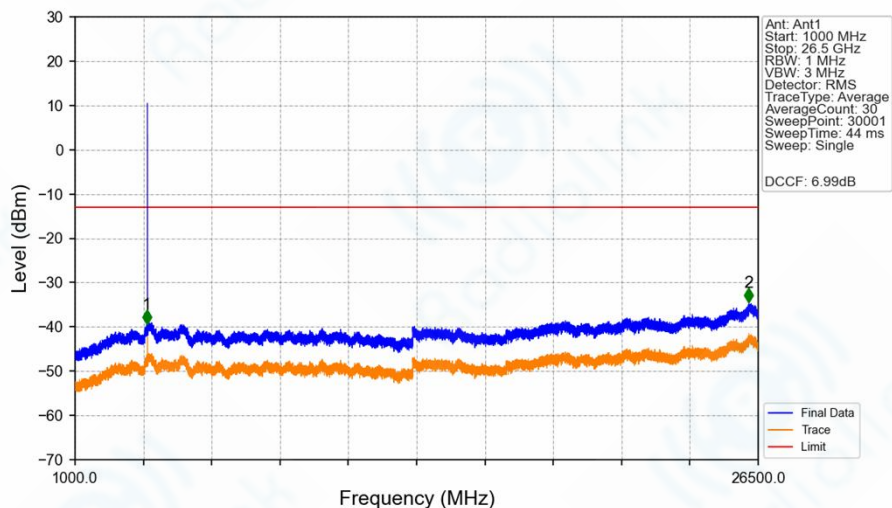
## n77a\_30kHz\_SISO\_NTNV\_30MHz\_DFT-s-OFDM PI/2 BPSK 3715.02MHz\_Edge\_1RB\_Left\_Ant1

| Start (MHz) | Stop (MHz) | RBW (MHz) | Method | Marker No. | Freq (MHz) | Level (dBm) | Limit (dBm) | Result |
|---|---|---|---|---|---|---|---|---|
| 1000 | 3695.02 | 1 | / | 1 | 3680.900 | -39.32 | -13 | Pass |
| 3735.02 | 26500 | 1 | / | 2 | 26153.200 | -34.50 | -13 | Pass |

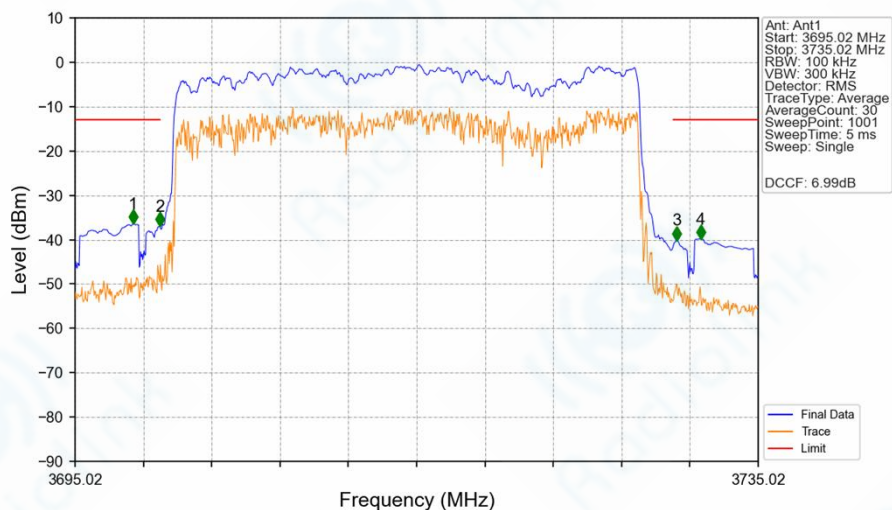
## n77a\_30kHz\_SISO\_NTNV\_30MHz\_DFT-s-OFDM PI/2 BPSK 3715.02MHz\_Outer\_Full\_Ant1

| Start (MHz) | Stop (MHz) | RBW (MHz) | Method | Marker No. | Freq (MHz) | Level (dBm) | Limit (dBm) | Result |
|---|---|---|---|---|---|---|---|---|
| 3695.02 | 3699.02 | 0.5 | CHP | 1 | 3698.420 | -36.37 | -13 | Pass |
| 3699.02 | 3700.02 | 0.27903 | CHP | 2 | 3699.980 | -36.98 | -13 | Pass |
| 3730.02 | 3731.02 | 0.27903 | CHP | 3 | 3730.260 | -40.13 | -13 | Pass |
| 3731.02 | 3735.02 | 0.5 | CHP | 4 | 3731.660 | -39.81 | -13 | Pass |

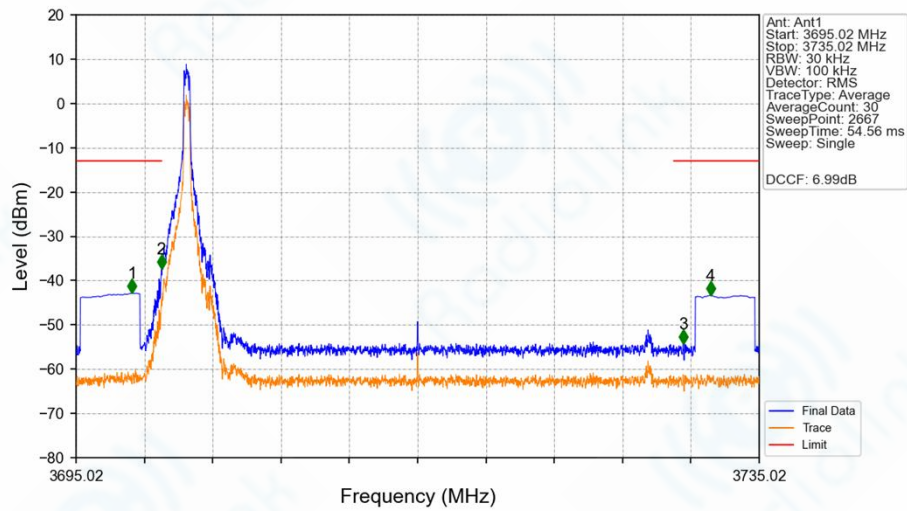
## n77a\_30kHz\_SISO\_NTNV\_30MHz\_DFT-s-OFDM PI/2 BPSK 3715.02MHz\_Inner\_1RB\_Left\_Ant1

| Start (MHz) | Stop (MHz) | RBW (MHz) | Method | Marker No. | Freq (MHz) | Level (dBm) | Limit (dBm) | Result |
|---|---|---|---|---|---|---|---|---|
| 3695.02 | 3699.02 | 0.5 | CHP | 1 | 3698.291 | -42.75 | -13 | Pass |
| 3699.02 | 3700.02 | 0.03 | / | 2 | 3700.016 | -37.34 | -13 | Pass |
| 3730.02 | 3731.02 | 0.03 | / | 3 | 3730.564 | -54.24 | -13 | Pass |
| 3731.02 | 3735.02 | 0.5 | CHP | 4 | 3732.169 | -43.34 | -13 | Pass |

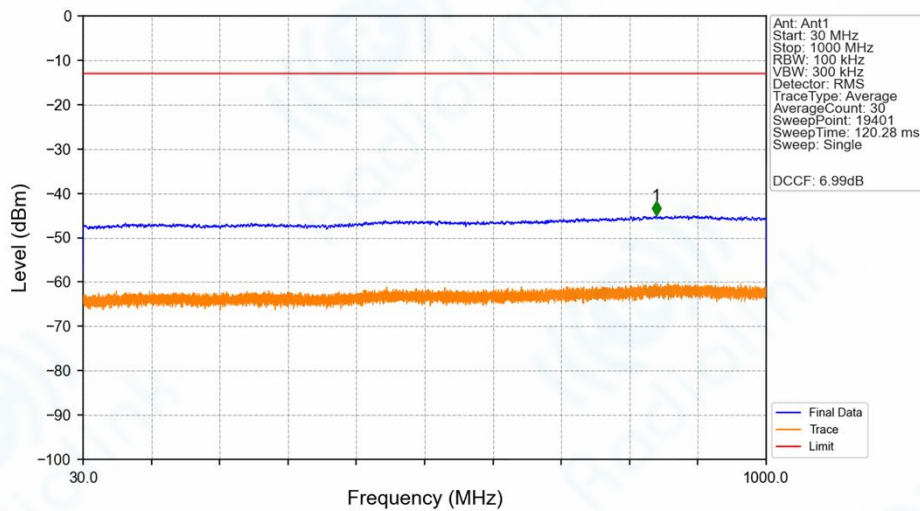
## n77a\_30kHz\_SISO\_NTNV\_30MHz\_DFT-s-OFDM PI/2 BPSK 3840MHz\_Edge\_1RB\_Left\_Ant1

| Start (MHz) | Stop (MHz) | RBW (MHz) | Method | Marker No. | Freq (MHz) | Level (dBm) | Limit (dBm) | Result |
|---|---|---|---|---|---|---|---|---|
| 30 | 1000 | 1 | CHP | 1 | 843.800 | -44.99 | -13 | Pass |

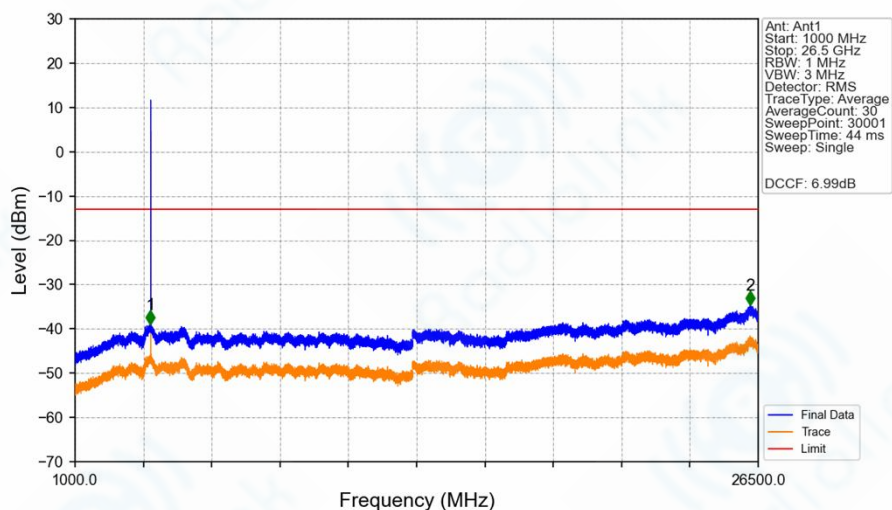
n77a\_30kHz\_SISO\_NTNV\_30MHz\_DFT-s-OFDM PI/2 BPSK 3840MHz\_Edge\_1RB\_Left\_Ant1

| Start (MHz) | Stop (MHz) | RBW (MHz) | Method | Marker No. | Freq (MHz) | Level (dBm) | Limit (dBm) | Result |
|---|---|---|---|---|---|---|---|---|
| 1000 | 3820 | 1 | / | 1 | 3816.050 | -38.90 | -13 | Pass |
| 3860 | 26500 | 1 | / | 2 | 26193.150 | -34.57 | -13 | Pass |

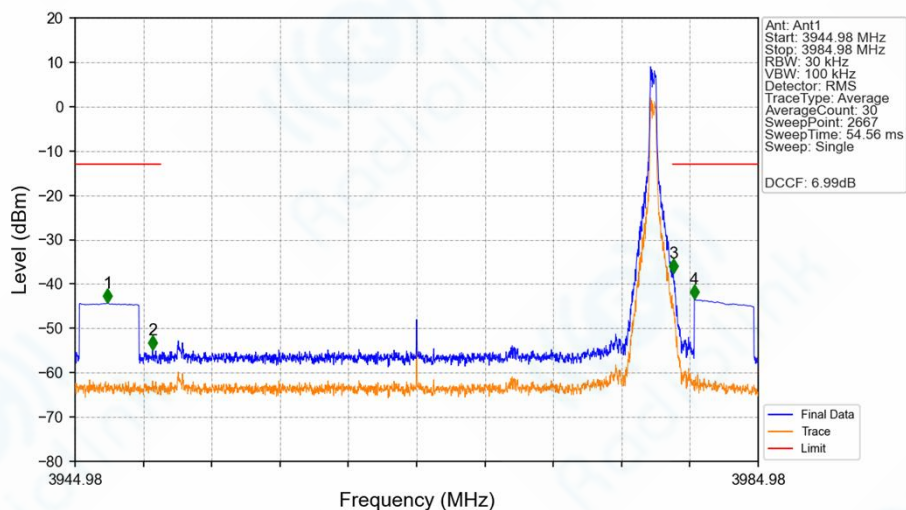
n77a\_30kHz\_SISO\_NTNV\_30MHz\_DFT-s-OFDM PI/2 BPSK 3964.98MHz\_Edge\_1RB\_Right\_Ant1

| Start (MHz) | Stop (MHz) | RBW (MHz) | Method | Marker No. | Freq (MHz) | Level (dBm) | Limit (dBm) | Result |
|---|---|---|---|---|---|---|---|---|
| 3944.98 | 3948.98 | 0.5 | CHP | 1 | 3946.885 | -44.33 | -13 | Pass |
| 3948.98 | 3949.98 | 0.03 | / | 2 | 3949.526 | -54.84 | -13 | Pass |
| 3979.98 | 3980.98 | 0.03 | / | 3 | 3979.999 | -37.48 | -13 | Pass |
| 3980.98 | 3984.98 | 0.5 | CHP | 4 | 3981.244 | -43.38 | -13 | Pass |

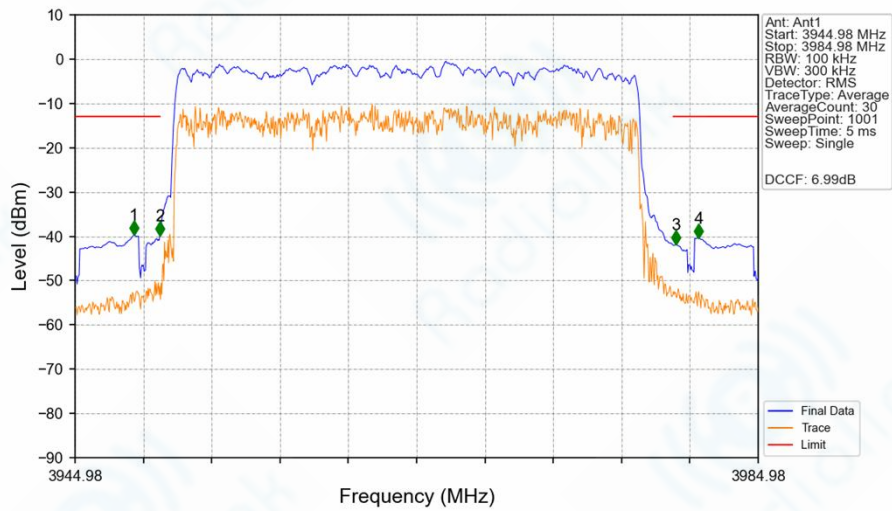
## n77a 30kHz\_SISO\_NTNV\_30MHz\_DFT-s-OFDM PI/2 BPSK\_3964.98MHz\_Outer\_Full\_Ant1

| Start (MHz) | Stop (MHz) | RBW (MHz) | Method | Marker No. | Freq (MHz) | Level (dBm) | Limit (dBm) | Result |
|---|---|---|---|---|---|---|---|---|
| 3944.98 | 3948.98 | 0.5 | CHP | 1 | 3948.420 | -39.75 | -13 | Pass |
| 3948.98 | 3949.98 | 0.28153 | CHP | 2 | 3949.940 | -39.80 | -13 | Pass |
| 3979.98 | 3980.98 | 0.28153 | CHP | 3 | 3980.180 | -41.79 | -13 | Pass |
| 3980.98 | 3984.98 | 0.5 | CHP | 4 | 3981.500 | -40.34 | -13 | Pass |

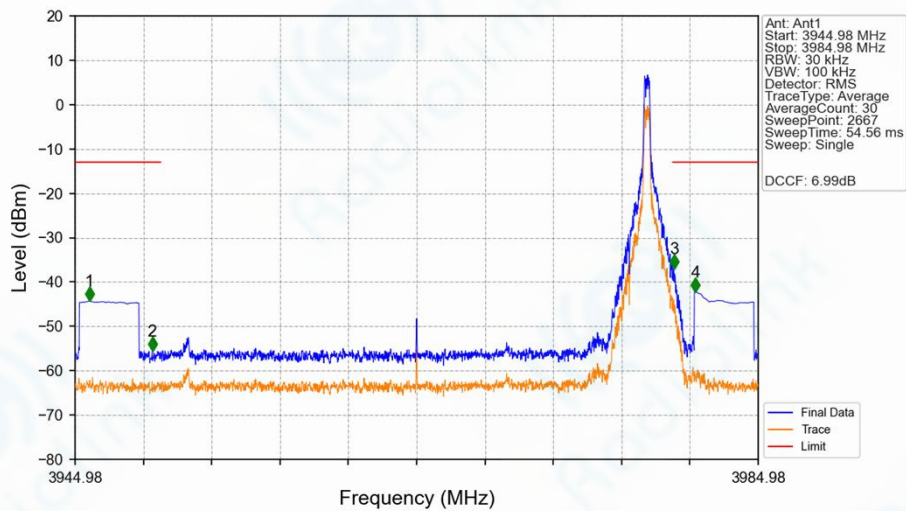
## n77a 30kHz\_SISO\_NTNV\_30MHz\_DFT-s-OFDM PI/2 BPSK\_3964.98MHz\_Inner\_1RB\_Right\_Ant1

| Start (MHz) | Stop (MHz) | RBW (MHz) | Method | Marker No. | Freq (MHz) | Level (dBm) | Limit (dBm) | Result |
|---|---|---|---|---|---|---|---|---|
| 3944.98 | 3948.98 | 0.5 | CHP | 1 | 3945.820 | -44.27 | -13 | Pass |
| 3948.98 | 3949.98 | 0.03 | / | 2 | 3949.496 | -55.49 | -13 | Pass |
| 3979.98 | 3980.98 | 0.03 | / | 3 | 3980.044 | -36.94 | -13 | Pass |
| 3980.98 | 3984.98 | 0.5 | CHP | 4 | 3981.304 | -42.17 | -13 | Pass |

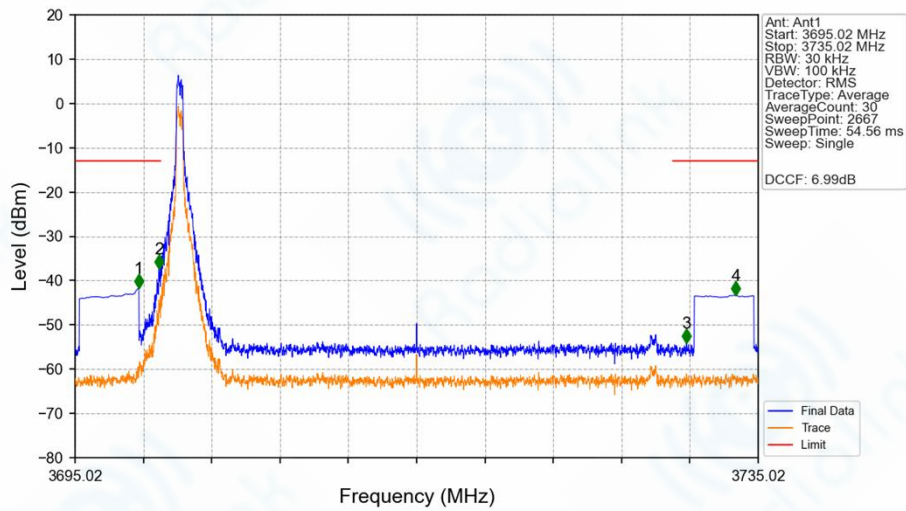
n77a\_30kHz\_SISO\_NTNV\_30MHz\_DFT-s-OFDM\_QPSK\_3715.02MHz\_Edge\_1RB\_Left\_Ant1

| Start (MHz) | Stop (MHz) | RBW (MHz) | Method | Marker No. | Freq (MHz) | Level (dBm) | Limit (dBm) | Result |
|---|---|---|---|---|---|---|---|---|
| 3695.02 | 3699.02 | 0.5 | CHP | 1 | 3698.756 | -41.64 | -13 | Pass |
| 3699.02 | 3700.02 | 0.03 | / | 2 | 3699.926 | -37.34 | -13 | Pass |
| 3730.02 | 3731.02 | 0.03 | / | 3 | 3730.819 | -54.10 | -13 | Pass |
| 3731.02 | 3735.02 | 0.5 | CHP | 4 | 3733.715 | -43.27 | -13 | Pass |

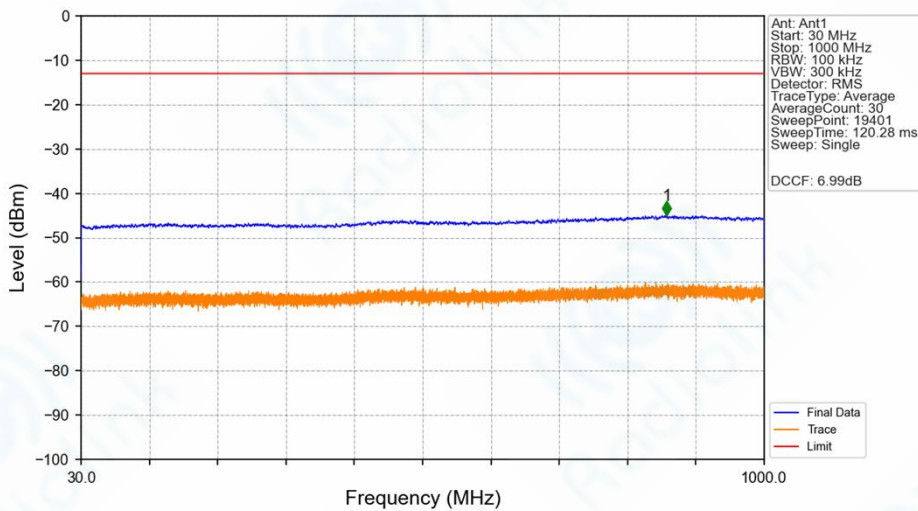
n77a\_30kHz\_SISO\_NTNV\_30MHz\_DFT-s-OFDM\_QPSK\_3715.02MHz\_Edge\_1RB\_Left\_Ant1

| Start (MHz) | Stop (MHz) | RBW (MHz) | Method | Marker No. | Freq (MHz) | Level (dBm) | Limit (dBm) | Result |
|---|---|---|---|---|---|---|---|---|
| 30 | 1000 | 1 | CHP | 1 | 861.500 | -44.91 | -13 | Pass |

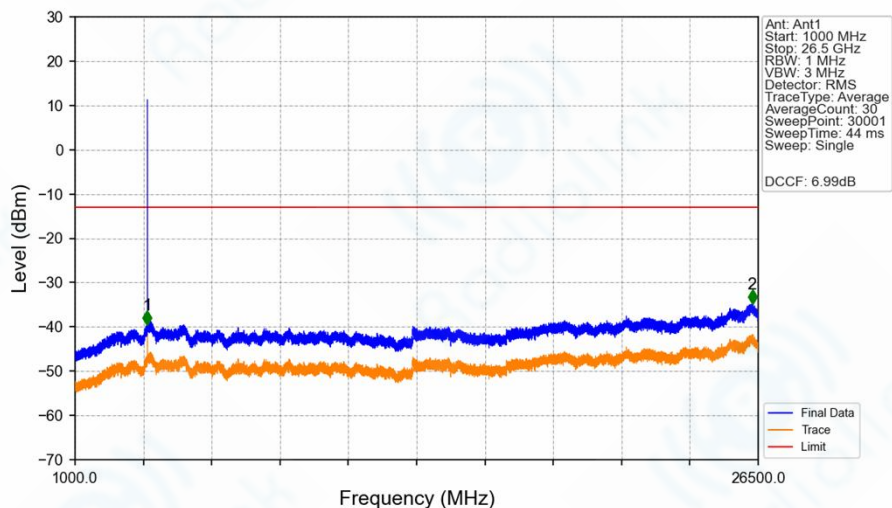
## n77a\_30kHz\_SISO\_NTNV\_30MHz\_DFT-s-OFDM\_QPSK\_3715.02MHz\_Edge\_1RB\_Left\_Ant1

| Start (MHz) | Stop (MHz) | RBW (MHz) | Method | Marker No. | Freq (MHz) | Level (dBm) | Limit (dBm) | Result |
|---|---|---|---|---|---|---|---|---|
| 1000 | 3695.02 | 1 | / | 1 | 3686.850 | -39.59 | -13 | Pass |
| 3735.02 | 26500 | 1 | / | 2 | 26274.750 | -34.73 | -13 | Pass |

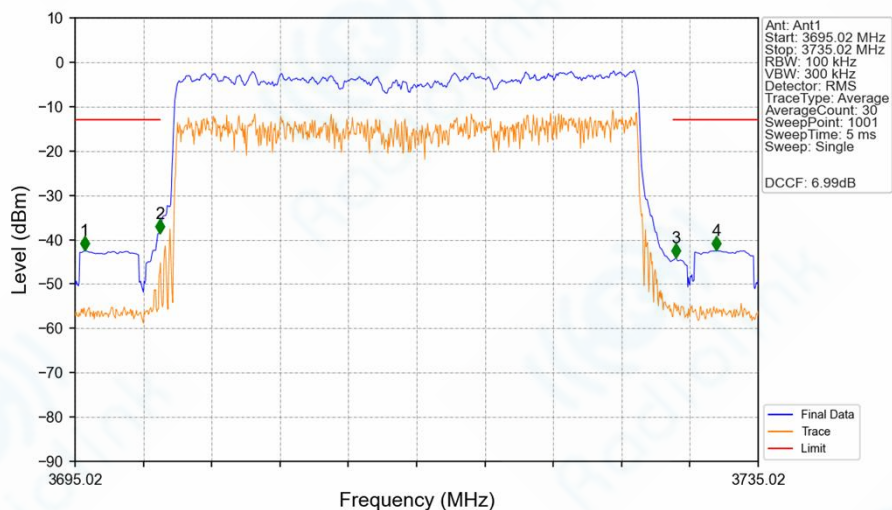
## n77a\_30kHz\_SISO\_NTNV\_30MHz\_DFT-s-OFDM\_QPSK\_3715.02MHz\_Outer\_Full\_Ant1

| Start (MHz) | Stop (MHz) | RBW (MHz) | Method | Marker No. | Freq (MHz) | Level (dBm) | Limit (dBm) | Result |
|---|---|---|---|---|---|---|---|---|
| 3695.02 | 3699.02 | 0.5 | CHP | 1 | 3695.580 | -42.47 | -13 | Pass |
| 3699.02 | 3700.02 | 0.28165 | CHP | 2 | 3699.980 | -38.53 | -13 | Pass |
| 3730.02 | 3731.02 | 0.28165 | CHP | 3 | 3730.180 | -44.10 | -13 | Pass |
| 3731.02 | 3735.02 | 0.5 | CHP | 4 | 3732.580 | -42.46 | -13 | Pass |

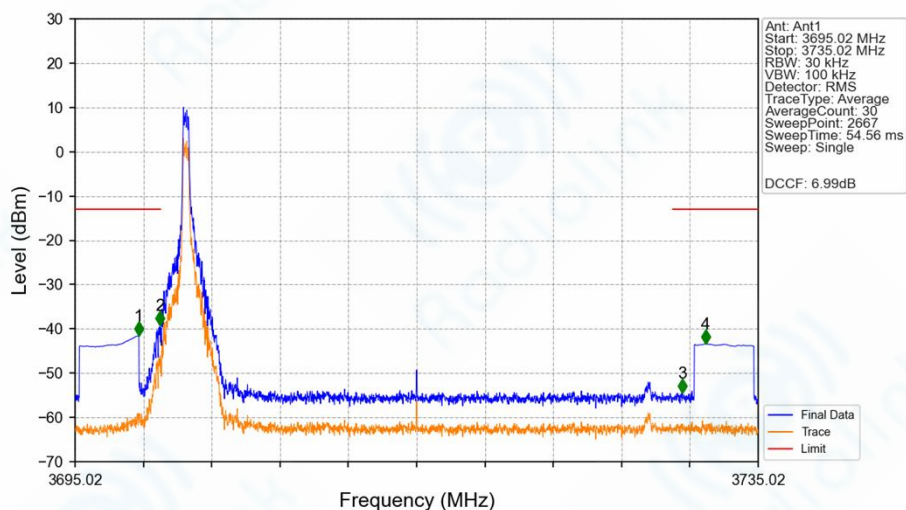
## n77a\_30kHz\_SISO\_NTNV\_30MHz\_DFT-s-OFDM\_QPSK\_3715.02MHz\_Inner\_1RB\_Left\_Ant1

| Start (MHz) | Stop (MHz) | RBW (MHz) | Method | Marker No. | Freq (MHz) | Level (dBm) | Limit (dBm) | Result |
|---|---|---|---|---|---|---|---|---|
| 3695.02 | 3699.02 | 0.5 | CHP | 1 | 3698.756 | -41.60 | -13 | Pass |
| 3699.02 | 3700.02 | 0.03 | / | 2 | 3700.001 | -39.09 | -13 | Pass |
| 3730.02 | 3731.02 | 0.03 | / | 3 | 3730.579 | -54.47 | -13 | Pass |
| 3731.02 | 3735.02 | 0.5 | CHP | 4 | 3731.944 | -43.29 | -13 | Pass |

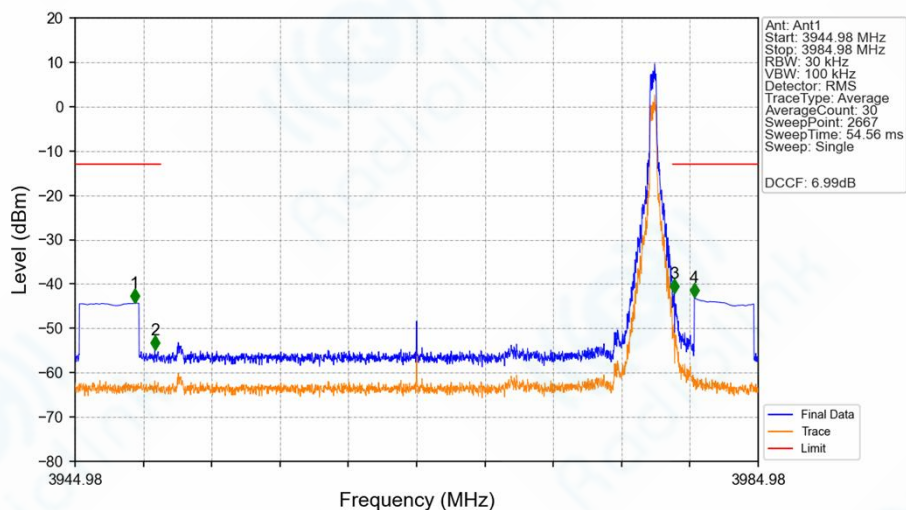
## n77a\_30kHz\_SISO\_NTNV\_30MHz\_DFT-s-OFDM\_QPSK\_3964.98MHz\_Edge\_1RB\_Right\_Ant1

| Start (MHz) | Stop (MHz) | RBW (MHz) | Method | Marker No. | Freq (MHz) | Level (dBm) | Limit (dBm) | Result |
|---|---|---|---|---|---|---|---|---|
| 3944.98 | 3948.98 | 0.5 | CHP | 1 | 3948.476 | -44.30 | -13 | Pass |
| 3948.98 | 3949.98 | 0.03 | / | 2 | 3949.646 | -54.83 | -13 | Pass |
| 3979.98 | 3980.98 | 0.03 | / | 3 | 3980.059 | -42.00 | -13 | Pass |
| 3980.98 | 3984.98 | 0.5 | CHP | 4 | 3981.244 | -42.96 | -13 | Pass |

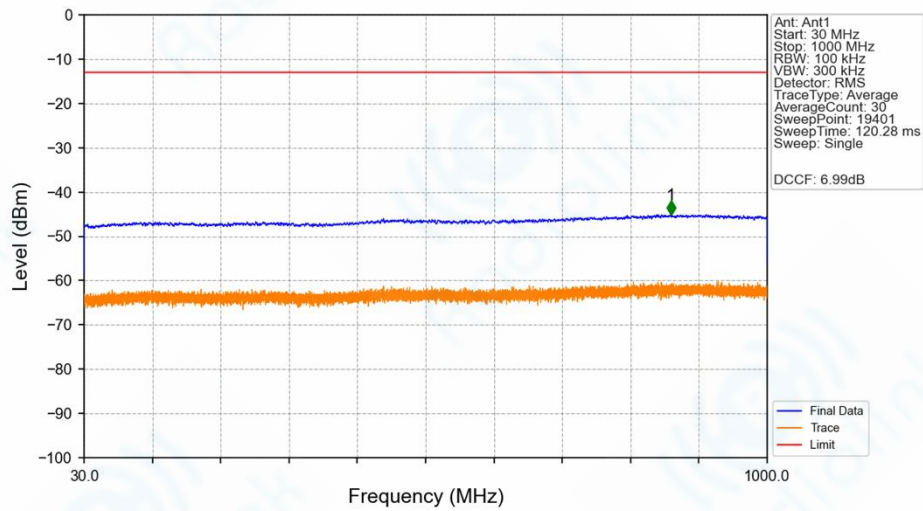
## n77a\_30kHz\_SISO\_NTNV\_30MHz\_DFT-s-OFDM\_QPSK\_3964.98MHz\_Edge\_1RB\_Right\_Ant1

| Start (MHz) | Stop (MHz) | RBW (MHz) | Method | Marker No. | Freq (MHz) | Level (dBm) | Limit (dBm) | Result |
|---|---|---|---|---|---|---|---|---|
| 30 | 1000 | 1 | CHP | 1 | 863.000 | -45.08 | -13 | Pass |

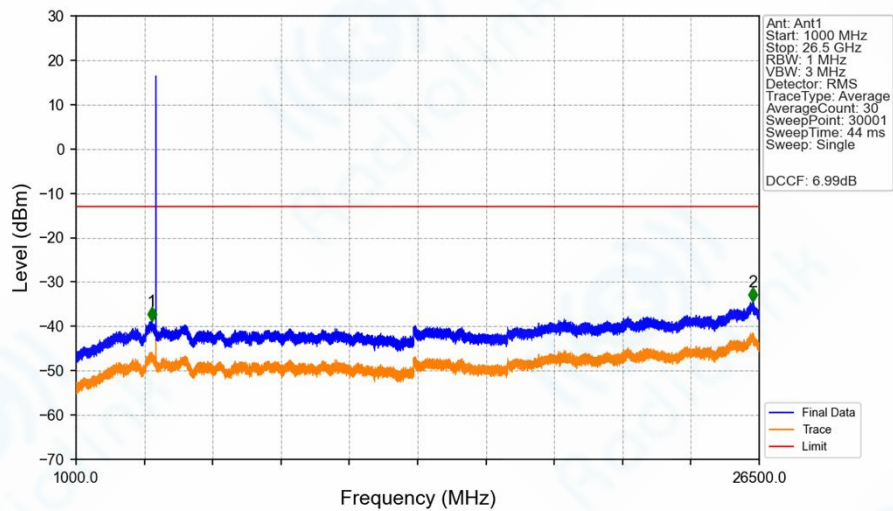
## n77a\_30kHz\_SISO\_NTNV\_30MHz\_DFT-s-OFDM\_QPSK\_3964.98MHz\_Edge\_1RB\_Right\_Ant1

| Start (MHz) | Stop (MHz) | RBW (MHz) | Method | Marker No. | Freq (MHz) | Level (dBm) | Limit (dBm) | Result |
|---|---|---|---|---|---|---|---|---|
| 1000 | 3944.98 | 1 | / | 1 | 3833.050 | -38.86 | -13 | Pass |
| 3984.98 | 26500 | 1 | / | 2 | 26257.750 | -34.46 | -13 | Pass |

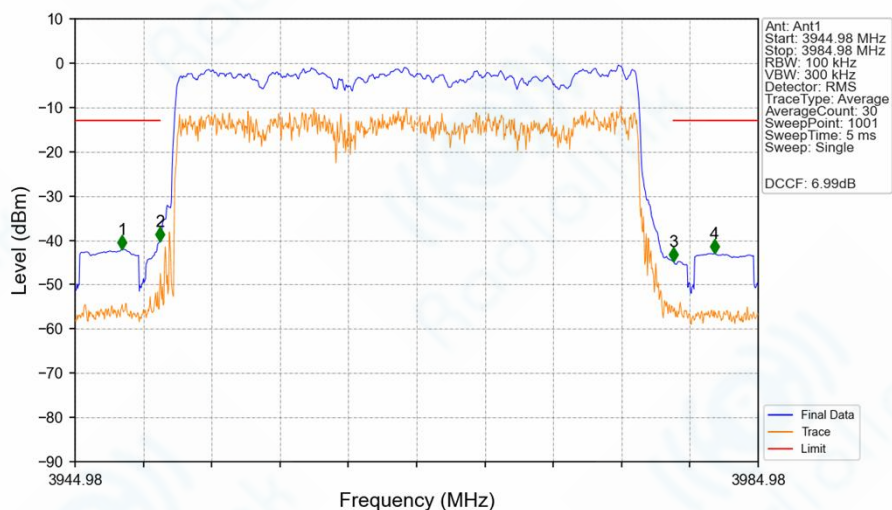
## n77a\_30kHz\_SISO\_NTNV\_30MHz\_DFT-s-OFDM\_QPSK\_3964.98MHz\_Outer\_Full\_Ant1

| Start (MHz) | Stop (MHz) | RBW (MHz) | Method | Marker No. | Freq (MHz) | Level (dBm) | Limit (dBm) | Result |
|---|---|---|---|---|---|---|---|---|
| 3944.98 | 3948.98 | 0.5 | CHP | 1 | 3947.740 | -42.03 | -13 | Pass |
| 3948.98 | 3949.98 | 0.27907 | CHP | 2 | 3949.940 | -40.17 | -13 | Pass |
| 3979.98 | 3980.98 | 0.27907 | CHP | 3 | 3980.020 | -44.77 | -13 | Pass |
| 3980.98 | 3984.98 | 0.5 | CHP | 4 | 3982.420 | -42.99 | -13 | Pass |

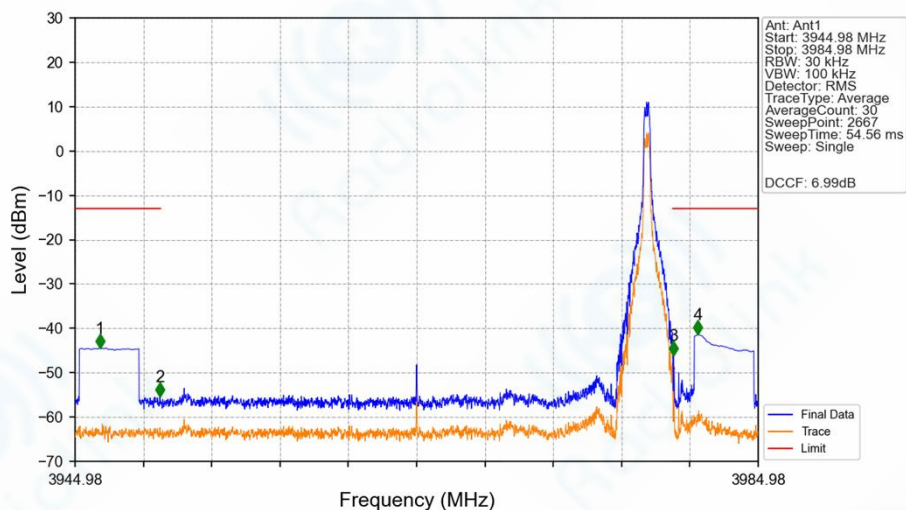
## n77a\_30kHz\_SISO\_NTNV\_30MHz\_DFT-s-OFDM\_QPSK\_3964.98MHz\_Inner\_1RB\_Right\_Ant1

| Start (MHz) | Stop (MHz) | RBW (MHz) | Method | Marker No. | Freq (MHz) | Level (dBm) | Limit (dBm) | Result |
|---|---|---|---|---|---|---|---|---|
| 3944.98 | 3948.98 | 0.5 | CHP | 1 | 3946.435 | -44.42 | -13 | Pass |
| 3948.98 | 3949.98 | 0.03 | / | 2 | 3949.946 | -55.38 | -13 | Pass |
| 3979.98 | 3980.98 | 0.03 | / | 3 | 3980.029 | -46.05 | -13 | Pass |
| 3980.98 | 3984.98 | 0.5 | CHP | 4 | 3981.439 | -41.41 | -13 | Pass |

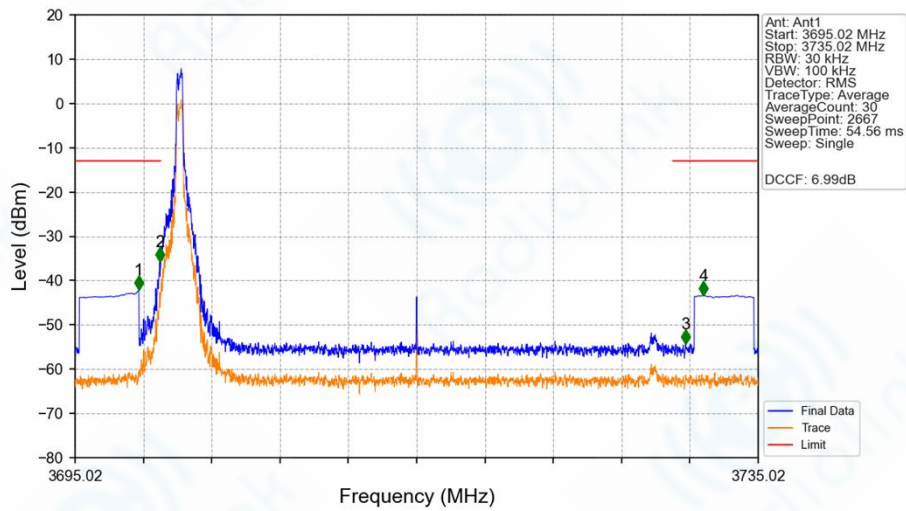
n77a\_30kHz\_SISO\_NTNV\_30MHz\_CP-OFDM\_QPSK\_3715.02MHz\_Edge\_1RB\_Left\_Ant1

| Start (MHz) | Stop (MHz) | RBW (MHz) | Method | Marker No. | Freq (MHz) | Level (dBm) | Limit (dBm) | Result |
|---|---|---|---|---|---|---|---|---|
| 3695.02 | 3699.02 | 0.5 | CHP | 1 | 3698.756 | -42.12 | -13 | Pass |
| 3699.02 | 3700.02 | 0.03 | / | 2 | 3699.986 | -35.63 | -13 | Pass |
| 3730.02 | 3731.02 | 0.03 | / | 3 | 3730.774 | -54.26 | -13 | Pass |
| 3731.02 | 3735.02 | 0.5 | CHP | 4 | 3731.824 | -43.35 | -13 | Pass |

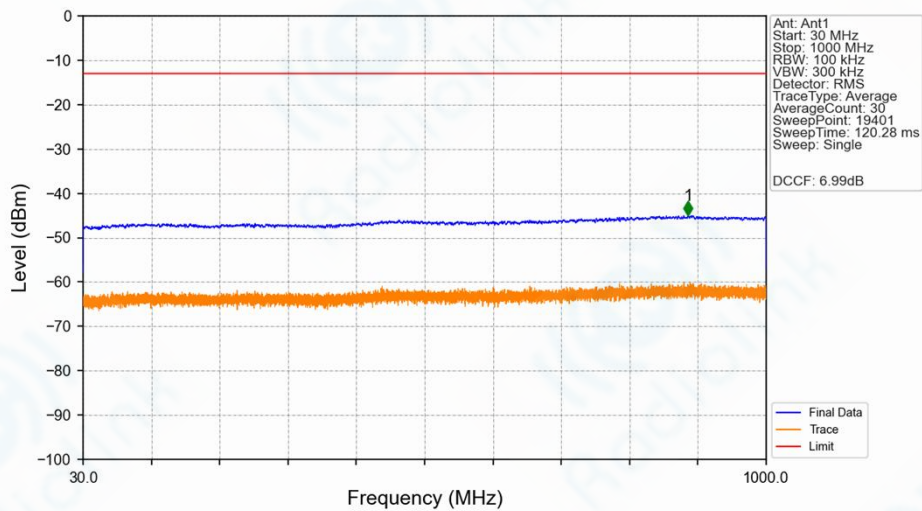
n77a\_30kHz\_SISO\_NTNV\_30MHz\_CP-OFDM\_QPSK\_3715.02MHz\_Edge\_1RB\_Left\_Ant1

| Start (MHz) | Stop (MHz) | RBW (MHz) | Method | Marker No. | Freq (MHz) | Level (dBm) | Limit (dBm) | Result |
|---|---|---|---|---|---|---|---|---|
| 30 | 1000 | 1 | CHP | 1 | 889.100 | -45.00 | -13 | Pass |

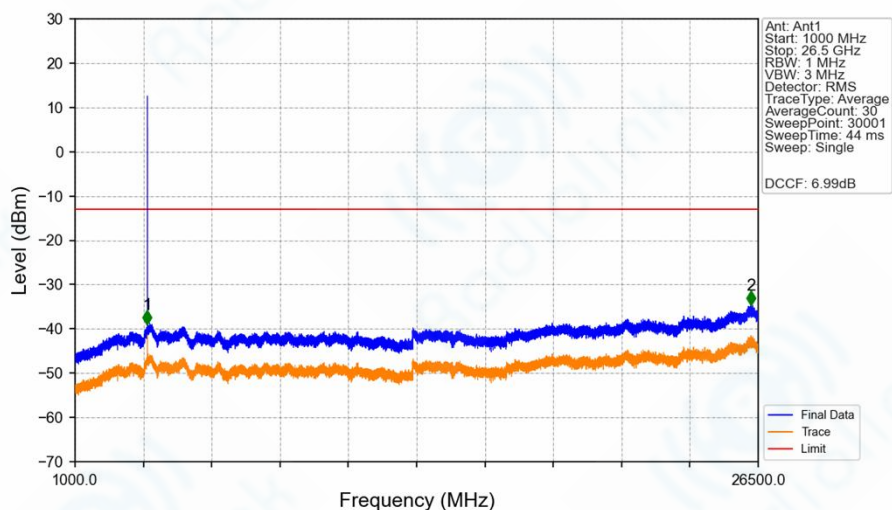
## n77a\_30kHz\_SISO\_NTNV\_30MHz\_CP-OFDM\_QPSK\_3715.02MHz\_Edge\_1RB\_Left\_Ant1

| Start (MHz) | Stop (MHz) | RBW (MHz) | Method | Marker No. | Freq (MHz) | Level (dBm) | Limit (dBm) | Result |
|---|---|---|---|---|---|---|---|---|
| 1000 | 3695.02 | 1 | / | 1 | 3694.500 | -39.06 | -13 | Pass |
| 3735.02 | 26500 | 1 | / | 2 | 26229.700 | -34.53 | -13 | Pass |

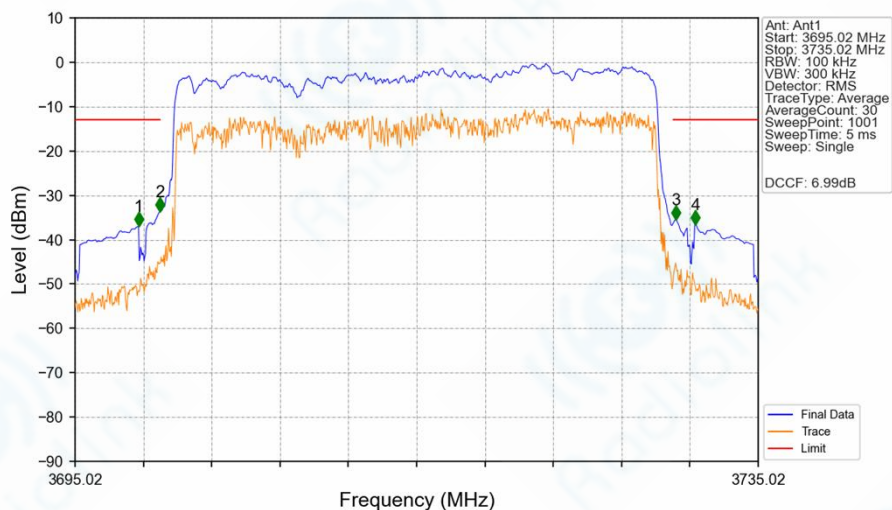
## n77a\_30kHz\_SISO\_NTNV\_30MHz\_CP-OFDM\_QPSK\_3715.02MHz\_Outer\_Full\_Ant1

| Start (MHz) | Stop (MHz) | RBW (MHz) | Method | Marker No. | Freq (MHz) | Level (dBm) | Limit (dBm) | Result |
|---|---|---|---|---|---|---|---|---|
| 3695.02 | 3699.02 | 0.5 | CHP | 1 | 3698.740 | -37.02 | -13 | Pass |
| 3699.02 | 3700.02 | 0.29415 | CHP | 2 | 3699.980 | -33.64 | -13 | Pass |
| 3730.02 | 3731.02 | 0.29415 | CHP | 3 | 3730.180 | -35.52 | -13 | Pass |
| 3731.02 | 3735.02 | 0.5 | CHP | 4 | 3731.340 | -36.57 | -13 | Pass |

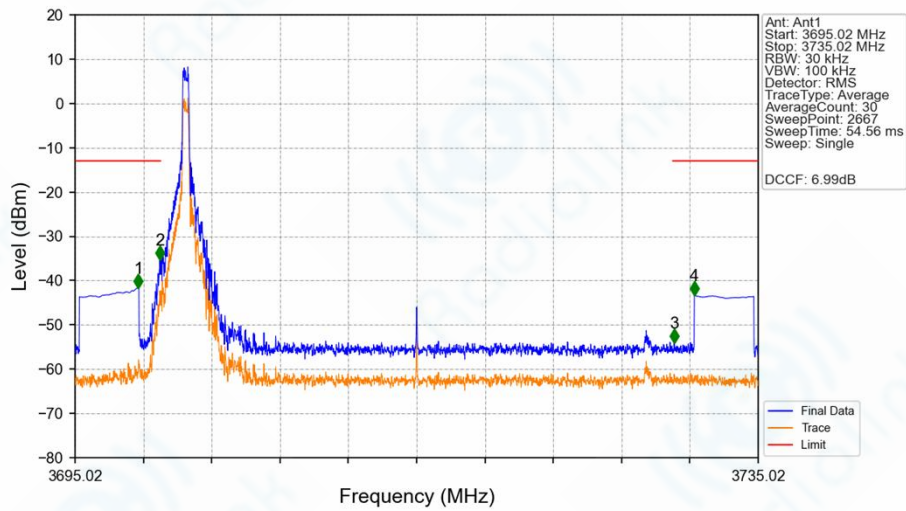
n77a\_30kHz\_SISO\_NTNV\_30MHz\_CP-OFDM\_QPSK\_3715.02MHz\_Inner\_1RB\_Left\_Ant1

| Start (MHz) | Stop (MHz) | RBW (MHz) | Method | Marker No. | Freq (MHz) | Level (dBm) | Limit (dBm) | Result |
|---|---|---|---|---|---|---|---|---|
| 3695.02 | 3699.02 | 0.5 | CHP | 1 | 3698.726 | -41.64 | -13 | Pass |
| 3699.02 | 3700.02 | 0.03 | / | 2 | 3699.986 | -35.30 | -13 | Pass |
| 3730.02 | 3731.02 | 0.03 | / | 3 | 3730.099 | -54.16 | -13 | Pass |
| 3731.02 | 3735.02 | 0.5 | CHP | 4 | 3731.284 | -43.36 | -13 | Pass |

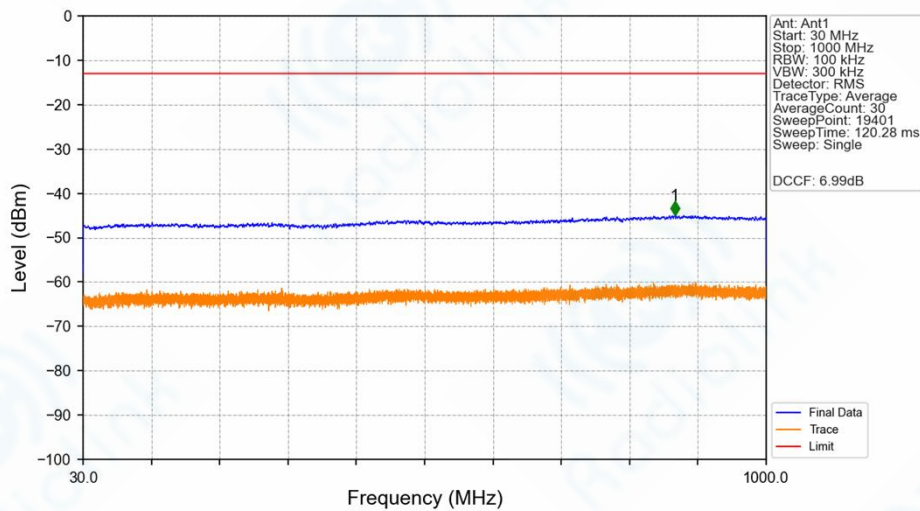
n77a\_30kHz\_SISO\_NTNV\_30MHz\_CP-OFDM\_QPSK\_3840MHz\_Edge\_1RB\_Left\_Ant1

| Start (MHz) | Stop (MHz) | RBW (MHz) | Method | Marker No. | Freq (MHz) | Level (dBm) | Limit (dBm) | Result |
|---|---|---|---|---|---|---|---|---|
| 30 | 1000 | 1 | CHP | 1 | 870.350 | -44.87 | -13 | Pass |

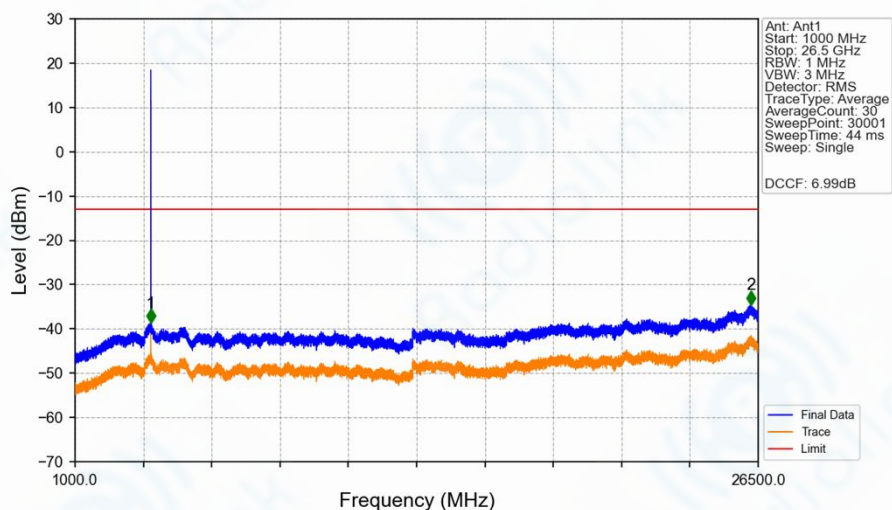
## n77a\_30kHz\_SISO\_NTNV\_30MHz\_CP-OFDM\_QPSK\_3840MHz\_Edge\_1RB\_Left\_Ant1

| Start (MHz) | Stop (MHz) | RBW (MHz) | Method | Marker No. | Freq (MHz) | Level (dBm) | Limit (dBm) | Result |
|---|---|---|---|---|---|---|---|---|
| 1000 | 3820 | 1 | / | 1 | 3819.450 | -38.56 | -13 | Pass |
| 3860 | 26500 | 1 | / | 2 | 26239.050 | -34.52 | -13 | Pass |

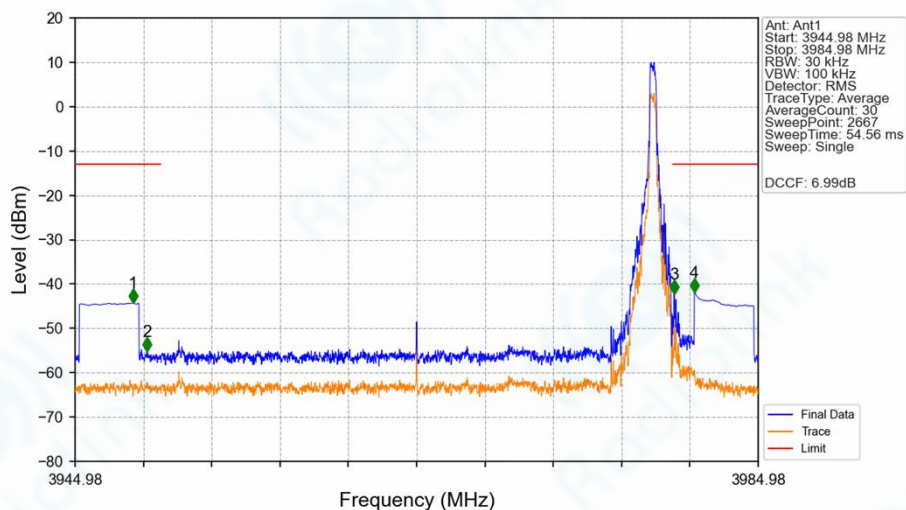
## n77a\_30kHz\_SISO\_NTNV\_30MHz\_CP-OFDM\_QPSK\_3964.98MHz\_Edge\_1RB\_Right\_Ant1

| Start (MHz) | Stop (MHz) | RBW (MHz) | Method | Marker No. | Freq (MHz) | Level (dBm) | Limit (dBm) | Result |
|---|---|---|---|---|---|---|---|---|
| 3944.98 | 3948.98 | 0.5 | CHP | 1 | 3948.386 | -44.27 | -13 | Pass |
| 3948.98 | 3949.98 | 0.03 | / | 2 | 3949.181 | -55.20 | -13 | Pass |
| 3979.98 | 3980.98 | 0.03 | / | 3 | 3980.044 | -42.27 | -13 | Pass |
| 3980.98 | 3984.98 | 0.5 | CHP | 4 | 3981.244 | -41.90 | -13 | Pass |

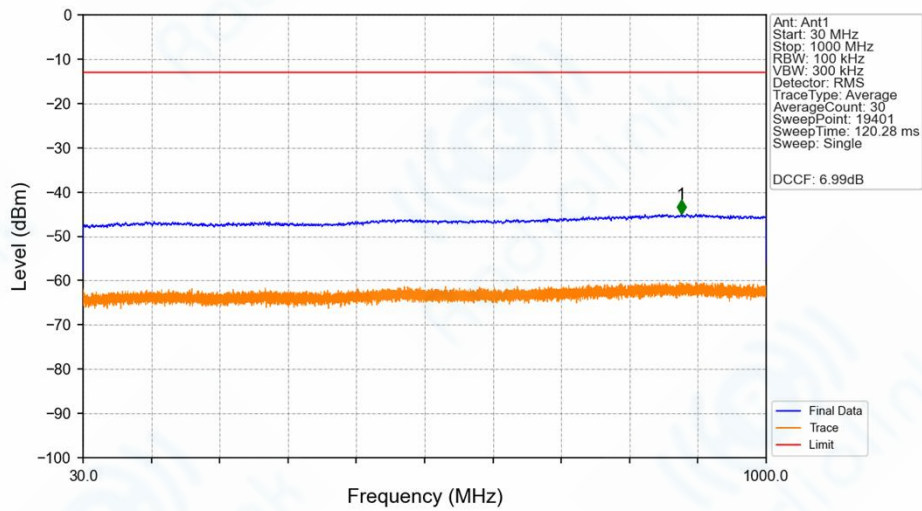
## n77a\_30kHz\_SISO\_NTNV\_30MHz\_CP-OFDM\_QPSK\_3964.98MHz\_Edge\_1RB\_Right\_Ant1

| Start (MHz) | Stop (MHz) | RBW (MHz) | Method | Marker No. | Freq (MHz) | Level (dBm) | Limit (dBm) | Result |
|---|---|---|---|---|---|---|---|---|
| 30 | 1000 | 1 | CHP | 1 | 879.100 | -44.92 | -13 | Pass |

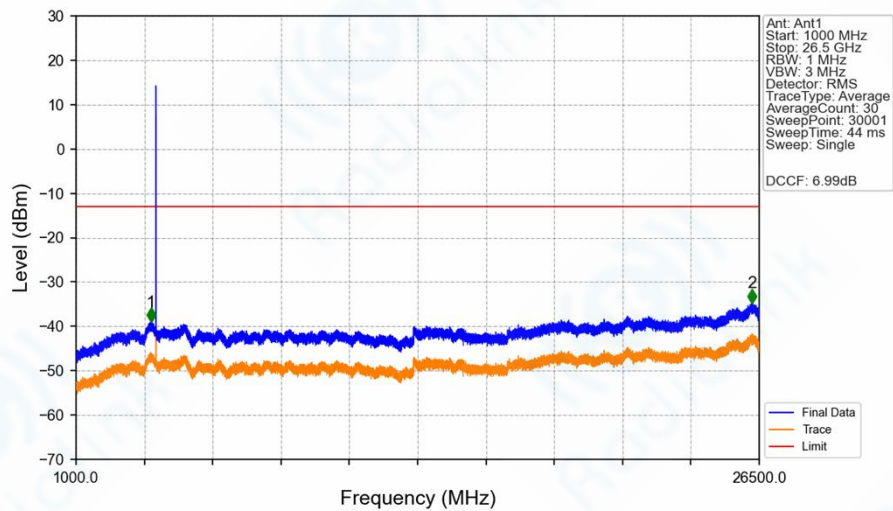
## n77a\_30kHz\_SISO\_NTNV\_30MHz\_CP-OFDM\_QPSK\_3964.98MHz\_Edge\_1RB\_Right\_Ant1

| Start (MHz) | Stop (MHz) | RBW (MHz) | Method | Marker No. | Freq (MHz) | Level (dBm) | Limit (dBm) | Result |
|---|---|---|---|---|---|---|---|---|
| 1000 | 3944.98 | 1 | / | 1 | 3788.850 | -38.91 | -13 | Pass |
| 3984.98 | 26500 | 1 | / | 2 | 26230.550 | -34.70 | -13 | Pass |

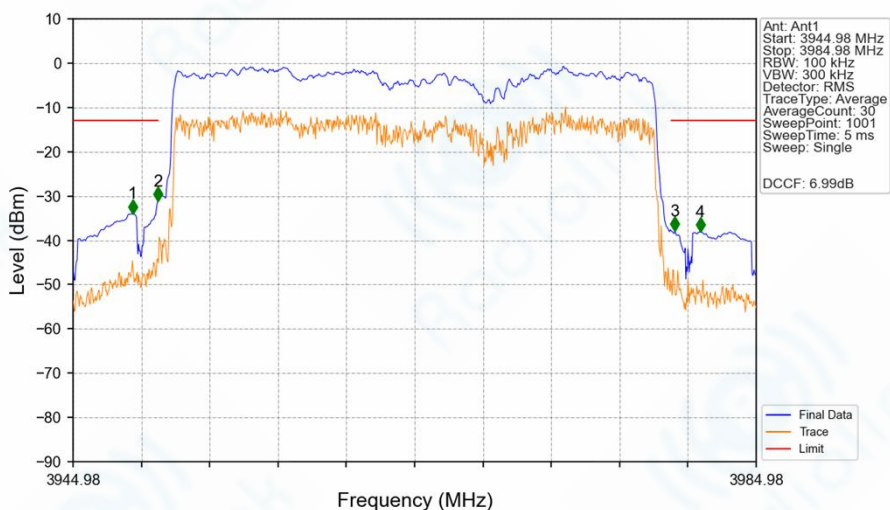
## n77a\_30kHz\_SISO\_NTNV\_30MHz\_CP-OFDM\_QPSK\_3964.98MHz\_Outer\_Full\_Ant1

| Start (MHz) | Stop (MHz) | RBW (MHz) | Method | Marker No. | Freq (MHz) | Level (dBm) | Limit (dBm) | Result |
|---|---|---|---|---|---|---|---|---|
| 3944.98 | 3948.98 | 0.5 | CHP | 1 | 3948.460 | -33.93 | -13 | Pass |
| 3948.98 | 3949.98 | 0.29201 | CHP | 2 | 3949.940 | -31.17 | -13 | Pass |
| 3979.98 | 3980.98 | 0.29201 | CHP | 3 | 3980.220 | -37.92 | -13 | Pass |
| 3980.98 | 3984.98 | 0.5 | CHP | 4 | 3981.700 | -38.09 | -13 | Pass |

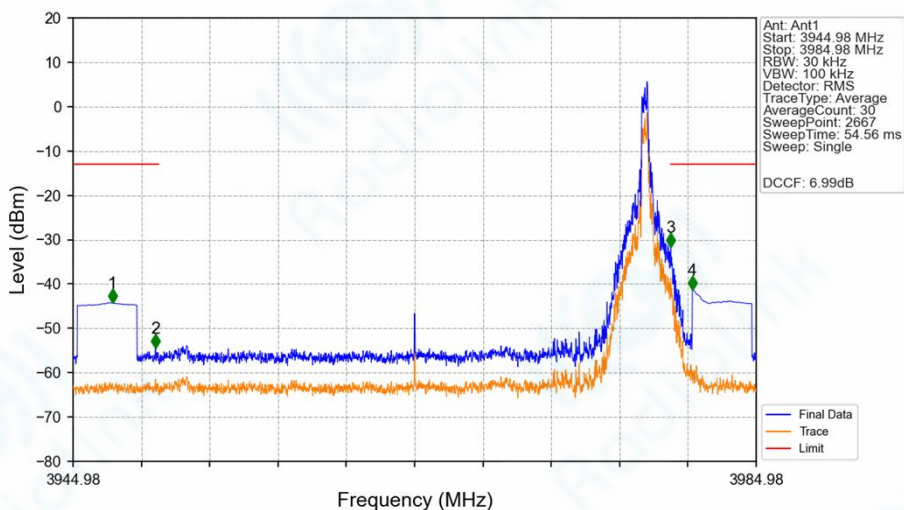
## n77a\_30kHz\_SISO\_NTNV\_30MHz\_CP-OFDM\_QPSK\_3964.98MHz\_Inner\_1RB\_Right\_Ant1

| Start (MHz) | Stop (MHz) | RBW (MHz) | Method | Marker No. | Freq (MHz) | Level (dBm) | Limit (dBm) | Result |
|---|---|---|---|---|---|---|---|---|
| 3944.98 | 3948.98 | 0.5 | CHP | 1 | 3947.276 | -44.21 | -13 | Pass |
| 3948.98 | 3949.98 | 0.03 | / | 2 | 3949.811 | -54.44 | -13 | Pass |
| 3979.98 | 3980.98 | 0.03 | / | 3 | 3979.984 | -31.75 | -13 | Pass |
| 3980.98 | 3984.98 | 0.5 | CHP | 4 | 3981.244 | -41.28 | -13 | Pass |

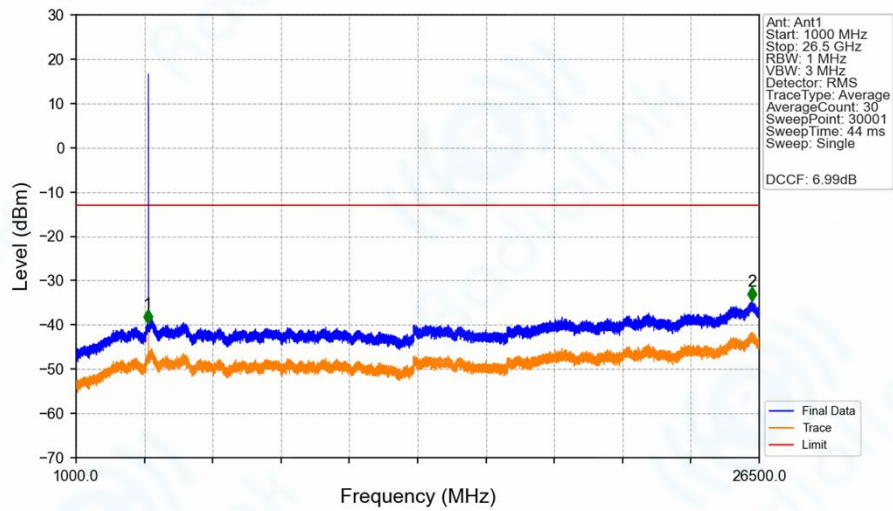
## n77a\_30kHz\_SISO\_NTNV\_40MHz\_DFT-s-OFDM PI/2 BPSK 3720MHz\_Edge\_1RB\_Left\_Ant1

| Start (MHz) | Stop (MHz) | RBW (MHz) | Method | Marker No. | Freq (MHz) | Level (dBm) | Limit (dBm) | Result |
|---|---|---|---|---|---|---|---|---|
| 1000 | 3695 | 1 | / | 1 | 3677.500 | -39.66 | -13 | Pass |
| 3745 | 26500 | 1 | / | 2 | 26229.700 | -34.67 | -13 | Pass |

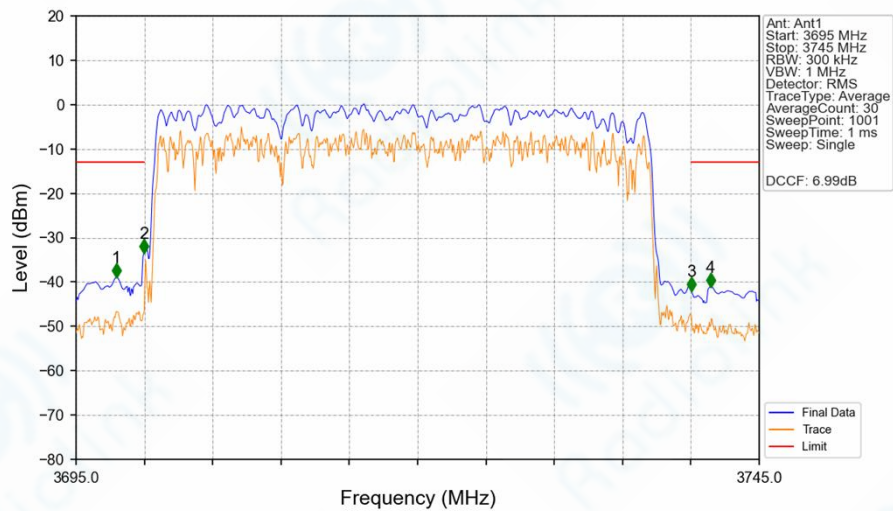
## n77a\_30kHz\_SISO\_NTNV\_40MHz\_DFT-s-OFDM PI/2 BPSK 3720MHz\_Outer\_Full\_Ant1

| Start (MHz) | Stop (MHz) | RBW (MHz) | Method | Marker No. | Freq (MHz) | Level (dBm) | Limit (dBm) | Result |
|---|---|---|---|---|---|---|---|---|
| 3695 | 3699 | 0.5 | CHP | 1 | 3697.950 | -38.94 | -13 | Pass |
| 3699 | 3700 | 0.35 | CHP | 2 | 3699.950 | -33.48 | -13 | Pass |
| 3740 | 3741 | 0.35 | CHP | 3 | 3740.050 | -42.08 | -13 | Pass |
| 3741 | 3745 | 0.5 | CHP | 4 | 3741.450 | -41.12 | -13 | Pass |

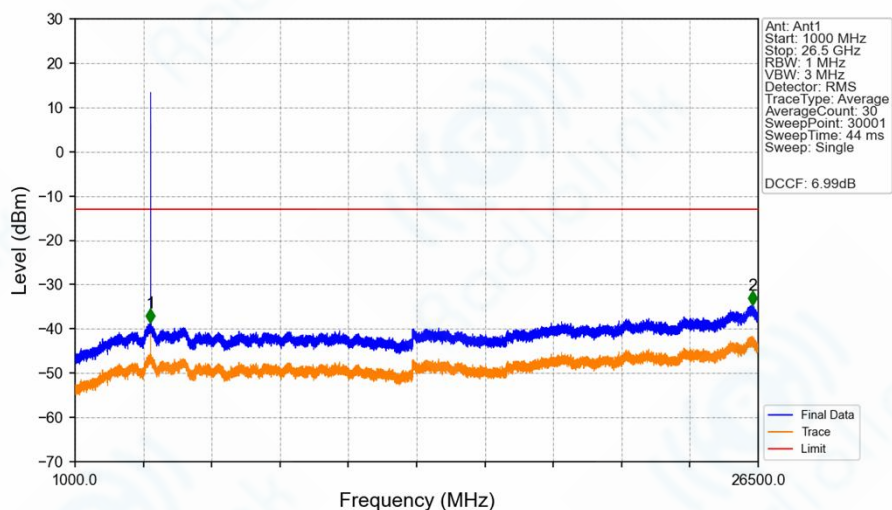
## n77a\_30kHz\_SISO\_NTNV\_40MHz\_DFT-s-OFDM PI/2 BPSK 3840MHz\_Edge\_1RB\_Left\_Ant1

| Start (MHz) | Stop (MHz) | RBW (MHz) | Method | Marker No. | Freq (MHz) | Level (dBm) | Limit (dBm) | Result |
|---|---|---|---|---|---|---|---|---|
| 1000 | 3815 | 1 | / | 1 | 3806.700 | -38.60 | -13 | Pass |
| 3865 | 26500 | 1 | / | 2 | 26282.400 | -34.66 | -13 | Pass |

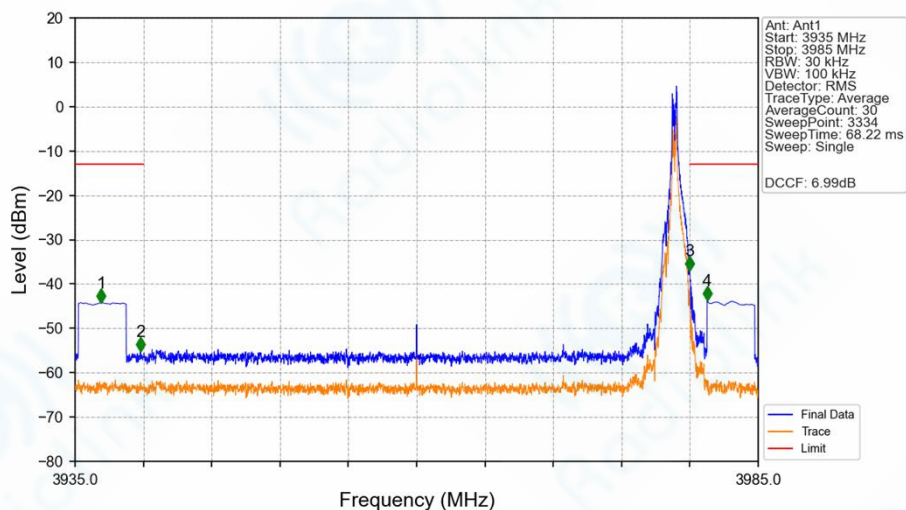
## n77a\_30kHz\_SISO\_NTNV\_40MHz\_DFT-s-OFDM PI/2 BPSK\_3960MHz\_Edge\_1RB\_Right\_Ant1

| Start (MHz) | Stop (MHz) | RBW (MHz) | Method | Marker No. | Freq (MHz) | Level (dBm) | Limit (dBm) | Result |
|---|---|---|---|---|---|---|---|---|
| 3935 | 3939 | 0.5 | CHP | 1 | 3936.920 | -44.21 | -13 | Pass |
| 3939 | 3940 | 0.03 | / | 2 | 3939.785 | -55.19 | -13 | Pass |
| 3980 | 3981 | 0.03 | / | 3 | 3980.005 | -36.99 | -13 | Pass |
| 3981 | 3985 | 0.5 | CHP | 4 | 3981.265 | -43.75 | -13 | Pass |

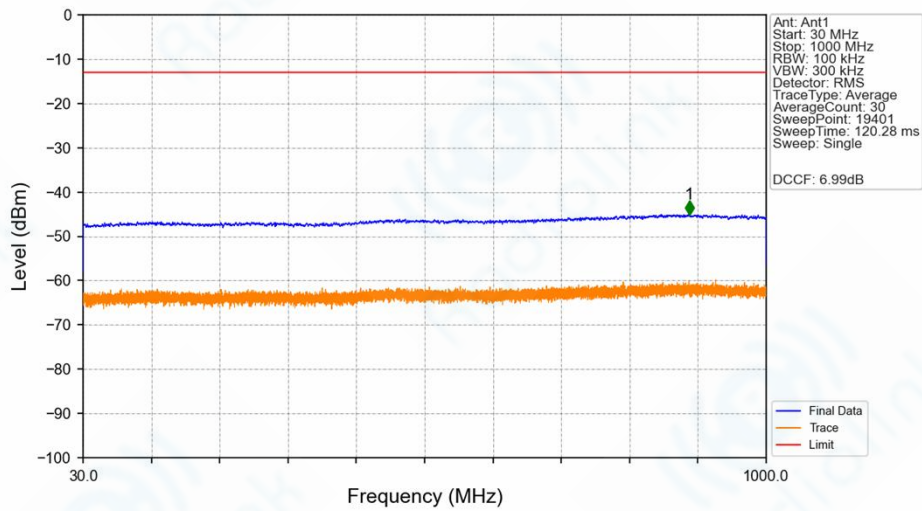
## n77a\_30kHz\_SISO\_NTNV\_40MHz\_DFT-s-OFDM\_PI/2\_BPSK\_3960MHz\_Edge\_1RB\_Right\_Ant1

| Start (MHz) | Stop (MHz) | RBW (MHz) | Method | Marker No. | Freq (MHz) | Level (dBm) | Limit (dBm) | Result |
|---|---|---|---|---|---|---|---|---|
| 30 | 1000 | 1 | CHP | 1 | 890.650 | -45.03 | -13 | Pass |

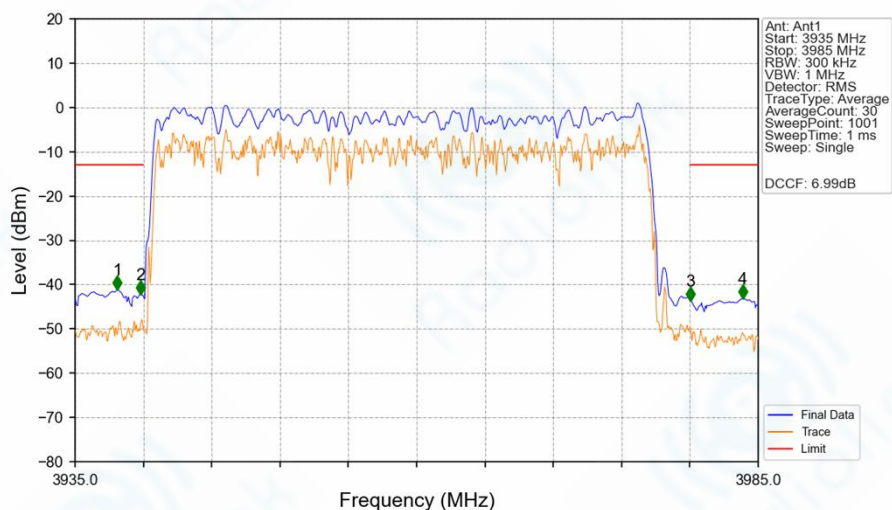
## n77a 30kHz SISO NTN 40MHz DFT-s-OFDM PI/2 BPSK 3960MHz Outer Full Ant1

| Start (MHz) | Stop (MHz) | RBW (MHz) | Method | Marker No. | Freq (MHz) | Level (dBm) | Limit (dBm) | Result |
| 3935 | 3939 | 0.5 | CHP | 1 | 3938.100 | -41.21 | -13 | Pass |
| 3981 | 3985 | 0.5 | CHP | 4 | 3983.850 | -43.19 | -13 | Pass |

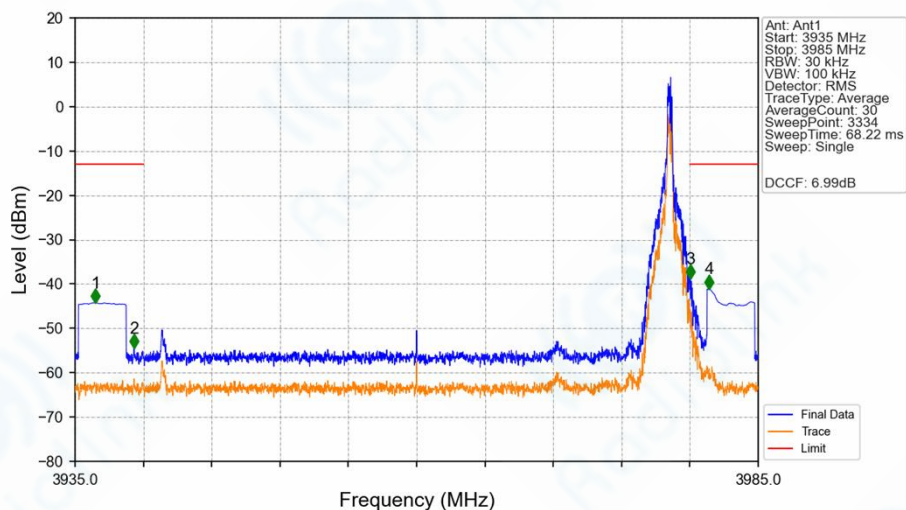
## n77a 30kHz SISO NTN 40MHz DFT-s-OFDM PI/2 BPSK 3960MHz Inner 1RB Right Ant1

| Start (MHz) | Stop (MHz) | RBW (MHz) | Method | Marker No. | Freq (MHz) | Level (dBm) | Limit (dBm) | Result |
| 3935 | 3939 | 0.5 | CHP | 1 | 3936.485 | -44.18 | -13 | Pass |

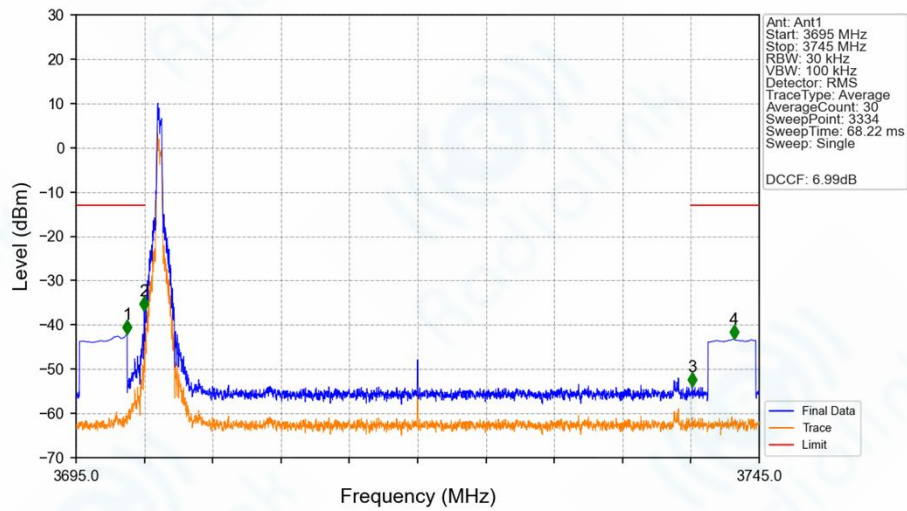
## n77a\_30kHz\_SISO\_NTNV\_40MHz\_DFT-s-OFDM\_QPSK\_3720MHz\_Edge\_1RB\_Left\_Ant1

| Start (MHz) | Stop (MHz) | RBW (MHz) | Method | Marker No. | Freq (MHz) | Level (dBm) | Limit (dBm) | Result |
| 3695 | 3699 | 0.5 | CHP | 1 | 3698.735 | -42.04 | -13 | Pass |
| 3741 | 3745 | 0.5 | CHP | 4 | 3743.155 | -43.23 | -13 | Pass |

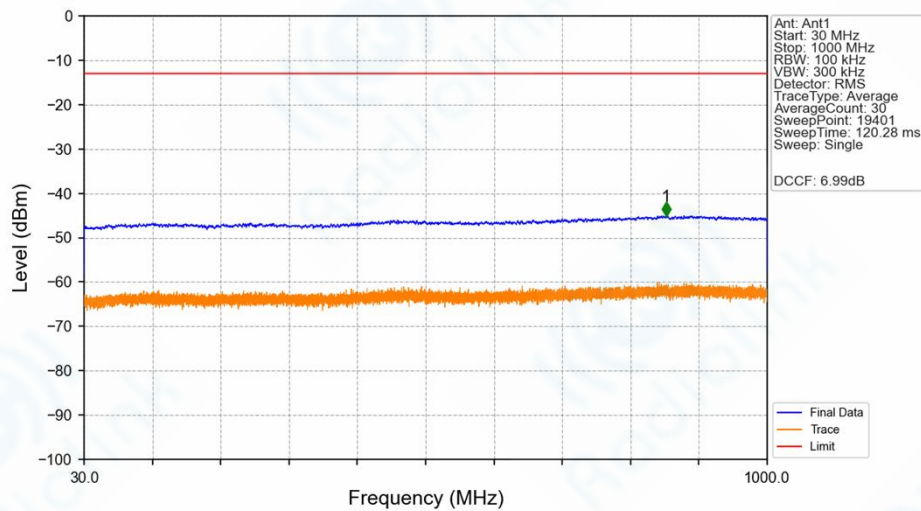
## n77a\_30kHz\_SISO\_NTNV\_40MHz\_DFT-s-OFDM\_QPSK\_3720MHz\_Edge\_1RB\_Left\_Ant1

| Start (MHz) | Stop (MHz) | RBW (MHz) | Method | Marker No. | Freq (MHz) | Level (dBm) | Limit (dBm) | Result |
| 30 | 1000 | 1 | CHP | 1 | 856.300 | -45.05 | -13 | Pass |
