### 5.2.3 30\_S\_30M\_NTNV

**Radiolink Testing (Shenzhen) Co., Ltd.**

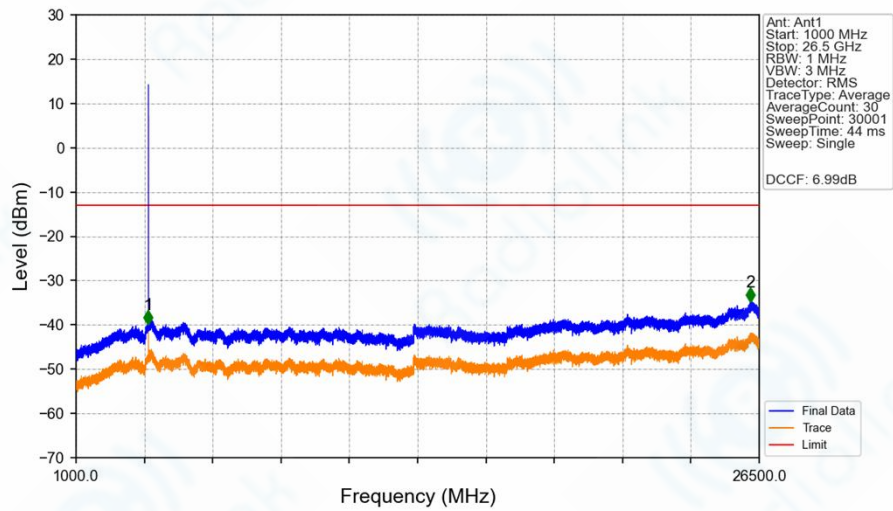
## n77a\_30kHz\_SISO\_NTNV\_40MHz\_DFT-s-OFDM\_QPSK\_3720MHz\_Edge\_1RB\_Left\_Ant1

| Start (MHz) | Stop (MHz) | RBW (MHz) | Method | Marker No. | Freq (MHz) | Level (dBm) | Limit (dBm) | Result |
| 1000 | 3695 | 1 | / | 1 | 3693.650 | -39.83 | -13 | Pass |
| 3745 | 26500 | 1 | / | 2 | 26173.600 | -34.83 | -13 | Pass |

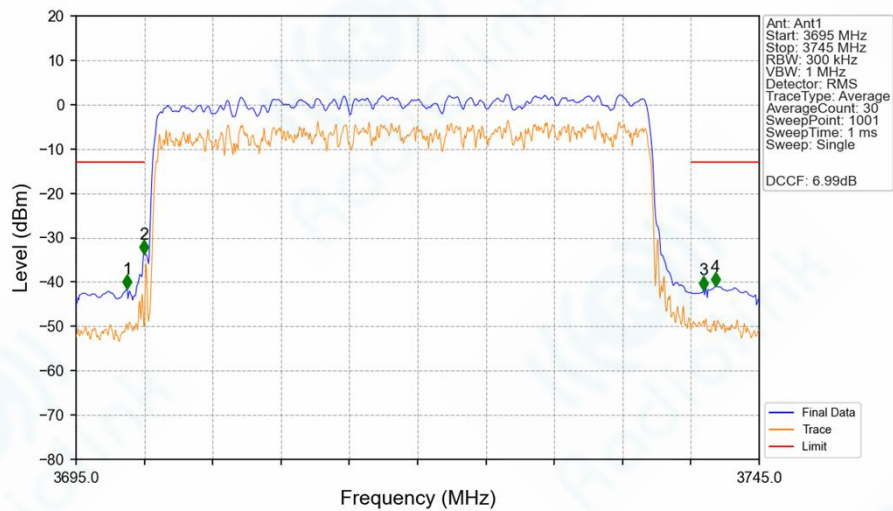
## n77a\_30kHz\_SISO\_NTNV\_40MHz\_DFT-s-OFDM\_QPSK\_3720MHz\_Outer\_Full\_Ant1

| Start (MHz) | Stop (MHz) | RBW (MHz) | Method | Marker No. | Freq (MHz) | Level (dBm) | Limit (dBm) | Result |
| 3695 | 3699 | 0.5 | CHP | 1 | 3698.750 | -41.45 | -13 | Pass |
| 3741 | 3745 | 0.5 | CHP | 4 | 3741.800 | -40.97 | -13 | Pass |

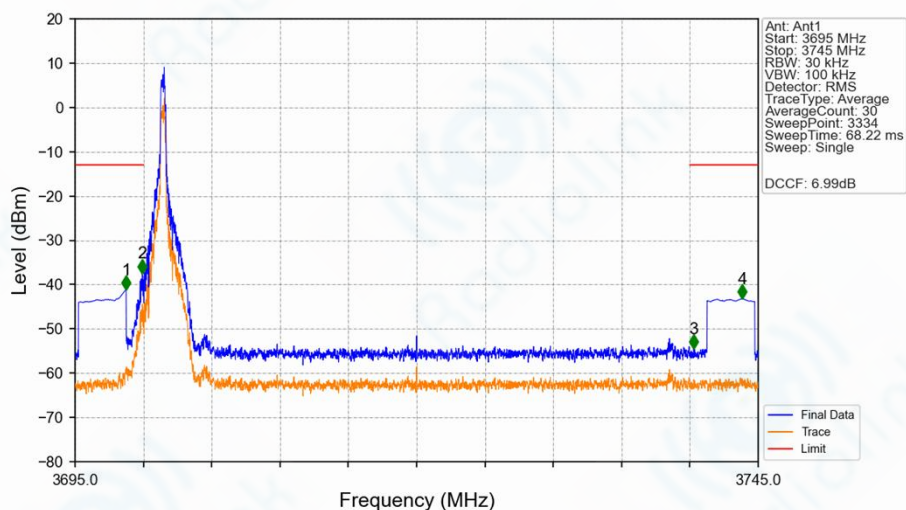
## n77a\_30kHz\_SISO\_NTNV\_40MHz\_DFT-s-OFDM\_QPSK\_3720MHz\_Inner\_1RB\_Left\_Ant1

| Start (MHz) | Stop (MHz) | RBW (MHz) | Method | Marker No. | Freq (MHz) | Level (dBm) | Limit (dBm) | Result |
| 3695 | 3699 | 0.5 | CHP | 1 | 3698.735 | -41.12 | -13 | Pass |
| 3741 | 3745 | 0.5 | CHP | 4 | 3743.830 | -43.17 | -13 | Pass |

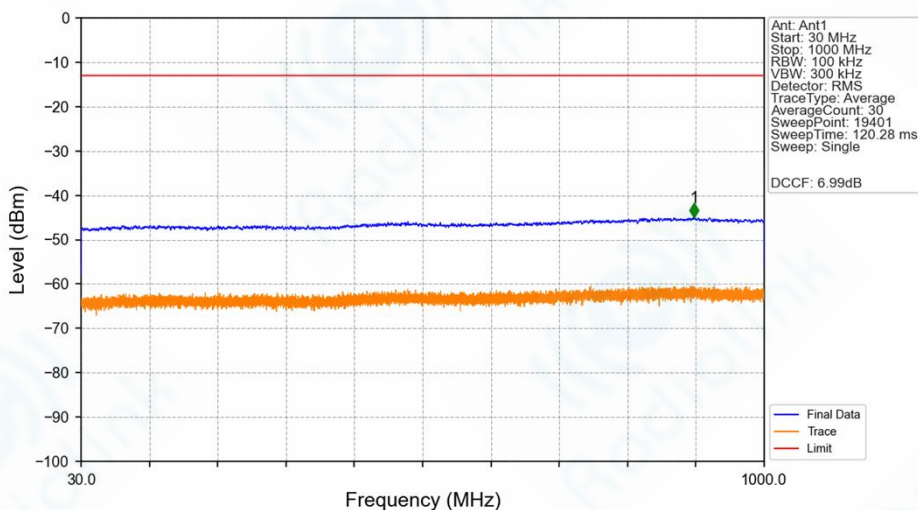
## n77a\_30kHz\_SISO\_NTNV\_40MHz\_DFT-s-OFDM\_QPSK\_3840MHz\_Edge\_1RB\_Left\_Ant1

| Start (MHz) | Stop (MHz) | RBW (MHz) | Method | Marker No. | Freq (MHz) | Level (dBm) | Limit (dBm) | Result |
| 30 | 1000 | 1 | CHP | 1 | 900.550 | -44.91 | -13 | Pass |
