n77h\_30kHz\_SISO\_NTNV\_10MHz\_DFT-s-OFDM\_PI/2\_BPSK\_3905.01MHz\_Inner\_1RB\_Right\_Ant1

Radiolink Testing (Shenzhen) Co., Ltd.

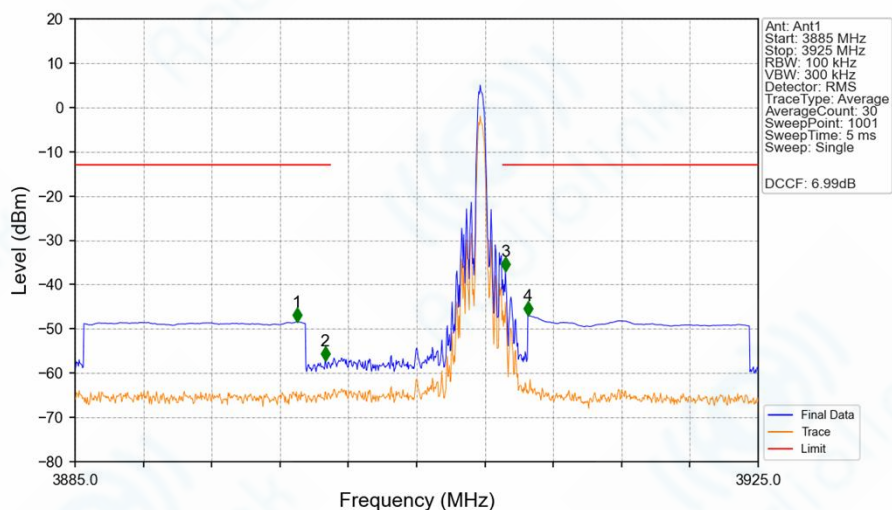
| Start (MHz) | Stop (MHz) | RBW (MHz) | Method | Marker No. | Freq (MHz) | Level (dBm) | Limit (dBm) | Result |
| 3885 | 3899 | 1 | CHP | 1 | 3898.000 | -48.42 | -13 | Pass |
| 3899 | 3900 | 0.1 | / | 2 | 3899.640 | -57.23 | -13 | Pass |
| 3910 | 3911 | 0.1 | / | 3 | 3910.200 | -36.94 | -13 | Pass |
| 3911 | 3925 | 1 | CHP | 4 | 3911.520 | -46.94 | -13 | Pass |

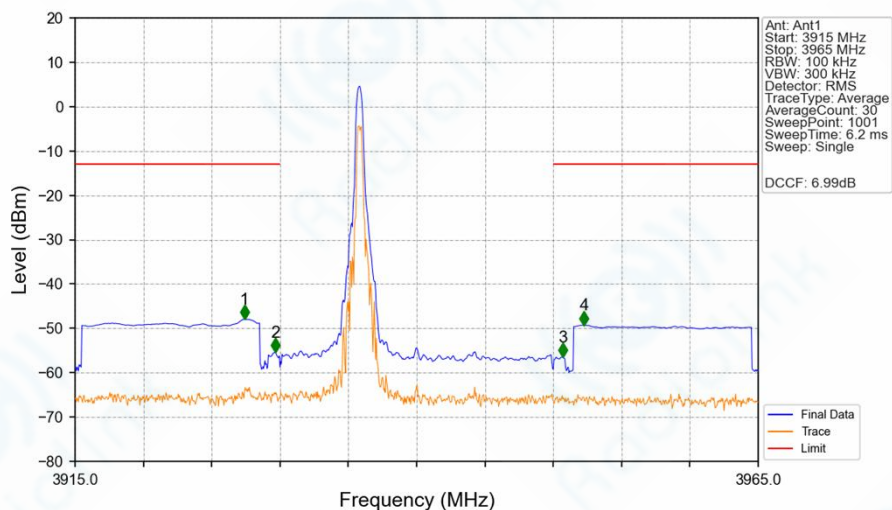
n77h\_30kHz\_SISO\_NTNV\_10MHz\_DFT-s-OFDM\_PI/2\_BPSK\_3939.99MHz\_Edge\_1RB\_Left\_Ant1

| Start (MHz) | Stop (MHz) | RBW (MHz) | Method | Marker No. | Freq (MHz) | Level (dBm) | Limit (dBm) | Result |
| 3915 | 3929 | 1 | CHP | 1 | 3927.400 | -47.94 | -13 | Pass |
| 3929 | 3930 | 0.2 | CHP | 2 | 3929.650 | -55.42 | -13 | Pass |
| 3950 | 3951 | 0.2 | CHP | 3 | 3950.700 | -56.46 | -13 | Pass |
| 3951 | 3965 | 1 | CHP | 4 | 3952.250 | -49.25 | -13 | Pass |

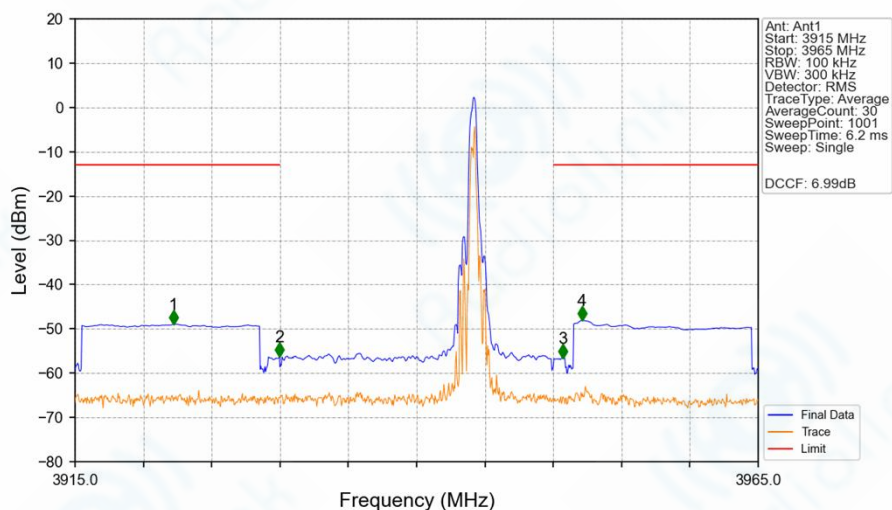
## n77h\_30kHz\_SISO\_NTNV\_10MHz\_DFT-s-OFDM\_PI/2\_BPSK\_3939.99MHz\_Edge\_1RB\_Right\_Ant1

| Start (MHz) | Stop (MHz) | RBW (MHz) | Method | Marker No. | Freq (MHz) | Level (dBm) | Limit (dBm) | Result |
| 3915 | 3929 | 1 | CHP | 1 | 3922.200 | -48.96 | -13 | Pass |
| 3929 | 3930 | 0.2 | CHP | 2 | 3929.950 | -56.32 | -13 | Pass |
| 3950 | 3951 | 0.2 | CHP | 3 | 3950.700 | -56.57 | -13 | Pass |
| 3951 | 3965 | 1 | CHP | 4 | 3952.100 | -48.06 | -13 | Pass |

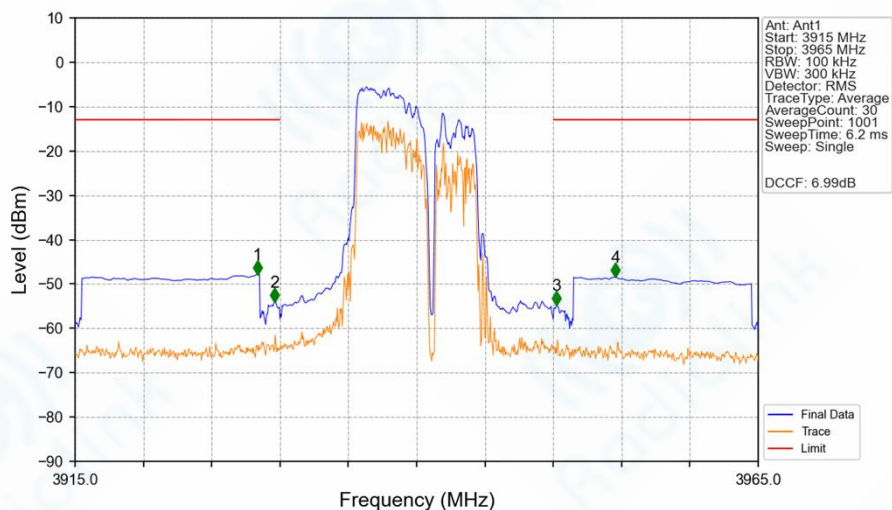
## n77h\_30kHz\_SISO\_NTNV\_10MHz\_DFT-s-OFDM\_PI/2\_BPSK\_3939.99MHz\_Outer\_Full\_Ant1

| Start (MHz) | Stop (MHz) | RBW (MHz) | Method | Marker No. | Freq (MHz) | Level (dBm) | Limit (dBm) | Result |
| 3915 | 3929 | 1 | CHP | 1 | 3928.350 | -47.85 | -13 | Pass |
| 3929 | 3930 | 0.2 | CHP | 2 | 3929.600 | -54.11 | -13 | Pass |
| 3950 | 3951 | 0.2 | CHP | 3 | 3950.250 | -54.76 | -13 | Pass |
| 3951 | 3965 | 1 | CHP | 4 | 3954.550 | -48.43 | -13 | Pass |

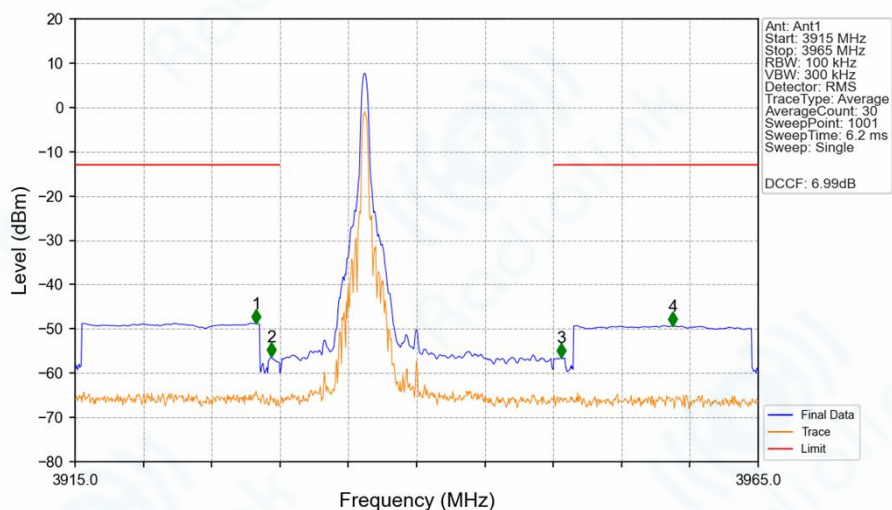
n77h 30kHz\_SISO\_NTNV\_10MHz\_DFT-s-OFDM PI/2 BPSK 3939.99MHz\_Inner\_1RB\_Left\_Ant1

| Start (MHz) | Stop (MHz) | RBW (MHz) | Method | Marker No. | Freq (MHz) | Level (dBm) | Limit (dBm) | Result |
| 3915 | 3929 | 1 | CHP | 1 | 3928.250 | -48.75 | -13 | Pass |
| 3929 | 3930 | 0.2 | CHP | 2 | 3929.350 | -56.33 | -13 | Pass |
| 3950 | 3951 | 0.2 | CHP | 3 | 3950.550 | -56.52 | -13 | Pass |
| 3951 | 3965 | 1 | CHP | 4 | 3958.750 | -49.29 | -13 | Pass |

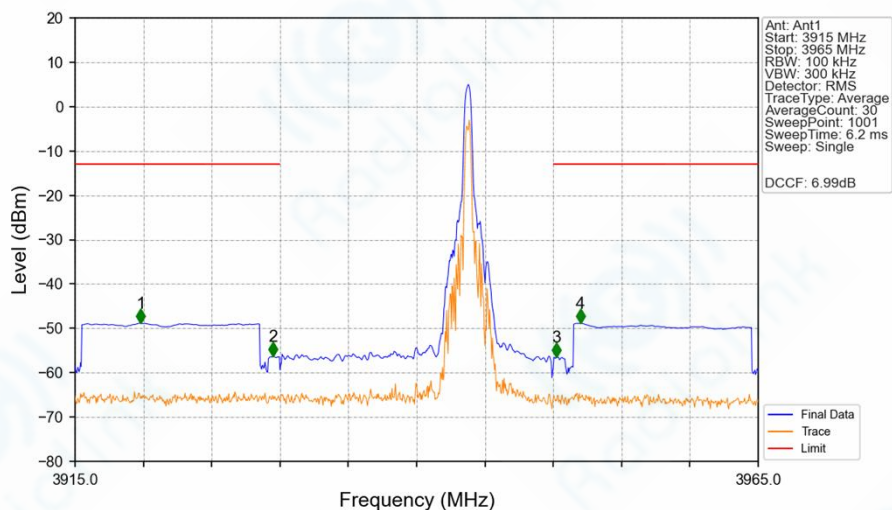
n77h 30kHz\_SISO\_NTNV\_10MHz\_DFT-s-OFDM PI/2 BPSK 3939.99MHz\_Inner\_1RB\_Right\_Ant1

| Start (MHz) | Stop (MHz) | RBW (MHz) | Method | Marker No. | Freq (MHz) | Level (dBm) | Limit (dBm) | Result |
| 3915 | 3929 | 1 | CHP | 1 | 3919.800 | -48.79 | -13 | Pass |
| 3929 | 3930 | 0.2 | CHP | 2 | 3929.500 | -56.33 | -13 | Pass |
| 3950 | 3951 | 0.2 | CHP | 3 | 3950.250 | -56.46 | -13 | Pass |
| 3951 | 3965 | 1 | CHP | 4 | 3952.000 | -48.87 | -13 | Pass |

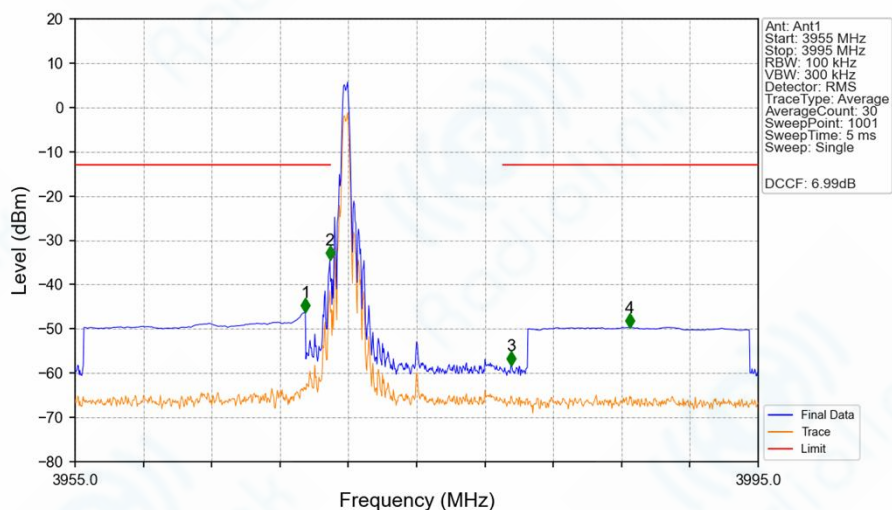
## n77h\_30kHz\_SISO\_NTNV\_10MHz\_DFT-s-OFDM\_PI/2\_BPSK\_3975MHz\_Edge\_1RB\_Left\_Ant1

| Start (MHz) | Stop (MHz) | RBW (MHz) | Method | Marker No. | Freq (MHz) | Level (dBm) | Limit (dBm) | Result |
| 3955 | 3969 | 1 | CHP | 1 | 3968.480 | -46.26 | -13 | Pass |
| 3969 | 3970 | 0.1 | / | 2 | 3969.920 | -34.34 | -13 | Pass |
| 3980 | 3981 | 0.1 | / | 3 | 3980.520 | -58.23 | -13 | Pass |
| 3981 | 3995 | 1 | CHP | 4 | 3987.480 | -49.68 | -13 | Pass |

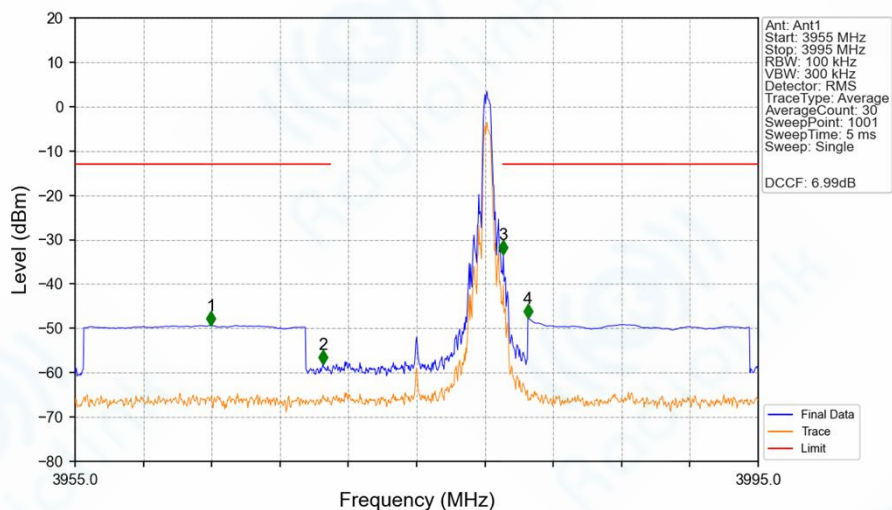
## n77h\_30kHz\_SISO\_NTNV\_10MHz\_DFT-s-OFDM\_PI/2\_BPSK\_3975MHz\_Edge\_1RB\_Right\_Ant1

| Start (MHz) | Stop (MHz) | RBW (MHz) | Method | Marker No. | Freq (MHz) | Level (dBm) | Limit (dBm) | Result |
| 3955 | 3969 | 1 | CHP | 1 | 3962.960 | -49.36 | -13 | Pass |
| 3969 | 3970 | 0.1 | / | 2 | 3969.520 | -58.05 | -13 | Pass |
| 3980 | 3981 | 0.1 | / | 3 | 3980.080 | -33.27 | -13 | Pass |
| 3981 | 3995 | 1 | CHP | 4 | 3981.520 | -47.71 | -13 | Pass |

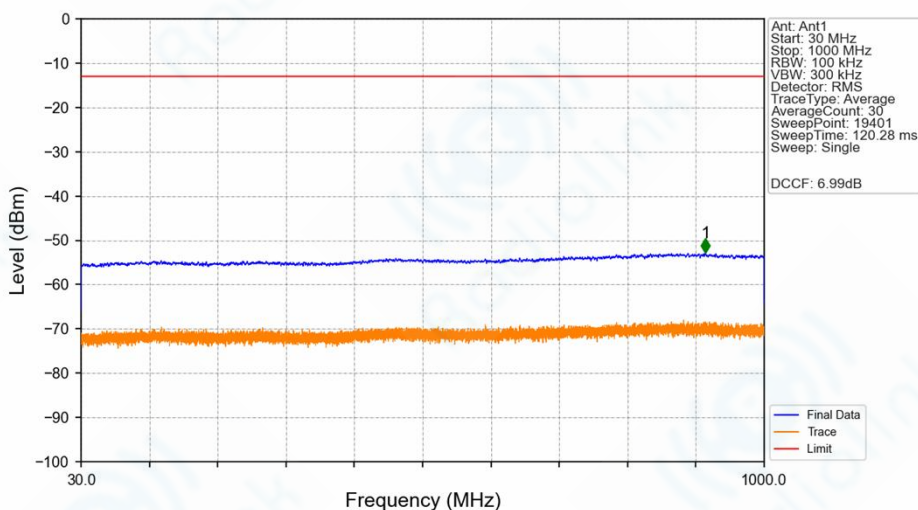
n77h\_30kHz\_SISO\_NTNV\_10MHz\_DFT-s-OFDM\_PI/2\_BPSK\_3975MHz\_Edge\_1RB\_Right\_Ant1

| Start (MHz) | Stop (MHz) | RBW (MHz) | Method | Marker No. | Freq (MHz) | Level (dBm) | Limit (dBm) | Result |
| 30 | 1000 | 1 | CHP | 1 | 916.600 | -52.82 | -13 | Pass |

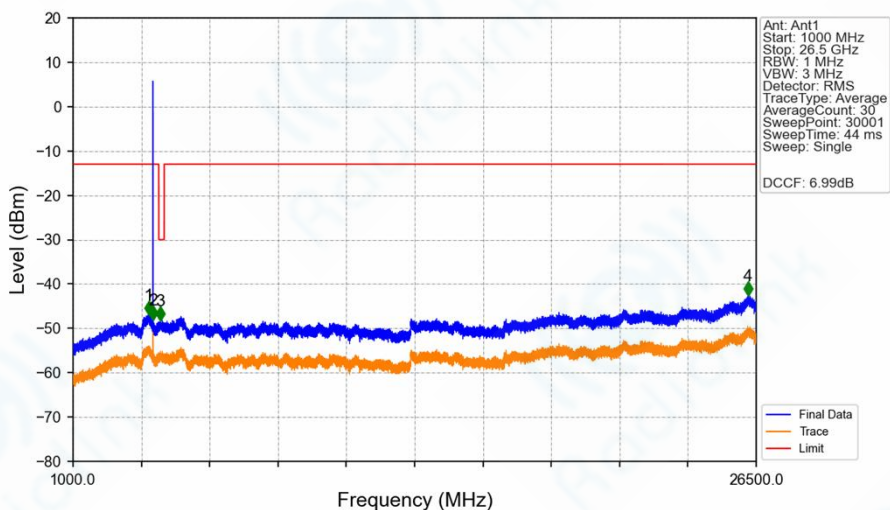
n77h\_30kHz\_SISO\_NTNV\_10MHz\_DFT-s-OFDM\_PI/2\_BPSK\_3975MHz\_Edge\_1RB\_Right\_Ant1

| Start (MHz) | Stop (MHz) | RBW (MHz) | Method | Marker No. | Freq (MHz) | Level (dBm) | Limit (dBm) | Result |
| 1000 | 3969 | 1 | / | 1 | 3831.350 | -46.94 | -13 | Pass |
| 3985 | 4200 | 1 | / | 2 | 3986.900 | -48.10 | -13 | Pass |
| 4200 | 4400 | 1 | / | 3 | 4264.000 | -48.18 | -30 | Pass |
| 4400 | 26500 | 1 | / | 4 | 26183.800 | -42.55 | -13 | Pass |

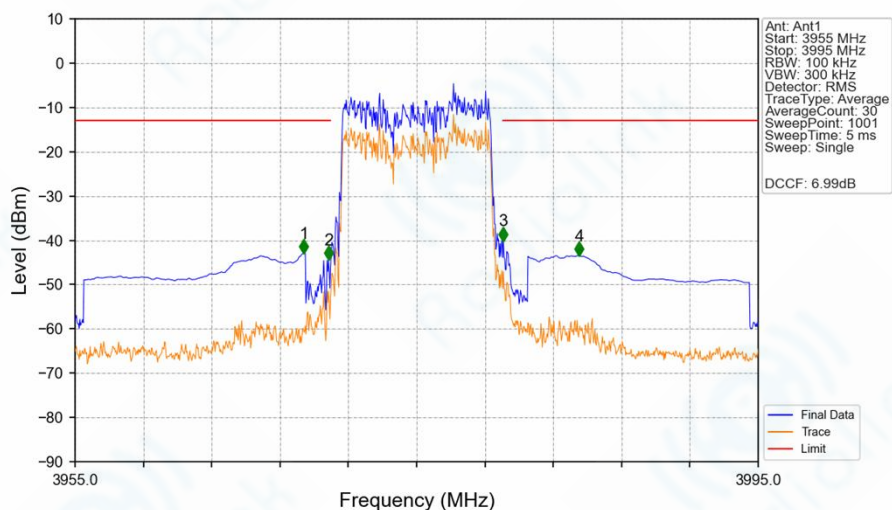
## n77h\_30kHz\_SISO\_NTNV\_10MHz\_DFT-s-OFDM PI/2 BPSK\_3975MHz\_Outer\_Full\_Ant1

| Start (MHz) | Stop (MHz) | RBW (MHz) | Method | Marker No. | Freq (MHz) | Level (dBm) | Limit (dBm) | Result |
| 3955 | 3969 | 1 | CHP | 1 | 3968.400 | -42.95 | -13 | Pass |
| 3969 | 3970 | 0.1 | / | 2 | 3969.840 | -44.48 | -13 | Pass |
| 3980 | 3981 | 0.1 | / | 3 | 3980.080 | -40.13 | -13 | Pass |
| 3981 | 3995 | 1 | CHP | 4 | 3984.520 | -43.46 | -13 | Pass |

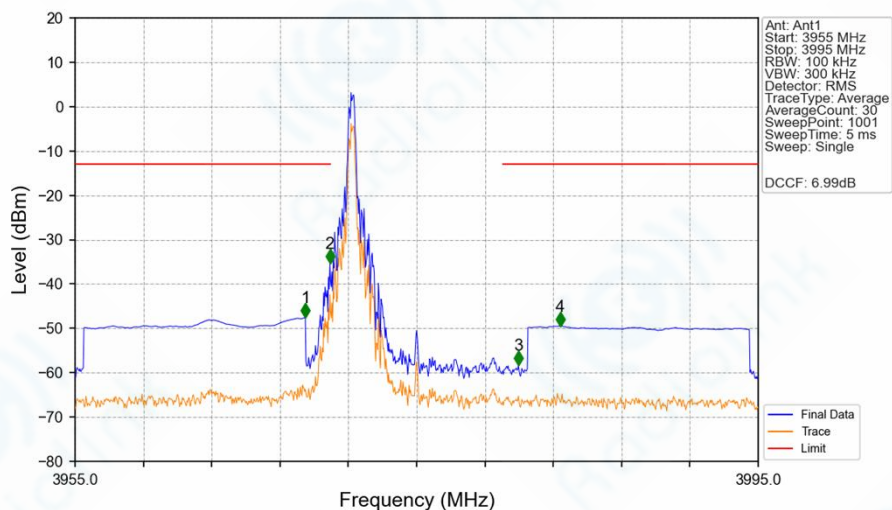
## n77h\_30kHz\_SISO\_NTNV\_10MHz\_DFT-s-OFDM PI/2 BPSK\_3975MHz\_Inner\_1RB\_Left\_Ant1

| Start (MHz) | Stop (MHz) | RBW (MHz) | Method | Marker No. | Freq (MHz) | Level (dBm) | Limit (dBm) | Result |
| 3955 | 3969 | 1 | CHP | 1 | 3968.480 | -47.60 | -13 | Pass |
| 3969 | 3970 | 0.1 | / | 2 | 3969.920 | -35.39 | -13 | Pass |
| 3980 | 3981 | 0.1 | / | 3 | 3980.960 | -58.27 | -13 | Pass |
| 3981 | 3995 | 1 | CHP | 4 | 3983.400 | -49.48 | -13 | Pass |

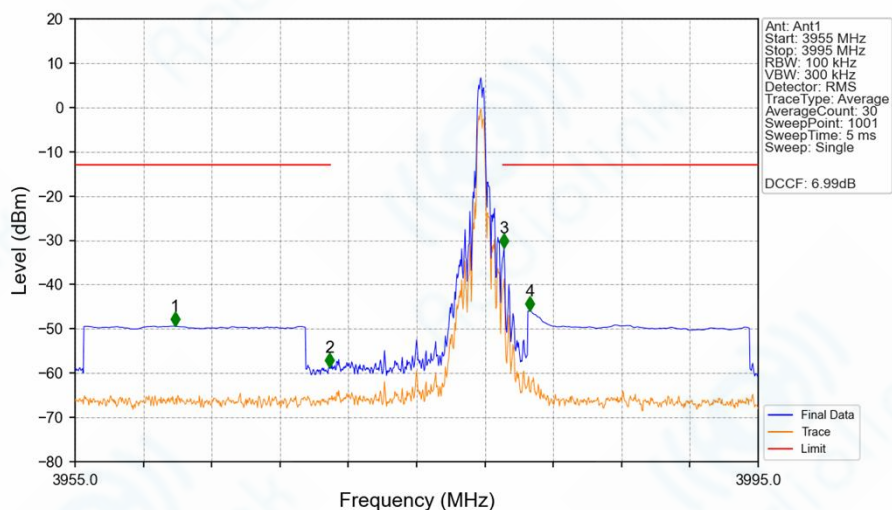
n77h\_30kHz\_SISO\_NTNV\_10MHz\_DFT-s-OFDM\_PI/2\_BPSK\_3975MHz\_Inner\_1RB\_Right\_Ant1

| Start (MHz) | Stop (MHz) | RBW (MHz) | Method | Marker No. | Freq (MHz) | Level (dBm) | Limit (dBm) | Result |
| 3955 | 3969 | 1 | CHP | 1 | 3960.840 | -49.39 | -13 | Pass |
| 3969 | 3970 | 0.1 | / | 2 | 3969.880 | -58.60 | -13 | Pass |
| 3980 | 3981 | 0.1 | / | 3 | 3980.120 | -31.73 | -13 | Pass |
| 3981 | 3995 | 1 | CHP | 4 | 3981.640 | -45.93 | -13 | Pass |

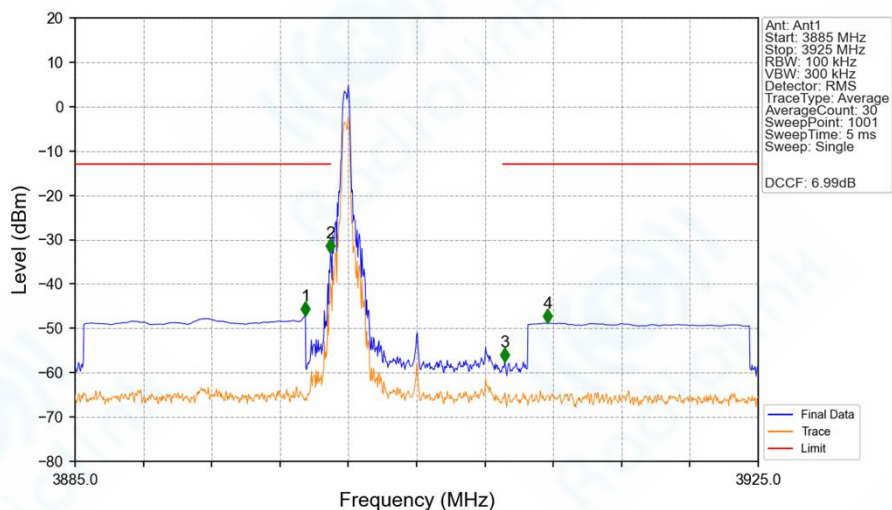
n77h\_30kHz\_SISO\_NTNV\_10MHz\_DFT-s-OFDM\_QPSK\_3905.01MHz\_Edge\_1RB\_Left\_Ant1

| Start (MHz) | Stop (MHz) | RBW (MHz) | Method | Marker No. | Freq (MHz) | Level (dBm) | Limit (dBm) | Result |
| 3885 | 3899 | 1 | CHP | 1 | 3898.480 | -47.11 | -13 | Pass |
| 3899 | 3900 | 0.1 | / | 2 | 3899.960 | -32.97 | -13 | Pass |
| 3910 | 3911 | 0.1 | / | 3 | 3910.160 | -57.54 | -13 | Pass |
| 3911 | 3925 | 1 | CHP | 4 | 3912.680 | -48.80 | -13 | Pass |

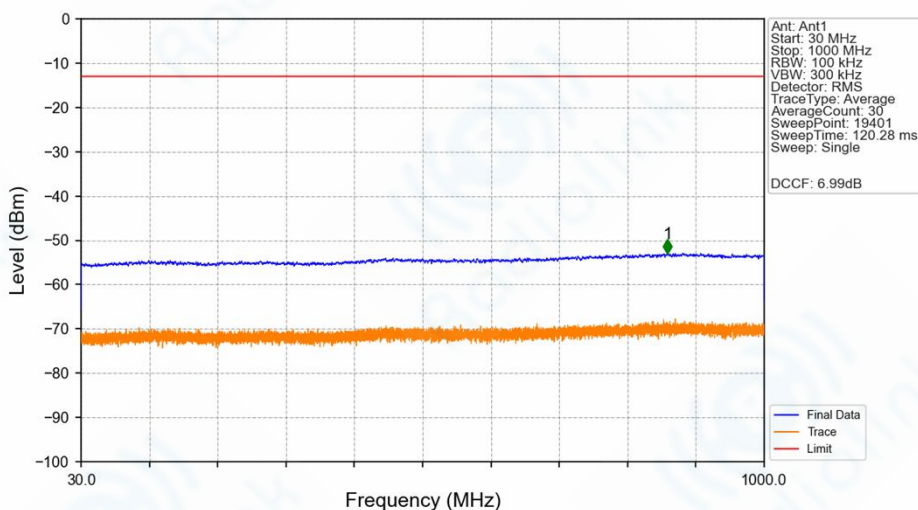
n77h\_30kHz\_SISO\_NTNV\_10MHz\_DFT-s-OFDM\_QPSK\_3905.01MHz\_Edge\_1RB\_Left\_Ant1

| Start (MHz) | Stop (MHz) | RBW (MHz) | Method | Marker No. | Freq (MHz) | Level (dBm) | Limit (dBm) | Result |
| 30 | 1000 | 1 | CHP | 1 | 862.800 | -52.93 | -13 | Pass |

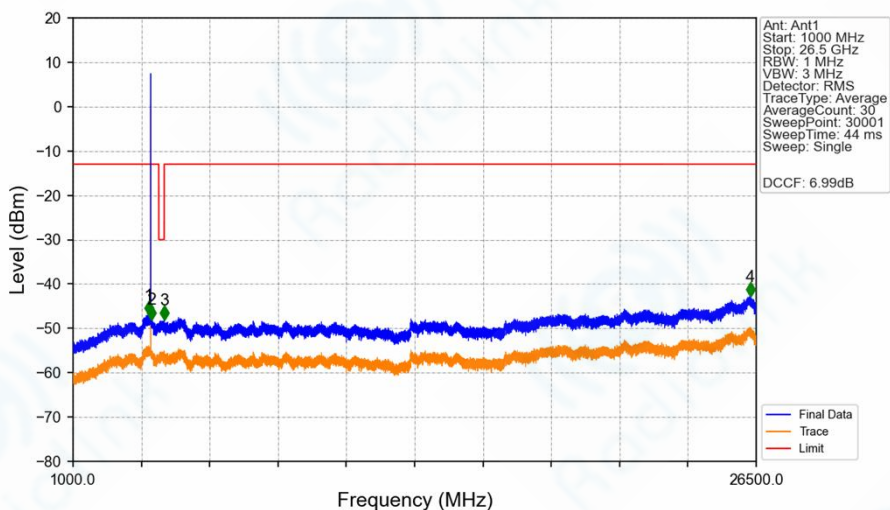
n77h\_30kHz\_SISO\_NTNV\_10MHz\_DFT-s-OFDM\_QPSK\_3905.01MHz\_Edge\_1RB\_Left\_Ant1

| Start (MHz) | Stop (MHz) | RBW (MHz) | Method | Marker No. | Freq (MHz) | Level (dBm) | Limit (dBm) | Result |
| 1000 | 3899 | 1 | / | 1 | 3821.150 | -46.93 | -13 | Pass |
| 3915 | 4200 | 1 | / | 2 | 3917.200 | -47.98 | -13 | Pass |
| 4200 | 4400 | 1 | / | 3 | 4398.300 | -48.10 | -30 | Pass |
| 4400 | 26500 | 1 | / | 4 | 26282.400 | -42.77 | -13 | Pass |

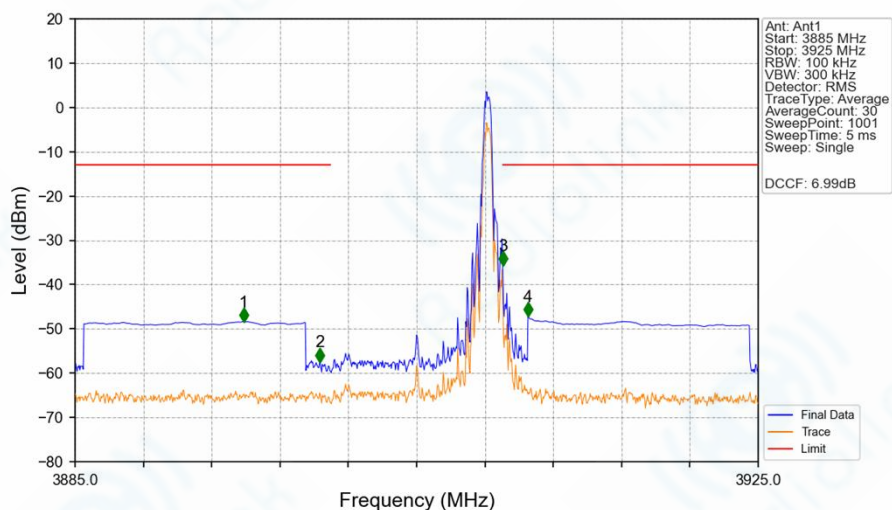
## n77h\_30kHz\_SISO\_NTNV\_10MHz\_DFT-s-OFDM\_QPSK\_3905.01MHz\_Edge\_1RB\_Right\_Ant1

| Start (MHz) | Stop (MHz) | RBW (MHz) | Method | Marker No. | Freq (MHz) | Level (dBm) | Limit (dBm) | Result |
| 3885 | 3899 | 1 | CHP | 1 | 3894.880 | -48.39 | -13 | Pass |
| 3899 | 3900 | 0.1 | / | 2 | 3899.320 | -57.45 | -13 | Pass |
| 3910 | 3911 | 0.1 | / | 3 | 3910.040 | -35.62 | -13 | Pass |
| 3911 | 3925 | 1 | CHP | 4 | 3911.520 | -47.24 | -13 | Pass |

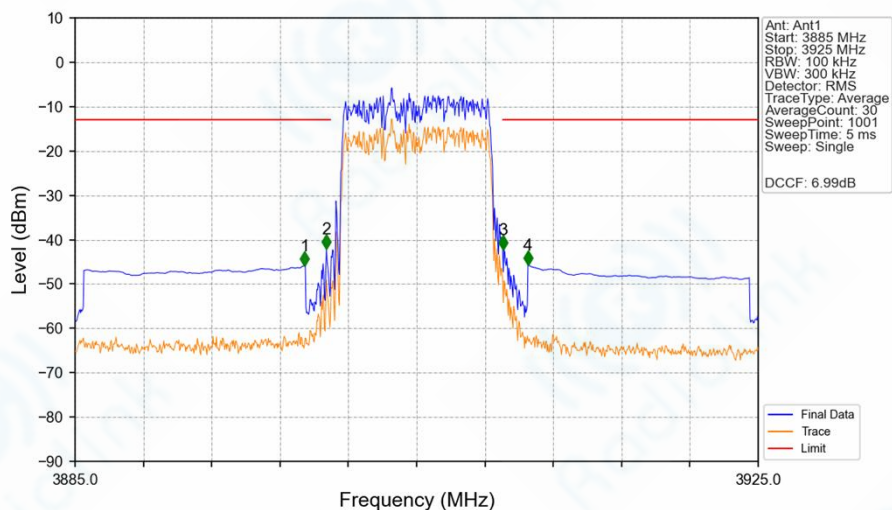
## n77h\_30kHz\_SISO\_NTNV\_10MHz\_DFT-s-OFDM\_QPSK\_3905.01MHz\_Outer\_Full\_Ant1

| Start (MHz) | Stop (MHz) | RBW (MHz) | Method | Marker No. | Freq (MHz) | Level (dBm) | Limit (dBm) | Result |
| 3885 | 3899 | 1 | CHP | 1 | 3898.440 | -45.86 | -13 | Pass |
| 3899 | 3900 | 0.1 | / | 2 | 3899.720 | -42.09 | -13 | Pass |
| 3910 | 3911 | 0.1 | / | 3 | 3910.040 | -42.22 | -13 | Pass |
| 3911 | 3925 | 1 | CHP | 4 | 3911.520 | -45.66 | -13 | Pass |

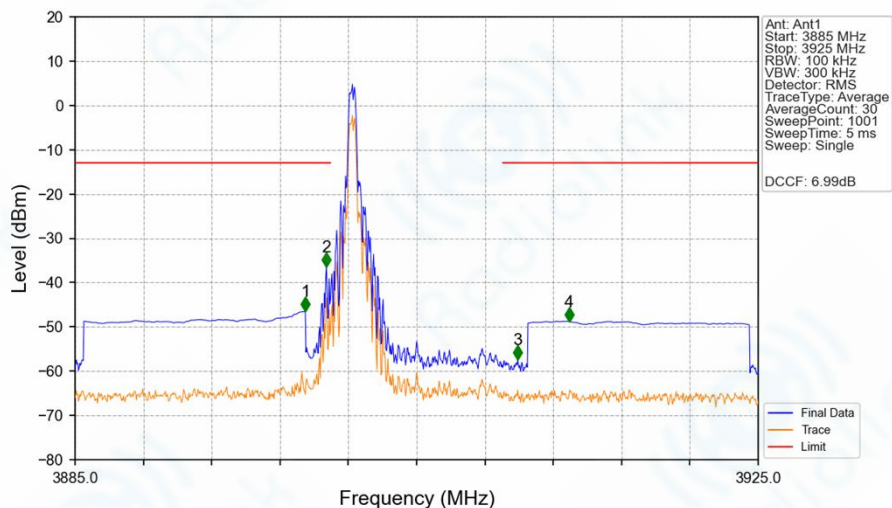
n77h\_30kHz\_SISO\_NTNV\_10MHz\_DFT-s-OFDM\_QPSK\_3905.01MHz\_Inner\_1RB\_Left\_Ant1

| Start (MHz) | Stop (MHz) | RBW (MHz) | Method | Marker No. | Freq (MHz) | Level (dBm) | Limit (dBm) | Result |
| 3885 | 3899 | 1 | CHP | 1 | 3898.480 | -46.50 | -13 | Pass |
| 3899 | 3900 | 0.1 | / | 2 | 3899.720 | -36.43 | -13 | Pass |
| 3910 | 3911 | 0.1 | / | 3 | 3910.920 | -57.31 | -13 | Pass |
| 3911 | 3925 | 1 | CHP | 4 | 3913.920 | -48.72 | -13 | Pass |

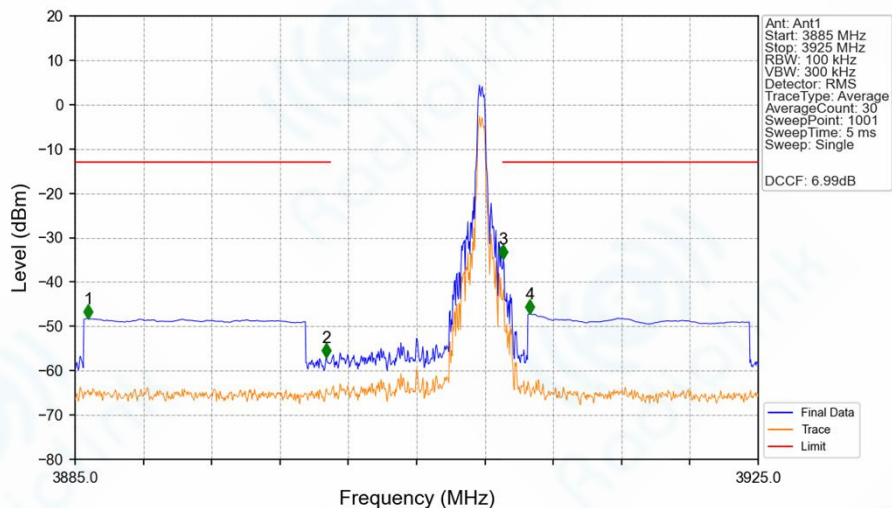
n77h\_30kHz\_SISO\_NTNV\_10MHz\_DFT-s-OFDM\_QPSK\_3905.01MHz\_Inner\_1RB\_Right\_Ant1

| Start (MHz) | Stop (MHz) | RBW (MHz) | Method | Marker No. | Freq (MHz) | Level (dBm) | Limit (dBm) | Result |
| 3885 | 3899 | 1 | CHP | 1 | 3885.760 | -48.21 | -13 | Pass |
| 3899 | 3900 | 0.1 | / | 2 | 3899.720 | -57.01 | -13 | Pass |
| 3910 | 3911 | 0.1 | / | 3 | 3910.080 | -34.69 | -13 | Pass |
| 3911 | 3925 | 1 | CHP | 4 | 3911.640 | -47.16 | -13 | Pass |

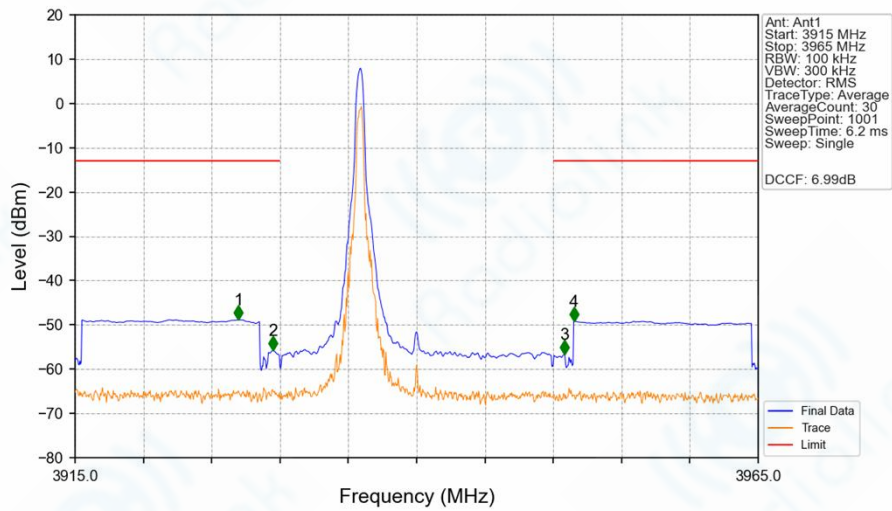
n77h\_30kHz\_SISO\_NTNV\_10MHz\_DFT-s-OFDM\_QPSK\_3939.99MHz\_Edge\_1RB\_Left\_Ant1

| Start (MHz) | Stop (MHz) | RBW (MHz) | Method | Marker No. | Freq (MHz) | Level (dBm) | Limit (dBm) | Result |
| 3915 | 3929 | 1 | CHP | 1 | 3926.950 | -48.87 | -13 | Pass |
| 3929 | 3930 | 0.2 | CHP | 2 | 3929.500 | -55.69 | -13 | Pass |
| 3950 | 3951 | 0.2 | CHP | 3 | 3950.800 | -56.68 | -13 | Pass |
| 3951 | 3965 | 1 | CHP | 4 | 3951.500 | -49.09 | -13 | Pass |

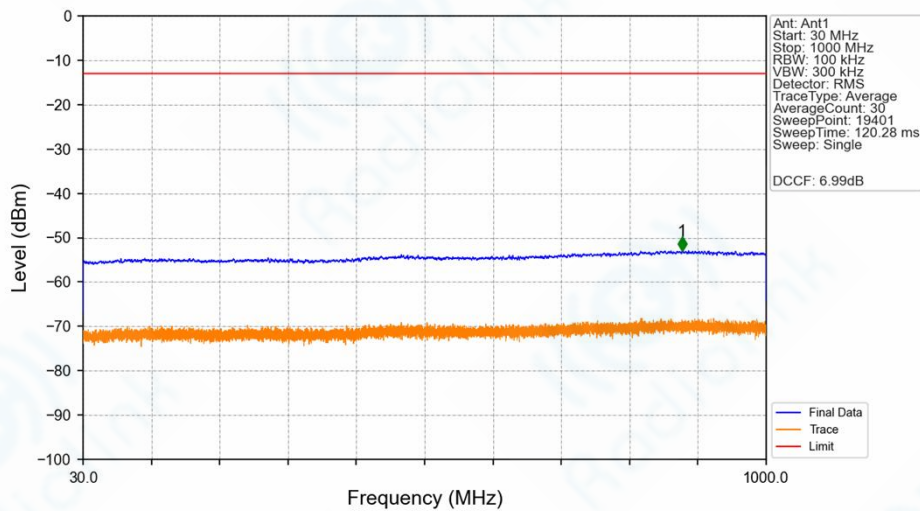
n77h\_30kHz\_SISO\_NTNV\_10MHz\_DFT-s-OFDM\_QPSK\_3939.99MHz\_Edge\_1RB\_Left\_Ant1

| Start (MHz) | Stop (MHz) | RBW (MHz) | Method | Marker No. | Freq (MHz) | Level (dBm) | Limit (dBm) | Result |
| 30 | 1000 | 1 | CHP | 1 | 880.600 | -52.91 | -13 | Pass |

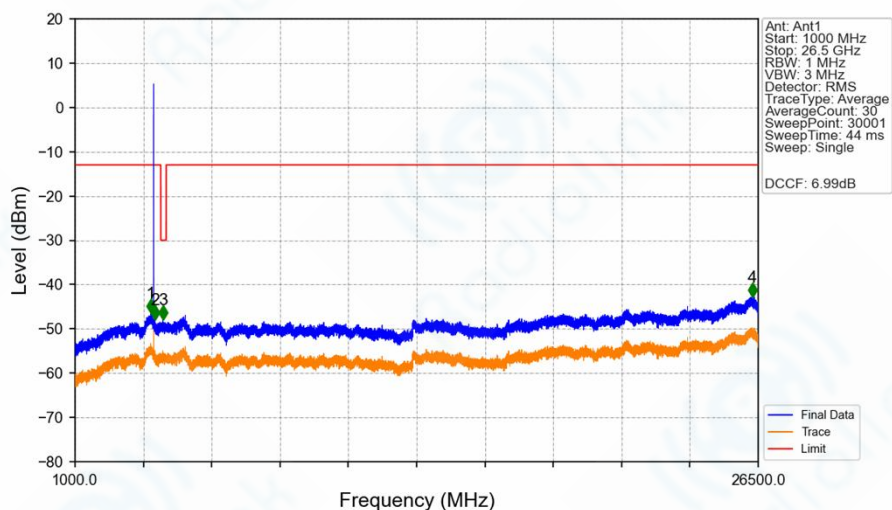
## n77h\_30kHz\_SISO\_NTNV\_10MHz\_DFT-s-OFDM\_QPSK\_3939.99MHz\_Edge\_1RB\_Left\_Ant1

| Start (MHz) | Stop (MHz) | RBW (MHz) | Method | Marker No. | Freq (MHz) | Level (dBm) | Limit (dBm) | Result |
| 1000 | 3929 | 1 | / | 1 | 3822.850 | -46.36 | -13 | Pass |
| 3955 | 4200 | 1 | / | 2 | 3976.700 | -47.85 | -13 | Pass |
| 4200 | 4400 | 1 | / | 3 | 4271.650 | -47.89 | -30 | Pass |
| 4400 | 26500 | 1 | / | 4 | 26279.000 | -42.75 | -13 | Pass |

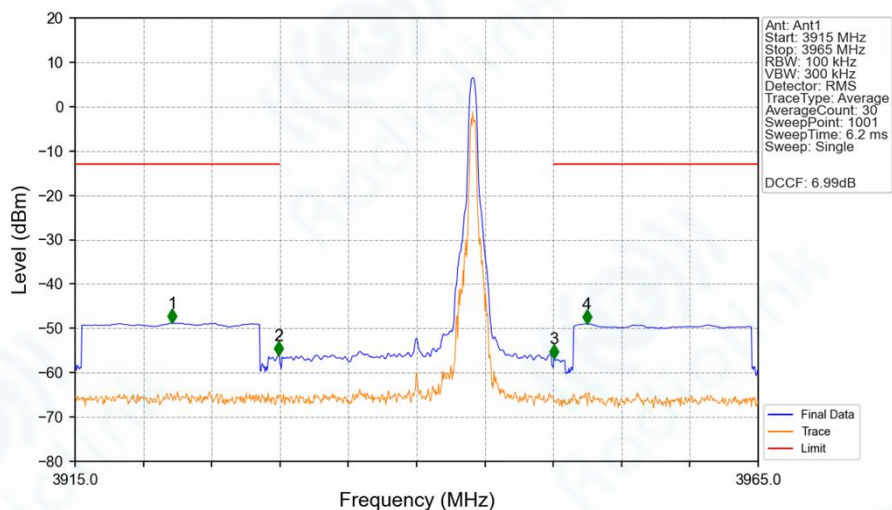
## n77h\_30kHz\_SISO\_NTNV\_10MHz\_DFT-s-OFDM\_QPSK\_3939.99MHz\_Edge\_1RB\_Right\_Ant1

| Start (MHz) | Stop (MHz) | RBW (MHz) | Method | Marker No. | Freq (MHz) | Level (dBm) | Limit (dBm) | Result |
| 3915 | 3929 | 1 | CHP | 1 | 3922.100 | -48.77 | -13 | Pass |
| 3929 | 3930 | 0.2 | CHP | 2 | 3929.900 | -56.04 | -13 | Pass |
| 3950 | 3951 | 0.2 | CHP | 3 | 3950.050 | -56.89 | -13 | Pass |
| 3951 | 3965 | 1 | CHP | 4 | 3952.450 | -48.96 | -13 | Pass |

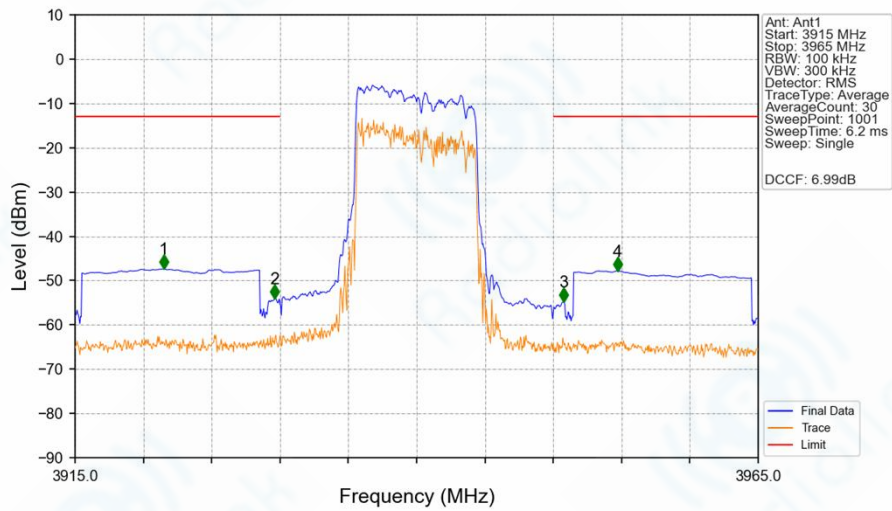
## n77h\_30kHz\_SISO\_NTNV\_10MHz\_DFT-s-OFDM\_QPSK\_3939.99MHz\_Outer\_Full\_Ant1

| Start (MHz) | Stop (MHz) | RBW (MHz) | Method | Marker No. | Freq (MHz) | Level (dBm) | Limit (dBm) | Result |
| 3915 | 3929 | 1 | CHP | 1 | 3921.500 | -47.38 | -13 | Pass |
| 3929 | 3930 | 0.2 | CHP | 2 | 3929.600 | -54.04 | -13 | Pass |
| 3950 | 3951 | 0.2 | CHP | 3 | 3950.750 | -54.71 | -13 | Pass |
| 3951 | 3965 | 1 | CHP | 4 | 3954.700 | -47.80 | -13 | Pass |

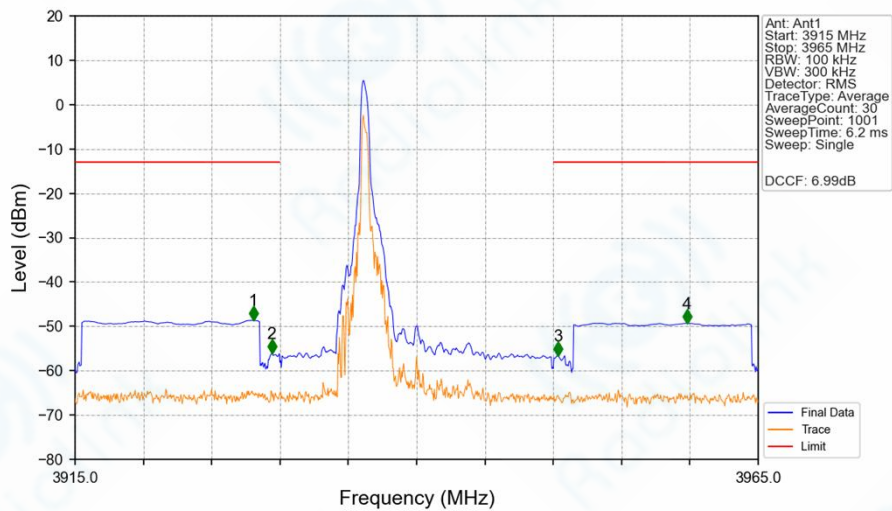
## n77h\_30kHz\_SISO\_NTNV\_10MHz\_DFT-s-OFDM\_QPSK\_3939.99MHz\_Inner\_1RB\_Left\_Ant1

| Start (MHz) | Stop (MHz) | RBW (MHz) | Method | Marker No. | Freq (MHz) | Level (dBm) | Limit (dBm) | Result |
| 3915 | 3929 | 1 | CHP | 1 | 3928.050 | -48.63 | -13 | Pass |
| 3929 | 3930 | 0.2 | CHP | 2 | 3929.400 | -56.02 | -13 | Pass |
| 3950 | 3951 | 0.2 | CHP | 3 | 3950.350 | -56.61 | -13 | Pass |
| 3951 | 3965 | 1 | CHP | 4 | 3959.800 | -49.27 | -13 | Pass |

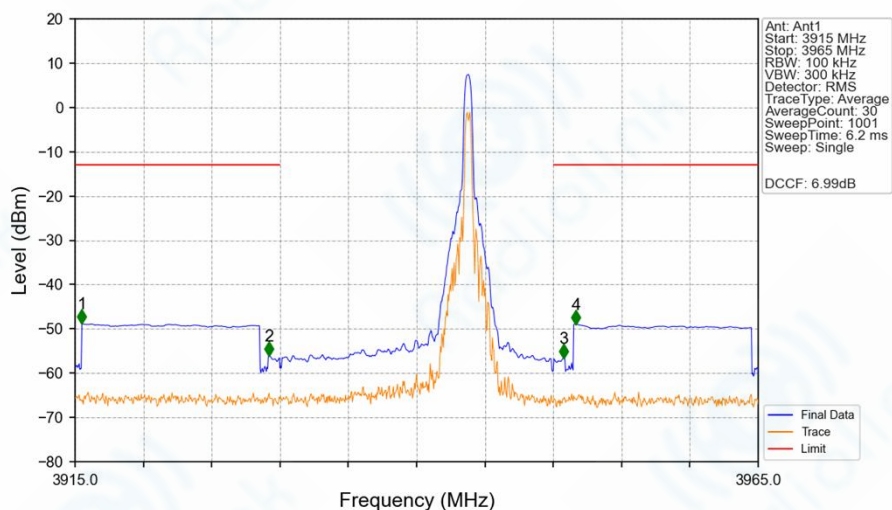
## n77h\_30kHz\_SISO\_NTNV\_10MHz\_DFT-s-OFDM\_QPSK\_3939.99MHz\_Inner\_1RB\_Right\_Ant1

| Start (MHz) | Stop (MHz) | RBW (MHz) | Method | Marker No. | Freq (MHz) | Level (dBm) | Limit (dBm) | Result |
| 3915 | 3929 | 1 | CHP | 1 | 3915.500 | -48.87 | -13 | Pass |
| 3929 | 3930 | 0.2 | CHP | 2 | 3929.200 | -56.01 | -13 | Pass |
| 3950 | 3951 | 0.2 | CHP | 3 | 3950.750 | -56.56 | -13 | Pass |
| 3951 | 3965 | 1 | CHP | 4 | 3951.650 | -48.93 | -13 | Pass |

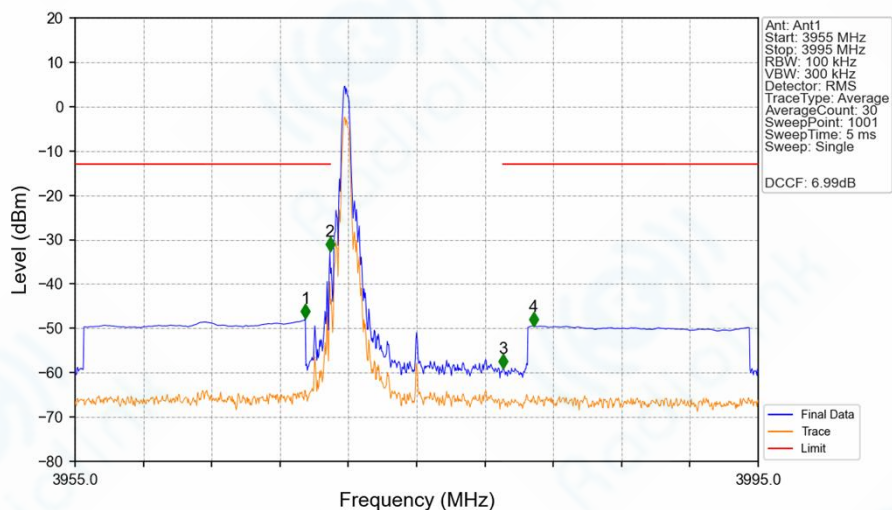
## n77h\_30kHz\_SISO\_NTNV\_10MHz\_DFT-s-OFDM\_QPSK\_3975MHz\_Edge\_1RB\_Left\_Ant1

| Start (MHz) | Stop (MHz) | RBW (MHz) | Method | Marker No. | Freq (MHz) | Level (dBm) | Limit (dBm) | Result |
| 3955 | 3969 | 1 | CHP | 1 | 3968.480 | -47.78 | -13 | Pass |
| 3969 | 3970 | 0.1 | / | 2 | 3969.920 | -32.57 | -13 | Pass |
| 3980 | 3981 | 0.1 | / | 3 | 3980.080 | -58.94 | -13 | Pass |
| 3981 | 3995 | 1 | CHP | 4 | 3981.840 | -49.44 | -13 | Pass |

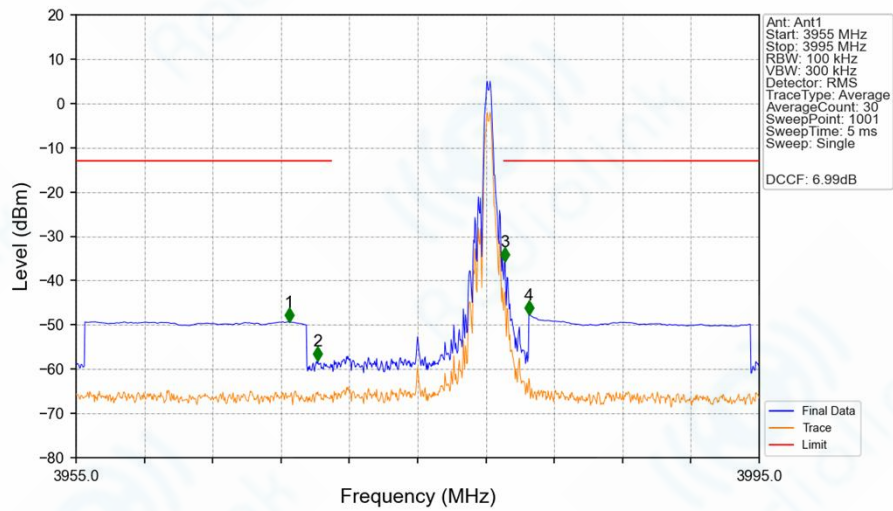
## n77h\_30kHz\_SISO\_NTNV\_10MHz\_DFT-s-OFDM\_QPSK\_3975MHz\_Edge\_1RB\_Right\_Ant1

| Start (MHz) | Stop (MHz) | RBW (MHz) | Method | Marker No. | Freq (MHz) | Level (dBm) | Limit (dBm) | Result |
| 3955 | 3969 | 1 | CHP | 1 | 3967.480 | -49.32 | -13 | Pass |
| 3969 | 3970 | 0.1 | / | 2 | 3969.160 | -58.11 | -13 | Pass |
| 3980 | 3981 | 0.1 | / | 3 | 3980.120 | -35.61 | -13 | Pass |
| 3981 | 3995 | 1 | CHP | 4 | 3981.520 | -47.64 | -13 | Pass |

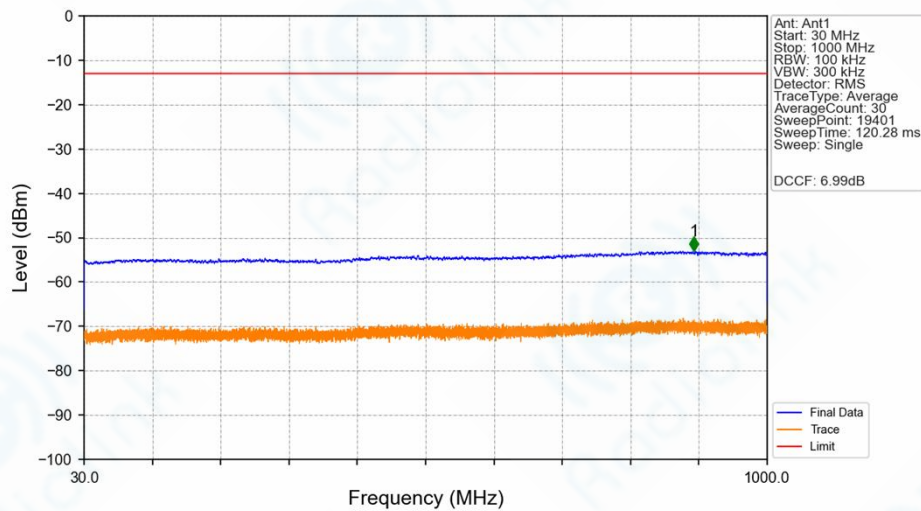
## n77h\_30kHz\_SISO\_NTNV\_10MHz\_DFT-s-OFDM\_QPSK\_3975MHz\_Edge\_1RB\_Right\_Ant1

| Start (MHz) | Stop (MHz) | RBW (MHz) | Method | Marker No. | Freq (MHz) | Level (dBm) | Limit (dBm) | Result |
| 30 | 1000 | 1 | CHP | 1 | 896.200 | -53.02 | -13 | Pass |

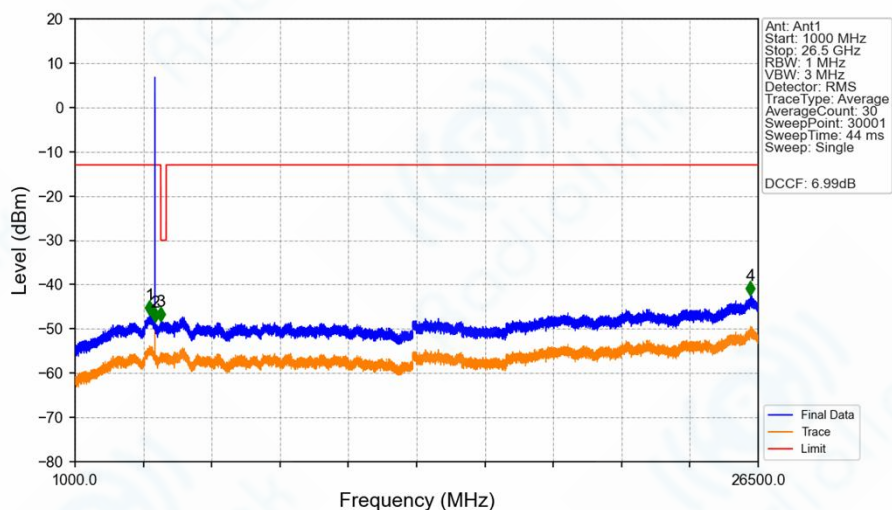
## n77h\_30kHz\_SISO\_NTNV\_10MHz\_DFT-s-OFDM\_QPSK\_3975MHz\_Edge\_1RB\_Right\_Ant1

| Start (MHz) | Stop (MHz) | RBW (MHz) | Method | Marker No. | Freq (MHz) | Level (dBm) | Limit (dBm) | Result |
| 1000 | 3969 | 1 | / | 1 | 3781.200 | -46.77 | -13 | Pass |
| 3985 | 4200 | 1 | / | 2 | 3998.800 | -48.48 | -13 | Pass |
| 4200 | 4400 | 1 | / | 3 | 4205.350 | -48.31 | -30 | Pass |
| 4400 | 26500 | 1 | / | 4 | 26211.850 | -42.39 | -13 | Pass |

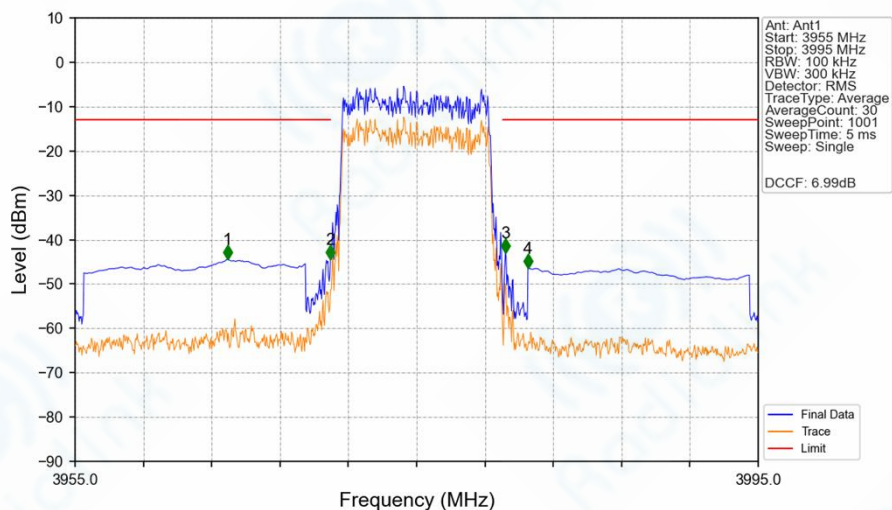
## n77h\_30kHz\_SISO\_NTNV\_10MHz\_DFT-s-OFDM\_QPSK\_3975MHz\_Outer\_Full\_Ant1

| Start (MHz) | Stop (MHz) | RBW (MHz) | Method | Marker No. | Freq (MHz) | Level (dBm) | Limit (dBm) | Result |
| 3955 | 3969 | 1 | CHP | 1 | 3963.920 | -44.47 | -13 | Pass |
| 3969 | 3970 | 0.1 | / | 2 | 3969.960 | -44.34 | -13 | Pass |
| 3980 | 3981 | 0.1 | / | 3 | 3980.200 | -42.91 | -13 | Pass |
| 3981 | 3995 | 1 | CHP | 4 | 3981.520 | -46.39 | -13 | Pass |

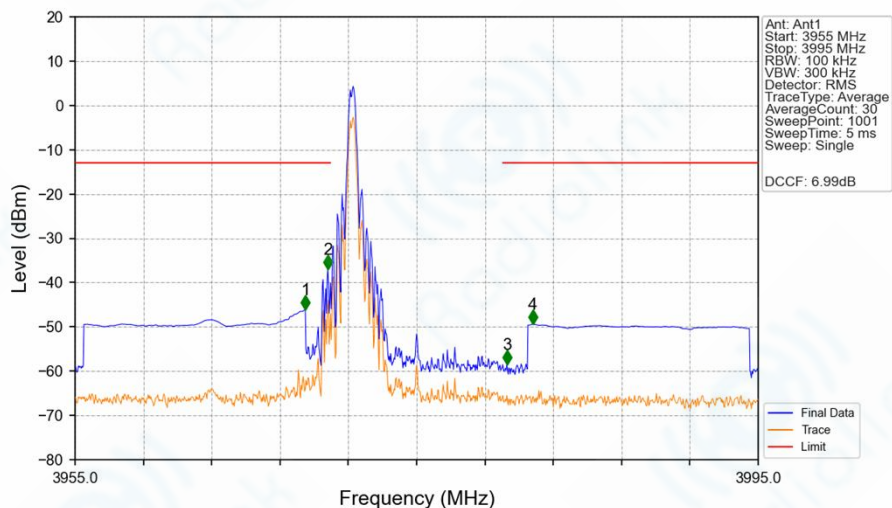
## n77h\_30kHz\_SISO\_NTNV\_10MHz\_DFT-s-OFDM\_QPSK\_3975MHz\_Inner\_1RB\_Left\_Ant1

| Start (MHz) | Stop (MHz) | RBW (MHz) | Method | Marker No. | Freq (MHz) | Level (dBm) | Limit (dBm) | Result |
| 3955 | 3969 | 1 | CHP | 1 | 3968.480 | -46.11 | -13 | Pass |
| 3981 | 3995 | 1 | CHP | 4 | 3981.800 | -49.36 | -13 | Pass |

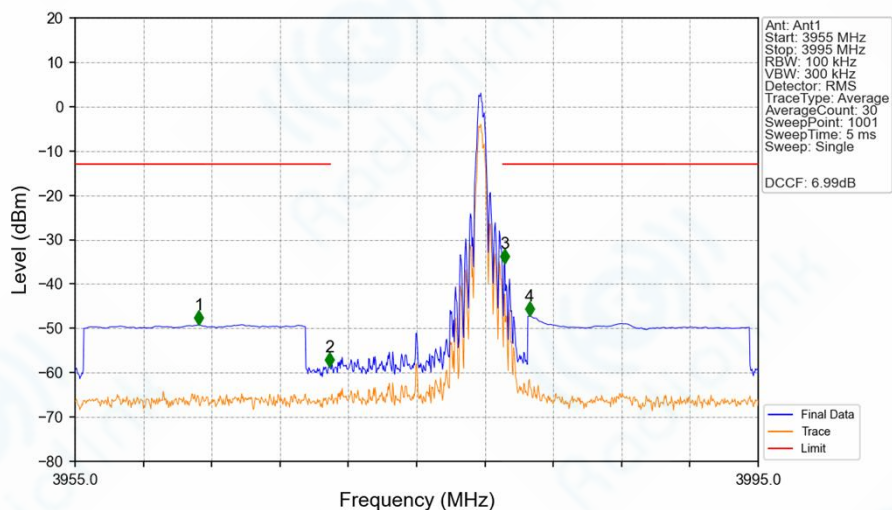
## n77h\_30kHz\_SISO\_NTNV\_10MHz\_DFT-s-OFDM\_QPSK\_3975MHz\_Inner\_1RB\_Right\_Ant1

| Start (MHz) | Stop (MHz) | RBW (MHz) | Method | Marker No. | Freq (MHz) | Level (dBm) | Limit (dBm) | Result |
| 3955 | 3969 | 1 | CHP | 1 | 3962.240 | -49.18 | -13 | Pass |

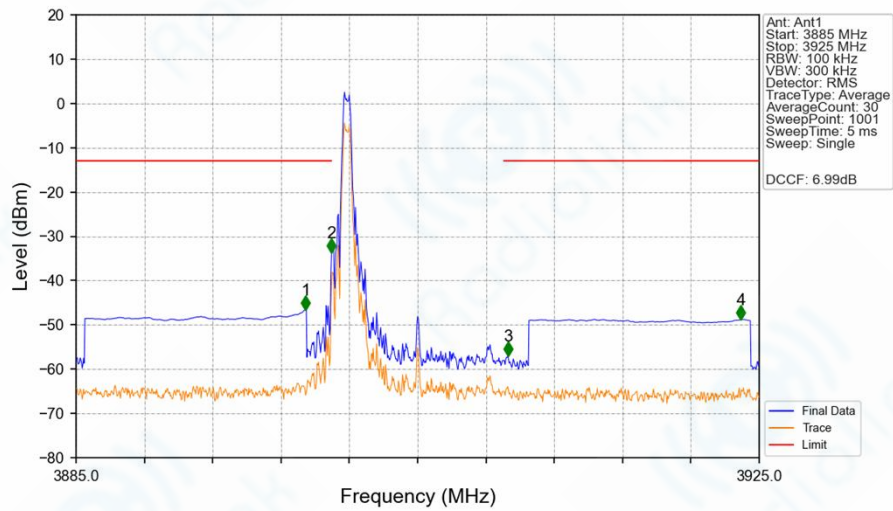
## n77h\_30kHz\_SISO\_NTNV\_10MHz\_CP-OFDM\_QPSK\_3905.01MHz\_Edge\_1RB\_Left\_Ant1

| Start (MHz) | Stop (MHz) | RBW (MHz) | Method | Marker No. | Freq (MHz) | Level (dBm) | Limit (dBm) | Result |
| 3885 | 3899 | 1 | CHP | 1 | 3898.440 | -46.57 | -13 | Pass |
| 3911 | 3925 | 1 | CHP | 4 | 3923.920 | -48.77 | -13 | Pass |

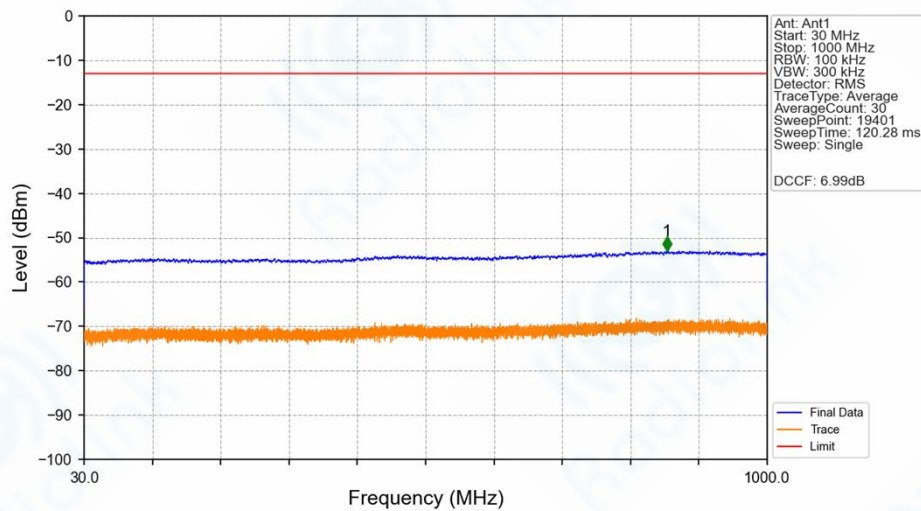
## n77h\_30kHz\_SISO\_NTNV\_10MHz\_CP-OFDM\_QPSK\_3905.01MHz\_Edge\_1RB\_Left\_Ant1

| Start (MHz) | Stop (MHz) | RBW (MHz) | Method | Marker No. | Freq (MHz) | Level (dBm) | Limit (dBm) | Result |
| 30 | 1000 | 1 | CHP | 1 | 857.850 | -52.98 | -13 | Pass |

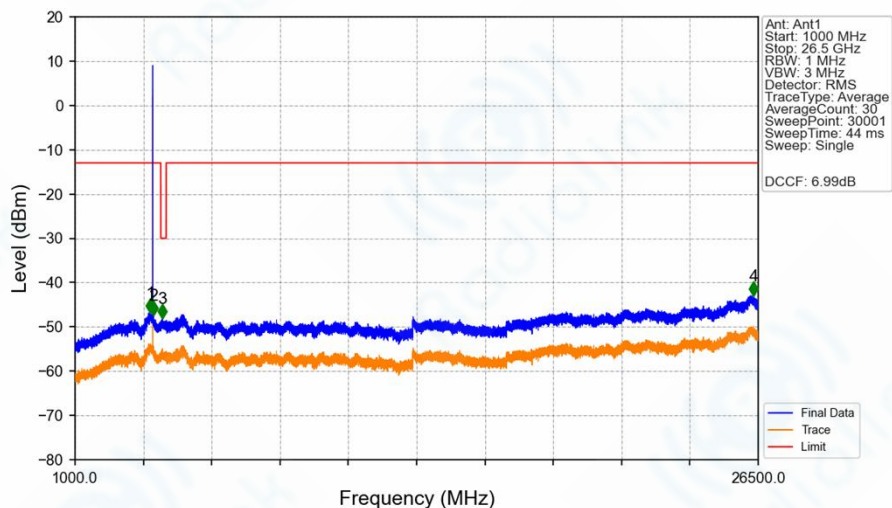
## n77h\_30kHz\_SISO\_NTNV\_10MHz\_CP-OFDM\_QPSK\_3905.01MHz\_Edge\_1RB\_Left\_Ant1

| Start (MHz) | Stop (MHz) | RBW (MHz) | Method | Marker No. | Freq (MHz) | Level (dBm) | Limit (dBm) | Result |
| 1000 | 3899 | 1 | / | 1 | 3810.100 | -46.80 | -13 | Pass |
| 4400 | 26500 | 1 | / | 4 | 26328.300 | -42.89 | -13 | Pass |

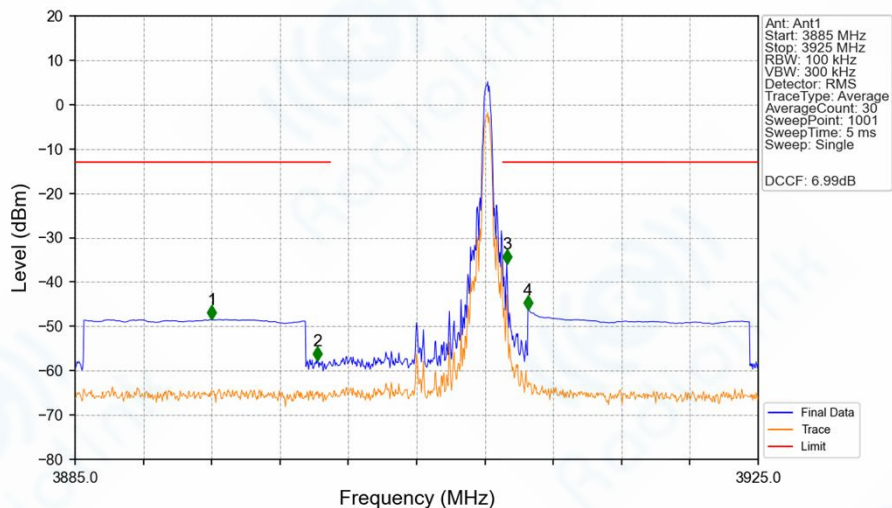
## n77h\_30kHz\_SISO\_NTNV\_10MHz\_CP-OFDM\_QPSK\_3905.01MHz\_Edge\_1RB\_Right\_Ant1

| Start (MHz) | Stop (MHz) | RBW (MHz) | Method | Marker No. | Freq (MHz) | Level (dBm) | Limit (dBm) | Result |
| 3885 | 3899 | 1 | CHP | 1 | 3893.000 | -48.46 | -13 | Pass |

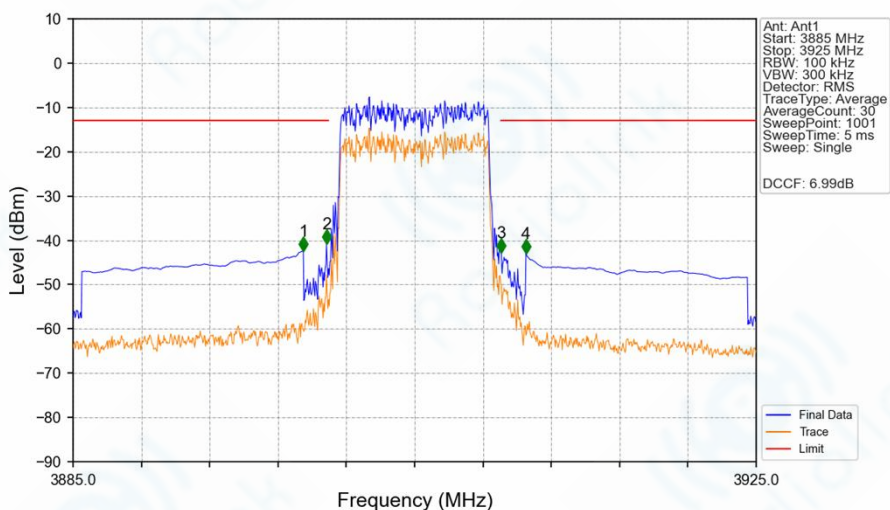
## n77h\_30kHz\_SISO\_NTNV\_10MHz\_CP-OFDM\_QPSK\_3905.01MHz\_Outer\_Full\_Ant1

| Start (MHz) | Stop (MHz) | RBW (MHz) | Method | Marker No. | Freq (MHz) | Level (dBm) | Limit (dBm) | Result |
| 3885 | 3899 | 1 | CHP | 1 | 3898.480 | -42.44 | -13 | Pass |
| 3911 | 3925 | 1 | CHP | 4 | 3911.520 | -42.92 | -13 | Pass |

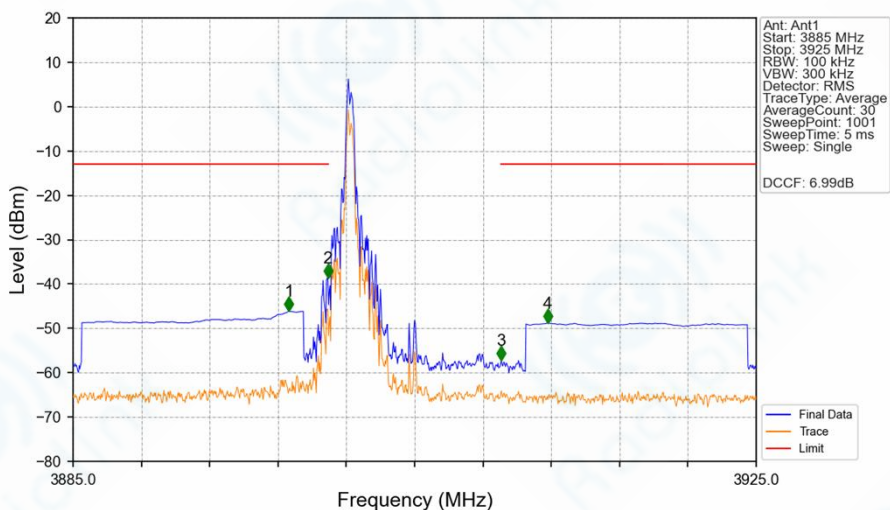
## n77h\_30kHz\_SISO\_NTNV\_10MHz\_CP-OFDM\_QPSK\_3905.01MHz\_Inner\_1RB\_Left\_Ant1

| Start (MHz) | Stop (MHz) | RBW (MHz) | Method | Marker No. | Freq (MHz) | Level (dBm) | Limit (dBm) | Result |
| 3885 | 3899 | 1 | CHP | 1 | 3897.640 | -46.04 | -13 | Pass |
| 3911 | 3925 | 1 | CHP | 4 | 3912.800 | -48.79 | -13 | Pass |
