n77h\_30kHz\_SISO\_NTNV\_10MHz\_DFT-s-OFDM\_PI/2\_BPSK\_3905.01MHz\_Inner\_1RB\_Right\_Ant1

Radiolink Testing (Shenzhen) Co., Ltd.

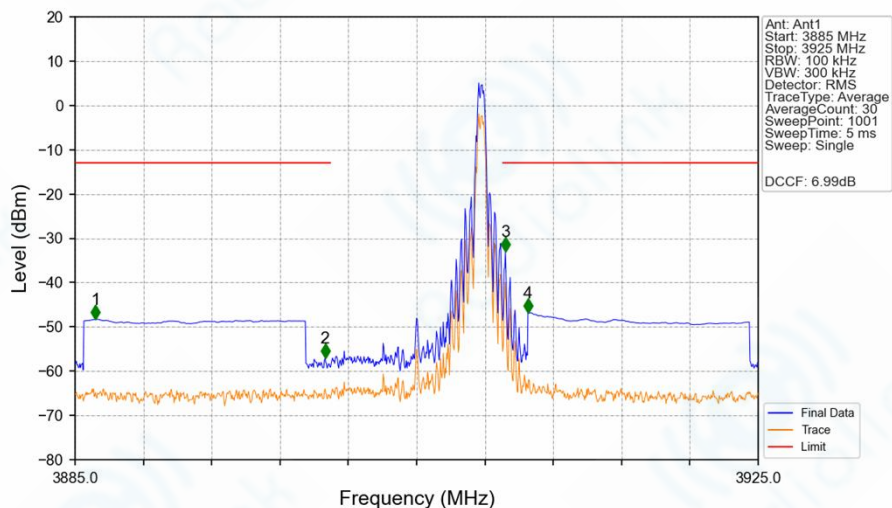
## n77h\_30kHz\_SISO\_NTNV\_10MHz\_CP-OFDM\_QPSK\_3905.01MHz\_Inner\_1RB\_Right\_Ant1

| Start (MHz) | Stop (MHz) | RBW (MHz) | Method | Marker No. | Freq (MHz) | Level (dBm) | Limit (dBm) | Result |
| 3885 | 3899 | 1 | CHP | 1 | 3886.200 | -48.29 | -13 | Pass |
| 3911 | 3925 | 1 | CHP | 4 | 3911.520 | -46.75 | -13 | Pass |

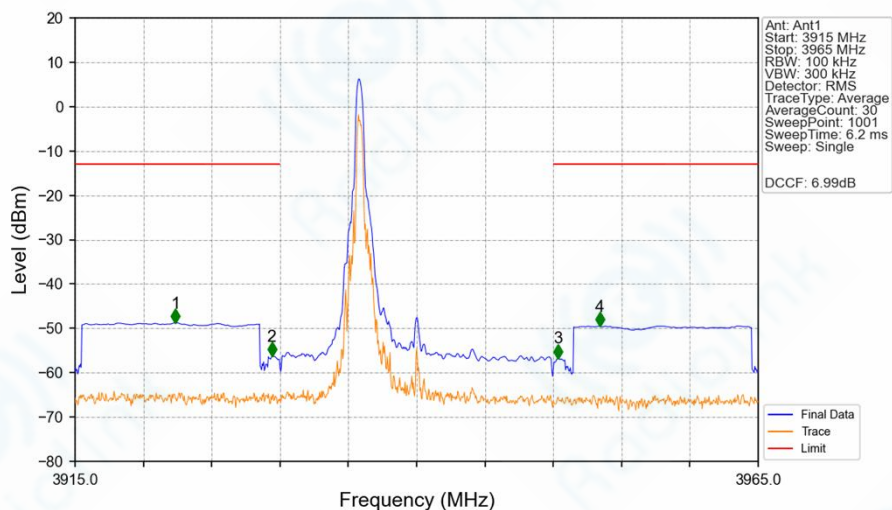
## n77h\_30kHz\_SISO\_NTNV\_10MHz\_CP-OFDM\_QPSK\_3939.99MHz\_Edge\_1RB\_Left\_Ant1

| Start (MHz) | Stop (MHz) | RBW (MHz) | Method | Marker No. | Freq (MHz) | Level (dBm) | Limit (dBm) | Result |
| 3915 | 3929 | 1 | CHP | 1 | 3922.350 | -48.72 | -13 | Pass |

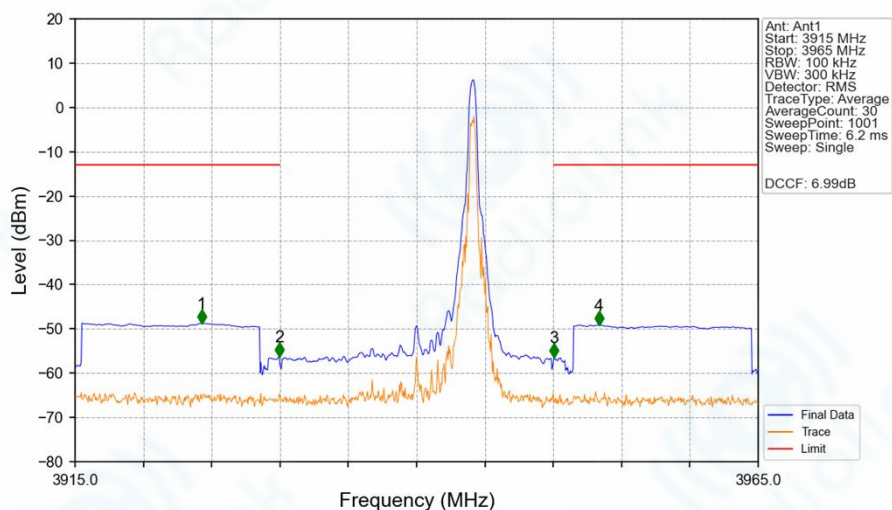
## n77h\_30kHz\_SISO\_NTNV\_10MHz\_CP-OFDM\_QPSK\_3939.99MHz\_Edge\_1RB\_Right\_Ant1

| Start (MHz) | Stop (MHz) | RBW (MHz) | Method | Marker No. | Freq (MHz) | Level (dBm) | Limit (dBm) | Result |
| 3915 | 3929 | 1 | CHP | 1 | 3924.250 | -48.75 | -13 | Pass |
| 3951 | 3965 | 1 | CHP | 4 | 3953.350 | -49.10 | -13 | Pass |

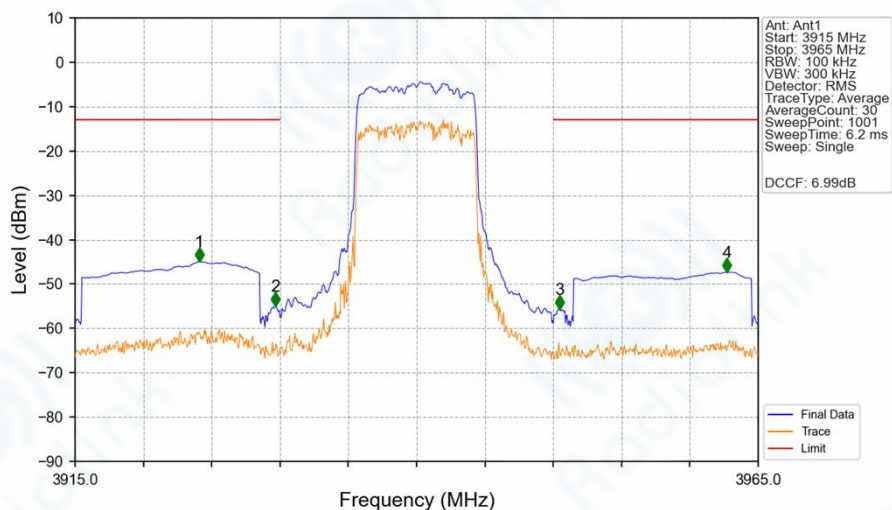
## n77h\_30kHz\_SISO\_NTNV\_10MHz\_CP-OFDM\_QPSK\_3939.99MHz\_Outer\_Full\_Ant1

| Start (MHz) | Stop (MHz) | RBW (MHz) | Method | Marker No. | Freq (MHz) | Level (dBm) | Limit (dBm) | Result |
| 3915 | 3929 | 1 | CHP | 1 | 3924.100 | -44.97 | -13 | Pass |

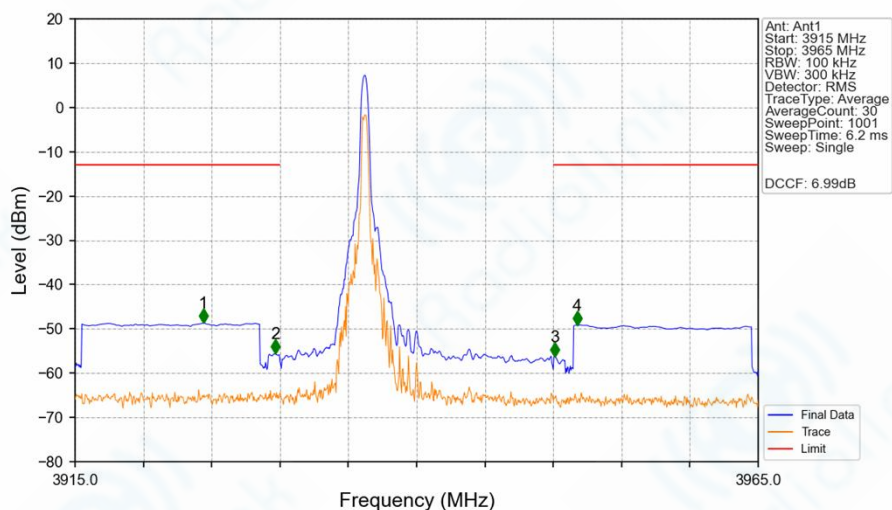
## n77h\_30kHz\_SISO\_NTNV\_10MHz\_CP-OFDM\_QPSK\_3939.99MHz\_Inner\_1RB\_Left\_Ant1

| Start (MHz) | Stop (MHz) | RBW (MHz) | Method | Marker No. | Freq (MHz) | Level (dBm) | Limit (dBm) | Result |
| 3915 | 3929 | 1 | CHP | 1 | 3924.400 | -48.69 | -13 | Pass |
| 3951 | 3965 | 1 | CHP | 4 | 3951.750 | -49.13 | -13 | Pass |

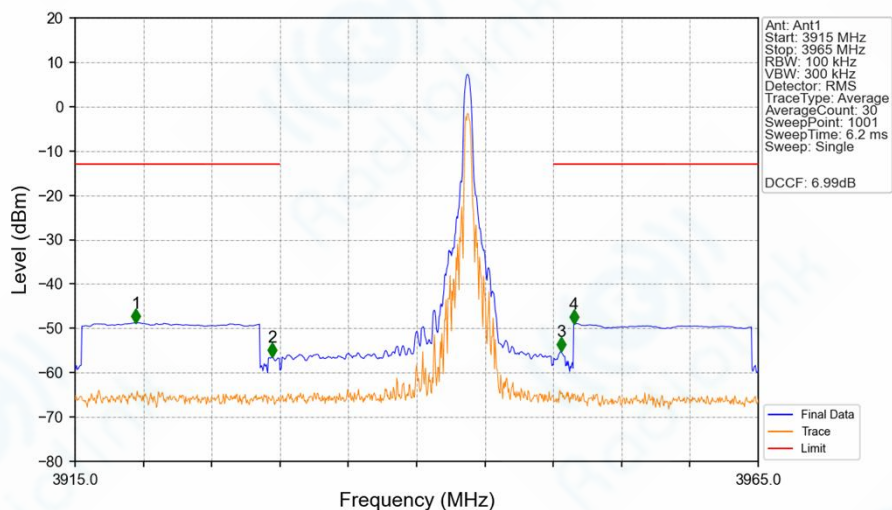
## n77h\_30kHz\_SISO\_NTNV\_10MHz\_CP-OFDM\_QPSK\_3939.99MHz\_Inner\_1RB\_Right\_Ant1

| Start (MHz) | Stop (MHz) | RBW (MHz) | Method | Marker No. | Freq (MHz) | Level (dBm) | Limit (dBm) | Result |
| 3915 | 3929 | 1 | CHP | 1 | 3919.450 | -48.76 | -13 | Pass |

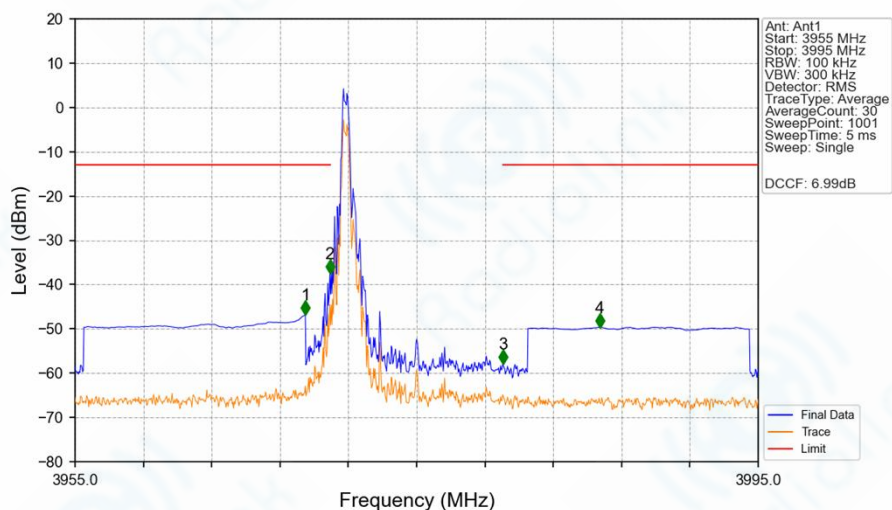
## n77h\_30kHz\_SISO\_NTNV\_10MHz\_CP-OFDM\_QPSK\_3975MHz\_Edge\_1RB\_Left\_Ant1

| Start (MHz) | Stop (MHz) | RBW (MHz) | Method | Marker No. | Freq (MHz) | Level (dBm) | Limit (dBm) | Result |
| 3955 | 3969 | 1 | CHP | 1 | 3968.480 | -46.83 | -13 | Pass |
| 3981 | 3995 | 1 | CHP | 4 | 3985.720 | -49.63 | -13 | Pass |

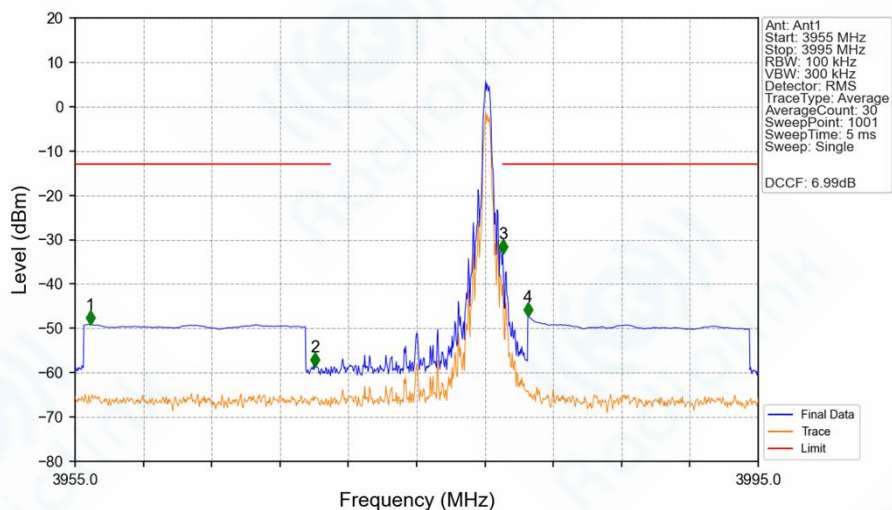
## n77h\_30kHz\_SISO\_NTNV\_10MHz\_CP-OFDM\_QPSK\_3975MHz\_Edge\_1RB\_Right\_Ant1

| Start (MHz) | Stop (MHz) | RBW (MHz) | Method | Marker No. | Freq (MHz) | Level (dBm) | Limit (dBm) | Result |
| 3955 | 3969 | 1 | CHP | 1 | 3955.880 | -49.09 | -13 | Pass |
