#### Band Edge

### Conducted RF Spurious Emission

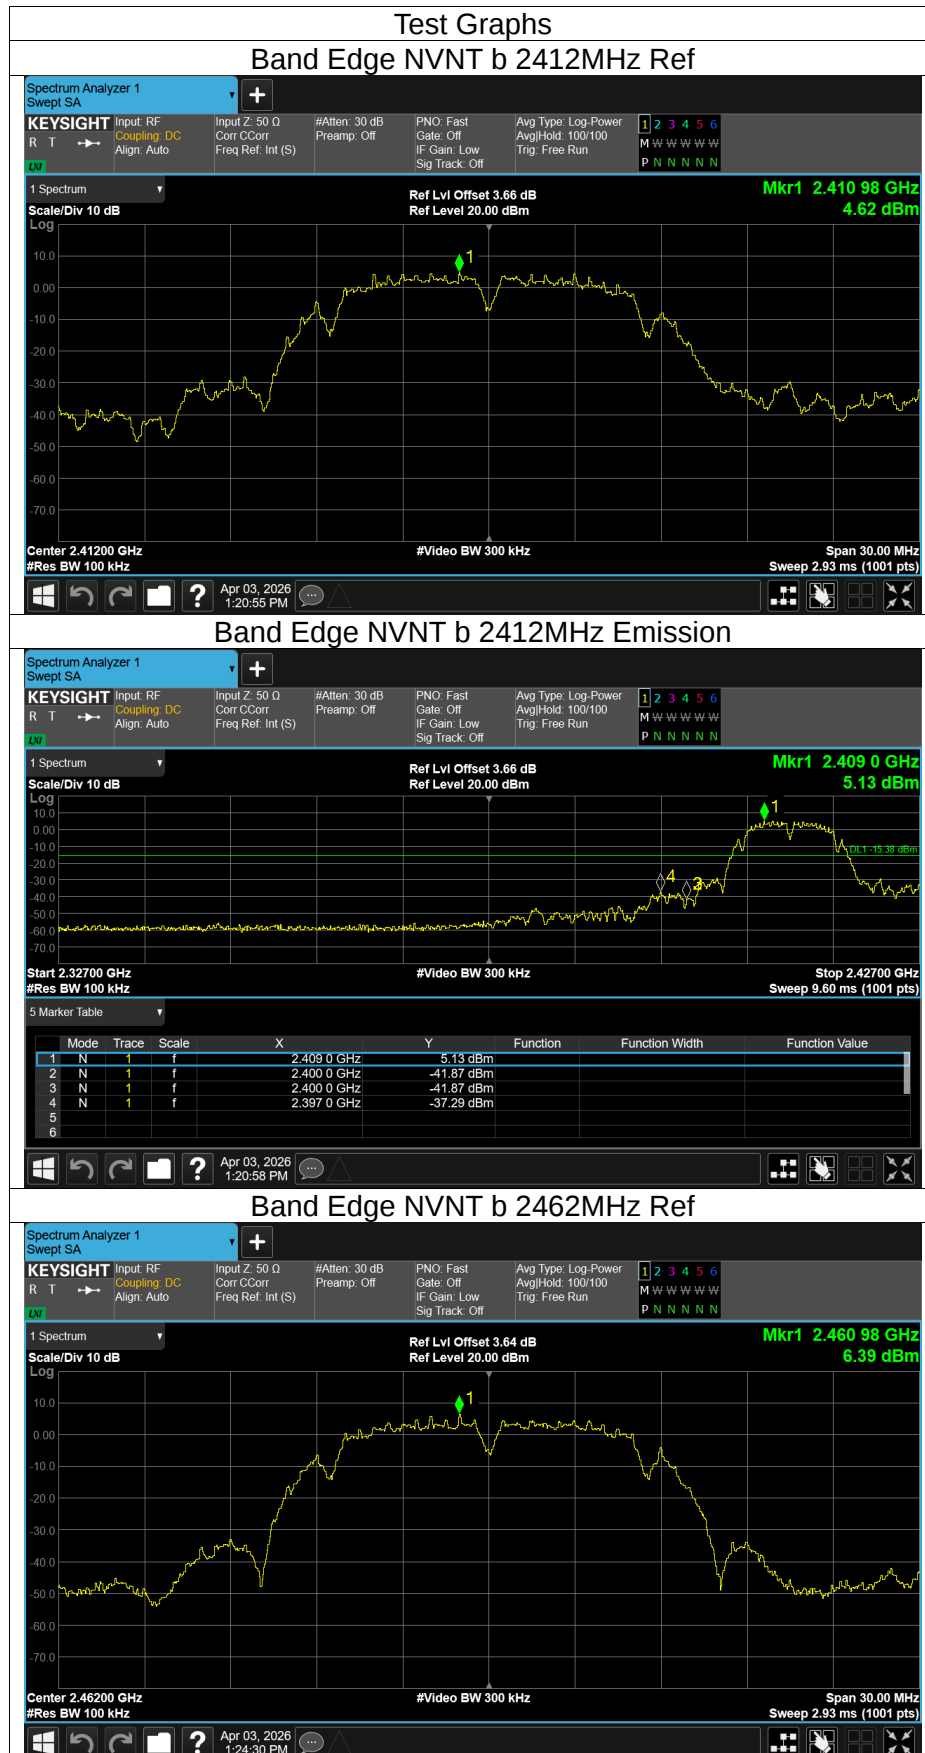
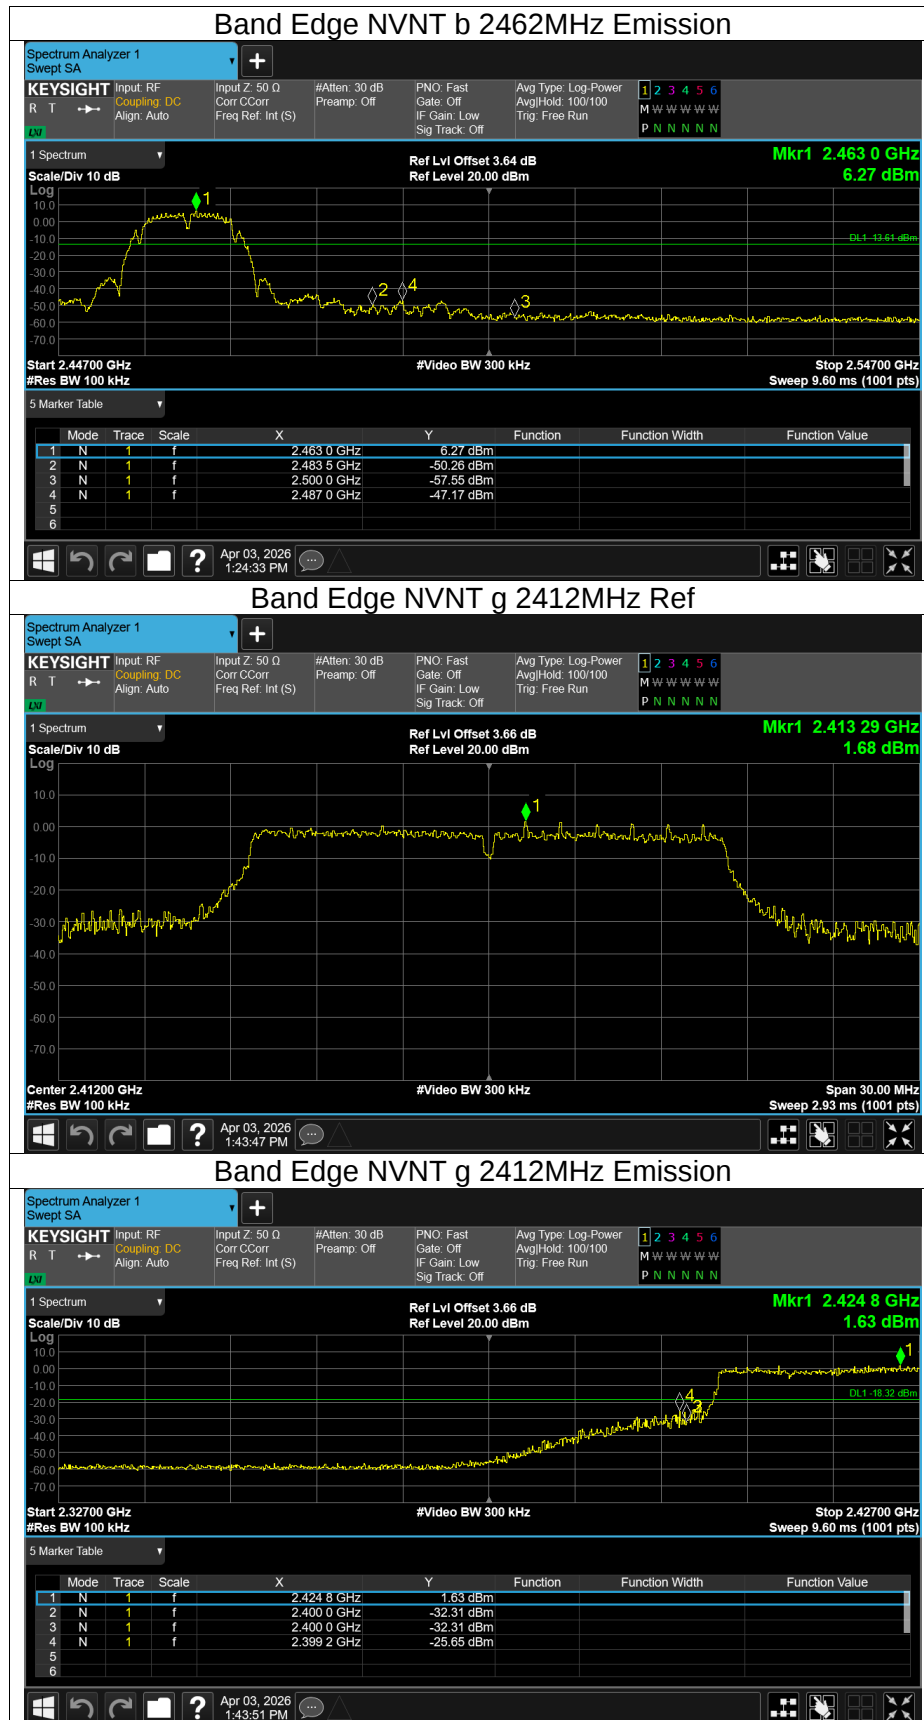
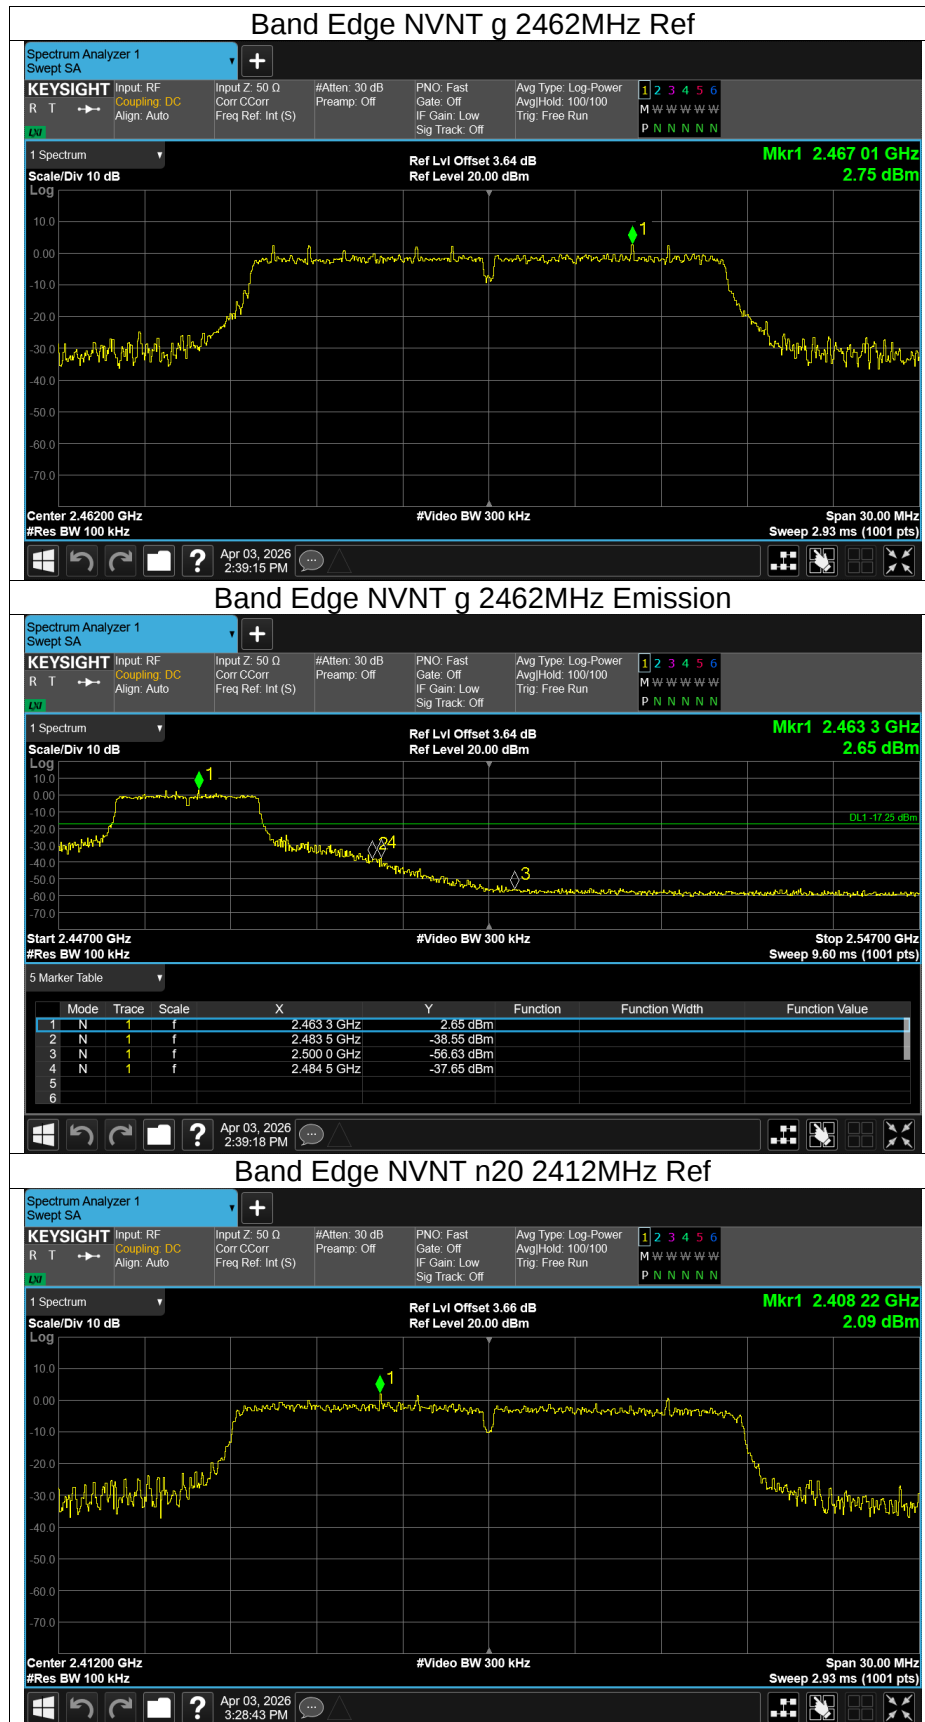
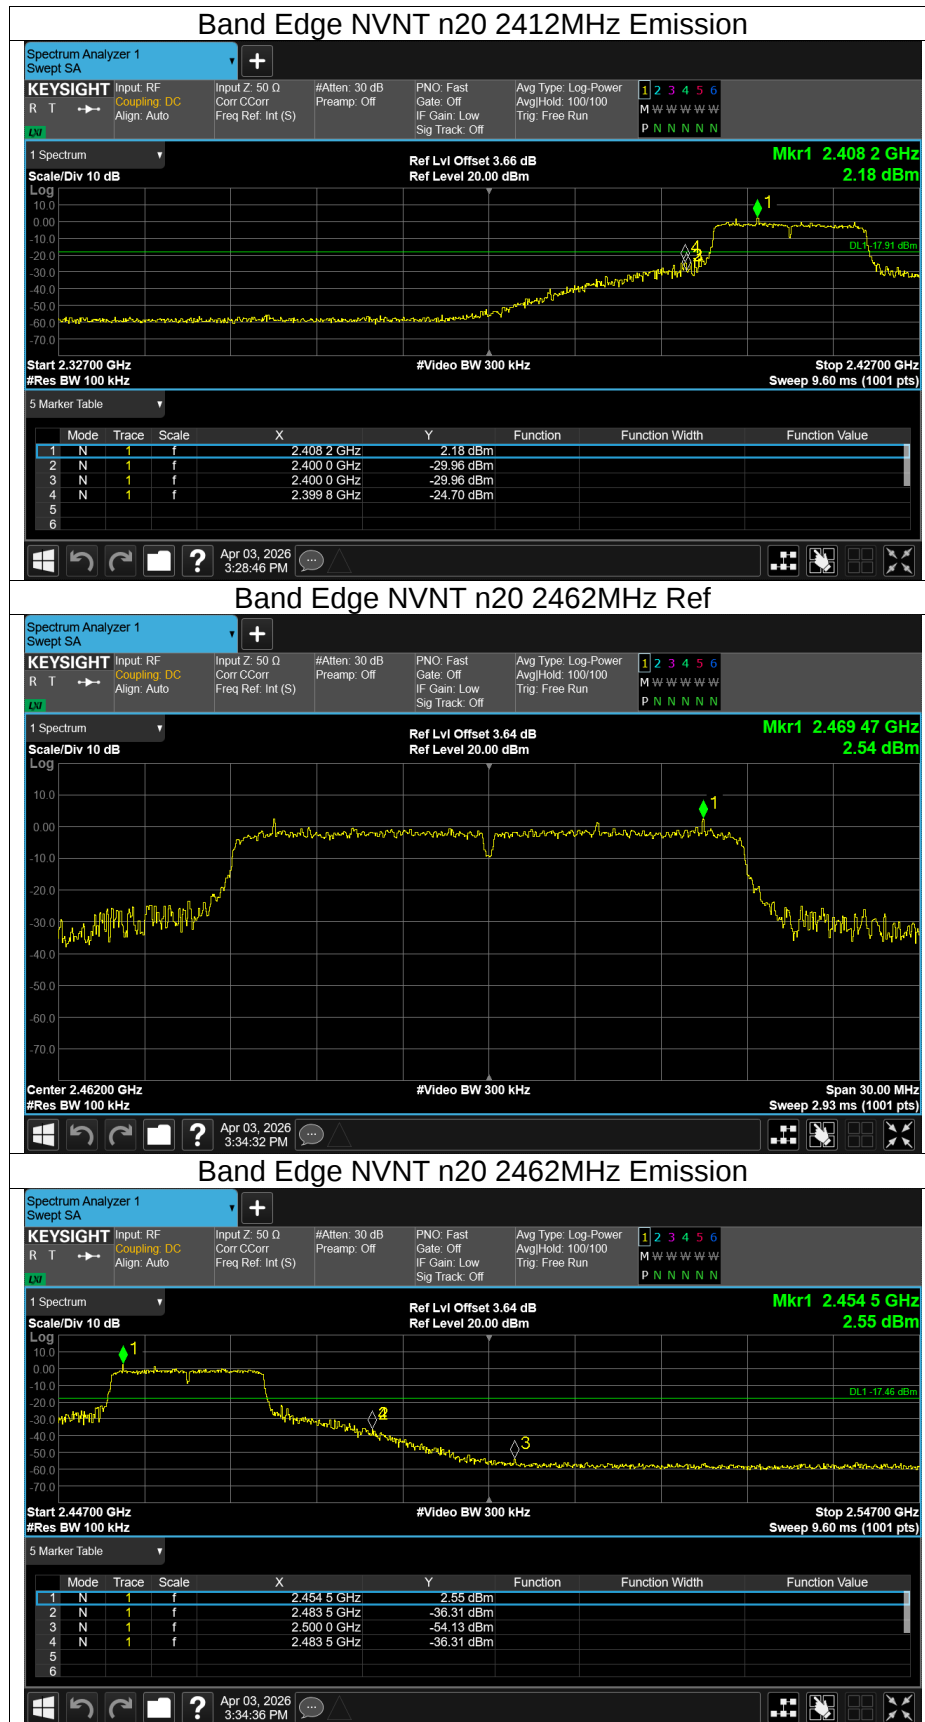
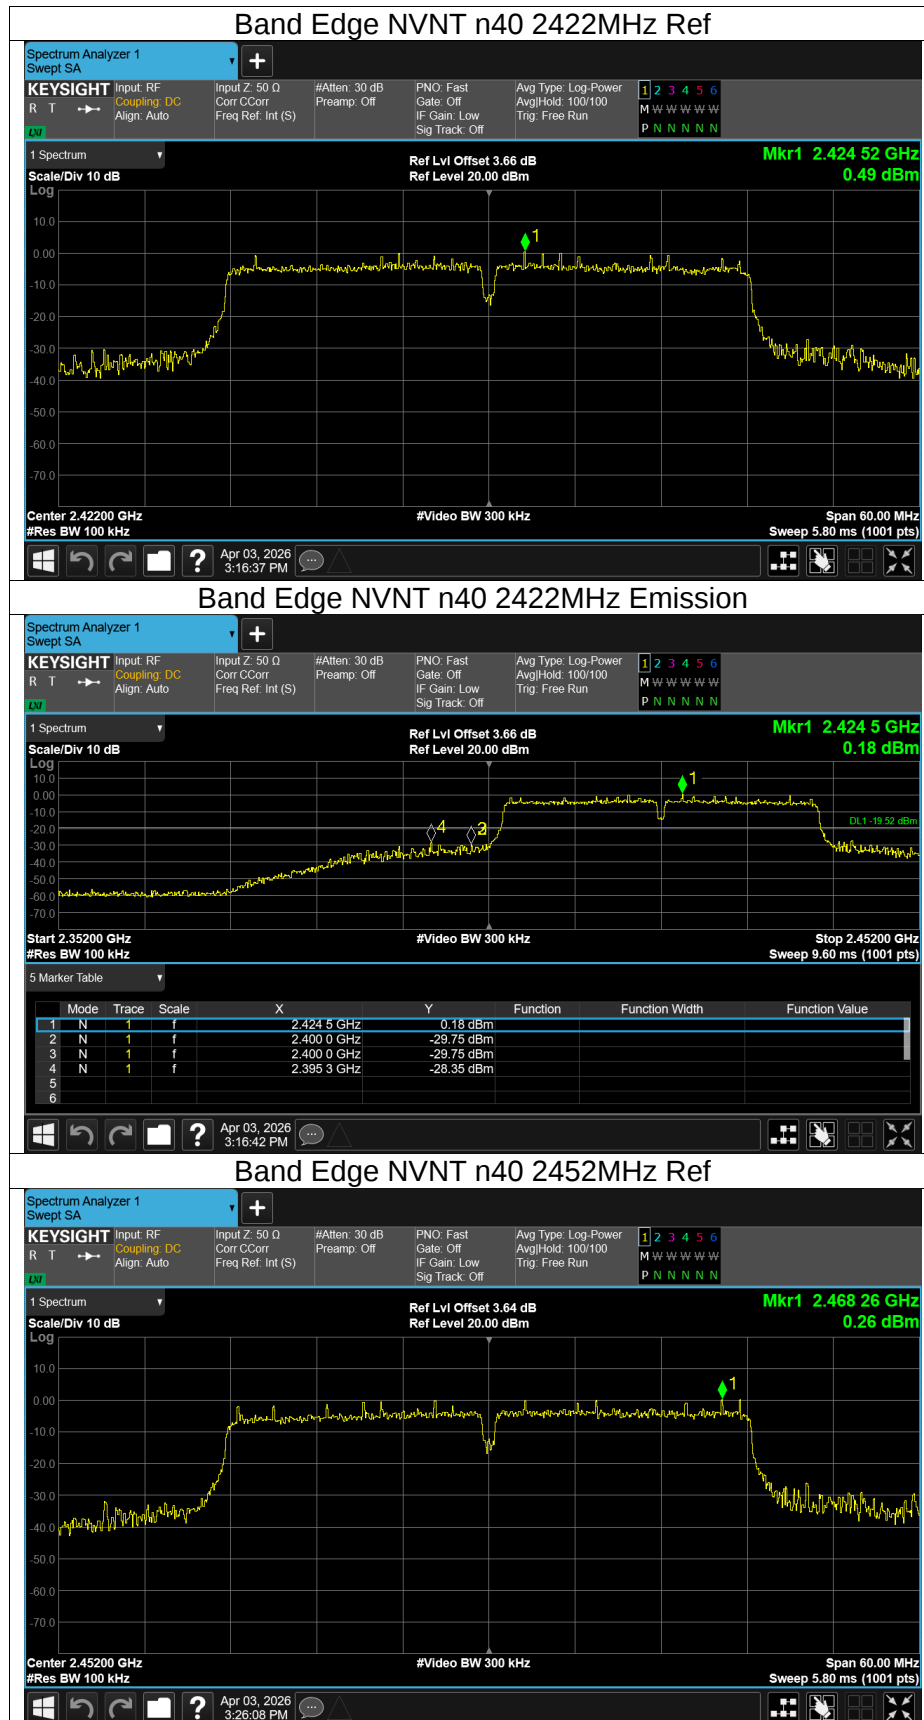
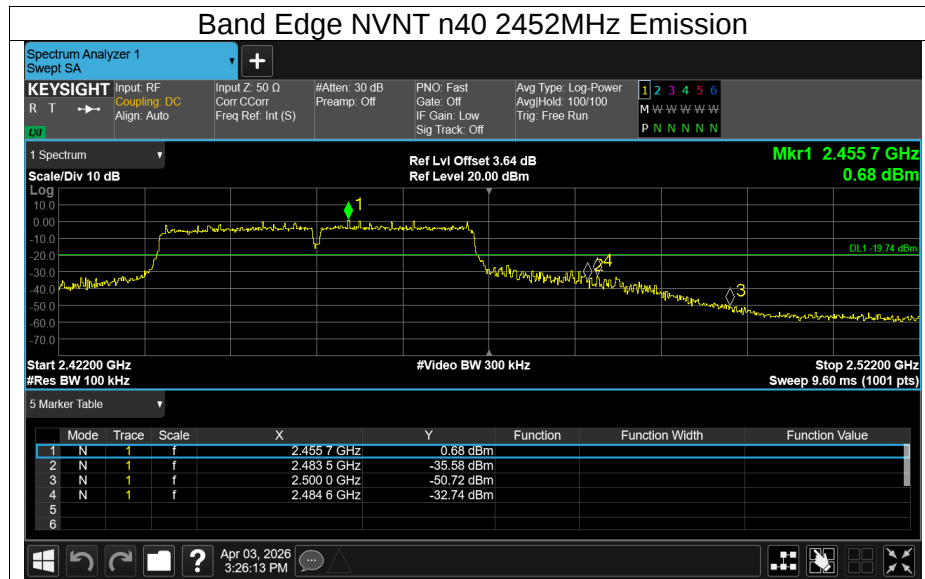
| Condition | Mode | Frequency (MHz) | Max Value (dBc) | Limit (dBc) | Verdict |
| NVNT | b | 2412 | -41.91 | -20 | Pass |
| NVNT | b | 2462 | -53.55 | -20 | Pass |
| NVNT | g | 2412 | -27.33 | -20 | Pass |
| NVNT | g | 2462 | -40.39 | -20 | Pass |
| NVNT | n20 | 2412 | -26.79 | -20 | Pass |
| NVNT | n20 | 2462 | -38.85 | -20 | Pass |
| NVNT | n40 | 2422 | -28.84 | -20 | Pass |
| NVNT | n40 | 2452 | -32.99 | -20 | Pass |

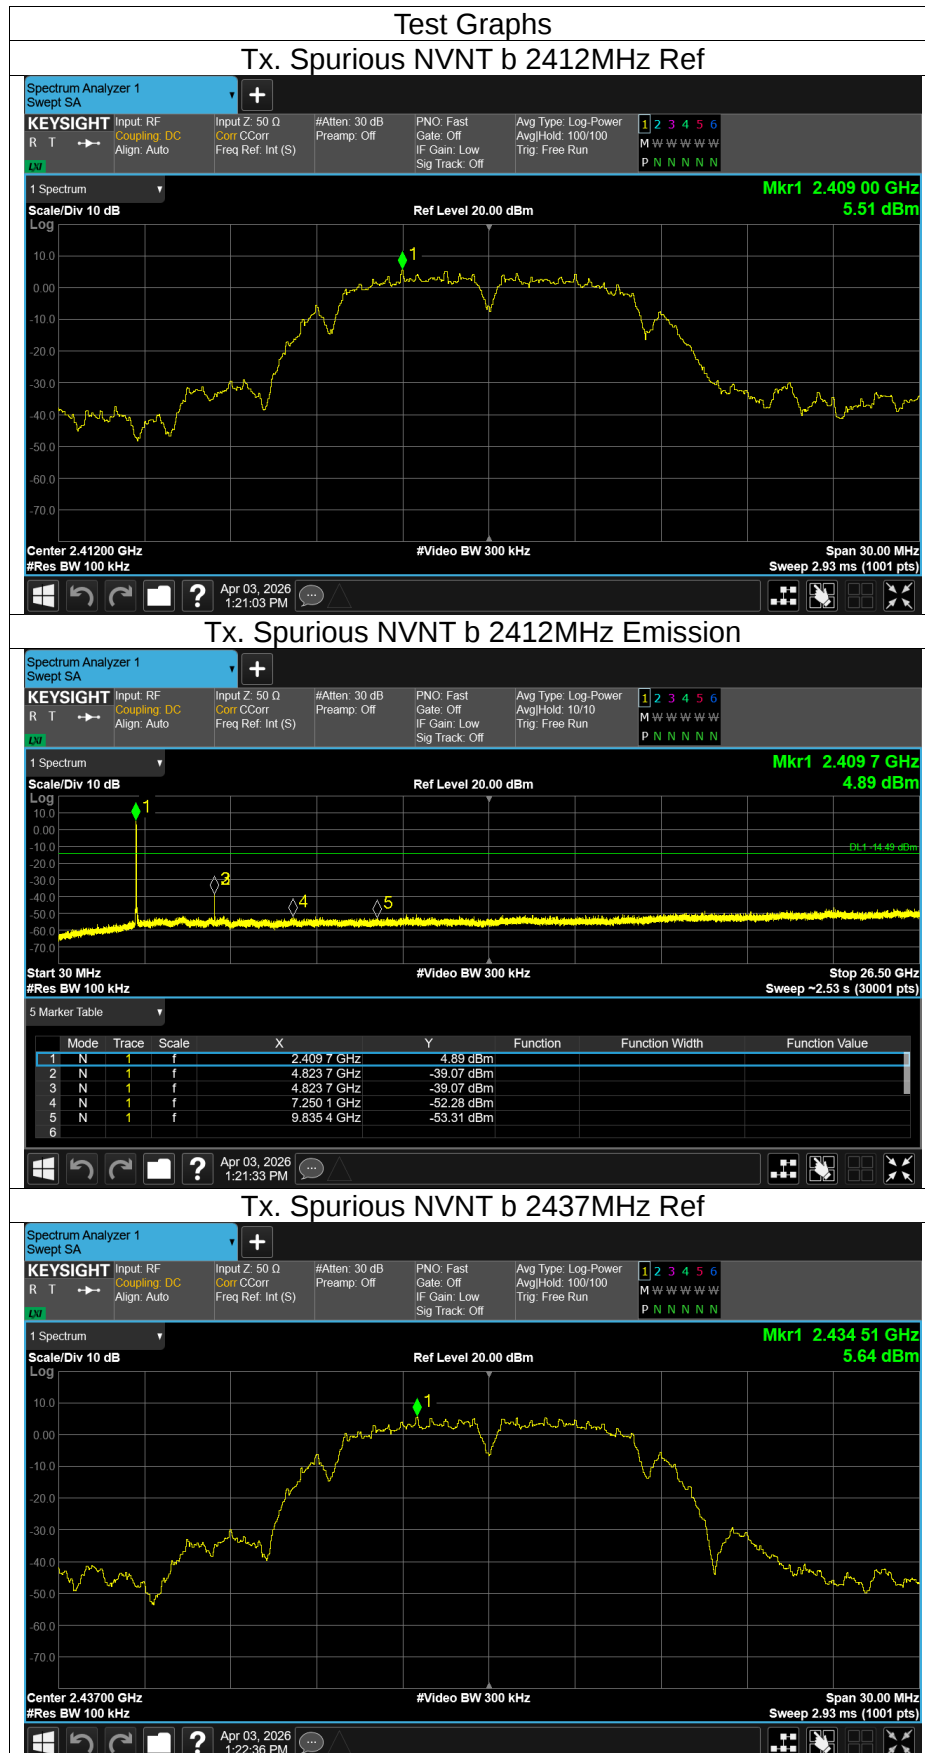
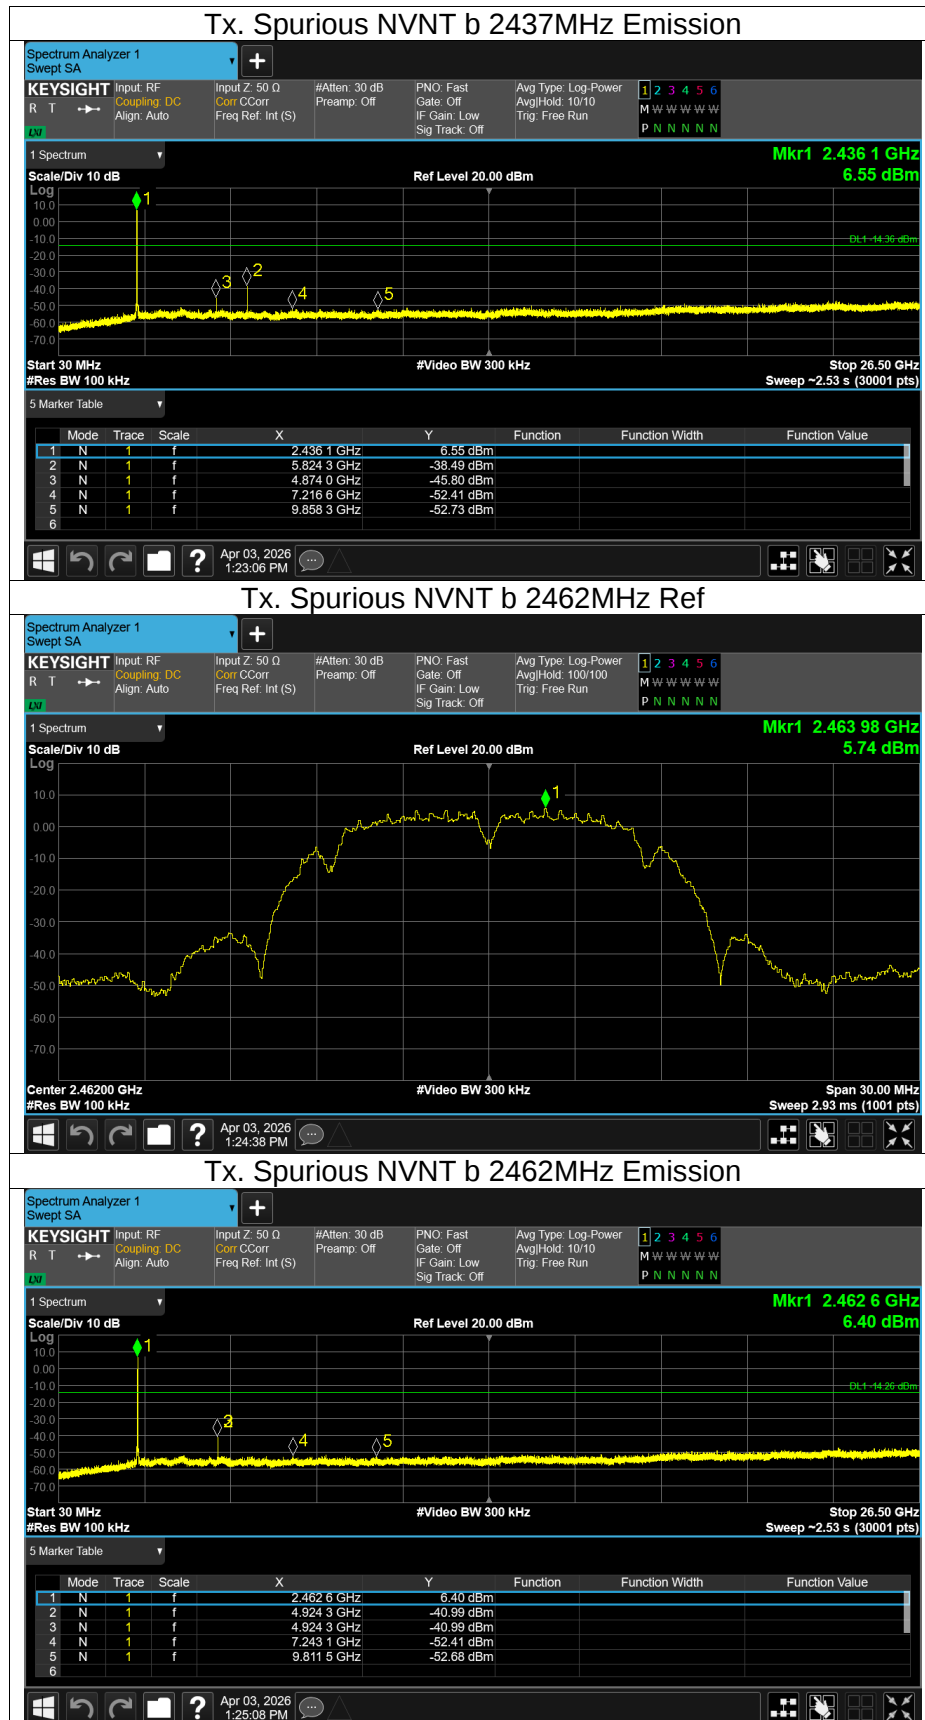
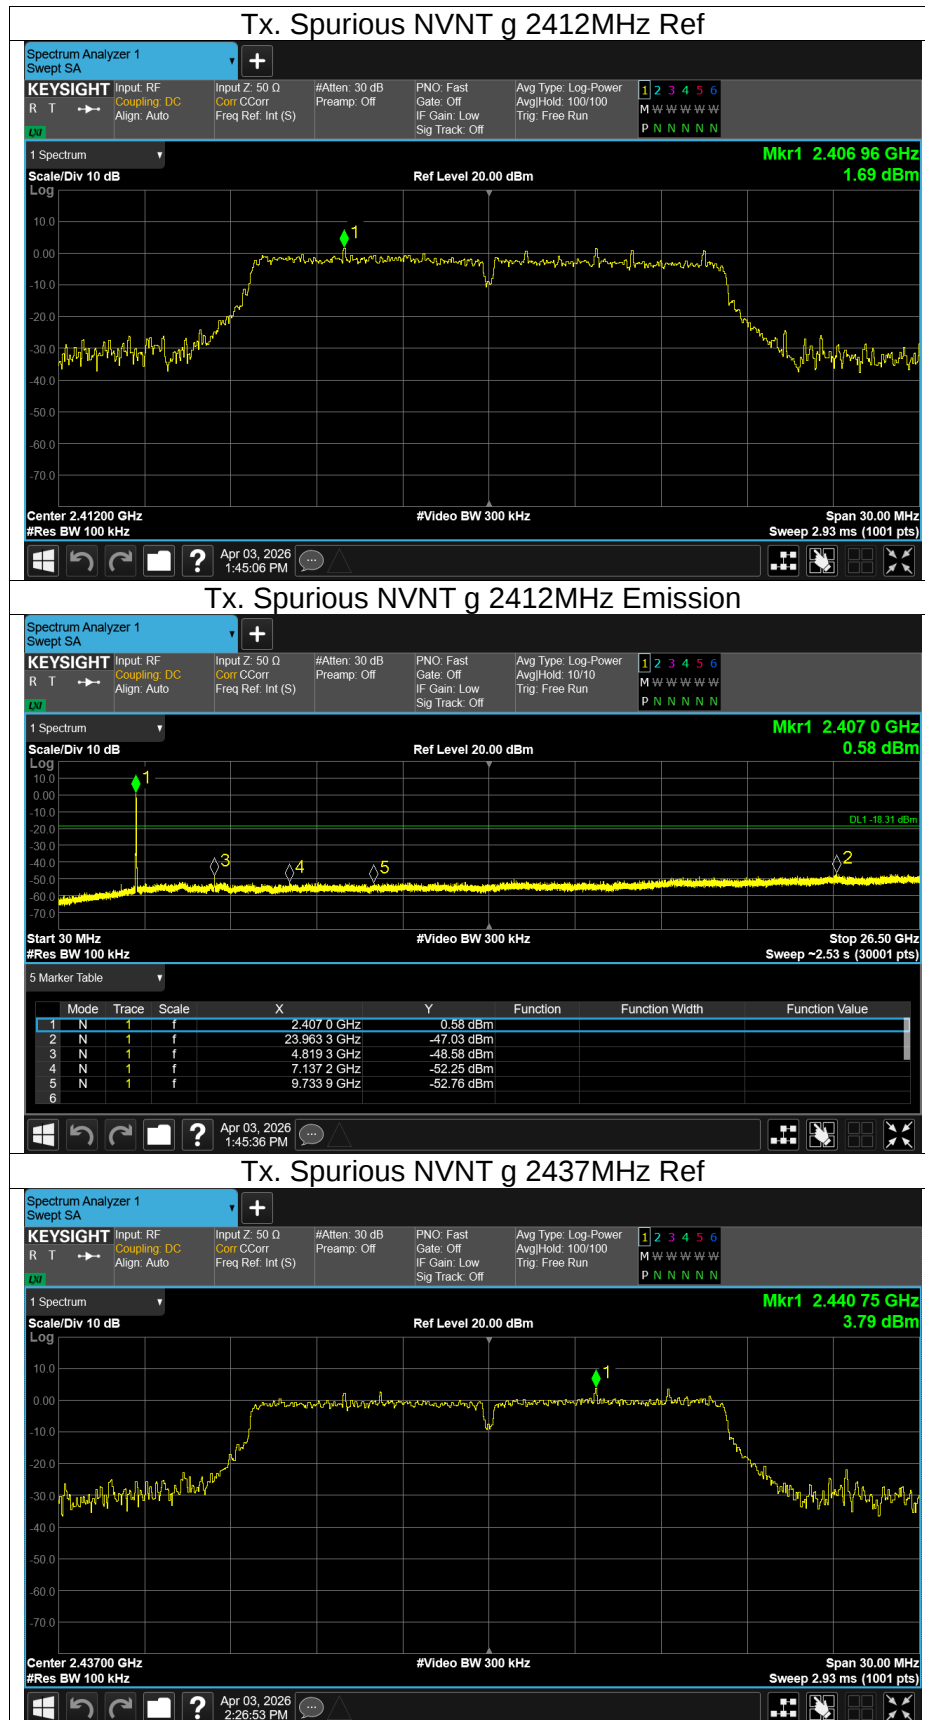
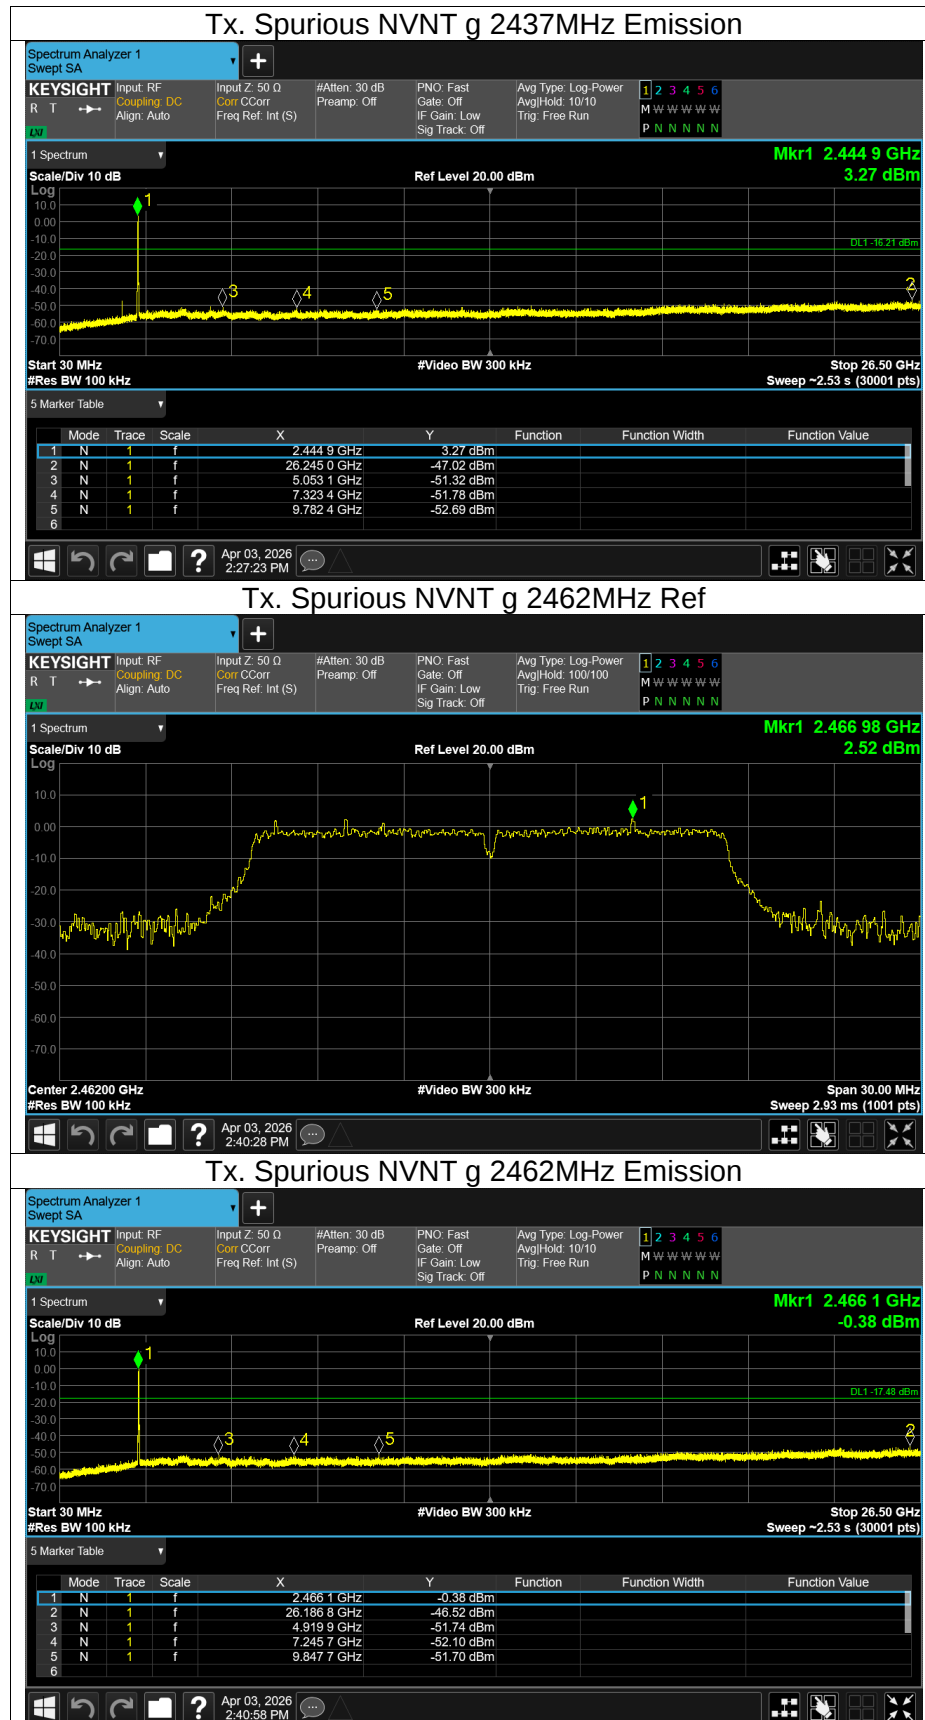
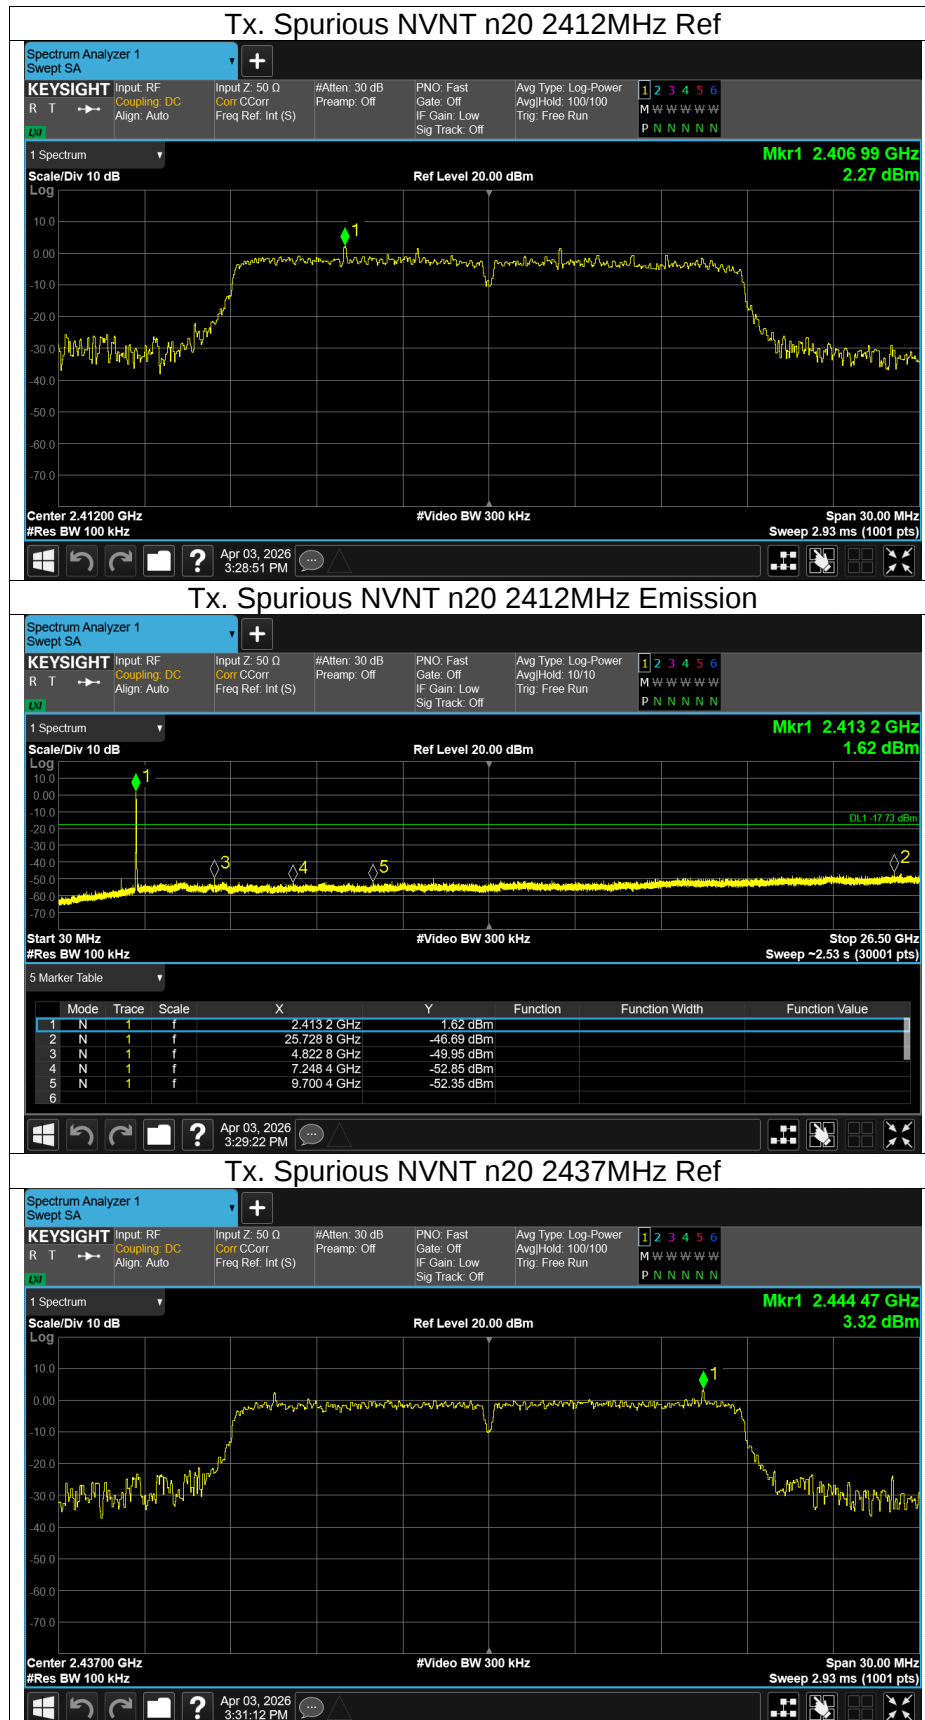
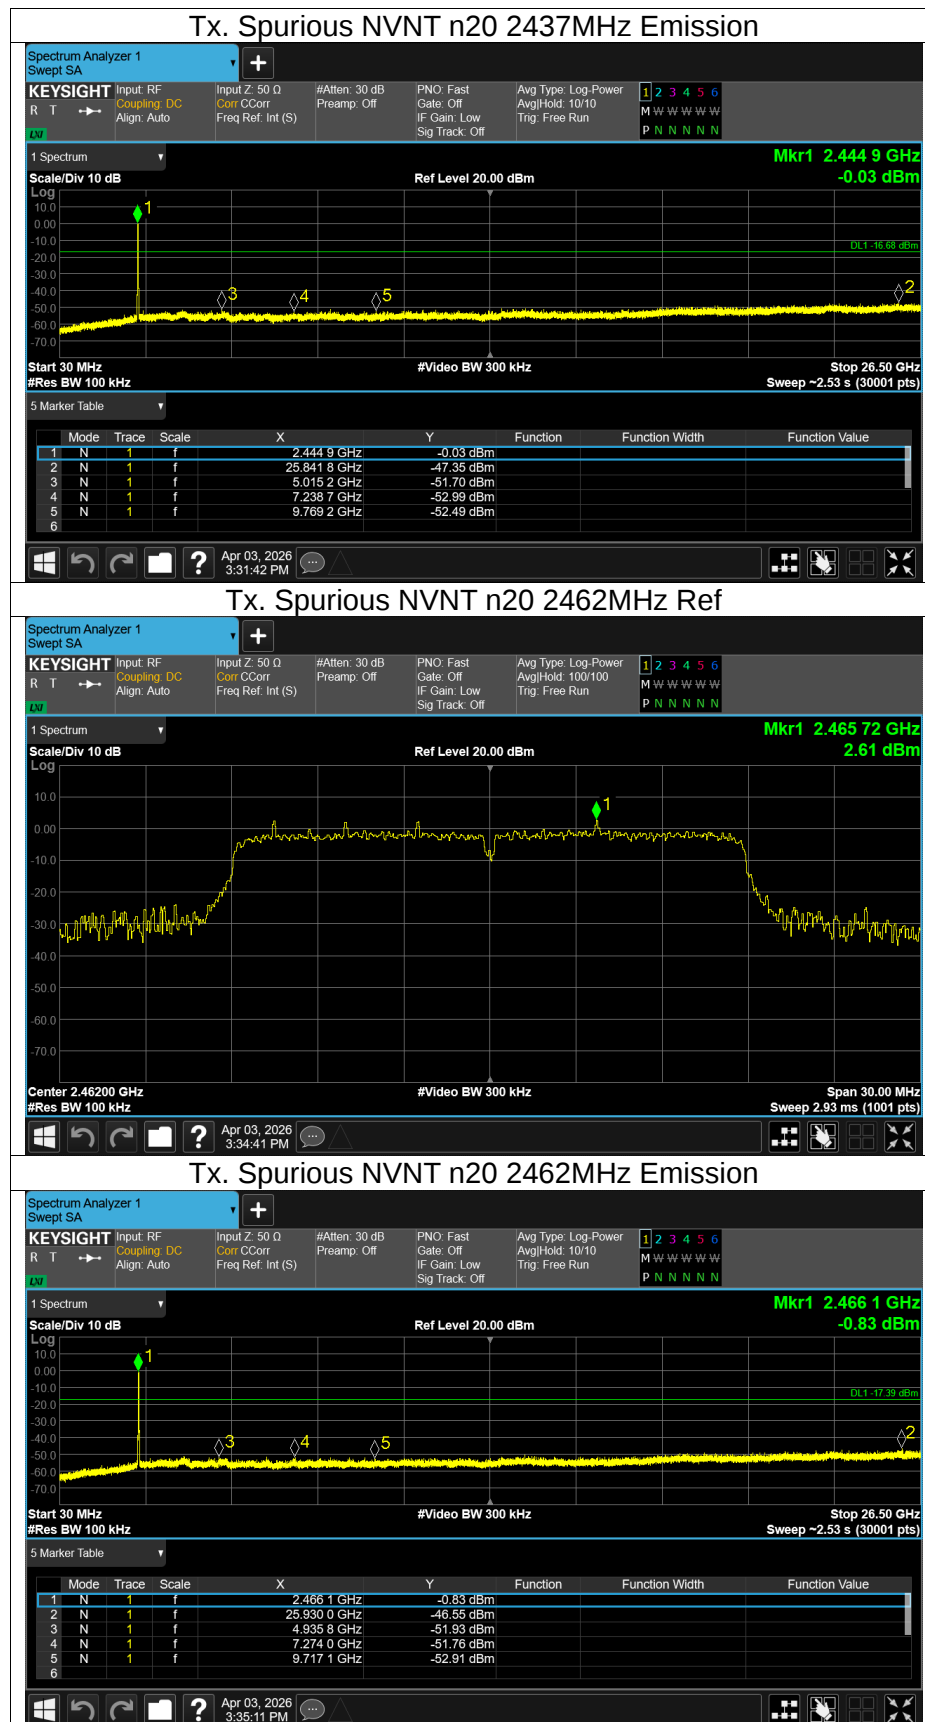
| Condition | Mode | Frequency (MHz) | Max Value (dBc) | Limit (dBc) | Verdict |
| NVNT | b | 2412 | -44.58 | -20 | Pass |
| NVNT | b | 2437 | -44.13 | -20 | Pass |
| NVNT | b | 2462 | -46.72 | -20 | Pass |
| NVNT | g | 2412 | -48.72 | -20 | Pass |
| NVNT | g | 2437 | -50.81 | -20 | Pass |
| NVNT | g | 2462 | -49.03 | -20 | Pass |
| NVNT | n20 | 2412 | -48.95 | -20 | Pass |
| NVNT | n20 | 2437 | -50.66 | -20 | Pass |
| NVNT | n20 | 2462 | -49.15 | -20 | Pass |
| NVNT | n40 | 2422 | -46.77 | -20 | Pass |
| NVNT | n40 | 2437 | -47.05 | -20 | Pass |
| NVNT | n40 | 2452 | -47.59 | -20 | Pass |
